# Water Resource Protection Plan

WDID# - 1B170595CHUM

APN 217-244-007; 217-251-003; 217-244-004; 217-225-007

**Timberland Resource Consultants**

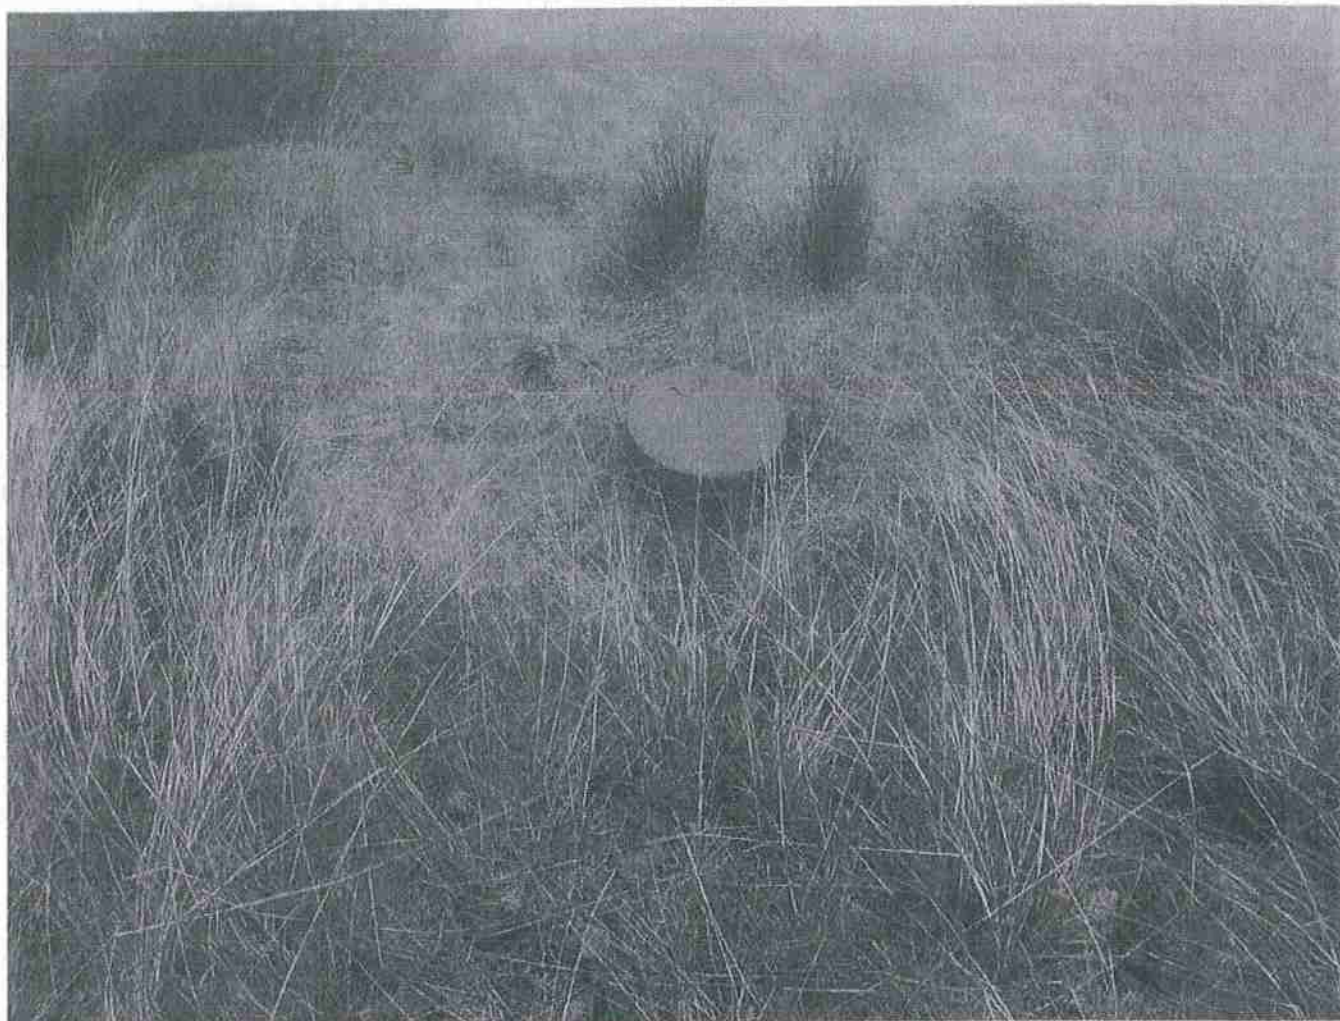
**Site 47:** Spring point of diversion, Utilized for domestic use only. Shallow cement cistern collects a spring in this location.

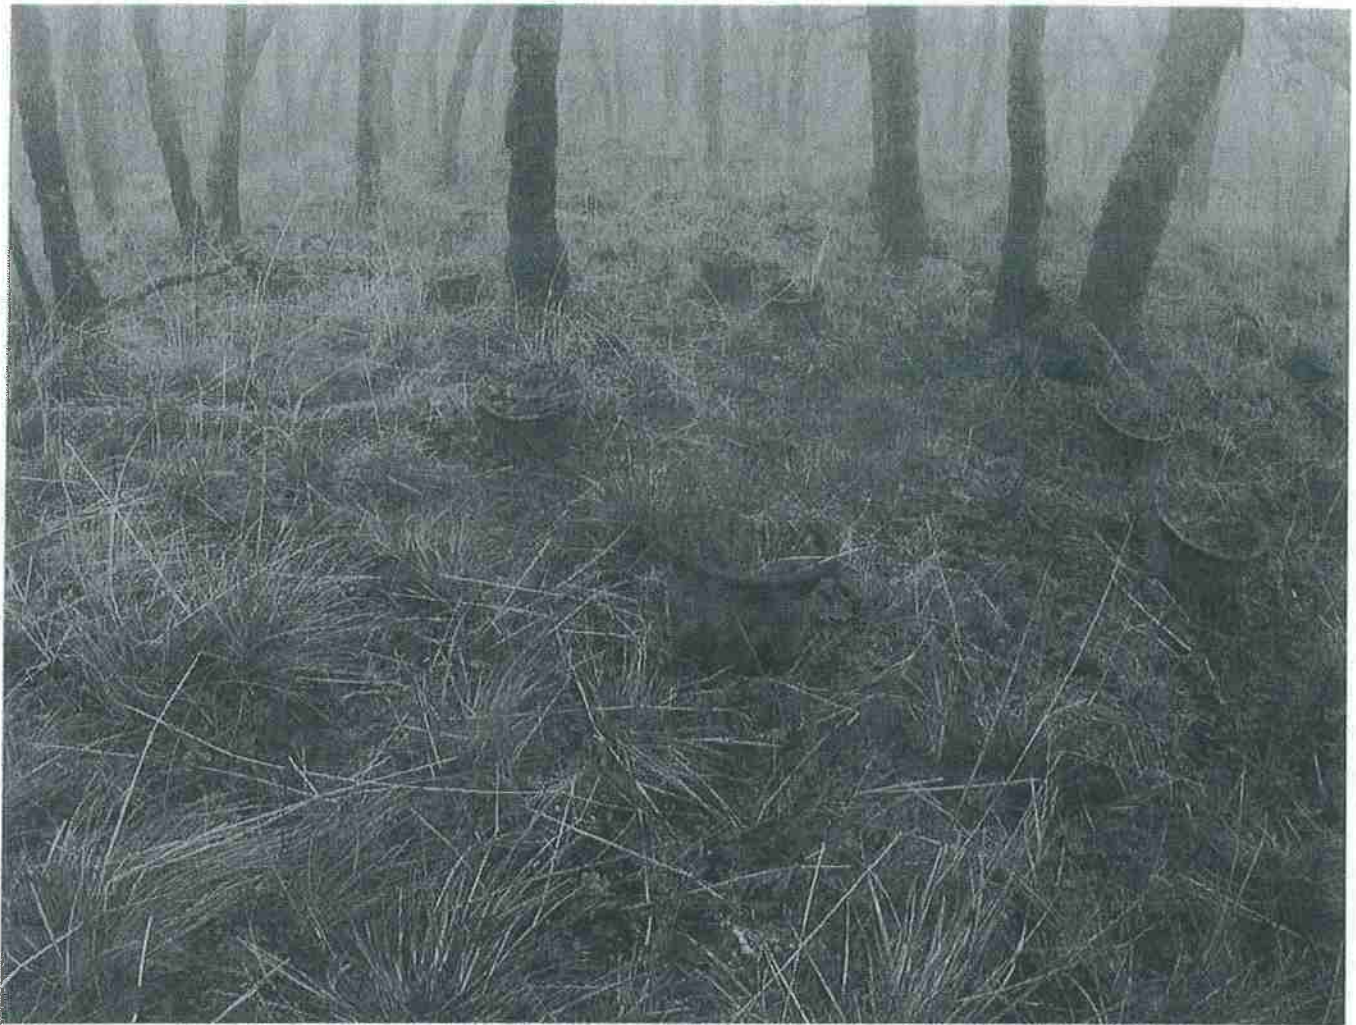
**Legacy cultivation area:** Approximately 2-acre area with approximately 200-300, 3-gallon pots situated throughout. This area has not been used in more than a decade.

The legacy cultivation area is located between two watercourses. This area is situated between a Class II 120ft to the north and a Class III 110ft to the southwest. During the removal of cultivation related waste, it should be noted that spent soil shall be disposed of in a one location outside the preferred riparian buffer of 200ft. All pots shall be removed and disposed of at a waste disposal facility or collected in an area that will not be mobilized into a watercourse.

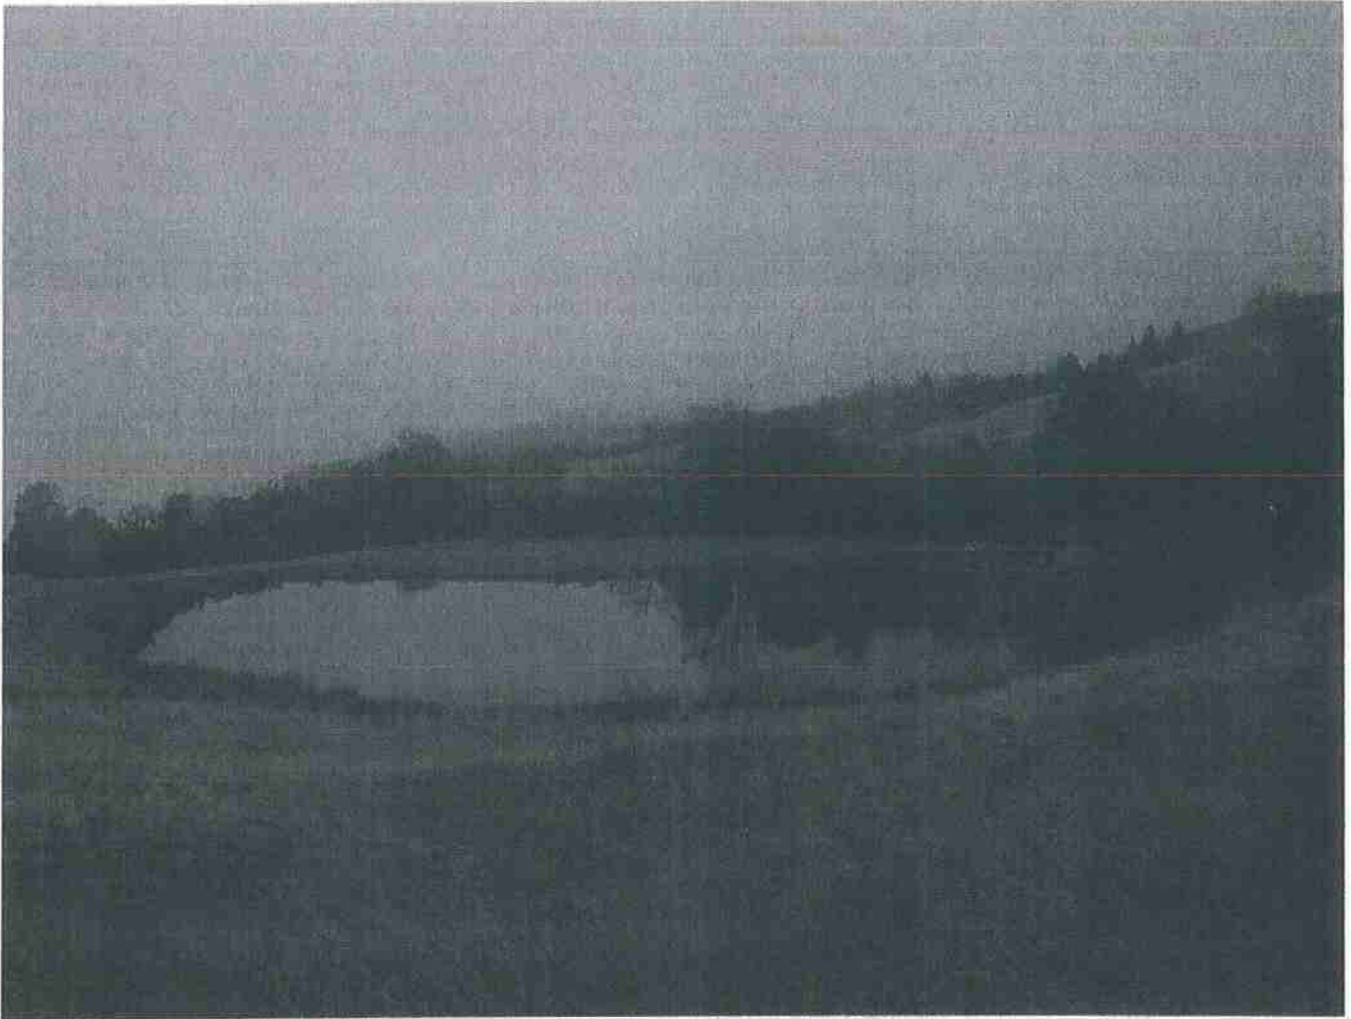
**Pond A:** Off stream pond that is used for agricultural irrigation water.

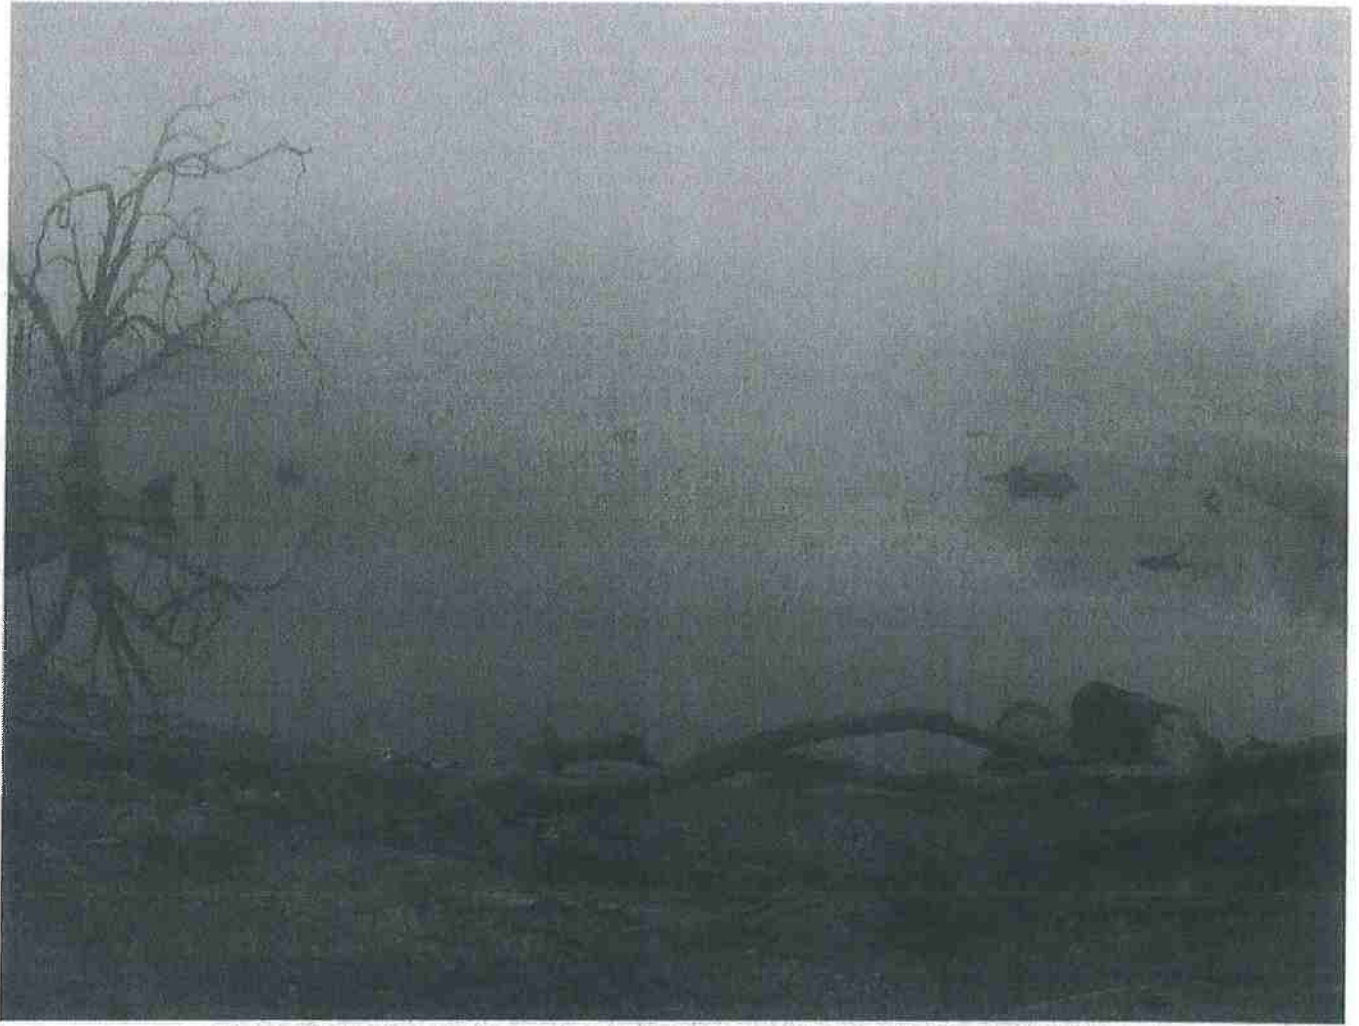
**Pond B:** On stream pond. Used for aesthetics and fire prevention.

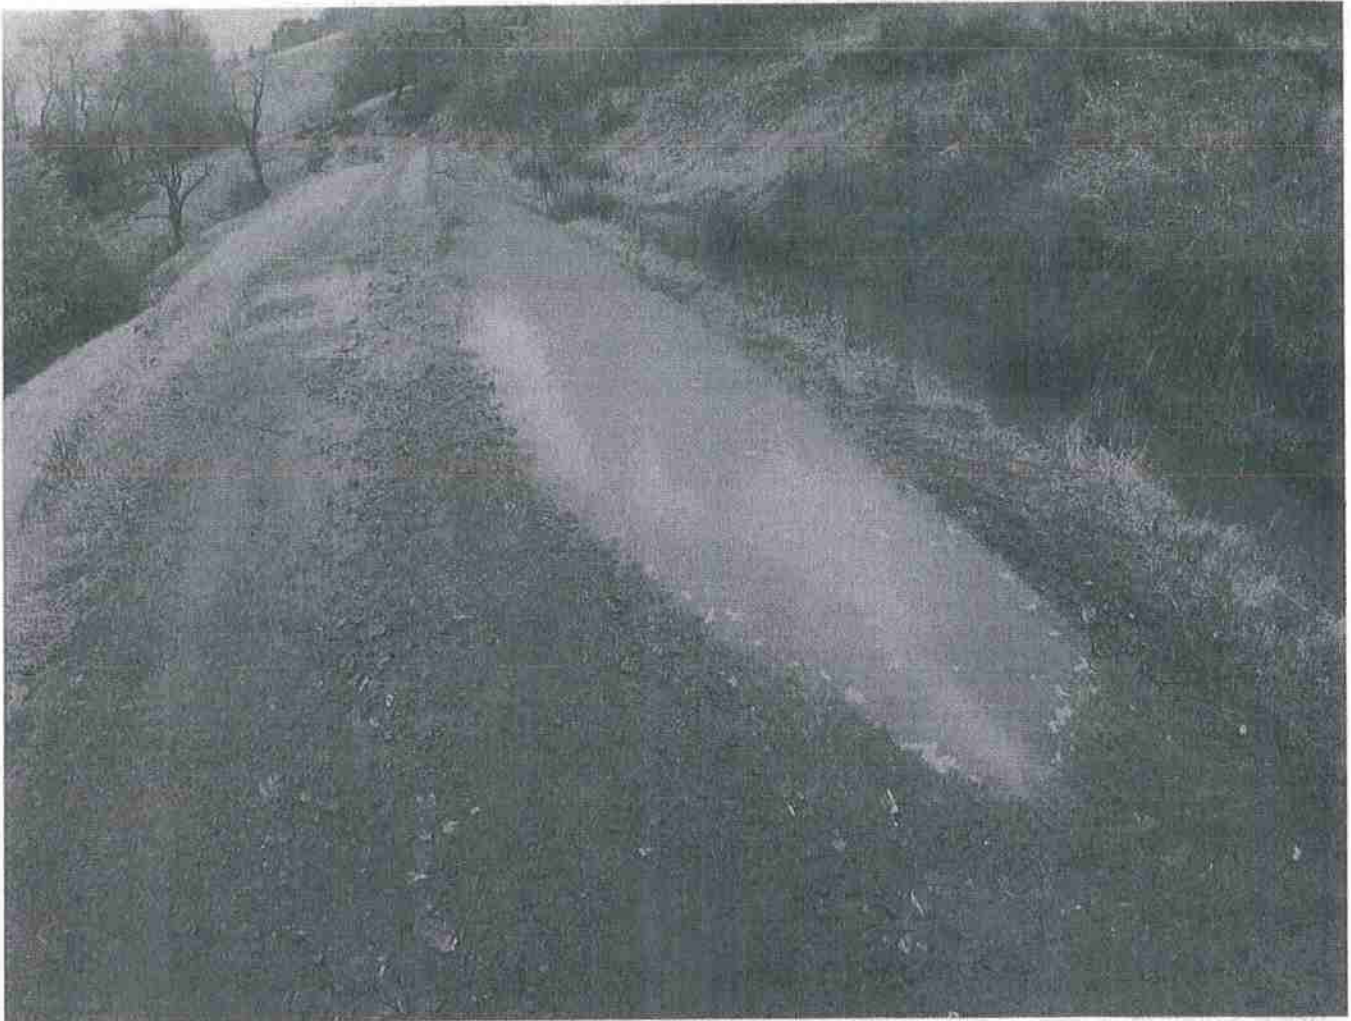
**Site 01:** Ponding water on road, it is being recommended to build up the road surface to contain surface water from a bank seep.

Unique Point	Lat-Long NAD 83	Road Type	Mitigation Planned	Monitor	1600	Standard Conditions	Treatment Priority	Date Completed
1	-123.601592 40.306187	Permanent	X	X	X	A.2.	Prior to 10/15/19 pending the approval of any required permits	
Current Condition: Class III watercourse crossing consisting of a 12" metal culvert. Culvert is too short with surface rust observed at the time of inspection. Culvert was deemed to be undersized for 100 year storm events.						Prescribed Action: Install an 18" culvert in this location per the specifications of the attached BMP's.		
2	-123.601345 40.30706	Permanent	X	X	X	A.2.	Interim measures immediately; Mitigation measures prior to 10/15/19 pending the approval of any required permits	
Current Condition: Class III watercourse crossing consisting of a 12" metal culvert. Culvert inlet was buried and surface rust was observed at the time of inspection. Culvert was deemed to be undersized for 100 year storm events.						Interim measure: The inlet of the culvert shall be cleared of obstructions and perched sediment. Prescribed Action: Install an 18" culvert in this location per the specifications of the attached BMP's.

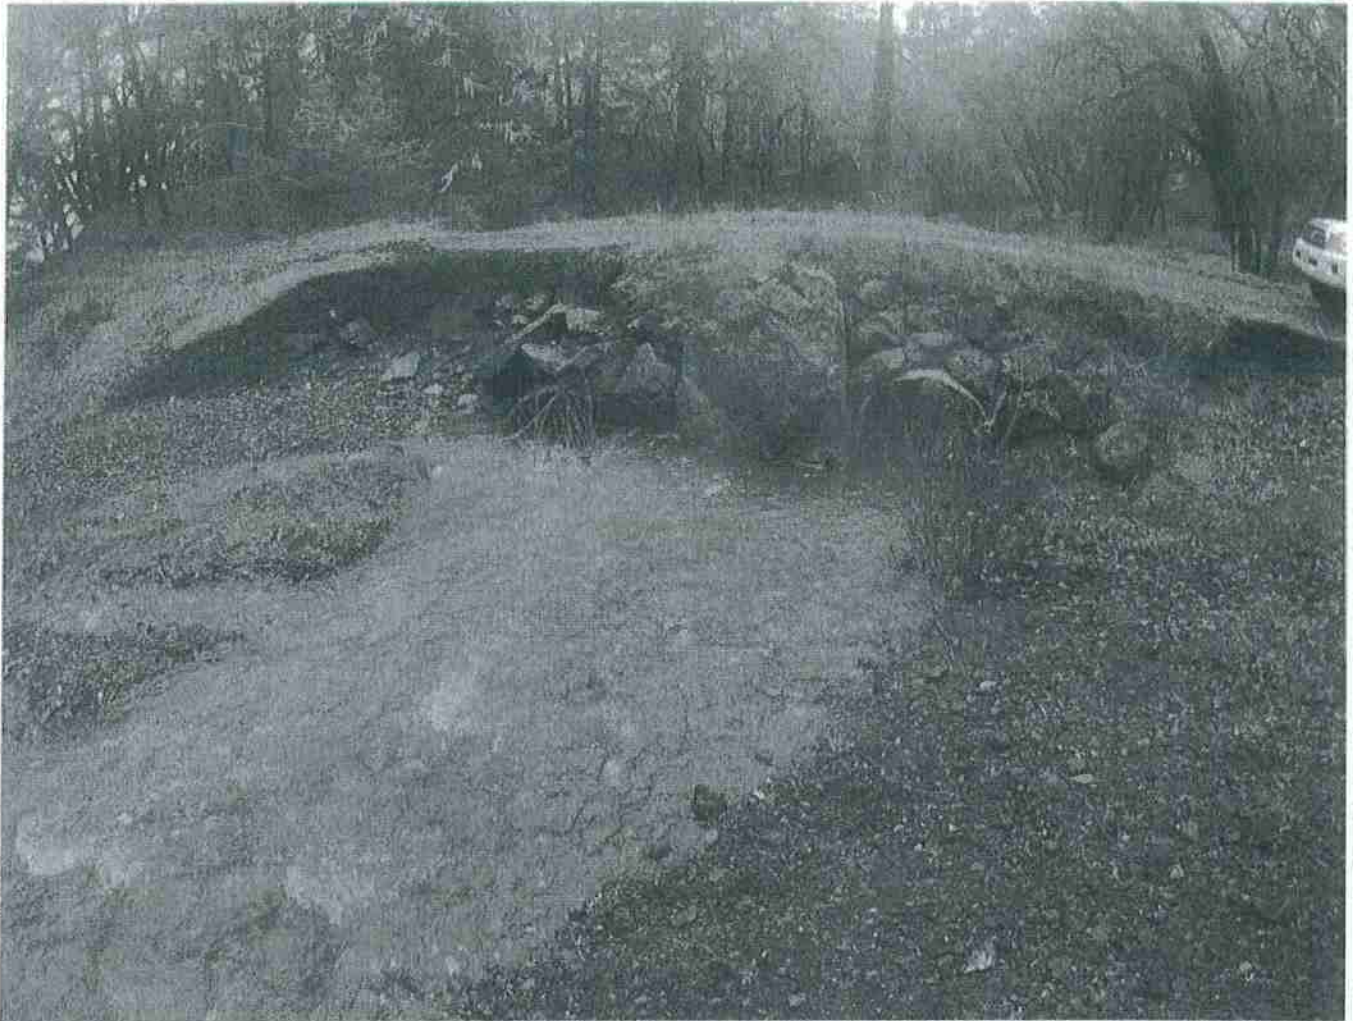
**Site 50:** Double barrel Class II watercourse crossing, consisting of a 48" metal culvert and a 48".  
See mitigation report for details.

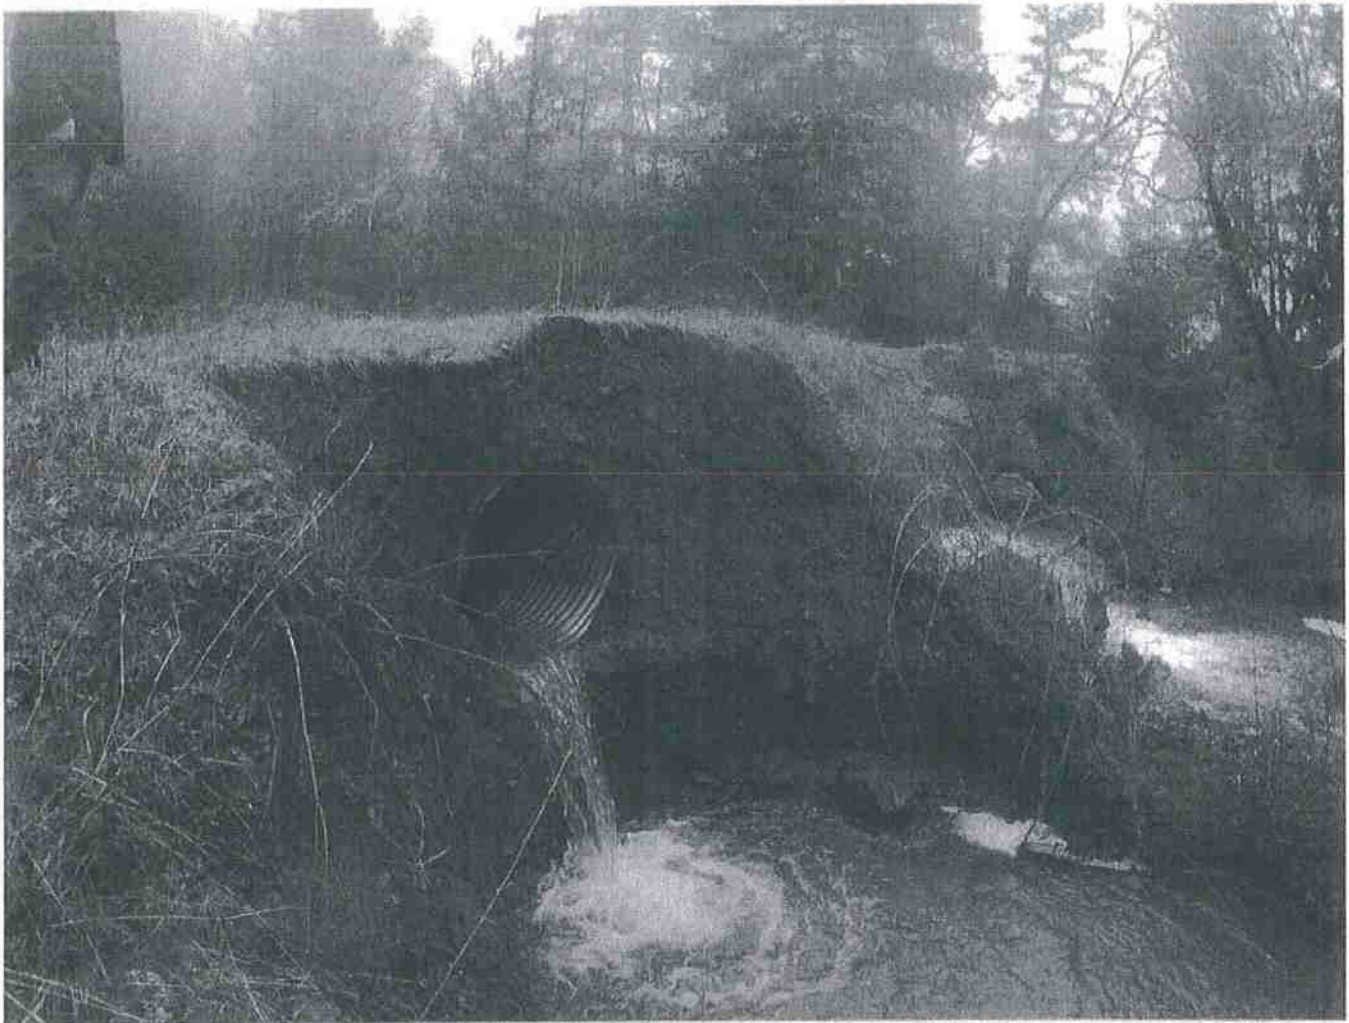
**Site 50** – Alternate view, this watercourse crossing is not functioning adequately due to the culverts being inadequately sized and too short. Additionally, the inlet of the metal culvert is crushed and obstructed. See mitigation report for further details.
