Reference: 018181

June 11, 2019

Subject: Engineering Geologic Evaluation and Soils Reporting for Existing and Proposed Improvements, APN's 216-081-013, 216-135-015, 216-136-004, and 216-135-008; Harris, Humboldt County, California

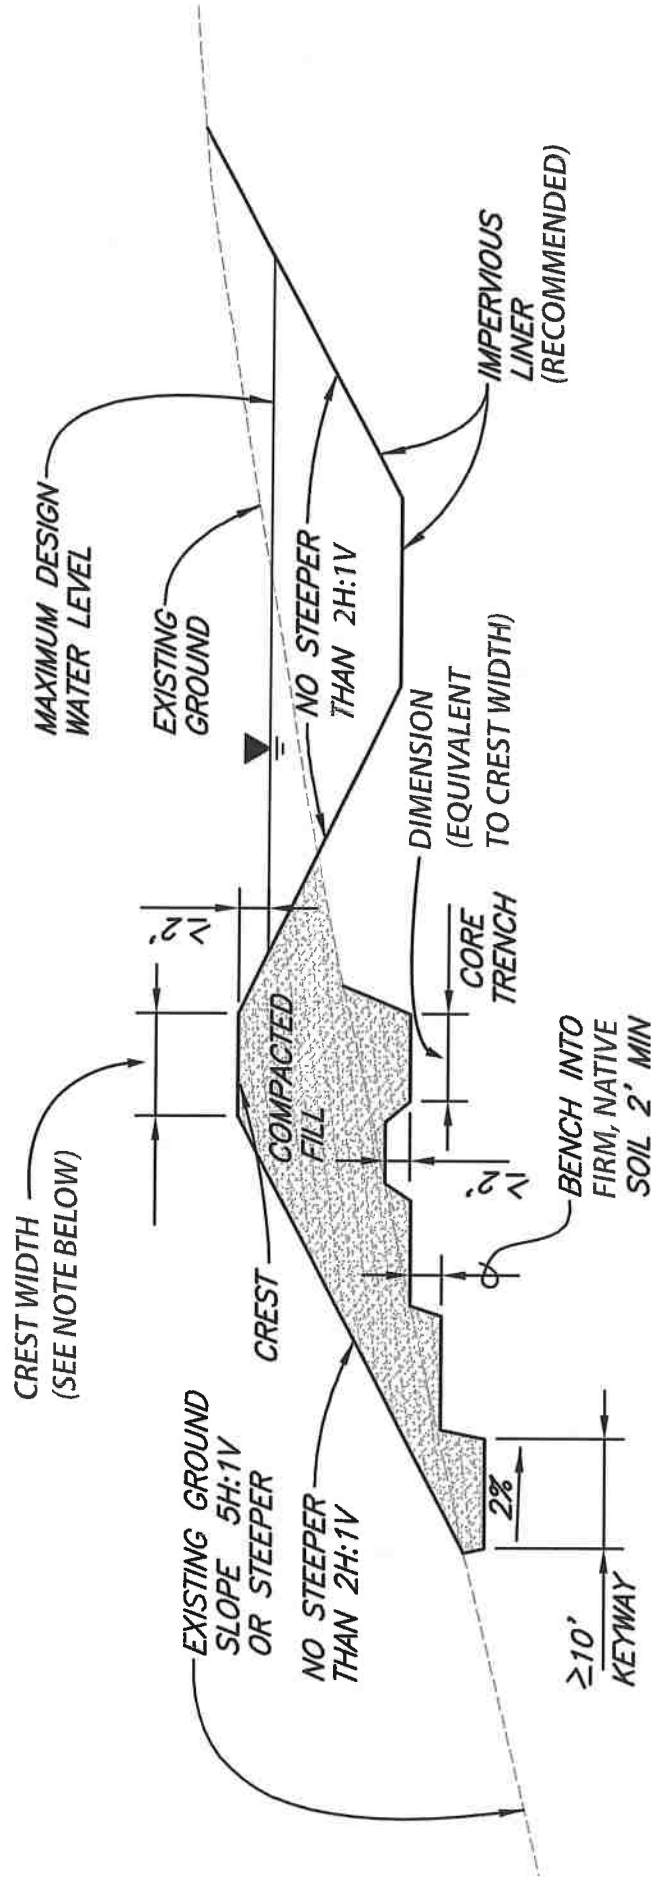
Figure 3

NOTE: THIS SCHEMATIC APPLIES TO EMBANKMENTS ON SLOPES OF 5H:1V OR STEEPER
CREST WIDTH: FOR EMBANKMENTS < 10 FEET HIGH, CREST WIDTH SHOULD BE A MINIMUM OF 6 FEET; FOR TALLER EMBANKMENTS, CREST WIDTH SHOULD BE 10 FEET

- Design the pond such that the volume of material from cuts is, at a minimum, equal to the volume of material needed for fills. If possible, design the pond such that the volume of material from cuts is approximately 10 percent greater than the volume of material needed for fills.
- The exterior and interior slopes of the pond embankments should be inclined no steeper than 2H:1V (see conceptual embankment section in Figure 3).

- The crest of pond embankments should be at least 2 feet (freeboard) above the maximum pond water level to minimize the potential for breaching during a seismic event.

- The crest of pond embankments should be at least 6 feet wide for embankments less than 10 feet high; taller embankments should have crest widths of at least 10 feet.

- A core trench at least 10 feet wide should be excavated beneath the axis of dam embankments. The trench should extend at least 2 feet vertically into firm, native soils.
