Project Inspection Report

APN: 316-071-004

Notification #1600-2017-0319-R1

October 20, 2022

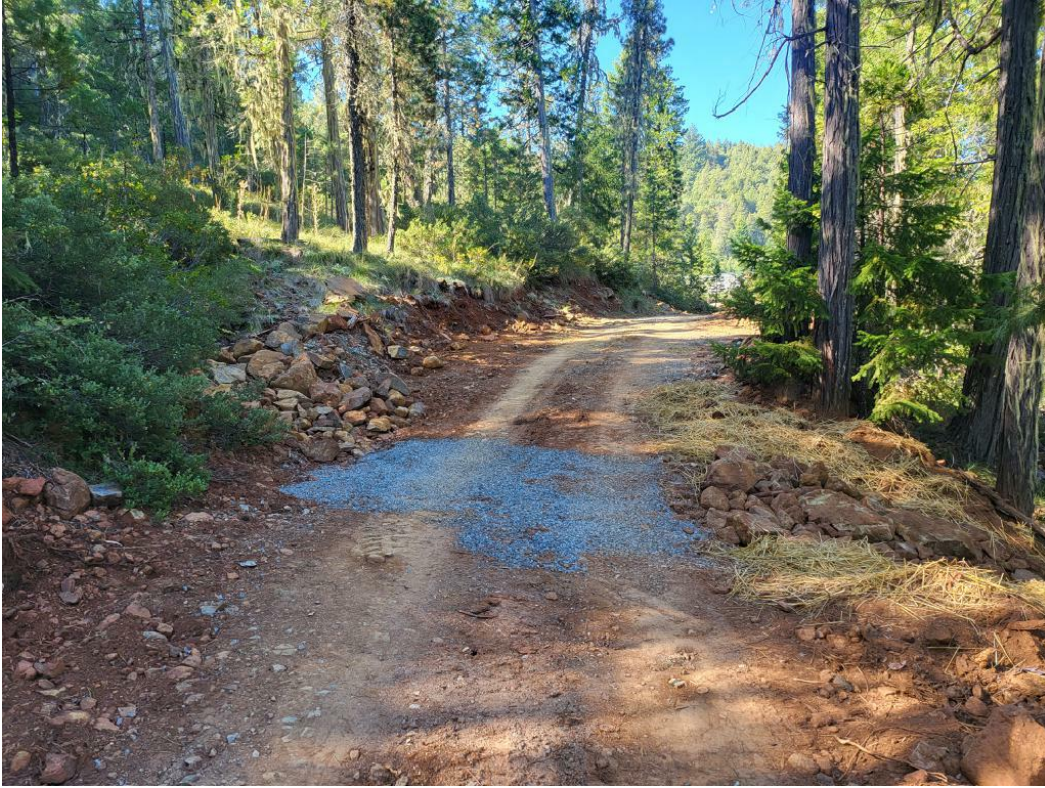
Status at 10/5 Site Visit: Armored ford has been properly installed.

Figure 1: MP2 Installed Rocked Ford.

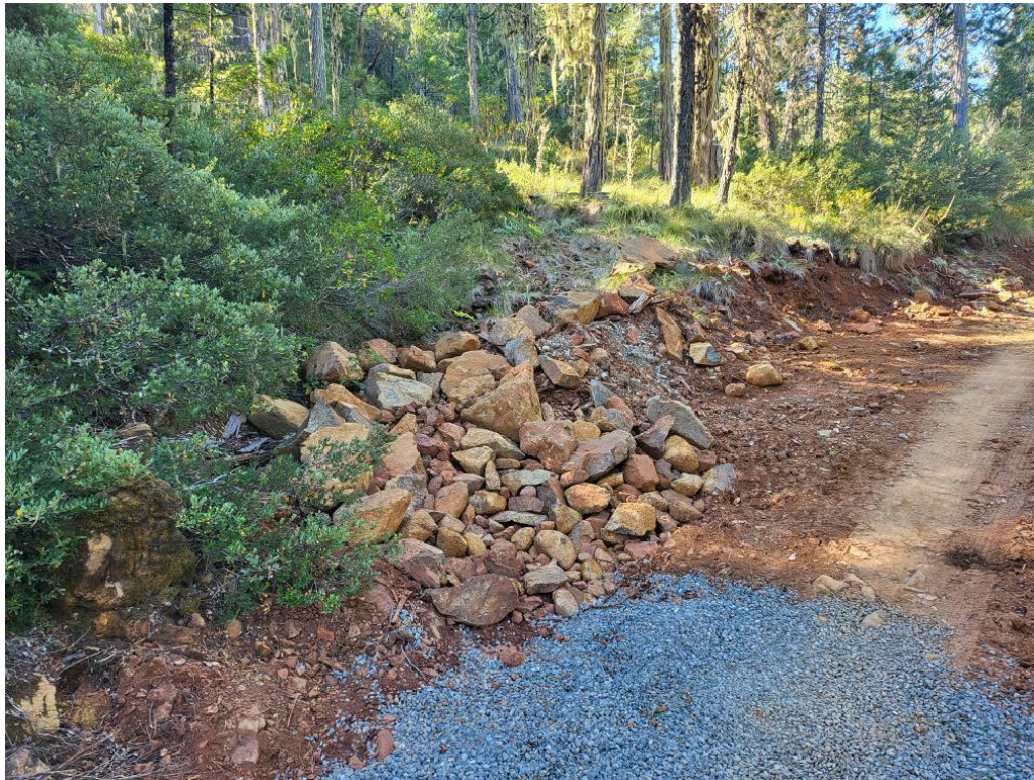
Figure 2: Rock placed upstream of rocked ford crossing.

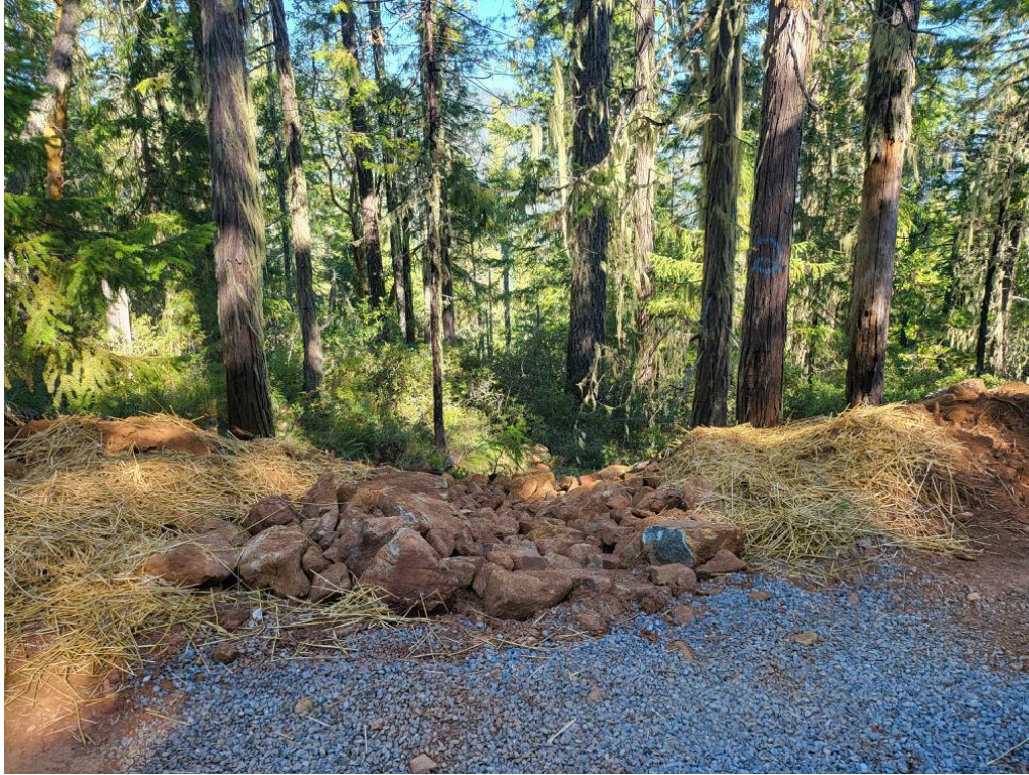
Figure 3: Rock armor placed downstream of MP2.

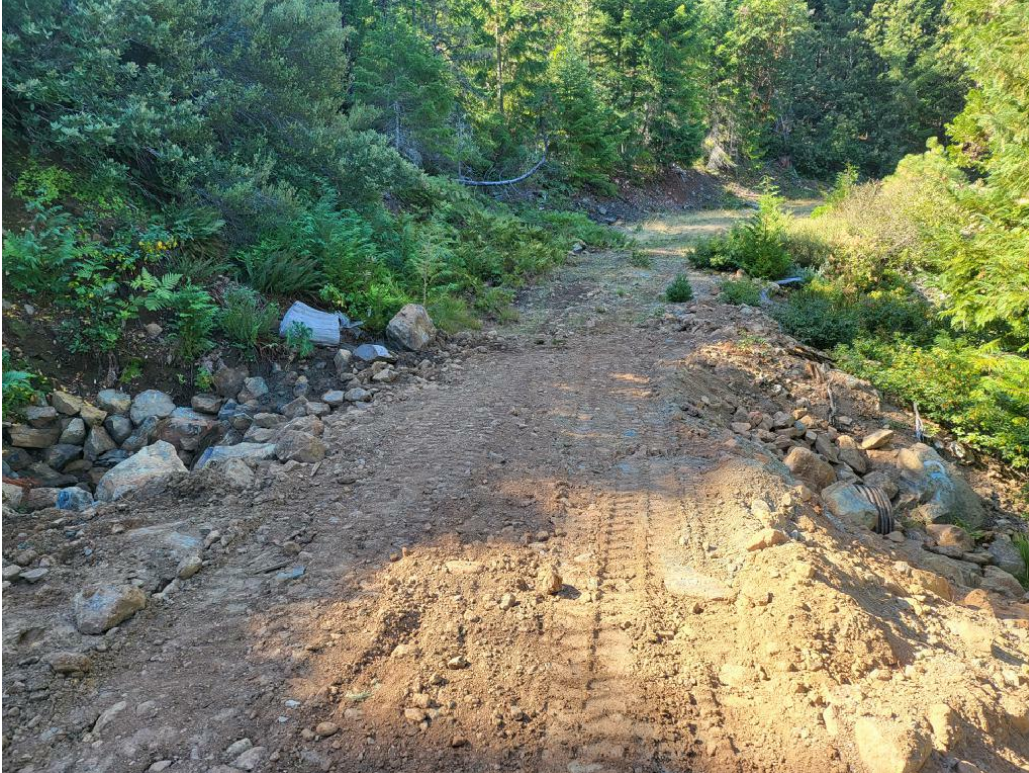
Status at 10/5 Site Visit: the 18" culvert has been properly replaced with a 24" culvert.

Figure 4: MP3 replaced 24" culvert.

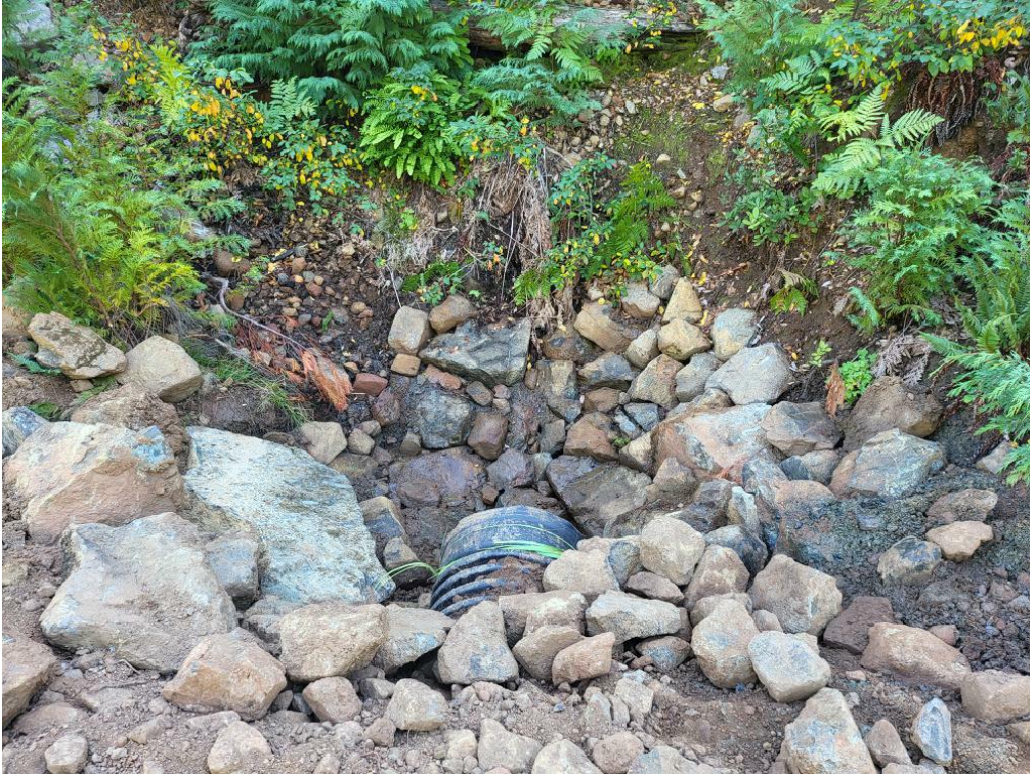
Figure 5: MP3 24" culvert inlet.

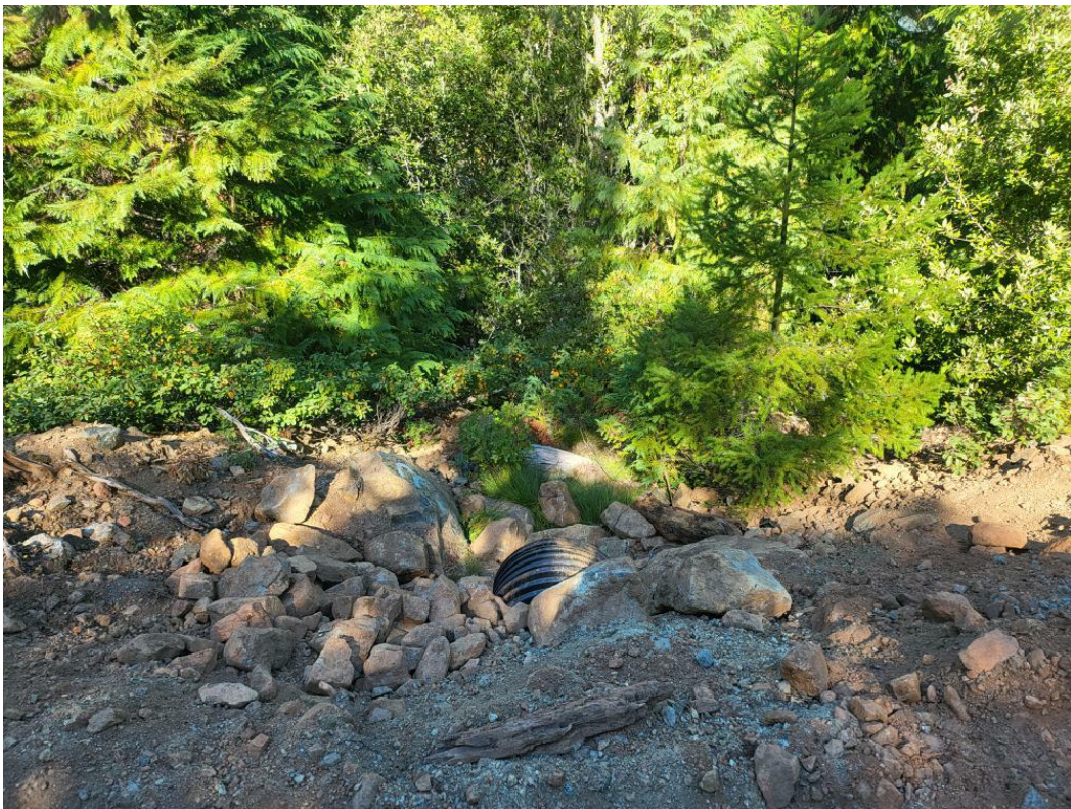
Figure 6: MP3 24" culvert outlet.

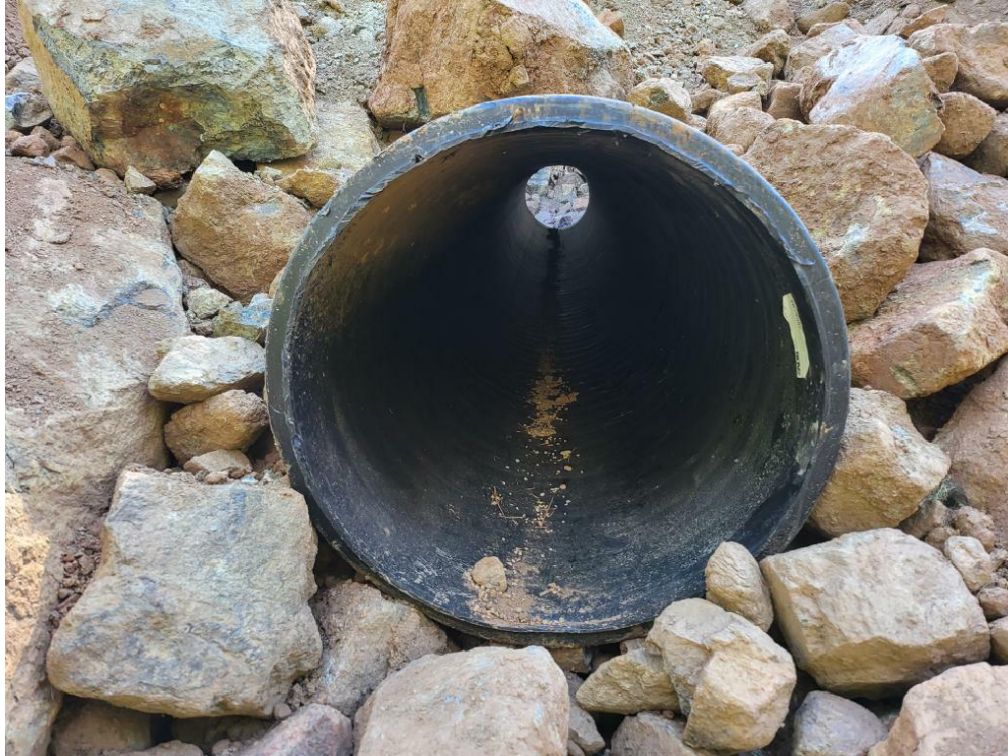
Figure 7: MP3 24" culvert cleared.

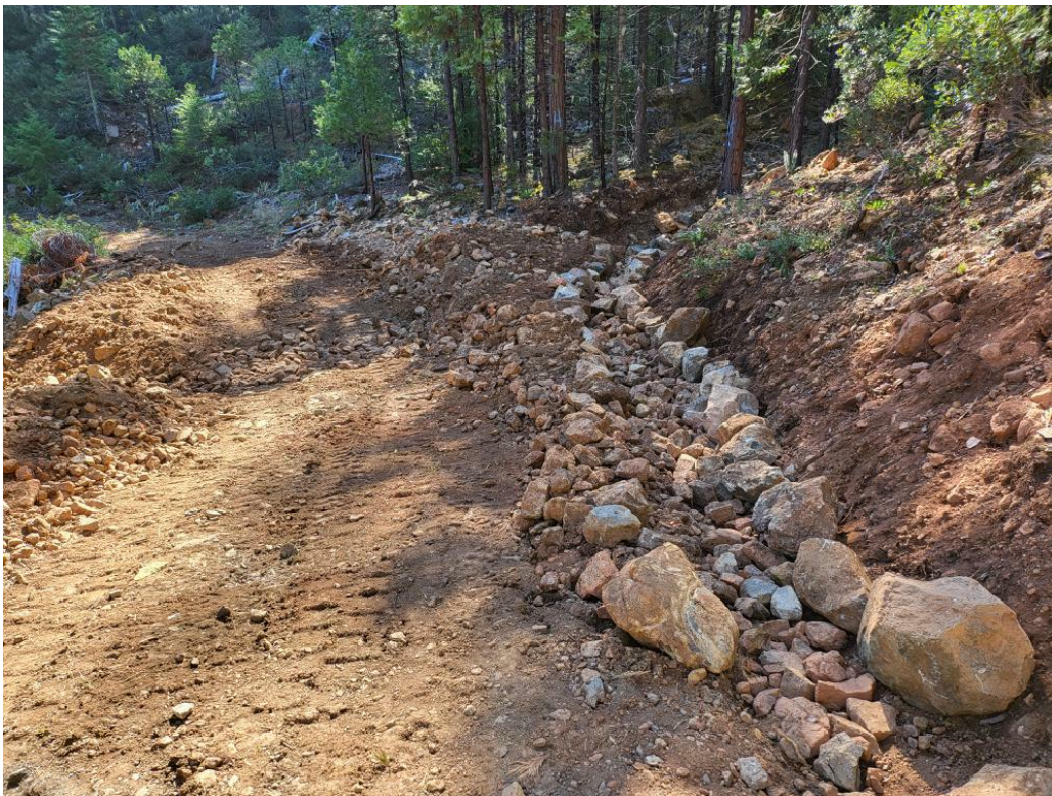
Status at 10/5 Site Visit: The 36" culvert has been properly installed and the 12" removed. The ditch has been rock armored and disconnected the roadway from the spring.

Figure 8: MP4 rocked ditch disconnecting spring from roadway.

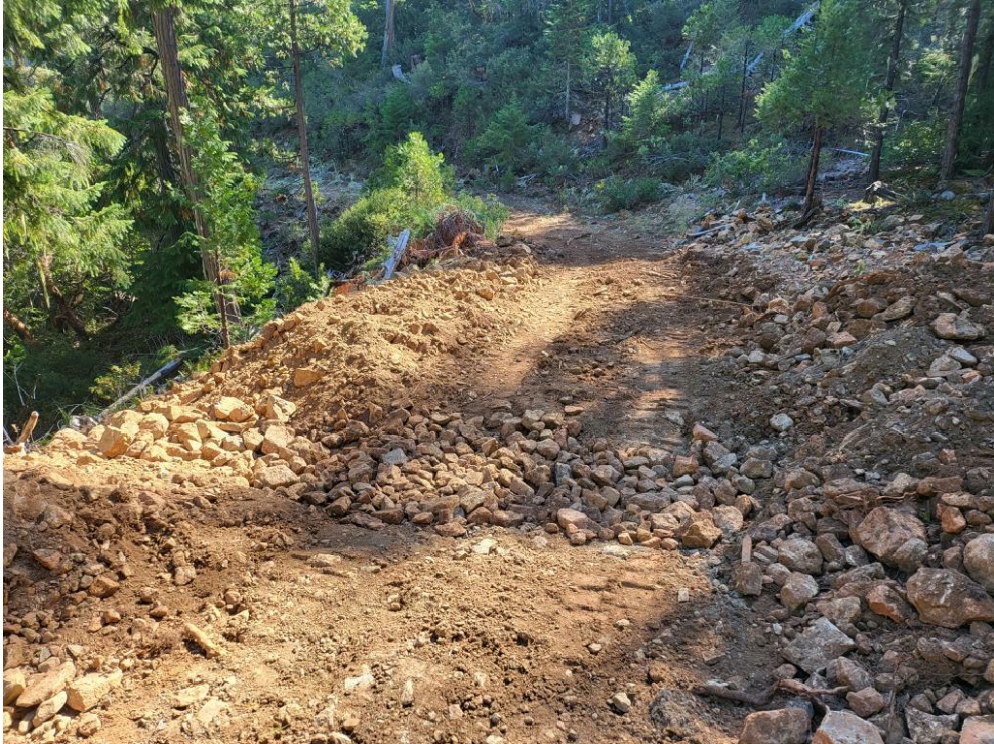
Figure 9: MP4 disconnected roadway.

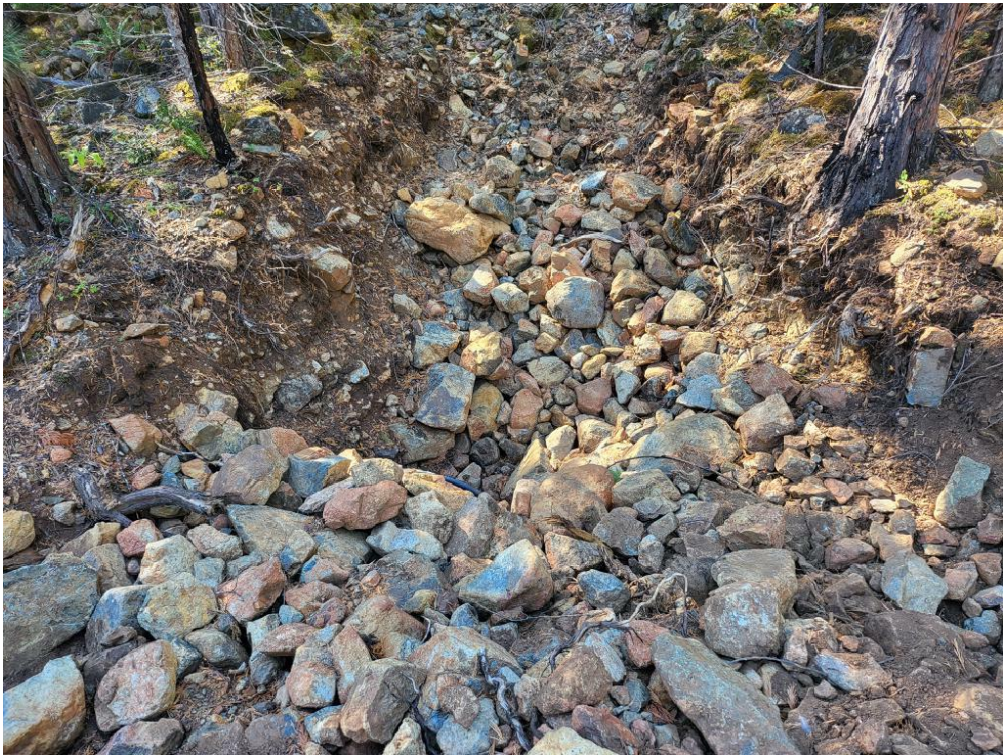
Figure 10: Upstream of MP4.

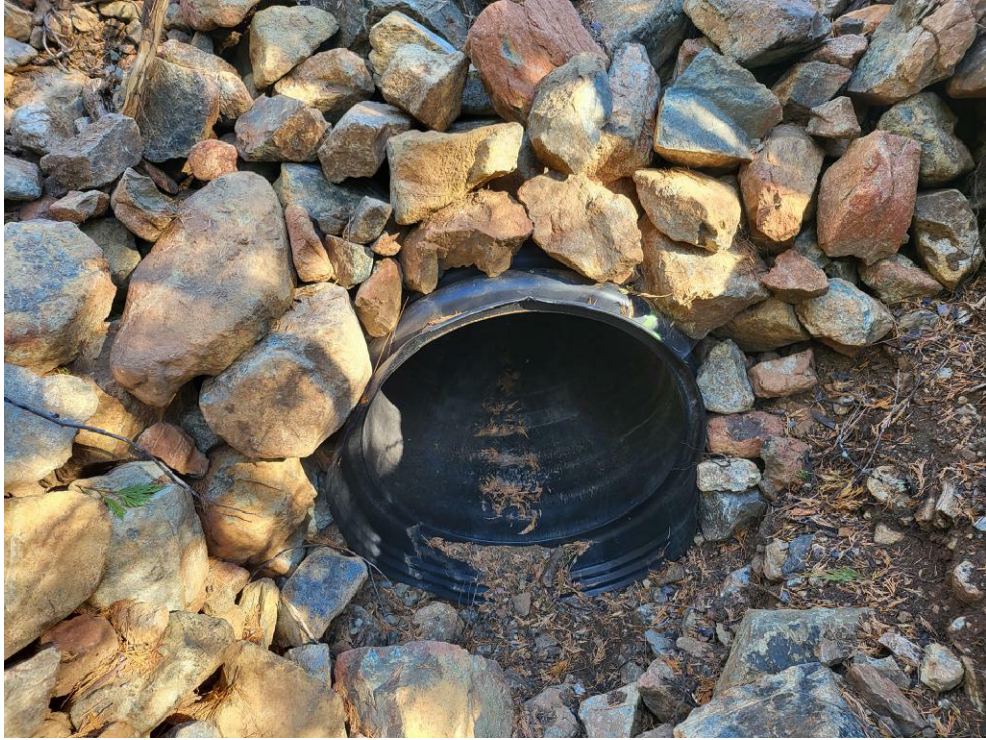
Figure 11: Inlet of Mp4.

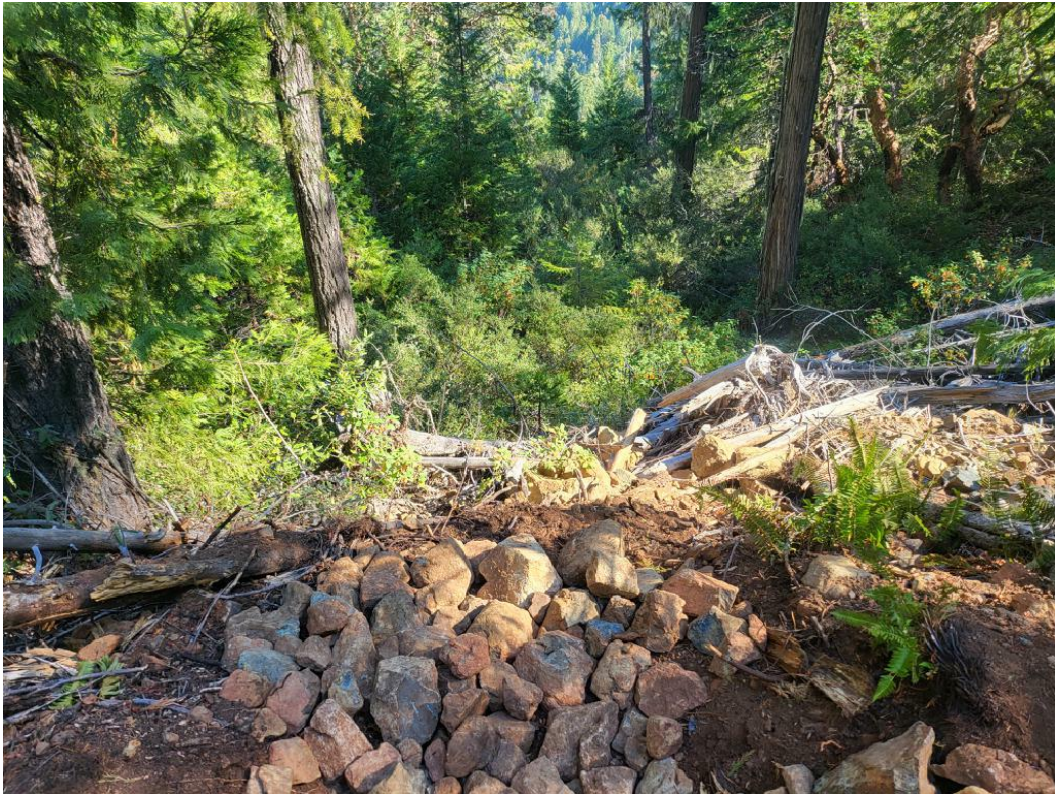
Figure 12: Downstream of MP4.

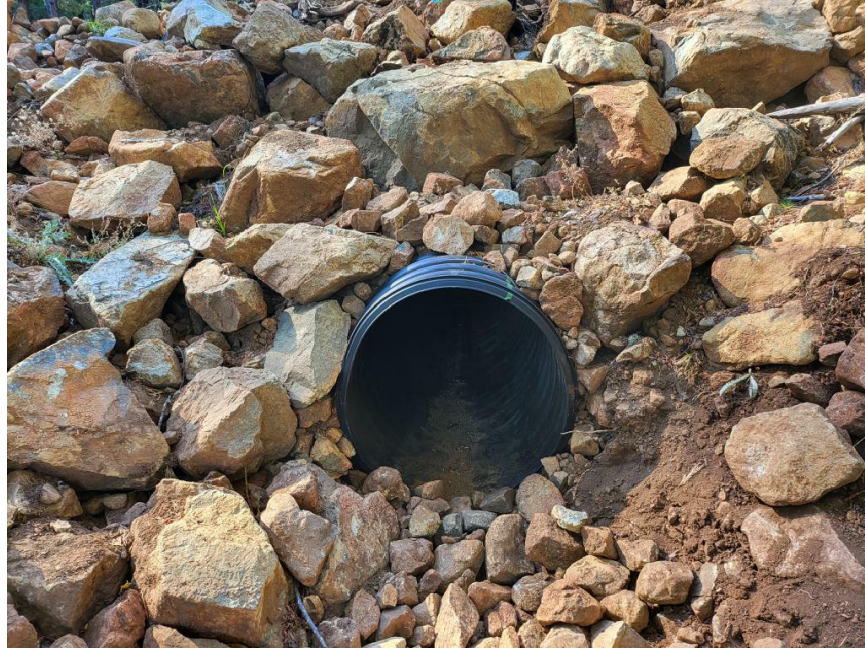
Figure 13: MP4 outlet.

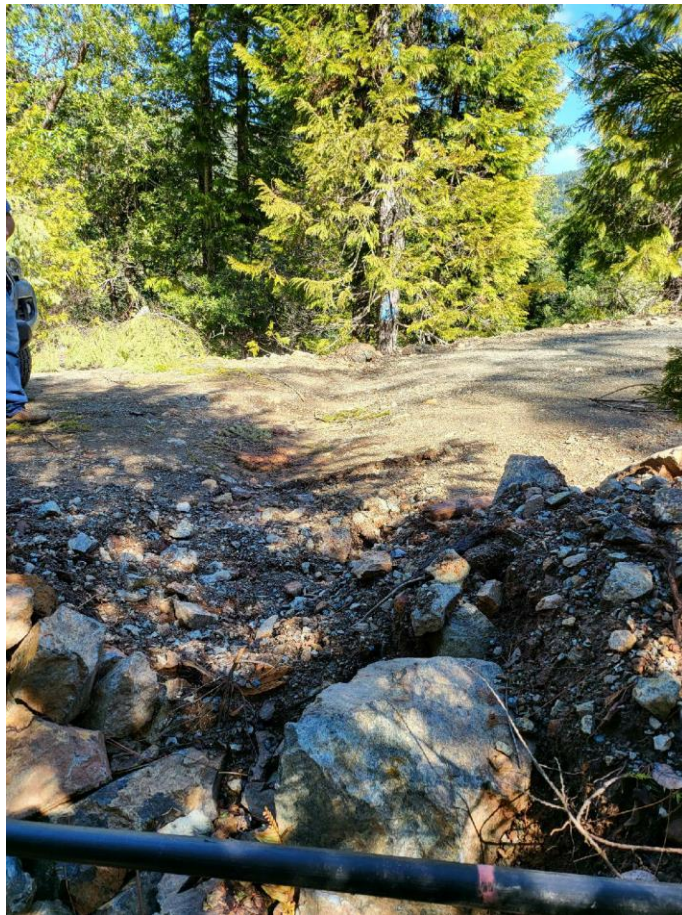
Status at 10/5 Site Visit: 24" culvert has been installed and disconnected from the adjacent channel.

Figure 14: MP6 replaced 24" culvert.

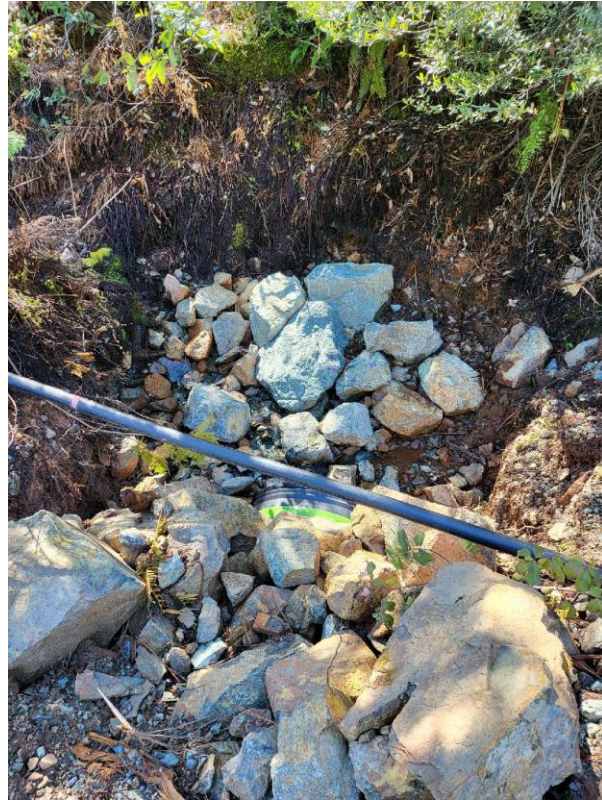
Figure 15: MP6 Inlet.

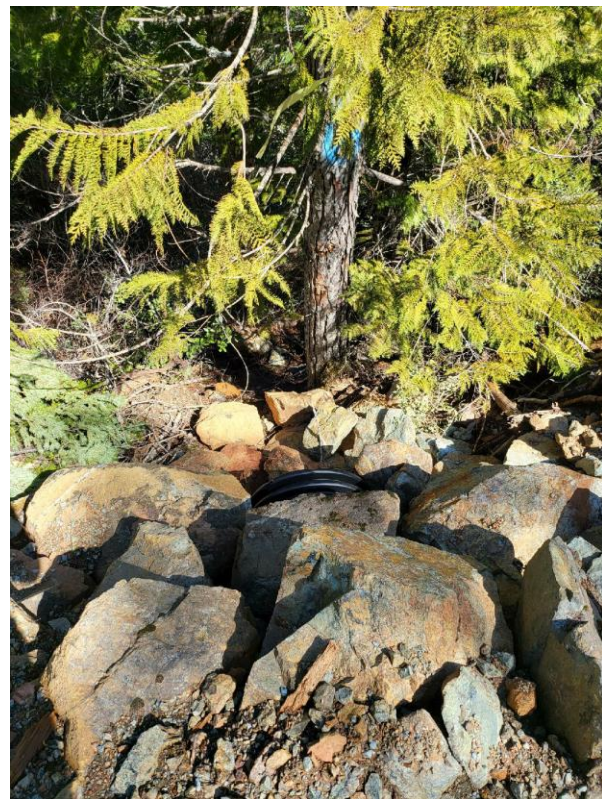
Figure 16: MP6 outlet.

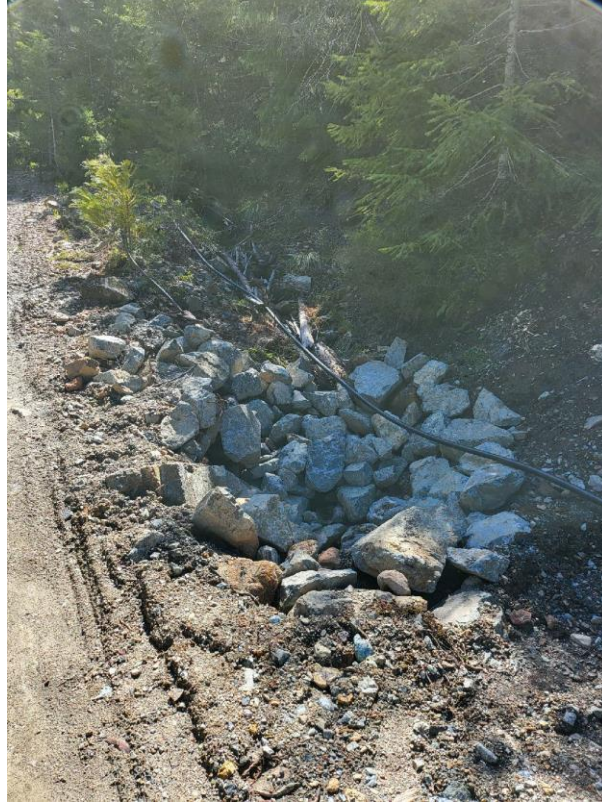
Status at 10/5 Site Visit: 18" culvert has been replaced with a 24" culvert.

Figure 17: MP7 inlet.

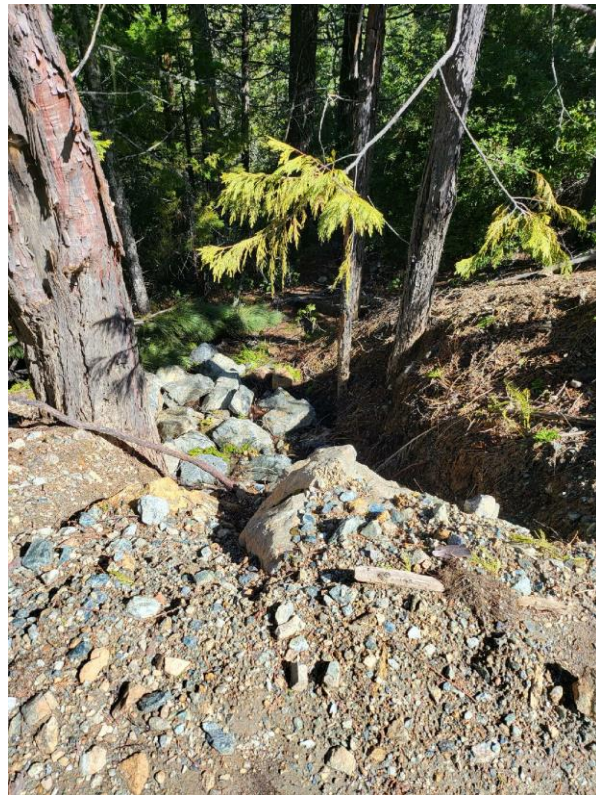
Figure 18: MP7 downstream.

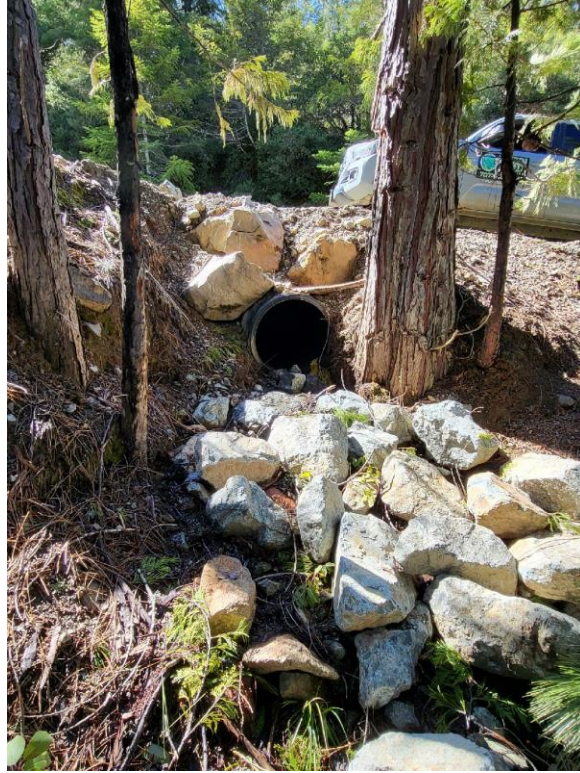
Figure 19: MP7 outlet.

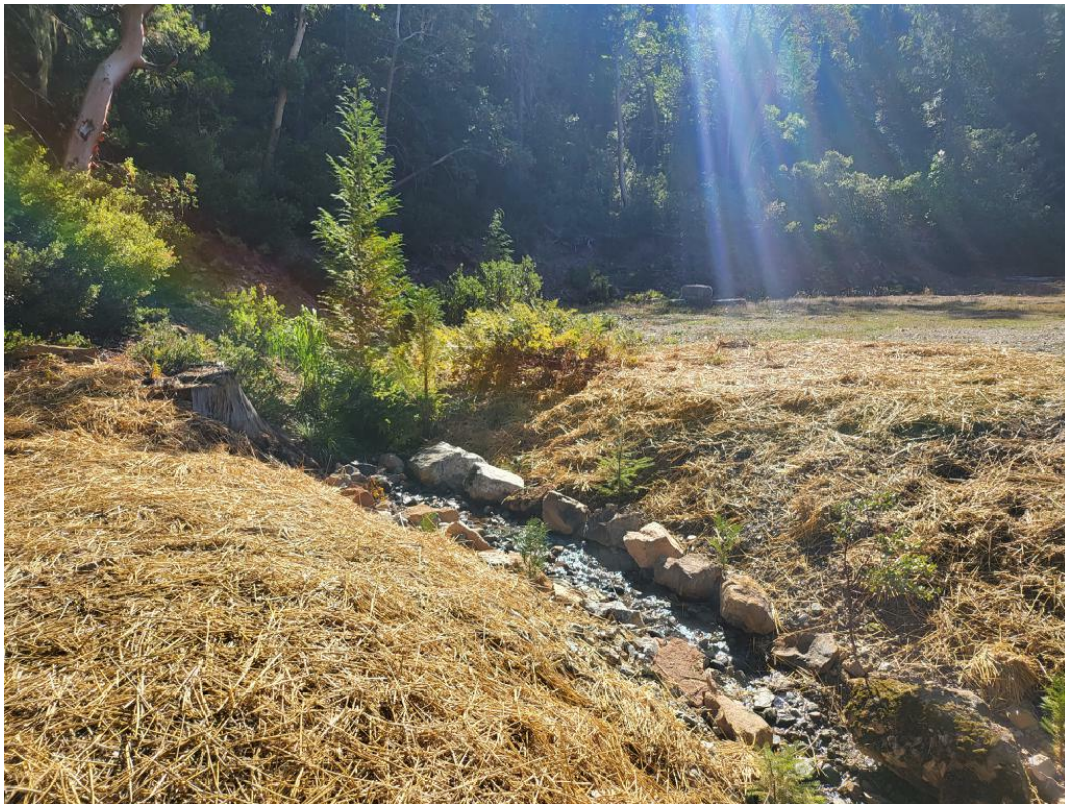
Status at 10/5 Site Visit: The culvert has been removed and the stream channel reconnected. Revegetation efforts have occurred with high survival rates as of 10/5/2022. The unstable fill and all garbage have been removed.

Figure 20: MP8 culvert remove and stream restored.

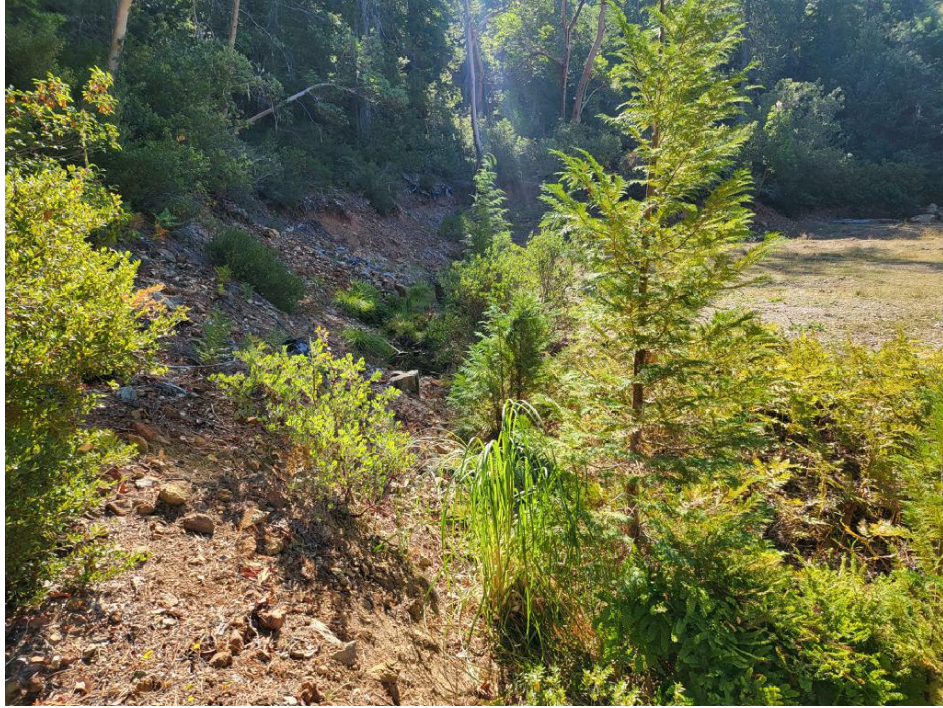
Figure 21: MP8 revegetation efforts.

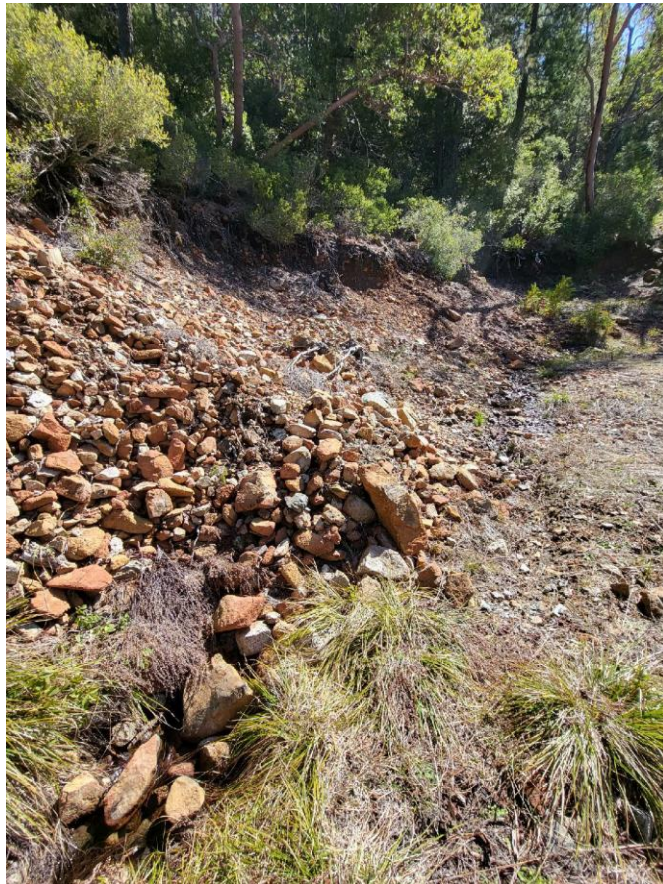
Figure 22: MP8 perched unstable fill removed.

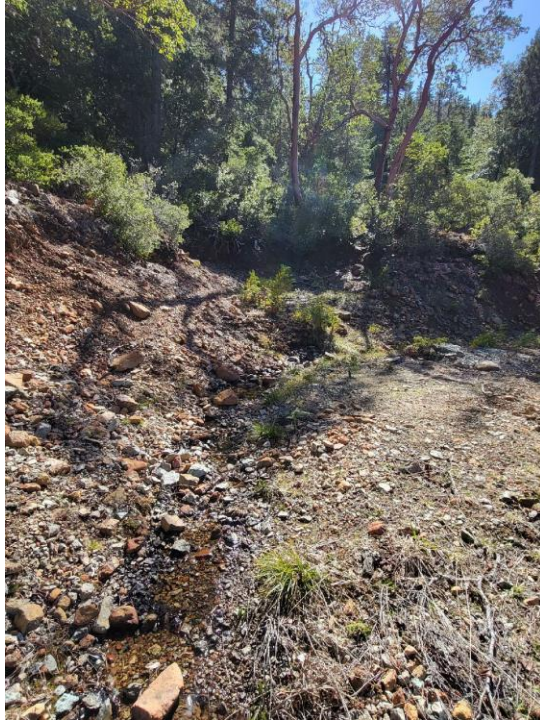
Figure 23: MP8 stream restoration.

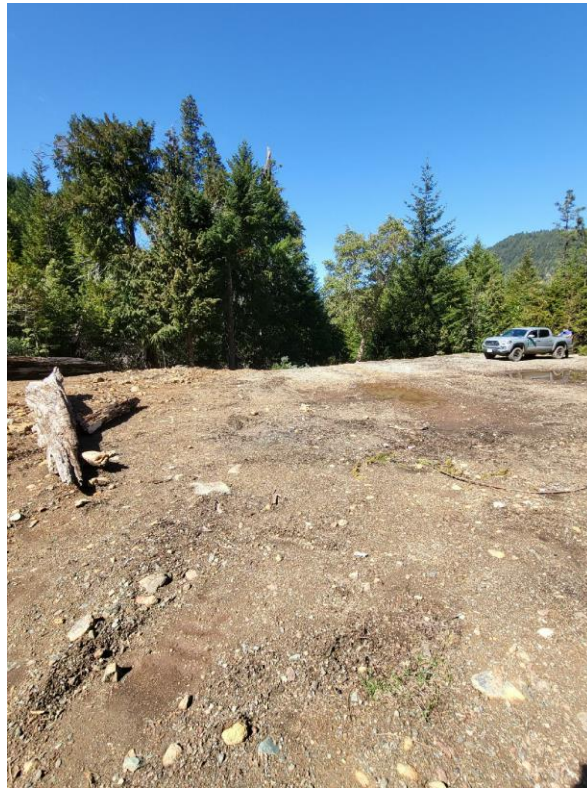
Figure 24: MP8 all trash removed.

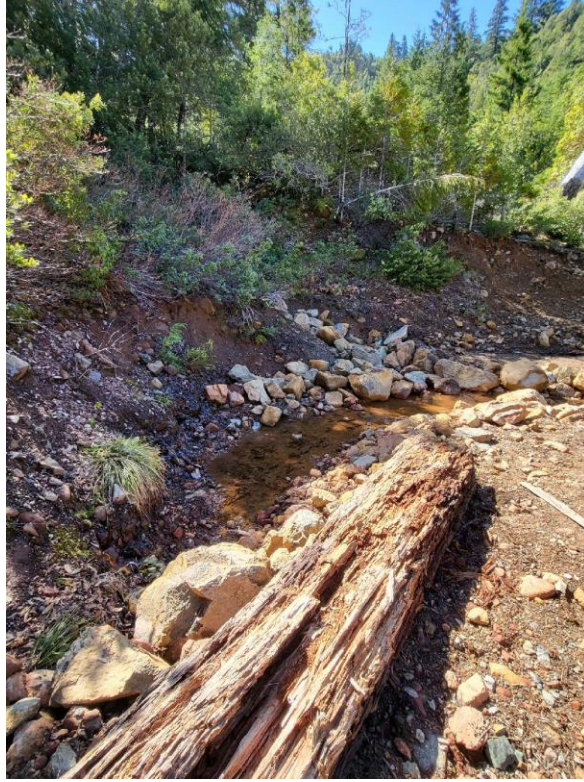
Figure 25: MP8 stream channel excavation to connect spring flow to Class II channel.

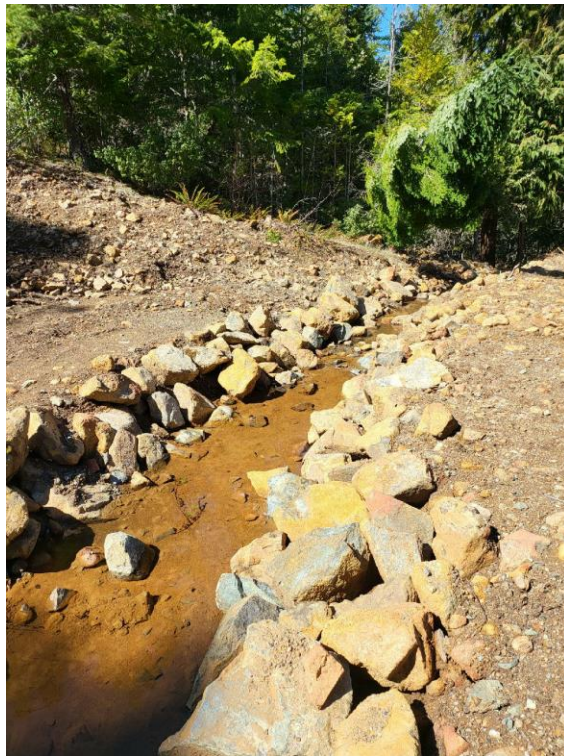
Figure 26: MP8 stream channel excavation to connect spring flow to Class II channel.

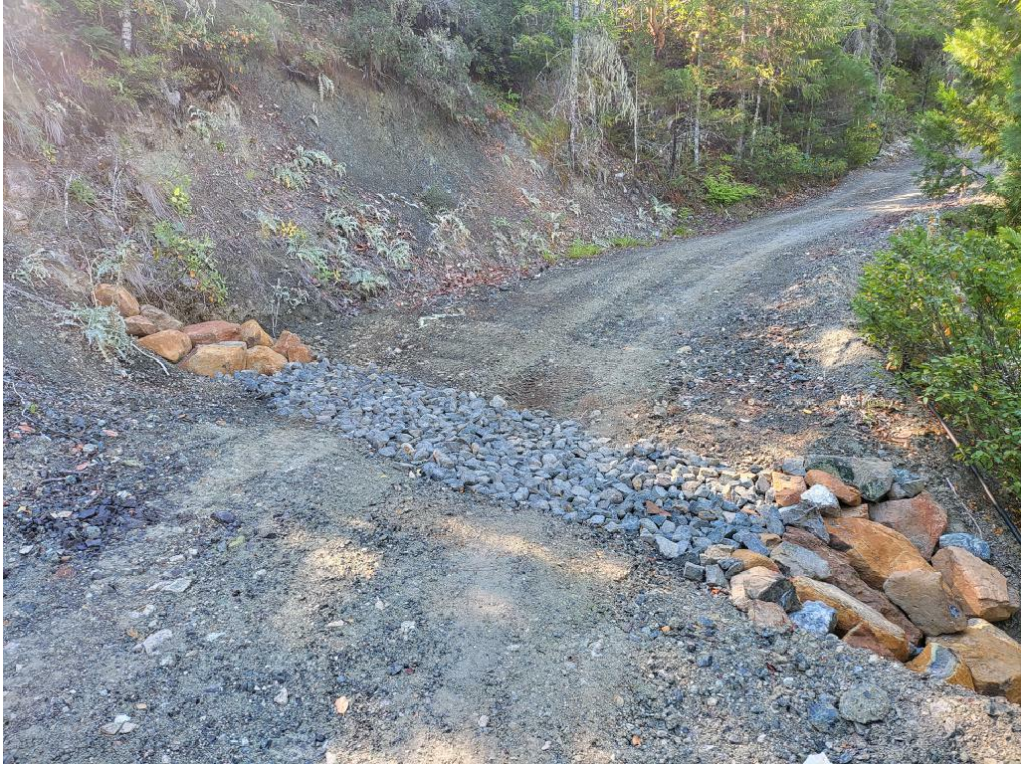
Status at 10/5 Site Visit: fill crossing excavated, and rock armor installed. Road approaches hydrologically disconnected.

Figure 27: MP9 installed rock armor.

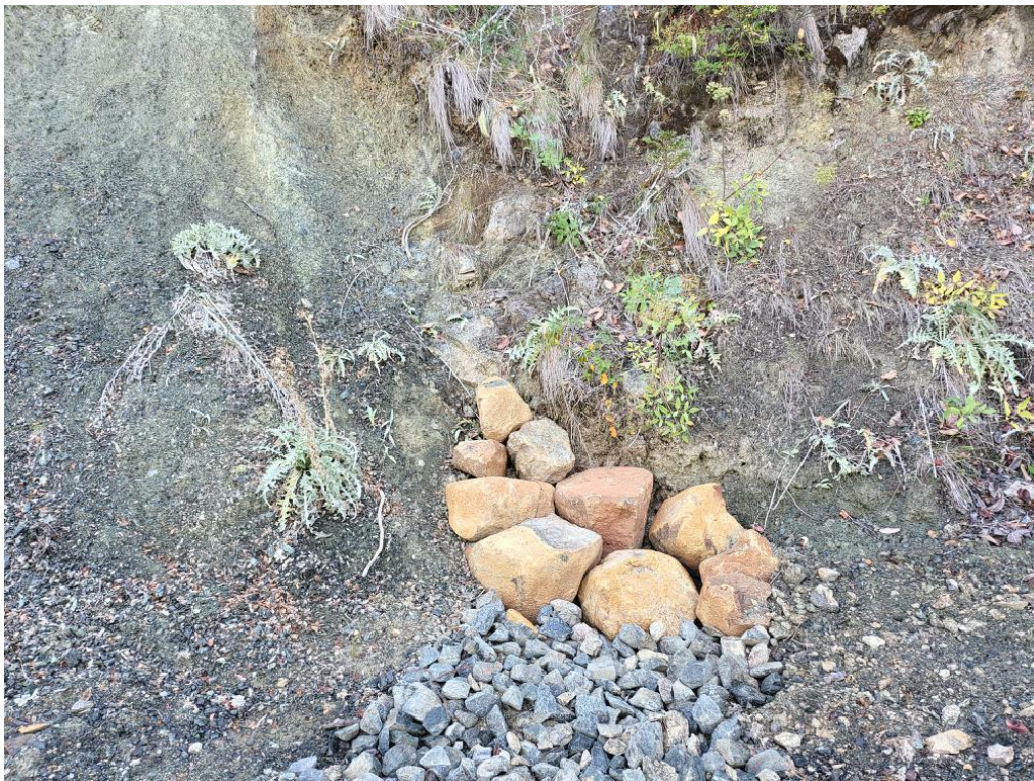
Figure 28: MP9 upstream.

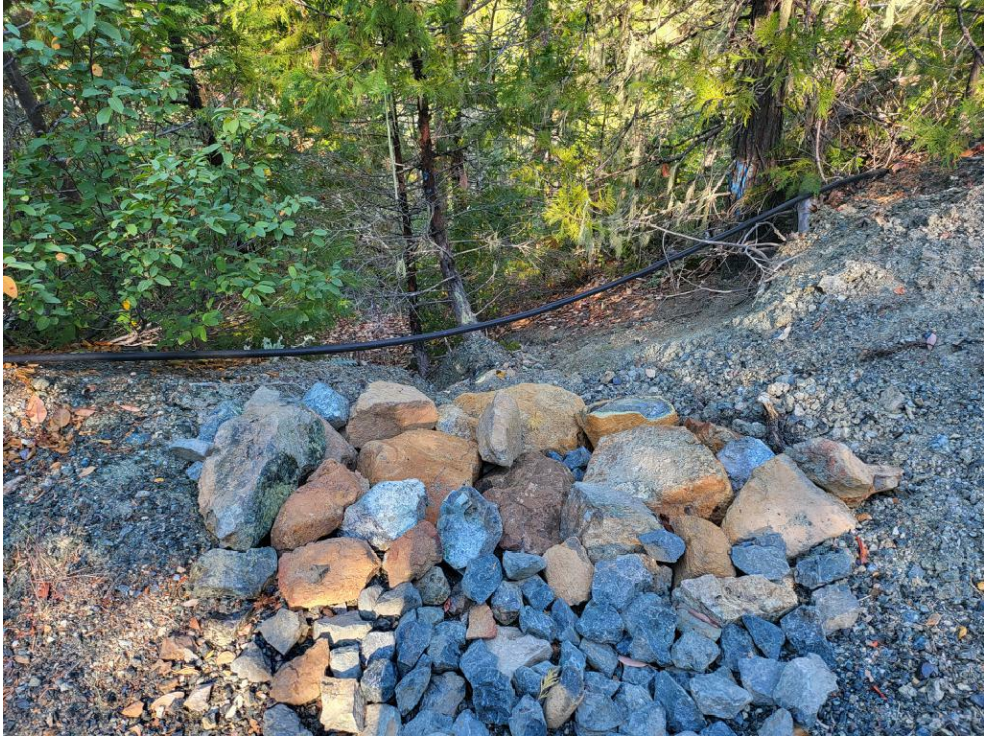
Figure 29: MP9 downstream.

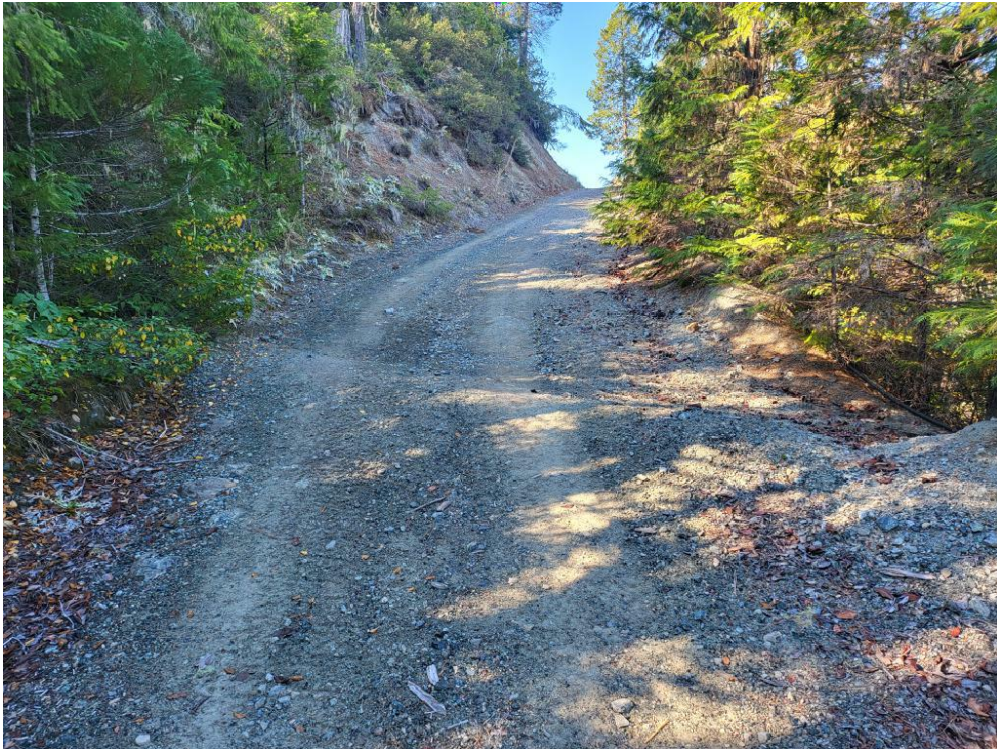
Figure 30: Water bar up the road from MP9.

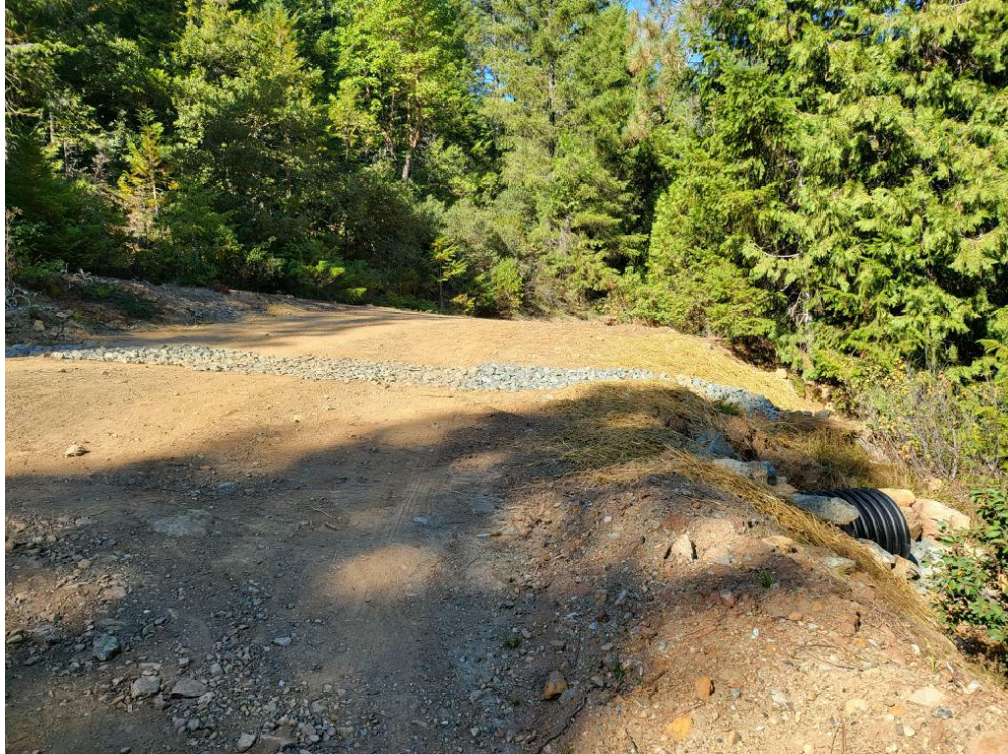
Status at 10/5 Site Visit: Culvert has been properly installed with the channel downstream excavated and reconstructed. The area has been revegetated and the boat removed.

Figure 31: MP10 replaced culvert and rocked road surface.

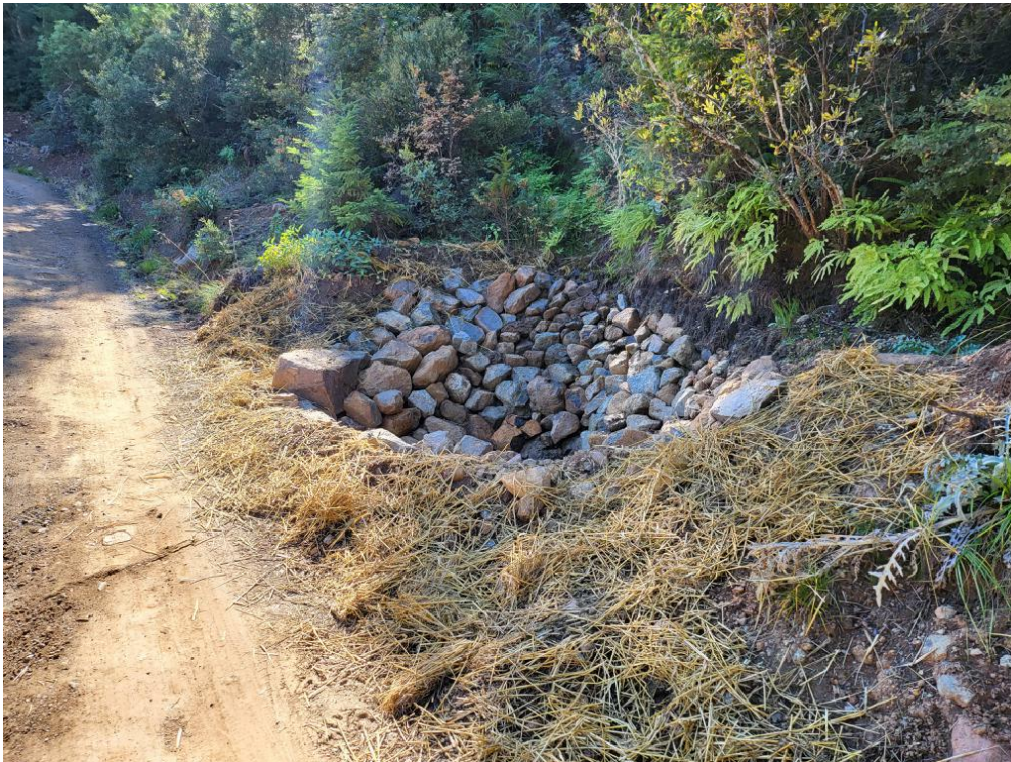
Figure 32: MP10 inlet.

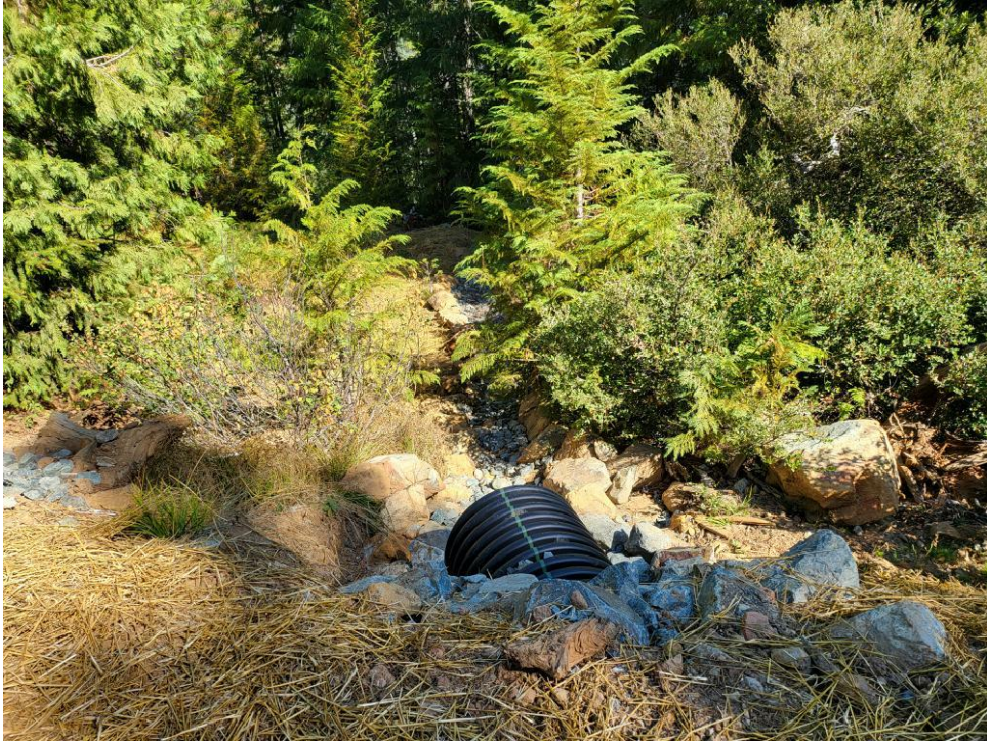
Figure 33: MP10 outlet with reconstructed channel.
