Project Inspection Report

APN: 316-071-004

Notification #1600-2017-0319-R1

October 20, 2022

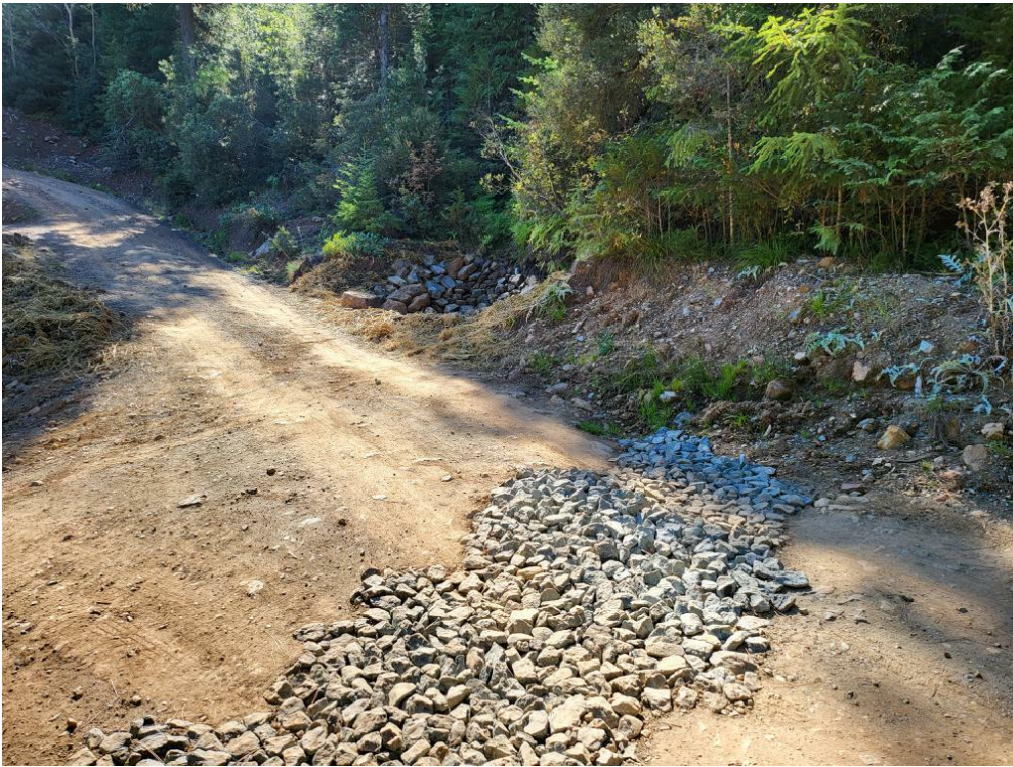
Figure 34: MP10 disconnected road surface from watercourse.

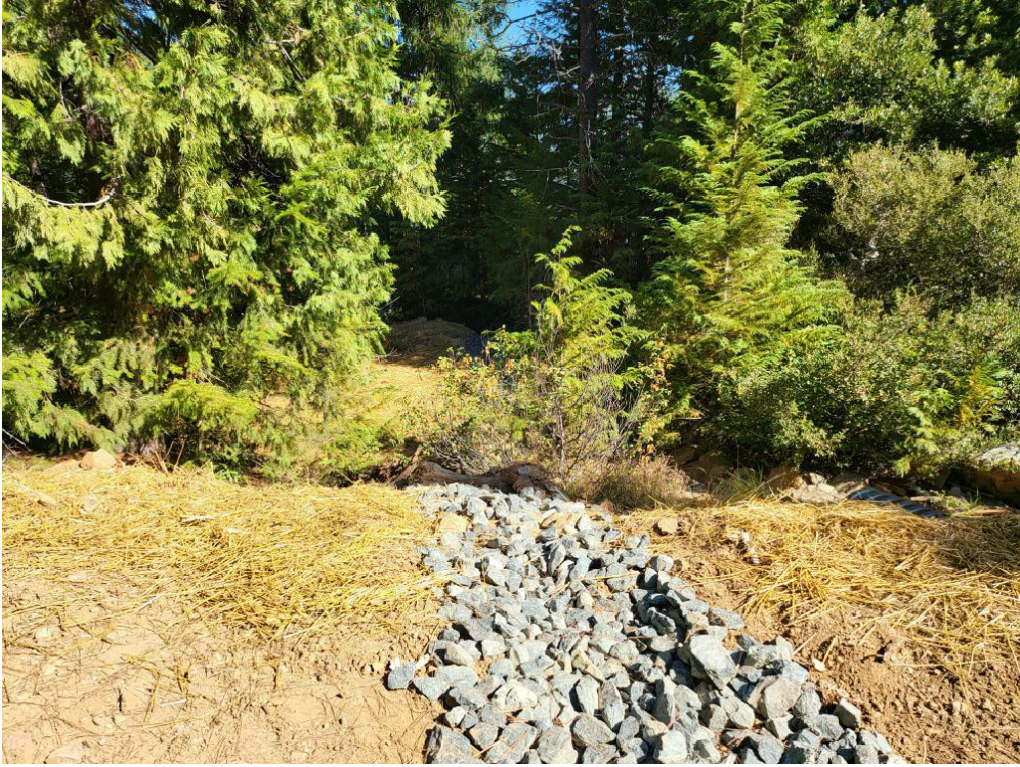
Figure 35: MP10 disconnected road surface from watercourse.

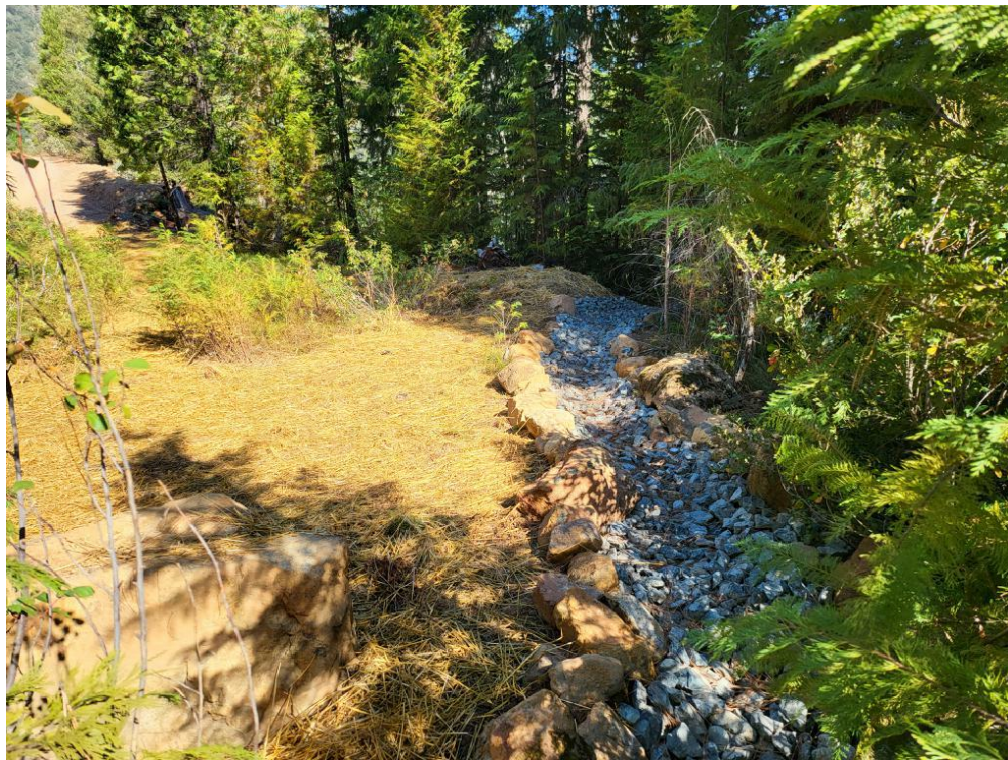
Figure 36: MP10 reconstructed channel, revegetation, and removal of boat.

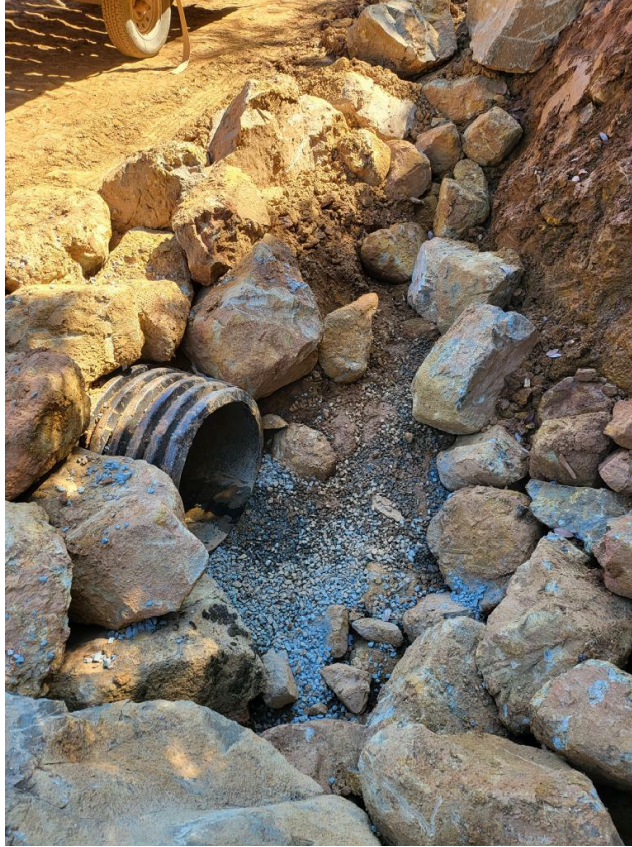
Status at 10/5 Site Visit: 12" Culvert has been replaced with 24" culvert.

Figure 37: MP12 inlet.

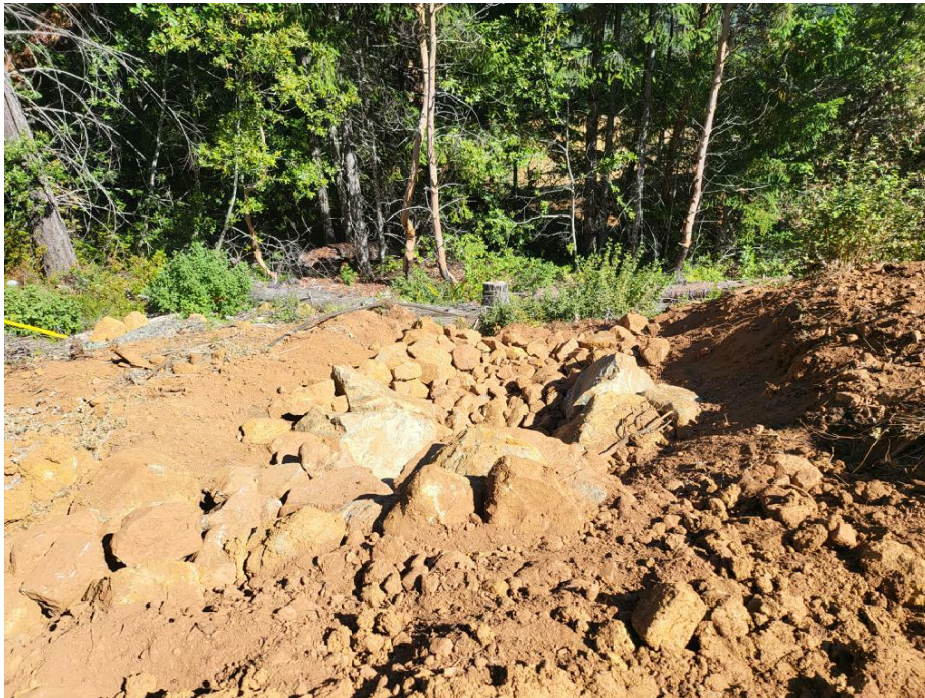
Figure 38: MP12 downstream.

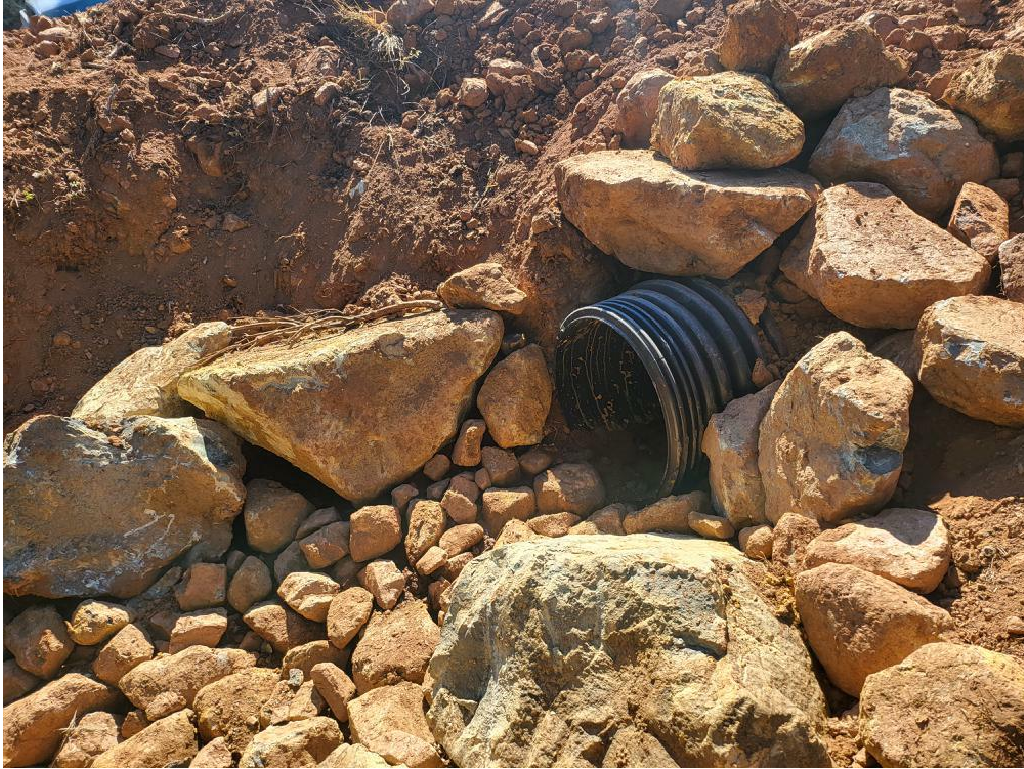
Figure 39: MP12 outlet.

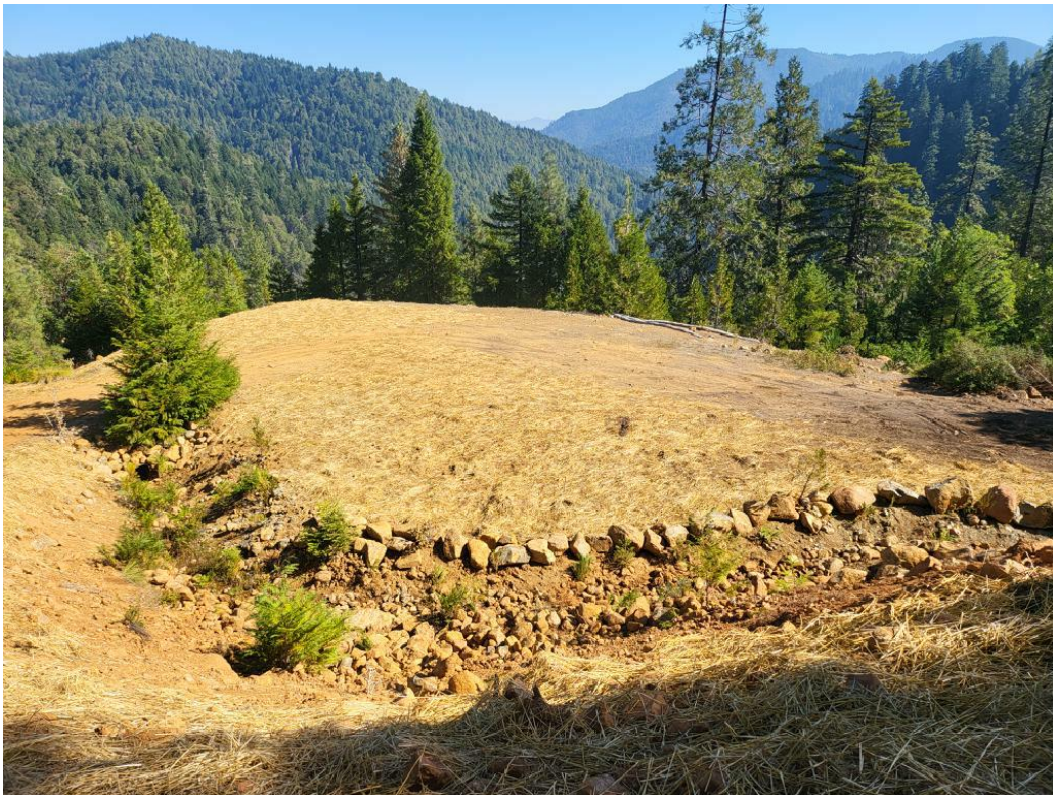
Status at 10/5 Site Visit: The western bank has been pulled back and the stream restored. The trash has been removed from the area and the culvert cleared. Revegetation efforts have been successful as of 10/5/2022.

Figure 40: MP13 overview.

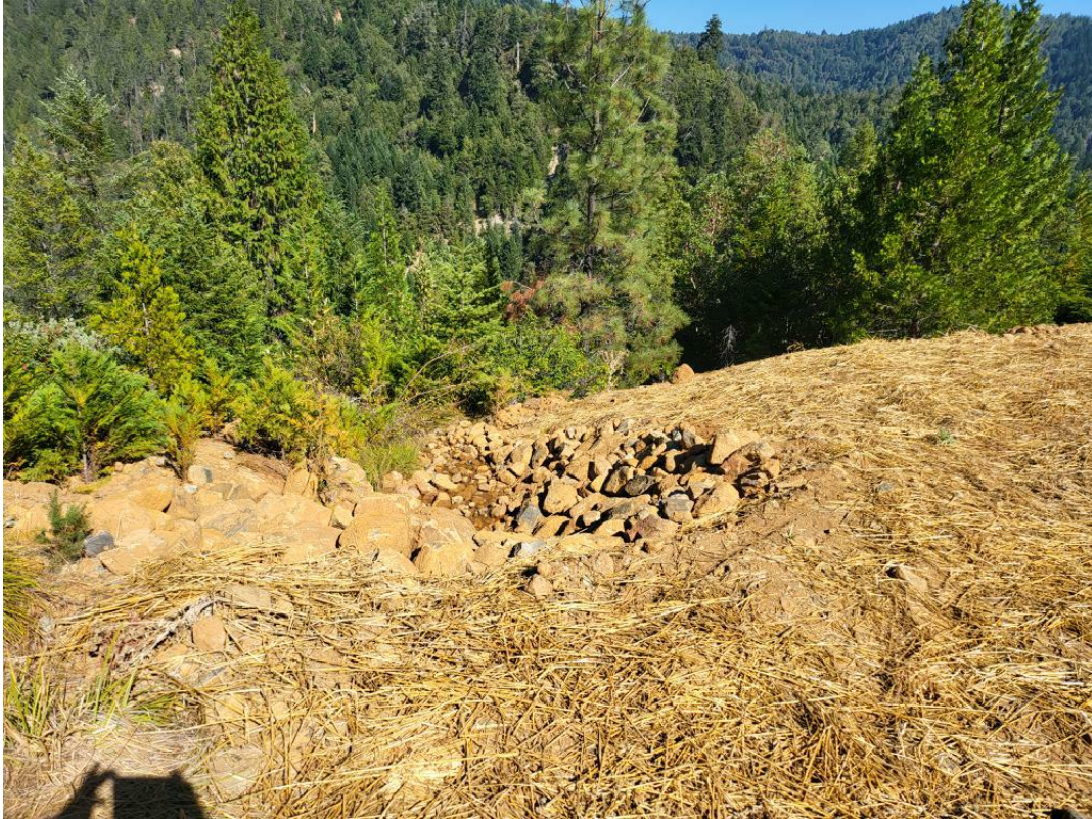
Figure 41: MP13 culvert downstream view.

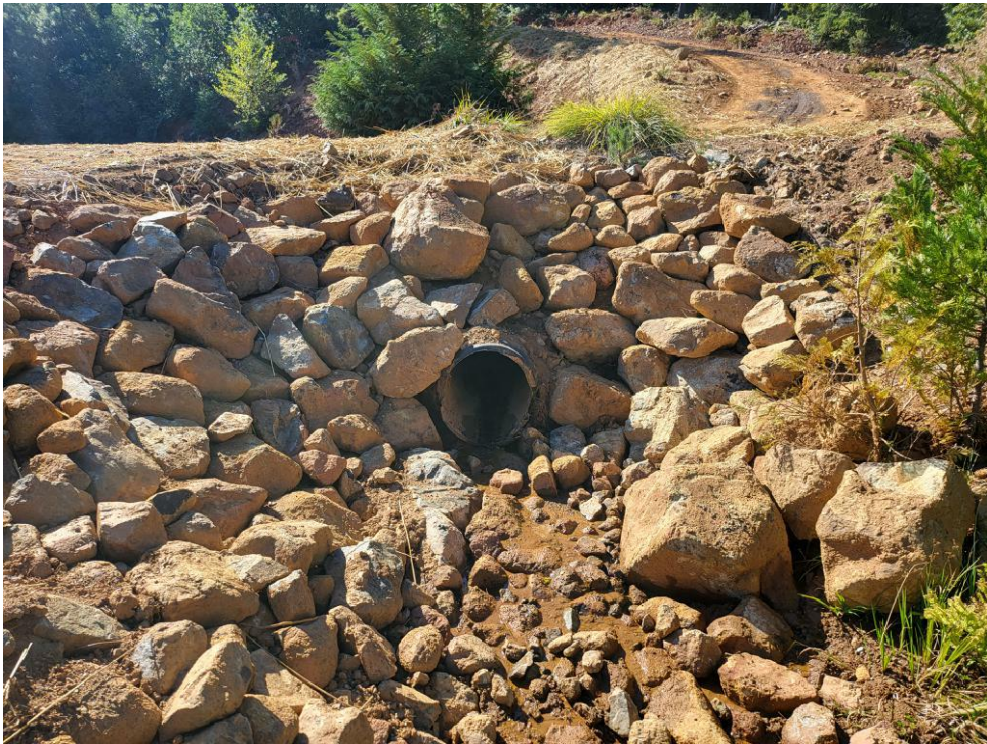
Figure 42: MP13 culvert outlet.

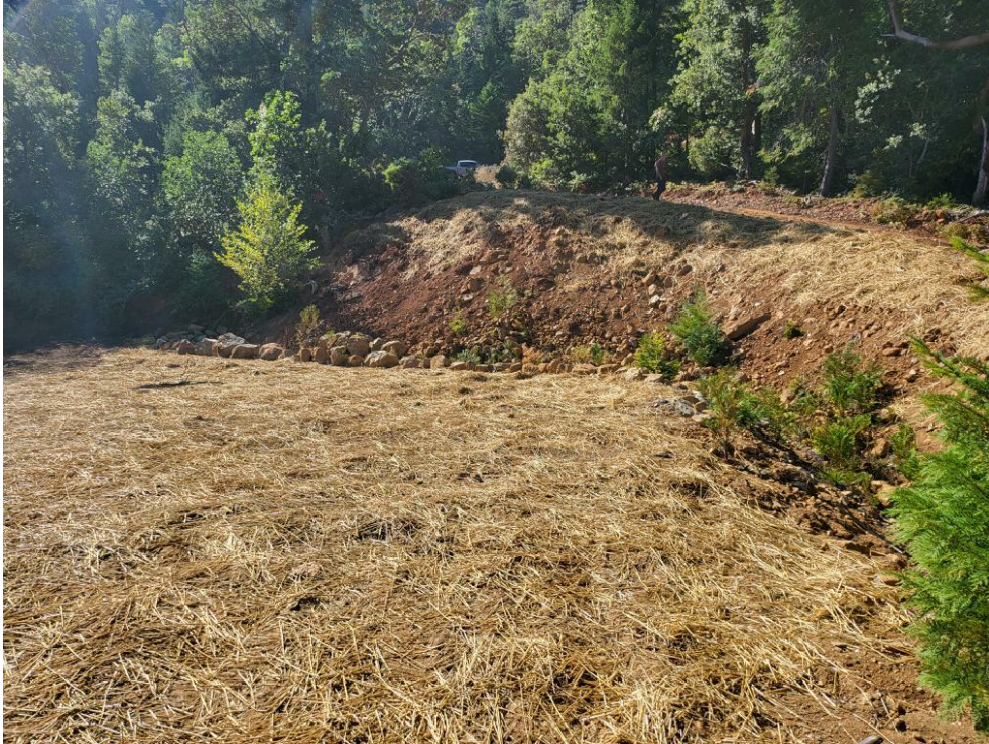
Figure 43: MP13 slope pulled back, stream restored with revegetation efforts currently succeeding as of 10/5/2022.

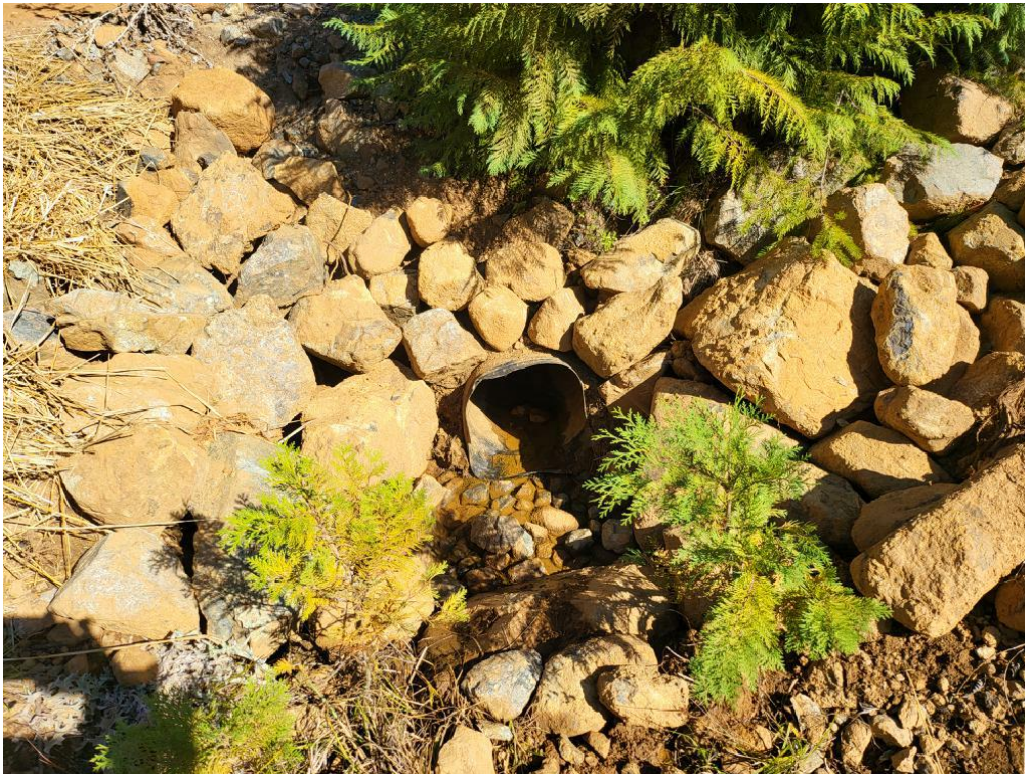
Figure 44: MP13 cleared culvert inlet.

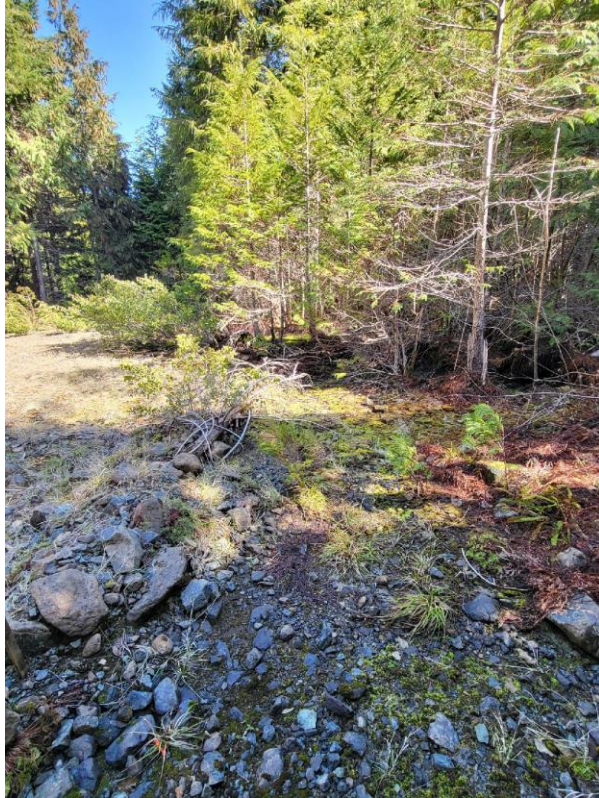
Status at 10/5 Site Visit: Crossing has been decommissioned and the area appears to be at natural stream bed elevation. Rock armor is lightly installed.

Figure 45: MP14 naturalized channel with rock.

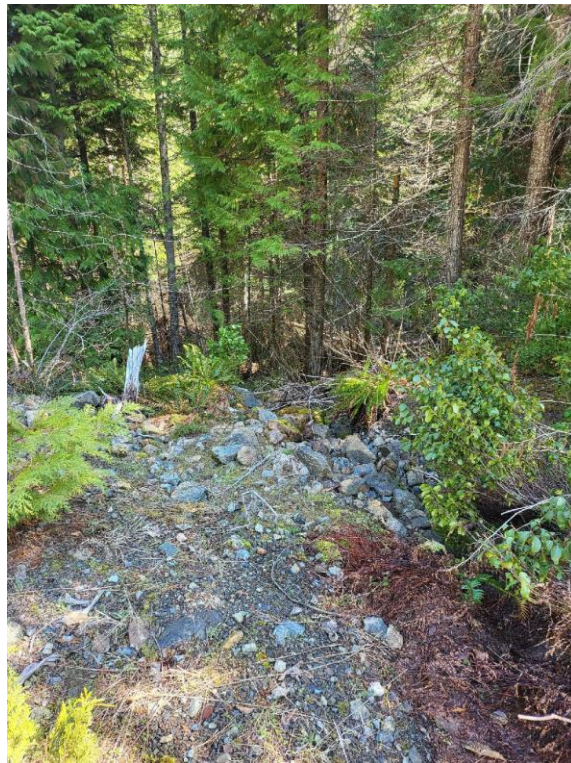
Figure 46: MP14 rock armor.

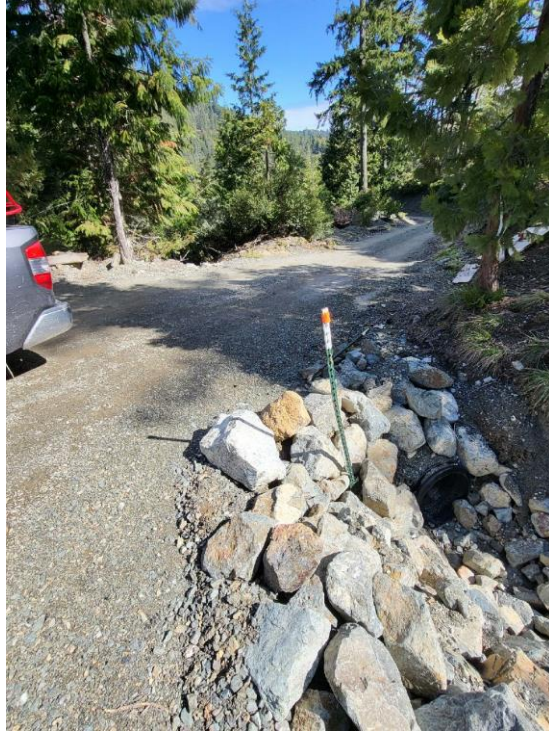
Status at 10/5 Site Visit: Channel has been reestablished along natural flow path with 24" culvert and rock armor installed.

Figure 47: MP19 24" culvert.

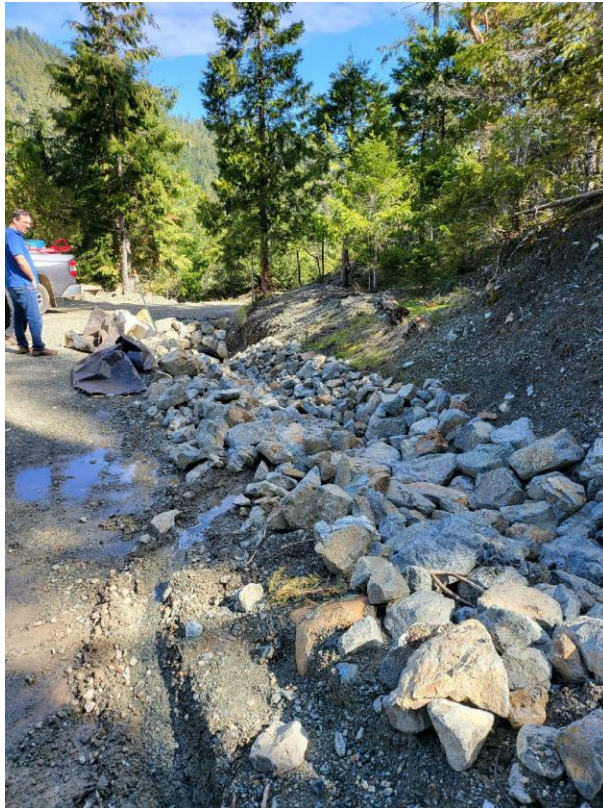
Figure 48: MP19 reestablished channel with rock armor.

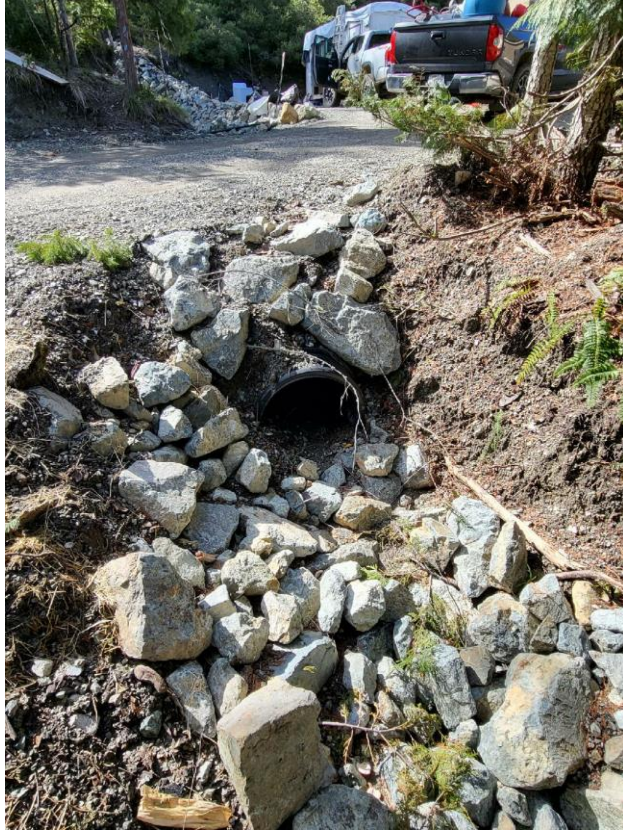
Figure 49: MP19 outlet.

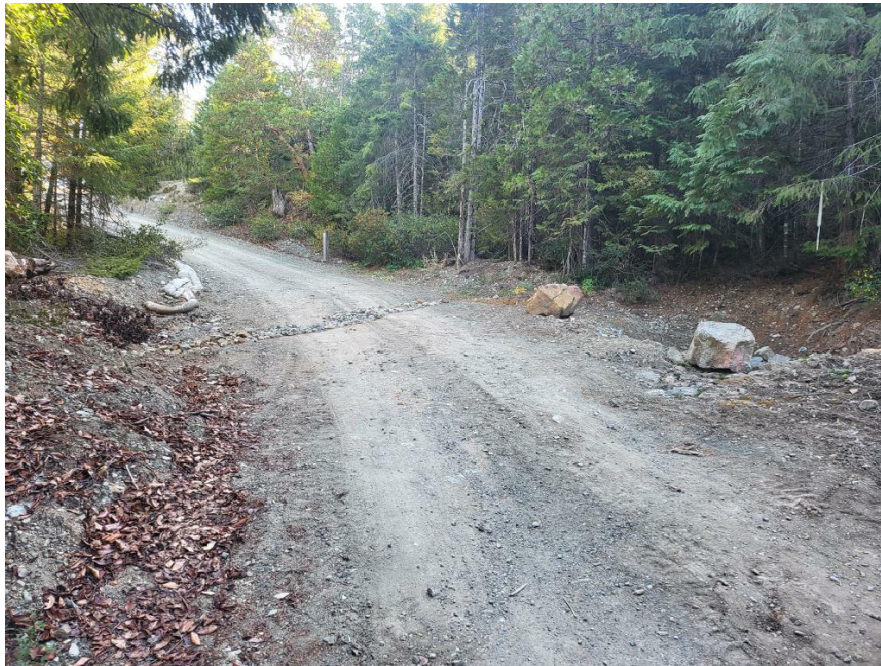
Status at 3/17 Site Visit: 24" culvert properly installed.

Figure 50: MP20 culvert and water bar.

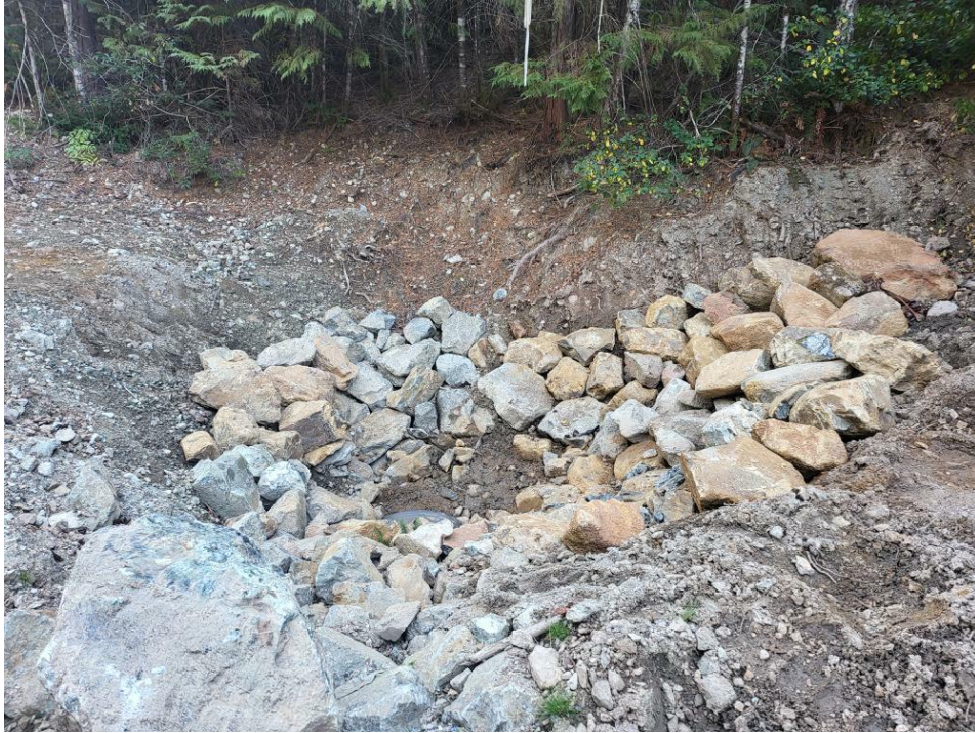
Figure 51: MP20 culvert inlet.

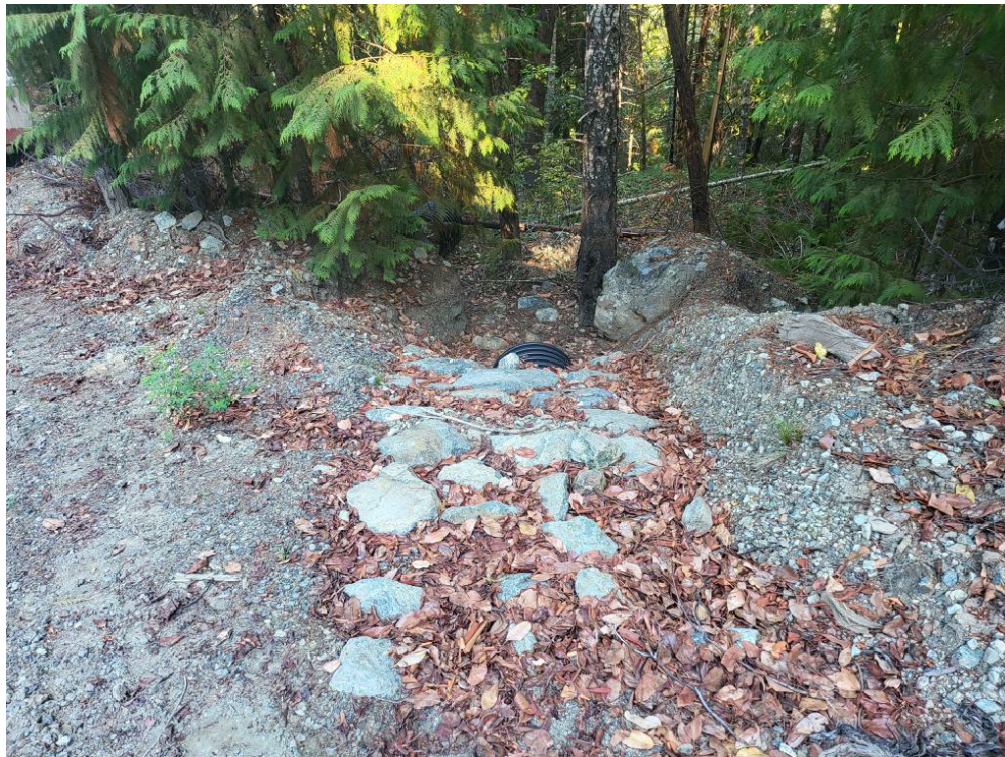
Figure 52: MP20 culvert outlet.

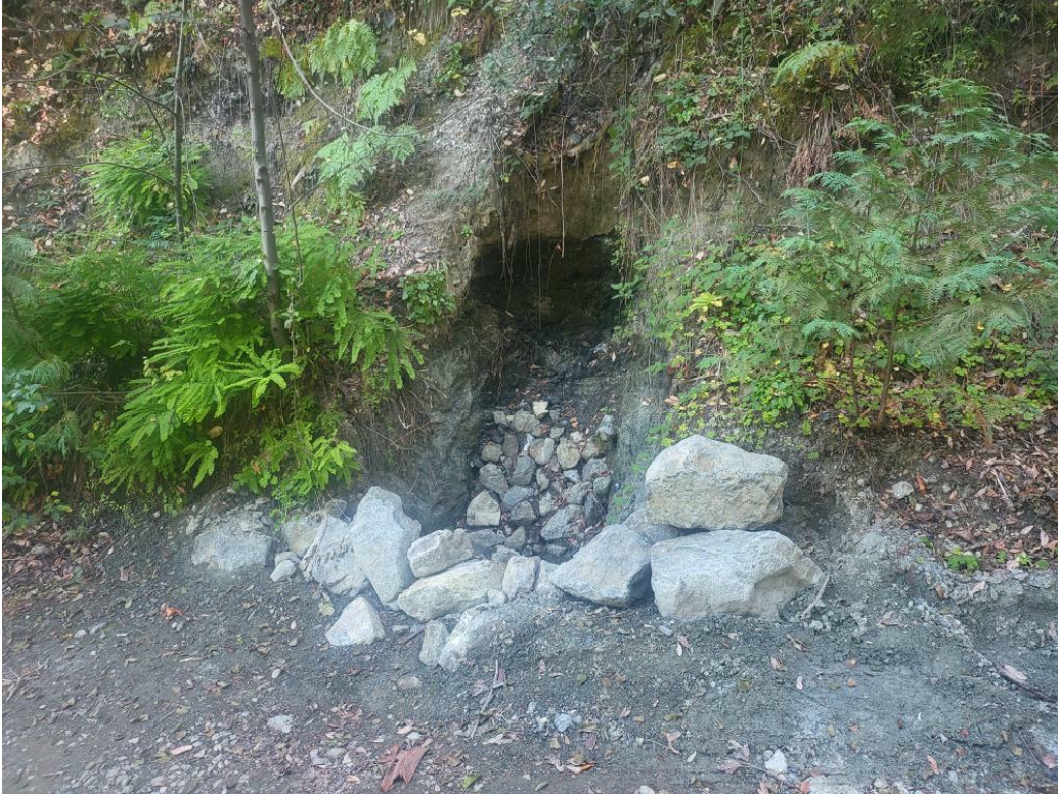
Status at 3/17 Site Visit: 24" culvert installed.

Figure 53: MP21 culvert inlet.

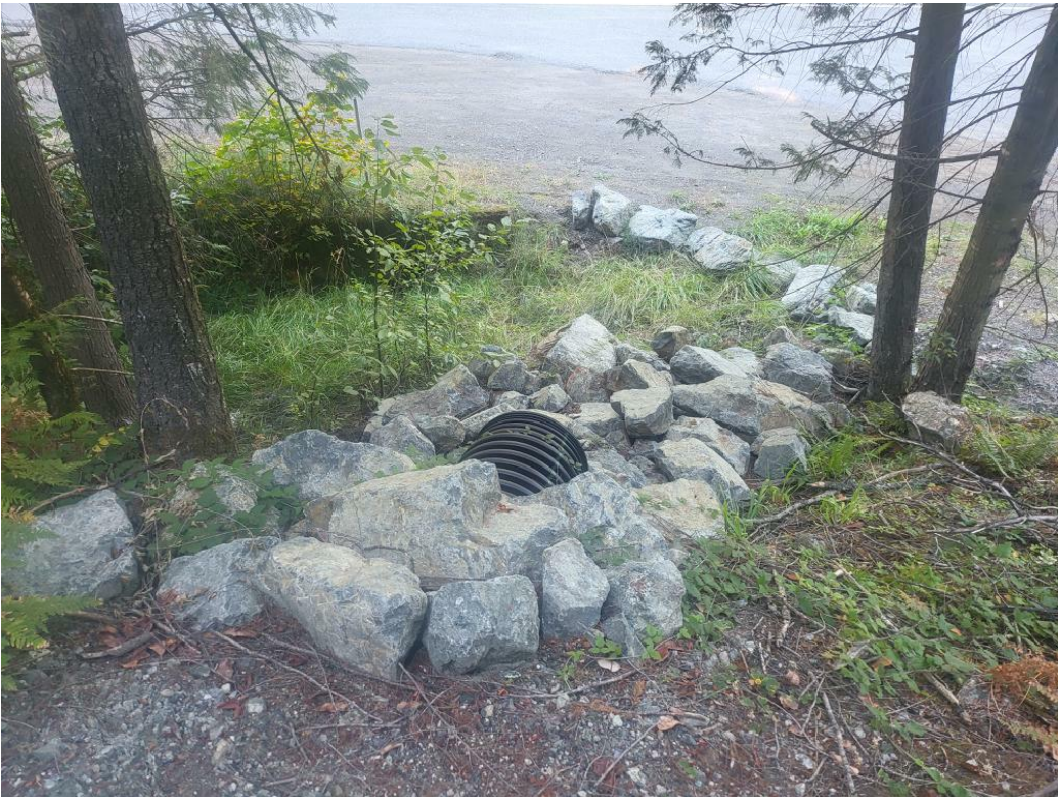
Figure 54: MP21 culvert outlet.

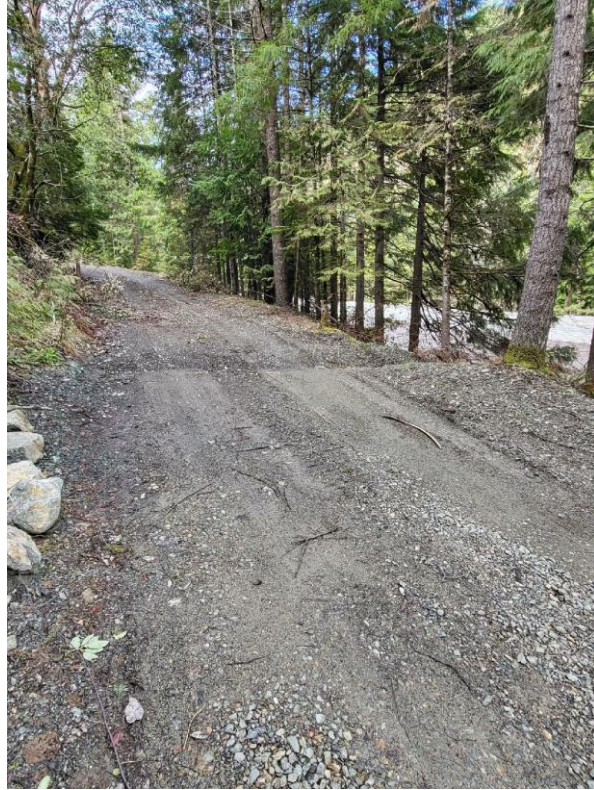
Figure 55: Water bar on roadway above MP21.

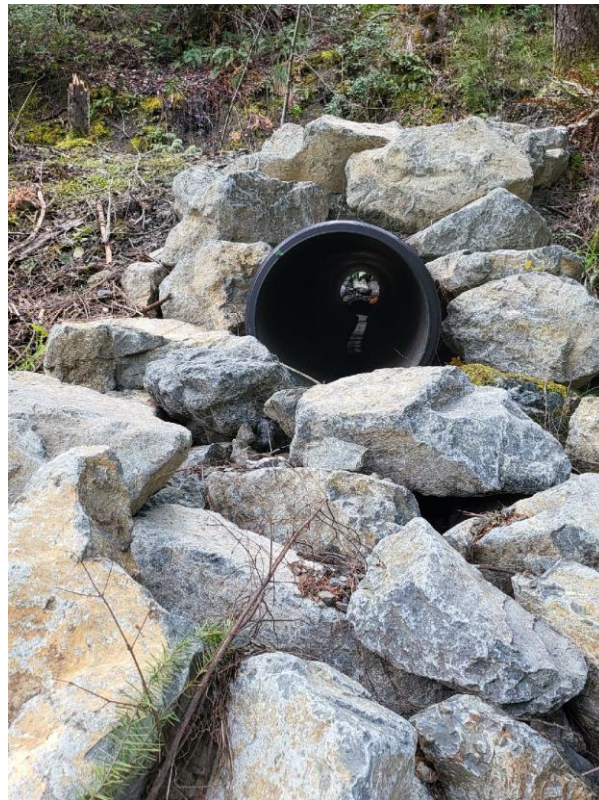
Figure 56: MP21 culvert.
