December 11th, 2020

NOTIFICATION NO. 1600-2019-0013-R1 – PROJECT INSPECTION REPORT

The points being inspected consist of the Stream Crossings #1-3 as referenced in the LSAA. The following specifies the crossing upgrades or decommissioning that were completed as described in the LSAA:

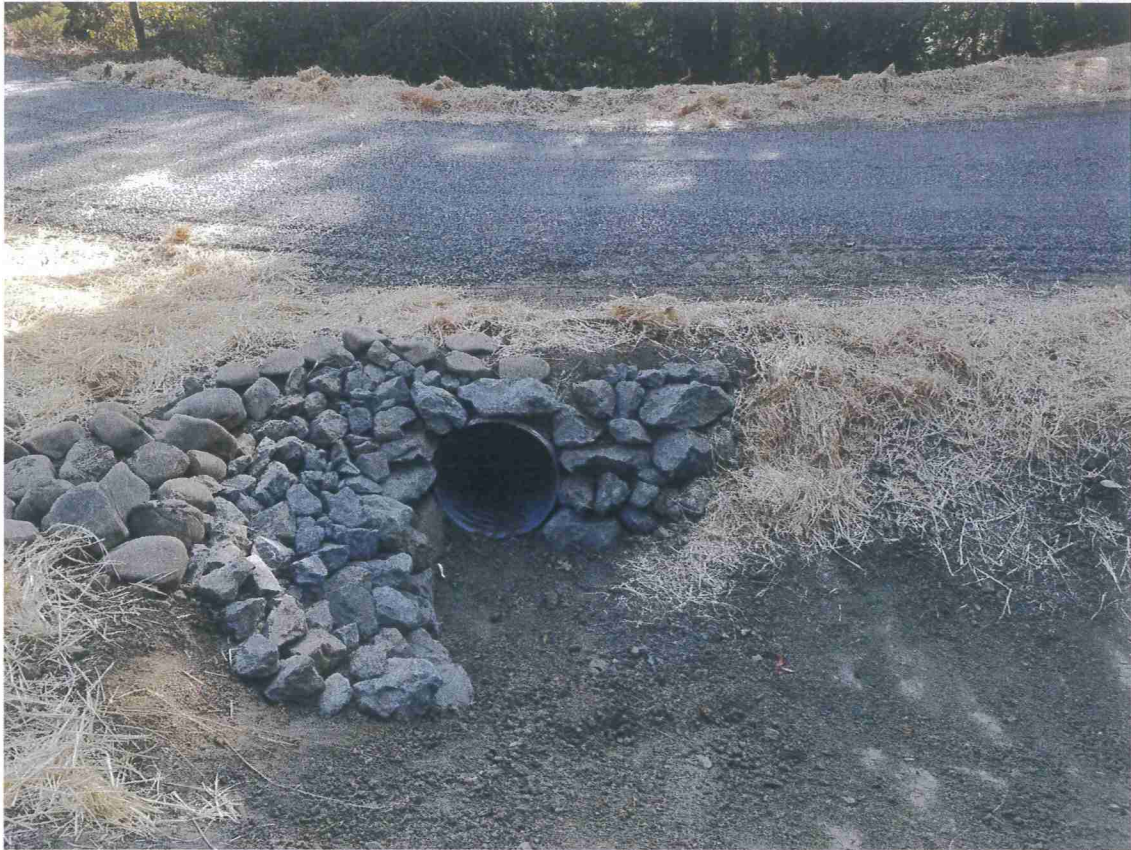
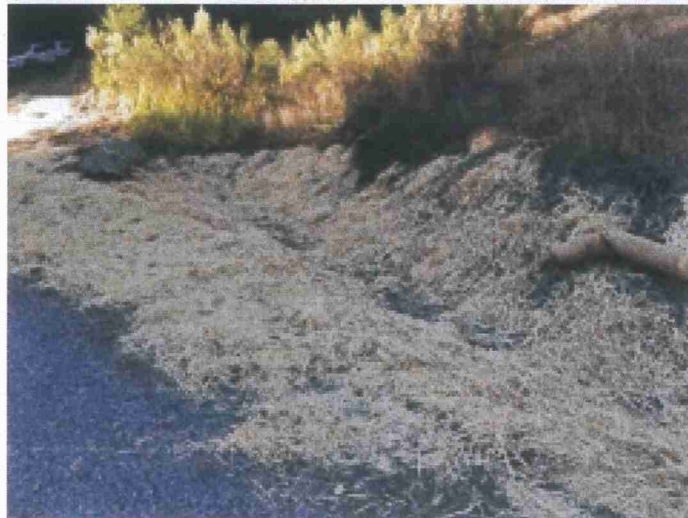
Picture 1 & 2: Crossing #1's inlet (top). Looking upstream from Crossing #1's inlet in the process of Erosion Control being applied. (bottom photo was provided by the Applicant on 11-12-2020.)

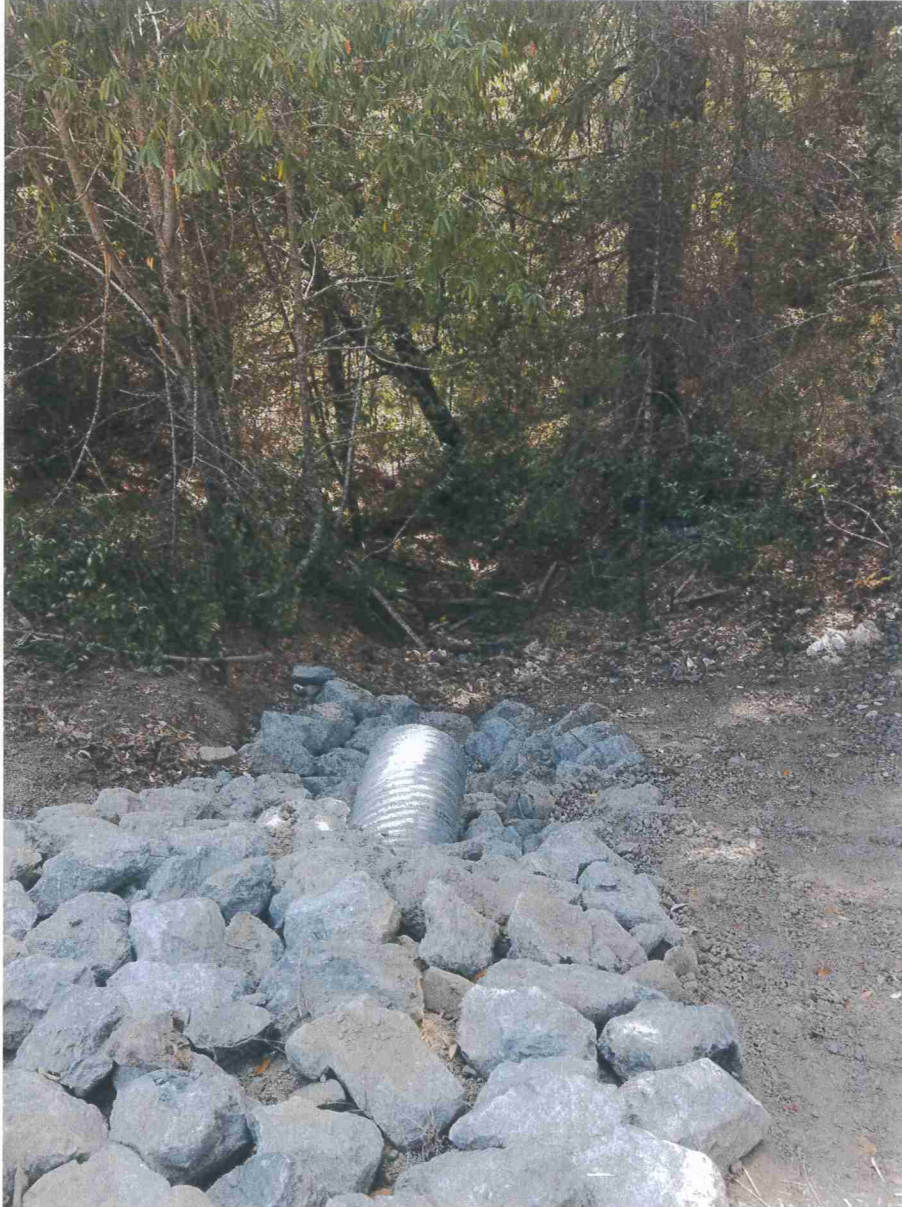
Picture 3: Crossing #1's outlet.

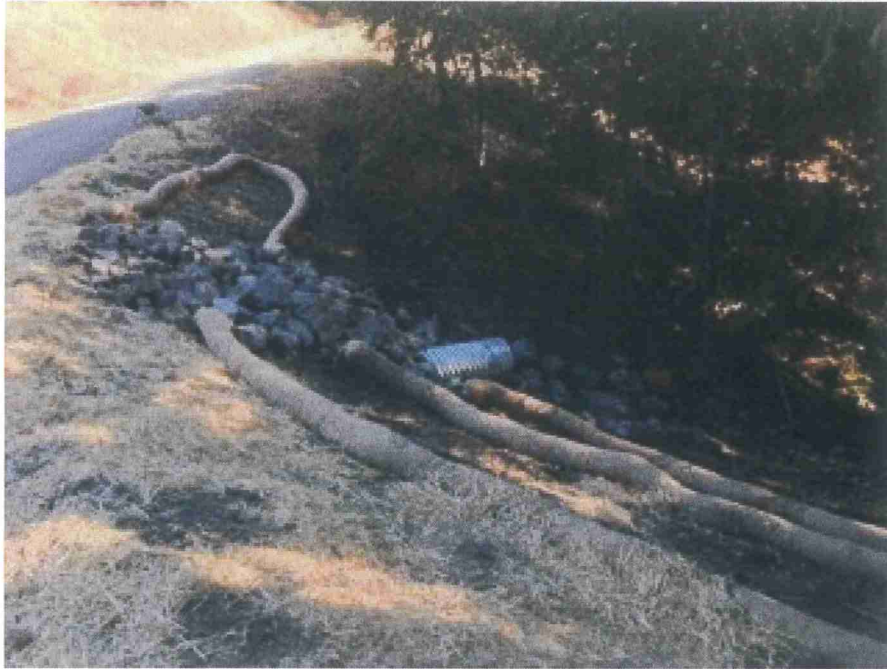
Picture 4: Crossing #1's outlet in the process of Erosion Control being applied. (photo was provided by the Applicant on 11-12-2020).

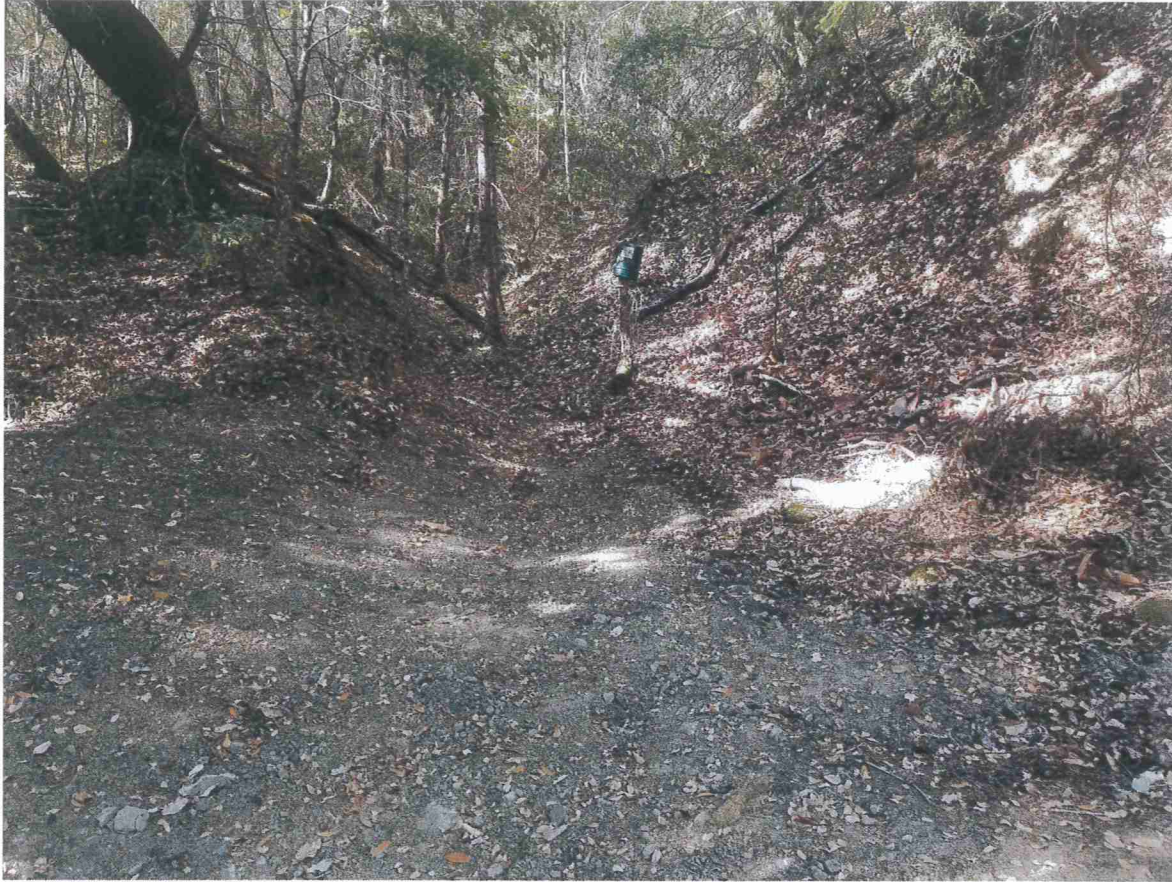
Picture 5: Crossing #2's inlet.

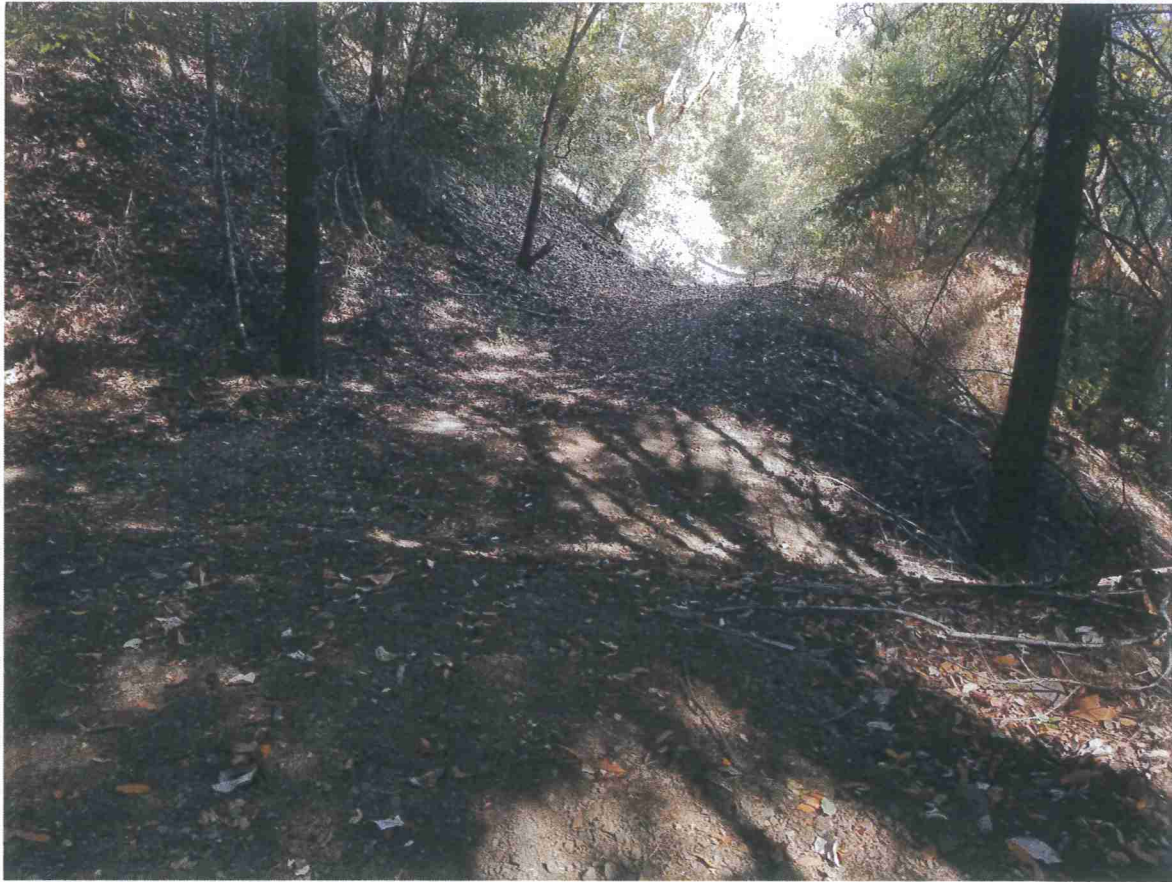
Picture 6: Crossing #2's outlet.

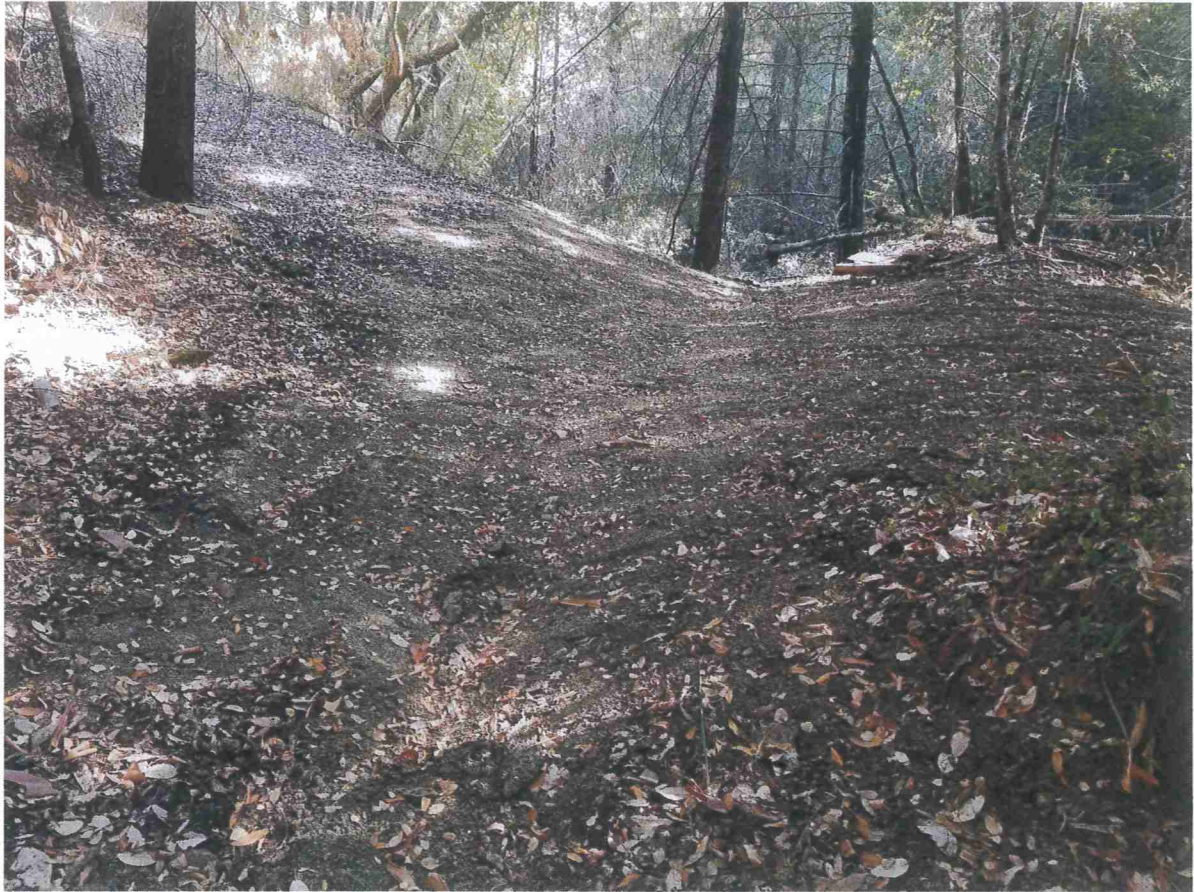
Picture 7: Crossing #2's Decommissioned.

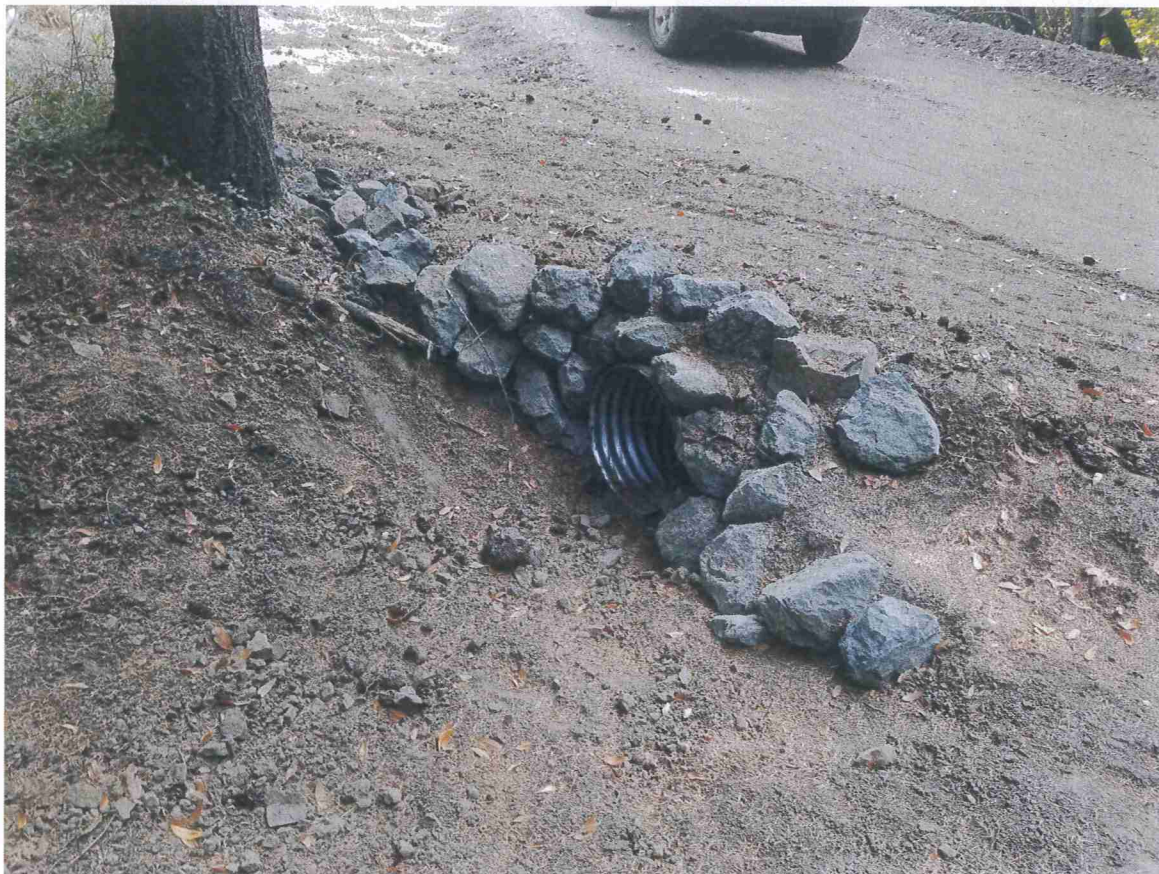
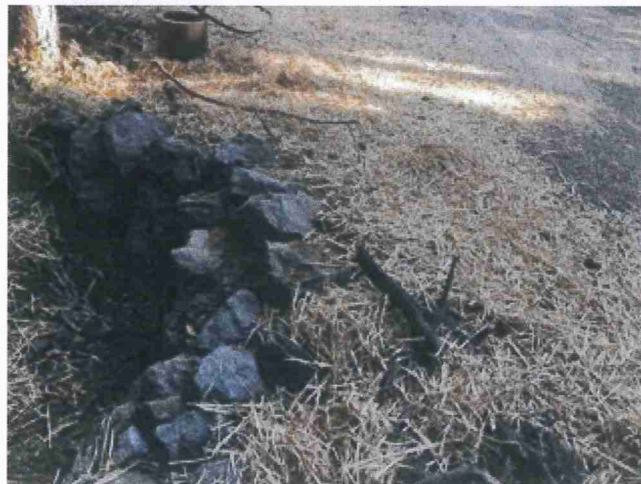
Picture 8 & 9: Crossing #3's inlet (top). Crossing #1's inlet in the process of Erosion Control being applied. (bottom photo was provided by the Applicant on 11-12-2020.)

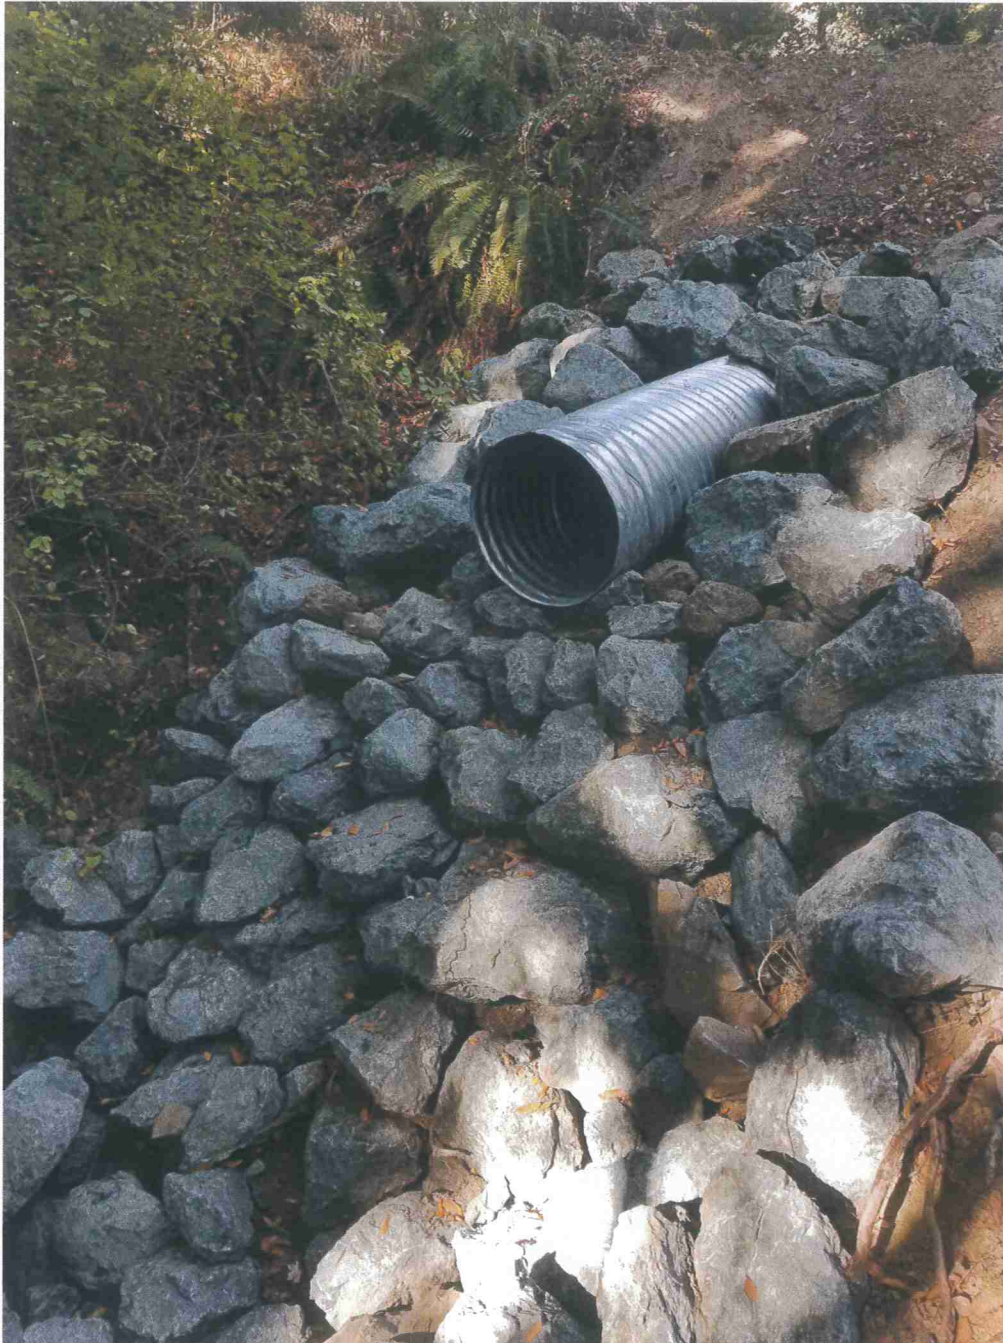
Picture 10: Crossing #3's outlet.

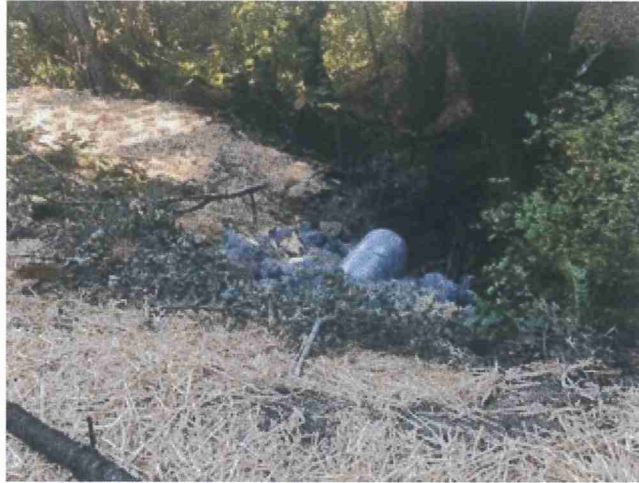
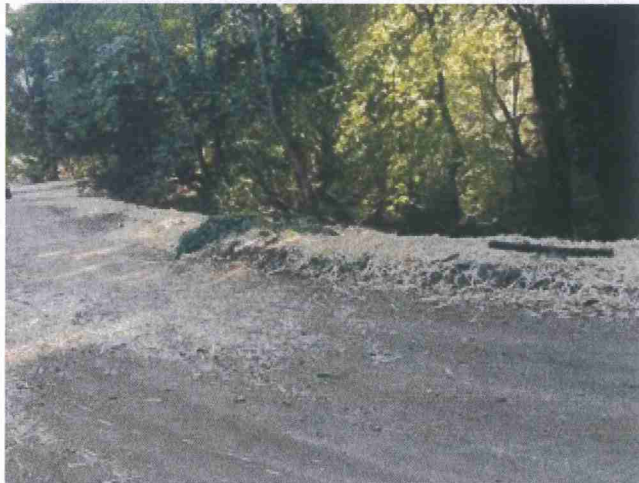
Picture 11 & 12: Crossing #3's outlet in the process of Erosion Control being applied. (photos were provided by the Applicant on 11-12-2020.)
