Restoration Plan

APN 311-221-026

Revised April 20th, 2023

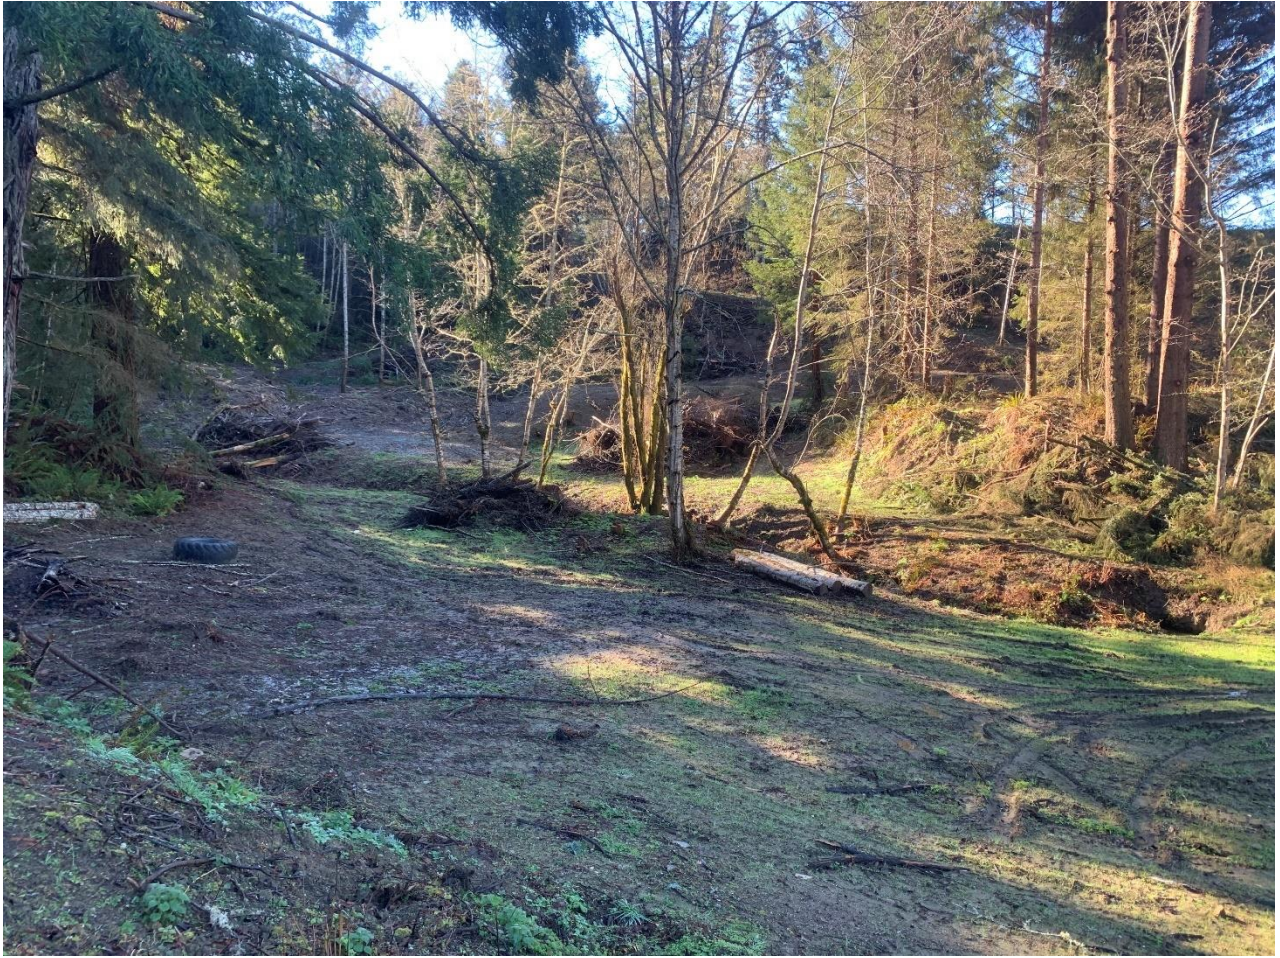
Photo #1: Northernmost Legacy Log Landing / Developed Flat in the SMA located on the north side of Willow Brook.

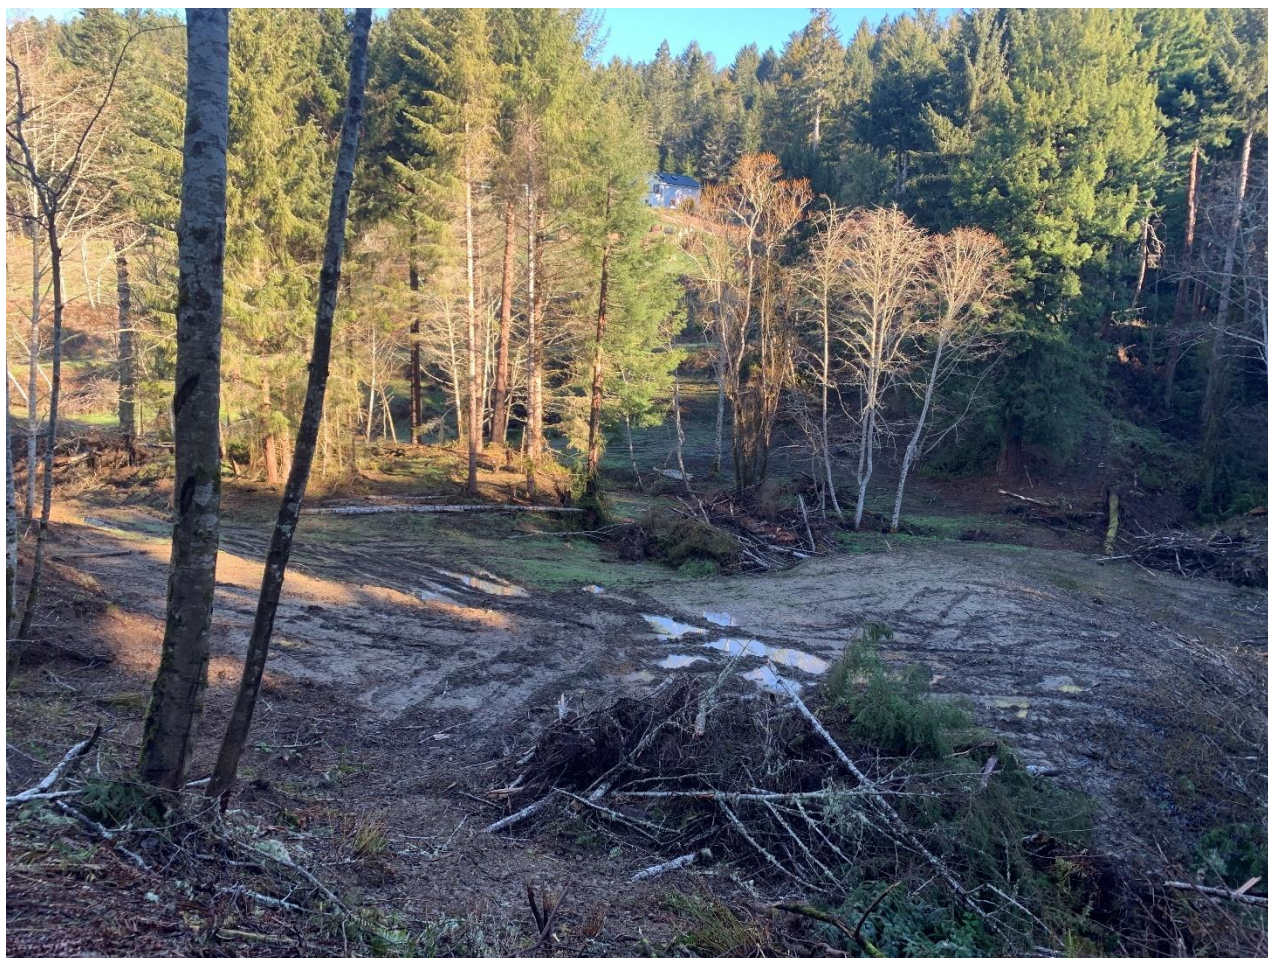
Photo #2: Southernmost Legacy Log Landing / Developed Flat in the SMA located on the south side of Willow Brook.

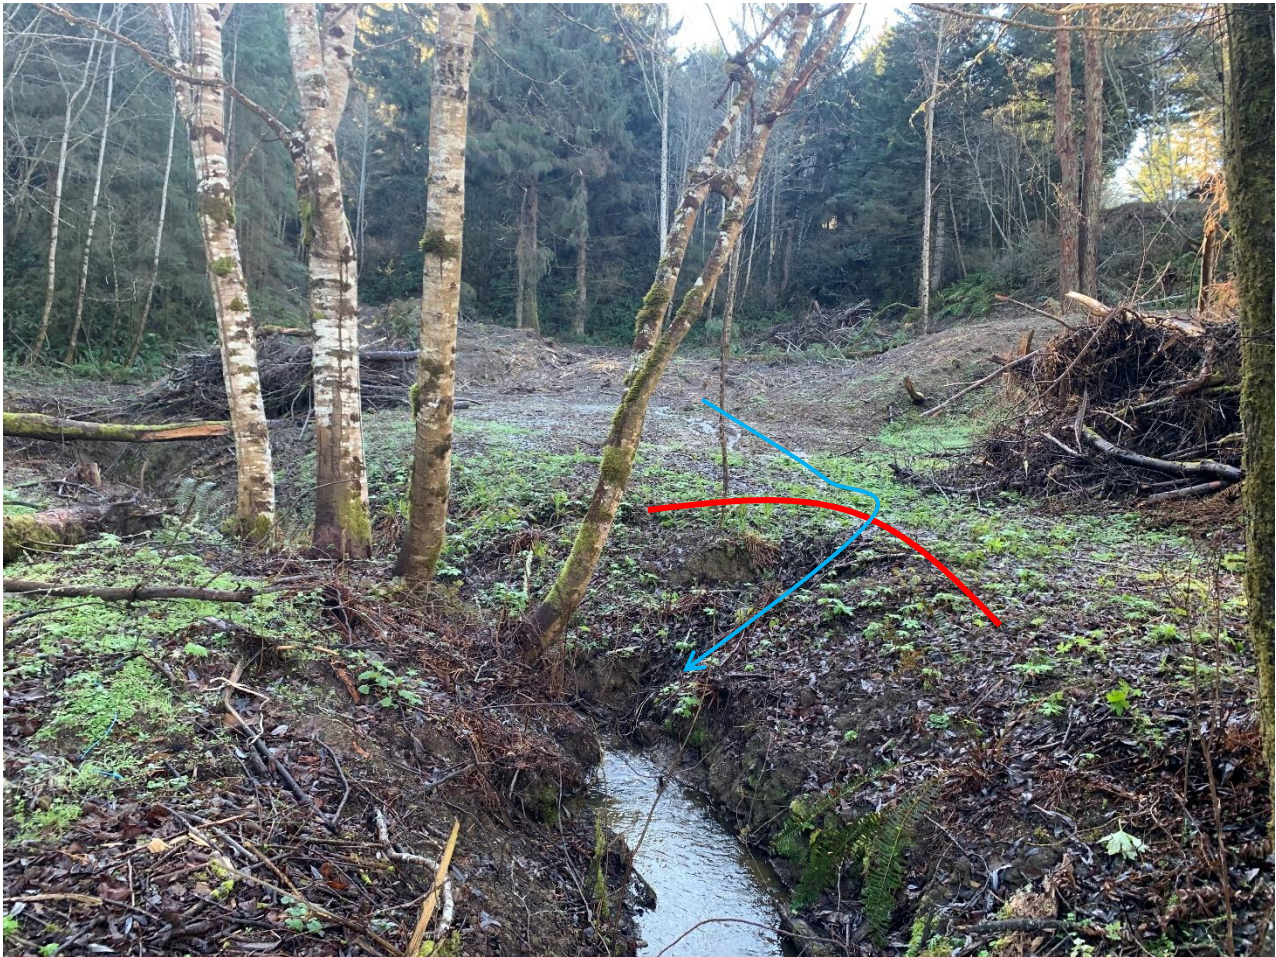
Two locations were identified, as shown on the Restoration Plan Map, which are potential conduits for sediment entering Willow Brook. Concentrated surface runoff from the north and south side of Willow Brook are discharging directly into the stream channel. The disturbed areas in the SMA are expected to revegetate quickly with native vegetation, which will be capable of trapping sediment before it enters the stream. However, in the interim the landowner shall place straw waddles in the locations shown on the Restoration Plan Map and as depicted on the attached photographs. In addition, the landowner shall apply Native Erosion Control Mix (distributed by Pacific Coast seed) to disturbed soils within the SMA. This seed mix consists of the following:

Photo #3: Concentrated surface runoff entering Willow Brook from the southside of the stream highlighted in blue. The landowner shall place straw waddles at the area highlighted in red.

1. Plant redwood trees in the areas depicted on the Restoration Plan Map to the specifications stated in the Restocking Plan.
2. Apply Native Erosion Control Mix to all disturbed soil in the SMA at a rate of 45 pounds per acre.
3. Place straw waddles in the locations shown on the Restoration Plan Map and as depicted on the attached photographs.

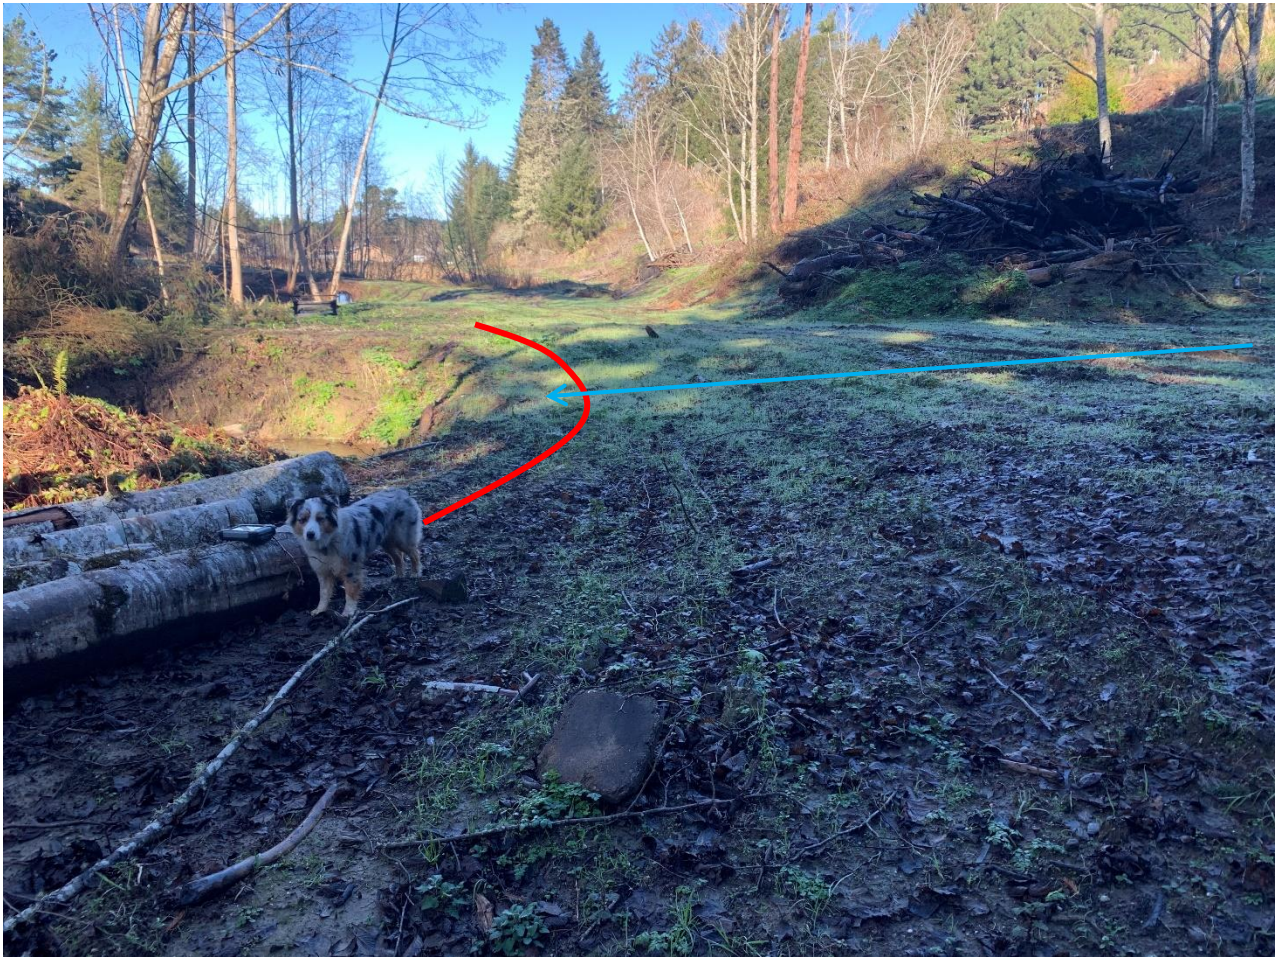
Photo #4: Concentrated surface runoff entering Willow Brook from the northside of the stream highlighted in blue. The landowner shall place straw waddles at the area highlighted in red.

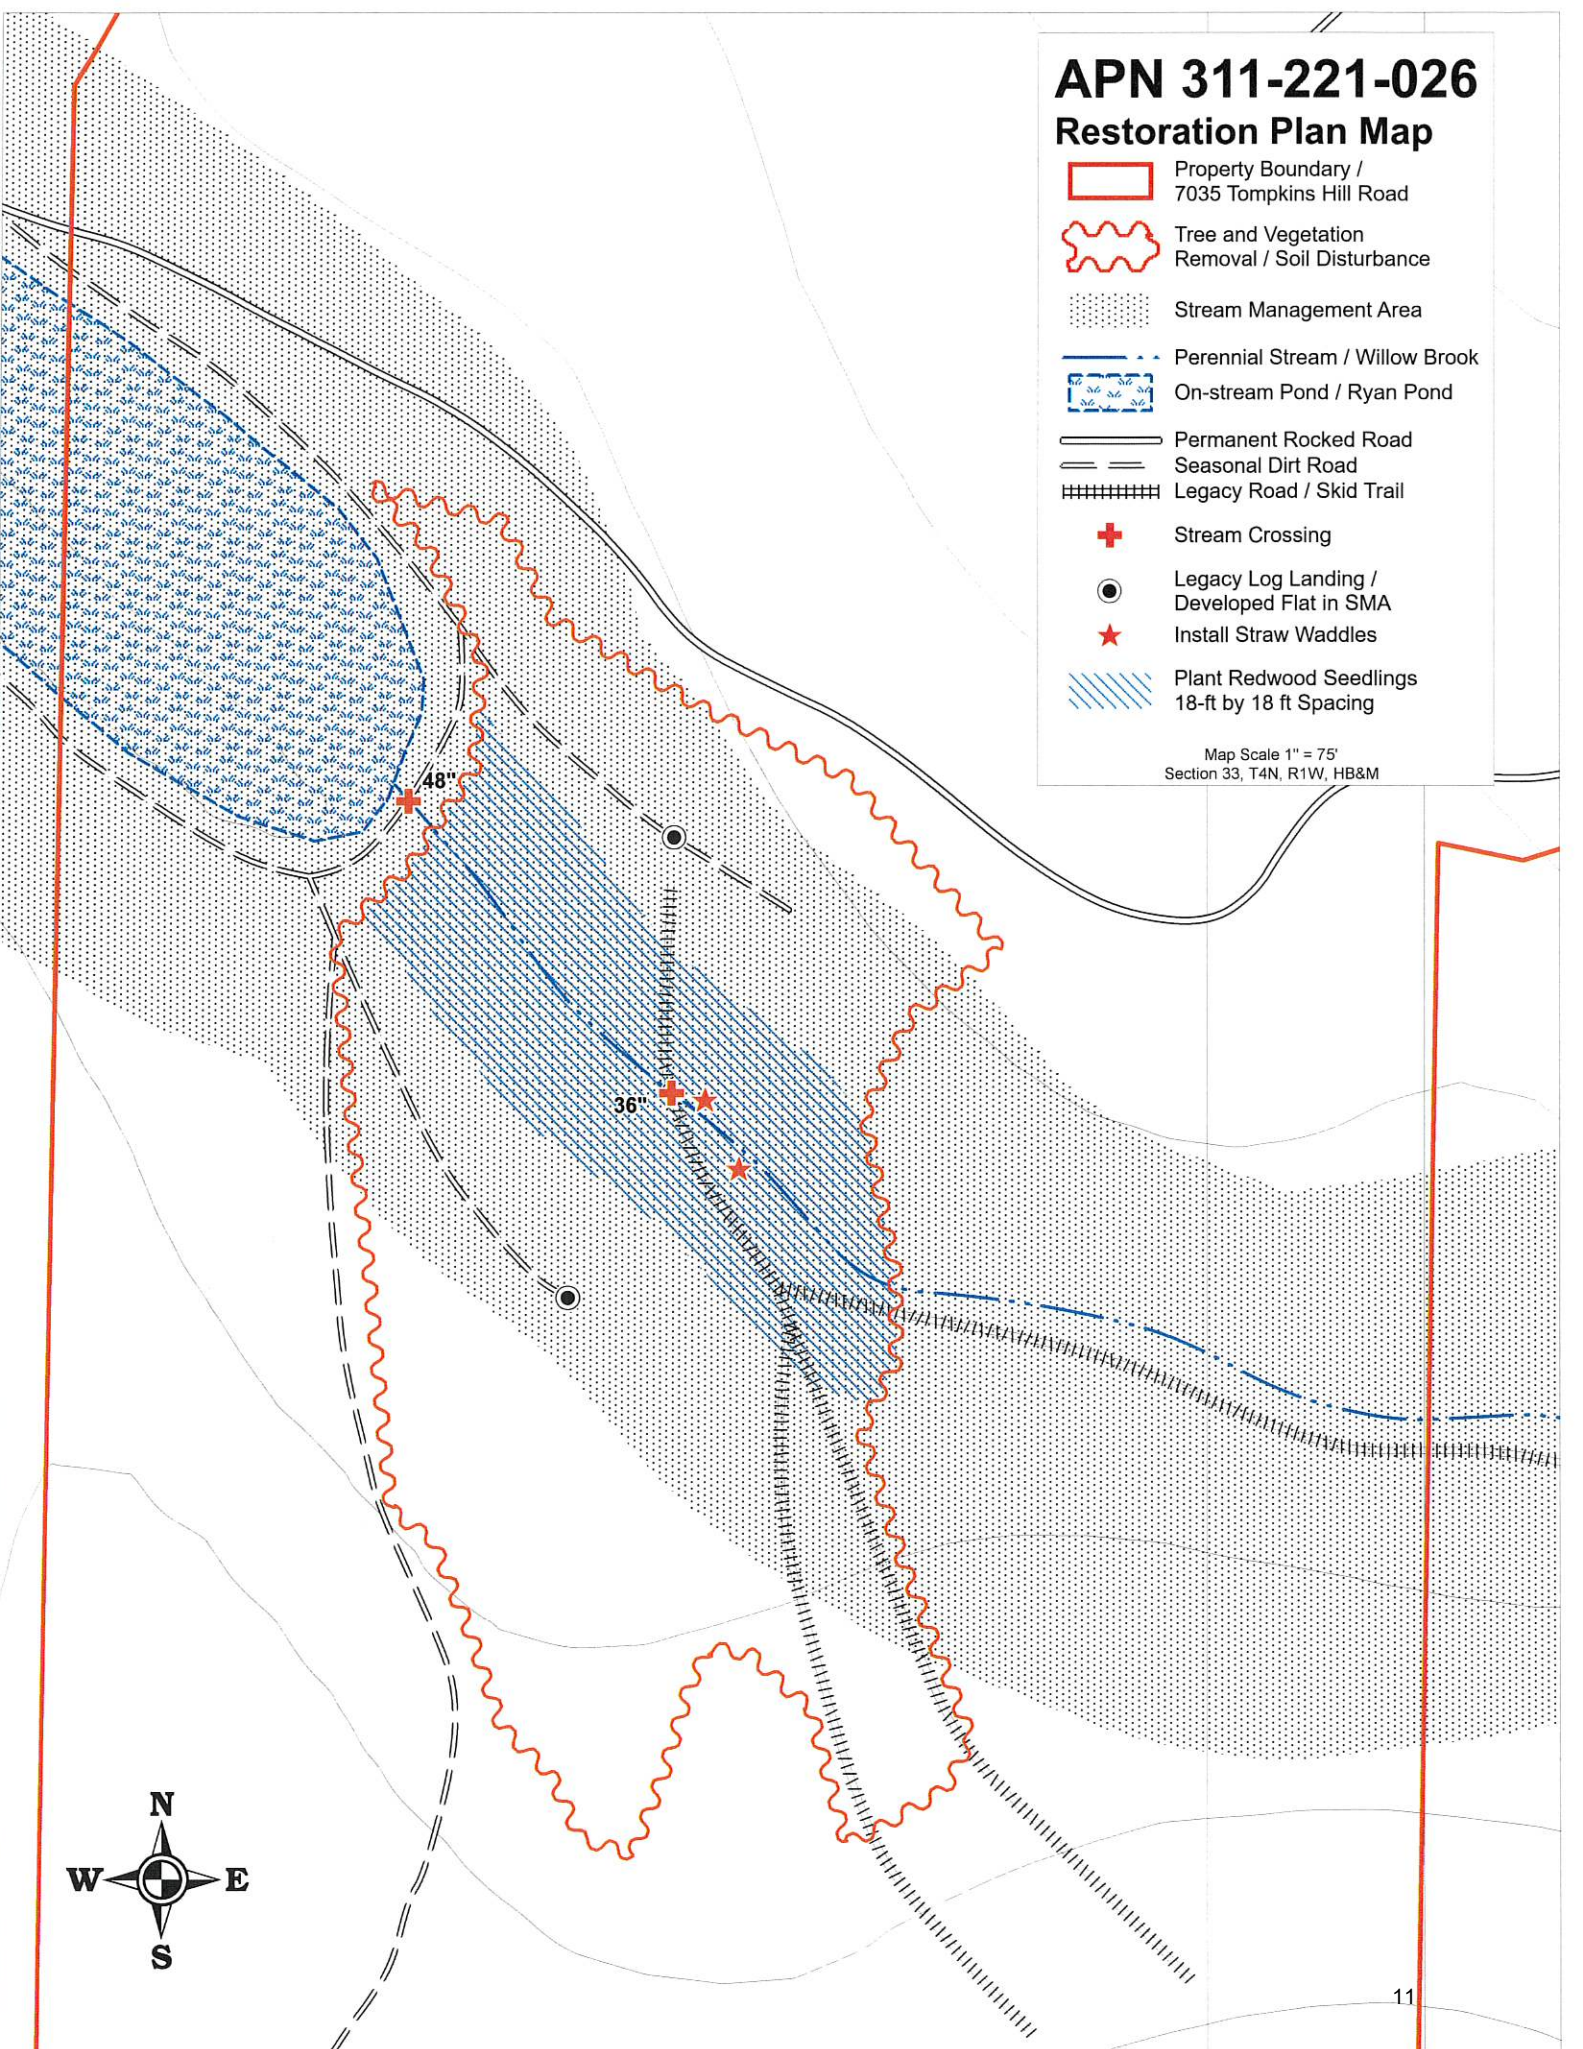
Restoration Plan Map

The removal of downed and wind-damaged red alder trees occurred on approximately 2.46 acres as shown on the Restoration Plan Map. 1.70 acres of salvage tree removal occurred within the SMA. The salvaging of downed and damaged trees resulted in the disturbance of soil and loss of vegetation as shown on the attached photographs. The salvage operation appears to have primarily utilized existing roads, skid trails, and log landings which are visible in historic aerial imagery and LIDAR imagery. The RPF did not observe any grading that involved the cutting and placement of fill material. Sash and woody debris created during the removal of downed and wind-damaged red alder trees was piled for future burning, and mechanically chipped which is providing ground cover to portions of the SMA. However, disturbed soil exists and two locations were identified as potential conduits to sediment entering Willow Brook.
