ATTACHMENT 1b  
Sprowl Creek Full Resubmittal

# ETA Humboldt, LLC

25 July 2023

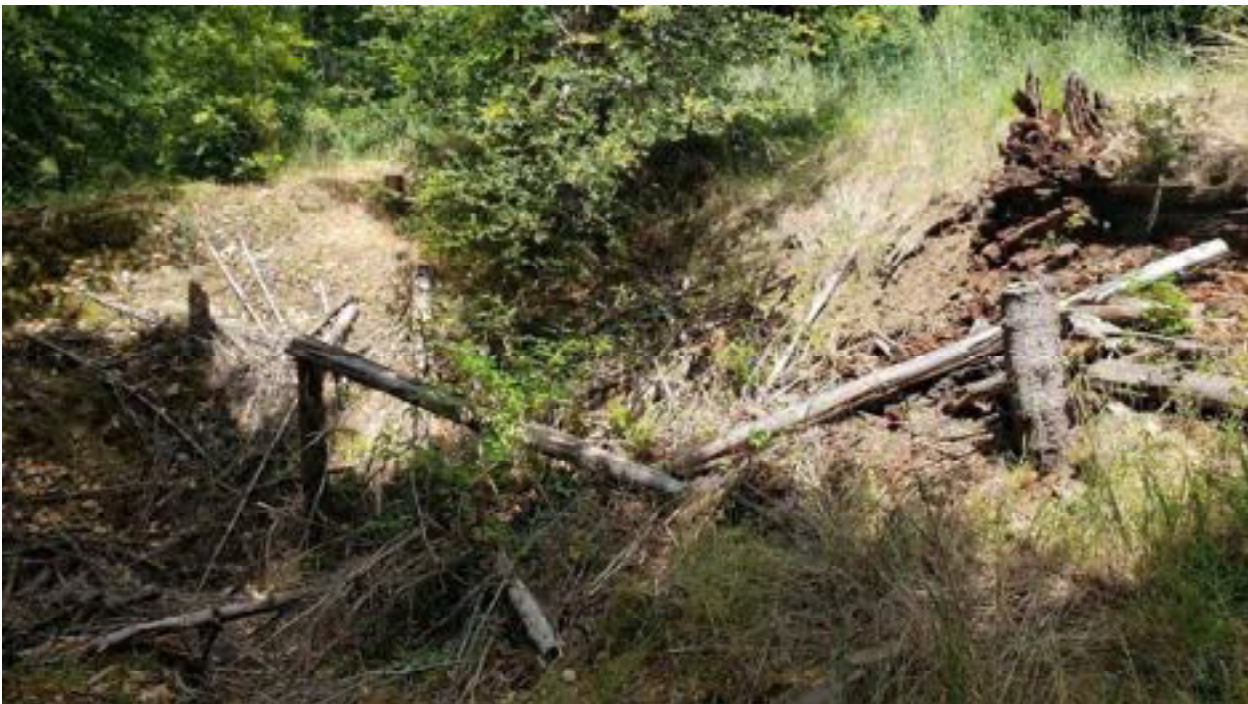
Site 19. Looking at the outlet.

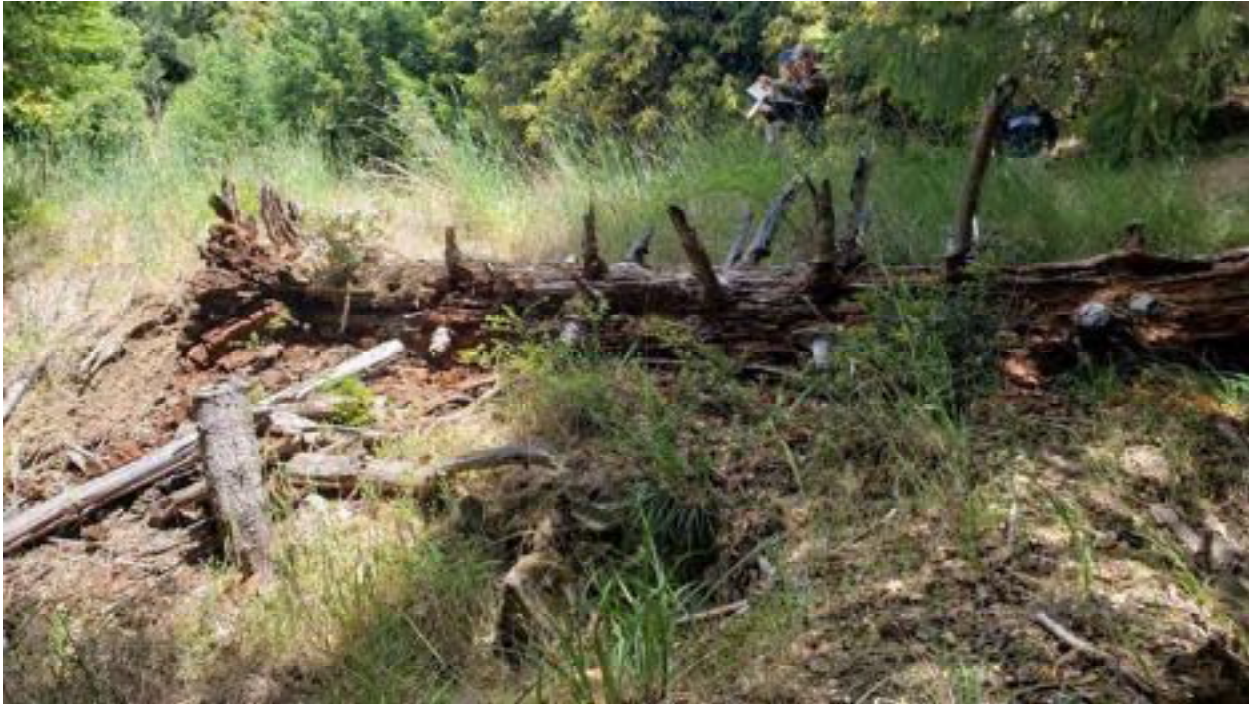
Site 19. Photo of the southeastern embankment of G5/G6/G, immediately down stream of the outlet of the watercourse crossing at Site 19. Note vegetation and rotted tree in the upper right. Indicative that this location has been in this condition for many years and was not recently created.

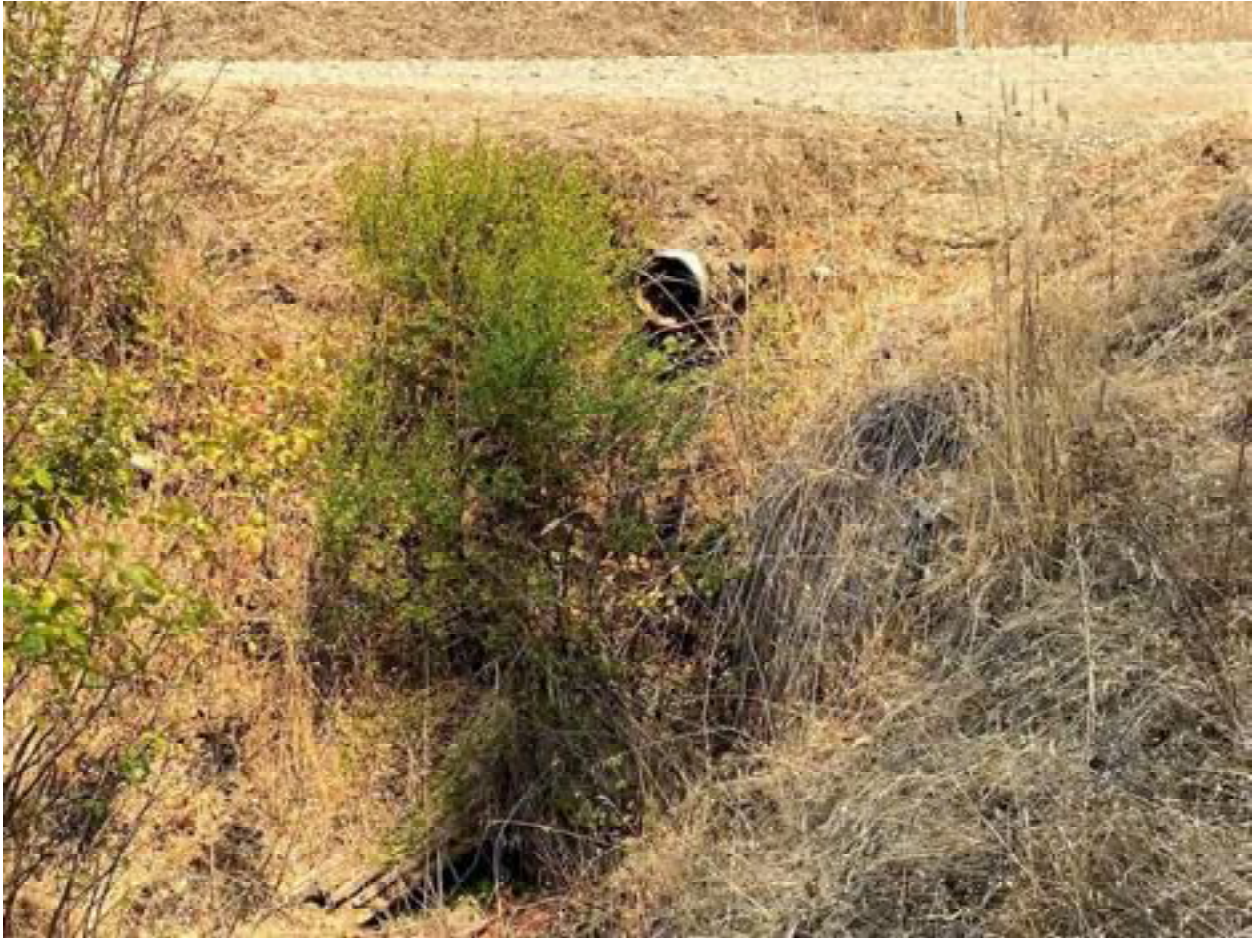
**Photo 9:** Stream Crossing 03. Looking upstream towards the outlet of the 8-inch diameter culvert at stream crossing 03. Photo date 9-1-2021.

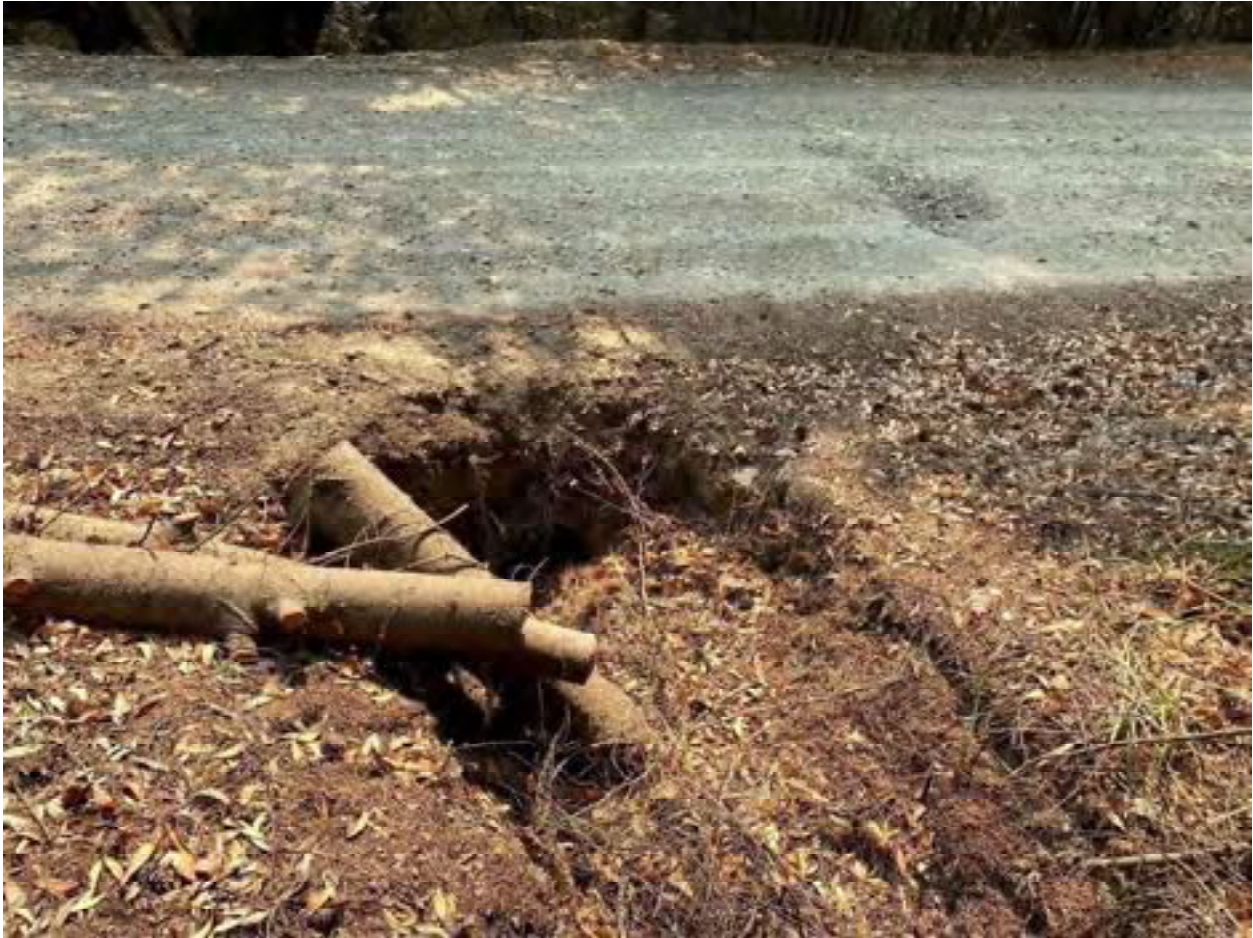
**Photo 21:** Stream Crossing 06. Looking downstream towards the inlet of the 12-inch diameter culvert at stream crossing 06. Photo date 9-1-2021.

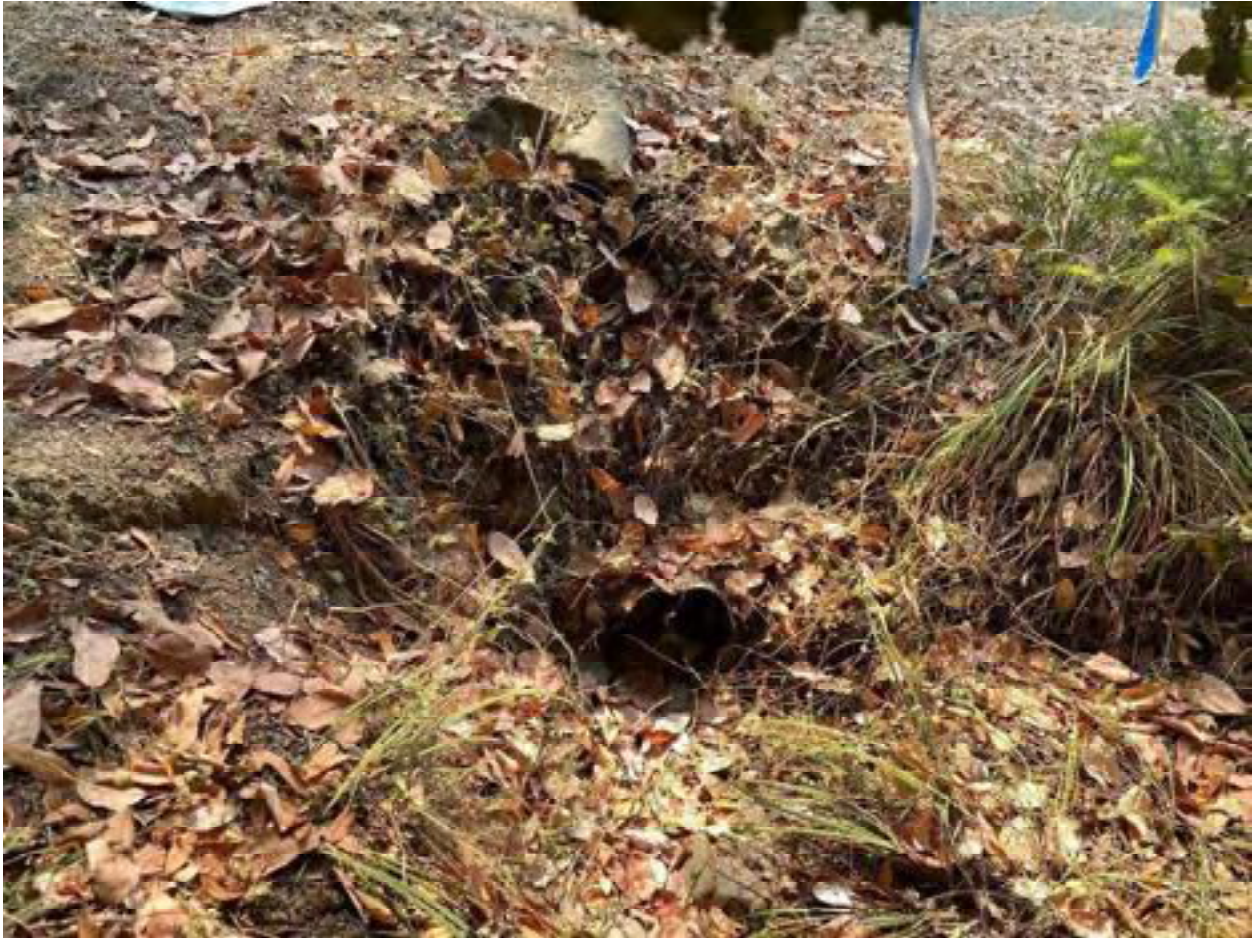
**Photo 25:** Stream Crossing 07. Looking downstream towards the inlet of the 12-inch diameter culvert at stream crossing 07. Photo date 9-1-2021.

Site 07/P1/WQ 7	-123.839607 40.019924	Permanent	X	X	X	Prior to 10/15/23 pending the approval of any required permits	
<p>Current Condition: Class III watercourse crossing consisting of a 12" diameter corrugated metal pipe that is too short, shotgunned, not-to-grade, eroding the road fillslope at the outlet, and undersized for the 100-year storm event.</p>						<p>Prescribed Action: Upgrade the existing culvert with an 30" diameter culvert per the specifications in the attached BMP's. See Permanent Culvert Crossing, Permanent Culvert Crossing Design: Critical Dip and Hydrologic Disconnect Placement, Critical Dip, Culvert Orientation, Inlet and Outlet Armoring, General Operations BMPs, and General Erosion Control specifications.</p>	
Unique Point	Lat-Long NAD 83	Road Type	Mitigation Planned	Monitor	1600	Treatment Priority	Date Completed
Site 08/WQ 8	-123.840219 40.019507	Permanent	X	X	X	Prior to 10/15/23 pending the approval of any required permits

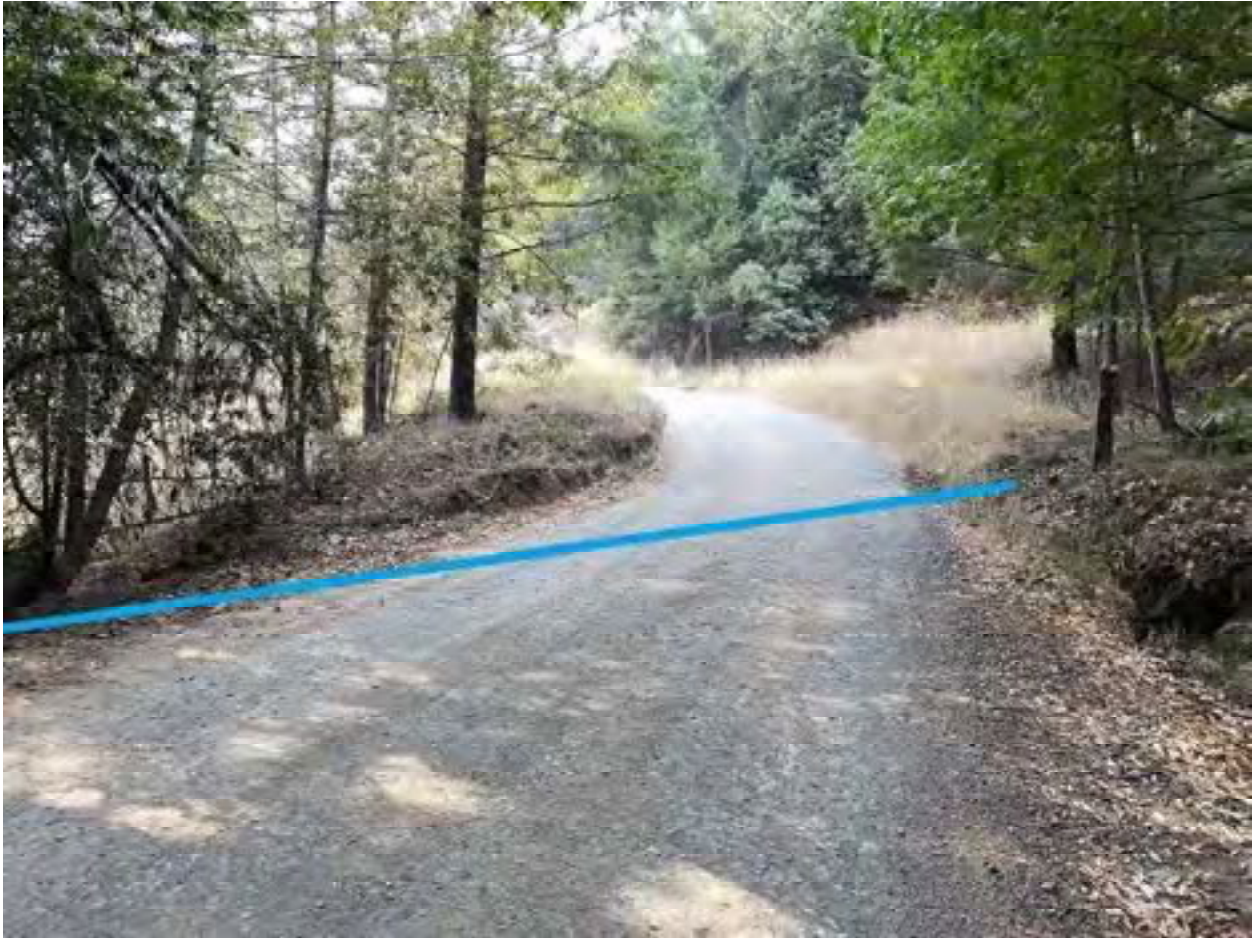
**Photo 42:** Stream Crossing 13. The roadside approach to stream crossing 13 facing North. The blue line indicates where the proposed culvert will be installed in-line with the native stream channel. Photo date 9-1-2021.

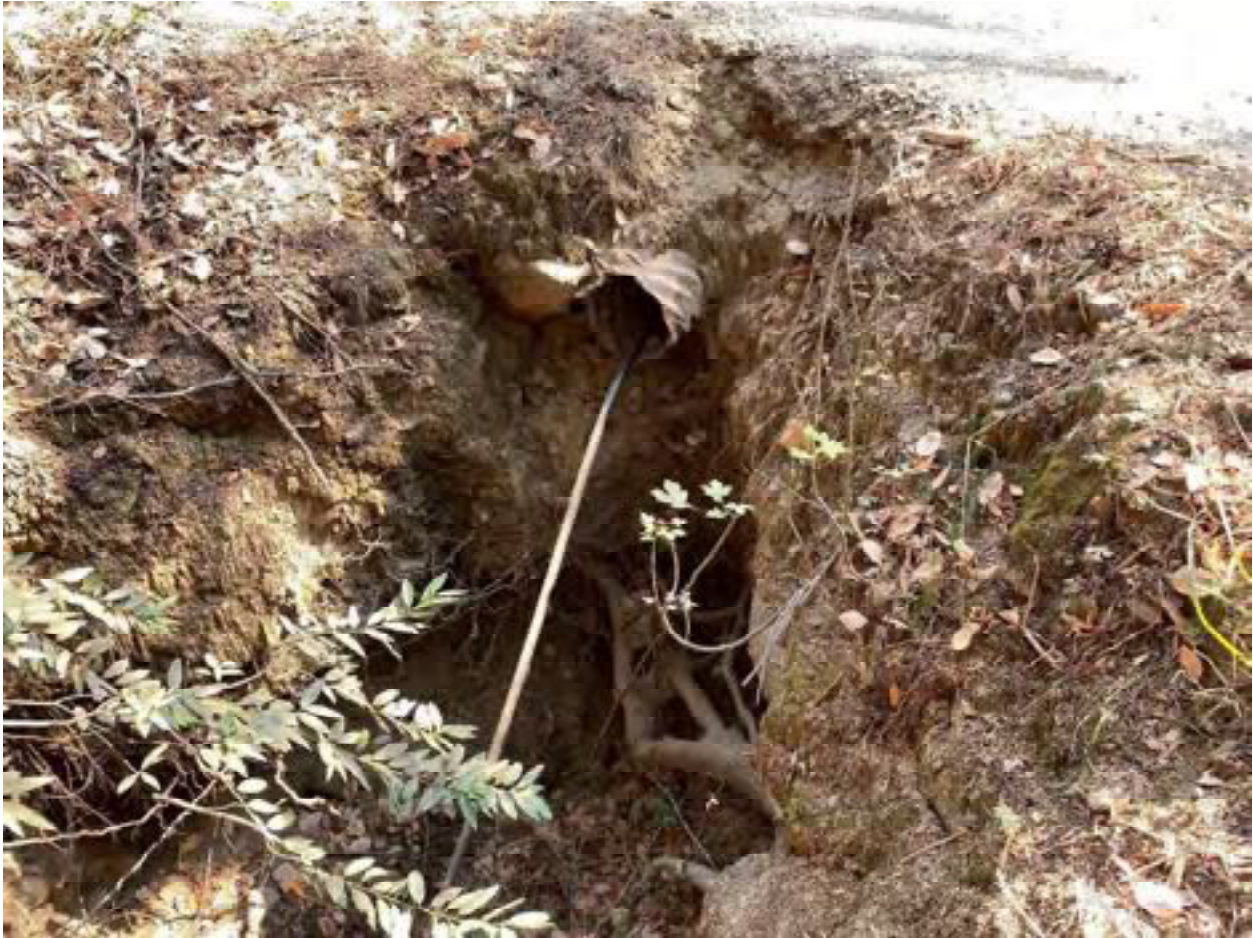
**Photo 45:** Stream Crossing 13. Looking upstream towards the outlet of the 12-inch DRC that is the current outlet of the water from stream crossing 13. Photo date 9-1-2021.

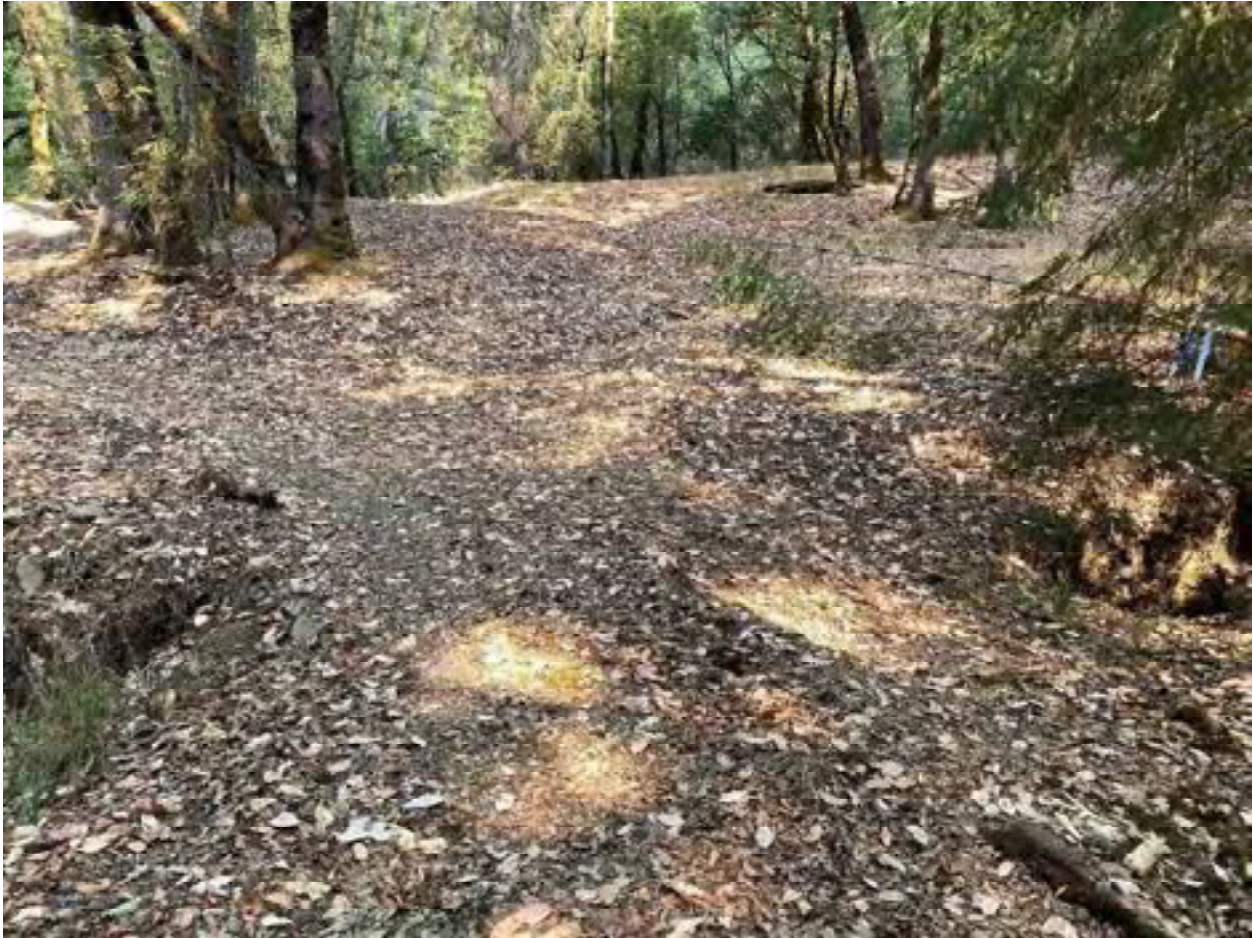
**Photo 49:** Stream Crossing 17. The roadside approach to stream crossing 17 that is proposed for removal facing East. Photo date 9-1-2021.

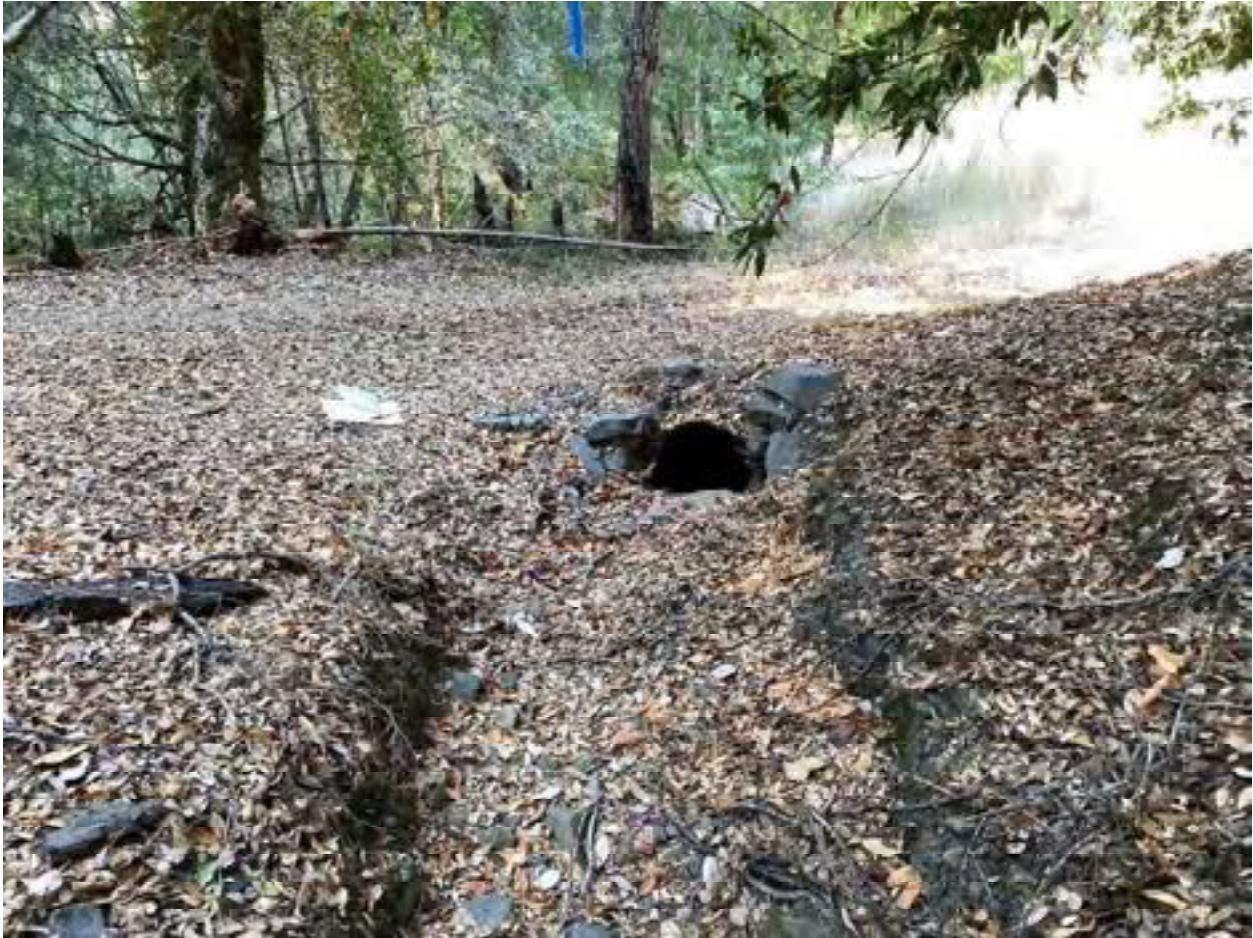
**Photo 52:** Stream Crossing 19. Looking downstream towards the inlet of the 18-inch diameter culvert that is proposed for removal at stream crossing 19. Photo date 9-1-2021.

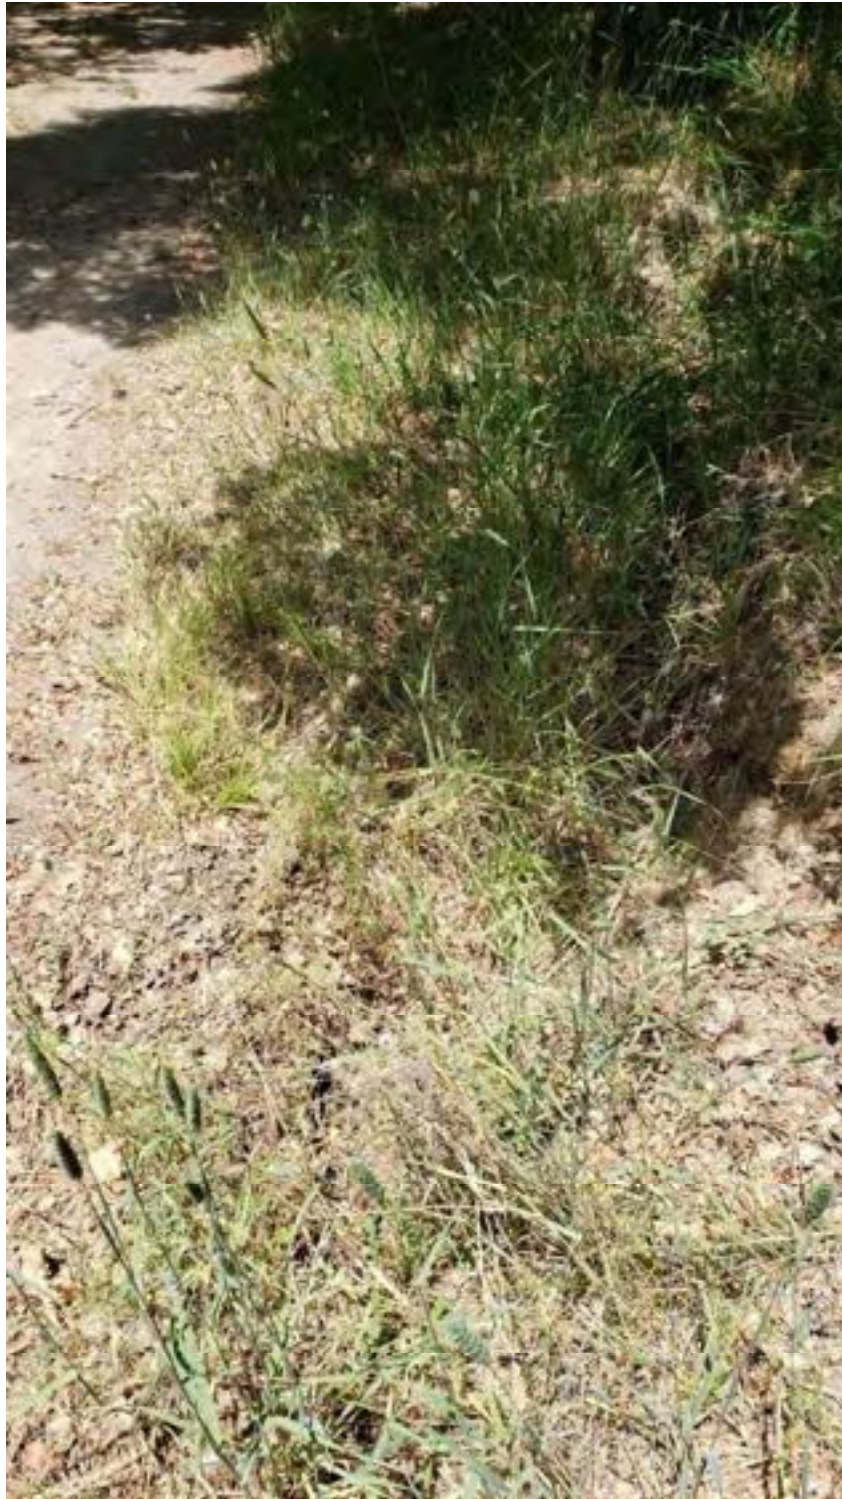
**Photo 73:** Stream Crossing 35. Looking towards the inlet of the 8-inch diameter culvert at stream crossing 35. Photo date 6-8-2021.
