DEPARTMENT OF FISH AND WILDLIFE
Northern Region, Eureka Field Office
619 2nd Street
Eureka, CA 95501

Field Note: Stream Setback Measurements and Coho Salmon Detections in Noisy Creek, Tributary to the Mad River, Humboldt County, California.

Survey Date: January 30, 2025

Survey Location: Kernen Construction (2350 Glendale Dr, McKinleyville, CA 95519) northern operations yard (APN 516-151-016). Lat/Long: 40.898260, -124.009751.

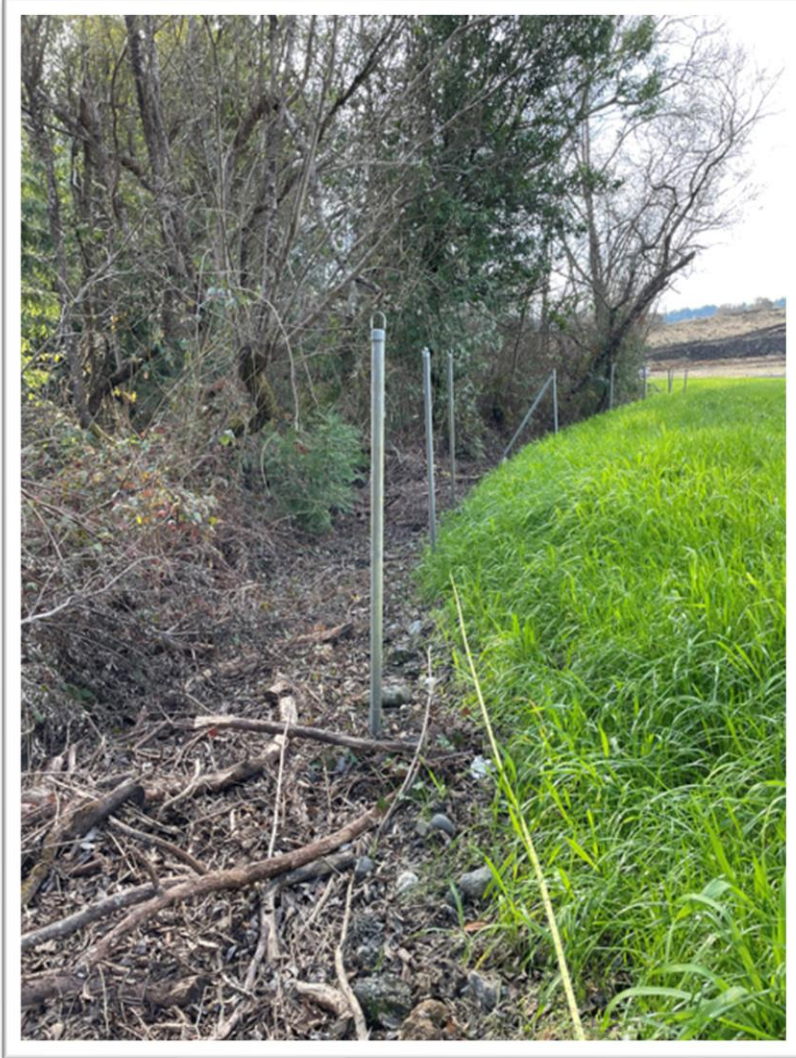
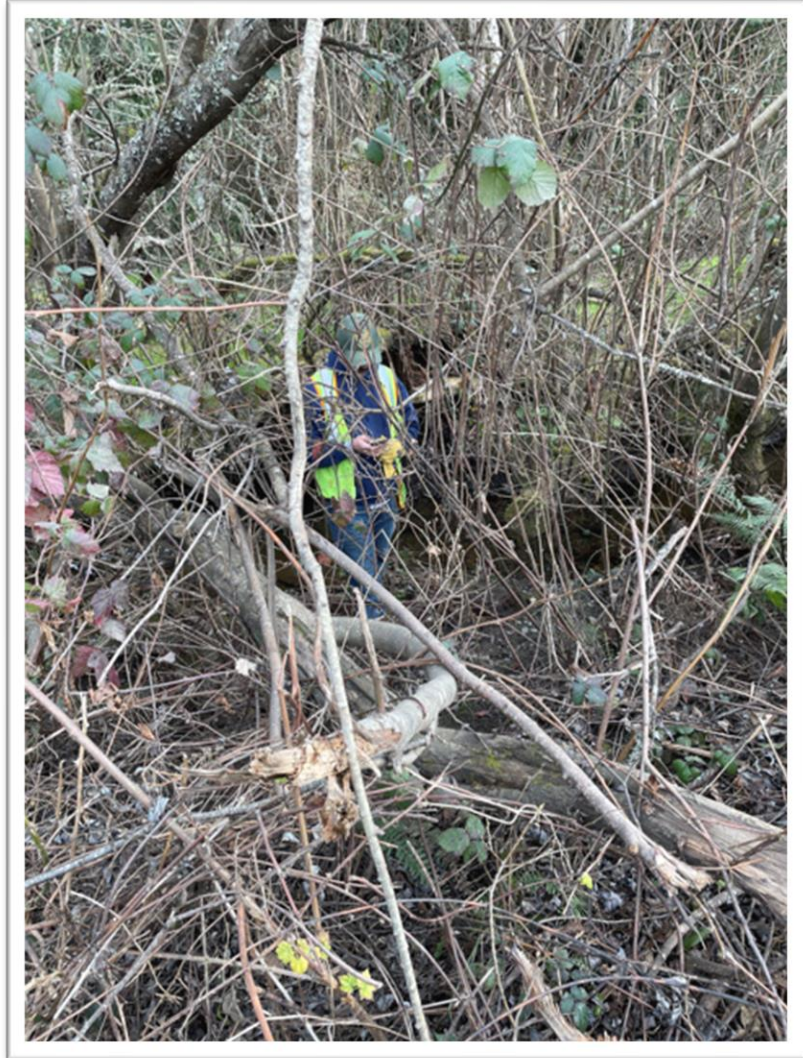
Figure 2. Characteristic riparian vegetation along the western bank of Noisy Creek. Red alder and willow dominate the overstory layer (left), with an understory primarily composed of Himalayan blackberry (right).

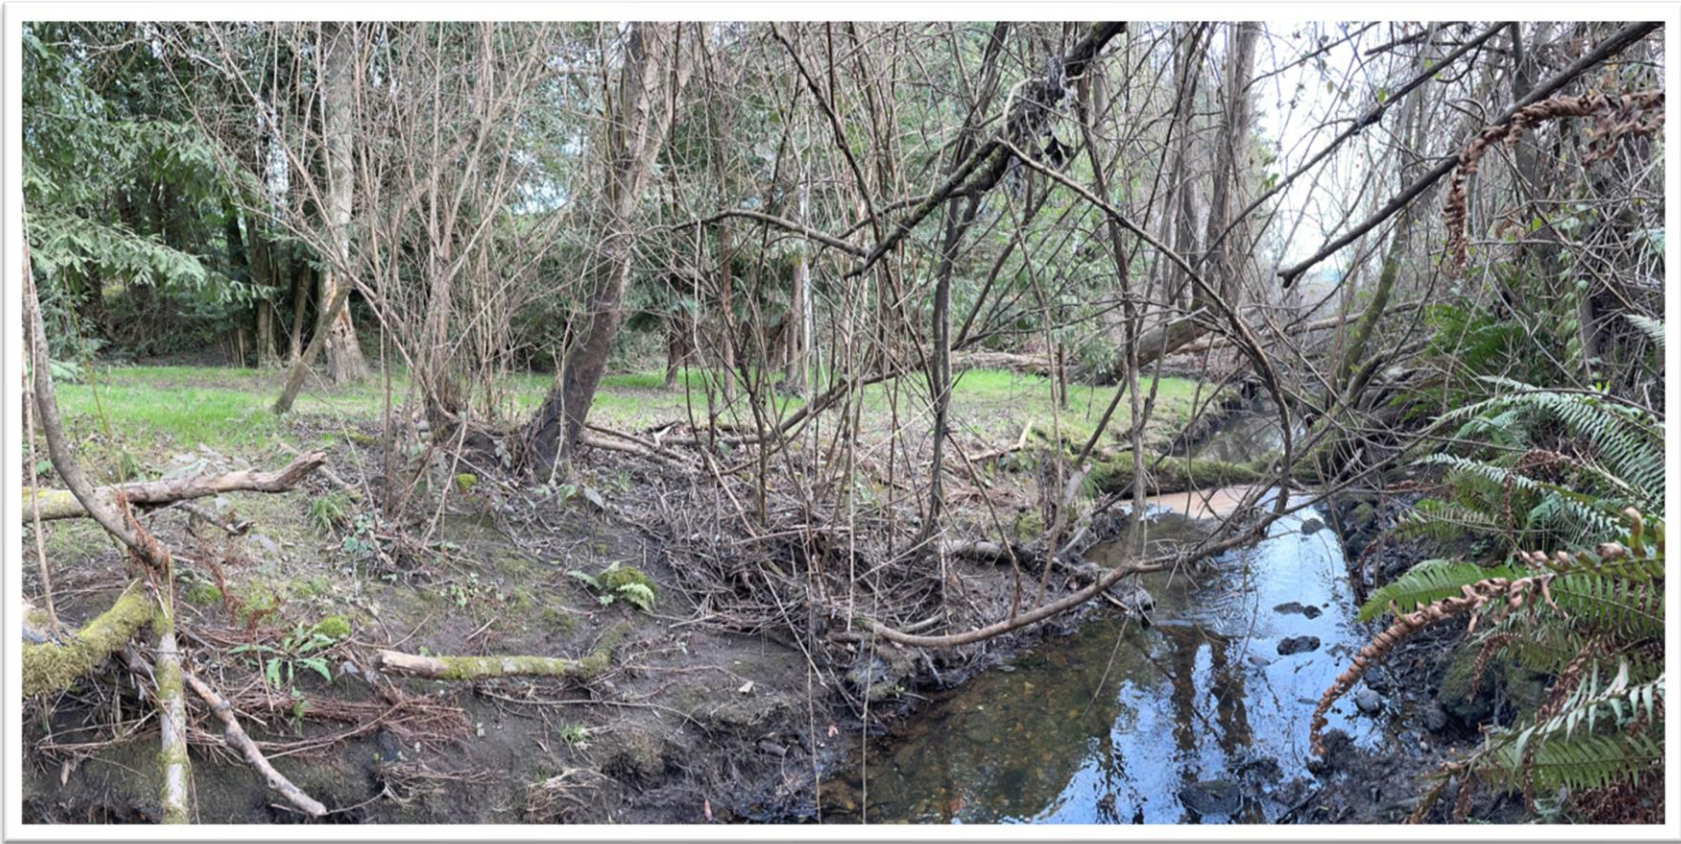
Figure 3. Floodplain terrace along the left bank (eastern side of Noisy Creek, with an overstory of red alder and willow. The understory shrub and herbaceous layers were sparse compared to the western bank (right).

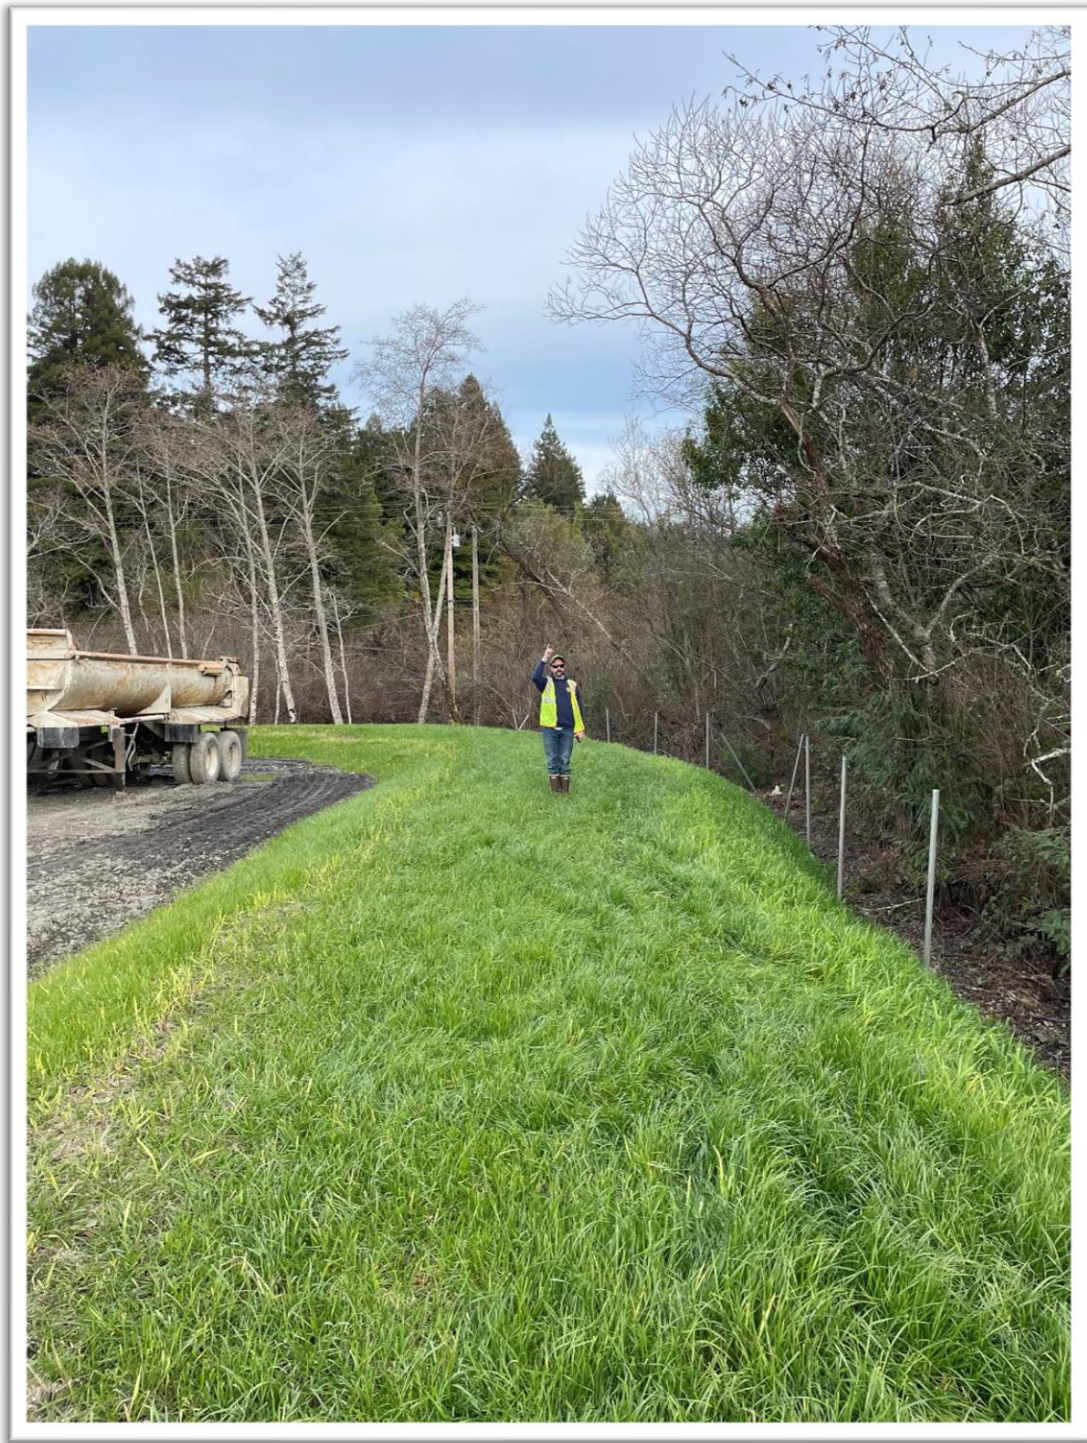
streambank using the internal receiver of an iPhone 12. Using a measuring tape, we measured the horizontal distance (to the nearest foot) from the bankfull channel edge to the streamside edge (toe) of the berm (Table 1). The setback was substantially wider at the first two locations (75 and 41 feet, respectively) just below the Glendale Drive crossing, after which distances constricted dramatically (fewer than ten feet at the narrowest point). Distances ranged from 8 to 75 feet, with a median value of 13.5 feet. Fifteen of the 18 measurements were less than 25 feet. At several points, the riparian dripline extended beyond the toe of the berm (Figure 4).

Figure 4. The dripline of the existing riparian canopy of Noisy Creek extends beyond the streamside edge of the berm, documented during the January 30, 2025, survey effort.

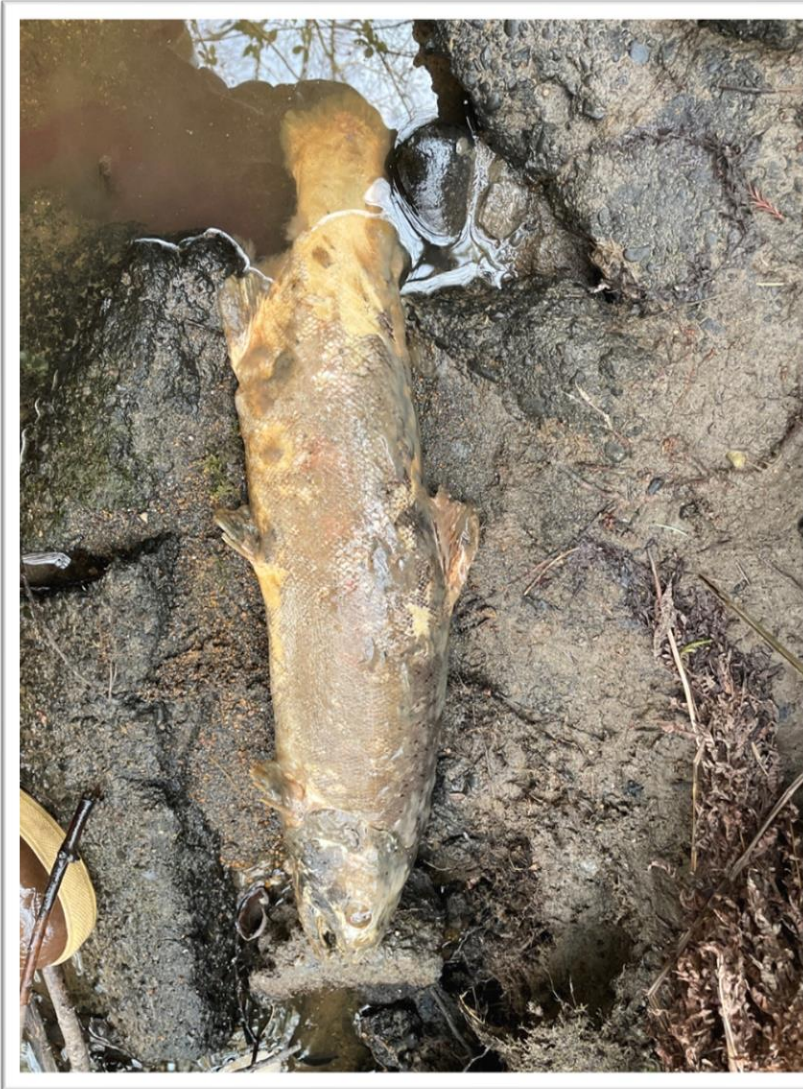
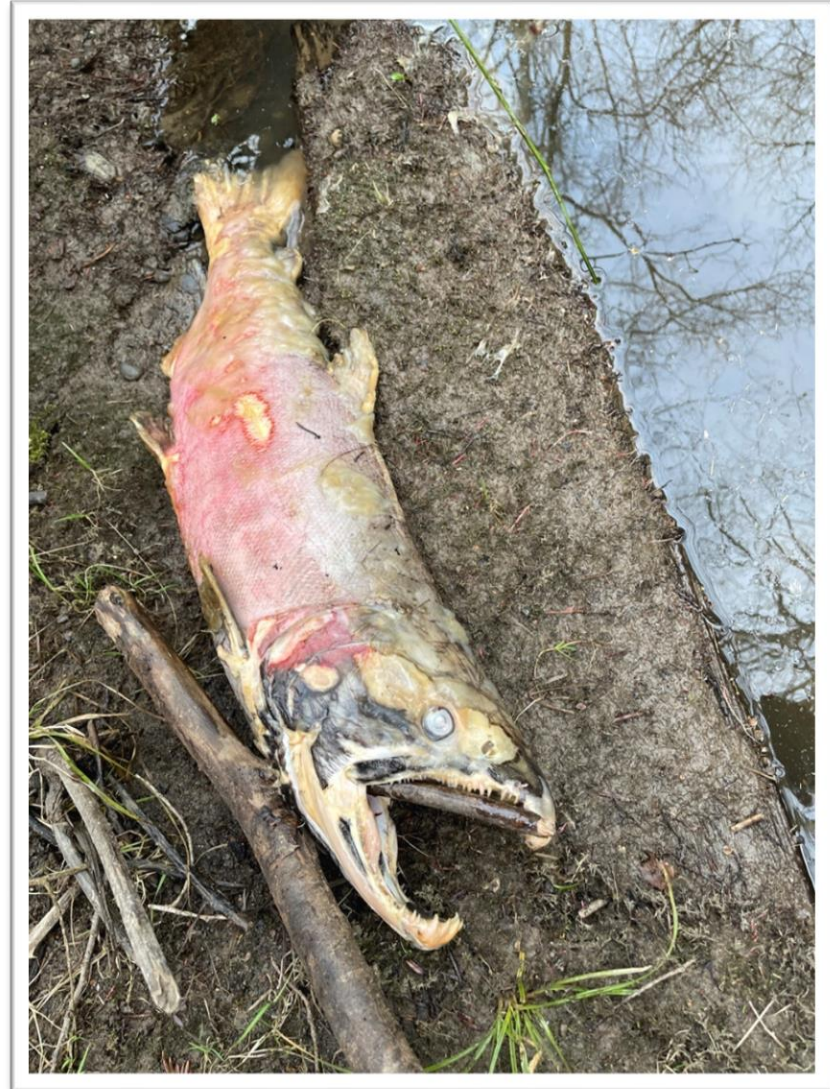
While conducting our survey, we observed the carcasses of two adult coho salmon (*Oncorhynchus kisutch*) within the reach, a male and female displaying signs of having recently spawned (Figure 5). We did not survey the reach for redds, however, on a prior visit to the construction yard on January 6, 2025, CDFW staff incidentally observed several spawning coho salmon across riffles approximately 200 to 300 feet downstream of the large CMP culvert.

Figure 5. Carcasses of adult female (left) and male (right) coho salmon (*Oncorhynchus kisutch*) observed in Noisy Creek during the January 30, 2025, survey effort.

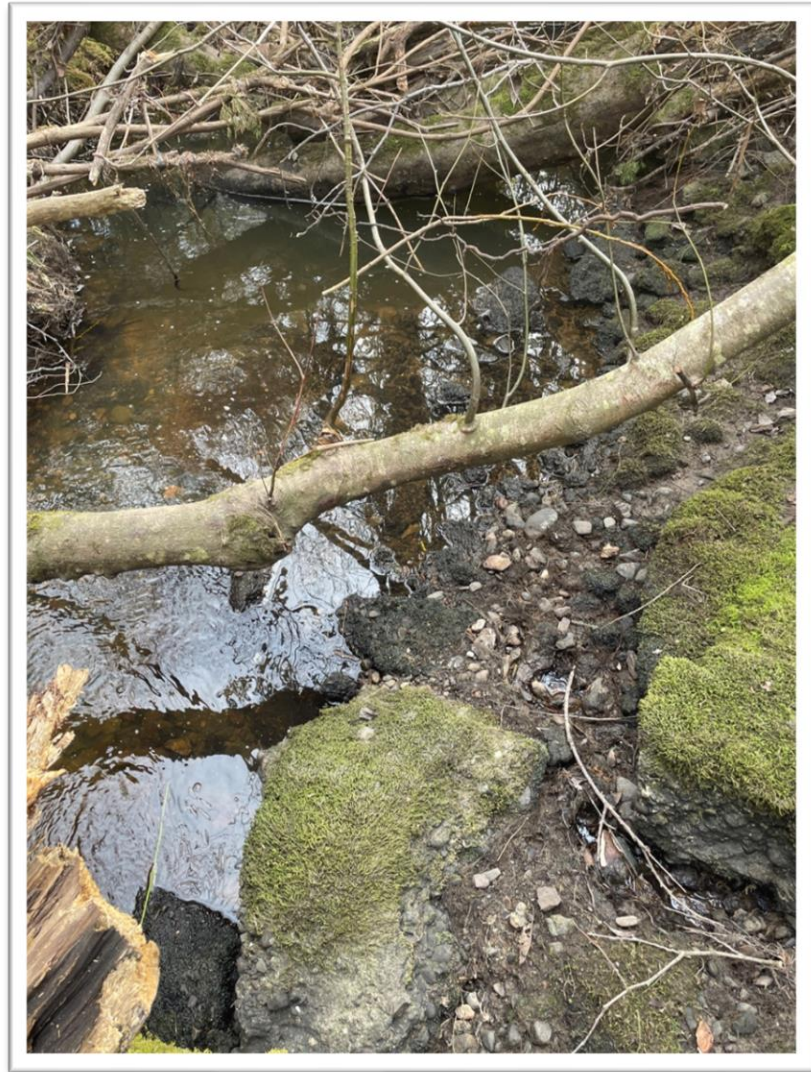
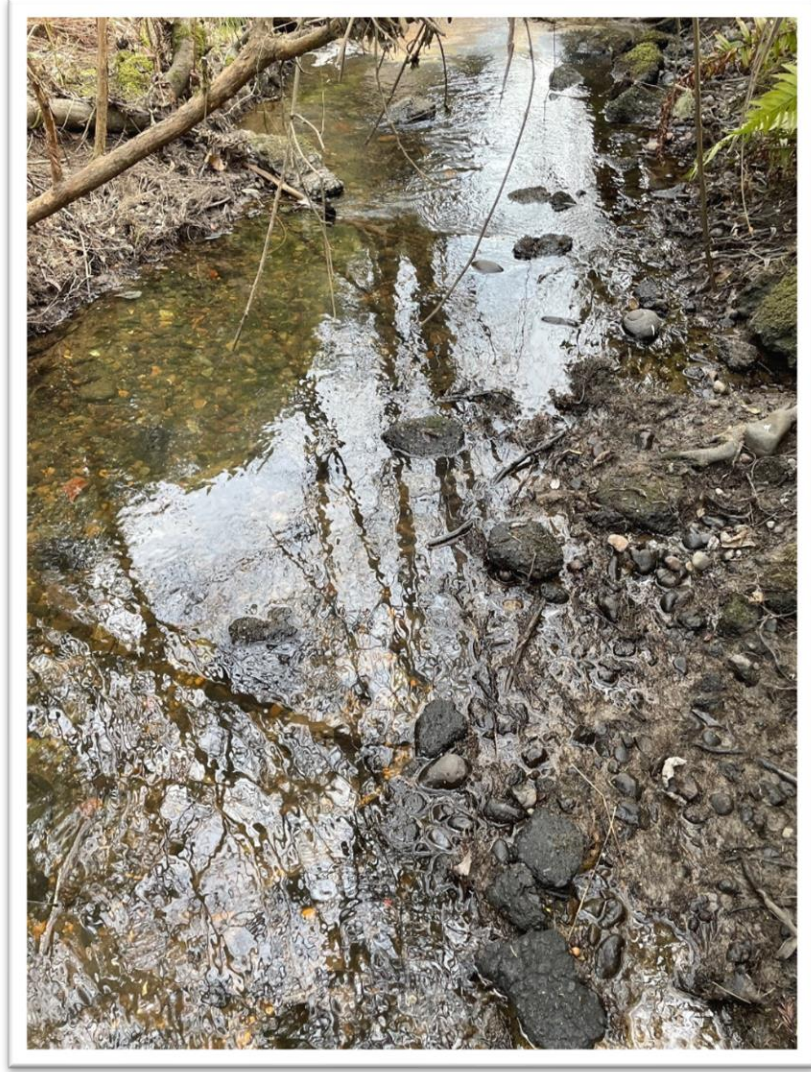
Figure 6. Concrete and asphalt debris in the channel and streambed of Noisy Creek, observed during the January 30, 2025, survey effort.

In addition to the salmon carcasses, we discovered waste concrete and asphalt debris abandoned in the streambed and channel (Figure 6). We recommend the composition and extent of this material be characterized and a plan for its removal and remediation of the streambed be developed and implemented following agency approvals.
