Report of Unauthorized Timberland Conversion Inspection and Recommendations

16533 Cobb Rd, Dinsmore, CA

Humboldt County APN 208-341-021

**Date of inspection:** 12/28/2017; by Merritt Lindgren RPF #2522 and Natural Resources Management field technician Aaron Katz. No one else was present.

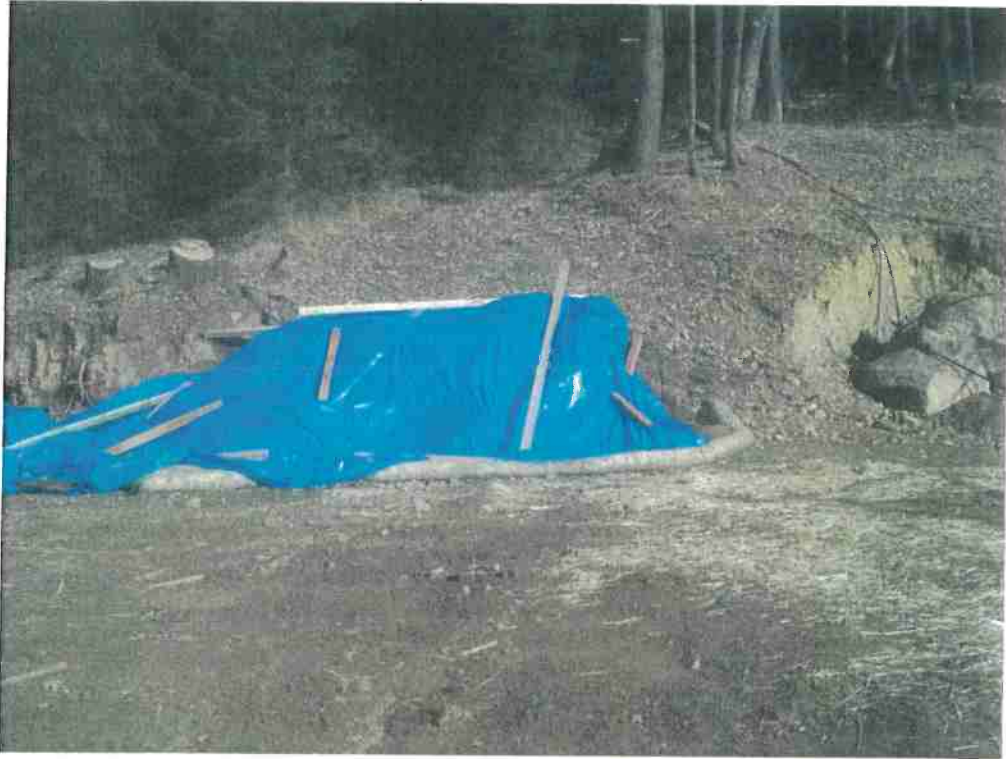
grow soil were tarped and straw waddled (see figure 1.). Cut bank failures have occurred on the banks of each terrace and the lower fill slope is also starting to fail. It does not appear that these failures are currently contributing sediment to any watercourse. Although portions of the upper cut bank have gentler slopes and has started to revegetate, there is a 40 foot wide bank failure on its northwestern side (see figure 2.). The landowner has started to stabilize this failure by placing large rocks along its base (see figures 2 & 3.). The cut bank of the lower terrace is nearly vertical and is starting to fail (see figure 4.). The fill slope on the downhill side of the lower terrace has been recently constructed and includes a car and large pieces of wood (see figure 6). It is also starting to fail (see figure 5).

Figure 1.  
Tarped soil and mulch

8. Remove the car and larger pieces of wood from the fill slope on the downhill side of the lower terrace and leave it at a 1:1 slope (45°).
9. Mulch and seed all of the exposed soils on the cut and fill slopes.

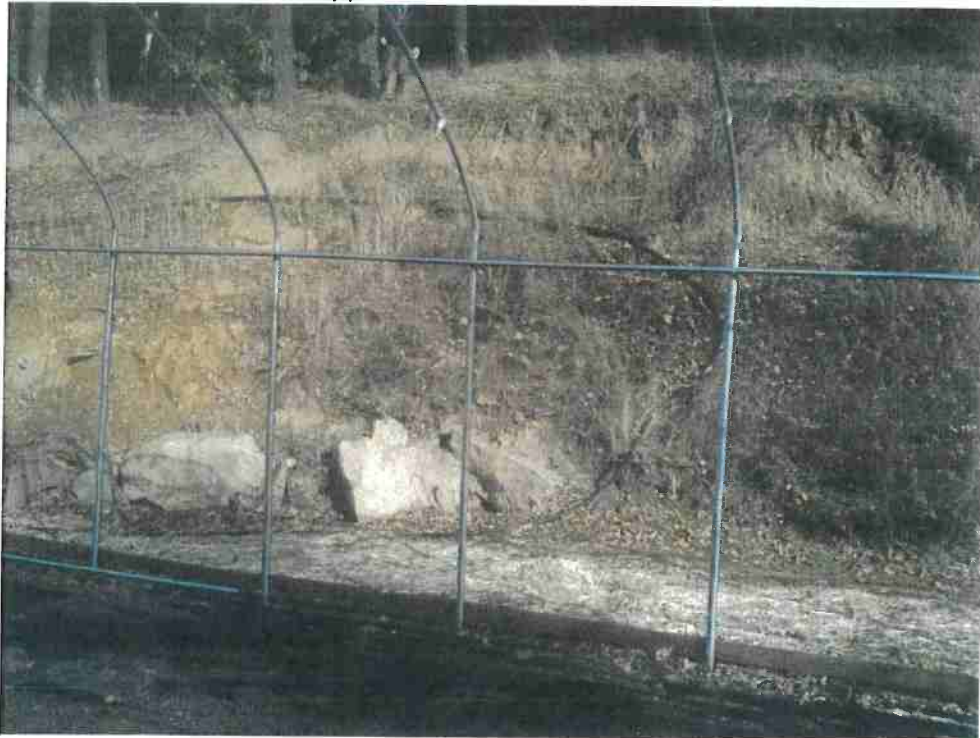
Figure 2  
Upper terrace Cut Bank Failure

6. Stabilize the cutbank failure on the northwest side of the upper terrace by adding more rock along its base.
7. Reslope the lower terrace cutbank to a 1:1 slope (45°) or improve the angle of the slope and line the bottom of it with large rocks.

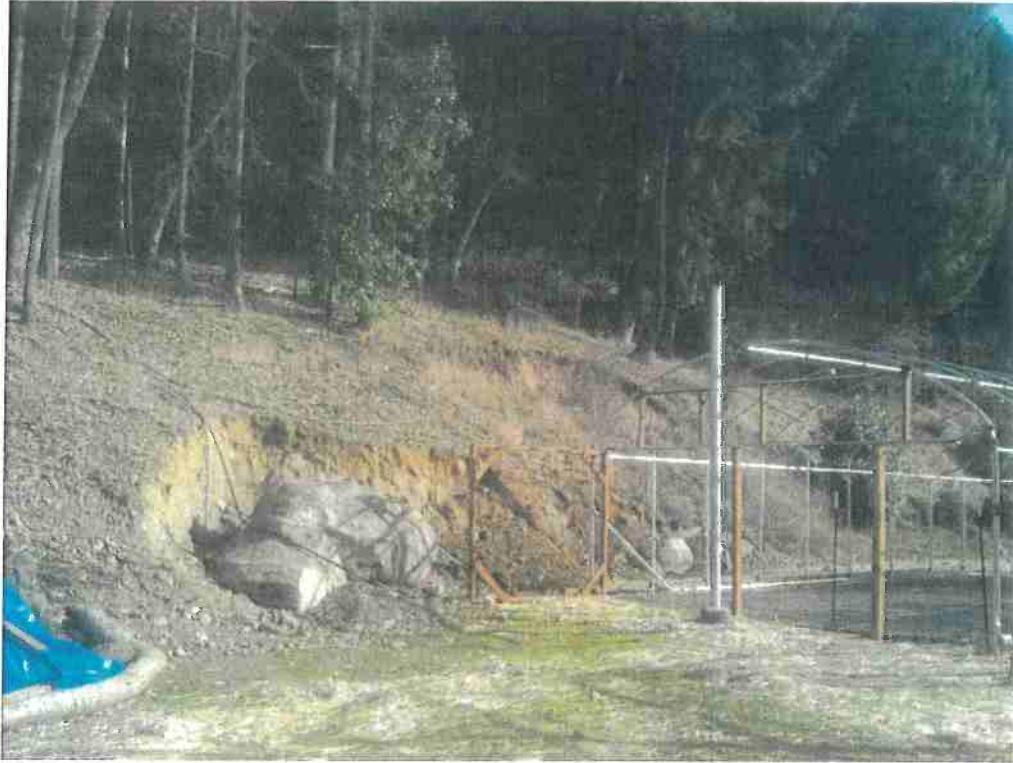
Figure 3  
Stabilization of Upper Cut Bank Failure

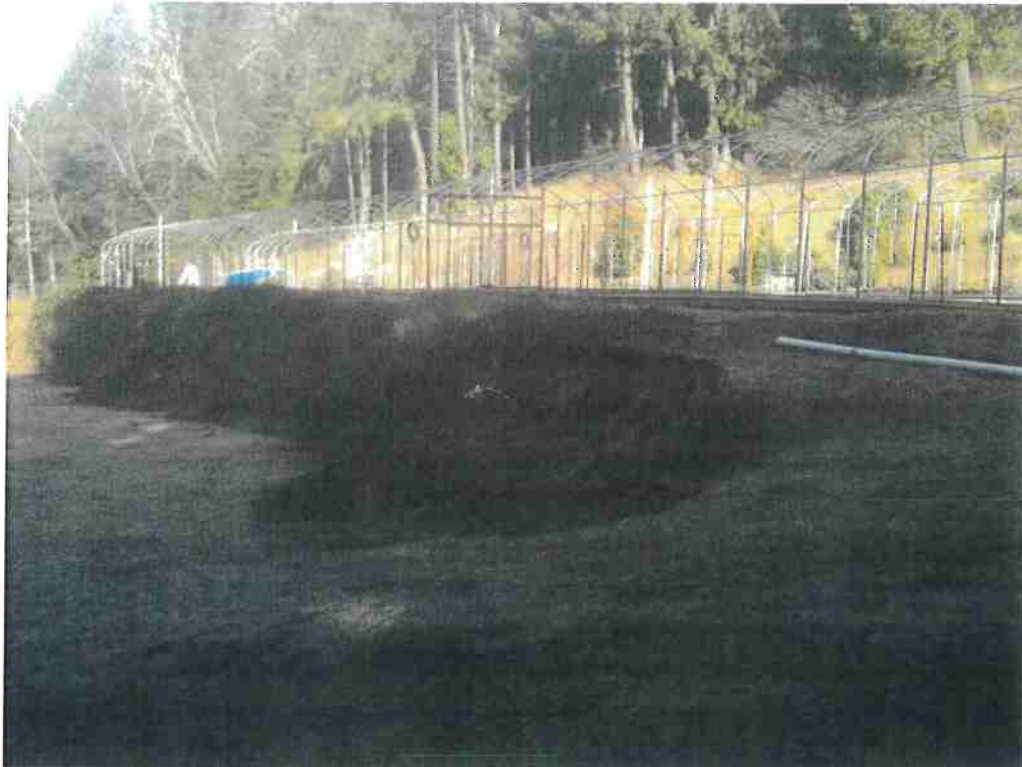
Figure 4  
Lower Terrace Cut Bank Failure

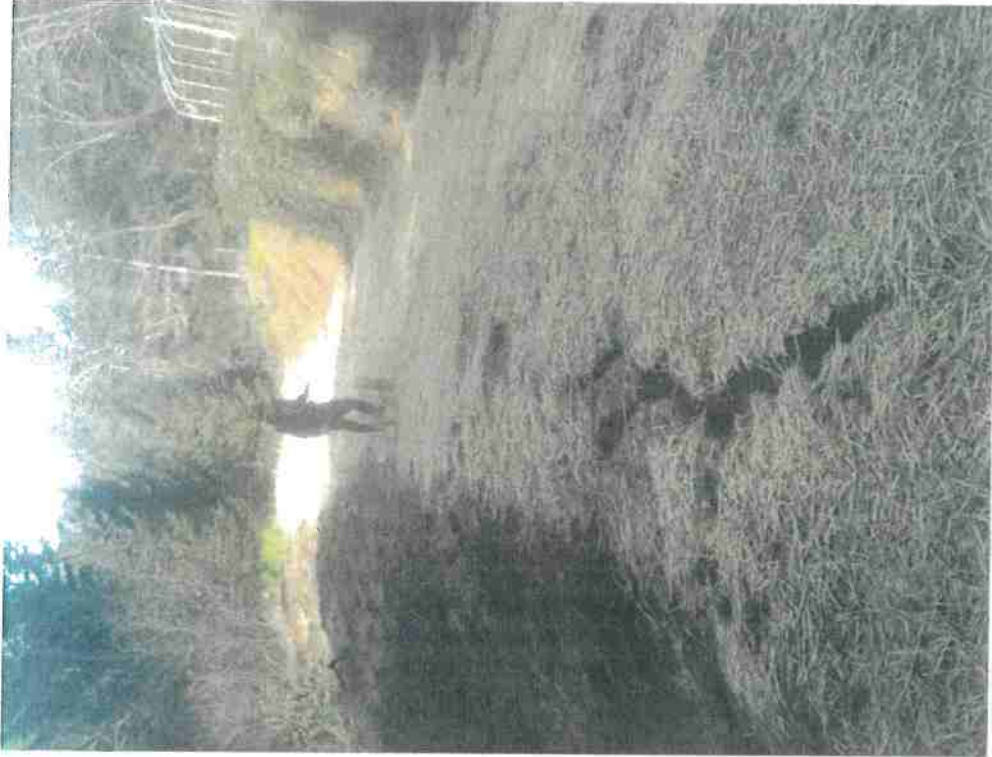
Figure 5  
Lower Terrace Fill Failure

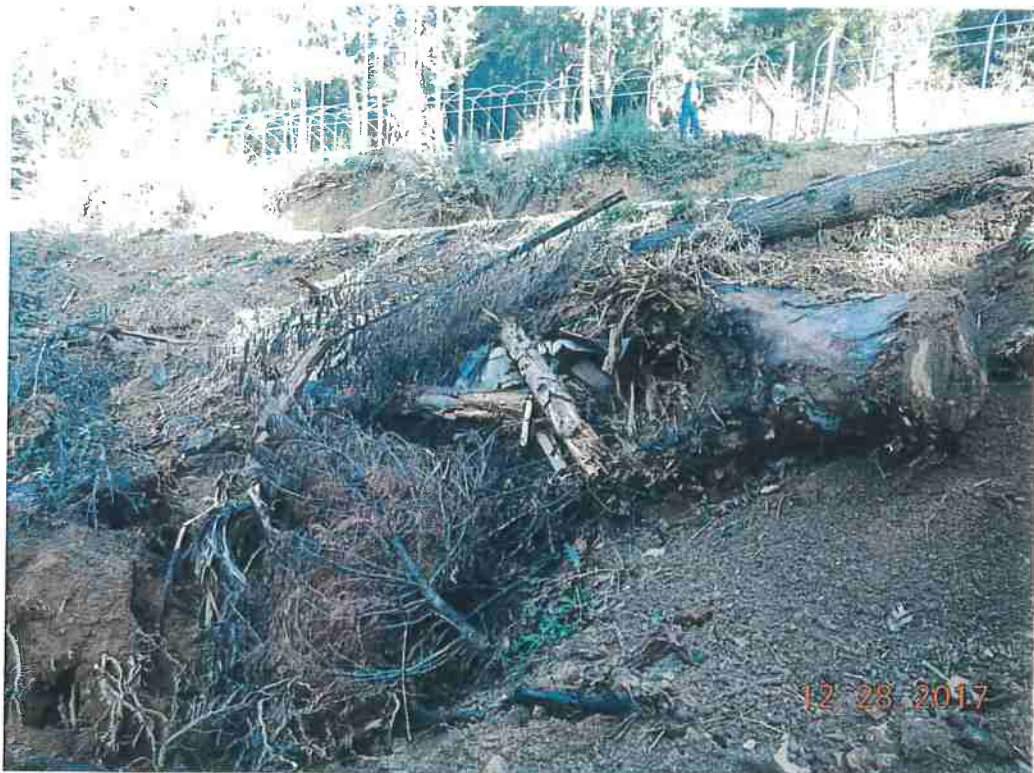
Figure 6  
Lower Terrace Fill Slope
