Attachments (exhibits) to Letter/report 18024-40022, 10/08/2018

PROJECT NAME: Humboldt Bay Trail South - Limited Visual Tree Risk Assessment

PROJECT NUMBER: 715036

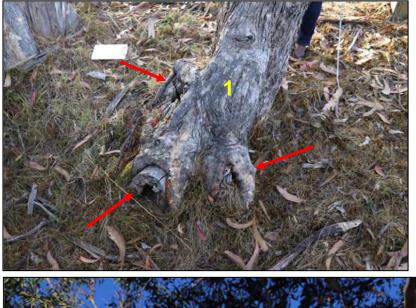
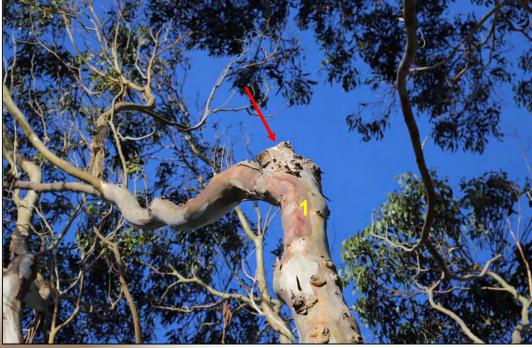
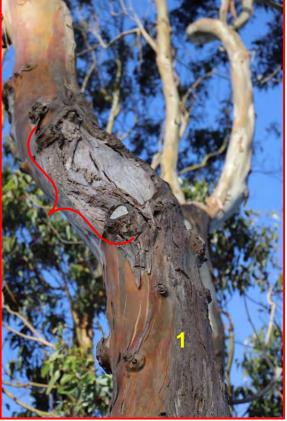
+ Tree no. 1 (continued):

Decaying areas at pruning cuts and trunk wounds. Below is a decayed wound on the tension side of the trunk that leans over the highway. Also illustrated are branch dieback and the very small volume of live foliage.

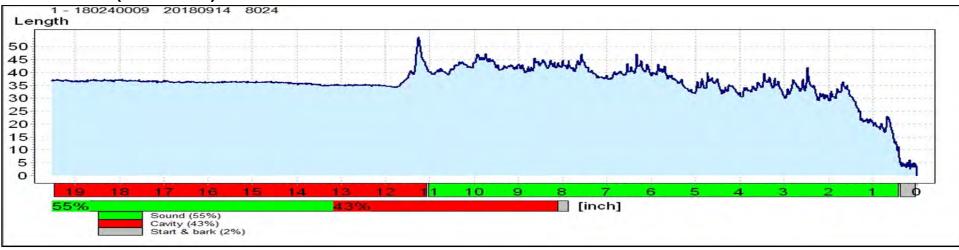
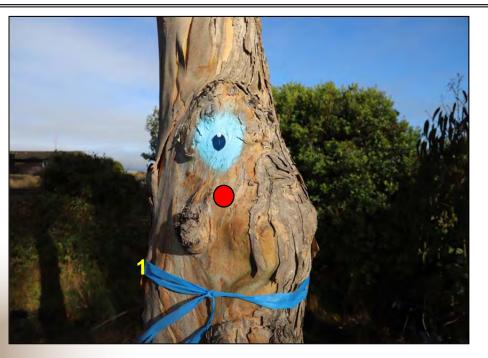
+ Tree no. 1 (continued):

The graph of this tree's trunk indicates a major column of decay beginning at eleven inches. The preceding irregularities suggest wood degradation and pockets of decay. The red spot and arrow indicate the testing location.

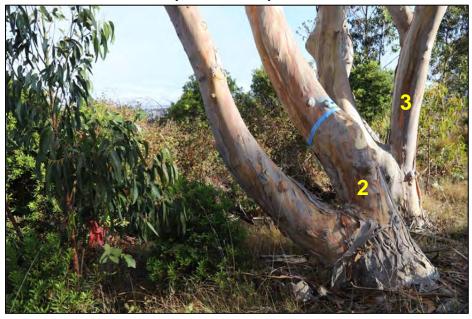
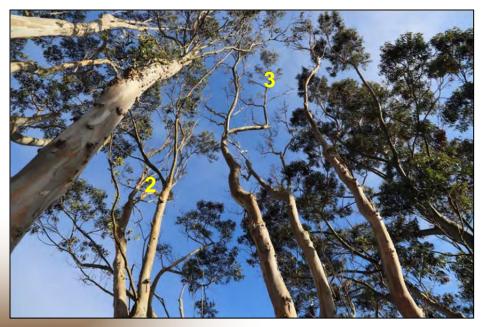
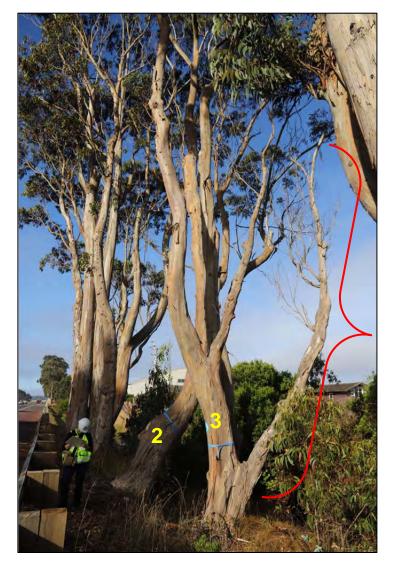
+ Trees nos. 2 & 3 (continued):

Both trees exhibit substantial leans to the west. The images below exhibit the profuse dieback of the few remaining branches and the negligible amount of live foliage in both (and surrounding) canopies. The image below exhibits an entirely dead stem leaning west.

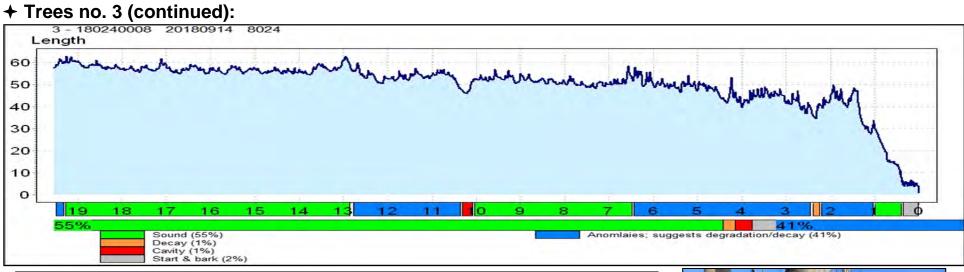
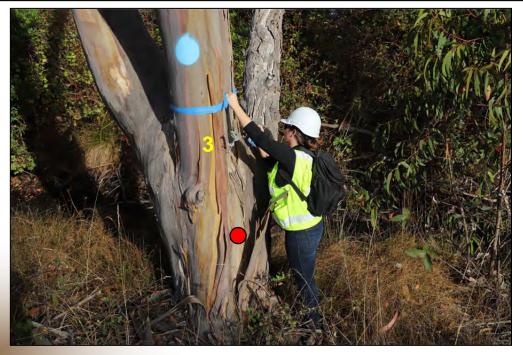
Tree no. 3: The graph of this tree's trunk does not indicate any substantial decay, in spite of the advanced state of decline and one entirely dead stem (west). The red spot and arrow indicate the testing location.

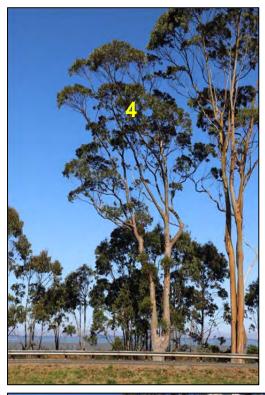
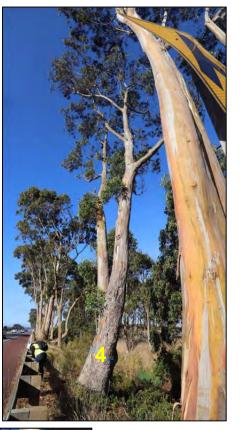
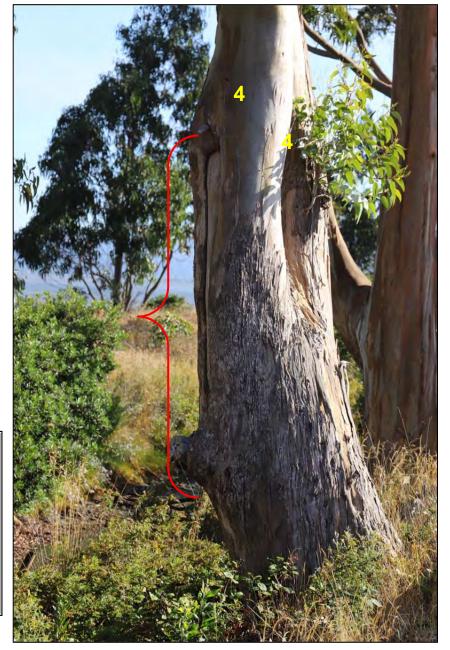
+ Tree no. 4:

Illustration of a greater than typical foliage volume. The tree is comprised of codominant stems with a weak attachment and both lean to the west. There is a decay column to the west of the lower trunk (marked in right image).

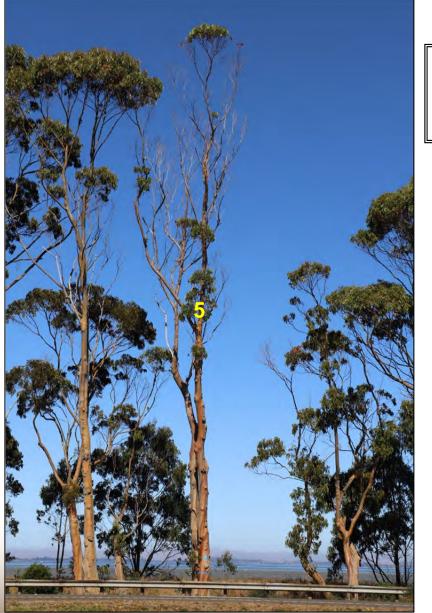
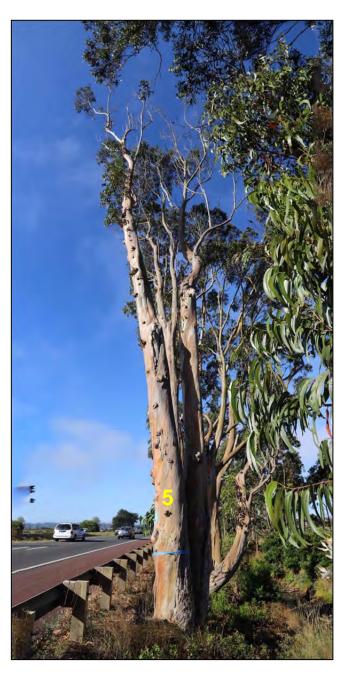
+ Tree no. 5:

Images illustrate codominant stems, negligible canopy volume, profuse branch dieback and lean over highway (east).

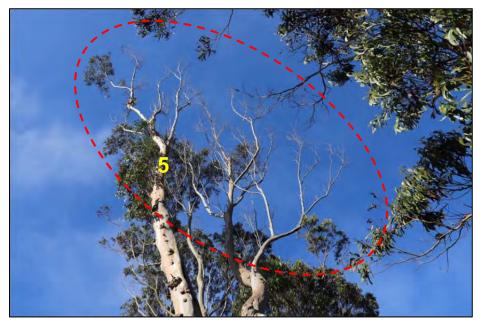
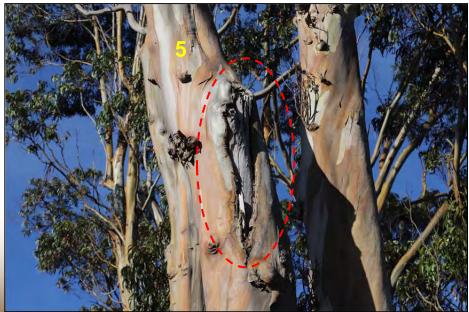
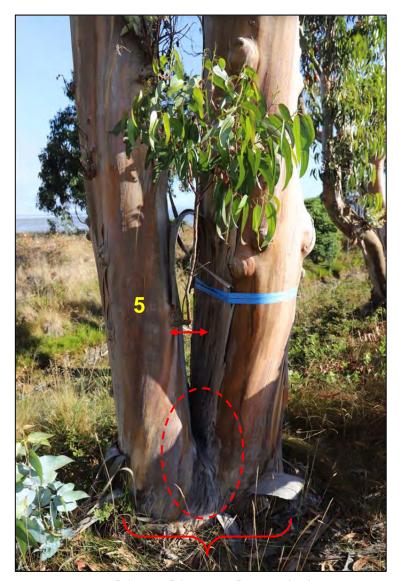
+ Tree no. 5 (continued):

Profuse dieback of branches, decay column extending from old pruning wound, codominant, weakly attached stems and excess soil over the root flare.

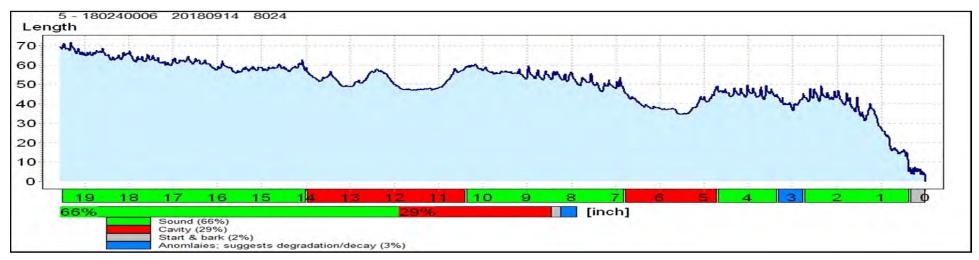
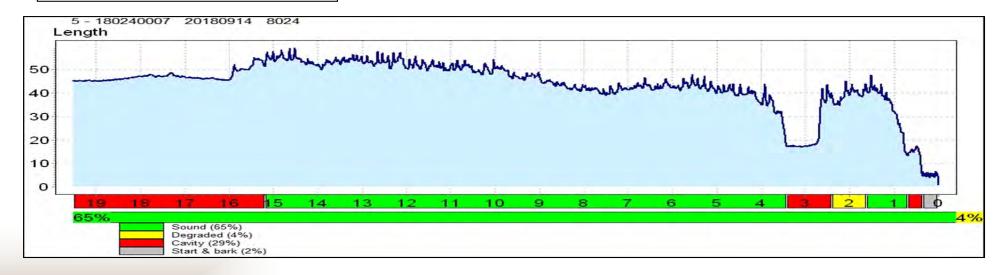
+ Tree no. 5 (continued):

Above: Graph of east stem, E-W @ 36" height. Below: Graph of west stem, N-S @ 48" height.

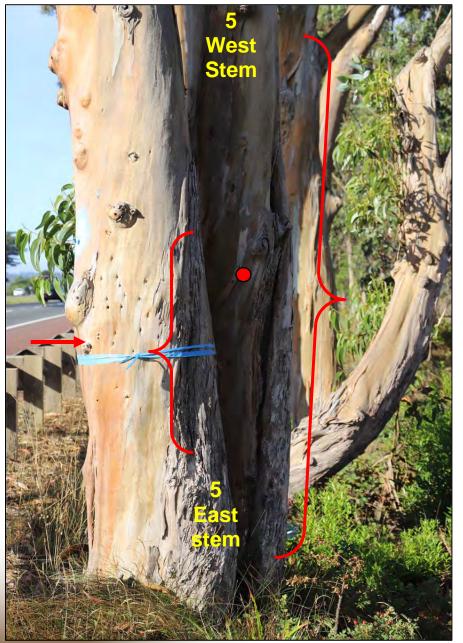
+ Tree no. 5 (continued):

Tree no. 5: The red spot and arrow indicate testing locations. The brackets indicate externally visible columns of decay.

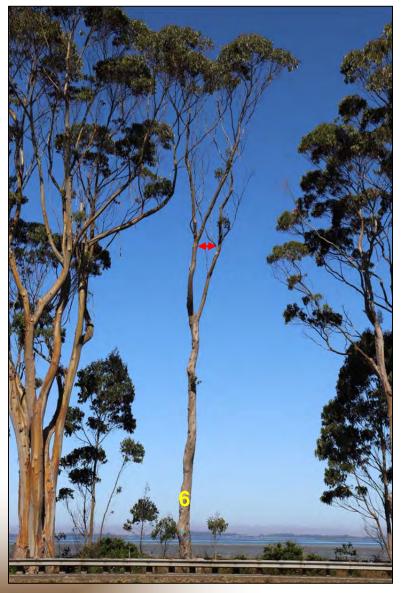
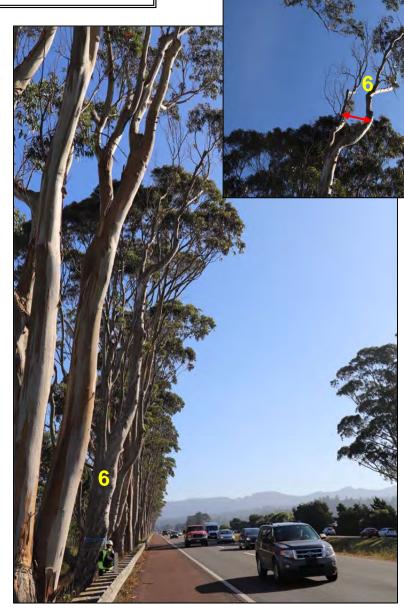
+ Tree no. 6:

Lean over highway, no lateral branches, codominant tops, branch dieback and negligible canopy.

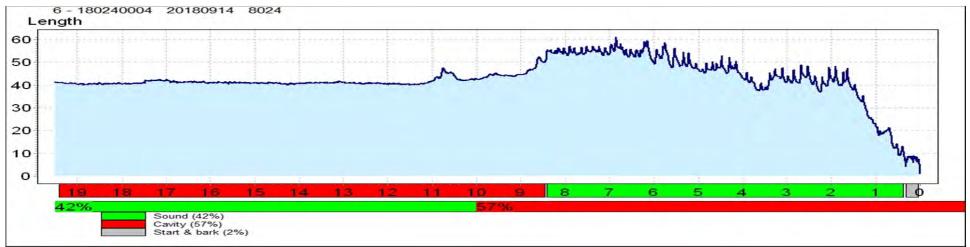
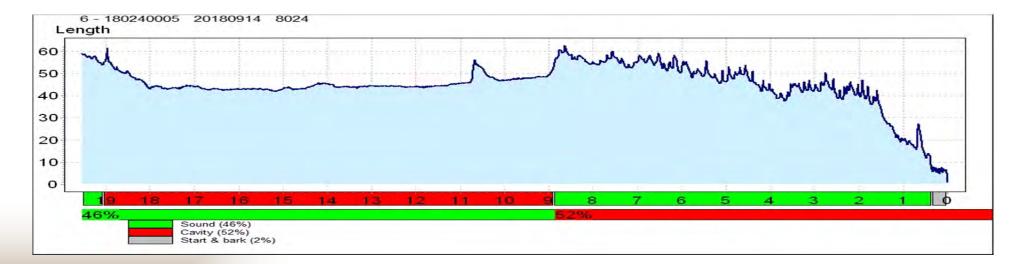
+ Tree no. 6 (continued):

Above: N-S @ 48" height. Below: E-W @ 48" height.

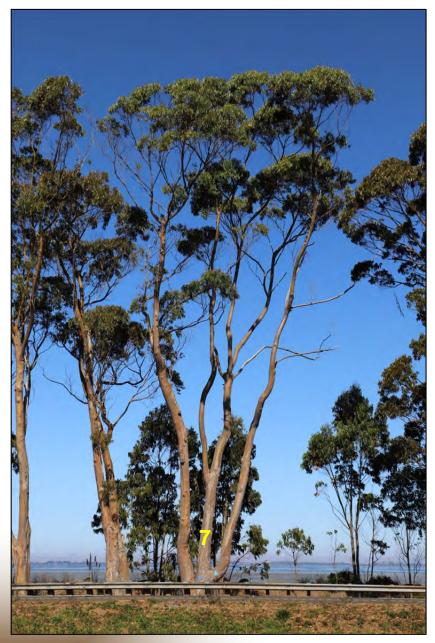
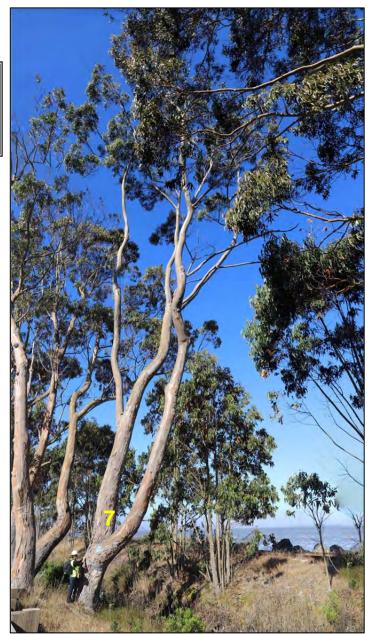
+Tree no. 7:

Codominant stems (3), low canopy volume, lack of live lateral branches, large dead limbs to west (5), lean to west.

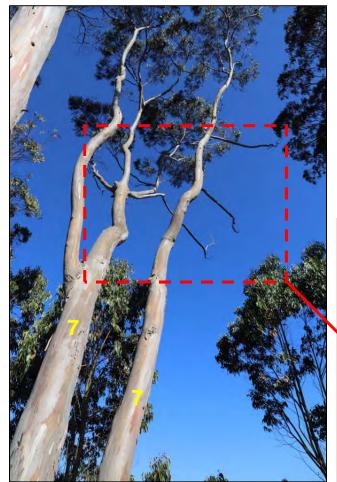
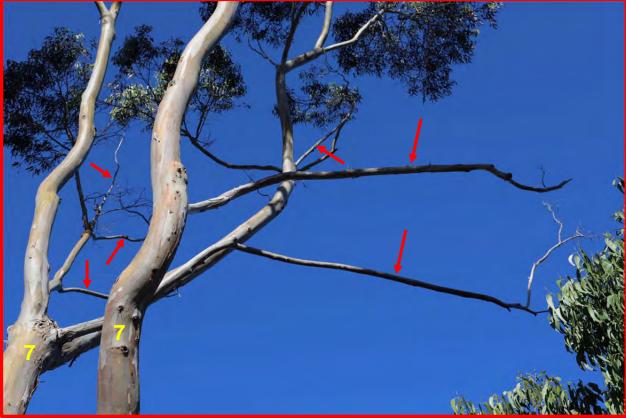
+ Tree no. 7 (continued):

Large, dead limbs; declining and negligible foliage.

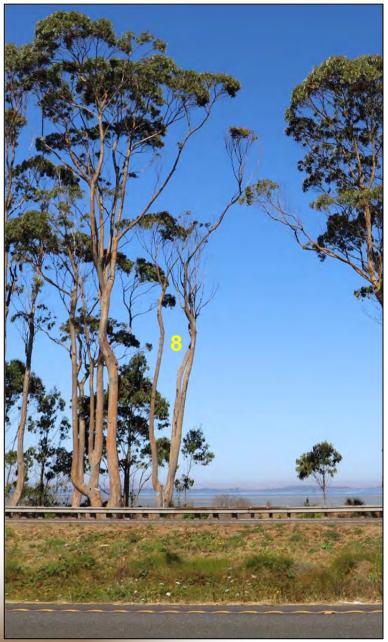
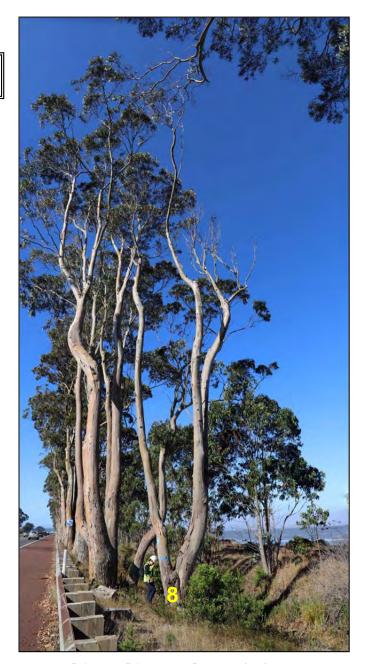
+ Tree no. 8:

Codominant stems, negligible foliage, lacking lateral branching.

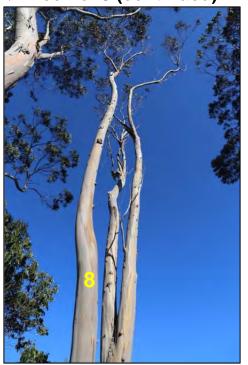
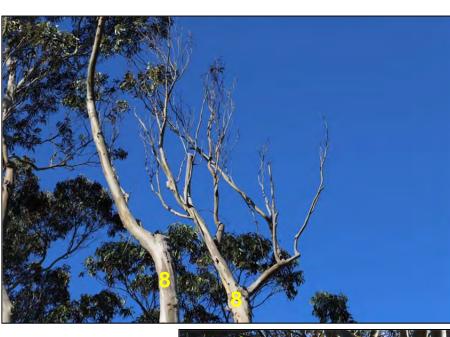
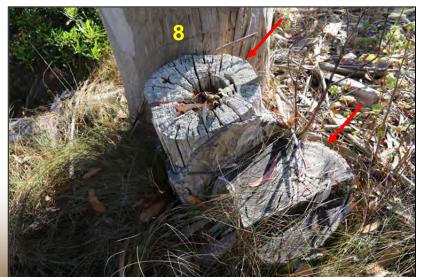
+ Tree no. 8 (continued):

Left: Negligible foliage, profuse branch/top dieback, lack of lateral branches, codominant stems (3). Below left: Decaying stubs from stem removals. Below right: weakly attached, codominant sprouts from old topping site.

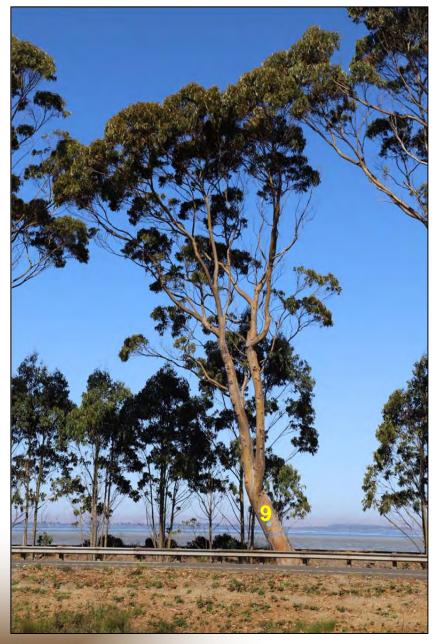
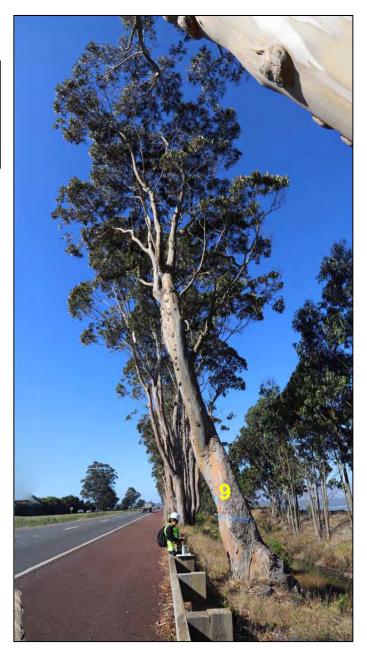
+ Tree no. 9:

Codominant stems, low canopy volume, branch dieback, low canopy volume, lacking lateral branching, lean to east (over highway).

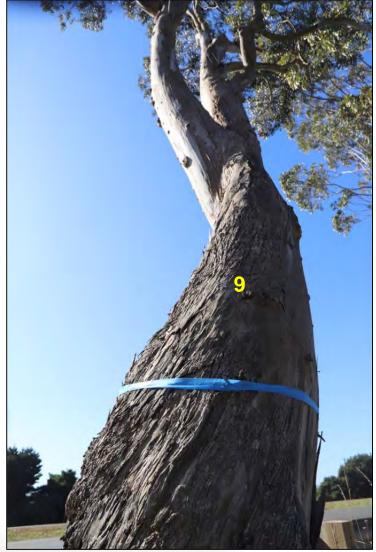
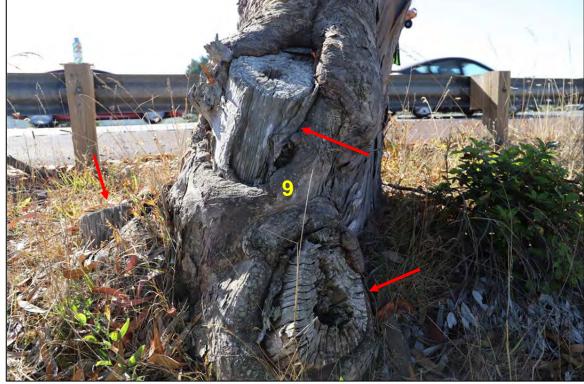
+ Tree no. 9 (continued):

Left: Codominant, weakly attached stems and lean to east. Below: decayed wounds from removal of stems. Coalesced into a column of decay.

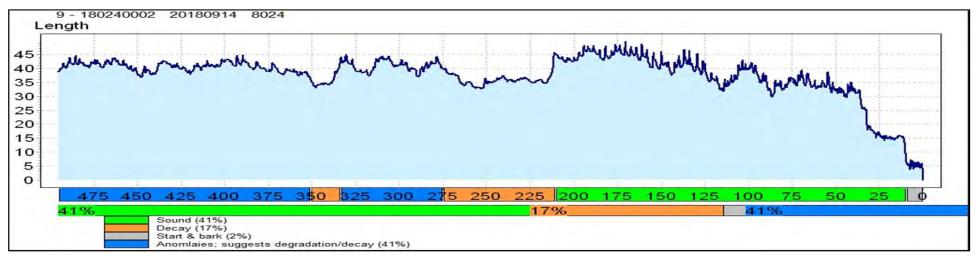
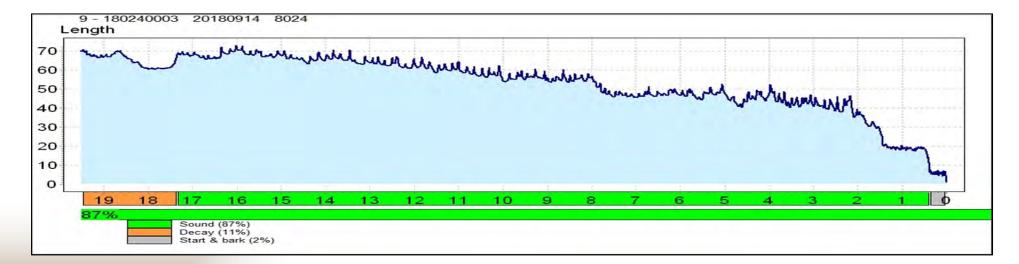
+ Tree no. 9 (continued):

Above: E-W @ 36" height. Below: NE-SW @ 48" height.

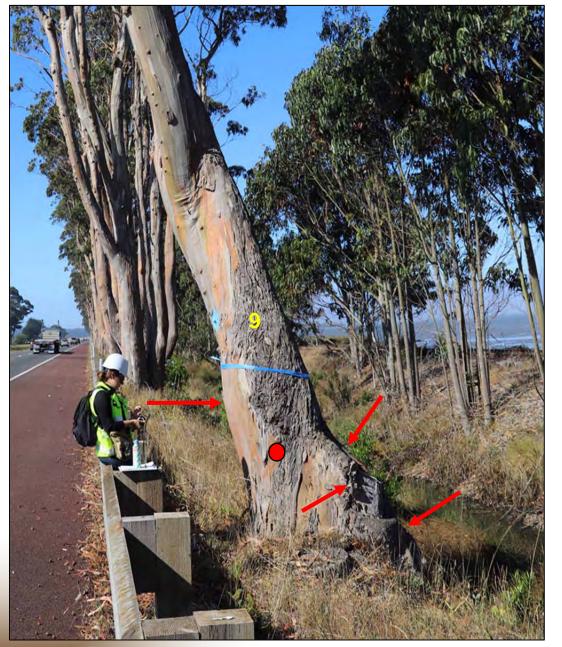
+ Tree no. 9 (continued):

The red spot and arrow indicate testing locations. Three, coalesced decaying wounds from stem removals on tension side of lean.

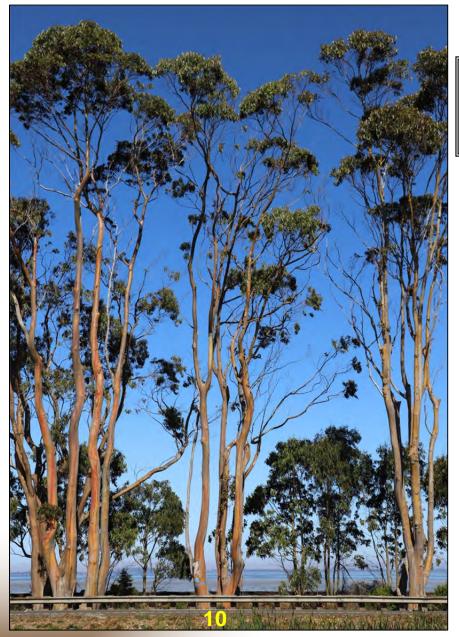
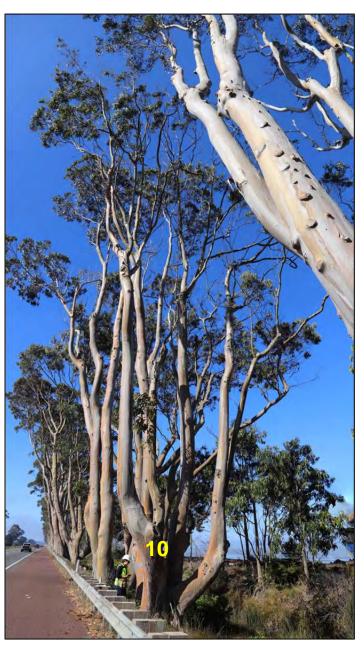
+ Tree no. 10:

Codominant stems (5), negligible canopy volume, branch dieback, lacking lateral branching.

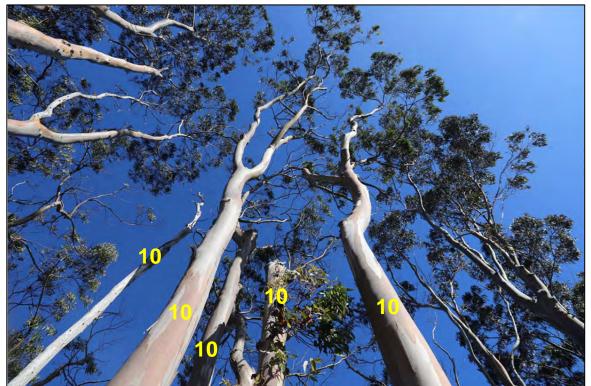
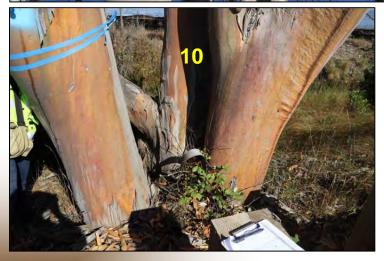
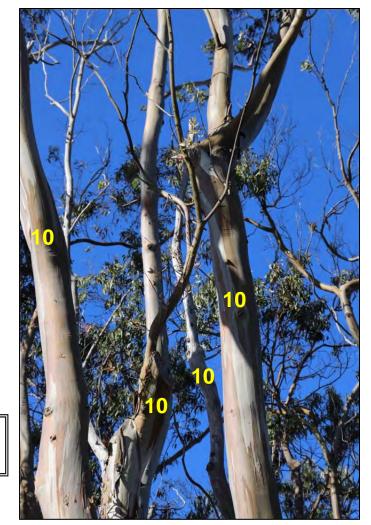
+ Tree no. 10 (continued):

Codominant stems (5), negligible canopy volume, branch dieback, lacking lateral branching.
