Dryad, LLC

October 8, 2018

Project name: Humboldt Bay Trail South -Limited Visual Tree Risk Assessment
 Project no.: 715036

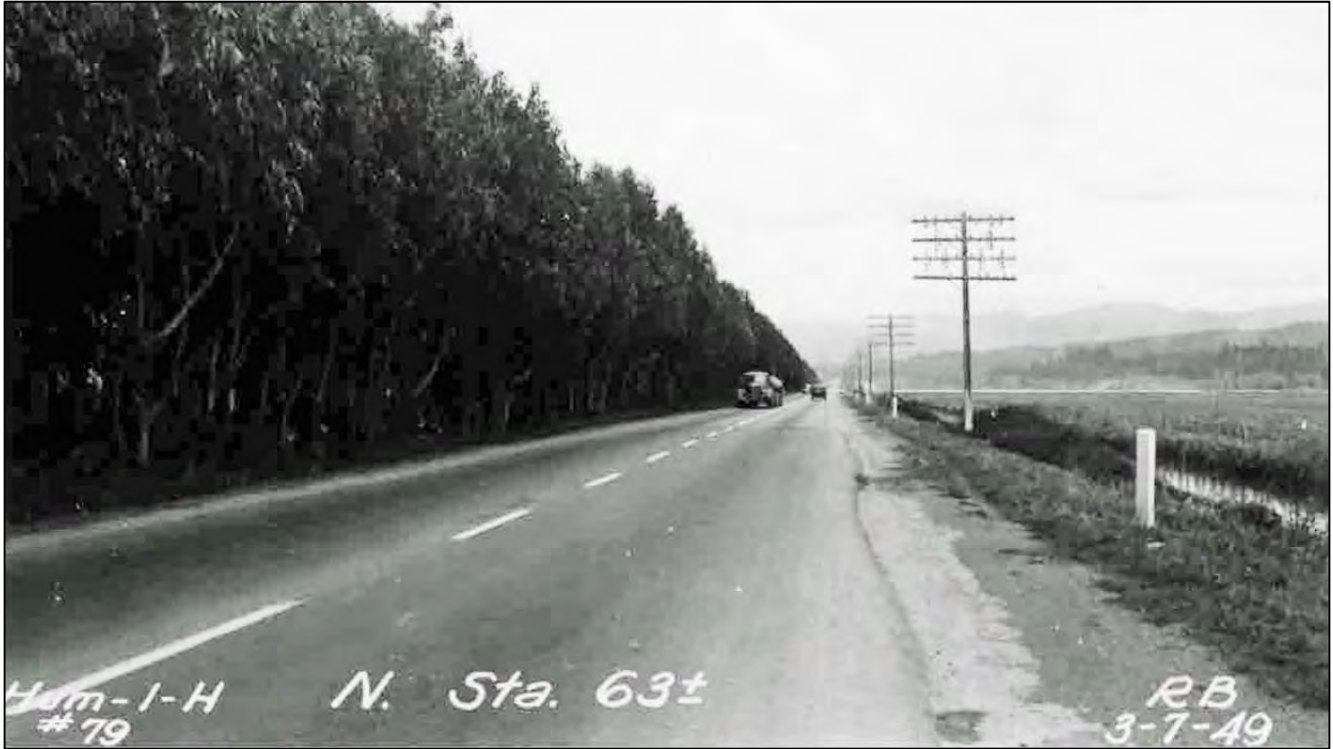
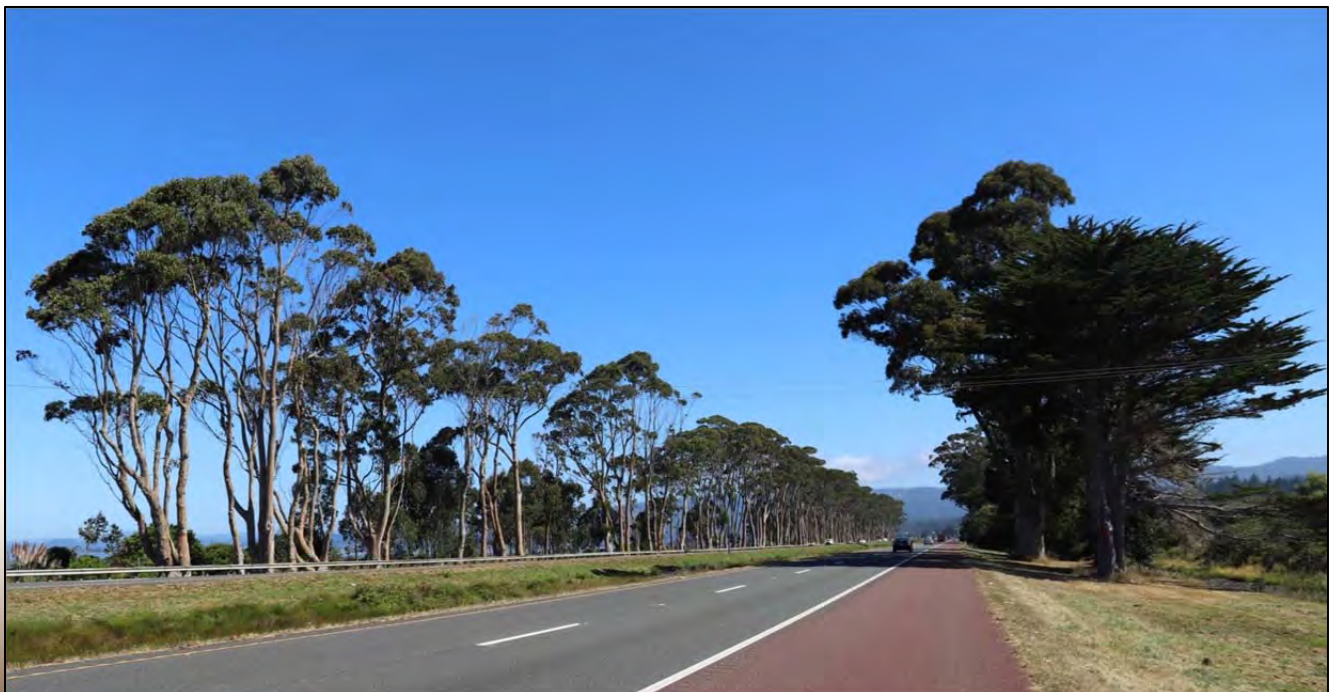
Stand & canopy density:

03/07/1949 (above): Historically , the stand was very dense with many more trees (Image excerpted from document 2.Maps and Photographs of Eucalyptus Trees along the future segment of the Humboldt Bay Trail, dated August 2, 2018.).
09/14/2018 (below): Similar view illustrating the current lack of density, increased height and top-heavy canopy, and trees devoid of lateral limbs and lower foliage.

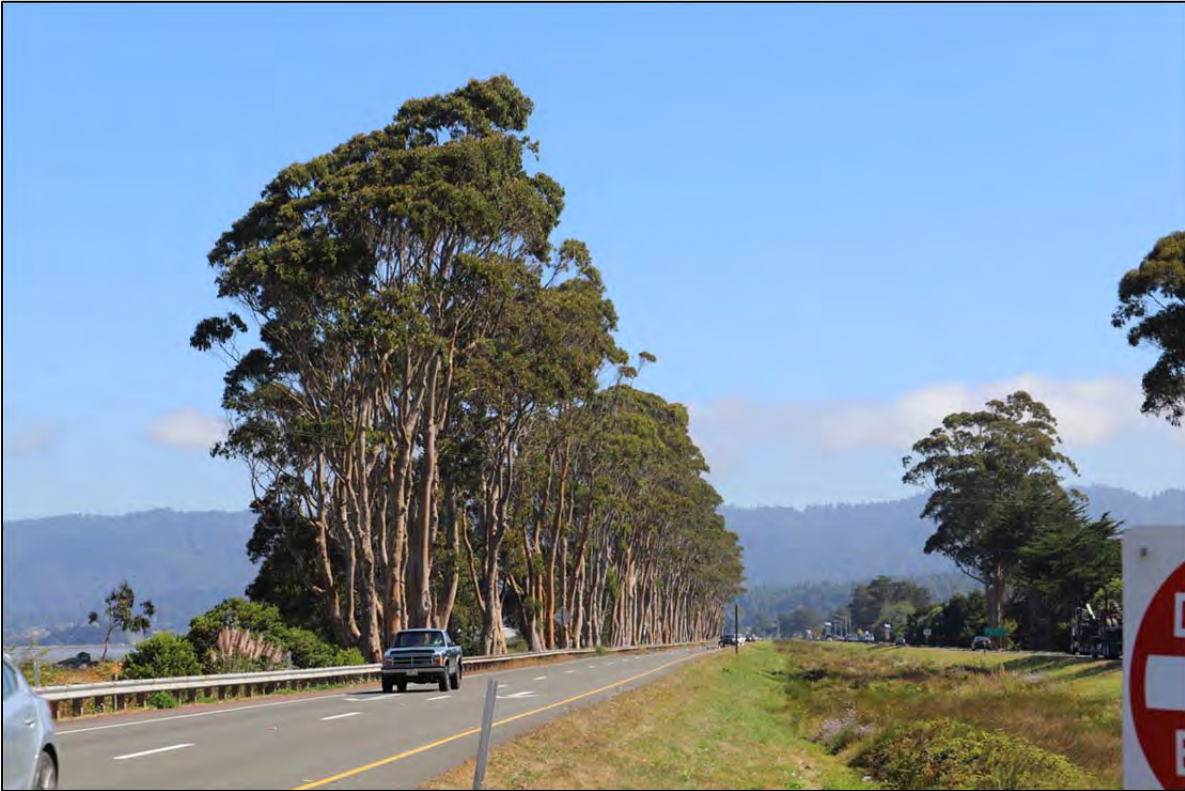
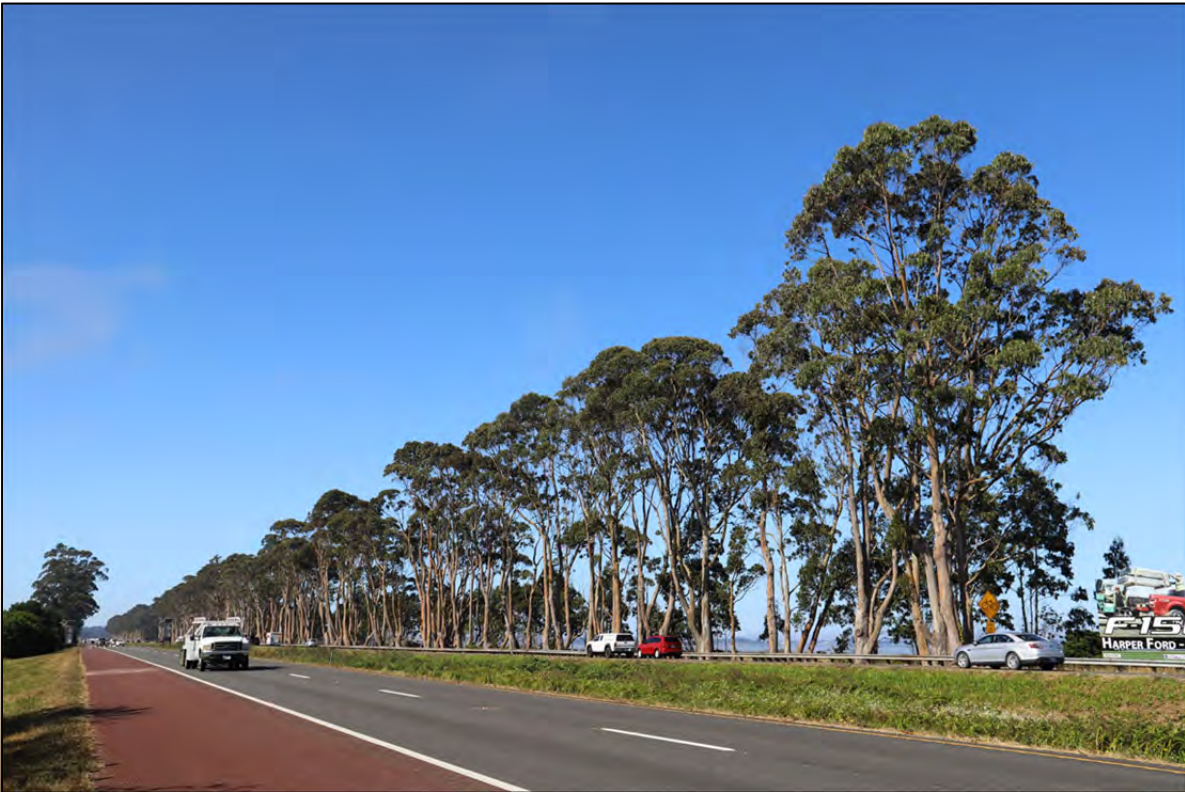
Stand & canopy density:

09/14/18: The stand looks reasonably dense when the trees are viewed at an angle, in succession.

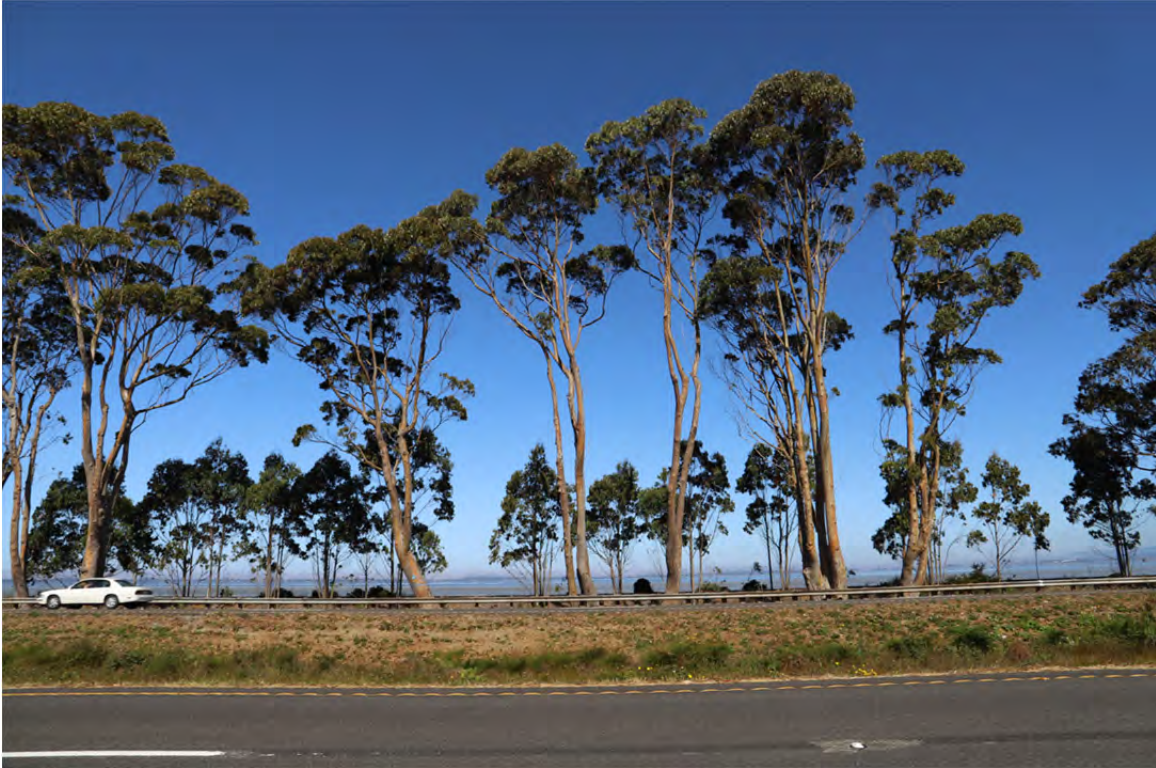
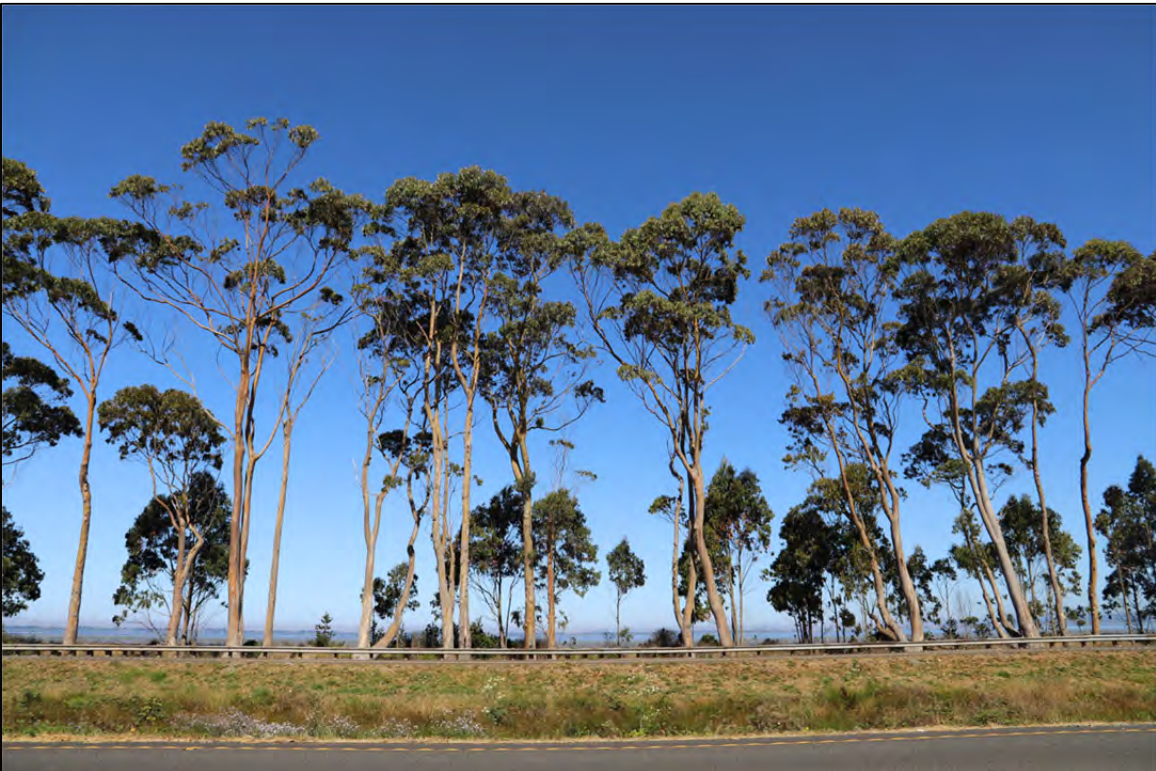
Stand & canopy density:

09/14/18: The stand's lack of density and sparse, top-heavy canopies are apparent in a perpendicular view. The smaller trees are saplings along the railroad tracks.

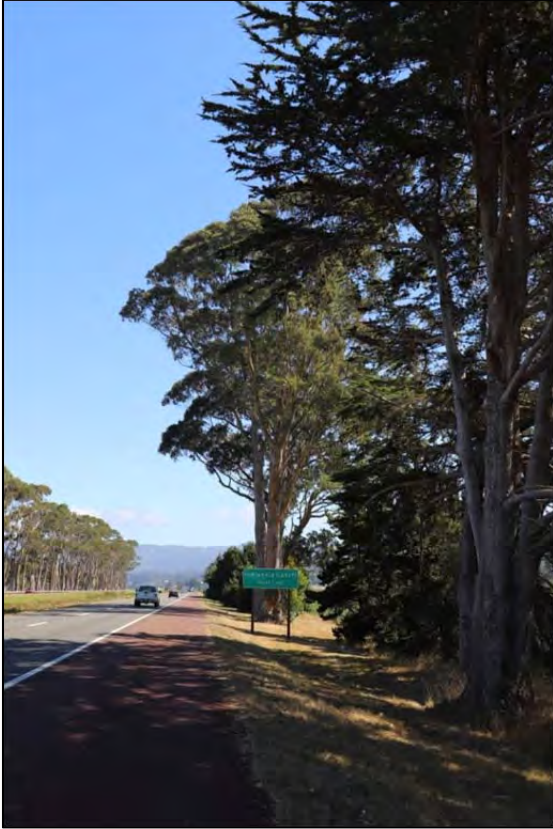
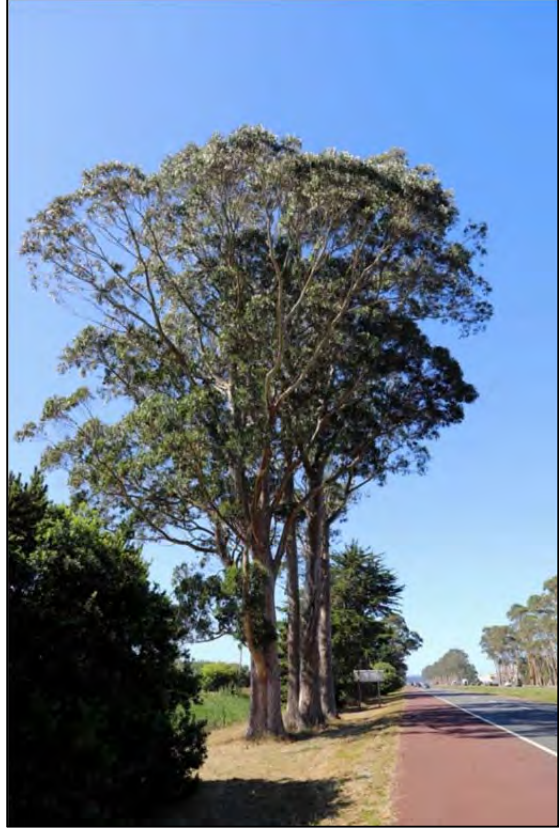
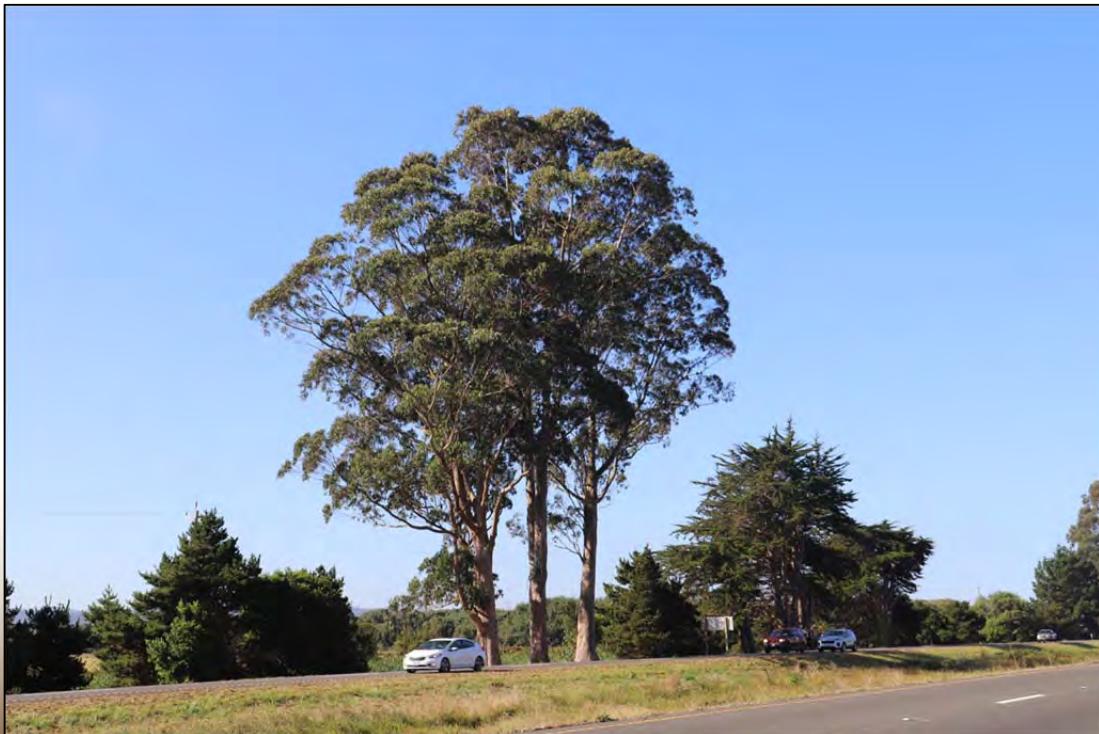
Example of viable bluegums (*Eucalyptus globulus*) in the vicinity:

A small stand of blue gums on the east side of Highway 101, adjacent to the middle of the subject tree stand. Illustrated is substantial growing space and distance from the highway, vigorous growth and viable architecture, rendering them good candidates for judicious pruning to mitigate any identified risk.

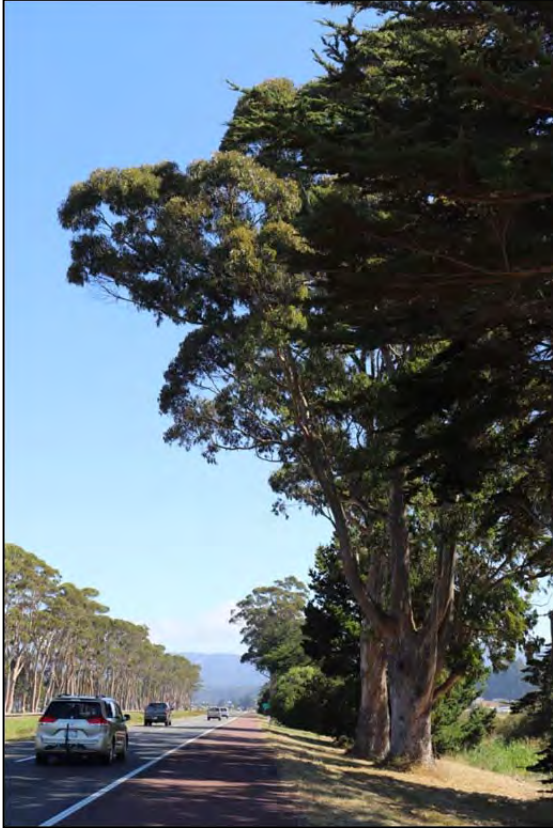
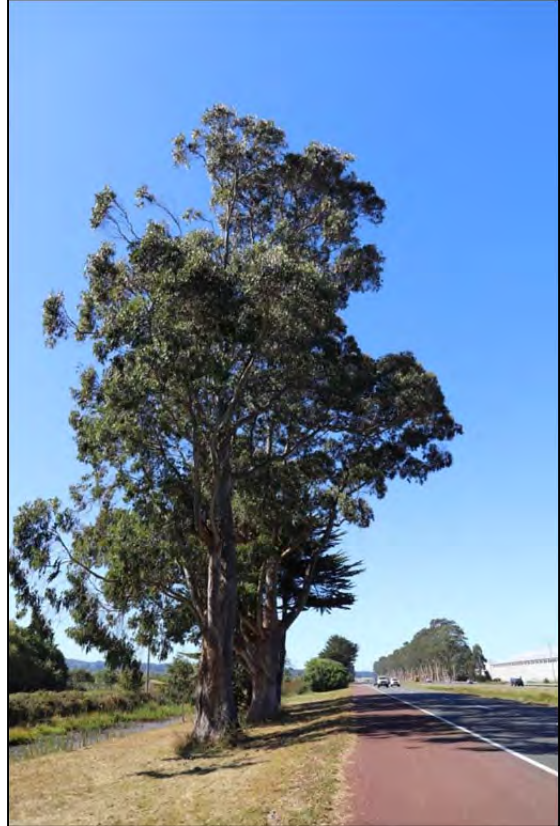
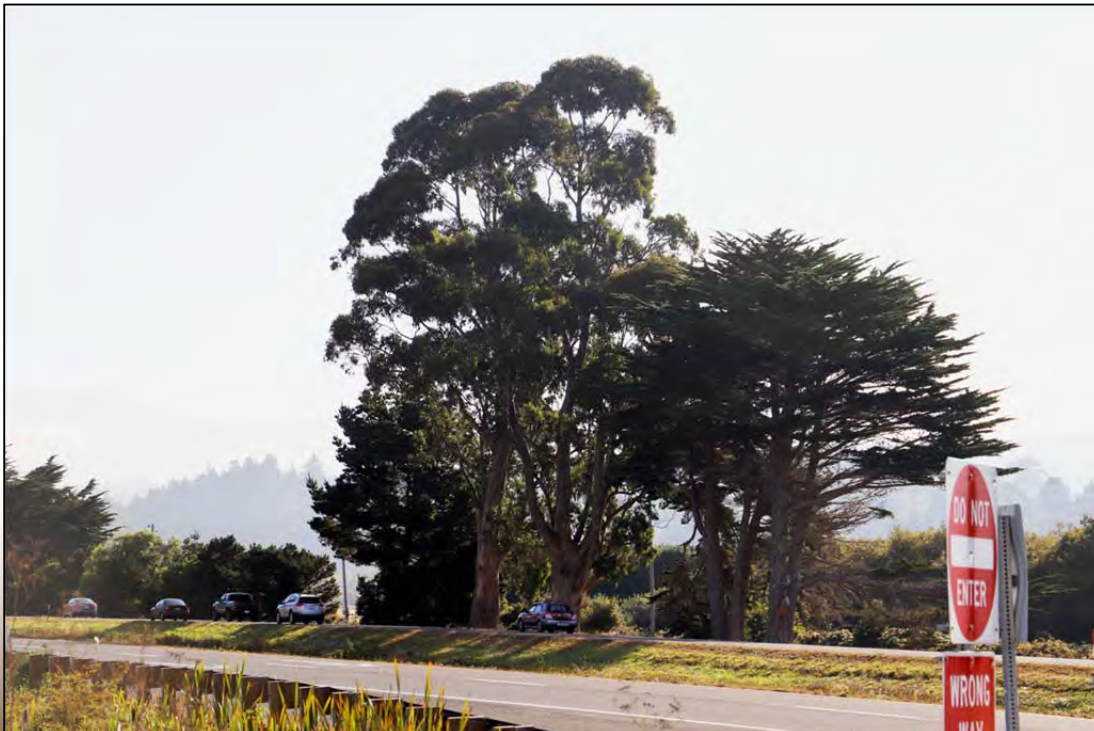
Example of viable bluegums (*Eucalyptus globulus*) in the vicinity:

A small stand of blue gums on the east side of Highway 101, adjacent to the south end of the subject tree stand. Illustrated is substantial growing space and distance from the highway, vigorous growth and viable architecture, rendering them good candidates for judicious pruning to mitigate any identified risk.
