Subject: SMA Revegetation Analysis of APN 311-221-026

Purpose Statement

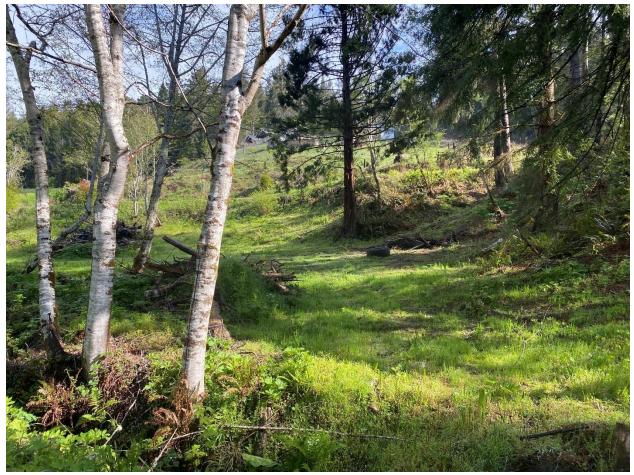
Picture 1: Looking north from the watercourse showing the revegetation of the disturbed area. Photo date 4-11-2023.

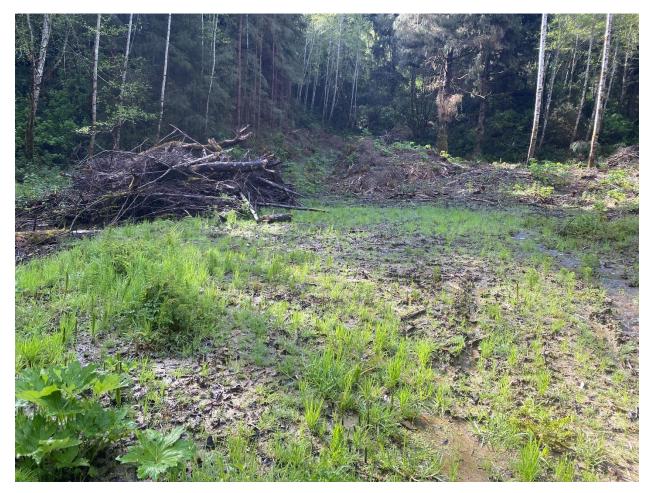
Picture 2: Looking south from the watercourse showing the revegetation of the disturbed area. Photo date 4-11-2023.

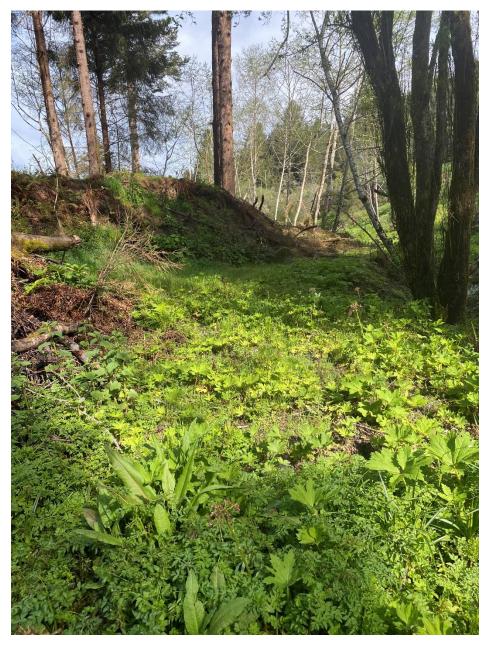
Picture 3: Looking north-west along the southern edge of the watercourse showing the revegetation of the disturbed area. Photo date 4-11-2023.

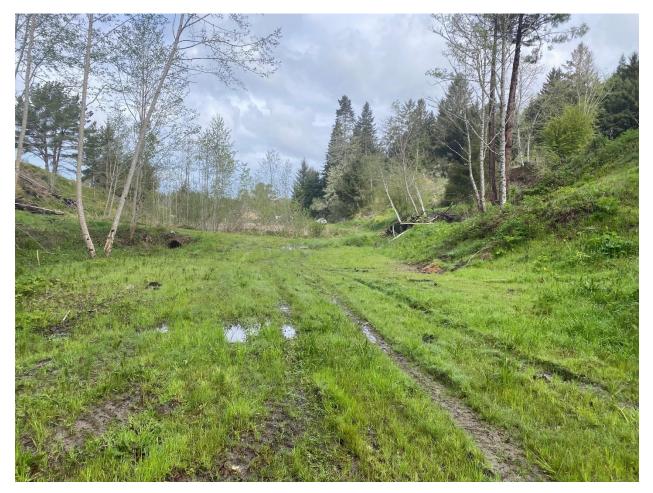
Picture 4: Looking north-west on the northern side of the watercourse showing the revegetation of the disturbed area. Photo date 4-11-2023.
