Subject: Oak Woodland Restoration Plan APN 216-082-006

APN 216-082-006 Oak Restoration Map

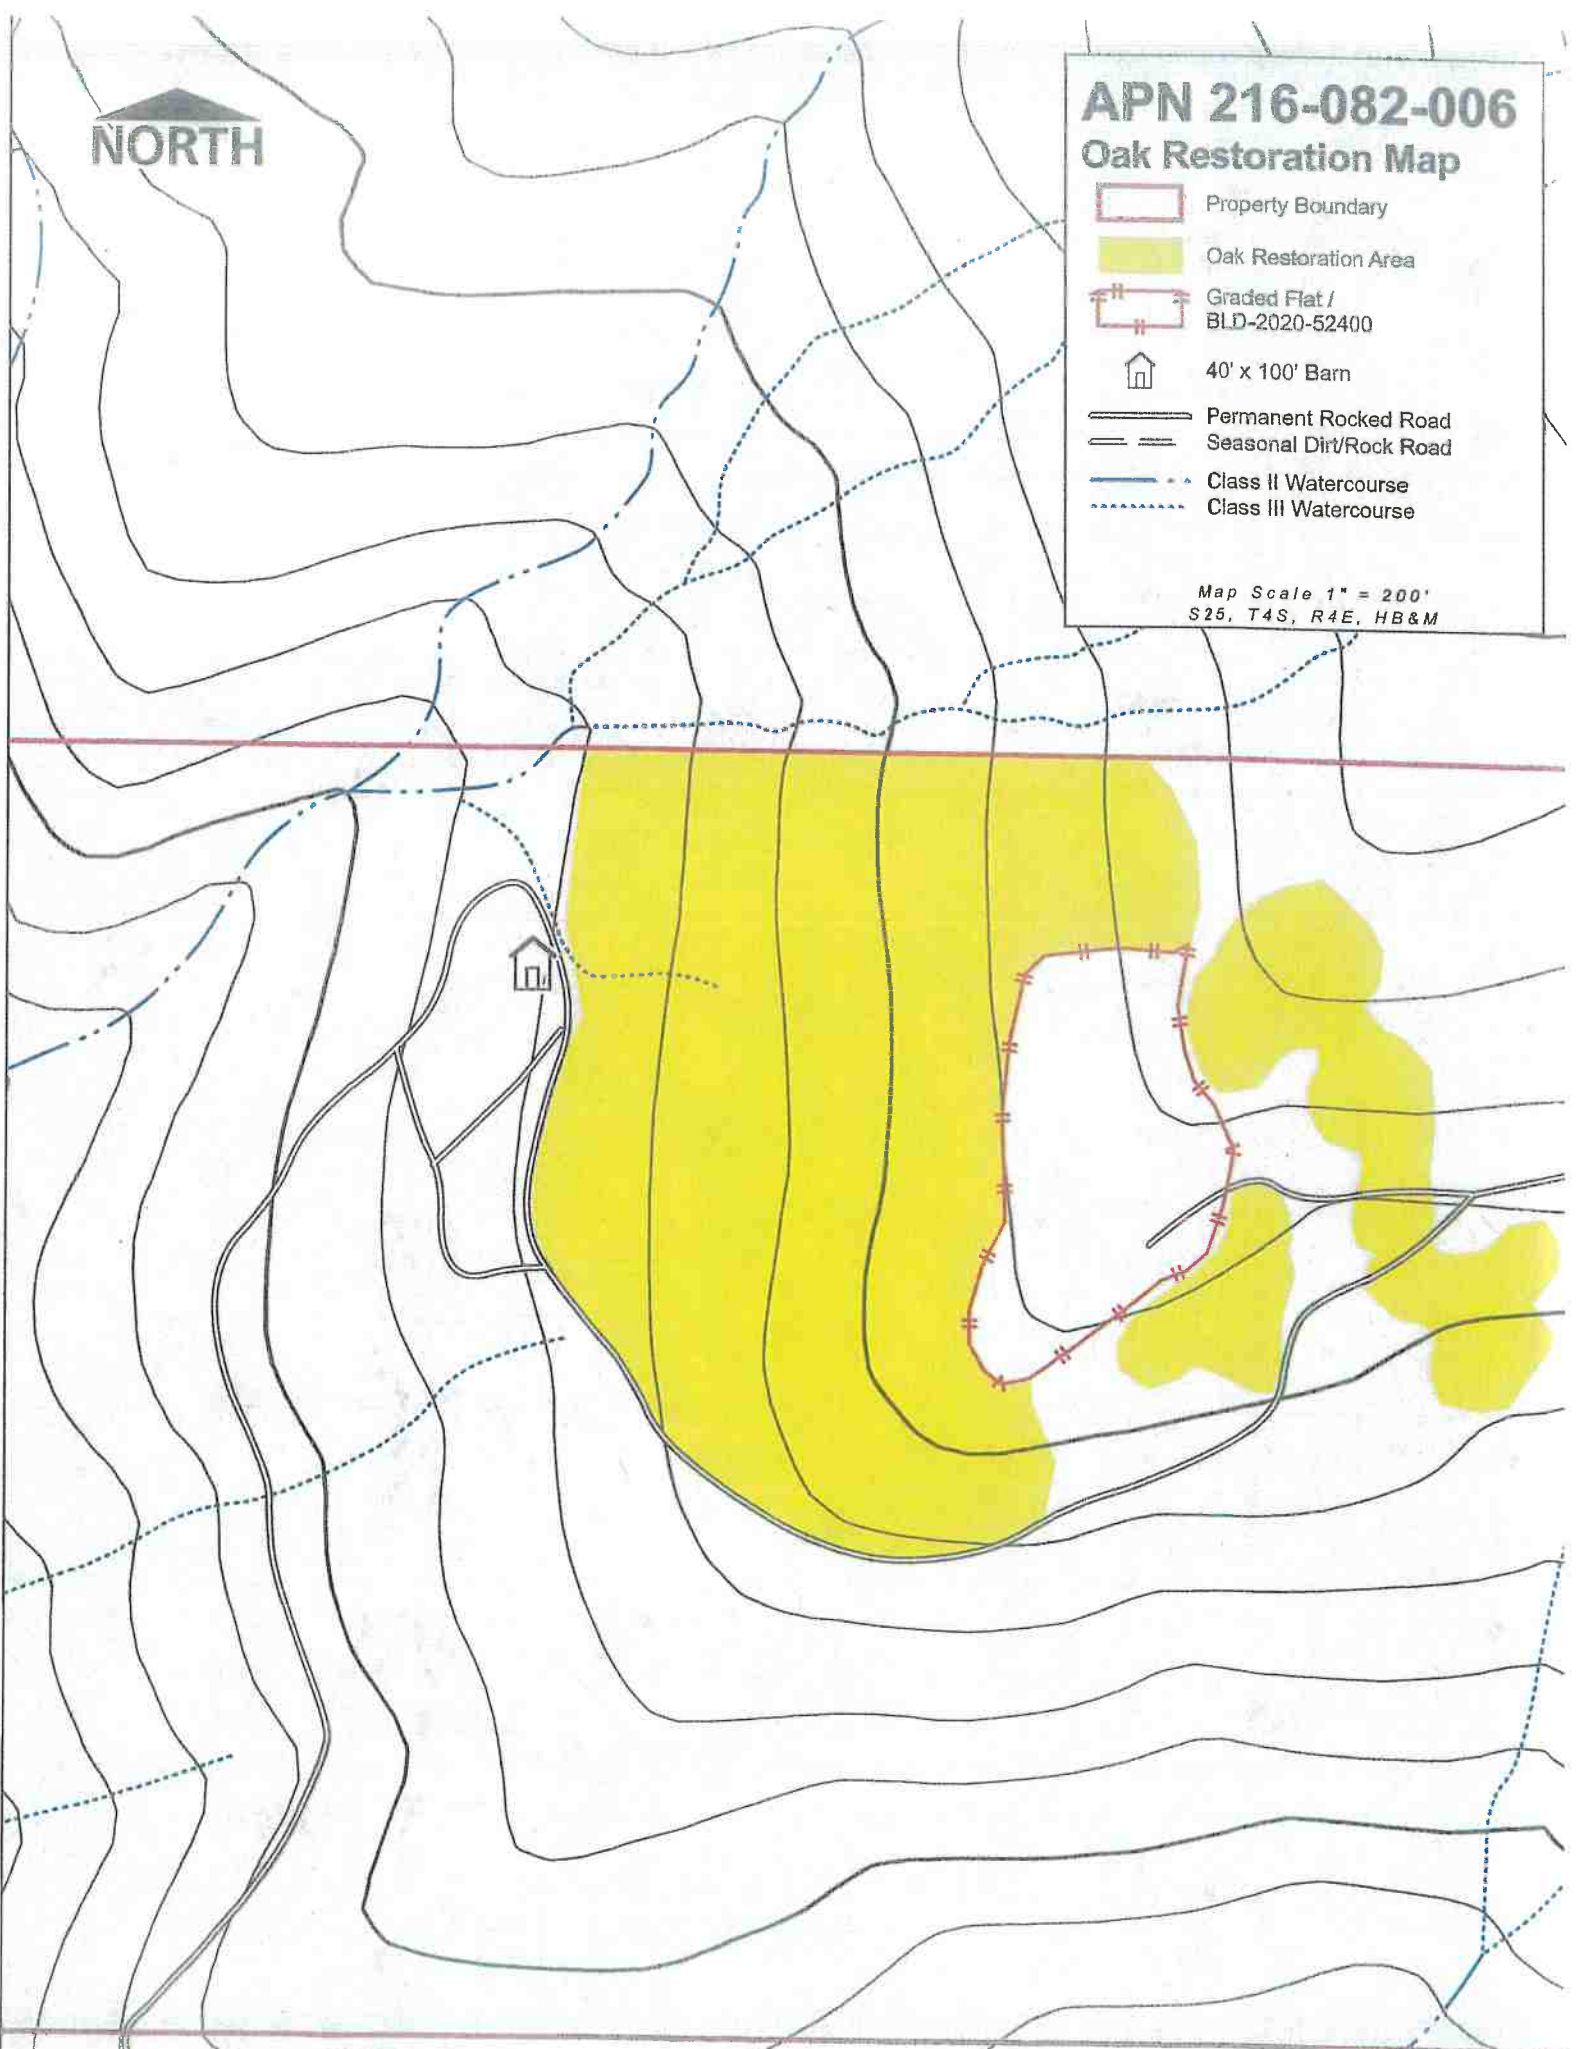
The activities described in this report were developed in general conformance with accepted oak restoration treatment practices and are prescribed to meet the specific conditions of the project area. After evaluating alternatives, the RPF supports oak woodland enhancement within APN 216-082-006 and recommends treatment of no less than 11.22 acres of oak woodland. The treatment area is depicted on the attached Oak Restoration Map.

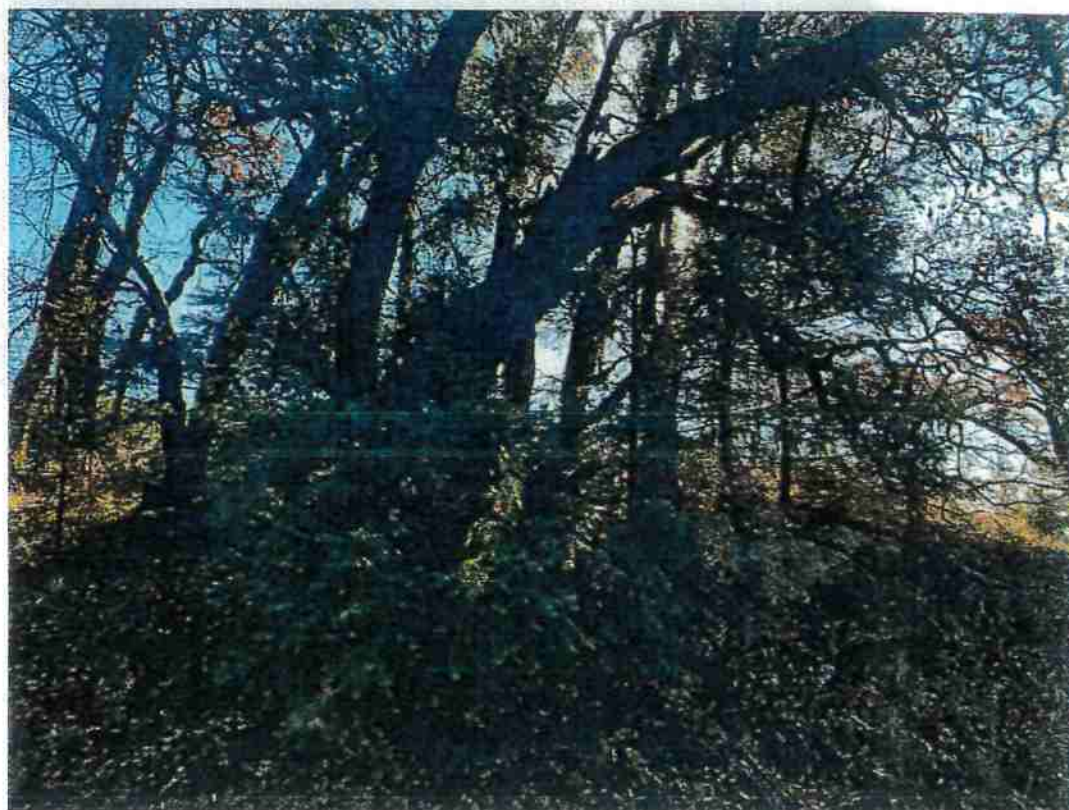
Oregon white oak and California black oak woodland with encroaching Douglas-fir trees. Above & below

- Remove Douglas-fir regeneration via hand crew (chain saws). Cut all Douglas-fir trees up to 12" DBH. Removal target is 80% or more of Douglas-fir stems. The cut needs to be made as low as possible on the stem, below the lowest live branch. Trees that are too difficult to fell safely can be girdled.

- Girdle (or cut) all Douglas-fir trees 12" DBH and greater if safety or damage to residual trees is a concern. Girdles must completely go around the tree and should consist of two parallel horizontal bands through the bark and cambium several inches apart. After the grooves have been made, the bark and cambium should be peeled away. Merchantable trees may be left for future commercial harvests.
