SUPPLEMENTAL INFORMATION #1

Project Title: **Ten Redwoods LLC Conditional Use Permit and Special Permit**

Record Number: PLN-11737-CUP
Assessor Parcel Number: 208-241-017
Area: Dinsmore Area

Incident Report 24CASRF000951-1

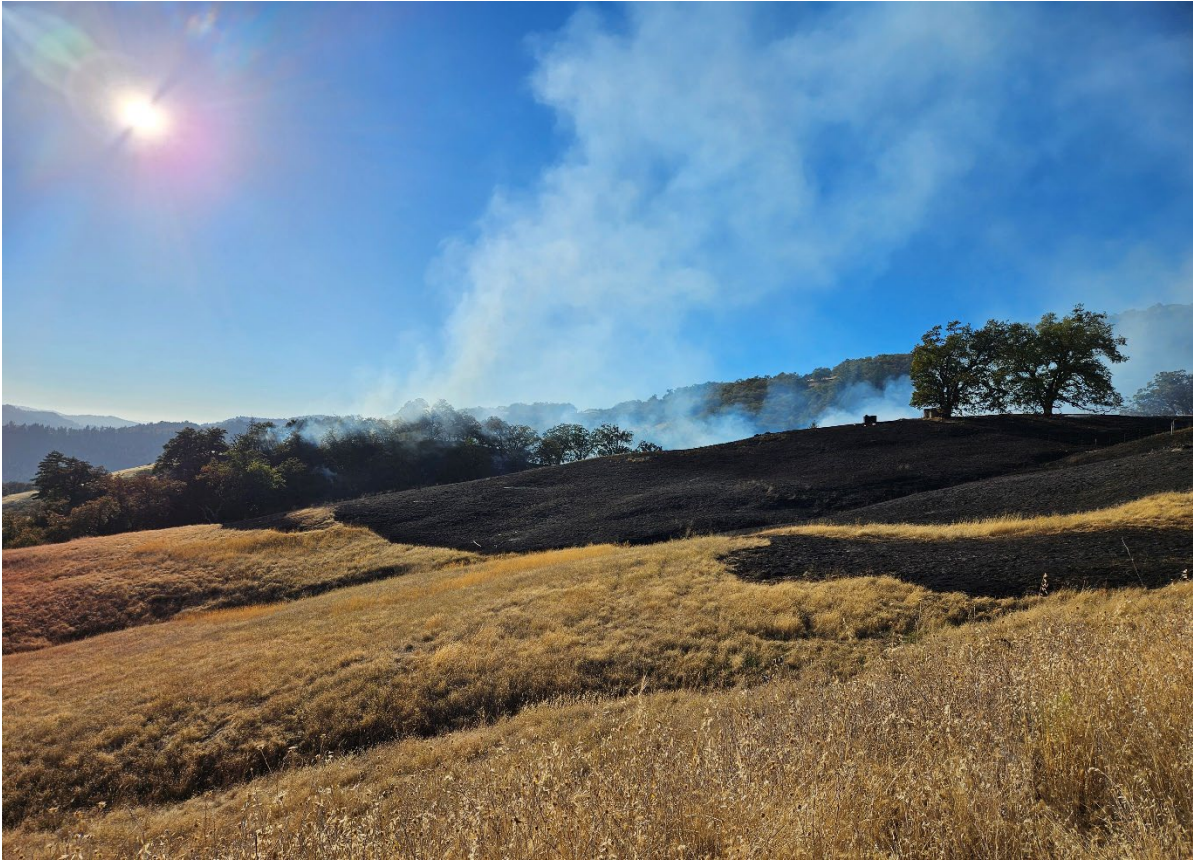
Looking west at the fire

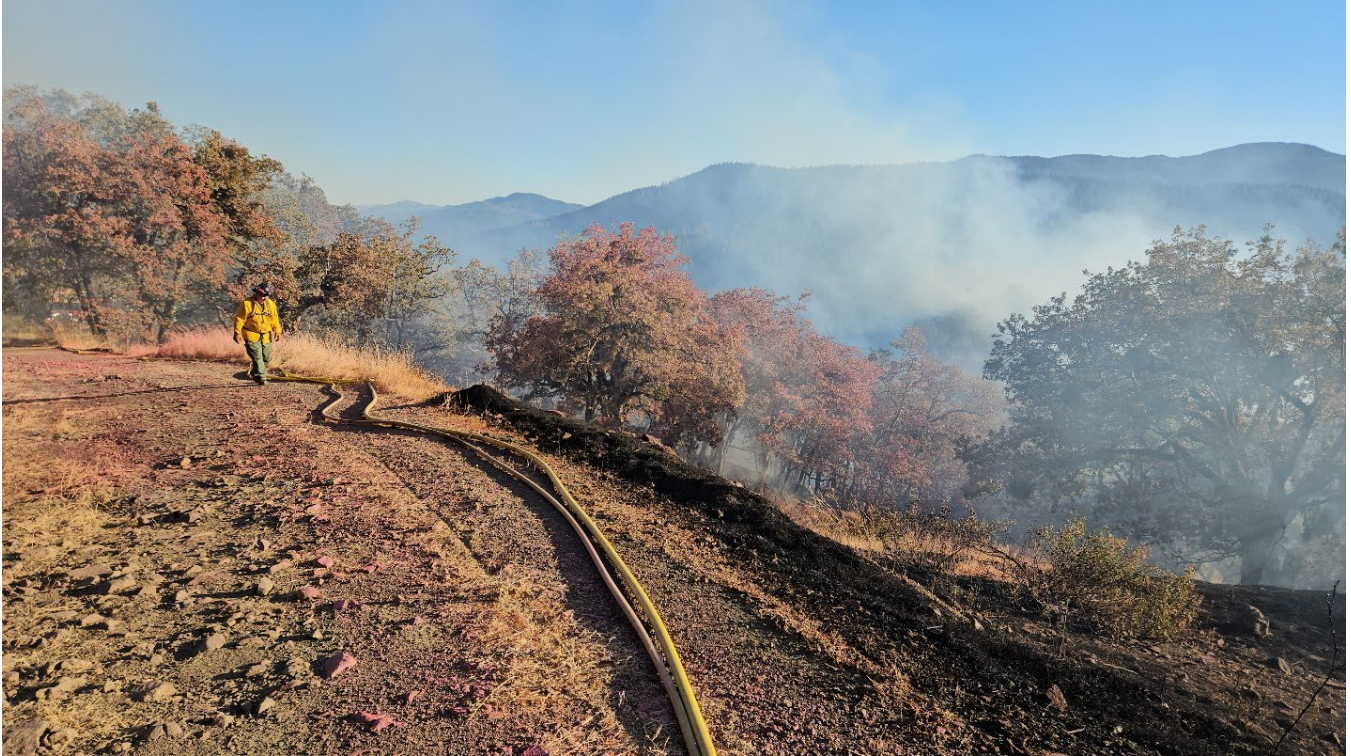
Fire crew works the perimeter 10/2/24

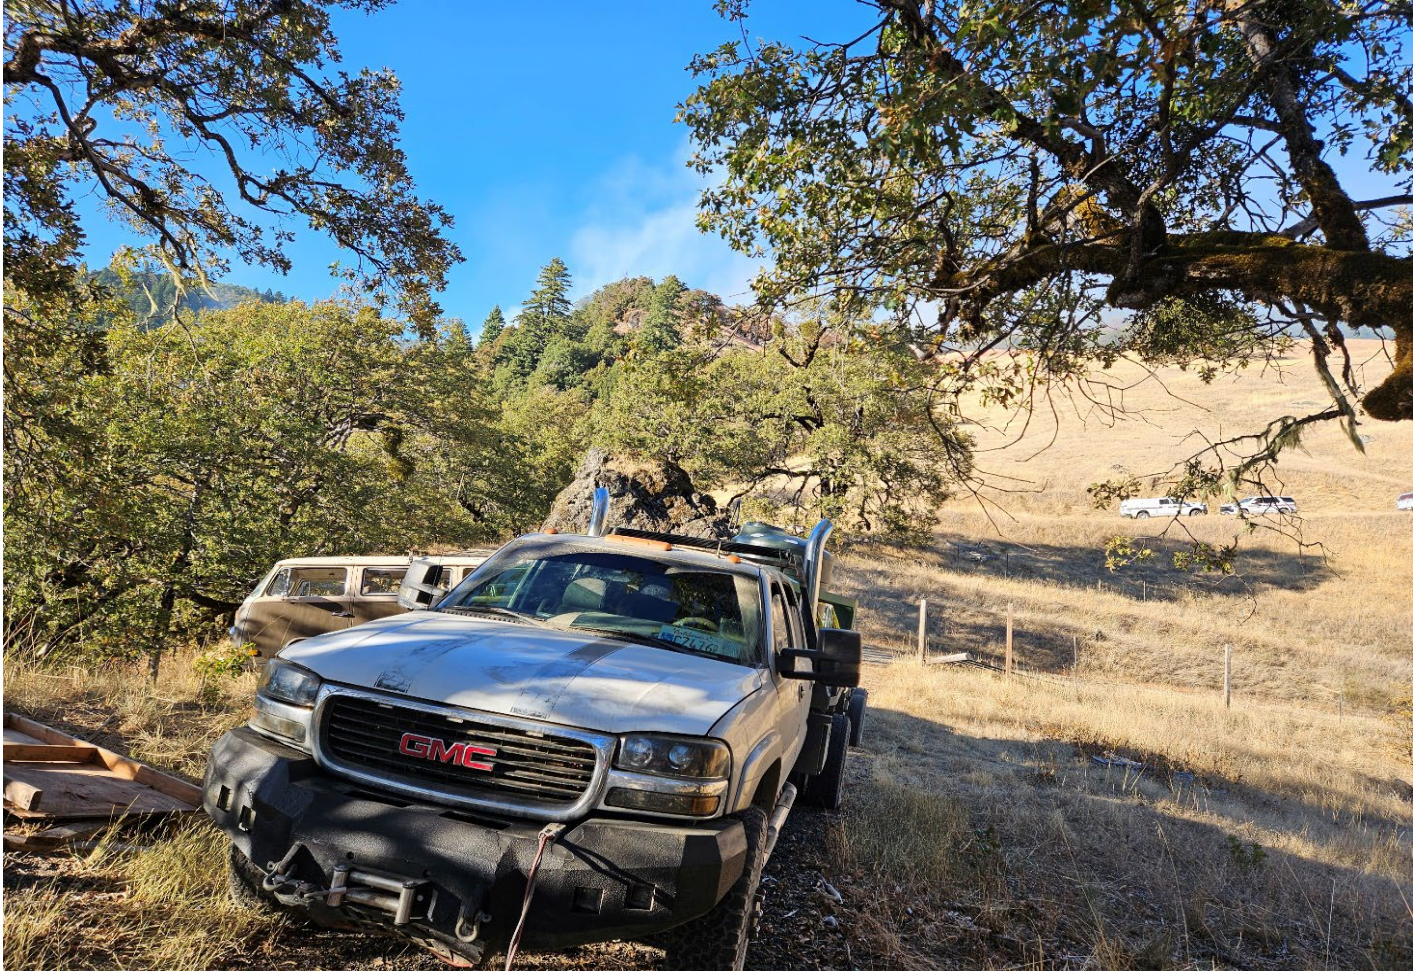
Looking North from the well on 208-241-011-000

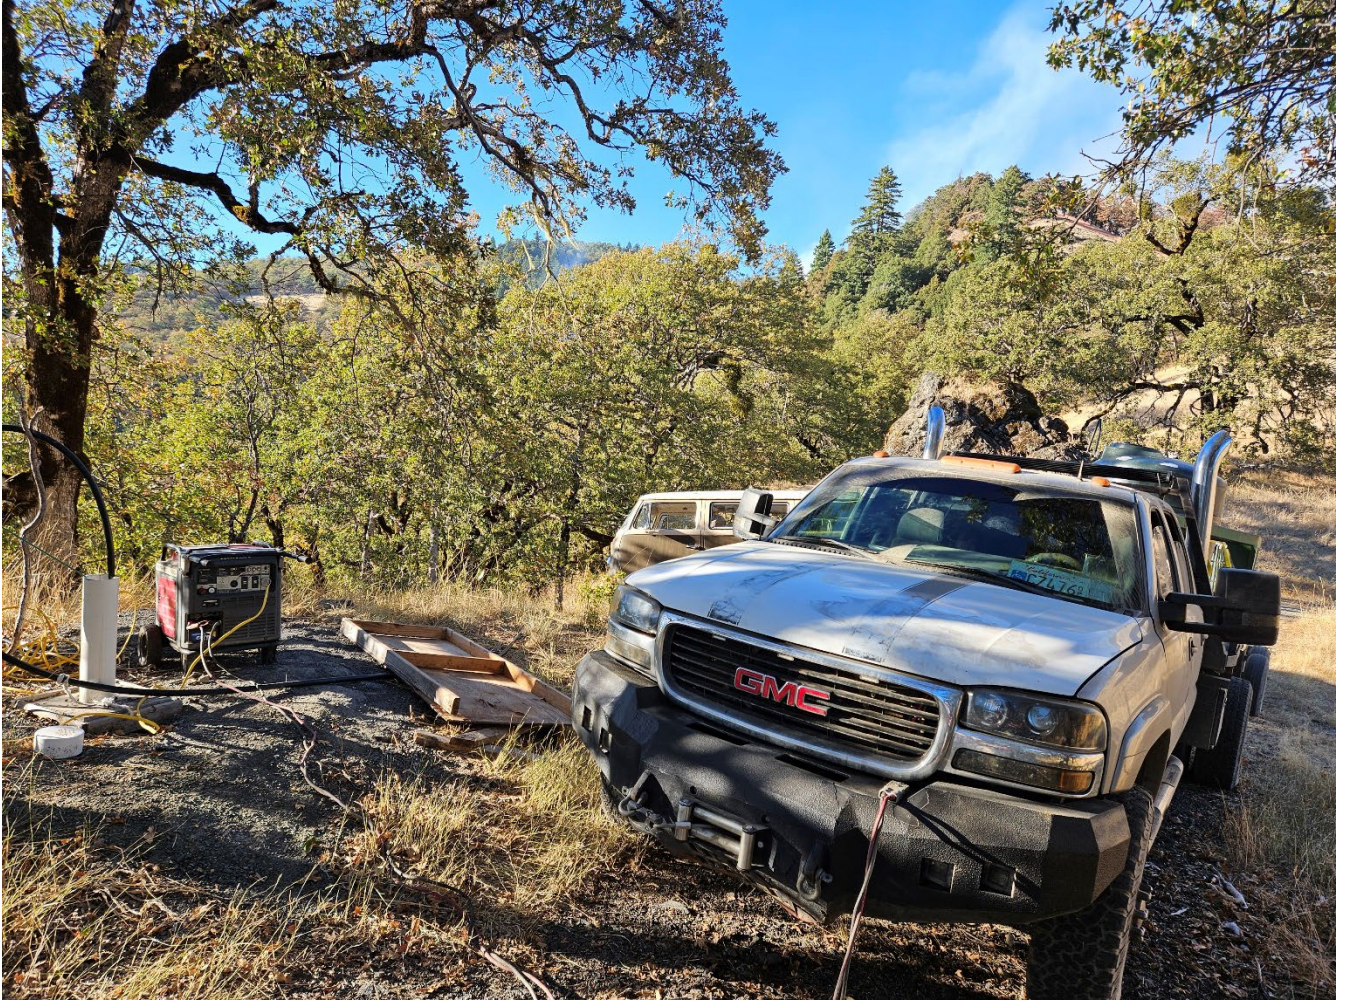
Wellhead and generator 208-241-011-000

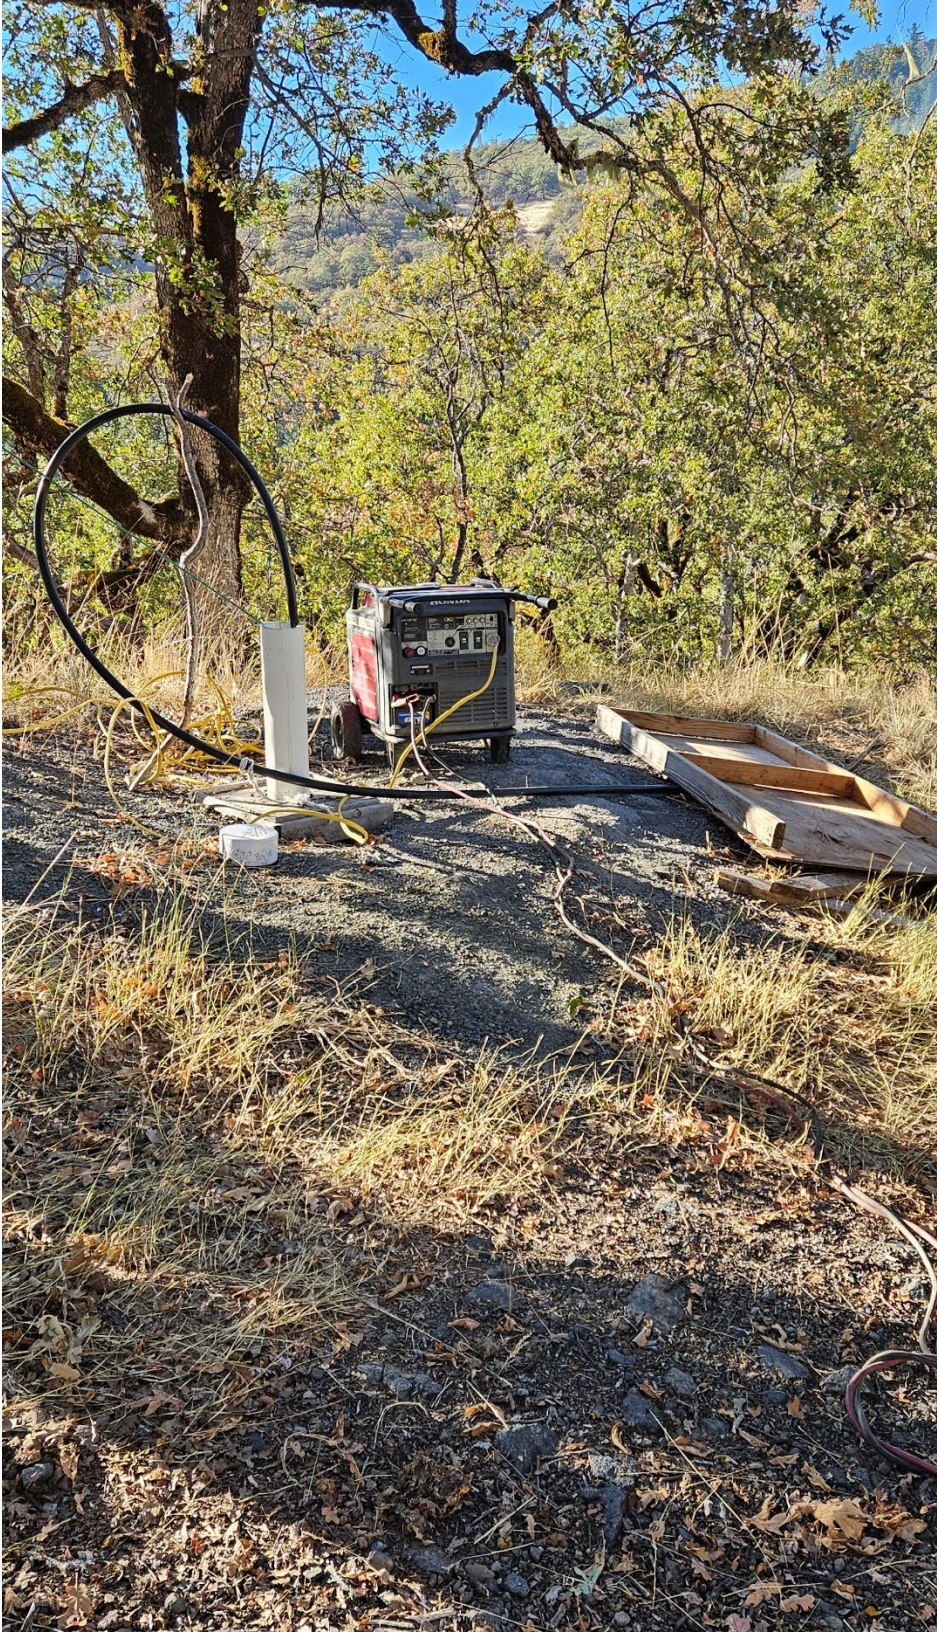
Well/Generator on parcel 208-241-011-000
