<b>Title:</b>	Startare Residential Rehabilitation and Façade Alterations
<b>Project:</b>	Historic Preservation HP-25-11
<b>Location:</b>	1627 Pine Street
<b>APN:</b>	004-071-015
<b>Applicant:</b>	William Startare
<b>Property Owner:</b>	William Startare and Erik Strombeck
<b>Purpose:</b>	After-the-fact approval of exterior façade alterations to rehabilitate a multi-family residence, including changes to siding, trim, doors, windows, porches, and lighting.
<b>Complete Application:</b>	February 11, 2026
<b>Deadline for Action:</b>	May 12, 2026
<b>General Plan:</b>	HDR – High Density Residential
<b>Zoning:</b>	R3 – Residential High
<b>California Environmental Quality Act (CEQA):</b>	If approved (or conditionally approved), then exempt under CEQA Guidelines §15331, Class 31 Historical Resource Restoration/Rehabilitation; if denied, then CEQA does not apply per CEQA Guidelines §15270.
<b>Staff Contact:</b>	Chris Lohofener, Senior Planner

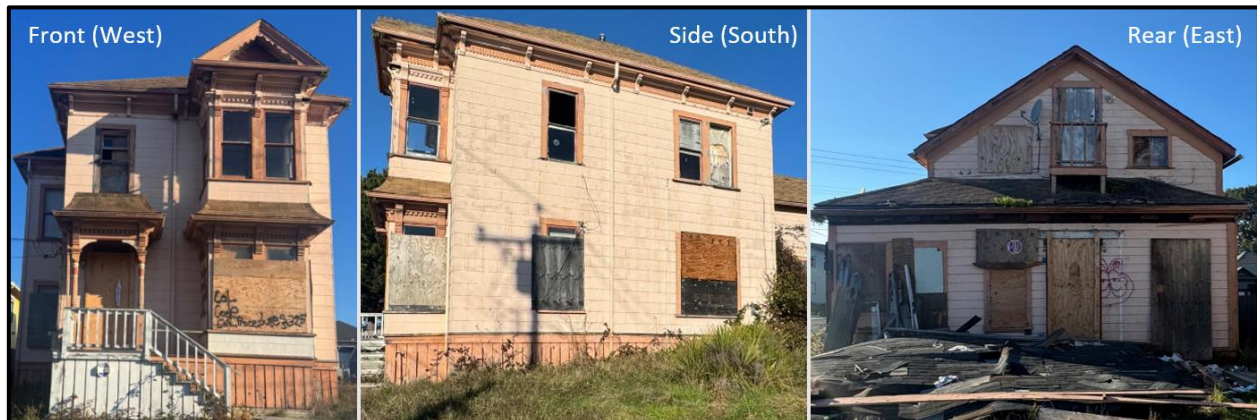
Figure 5: Prior Conditions, 2024.

According to the Applicant, the residence was purchased at a foreclosure auction on December 3, 2024, when the building was boarded, the rear porch had collapsed, and the roof and exterior elements were in poor condition. Applicant photographs, City images, and a prior real estate

listing generally support this description, showing substantial deferred maintenance, including a failed rear porch, broken and boarded openings, and deteriorated siding (Figure 5).

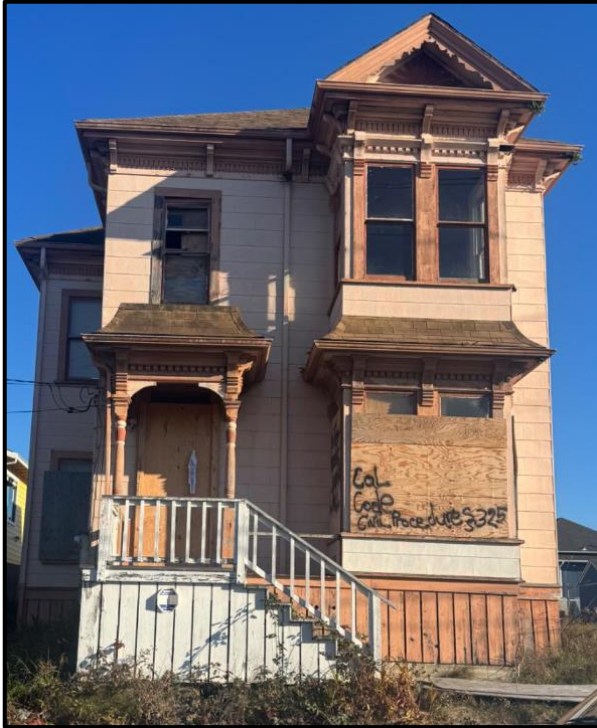
**Figure 6: Pine Street Façade, 2024.**

Prior documentation from the Green Book, archived records, Google StreetView, and real estate listing materials show the Pine Street façade as the building’s primary frontage, with the two-story pedimented bay, front porch, and entry sequence serving as key elements of its Eastlake character. The elevation featured a traditional main doorway, wood window assemblies with trim and

projecting sills, decorative wood detailing, square bay with triangular pediment, and porch details that defined the building's primary frontage (Figure 6).

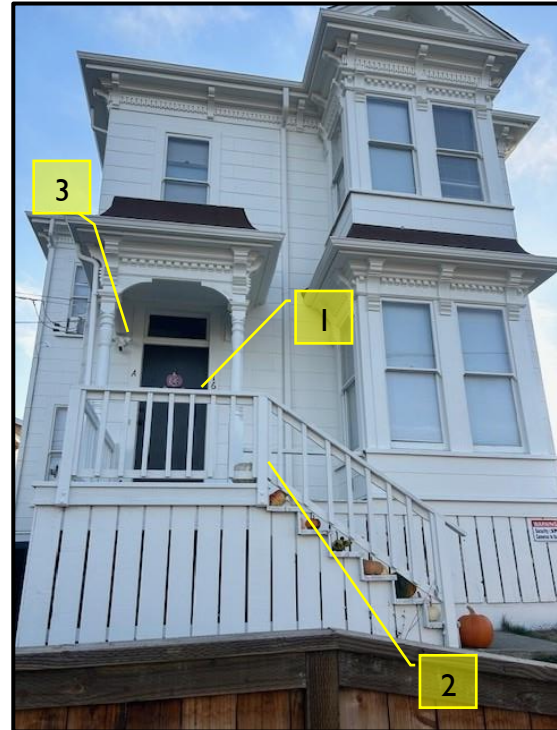
**Figure 7: Pine Street Façade, Post-Rehabilitation, 2025.**

In its current condition, the Pine Street façade appears to retain its overall massing, bay configuration, original siding, windows and projecting sills, and original porch location, while incorporating targeted changes at the main entry. These include new door hardware and a replacement light fixture at the front door, along with an existing reconstructed porch approved under a prior Historic Preservation Permit (HP-11-0005), where some porch elements differ from the that approval but predate the current ownership (Figure 7).

1. New door hardware was installed at the main entry, replacing a traditional brass knob and deadbolt with a traditional black knob and deadbolt, as described by the Applicant (Figure 7).
2. The Applicant reports that no recent work was done on the front porch and that its repair occurred before the current ownership. City records show the porch was repaired under Historic Preservation Permit HPO-11-0005 (2011), with conditions requiring: (1) turned stair balusters, (2) staircase skirting matching the house, and (3) paint consistent with the residence. Field observations indicate the skirting and paint are consistent with those conditions, but the balusters are 2x2 dimensional lumber rather than turned balusters (Figure 7). Because this condition predates the current owner, it is treated as an existing condition.

3. A new white motion-activated light fixture was installed above the doorway (Figures 7 and 8). The timing of replacement for the previous fixture is unknown.

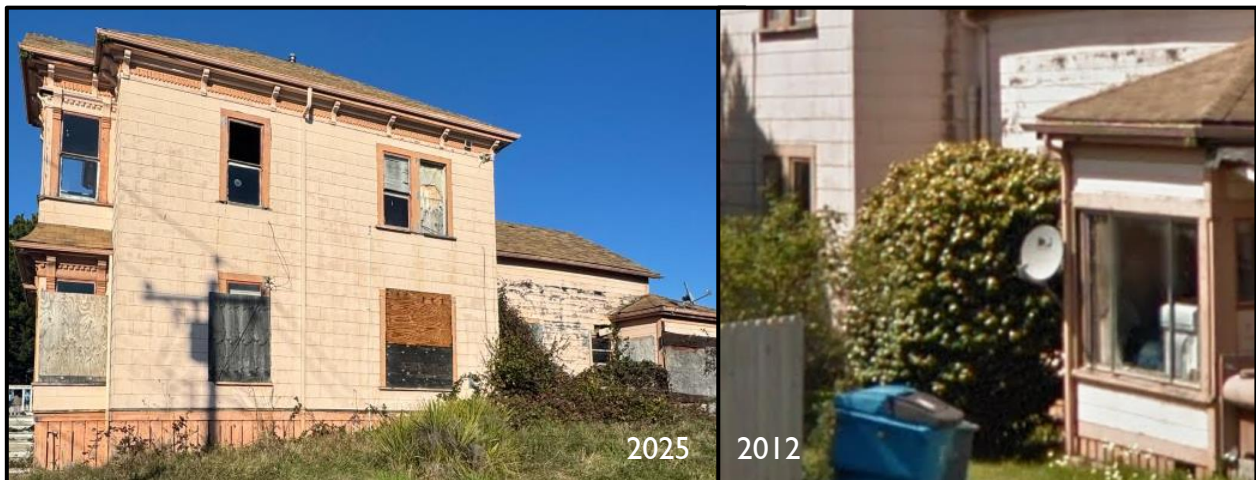
**Figure 9: Church Street Façade, Prior Conditions, 2025 and 2012.**

Prior documentation and listing materials show the south elevation with a mix of asbestos and wood lap siding, wood windows, a door opening, and a large window on the projection in the back corner that read as a prominent feature of the elevation and alcove (Figure 9, 2012 photo). These openings and associated trim features, siding patterns, and decorative features were in place prior to rehabilitation efforts (Figure 9).

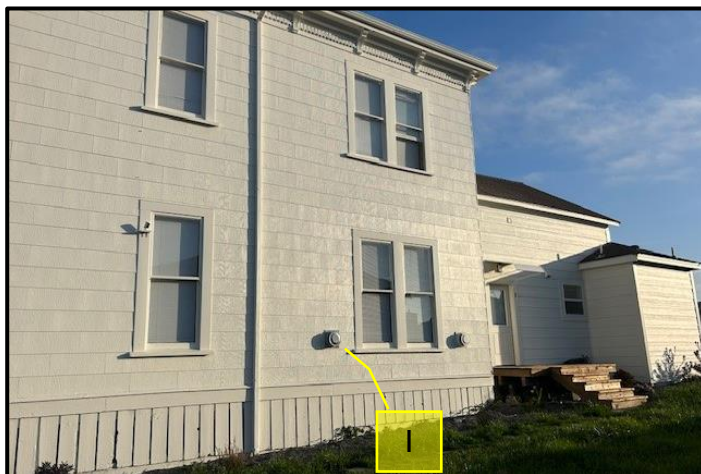
**Figure 10: Church Street Façade, Post-Rehabilitation, 2025.**

In its current condition, the front portion of the structure retains many original wooden window assemblies and projecting sills, and also includes new heater and kitchen-related vents. The siding appears to be asbestos. On the rear portion, a new exterior light was installed above the alcove doorway, and Hardie lap siding installed in place of wood lap siding. Several prior window and door assemblies have been removed, modified, or infilled, including conversion of a former window to a doorway with a small deck, replacement of a wood sash window with a vinyl unit and simplified trim, and enclosure of other historic or earlier openings with new siding.

1. A new heater outlet vent has been installed. (Figure 10).
2. A new vent has been installed, presumed to serve kitchen appliances added as part of the interior remodel (Figure 11).

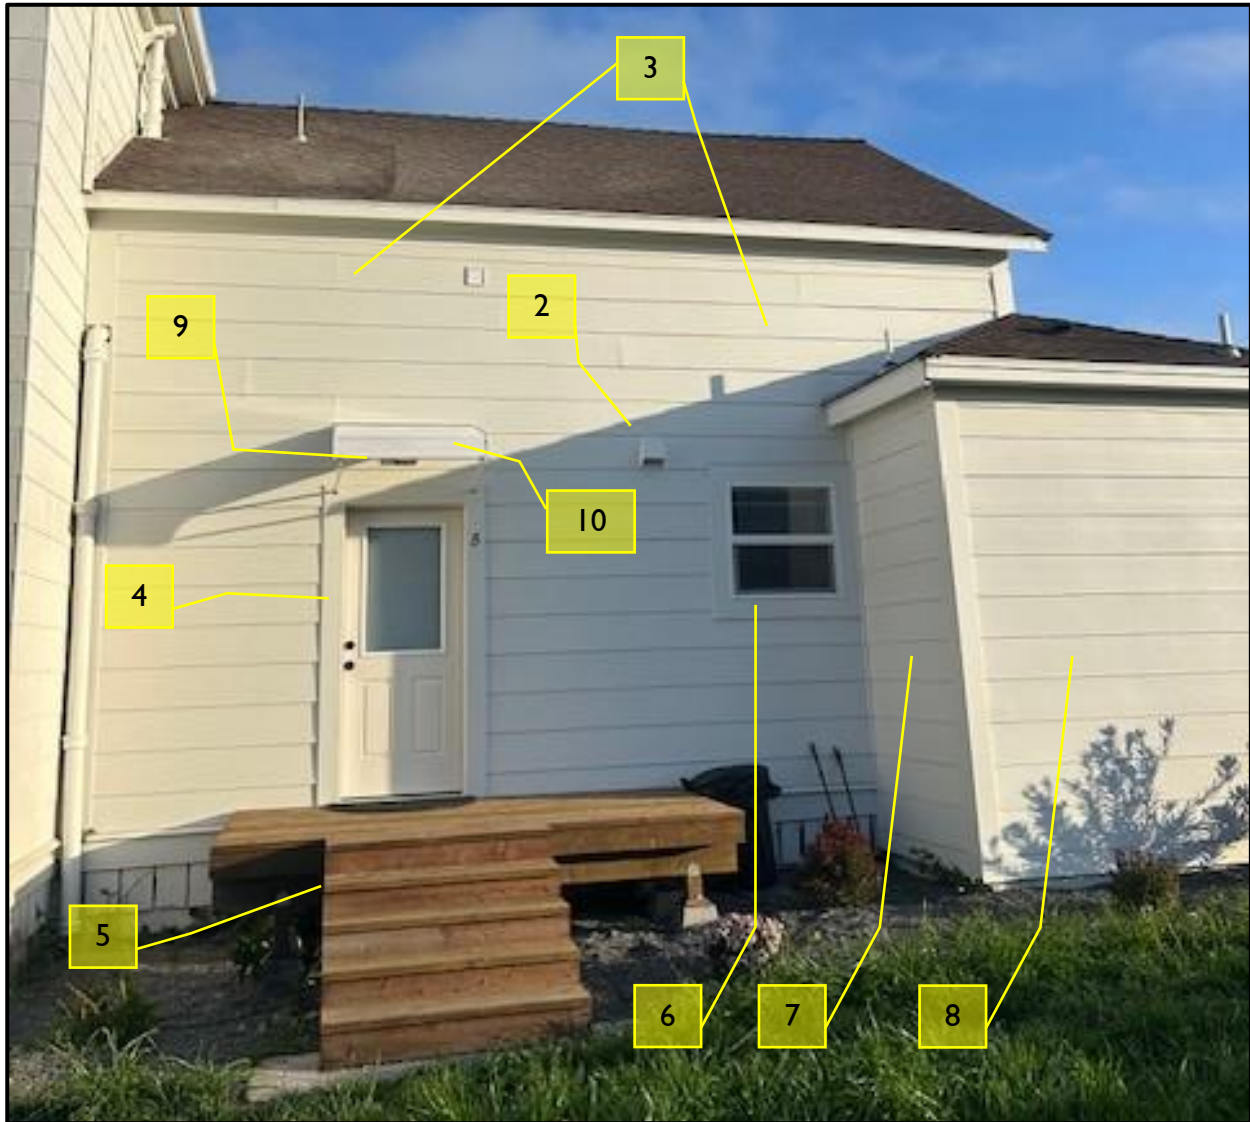
**Figure 11: Church Street Façade, Alcove, Post-Rehabilitation, 2025.**

3. Hardie lap siding has been installed throughout the alcove in place of the previous wood lap siding (Figure 11).
4. Based on the 2024 real estate listing floor plans and archived photos, a double-hung wood window assembly, consistent with other windows on the residence, previously occupied this alcove wall area. That window assembly has been removed and replaced with a new doorway, including new half-light fiberglass door with round black doorknob, 1x4 trim, and aluminum threshold (Figures 9 and 11, also see Attachment 2 for floor plans and interior photos depicting room layout).

5. A new pressure-treated wood deck on pier blocks has been constructed beneath the new doorway. The Applicant reports that an older landing was replaced in this location, however, available photos show a window opening and a large shrub rather than a prior landing (Figures 9 and 11).

6. The original window opening appears to remain, but the historic wood sash window has been replaced with a modern vinyl unit. The original wood casing and projecting sill have been removed and replaced with flat 1x4 trim (Figure 11).

7. According to the 2024 real estate listing floor plans, a 30-inch doorway previously existed at this location, likely with associated trim details. The Applicant reports that the door had been removed and the opening boarded prior to his ownership. This doorway has now been removed and infilled with Hardie lap siding (Figures 9 and 11).

8. A window opening approximately 6 feet by 5 feet, with projecting trim, previously occupied most of this wall. It is unclear whether this window was original to the building. The Applicant reports that the window had been “smashed out” and boarded prior to his ownership, and the opening has since been removed and covered with Hardie lap siding (Figures 9 and 11).

10. The awning was installed as part of the rehabilitation but has since been removed. The Applicant stated that he intends to develop a different design to protect the entryway – any new exterior alteration will be conditioned for HPC approval.

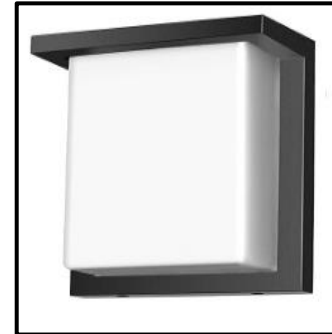
**Figure 12. New Light Fixture.**

9. A new light fixture has been installed above the new doorway in the alcove. (Figures 11 and 12). It is unclear whether the fixture complies with the City’s Dark Sky regulations; if not, it must be brought into compliance.

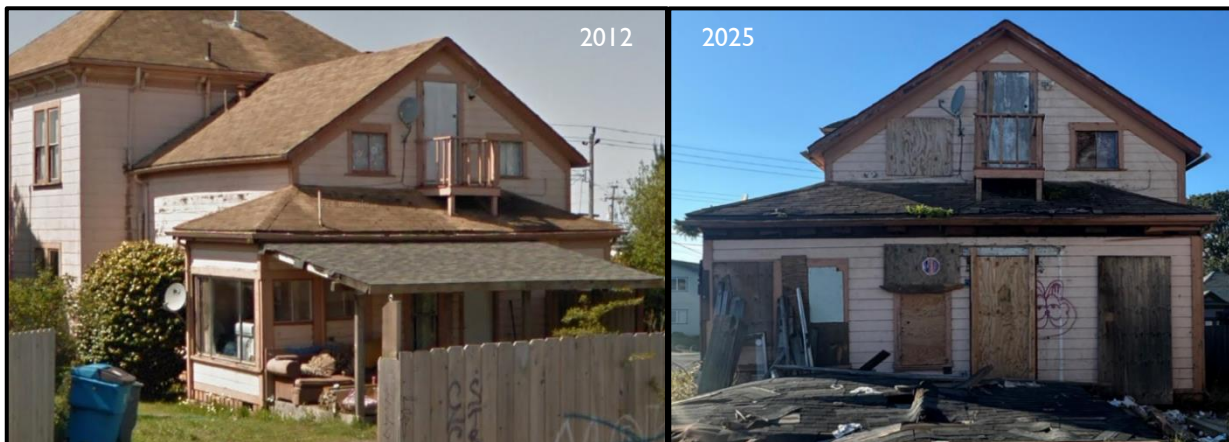
**Figure 13: Alley Façade, Prior Conditions, 2012 and 2025.**

Prior documentation from 2024 and 2025, and real estate listing materials, show a second-story door opening with a small balcony/landing and simple wood guardrail at the center gable, multiple wood window openings with trim on both levels, and narrow wood lap siding, much of it covered with plywood boarding (Figure 13). As mentioned earlier, a ground-level porch/landing structure that was constructed under Building Permit B09-0914, was in poor condition and ultimately demolished in 2025.

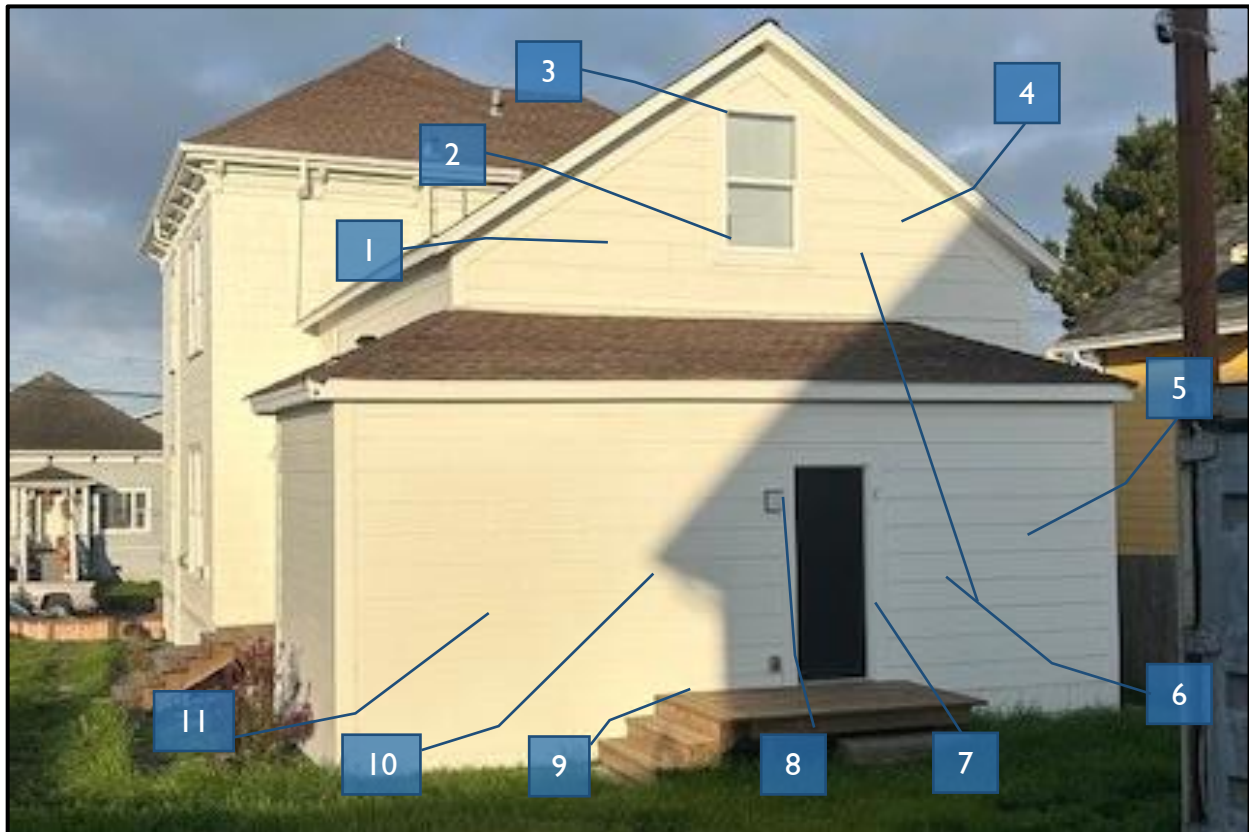
**Figure 14: Alley Façade, Post-Rehabilitation, 2025.**

In the present condition, the overall massing and roof forms remain the same, but individual openings and materials have been reorganized (Figure 14). The former second-story balcony, door, and windows have been removed and replaced by a single window at the center of the gable, with simplified 1x4 flat trim. On the lower level, prior window and door locations have been consolidated into a solid rear door and a reduced number of windows, with some earlier openings infilled. The elevation is now clad in new lap siding and trim, and the rear porch has been replaced by a small wood landing and steps serving the rear door. Below is a numbered, item-by-item description of these changes, keyed to the annotated post-rehabilitation photograph in Figure 14.

1. It is unclear if the original window had been replaced prior to the current owner, but the window opening, wood casing, and projecting sill have been removed and infilled with Hardie lap siding.
2. It is unclear if the door and balcony feature were original or historic components of the home. However, the door and wood casing were removed, as well as the small balcony and railing.
3. A modern vinyl window unit and flat 1x4 trim, as well as Hardie lap siding, were installed in place of the removed door and balcony described above.
4. It is unclear if the original window had been replaced prior to the current owner, but the window opening, wood casing, and projecting sill have been removed and infilled with Hardie lap siding.
5. The original double-hung wood sash window unit, wood casing and projecting sill have been removed and infilled with Hardie lap siding.

6. Hardie lap siding and new corner trim has been installed throughout the rear façade in place of the previous wood lap siding.
7. The door opening appears to remain in place, but the door and wood casing have been removed. In its place is a modern wood slab door with flat 1x4 trim and a black round doorknob.

8. A new light fixture has been installed above the new doorway in the alcove. (Figures 12 and 14).
9. The deteriorated landing and overhang were removed and a new pressure-treated wood deck on pier blocks has been constructed beneath the new doorway.

10. It is unclear if the original window had been replaced prior to the current owner, but the window opening, wood casing, and projecting sill have been removed and infilled with Hardie lap siding.

11. It is unclear if the original window had been replaced prior to the current owner, but the window opening, wood casing, and projecting sill have been removed and infilled with Hardie lap siding.

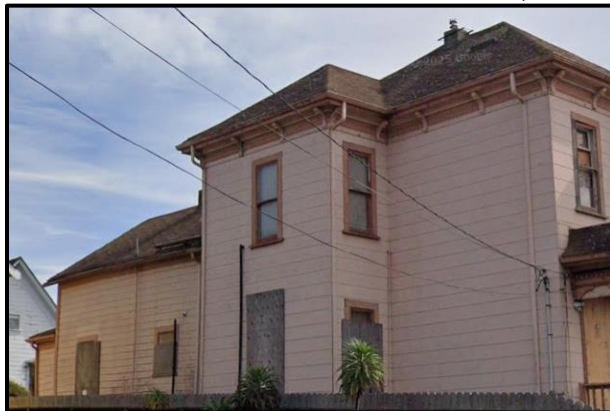
**Figure 15: Interior Lot Line Façade, Prior Conditions, 2024.**

Prior evidence shows that the original window assemblies and decorative features seem to remain intact (Figure 15). The north façade has been altered primarily to address building maintenance and utility needs. Work on this side of the structure has focused on replacement of deteriorated exterior cladding with new Hardie lap siding, and installation of new plumbing components to serve interior mechanical systems (Figure 16).

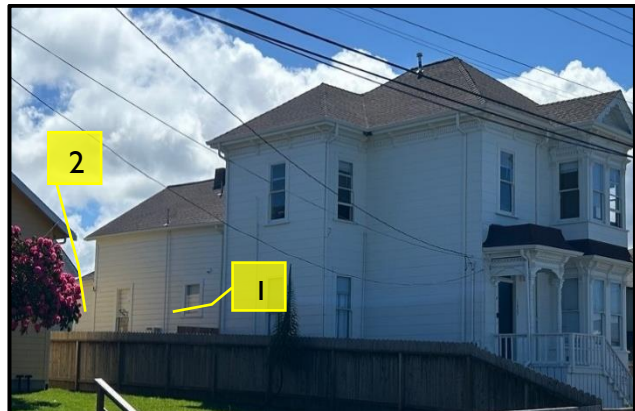
**Figure 16: Interior Lot Line Façade, Post-Rehabilitation, 2025. View from Street (upper) and View from Alley (lower).**

1. New plumbing was installed to accommodate a new water heater.
2. Hardie lap siding and new corner trim has been installed throughout the interior lot line façade in place of the previous wood lap siding.
