RE: **Notice of Violation of Fish and Game Code - Request for Restoration Plans
Addendum to July 17, 2020 “Notice of Violation of Fish and Game Code Response”**
APNs: 216-317-006, 216-317-007, 216-317-008, 216-317-003, and 216-317-004

DFW VIOLATION RESOLUTION

DOBBYN CREEK AREA
 ALDERPOINT ROAD, ALDERPOINT, CA 95511
 REMEDIATION PLAN AREA AND DETAILS

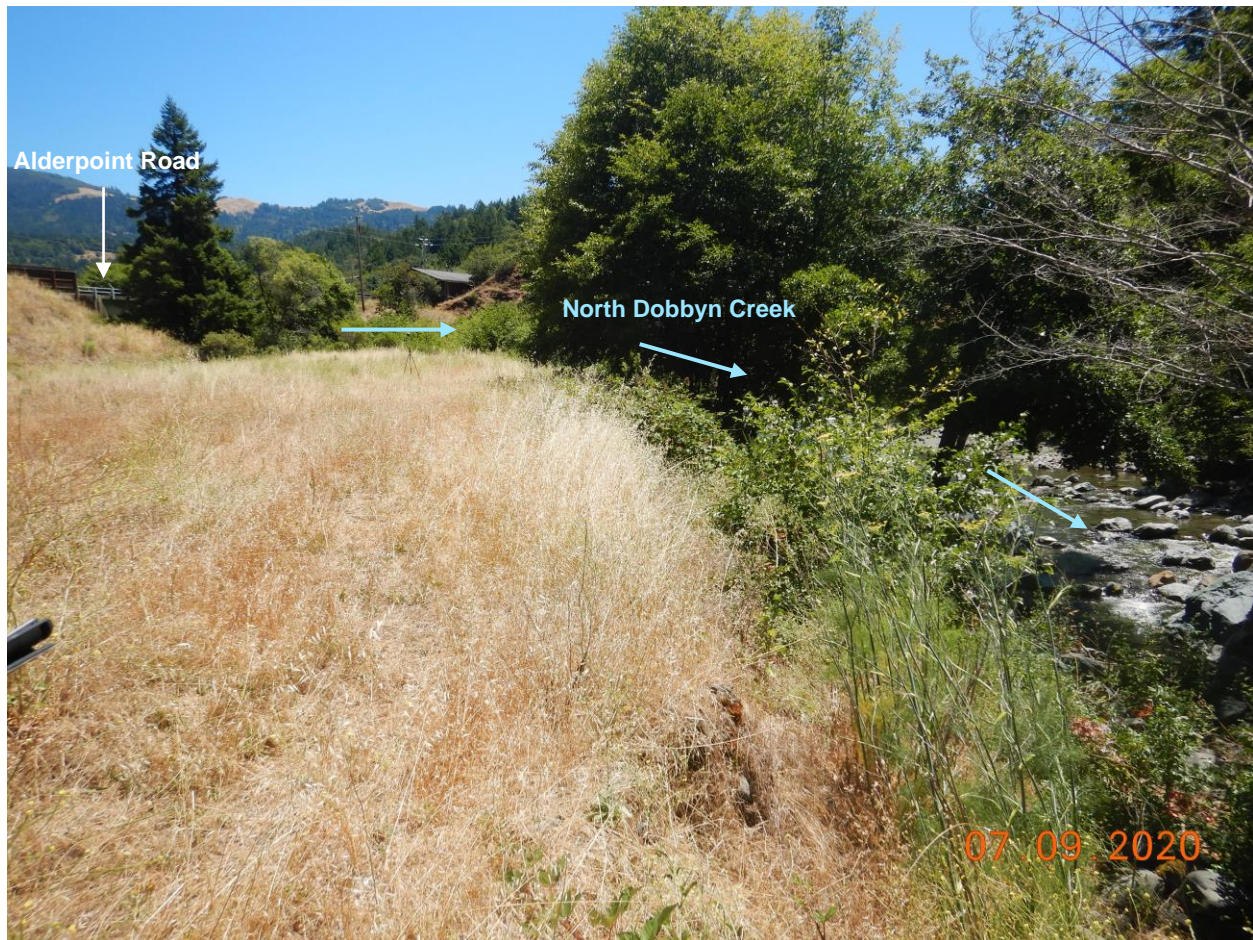
Attachment D – Figure 1

The section of bank along North Dobbyn Creek and Dobby Creek will be monitored for erosion (Figure 1). Riparian trees will be planted along a 150-foot section of North Dobbyn Creek. Sensitive habitat and signage will be posted along the revegetation site. Interim erosion control measures including the distribution of straw hay mulch and possible erosion control blankets may be utilized to ensure soil is stabilized during the revegetation process.

Figure 1. Section of Revegetated Bank on North Dobbyn Creek to be Monitored and Flagged as Sensitive Habitat Area.

All non-native organics waste and woody debris is to be removed from the sensitive habitat area. During the remediation process, excess material is to be collected onsite and stored in a stable location where they cannot enter a watercourse. Disturbed areas that have not successfully revegetated will be planted with native riparian vegetation and trees to match the surrounding area.
