# Biological and Wetland Assessment—Revision 1

Garberville Sanitary District  
Robertson/Wallan/Hurlbutt Tanks  
Replacement Project

**October 2023**

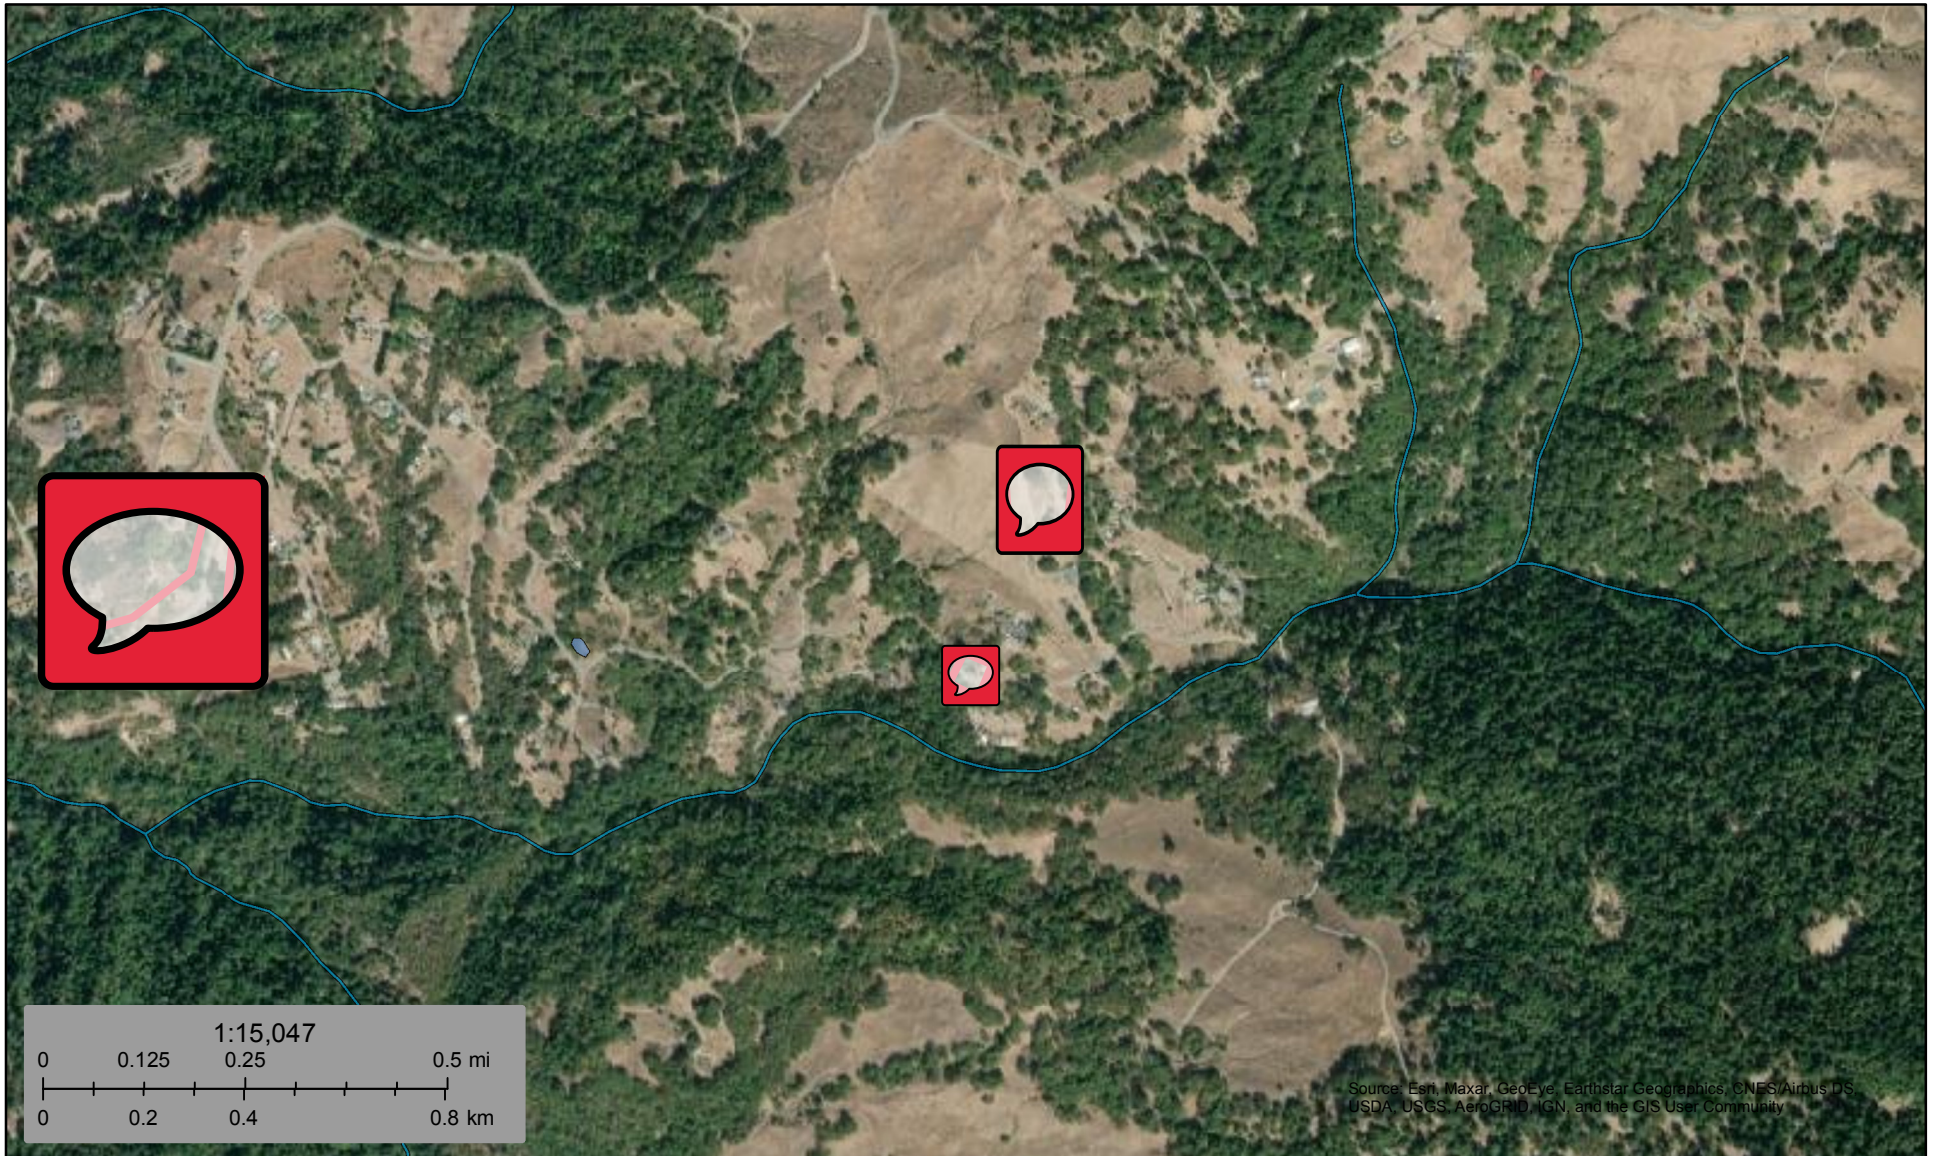
1

# National Wetland Inventory and Drought Monitor

**Wetlands**

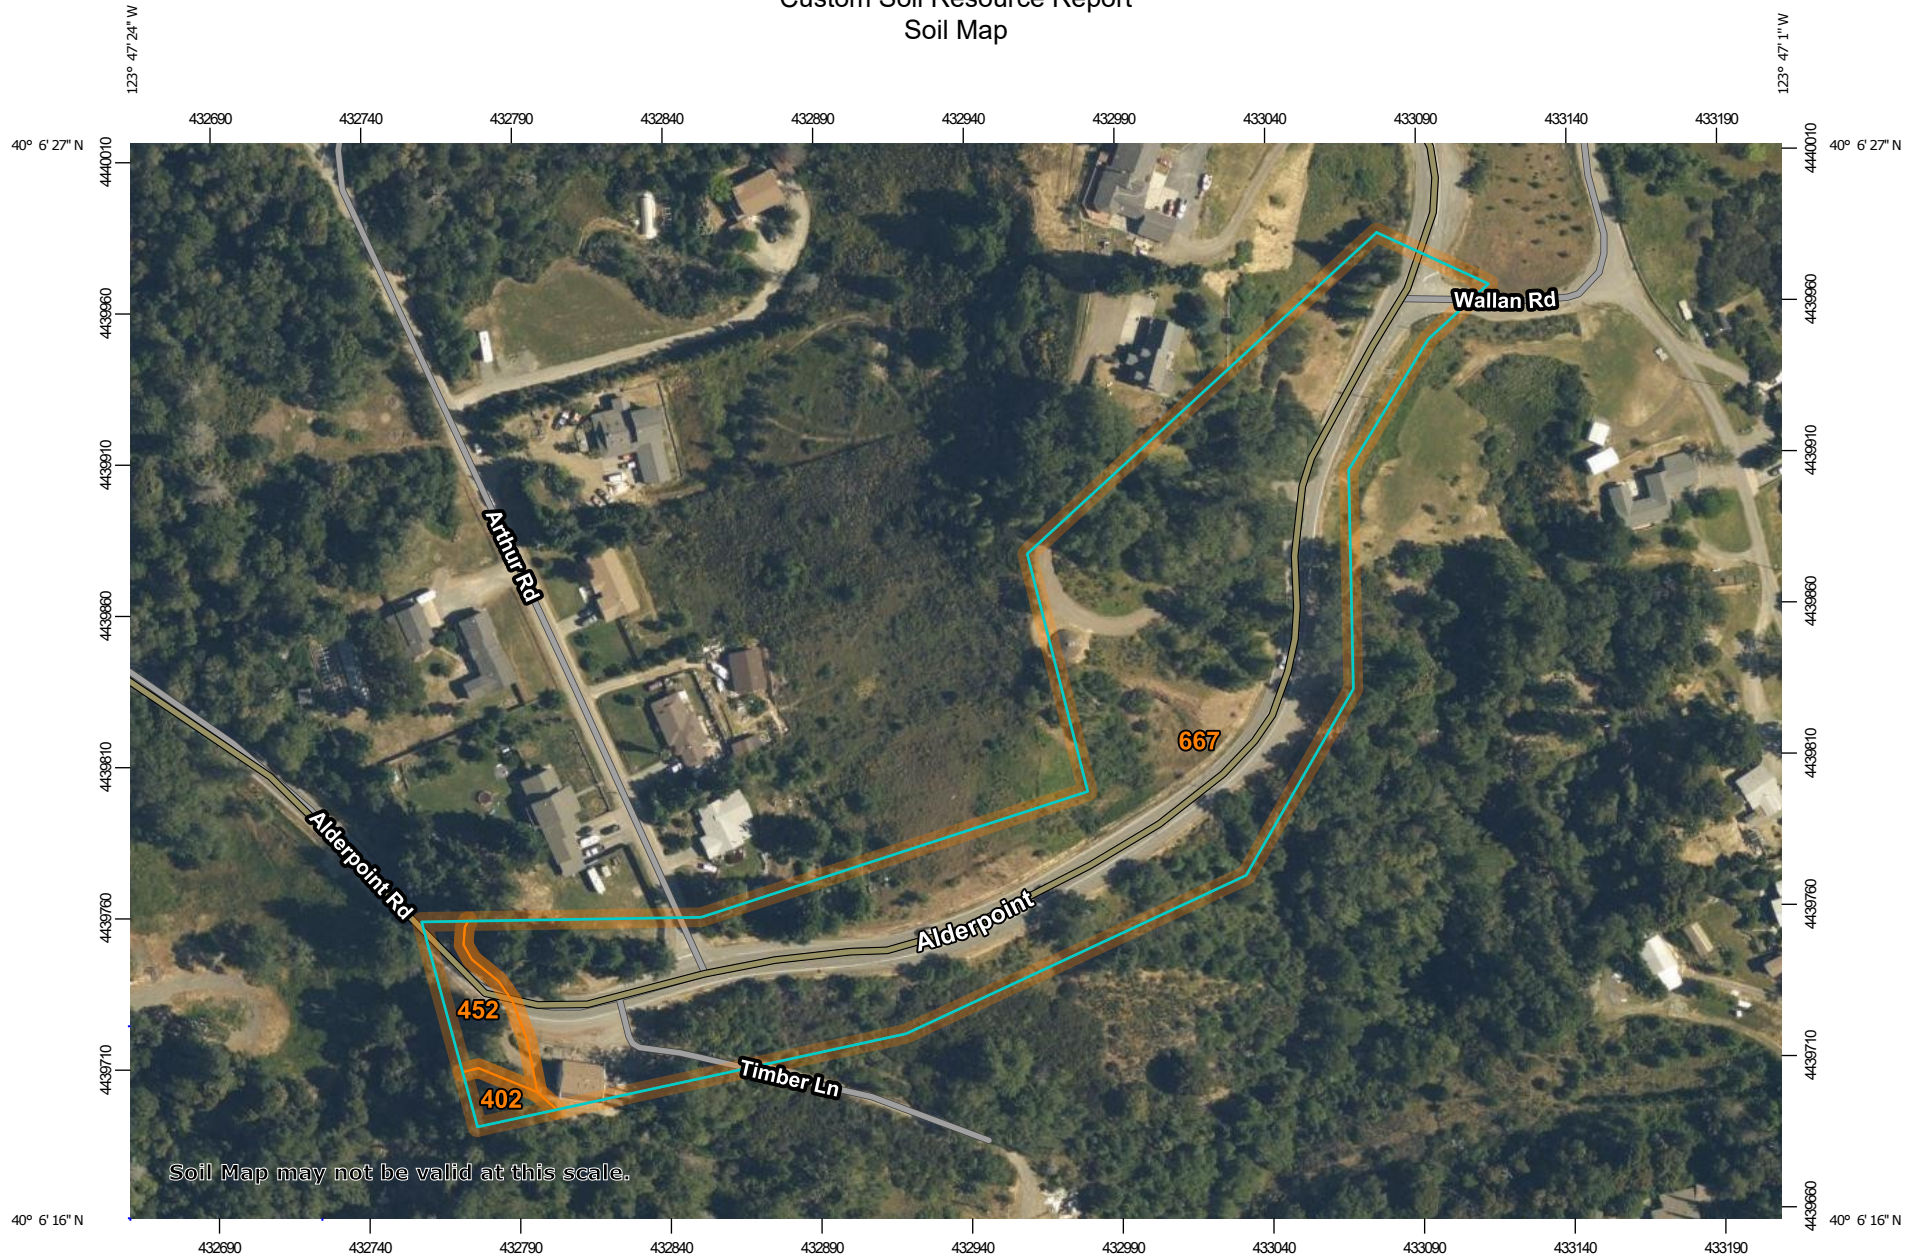
# Custom Soil Resource Report Soil Map

The soil map section includes the soil map for the defined area of interest, a list of soil map units on the map and extent of each map unit, and cartographic symbols displayed on the map. Also presented are various metadata about data used to produce the map, and a description of each soil map unit.

Map Scale: 1:2,510 if printed on A landscape (11" x 8.5") sheet.

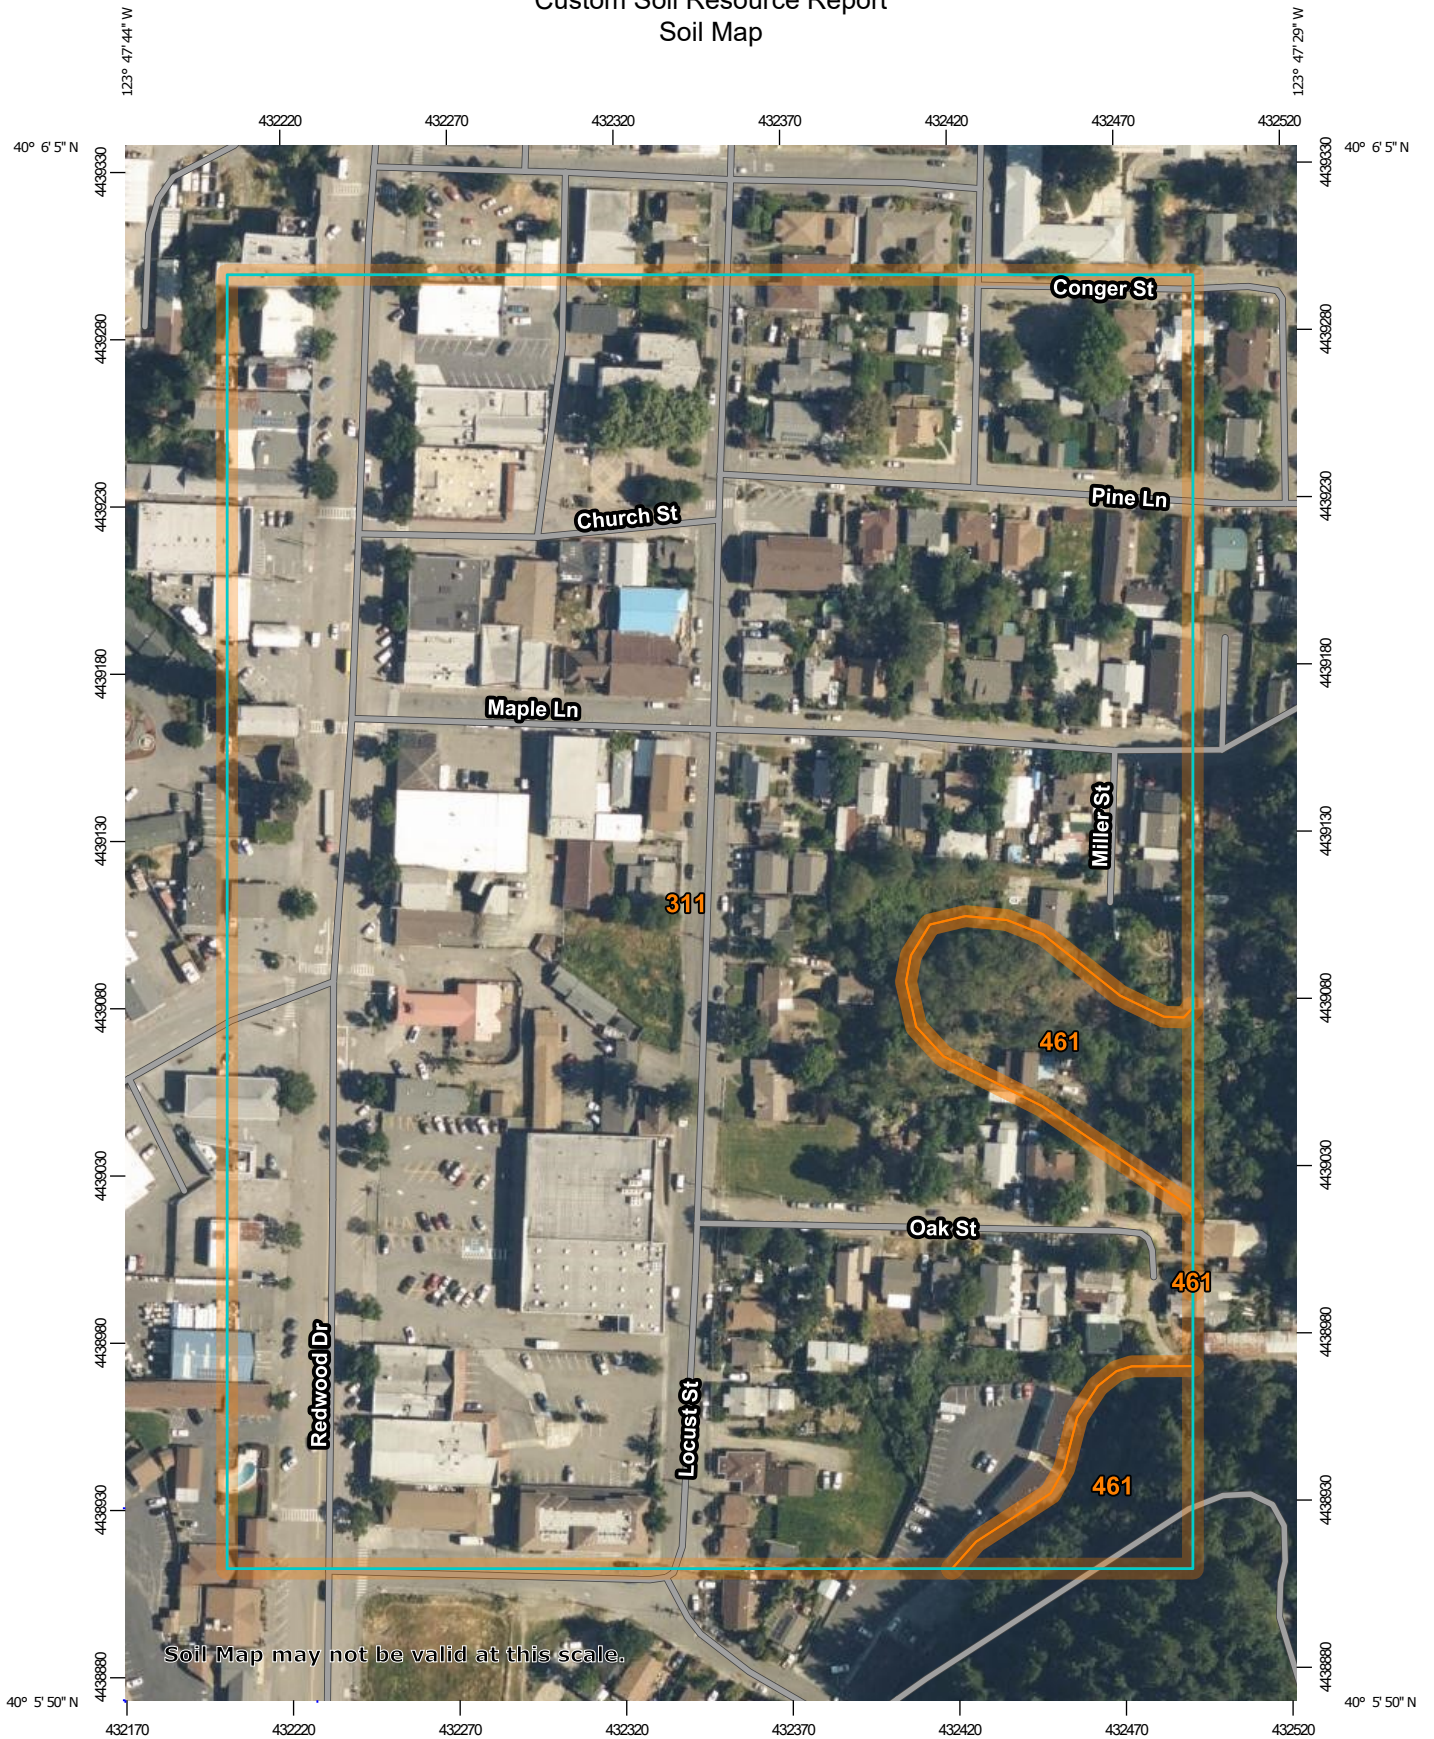
# Custom Soil Resource Report Soil Map

The soil map section includes the soil map for the defined area of interest, a list of soil map units on the map and extent of each map unit, and cartographic symbols displayed on the map. Also presented are various metadata about data used to produce the map, and a description of each soil map unit.

Map Scale: 1:2,270 if printed on A portrait (8.5" x 11") sheet.

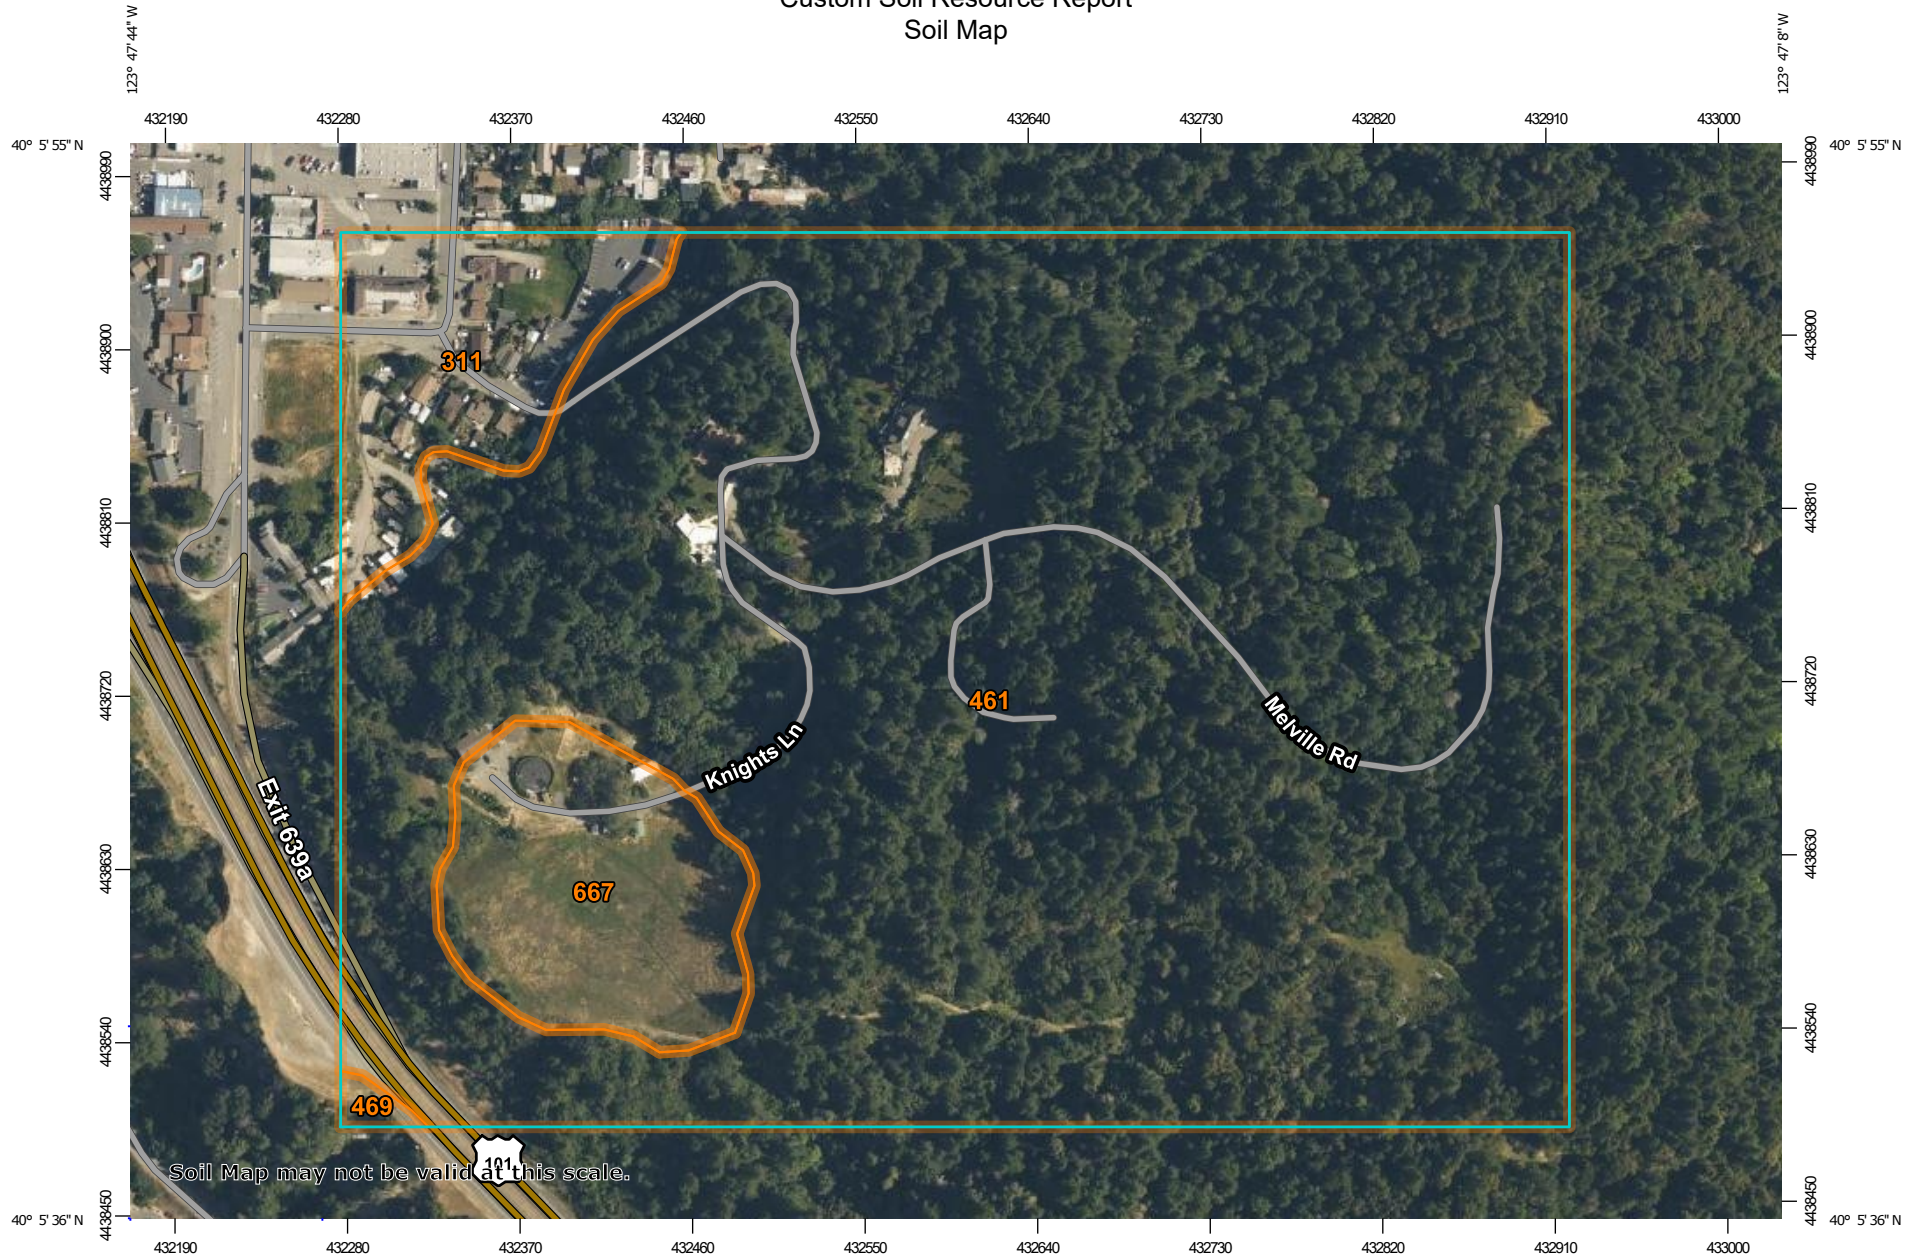
# Custom Soil Resource Report Soil Map

The soil map section includes the soil map for the defined area of interest, a list of soil map units on the map and extent of each map unit, and cartographic symbols displayed on the map. Also presented are various metadata about data used to produce the map, and a description of each soil map unit.

Map Scale: 1:3,940 if printed on A landscape (11" x 8.5") sheet.

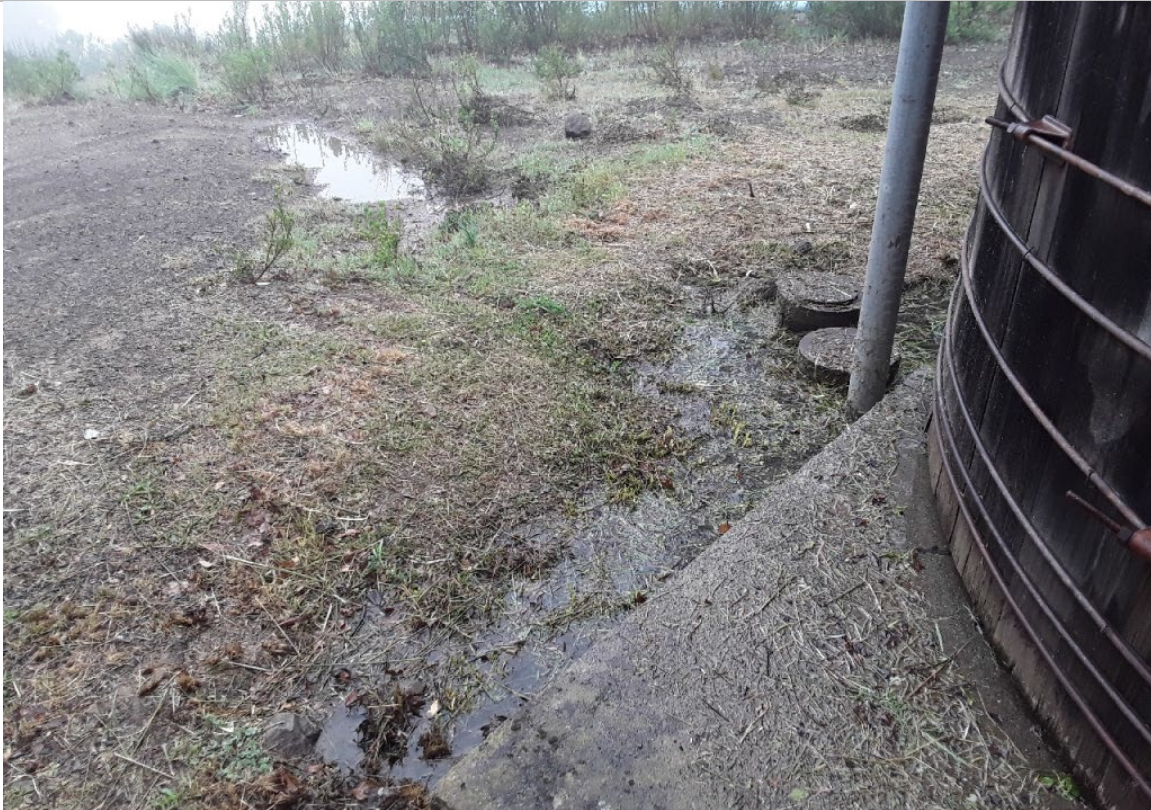
**Photo 1: Wallan tank site looking south. Note upland conditions around the tank with pooled water from tank leak. This area was not considered wetland due to the completely artificial conditions and lack of hydrophytes and hydric soils. Photo taken April 19, 2022.**

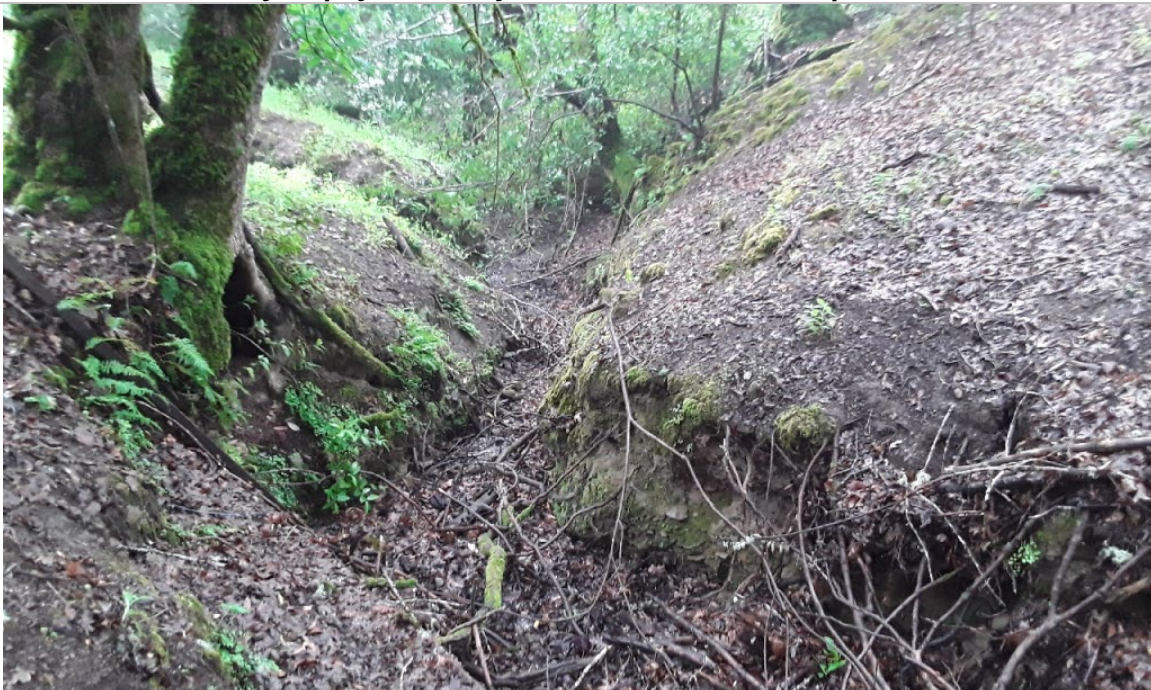
**Photo 2: Stream #1, looking upstream (North). Note steep sloping ravine and eroded stream channel. Intermittent stream flow lines are temporarily obscured by litter and debris from forested slopes. Photo taken April 19, 2022.**

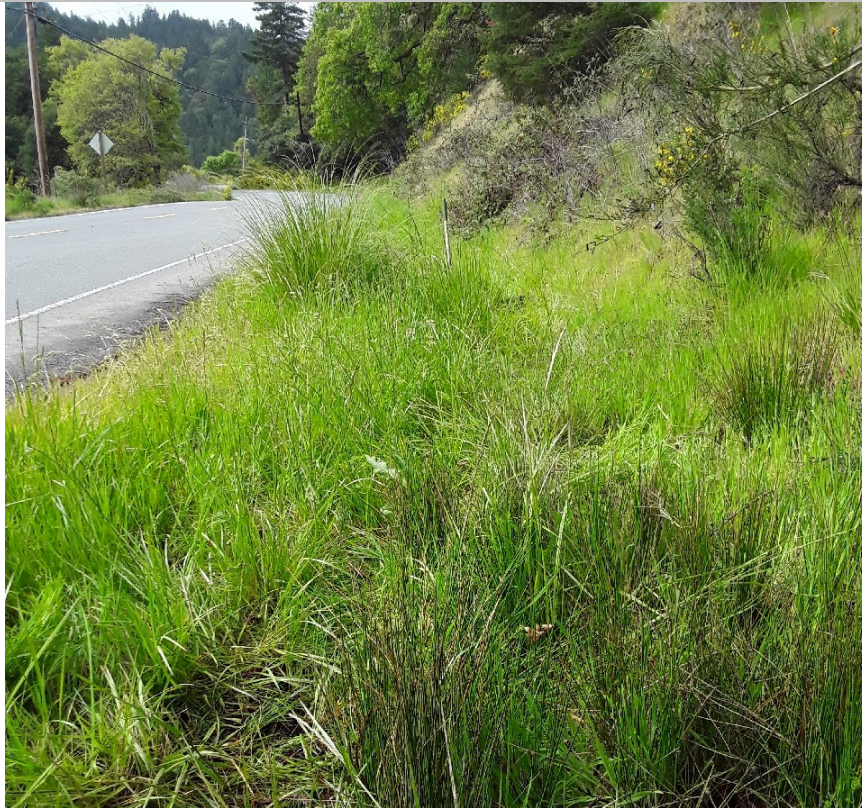
**Photo 3: Looking south along Alderpoint Road at Wetland #1 within the vicinity of TP1. Wetland conditions are restricted to the lowest elevations between the road surface and the hillslope as shown by hydrophytic vegetation. Photo taken April 19, 2022.**

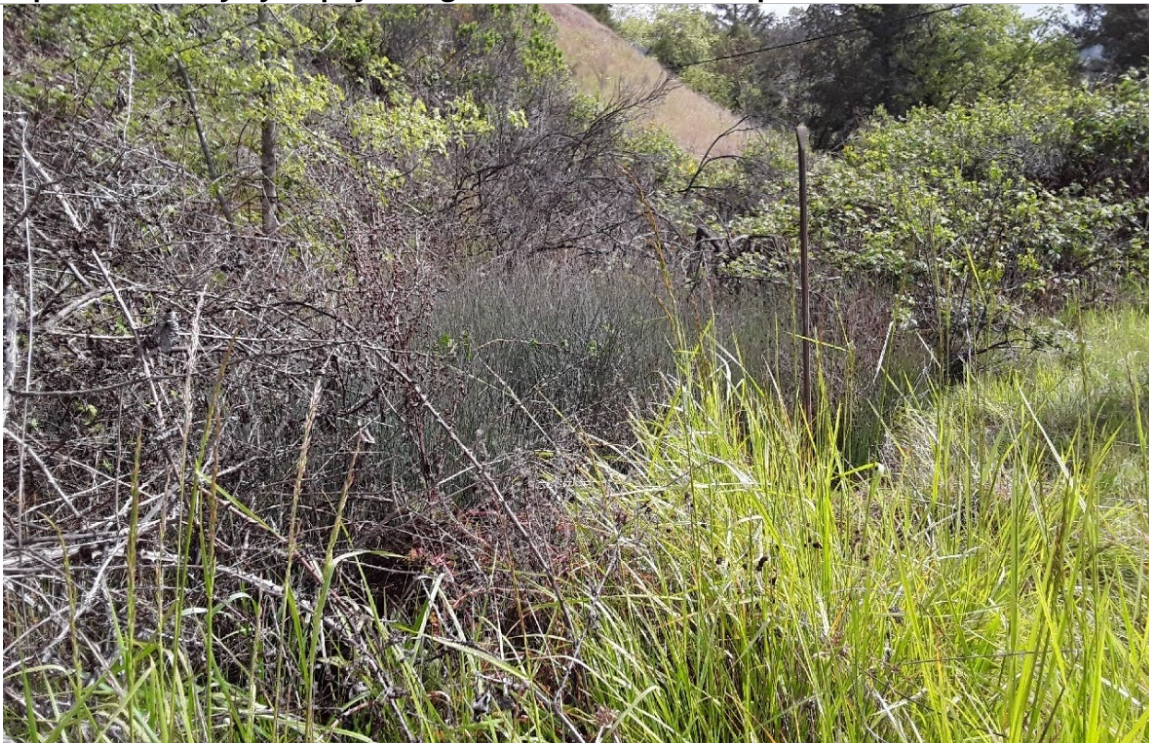
**Photo 4: Looking northeast at Wetland #2 north of Alderpoint Road within a flat area. Note the hydrophytic vegetation dominance and slight depression. Photo taken April 19, 2022.**

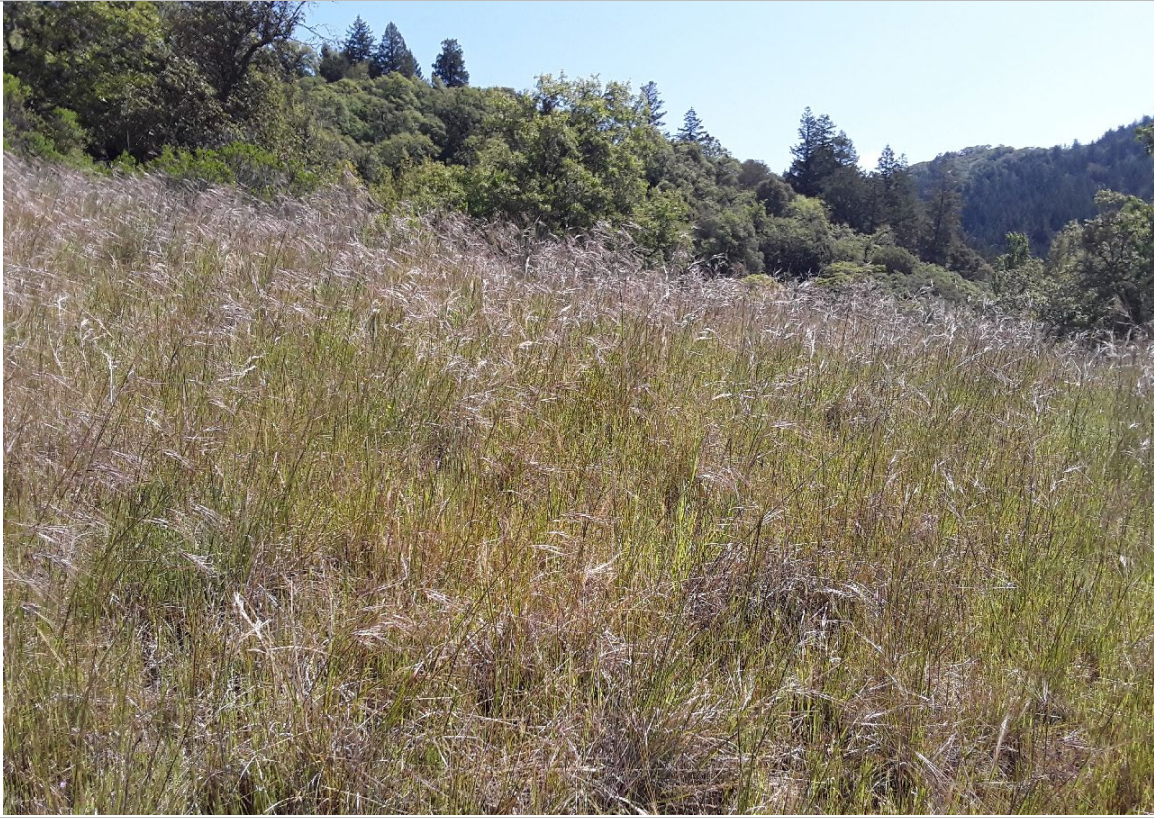
**Photo 5: Purple needlegrass grassland representative conditions, looking east near the Wallan Tank site. Note dense cover by purple needlegrass and abundant seed production. Photo taken April 27, 2022.**

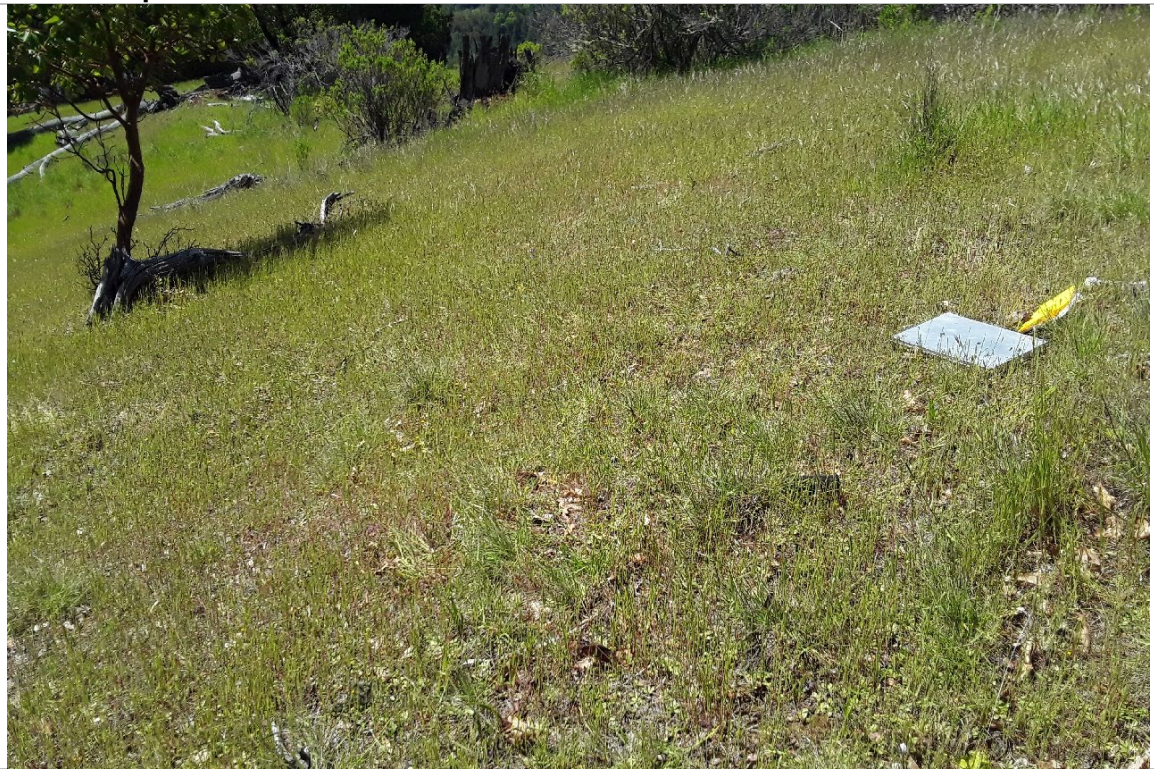
**Photo 6: California oatgrass meadow looking south. California oatgrass is dominant within this area near the Wallan Tank site. Photo taken April 27, 2022.**

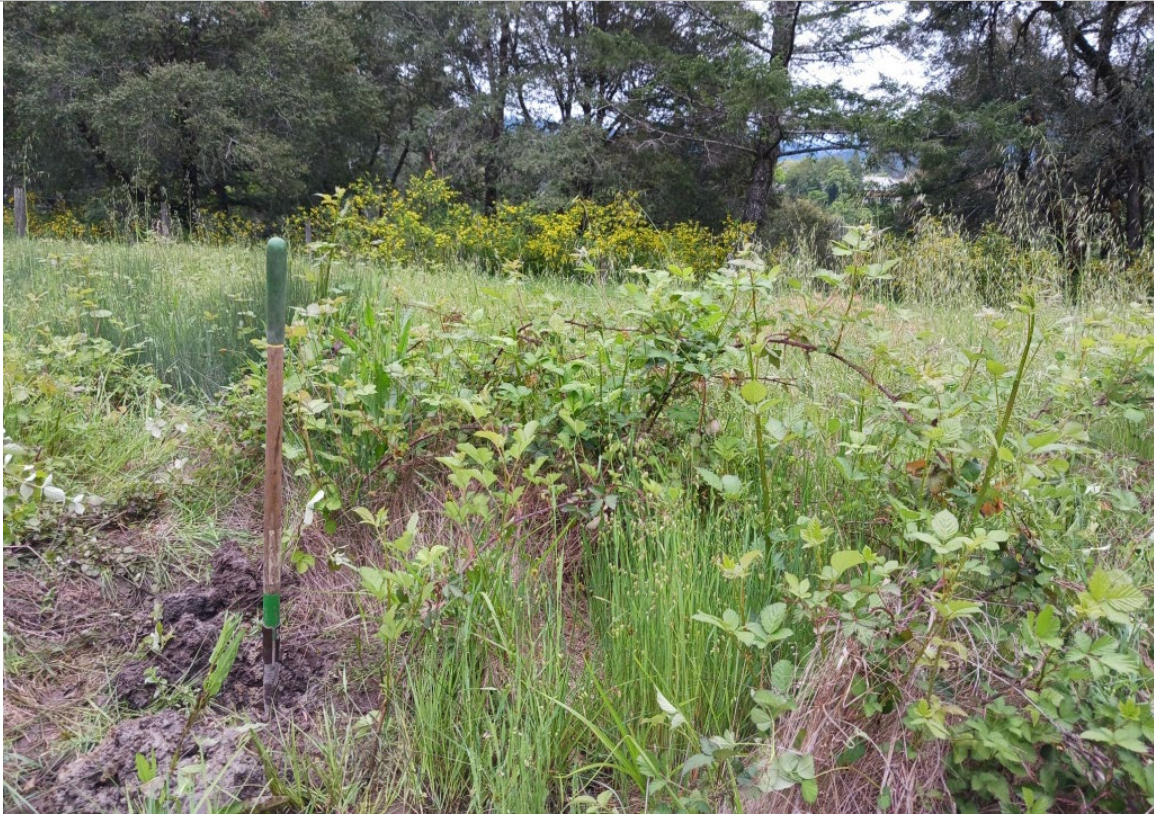
**Photo 7: Wetland #3 near CalFire Station looking southwest. Note abundance of Harford's sedge. Photo taken May 10, 2023.**

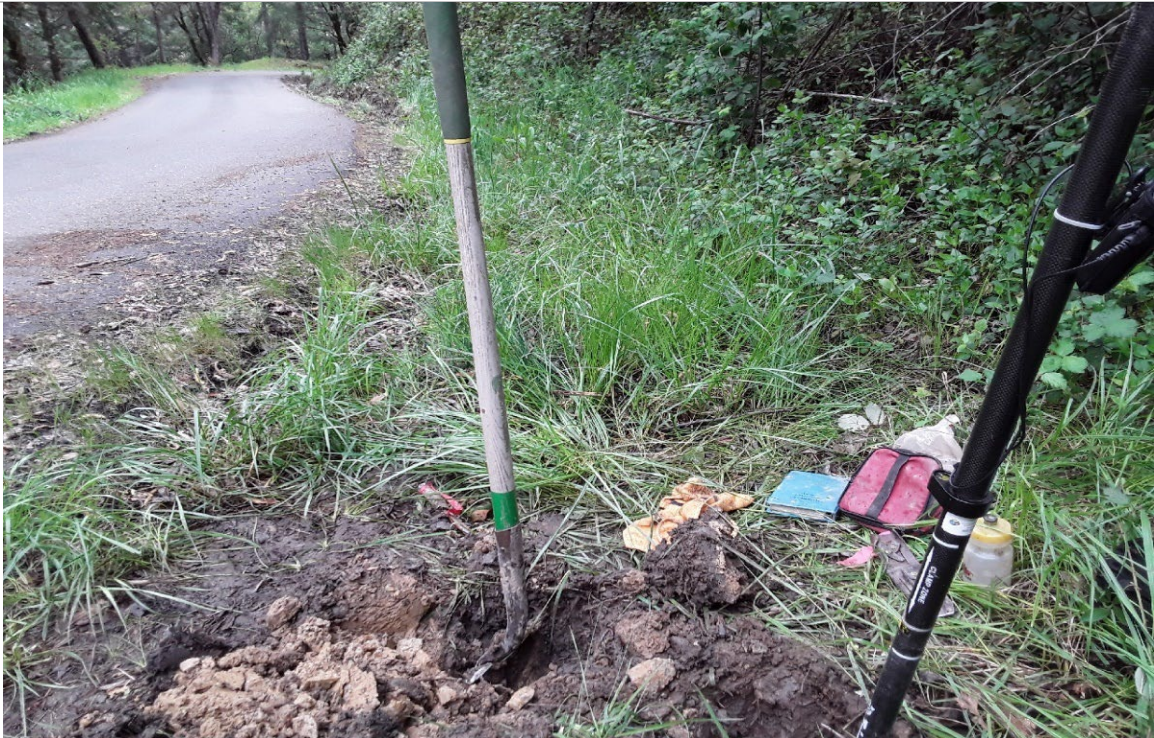
**Photo 8: Looking down Hillcrest Drive (north) at head of Wetland #4 within the vicinity of TP8. Wetland continues downslope within inboard ditch. Photo taken April 19, 2022.**

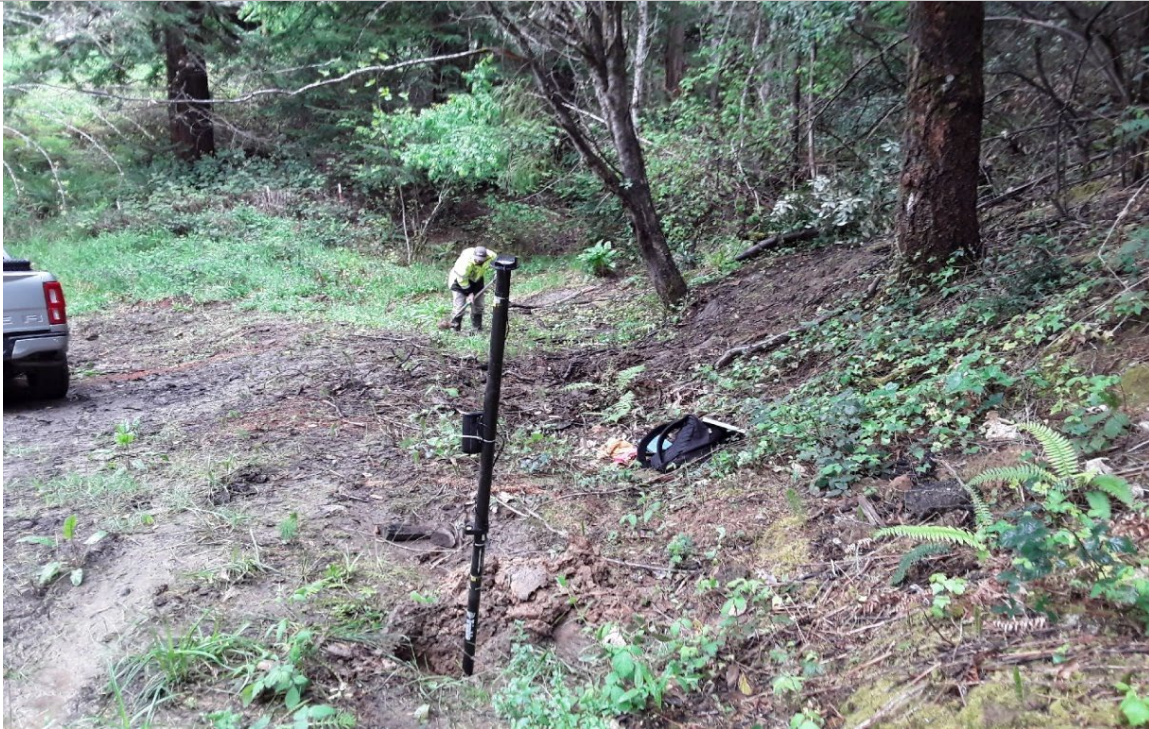
**Photo 9: Looking east across Wetland #5 within the vicinity of TP10. Wetland conditions are contained within a shallow swale and are likely connected to Stream #2 and culvert in the topographic low point visible beyond the wetland scientist. Photo taken April 19, 2022.**

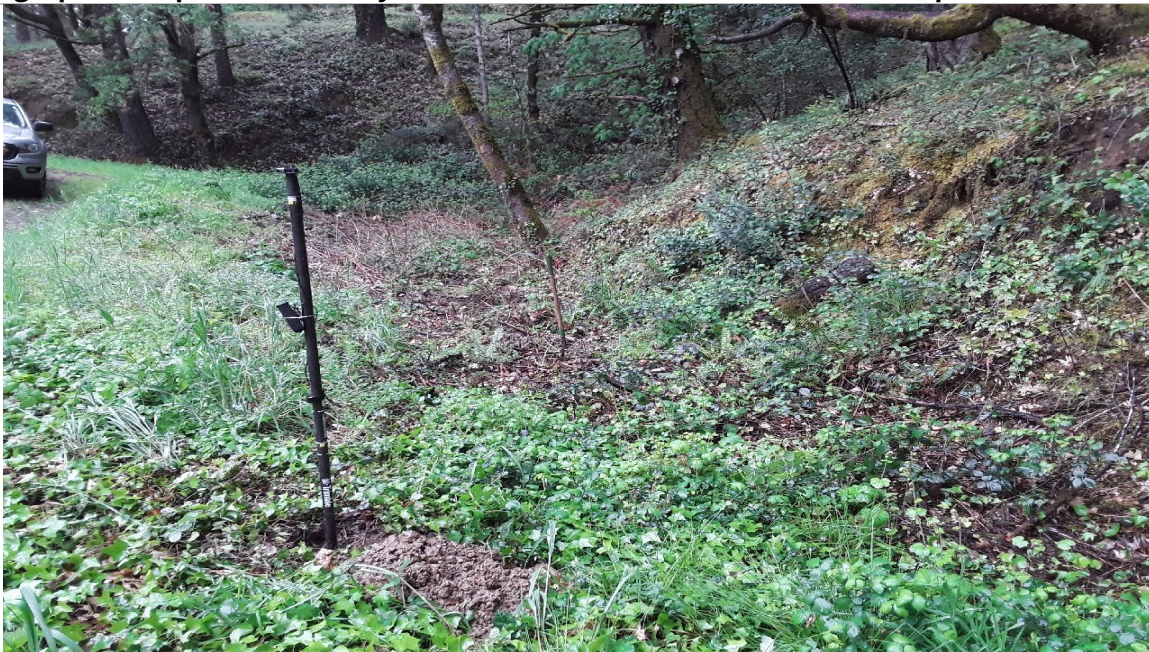
**Photo 10: Looking east toward Wetland #6. TP13 location (upland) shown by survey rod and wetland TP12 location shown by shovel. Melville Drive occurs immediately left of the photo which has created the basin containing the wetland. Photo taken April 19, 2022.**

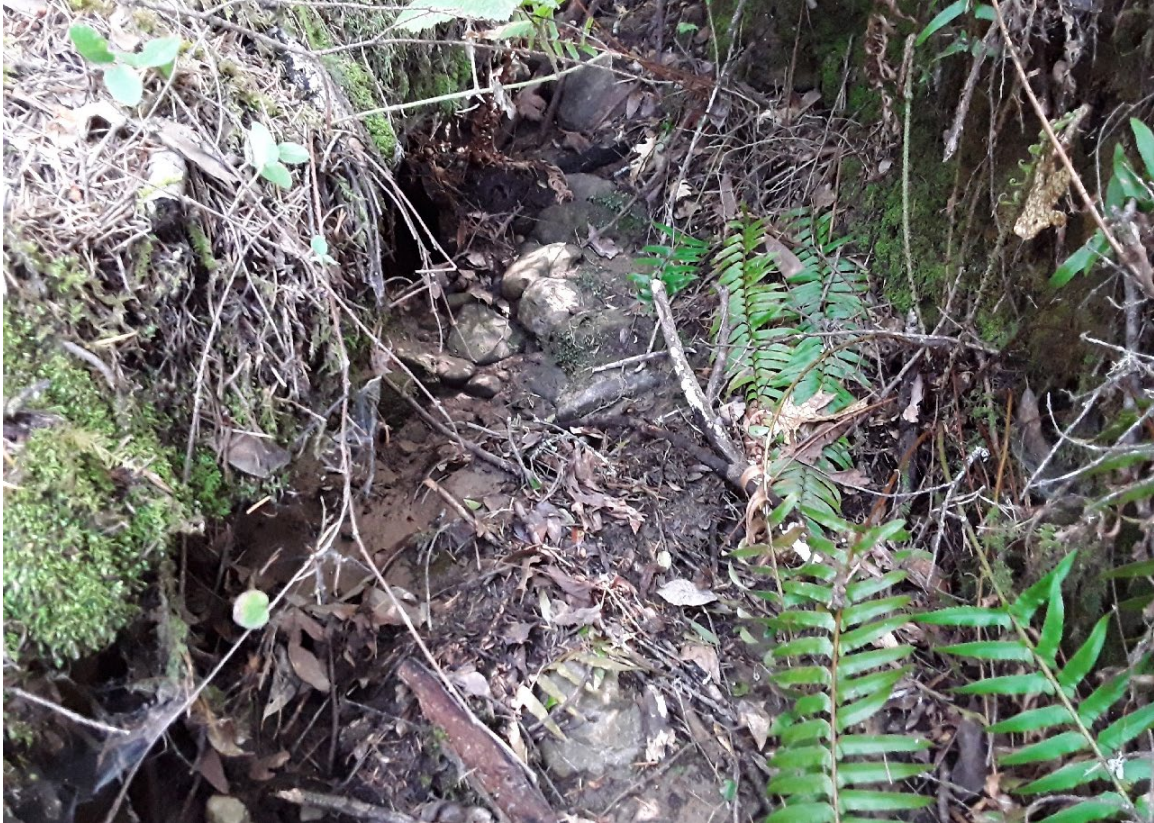
**Photo 11: Stream #2, looking upstream (southeast) at OHWM delineation point 5. Note incised channel with OHWM conditions. Seasonal, intermittent stream without water at time of delineation. Photo taken May 2, 2022.**

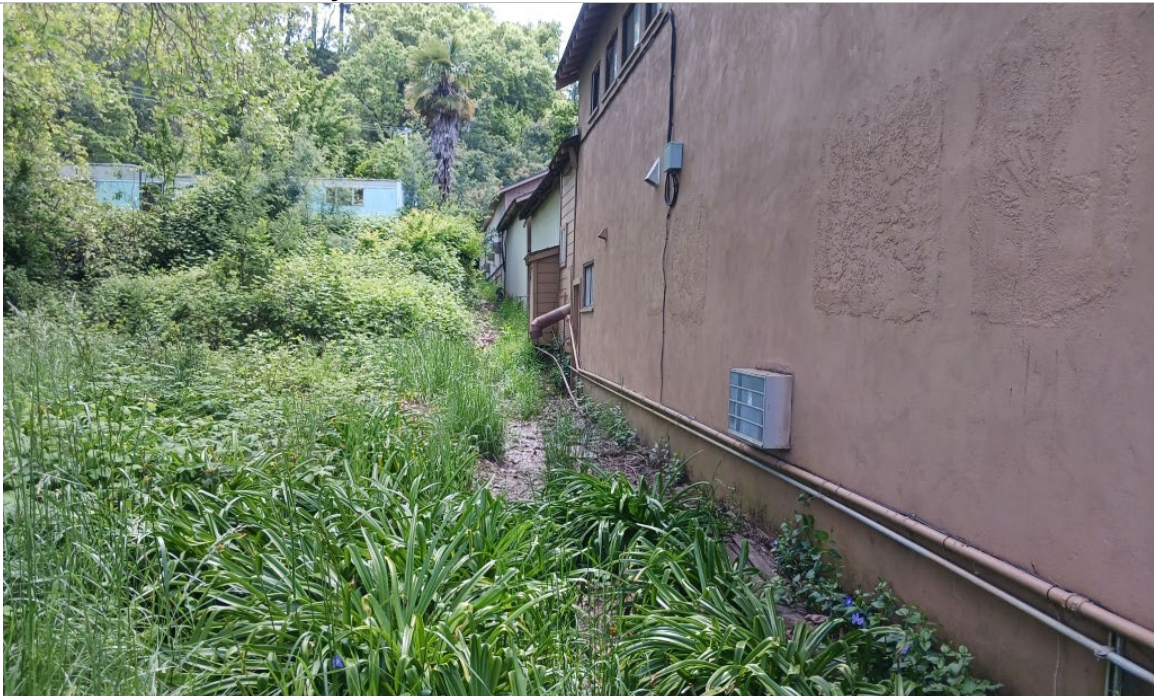
**Photo 12: Looking south toward the drainage swale between the motel and trailer park visible upslope. Wetland #7 is in the left side of the photo. Note developed and disturbed nature of the area. Photo taken May 9, 2023.**

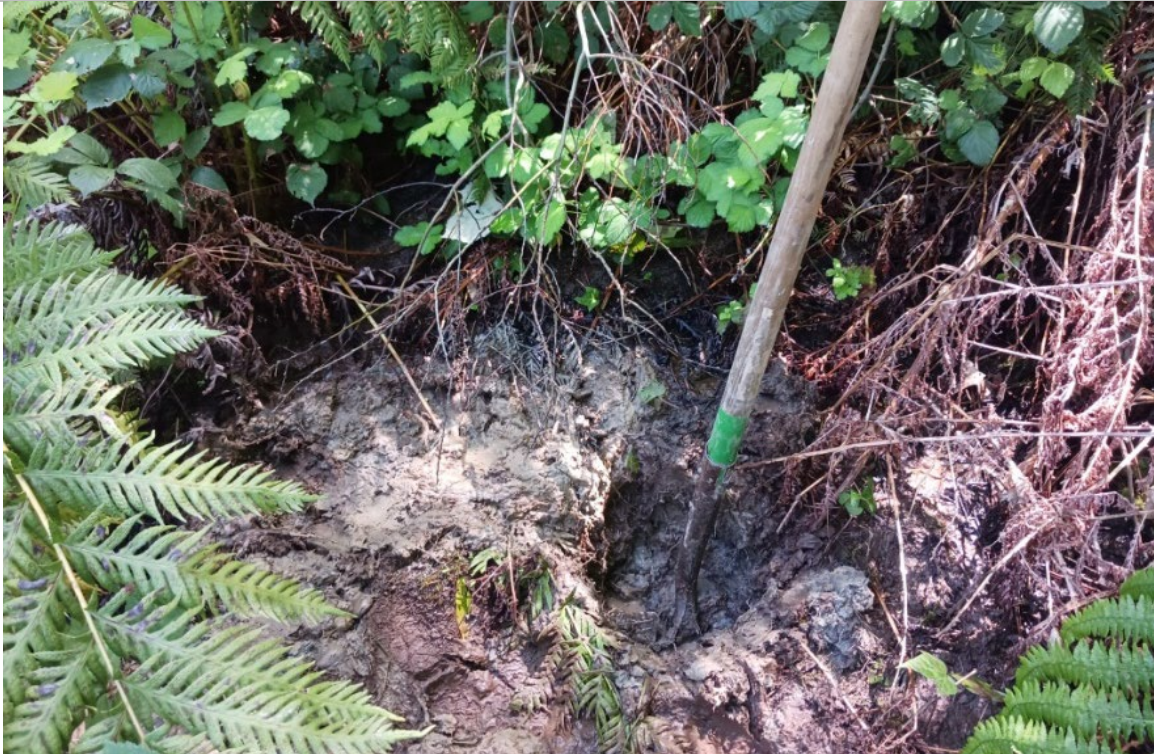
**Photo 13: Wetland #8 in slope failure slump with strong hydric soil and wetland hydrology indicators. Photo taken May 9, 2023.**

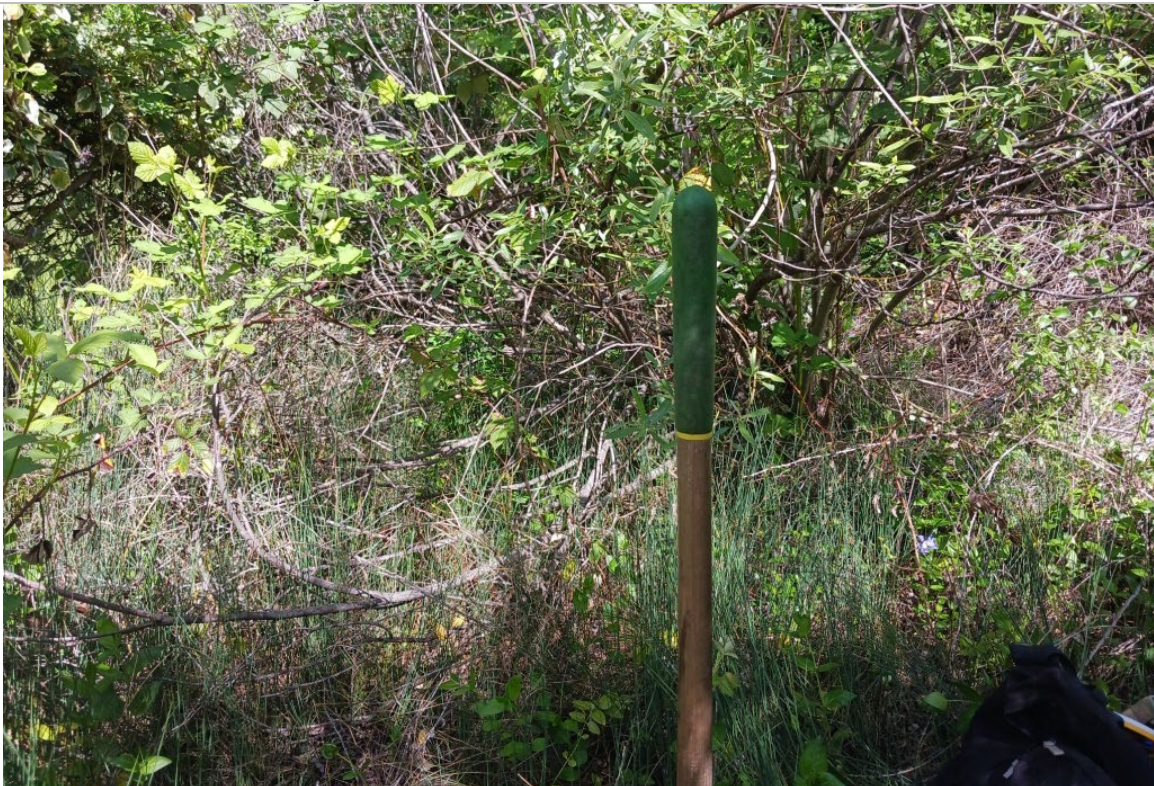
**Photo 14: Wetland #9 in hillslope cut, looking west. TP27 is located at the base of the shovel. Note arroyo willow cover. Photo taken May 10, 2023.**
