# Biological and Wetland Assessment—Revision 1

Garberville Sanitary District  
Robertson/Wallan/Hurlbutt Tanks  
Replacement Project

**October 2023**

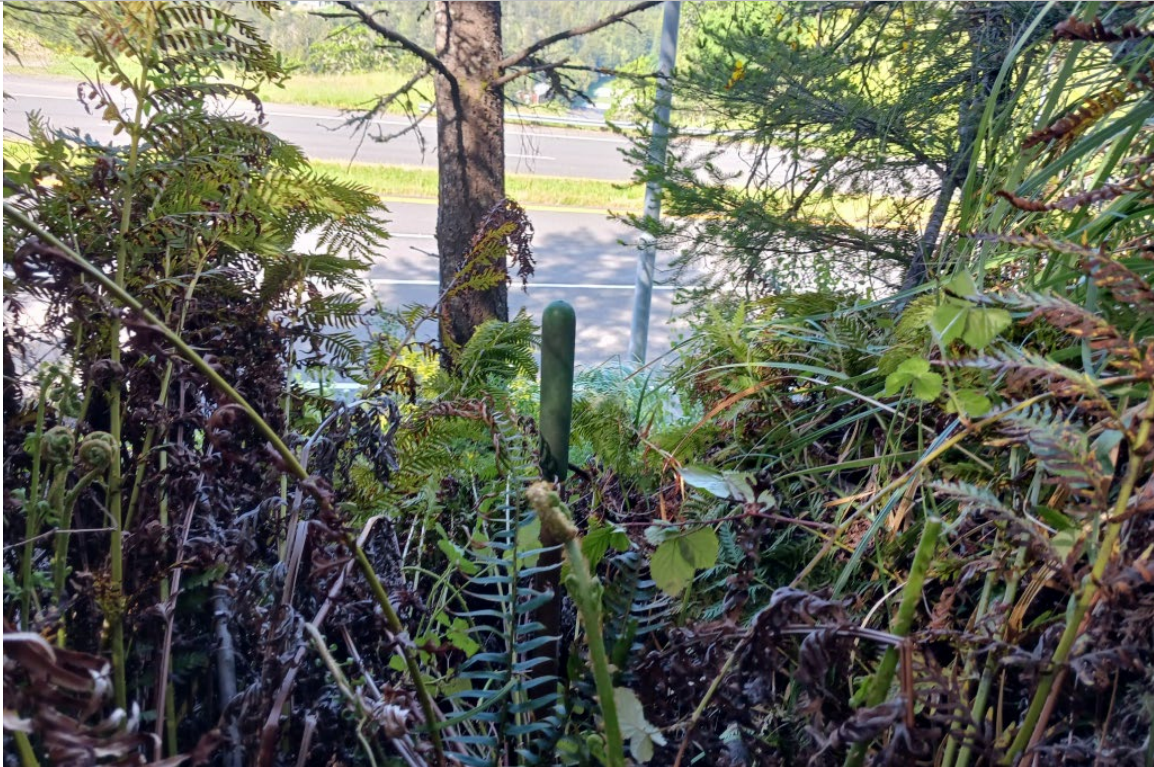
**Photo 15: Wetland #10 located mid-slope in a large roadcut above U.S. Highway 101, looking west (TP19 at base of shovel). Photo taken May 9, 2023.**

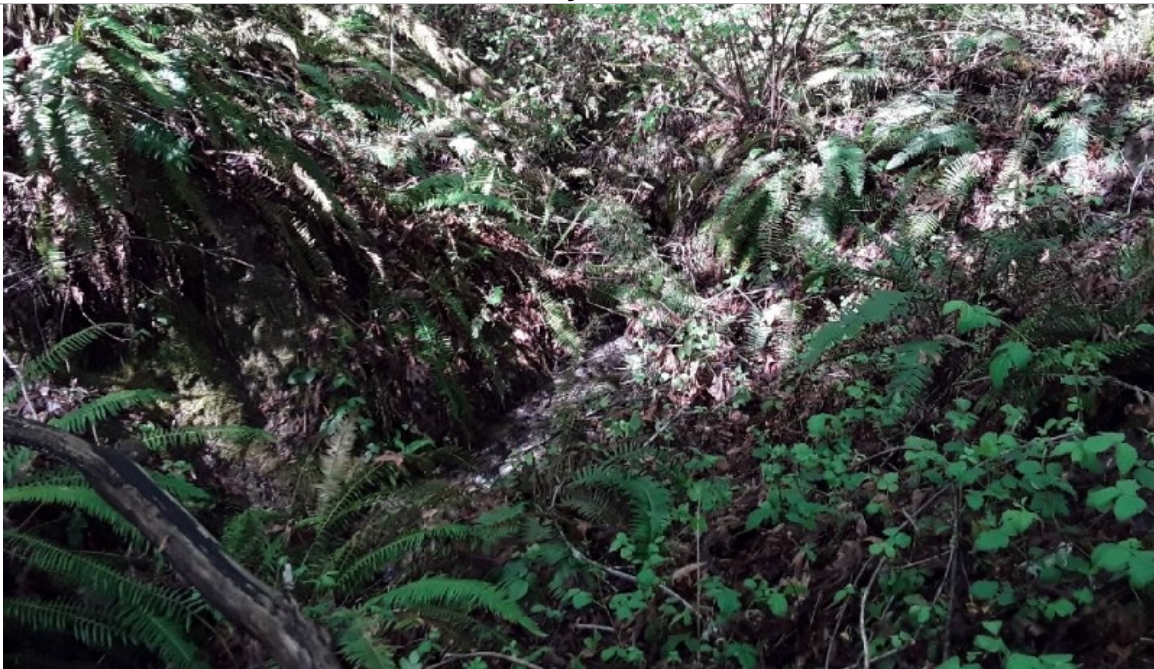
**Photo 16: Stream #3 within the vicinity of OHWM 3, looking northeast into the ravine containing the stream. Note dense vegetation and stream conditions evident in the center of the photo. Photo taken April 15, 2022.**

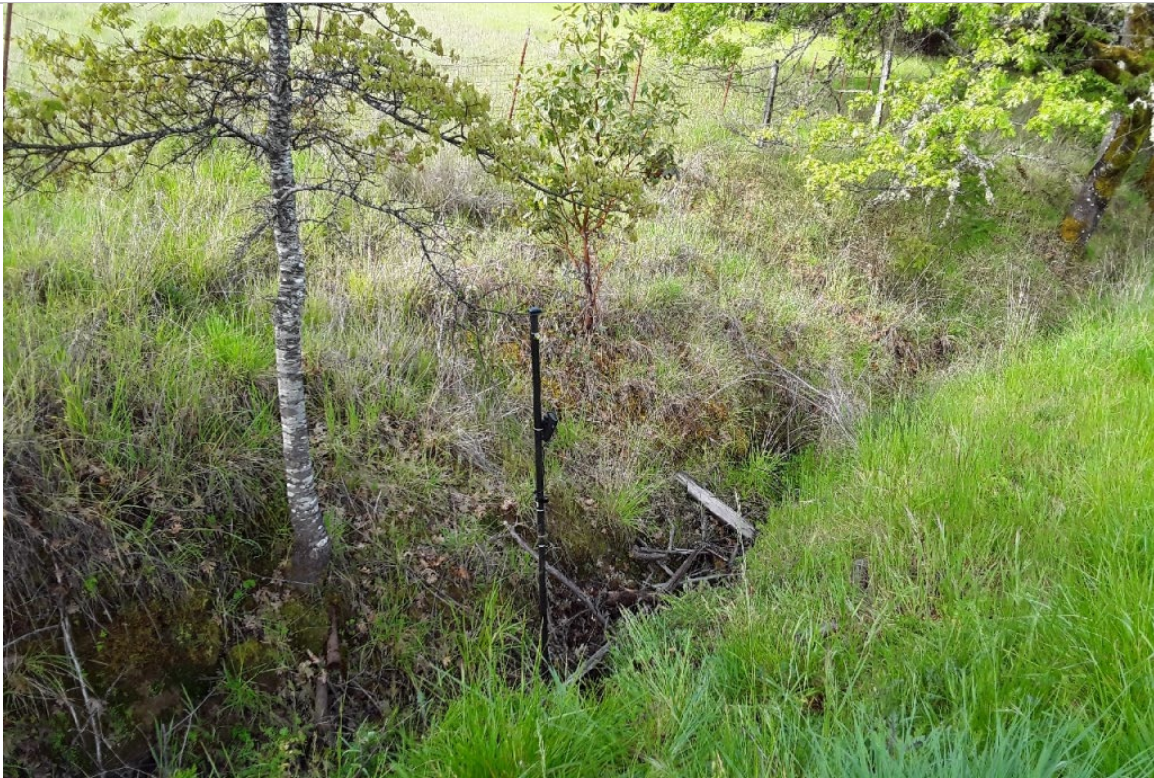
**Photo 17: Stream #4 headwaters, looking downslope (southeast) within the vicinity of OHWM point 2 (at survey rod). Note stream is contained within a partially excavated swale. OHWM indicators begin just upslope of the OHWM delineation point. Photo taken April 15, 2022.**

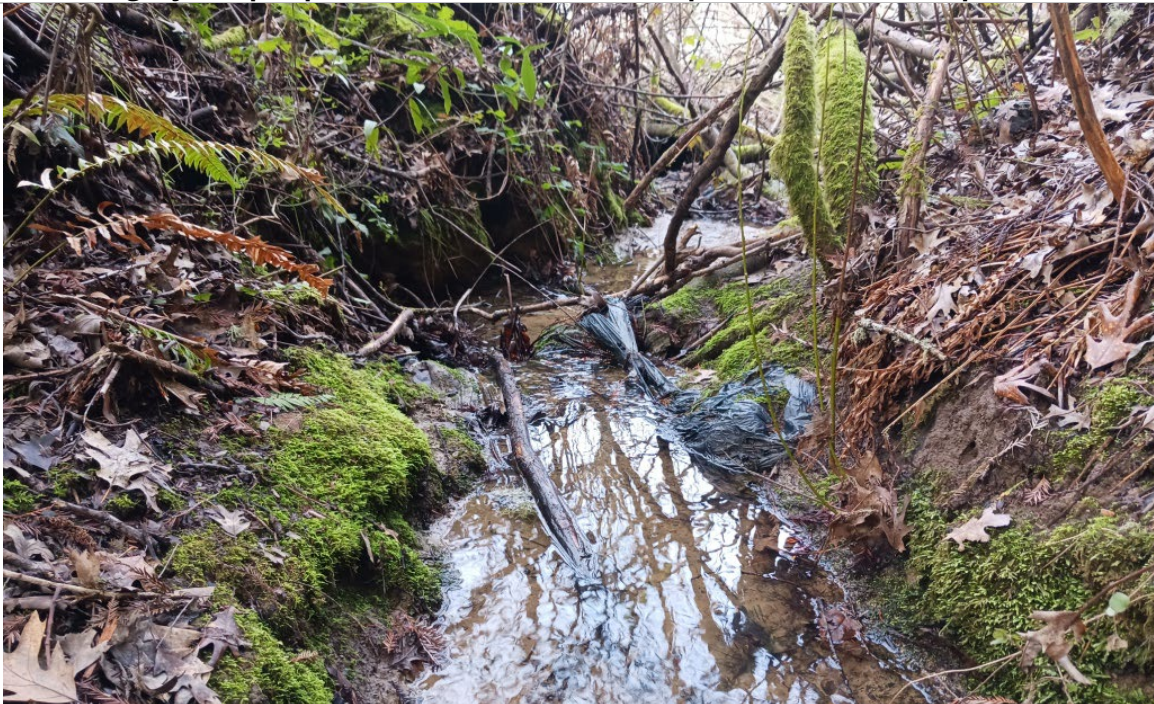
**Photo 18: Stream #5 looking downstream within vicinity of OHWM 4. The culvert under U.S. Highway 101 is barely visible in the upper center of the photo. Note well defined channel. Flows are likely intermittent but were present during the delineation. Photo taken February 17, 2023.**
