PACIFIC WATERSHED ASSOCIATES INC.

December 10, 2020

Re: Work Completion Report for Karen and Dennis Silva, Representatives of Bridgeville Organic Pharms, LLC, Notification No. 1600-2018-0843-R1 (Silva Water Diversion and Stream Crossings Project) on Humboldt County APN 210-012-019.

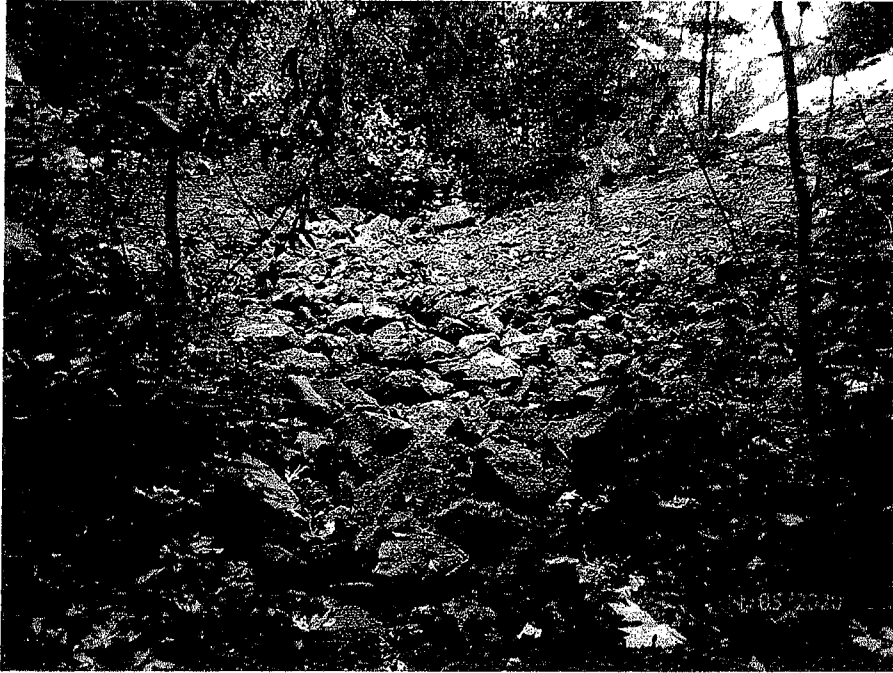
Photo 1A - Stream Crossing #1 (SC #1): View looking downstream from the channel across and at the outboard edge of the road (Photo 11/5/2020).

Stream Crossing #1 (40.505507, -123.700674): An undersized 36-inch diameter corrugated metal culvert was installed on a Class II watercourse. Due to the steep channel gradient and high coarse gravel and cobble bedload sediment transport rates upstream of the crossing, the undersized culvert had partially plugged at the inlet resulting in stream flow incising into the roadbed on the left edge of the culvert and washing out the crossing. The culverted stream crossing was replaced with a substantial armored fillslope crossing. The existing road fill material from the outboard edge of the roadbed and the culvert were removed from the stream channel and adjacent streamside hillslopes, the roadbed was dipped through the crossing

approximately 2 feet vertically, and 20 yd³ of locally derived 0.5-3.0-foot diameter rock armor was installed to armor the outboard fillslope and channel across the roadbed (Photos 1A – 1F).

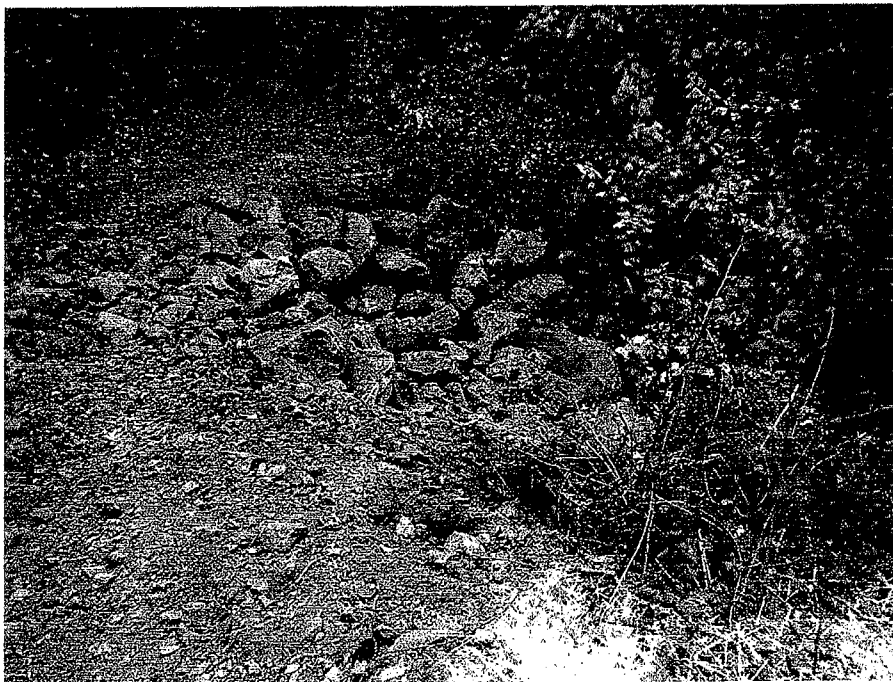
Photo 1D - SC #1: View looking at the armored fillslope crossing from the right outboard edge of the road (Photo 11/5/2020).

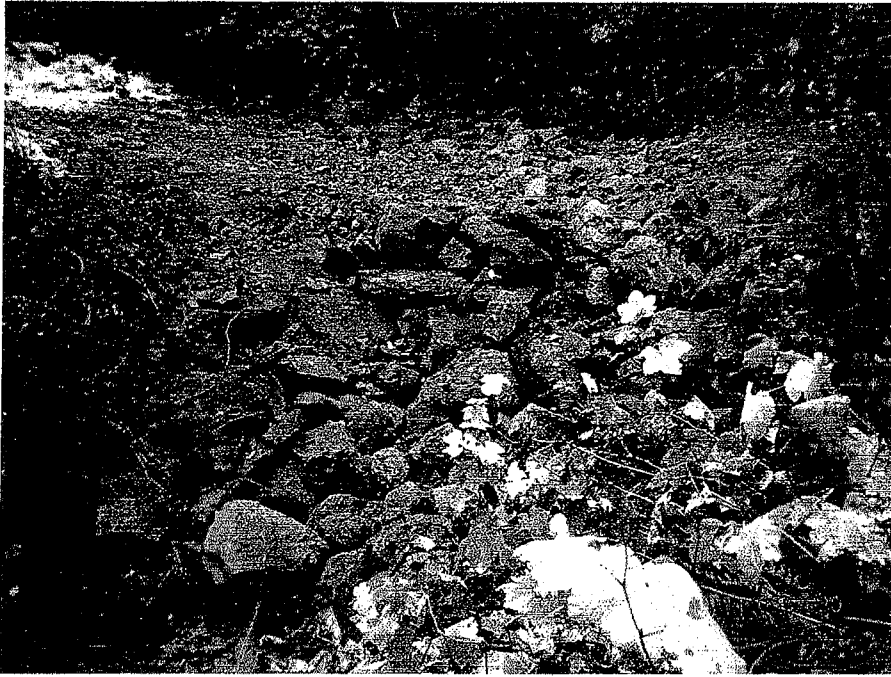
Photo 1E - SC #1: View looking upstream at the armored fillslope crossing from the lower left side of the channel (Photo 11/5/2020).

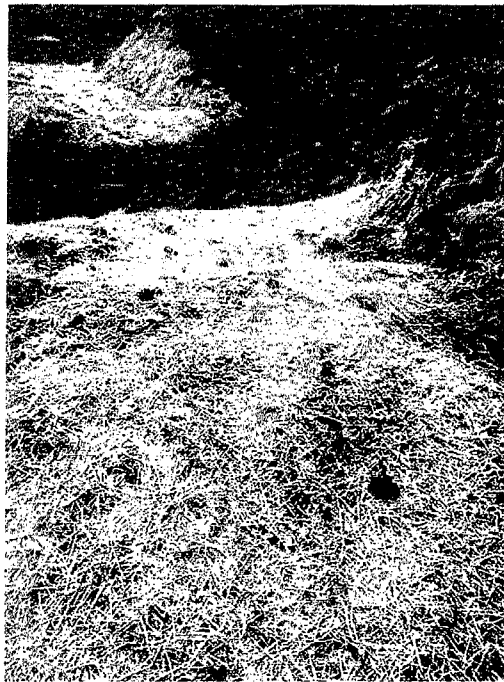
Photo 1F - SC #1: View looking at the armored fillslope crossing and implemented erosion control measures from the left road approach (Photo 11/13/2020).

Bare soil areas at both stream crossings were mulched with straw to mitigate raindrop impact and seeded to increase revegetation, root structure and soil stability. These areas were mulched with weed-free straw at a rate no less than 4,000 lb/acre of straw and seeded with native erosion control seed at no less than 50 lb/acre of seed (Appendix A). Active stream flow was not observed in either stream channel at the work locations before or during work activities and no stream dewatering or diversion around the work area was required. Excess fill material from stream crossing upgrade activities was endhauled to an area up the right road from SC #1 and stored in a location with no threat of delivery to surface waters.

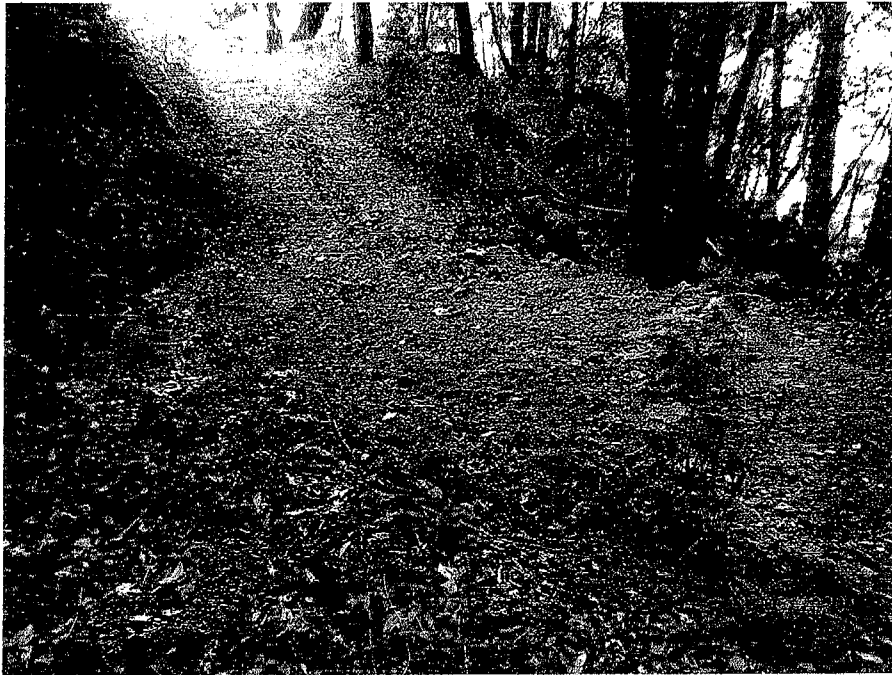
Photo 2A - SC #2: View looking downslope toward the existing, functioning well armored fillslope crossing post improvements from the upper right hillslope (Photo 11/5/2020).

Stream Crossing #2 (40.505155, -123.701849): An existing, well-functioning for several decades armored fillslope crossing on a Class II watercourse was upgraded with the addition of 15 yd³ of locally derived 1.0-3.5-foot diameter rock armor installed to reinforce the existing structure. A section of old crib log was removed from the left outboard edge of the road within the armored fillslope footprint during upgrade activities. A small lobe of aggraded sediment and over-steepened material was excavated from the upper right streamside hillslope and inboard edge of the road to reduce sinuosity and stream deflection and mitigate the potential for future erosion and fine-grained material from entering the stream channel. A rolling dip was installed approximately 100-120 feet up the right road approach to hydrologically disconnect any concentrated road runoff from the stream crossing (Photos 2A – 2F).

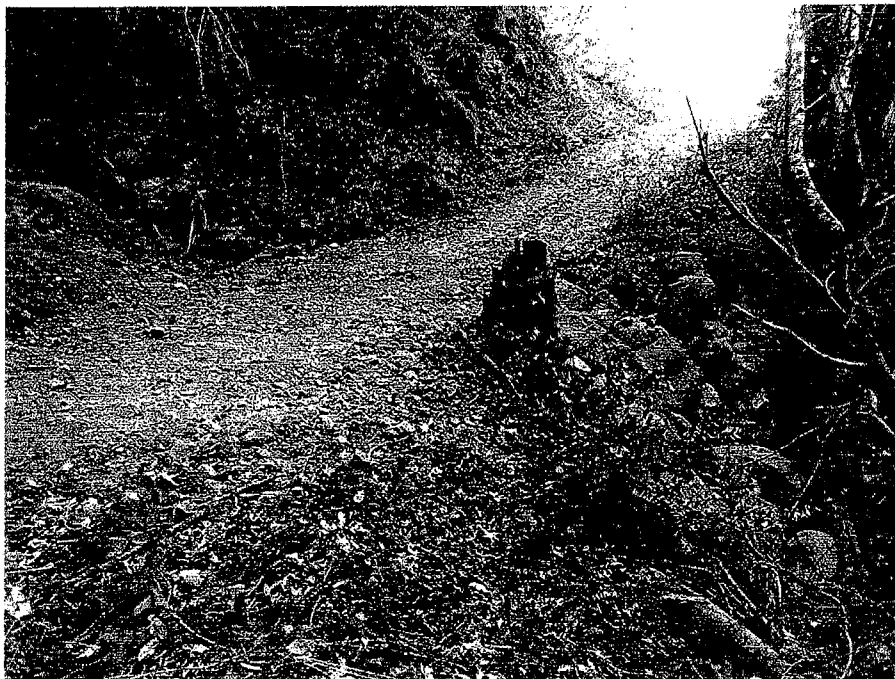
Photo 2B - SC #2: View looking toward the armored fillslope crossing post the addition of additional rock armor from the right outboard edge of the road (Photo 11/5/2020).
