Mad River Properties, Inc.
2660 Clay Road McKinleyville, CA 95519; (707) 496-0054

Mario Dimitrov Less Than Three Acre Conversion Mitigation Plan

This document has been prepared pursuant to Section 55.4.10(j) of the Humboldt County Commercial Medical Marijuana Land Use Ordinance, applications for Commercial Cannabis Activity occupying sites created through prior unauthorized conversion of timberland. The document evaluates site conditions and conversion history for the parcel and contains a Registered Professional Foresters (RPF's) recommendation as to remedial actions necessary to bring the conversion area into compliance with provisions of the Forest Practice Act.

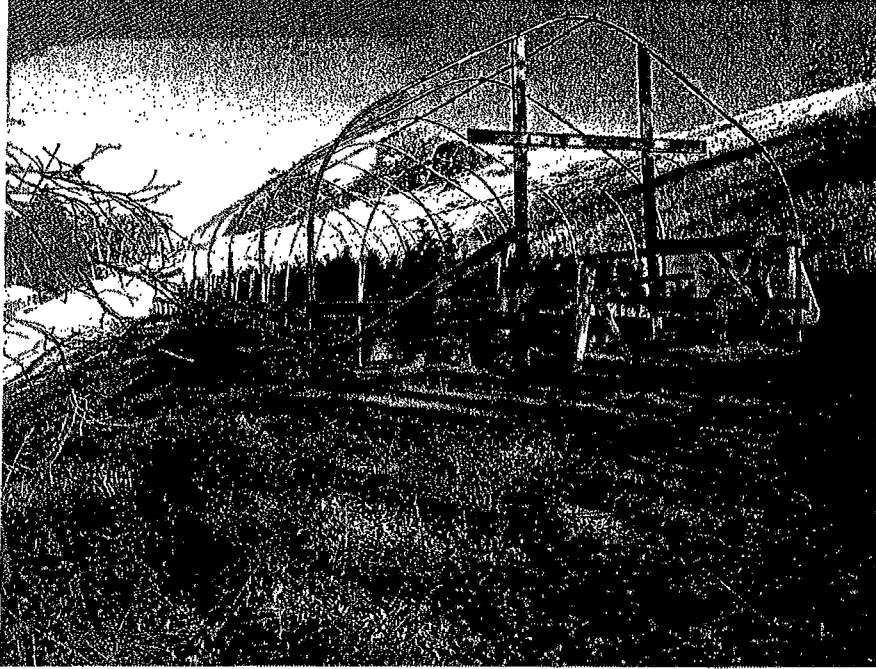
Site A Looking West:

History: The site was first converted with grading and a hoop house between 2010 and 2012. Currently the site is occupied by 80' by 20' hoop house. No timber harvesting has occurred in or around this site in the last ten years. No permit was obtained from CALFIRE to convert the area for such use. The conversion is not within a riparian buffer. There are no rare, threatened or endangered animals and plants present within 1000' as

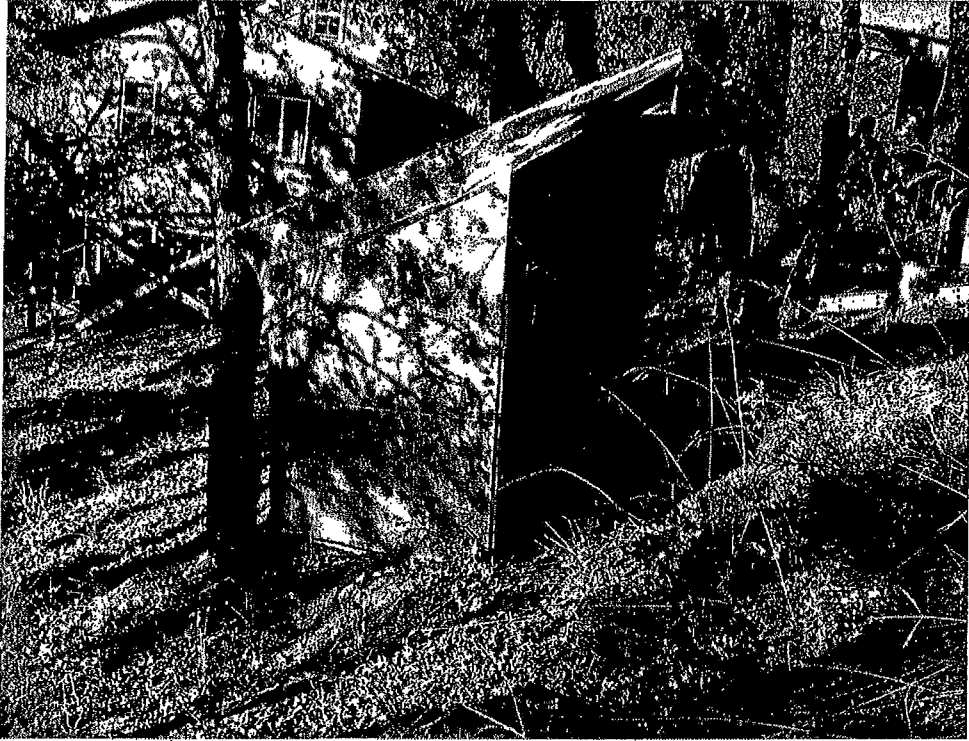
Site B Looking Southwest:

History: The site was first converted with clearing between 2005 and 2009. The site was expanded in 2010 with a structure. Currently the site is occupied by a 40' by 20' structure. No timber harvesting has occurred in or around this site in the last ten years. No permit was obtained from CALFIRE to convert the area for such use. The conversion is not within a riparian buffer. There are no rare, threatened or endangered animals and plants present within 1000' as per 2018 CNDDDB search. No hazard reduction issues present Ownership of Parcel 210-144-012 at the time of the illegal conversion was unknown.

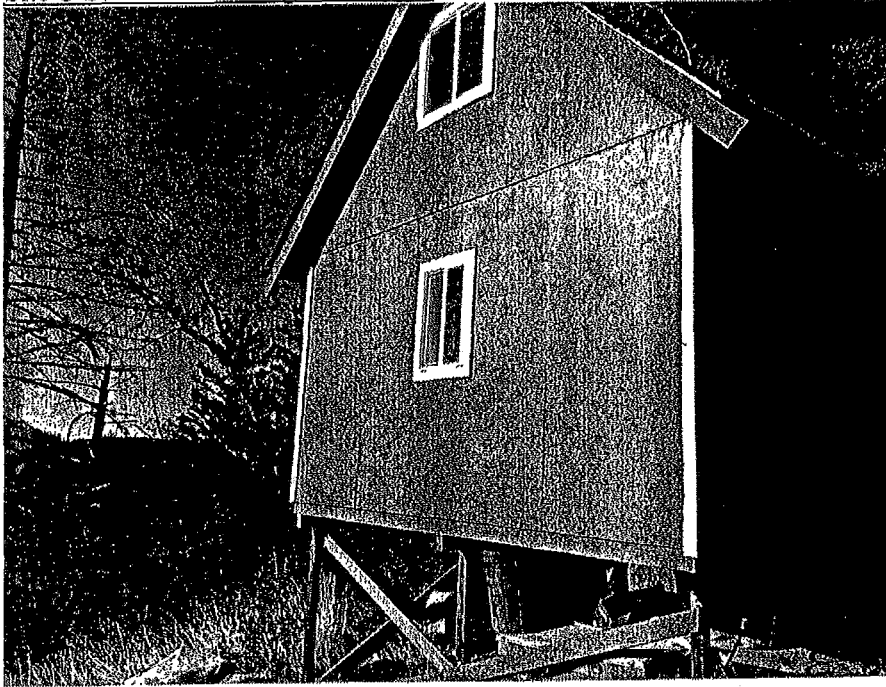
Site C Structure Looking Southwest:

History: The site was first converted with clearing and a greenhouse between 2005 and 2009. The site was expanded in 2010 with a pond. The site was expanded between 2010 and 2012 with a structure. Currently the site is occupied by a 85' by 30' hoop house, a 20' by 30' structure, a water tank and 1,400 sq. foot pond. No timber harvesting has occurred in or around this site in the last ten years. No permit was obtained from CALFIRE to convert the area for such use. The conversion is not within a riparian buffer. There are no rare, threatened or endangered animals and plants present within 1000' as per 2018 CNDDDB search. No hazard reduction issues present Ownership of Parcel 210-144-012 at the time of the illegal conversion was unknown.

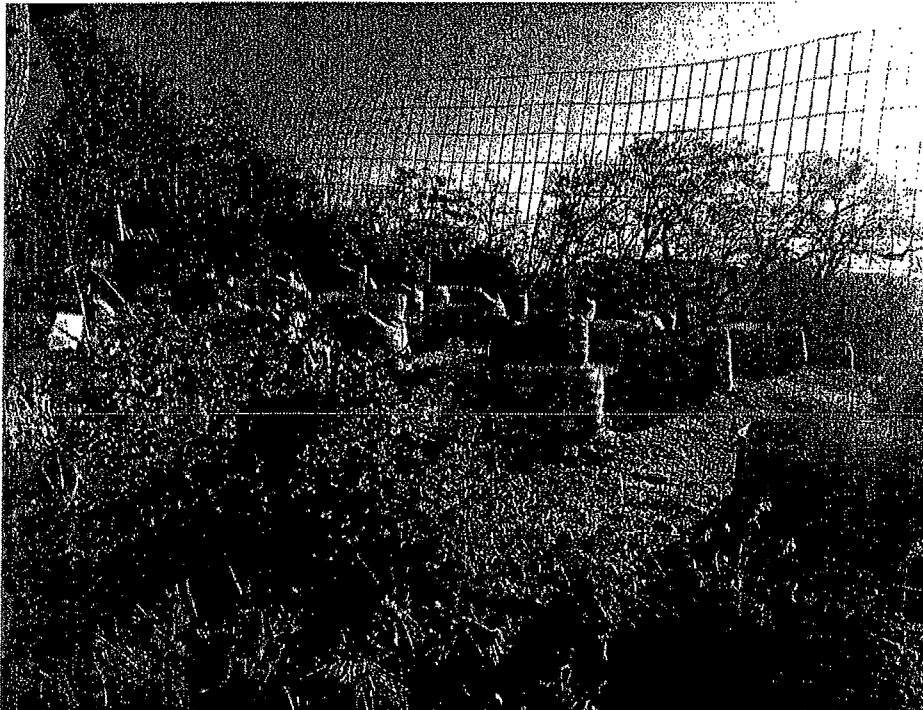
Site D Looking North:

History: The site was first converted with clearing and a greenhouse between 2005 and 2009. The site was expanded between 2010 and 2012 by clearing more trees. Currently the site is occupied by a 60' by 150' outdoor pot area. No timber harvesting has occurred in or around this site in the last ten years. No permit was obtained from CALFIRE to convert the area for such use. The conversion is not within a riparian buffer. There are no rare, threatened or endangered animals and plants present within 1000' as per 2018 CNDDDB search. No hazard reduction issues present Ownership of Parcel 210-144-012 at the time of the illegal conversion was unknown.
