**Murray Field Obstacles
and Tree Abatement Recommendations**

**Reported by Ethan Coonen
and Natural Resources Management Corporation**

May 20, 2022

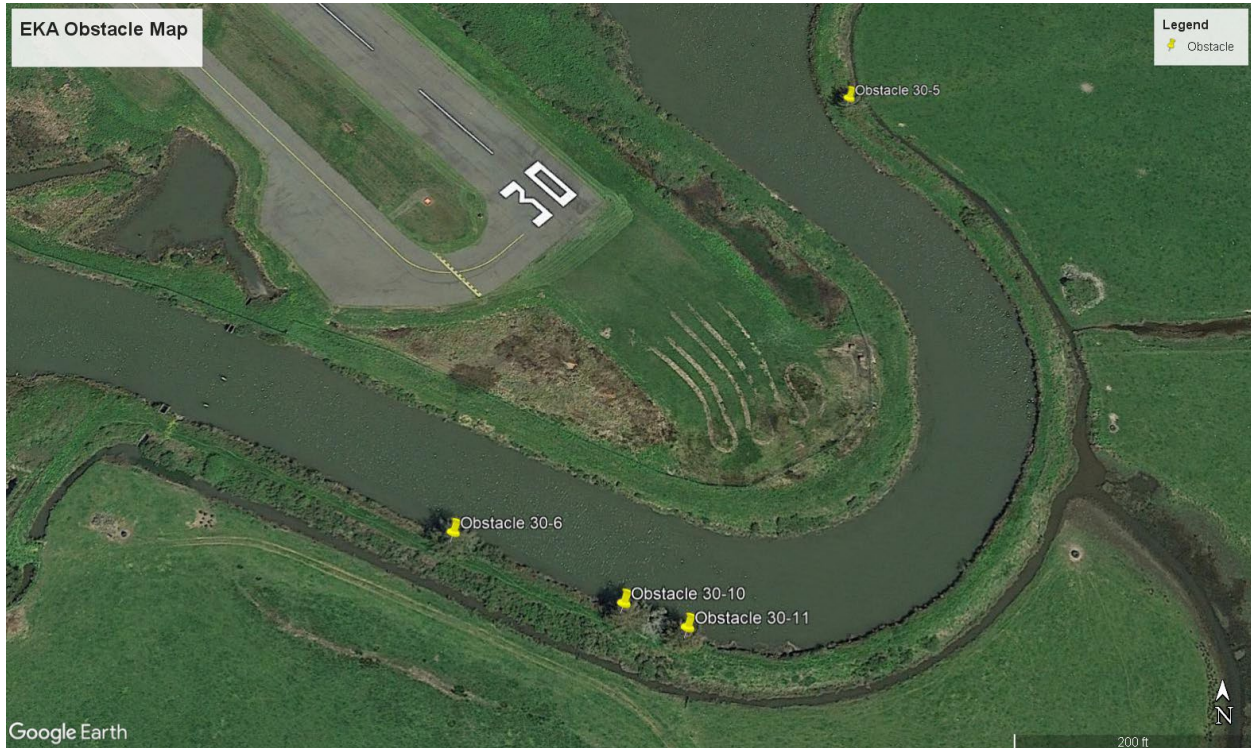
Figure 1. Aerial image of Murray Field Airport obstacles.

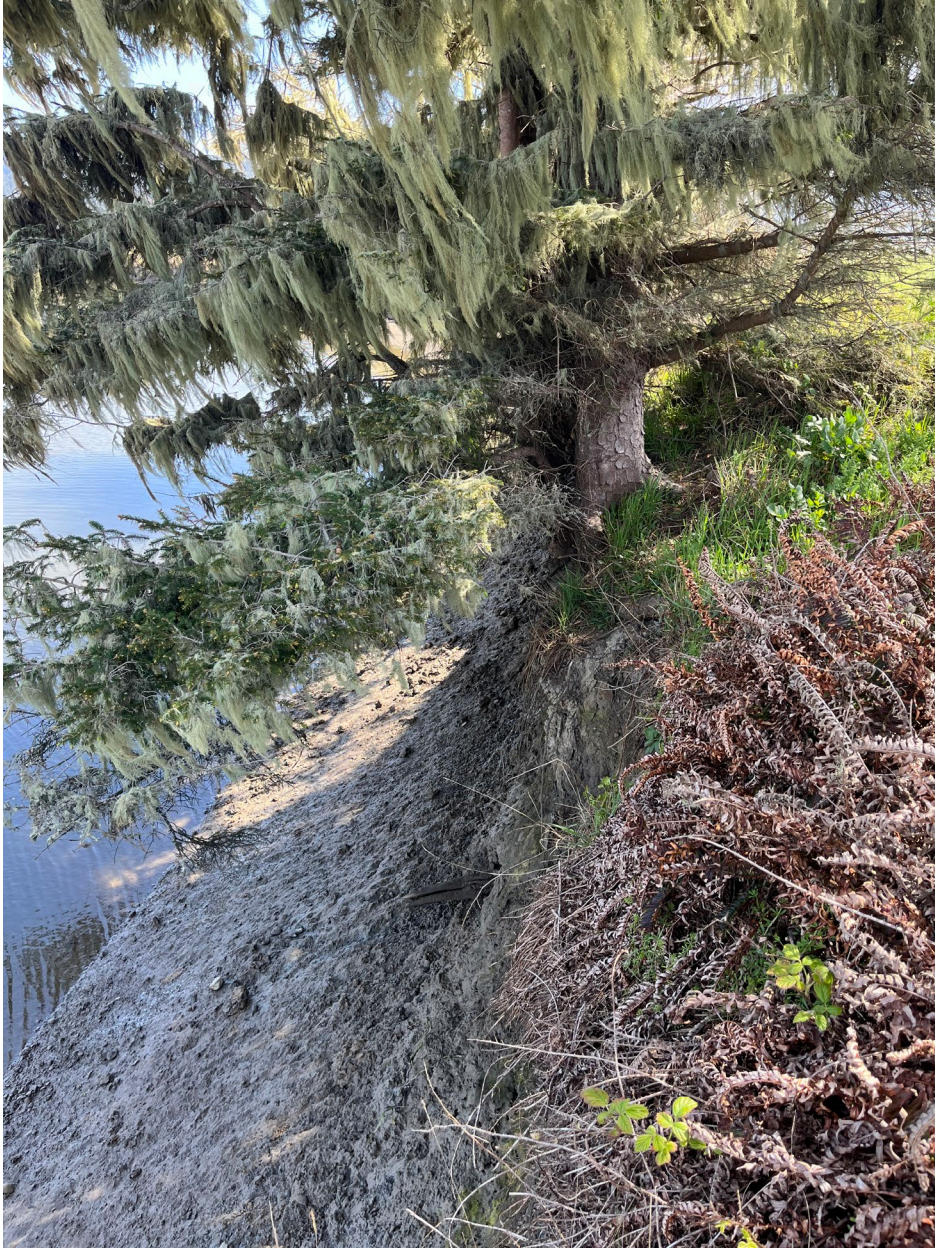
Photo 1. Example for project site conditions. All the trees, except one, are growing along the levee edge at the top of the slough bank.

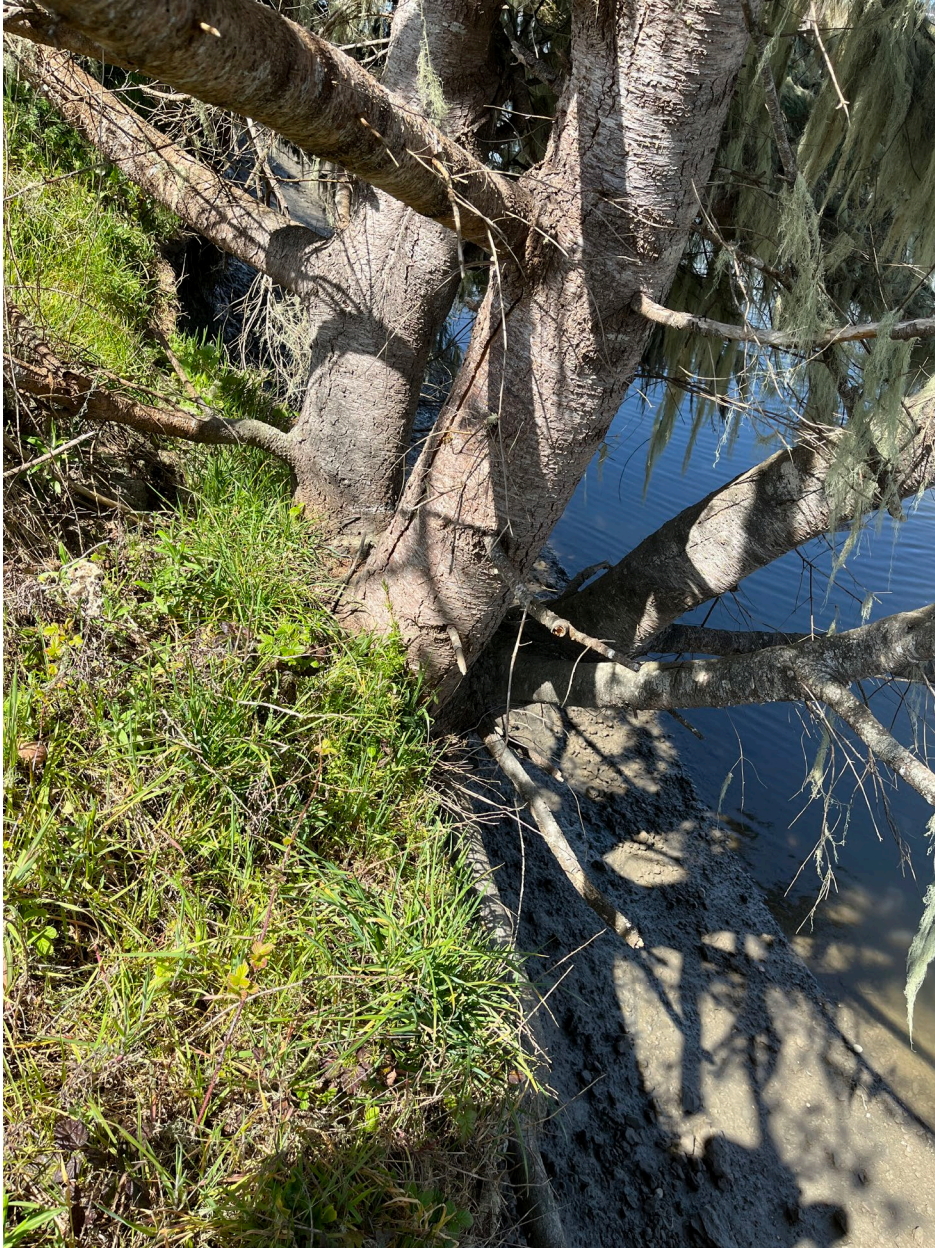
Photo 2. Example for project site conditions. All the trees, except one, are growing along the levee edge at the top of the slough bank.

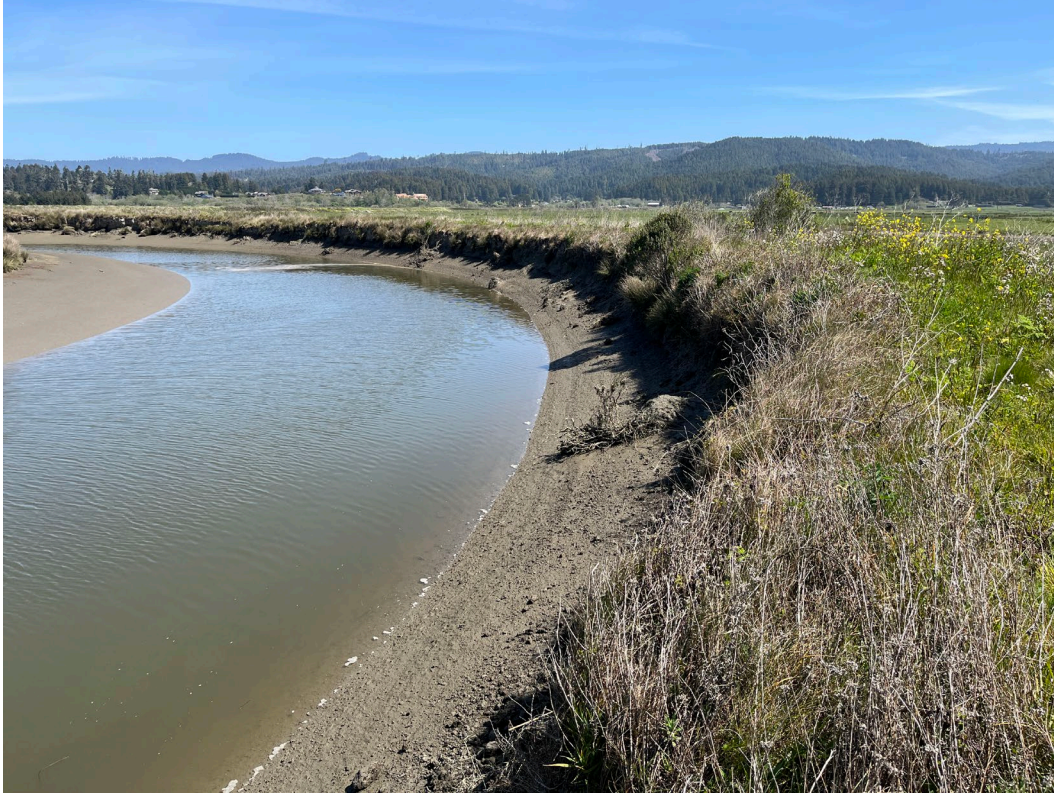
Photo 3. Example of levee edge where erosions is slowly occurring.

- 6) No tree material or equipment may enter the slough at any point.
- 7) Armor areas of disturbed soil with biodegradable materials. Use biodegradable landscape stakes to secure woven fabric made of jute or coir. Depending on extent of root removal, each site a tree was removed from will need an approximately 6 by 5-foot covering. Stakes should be spaced every 2-feet so each tree removal site will need at least 4-square-yards of fabric and 16 stakes.

- 9) Monitor the site for erosion and revegetation success. Return to the site each year for at least 3 years to assess if rates of erosion are faster at the tree removal sites than other portions of the levee. Also, assess if the coyote brush plants or other vegetation are colonizing the site successfully. If accelerated rates of erosion are observed, then consult with a civil engineer. If vegetation does not occupy at least 80% of the area by the third year, then consult with a restoration specialist.

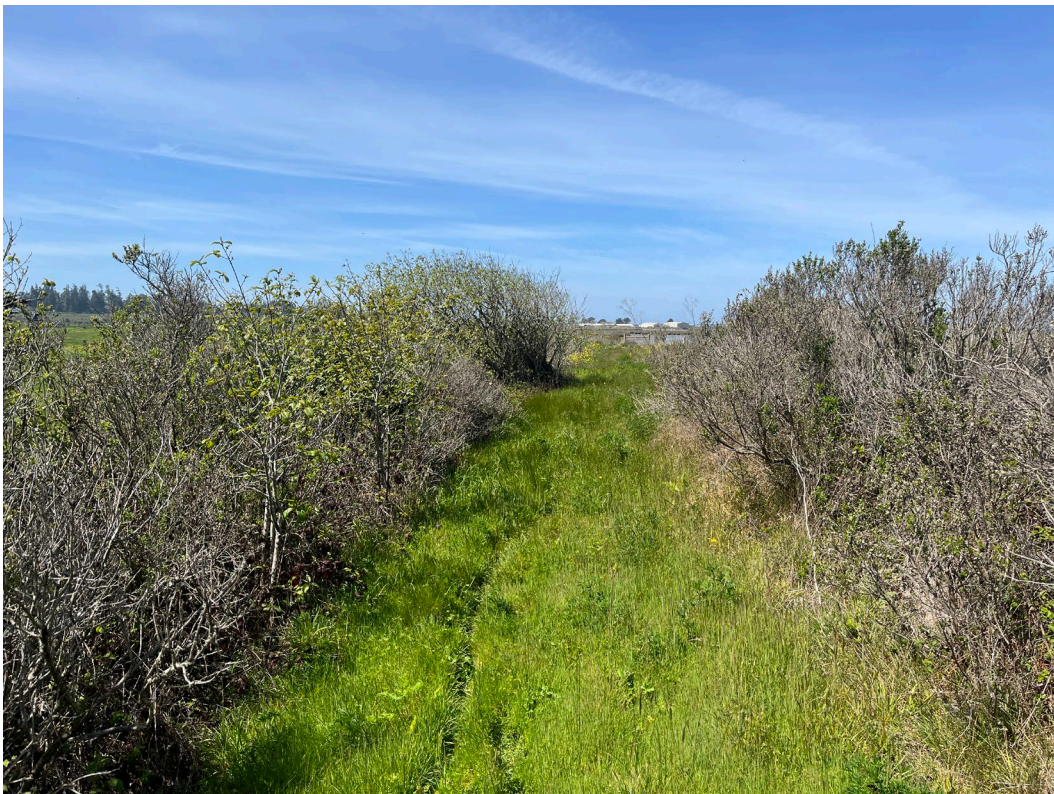
Photo 4. Example of access road along top of levee and vegetation colonizing the levee. The access road is mowed once a year.
