**Disturbed Area Stabilization Plan
Technical Report
Order WQ 2019-0001-DWQ**

For
APN 208-221-013 and 208-221-014

Located at
**Parcels 51 and 52, Timberline Ranch Estates RS, BK 26
Mad River, California**

October 2021

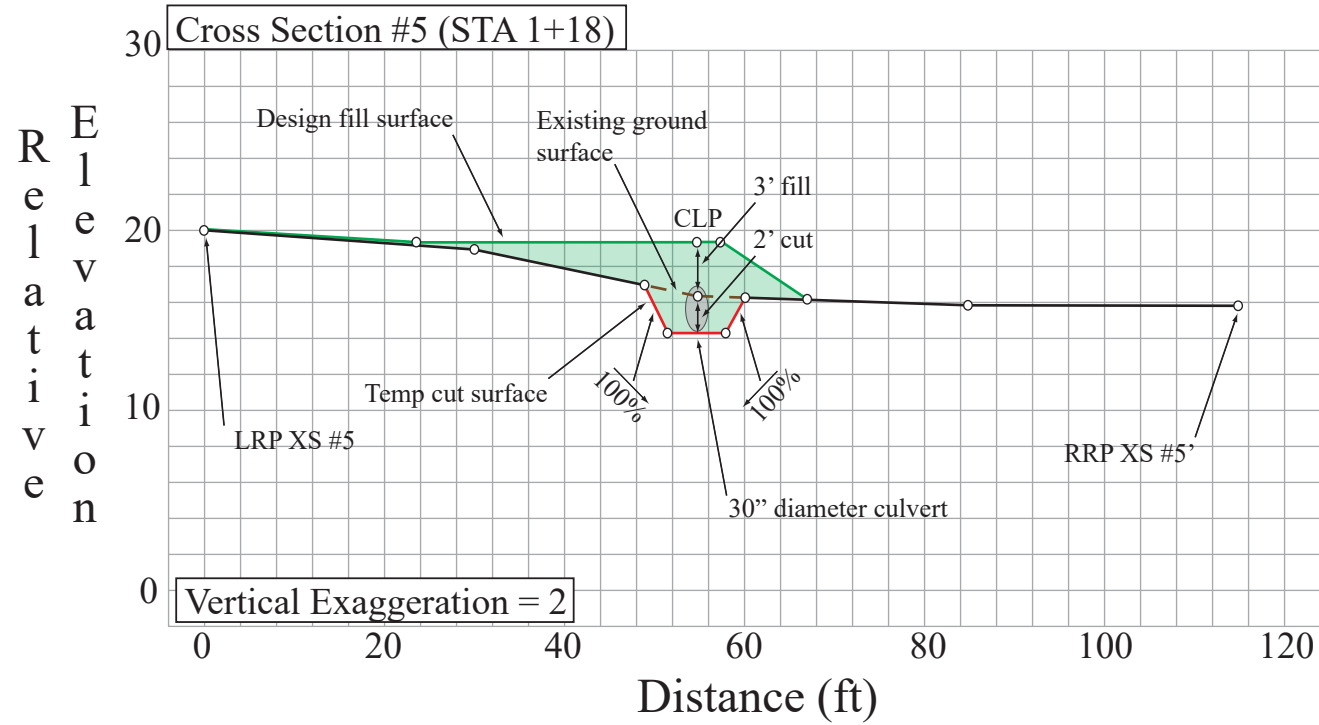
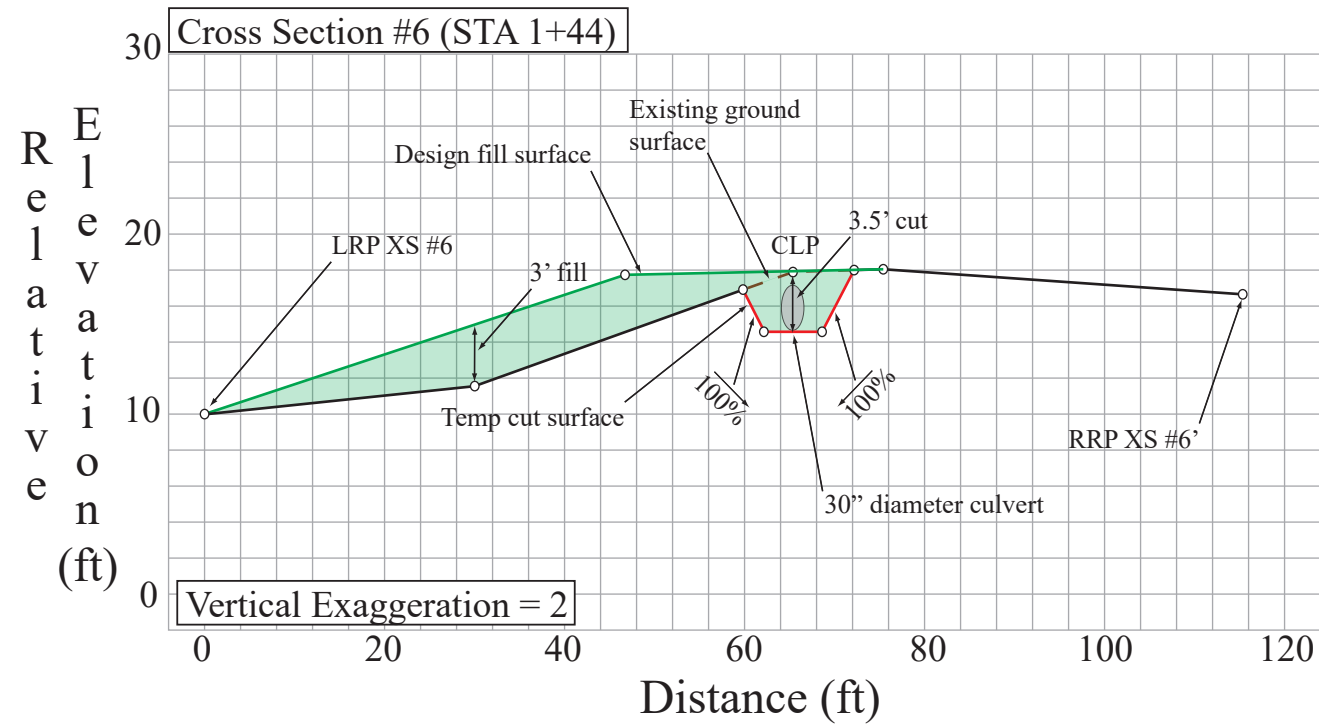
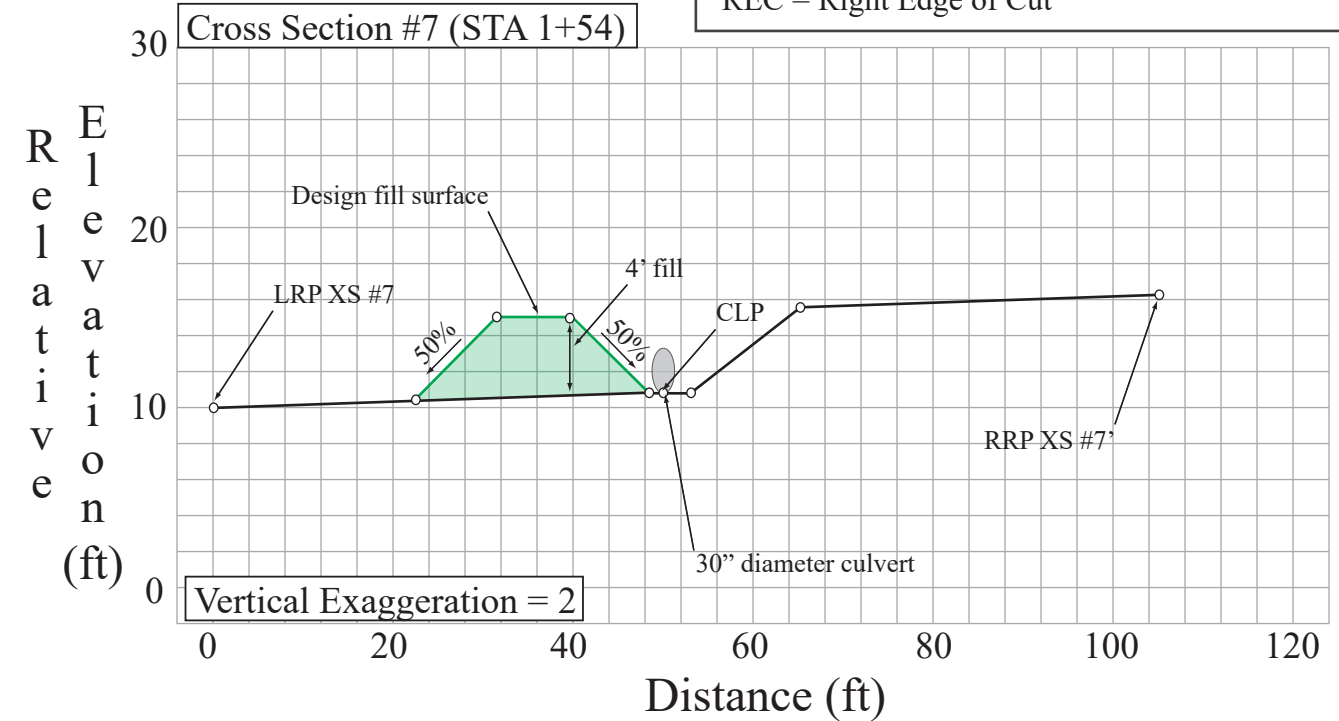
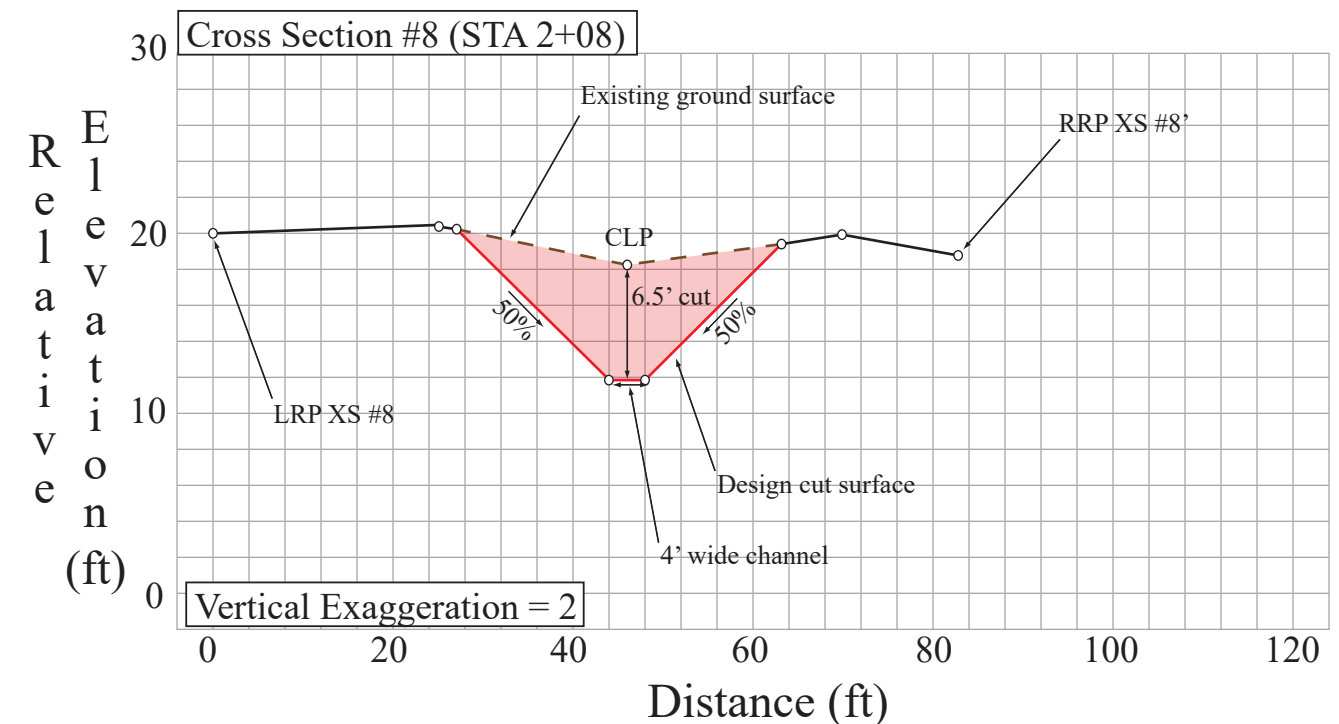
PROJECT PLAN DESCRIPTION:
 Proposed Stream Crossing #5
 Cross Sections #5 - #8
 Drosihn Project Site
 APN # 208-221-013

Balanced Cut/Fill Volume: 300 cu yds

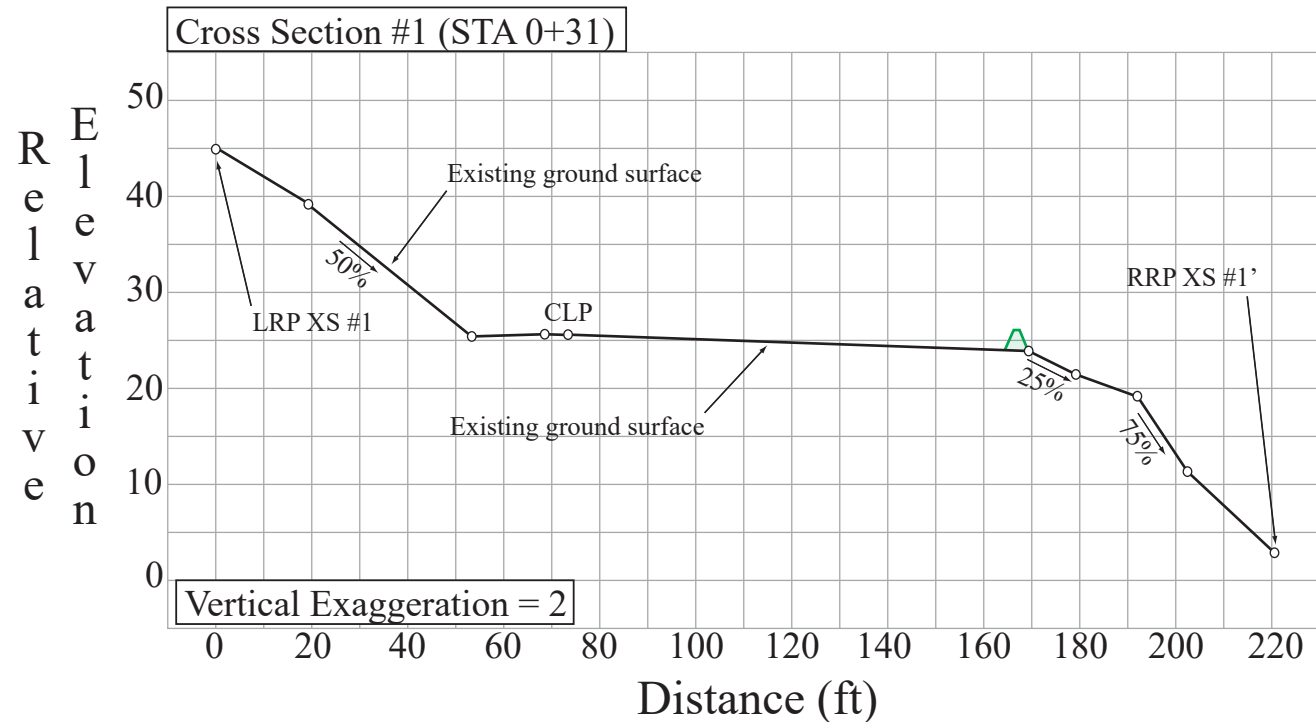
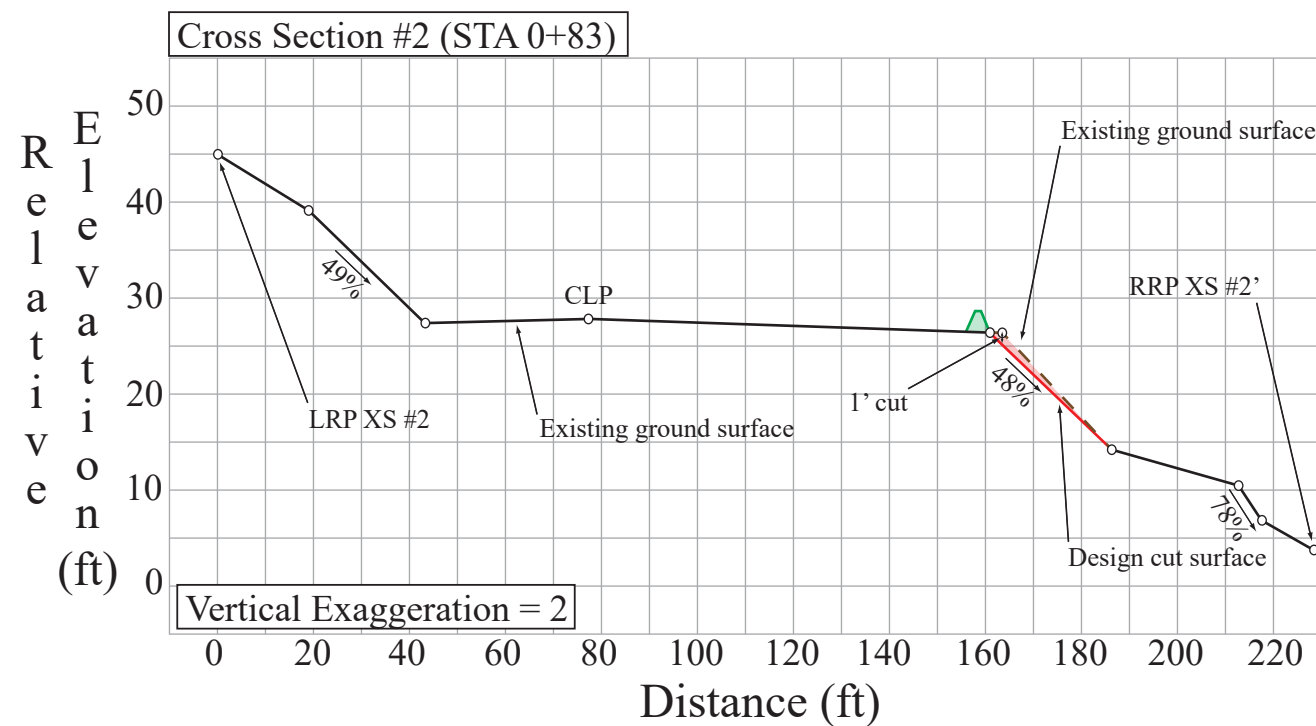
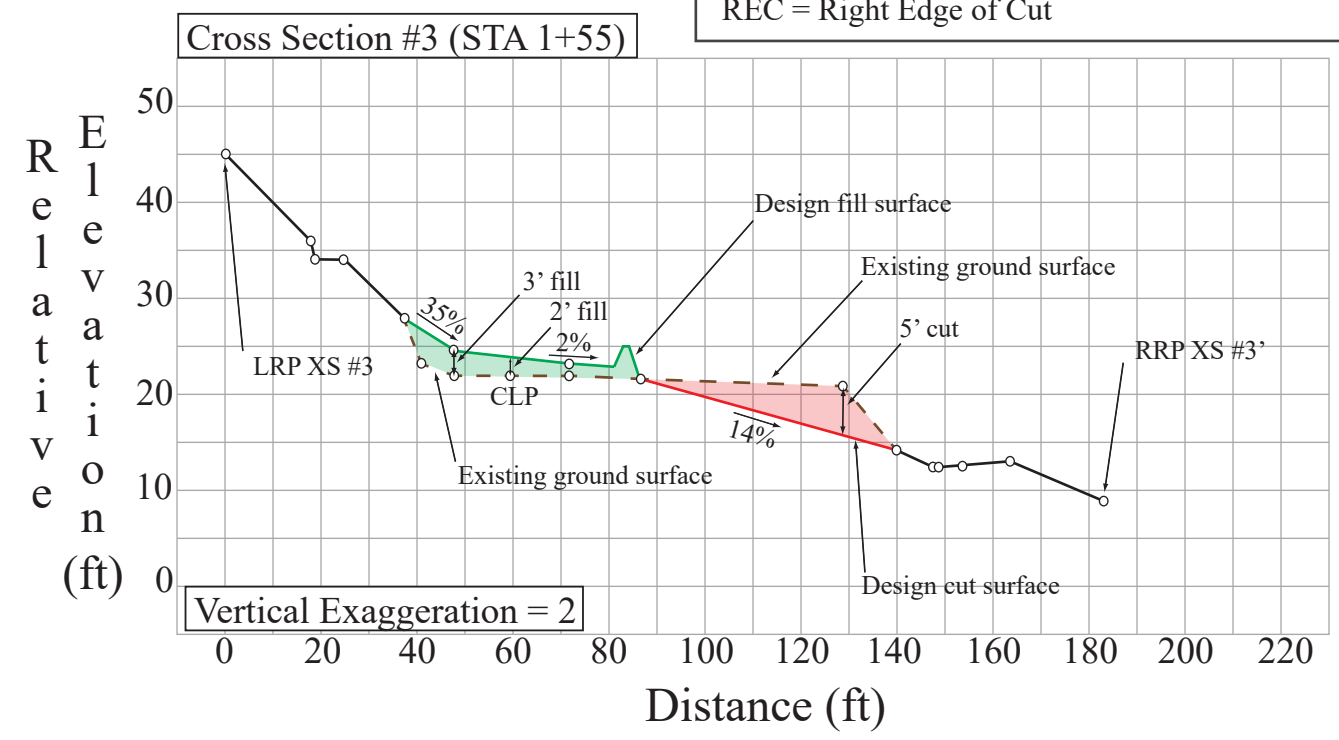
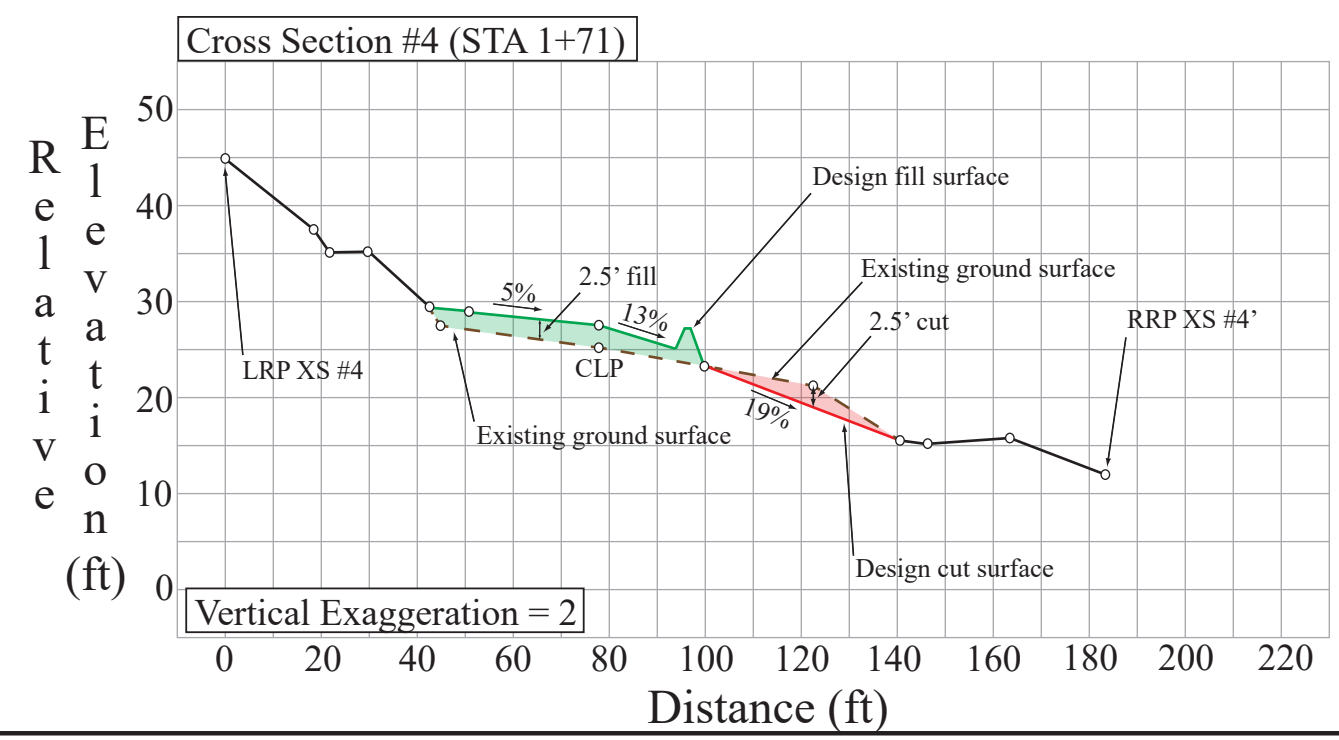
Balanced Cut/Fill Volume: 300 cu yds
