Aquatic Resources Impact Assessment

APN: 214-142-012

March 2022

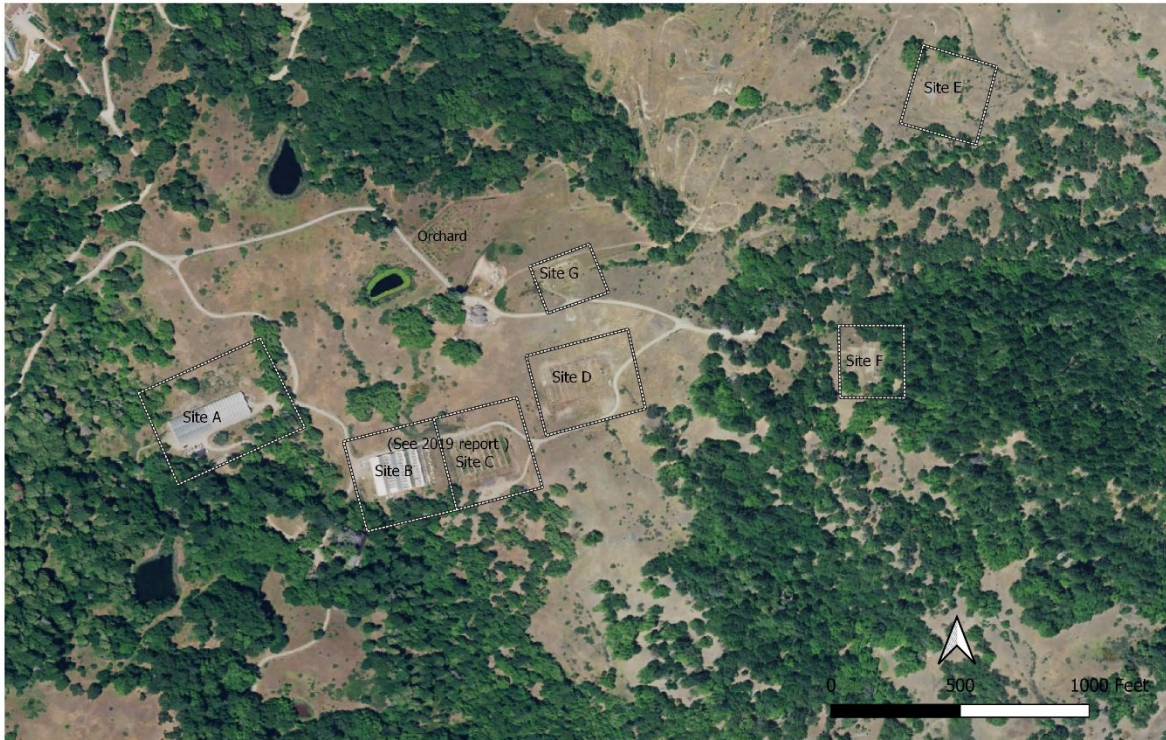
Figure 2. Cultivation Site Map.

Site visits were conducted on September 1, 2021, and January 27, 2022. Five current and past cultivation sites were evaluated for potential impacts to aquatic resources (Figure 2). Where present, wetlands were delineated by Kyle Wear, M.A. Mr. Wear has over 25 years of experience conducting floristic surveys and other botanical work in northern California and over 15 years of experience conducting wetland delineations. Mr. Wear is also trained in wetland delineation by the Wetland Training Institute.

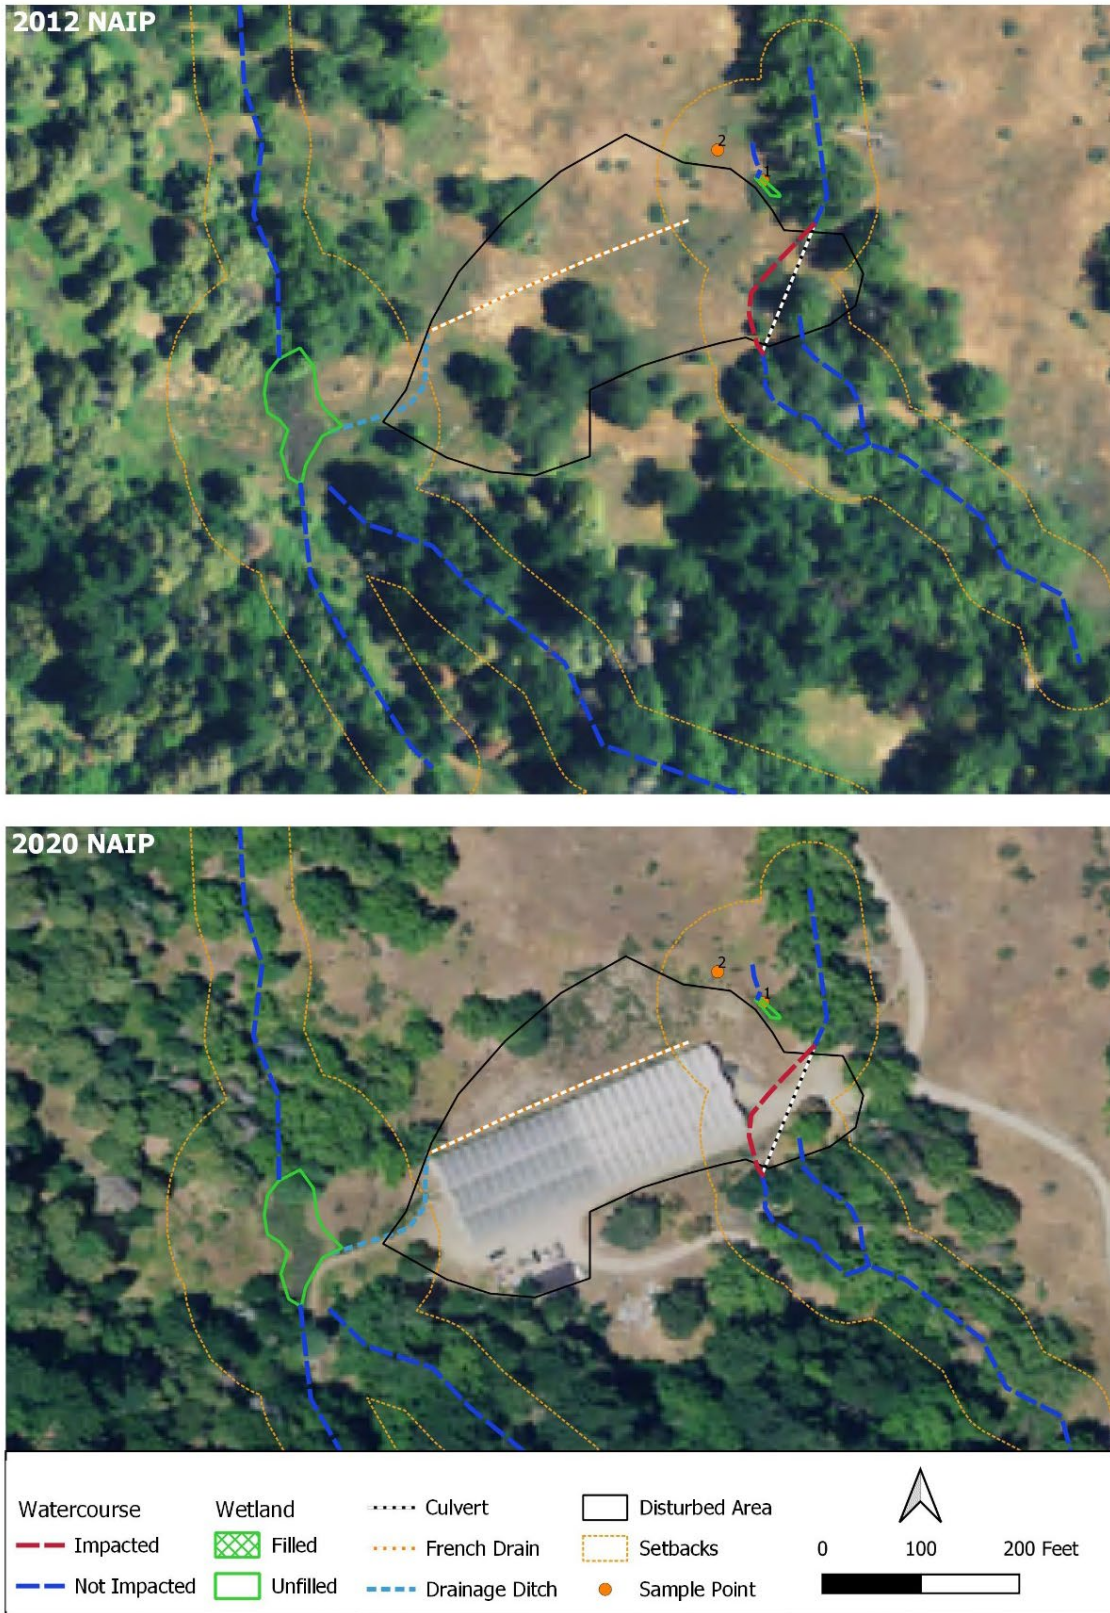
Figure 3. Site A Aquatic Resources Map.

The site is currently used for cultivation and includes a mixed light greenhouse and generators. There is a feature in the undisturbed area near the top of the cutbank that includes a small gulch above a small seasonal wetland (Figure 3). The feature is an erosional feature or earthflow sag and is not continuous with the impacted area. The feature is obscured by adjacent upland vegetation canopy and is not visible in aerial images. The small wetland is dominated by rushes (*Juncus effusus* [FACW] and *J. Patens* [FACW]) (Sample Point 1). The soil is 10yr 2/2 with 7.5yr redox concentrations and meets hydric soil indicator F6 (Redox Dark Surface). This area was sampled in September 2021 during a drought year; however, the small feature includes secondary hydrology indicators B10 (Drainage Patters), D2 (Geomorphic Position), and D5 (FAC-Neutral Test).

There is a Class III watercourse east of the graded flat. The cutbank includes seasonal bank seeps that drain into a French Drain along the base of the slope, then west into a drainage ditch, and into wetland associated with a Class II watercourse. The bank seeps are a result of daylighting groundwater that was otherwise well beneath the surface and are not natural wetland features.

The site was graded between August 2012 and May 2014. The total impacted area is approximately 88,375 square feet (2.029 acres). There has been concern raised that a part of the disturbed area that appears darker brownish green than the adjacent grassland in some of the pre-disturbance images could be wetland, especially the 2005 images. However, in the 2012 Google Earth image, which has higher resolution, the area appears to be grassland, coyote

A July 2021 report by Trinity Valley Consulting Engineers indicates the Class III stream is diverted from its original channel into a culvert under the access road. This resulted in the filling of approximately 158 feet of the channel.

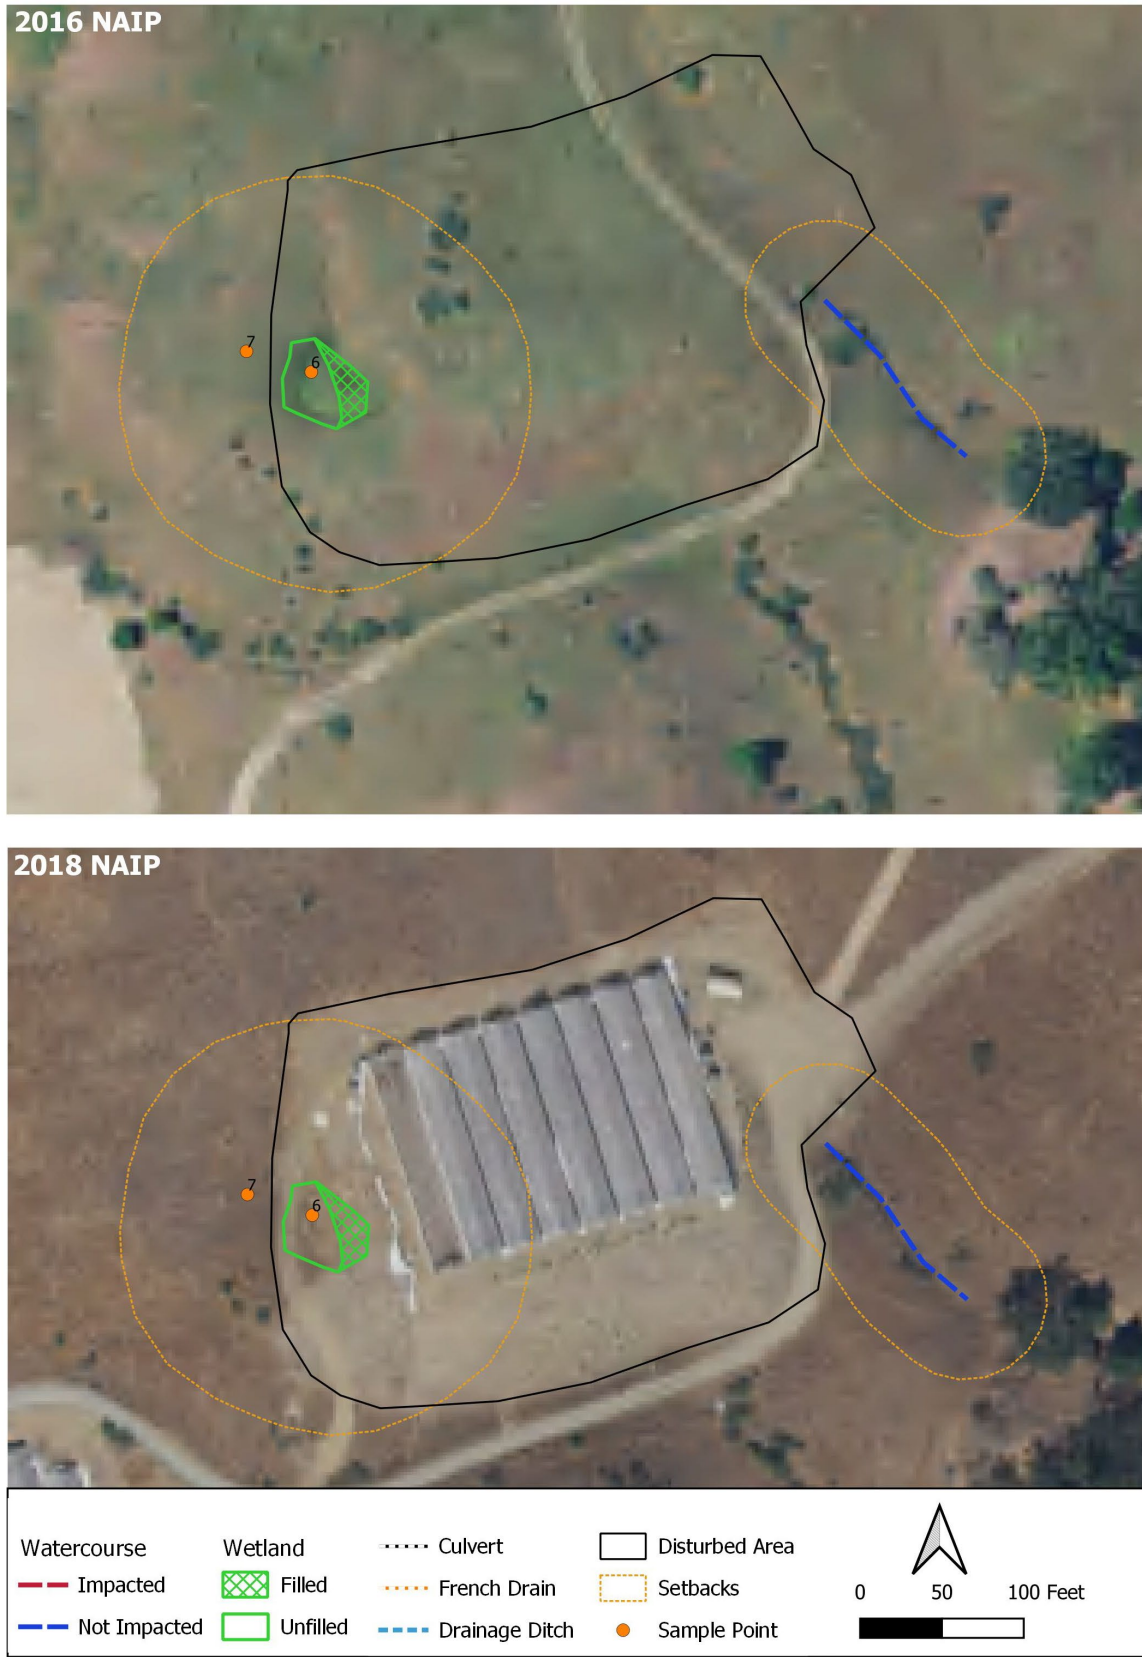
Figure 4. Site D Aquatic Resources Map.

There is a small seasonal wetland in a depression on an earthflow sag just west of the graded flat (Figure 4). Dominant plants in the wetland include nut grass (*Cyperus eragrostis* [FACW]), rush (*Juncus effusus* [FACW]), and pennyroyal (*Mentha pelugium* [OBL]) (Sample Point 6). The soil is generally 10yr 4/1 with 7.5yr redox concentrations and meets hydric soil indicator F3 (Depleted Matrix). The water table was approximately eight inches below the surface with saturation to approximately three inches. There was an algal mat over some of the wetland. Wetland hydrology indicators present included A2 (High Water Table), A3 (Saturation), and B4 (Algal Mat or Crust).

There is a Class III stream near the southwest corner of the disturbed area. Like Site A, grading exposed the water table on the cutbank resulting in seasonal seeps that drain onto the flat, but these are not natural features.

Development of the site is first visible in 2018. Cultivation at the site appears to have ceased by 2019. The disturbed area is approximately 84,368 square feet (1.937 acres). Approximately 673 square feet (0.015 acre) of the wetland visible on pre-disturbance images is under the toe of the fillslope.

The nearby Class III watercourse does not appear to have been impacted. The current top of the watercourse is consistent with pre-disturbance images (Appendix B).

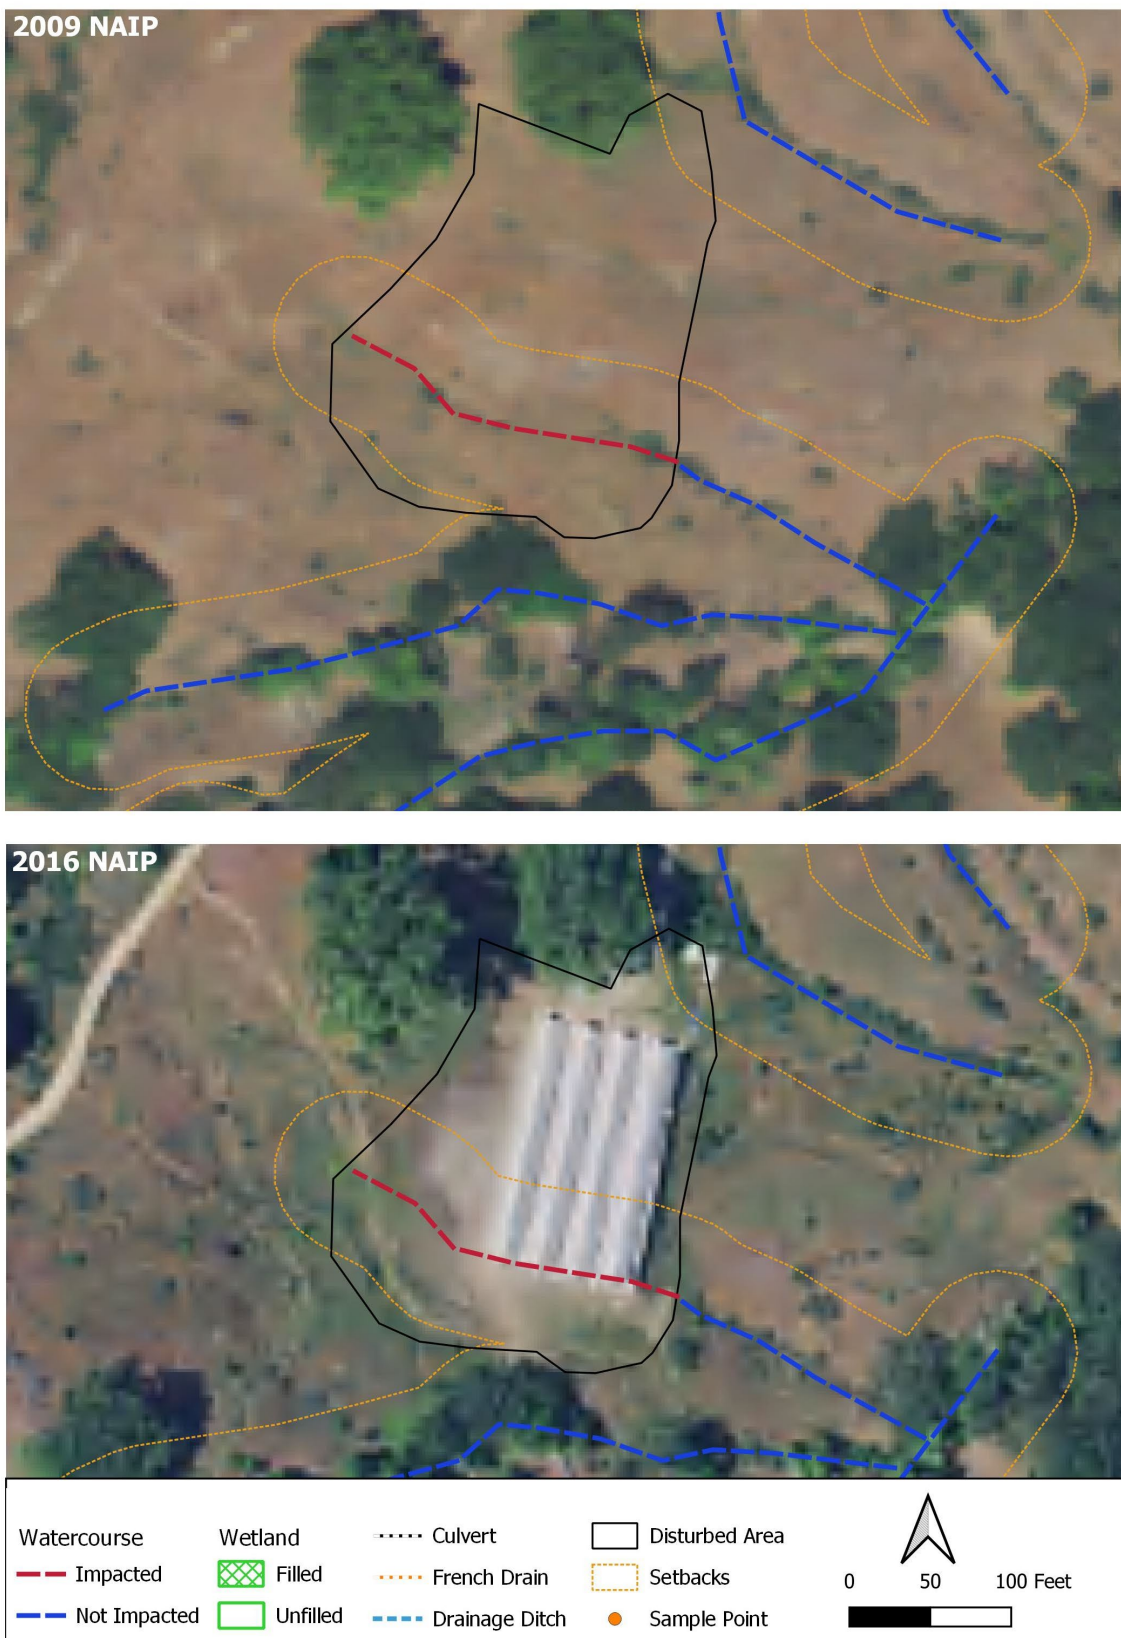
Figure 5. Site E Aquatic Resources Map.

There are no wetlands near the site (Figure 5). There are stands of nut grass (*Cyperus eragrostis* [FACW]) on the flat associated with areas where runoff concentrates, but it is not a natural wetland feature. The surrounding grassland has upland vegetation with stands of orchard grass (*Dactylis glomerata* [FACU]), rattlesnake grass (*Briza maxima* [UPL]), Mediterranean barley (*Hordeum marinum* [FAC]), rough cat's-ear (*Hypochaeris radicata* [FACU]), and coyote brush

There are five Class III streams northeast, east, and south of the disturbed area.

Grading occurred between 2009 and 2012. The site was used for cultivation until at least 2016. The total disturbed area is approximately 45,436 square feet (1.043 acres), which included approximately 220 feet of a Class III watercourse (Appendix B). There is no evidence of wetlands in the pre-disturbance images.

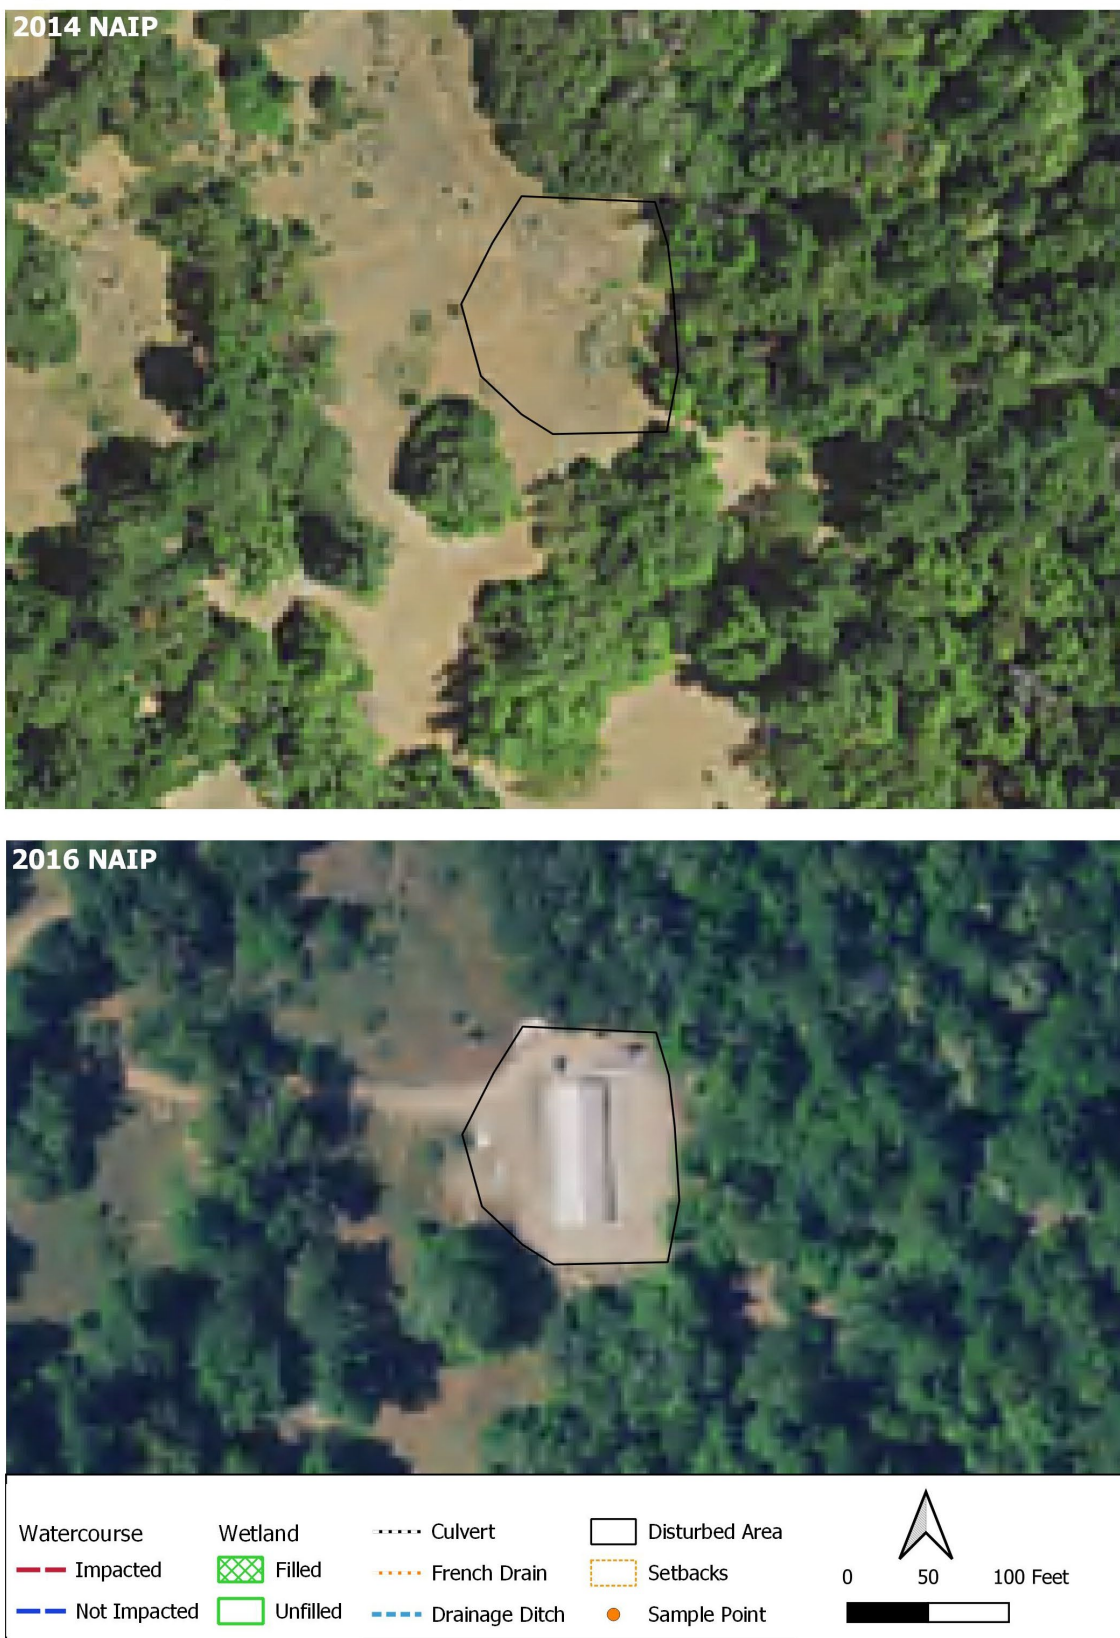
Figure 6. Site F Aquatic Resources Map.

There are no wetlands or streams near the site (Figure 6). There is a small patch of nut grass (*Cyperus eragrostis* [FACW]) and pennyroyal (*Mentha pelugium* [OBL]) associated with drainage from the flat, but it is not a natural feature. The surrounding grassland includes California oatgrass (*Danthonia californica* [FAC]), blue wildrye (*Elymus glaucus* [FACU]), rattlesnake grass (*Briza maxima* [UPL]), bracken fern (*Pteridium aquilinum* [FACU]), rough cat's-ear (*Hypochaeris radicata* [FACU]), and scattered coyote brush (*Baccharis pilularis* [UPL]). The surrounding trees include Douglas-fir (*Pseudotsuga menziesii* [FACU]), Oregon white oak (*Quercus garryana* [FACU]), madrone (*Arbutus menziesii* [UPL]), and California bay (*Umbellularia californica* [FAC]).

The site was graded between 2014 and 2016. The site was used for cultivation until at least 2018. The total impacted area is approximately 16,309 square feet (0.374 acre). No aquatic resources were impacted.

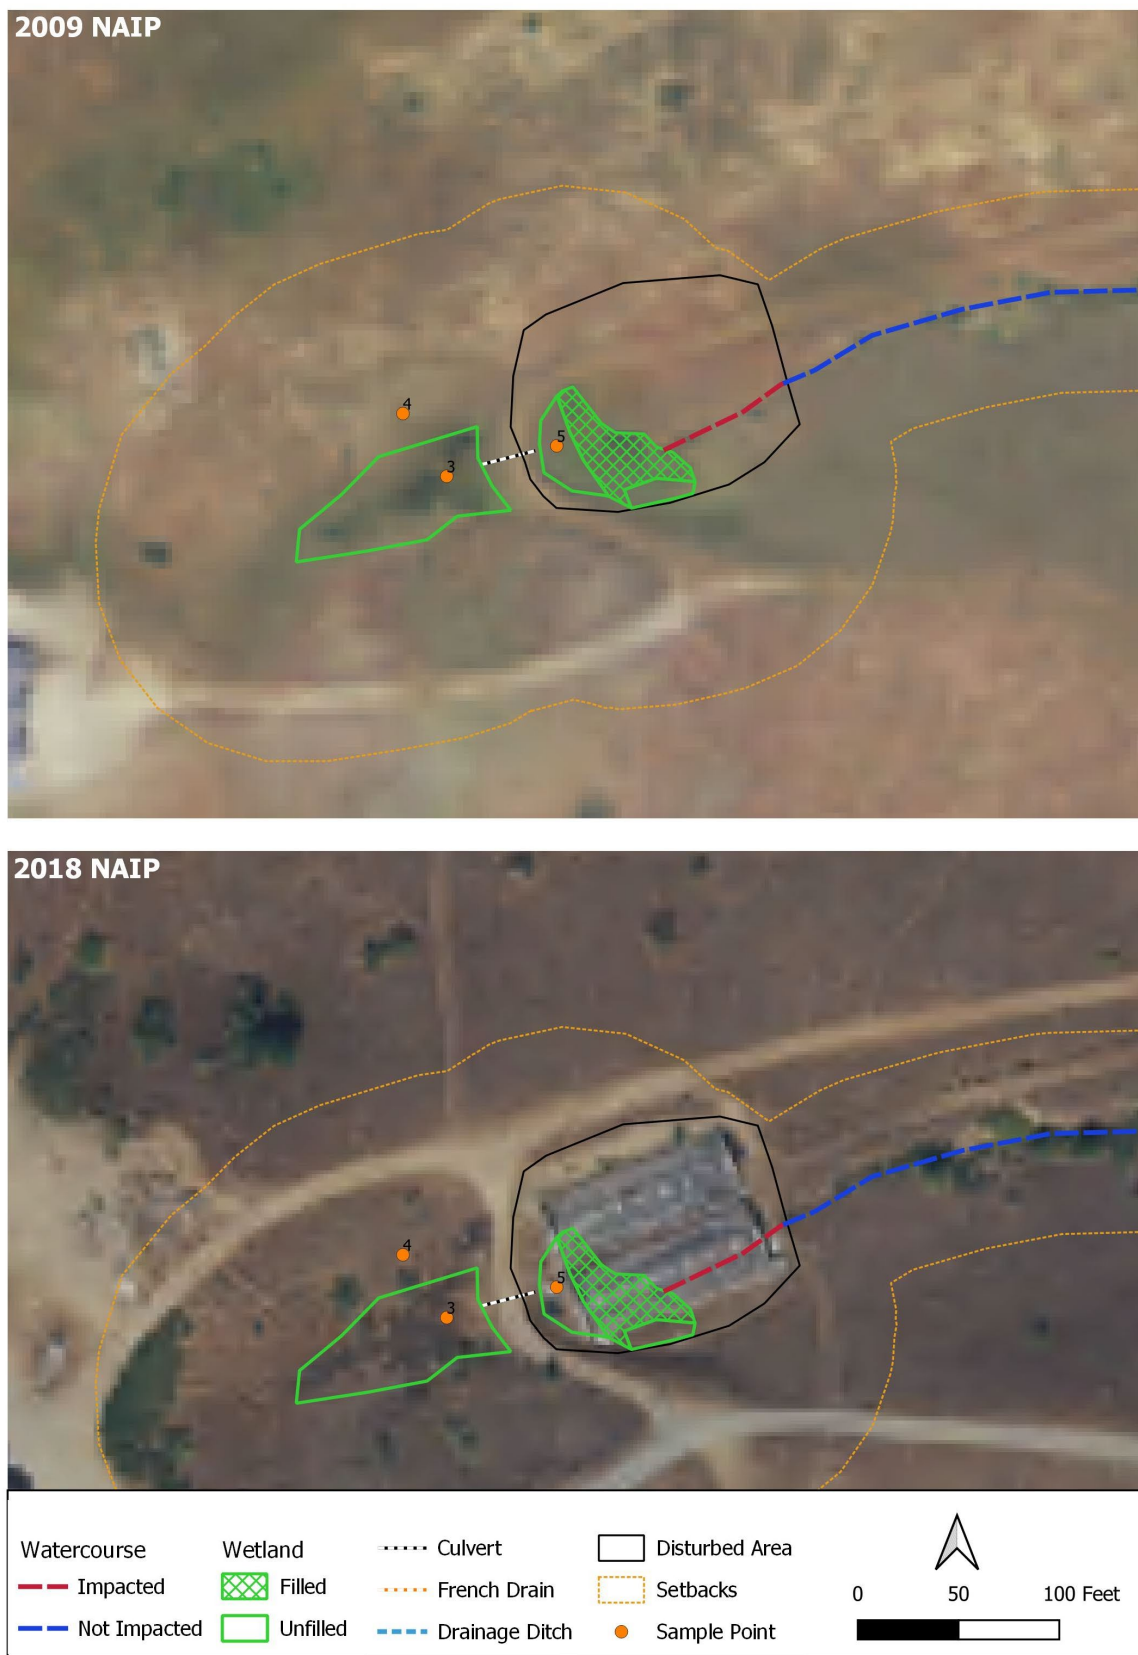
Figure 7. Site G Aquatic Resources Map.

There is a seasonal wetland directly west of the disturbed area (Figure 7). The wetland includes stands of rushes (*Juncus effusus* [FACW] and *J. Patens* [FACW]), nut grass (*Cyperus eragrostis* [FACW]), and pennyroyal (*Mentha pelugium* [OBL]) (Sample Points 3 and 5). The soil in the wetland is generally 10yr 4/1 with 7.5yr 5/6 redox concentrations. The soil meets hydric soil indicator F3 (Depleted Matrix). Wetland hydrology indicators present included A1 (Surface Water), A2 (High Water Table), and A3 (Saturation).

A Class III watercourse flows east from the disturbed area.

The area was graded between June 2009 and September 2010 and used for cultivation until at least 2016. The total impacted area is approximately 13,257 square feet (0.304 acre). The wetland and upper extent of the Class III watercourse extend under the graded area in the pre-disturbance images. Approximately 1,511 square feet (0.035 acre) of wetland and approximately 68 feet of the Class III watercourse were filled. The road through the wetland was not included in the impacted area because it is visible in 2004 and is a baseline condition.

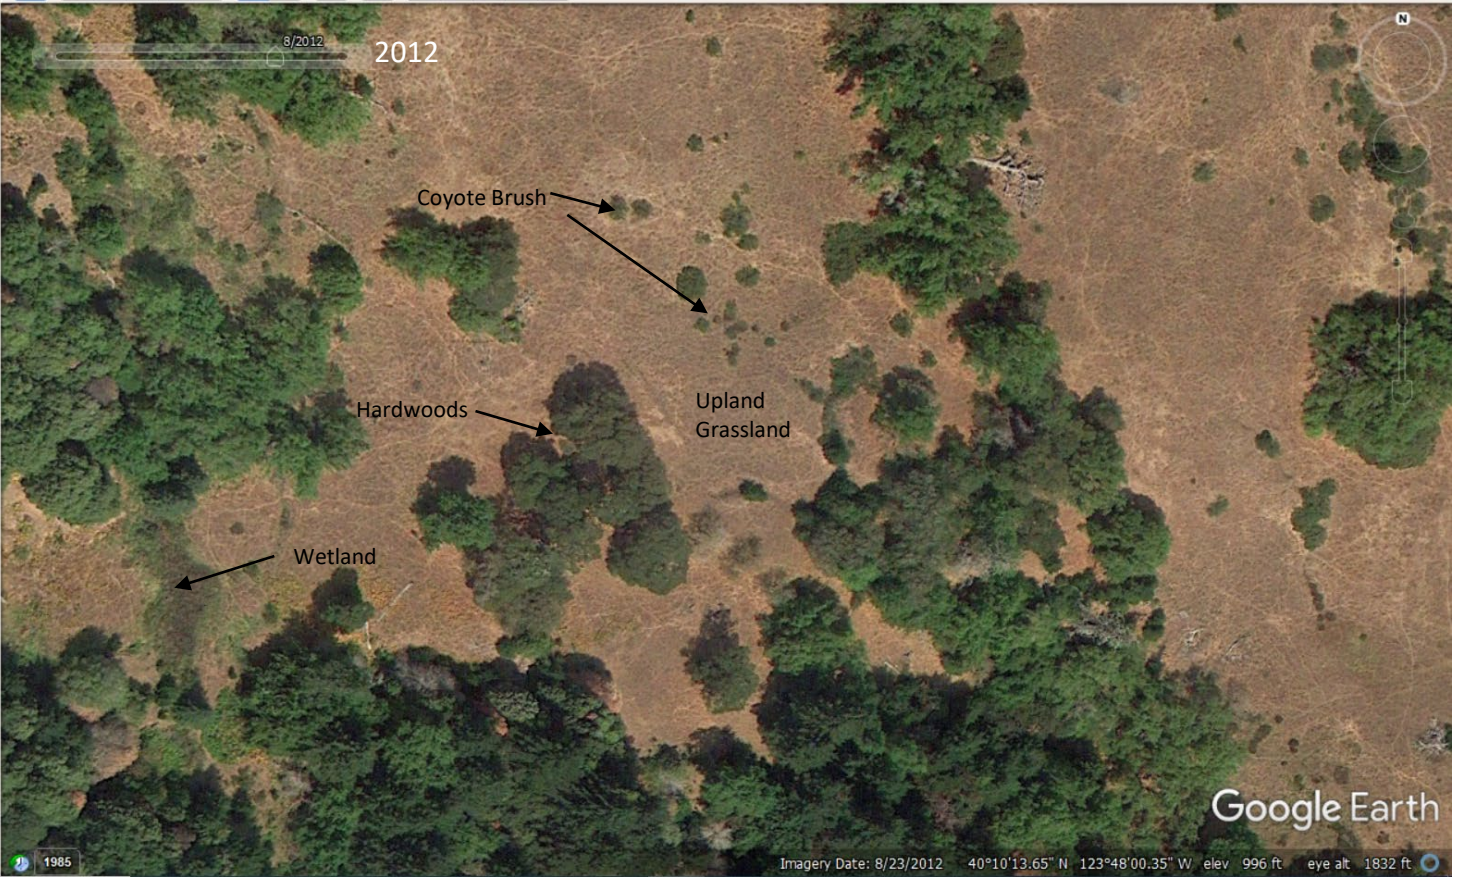
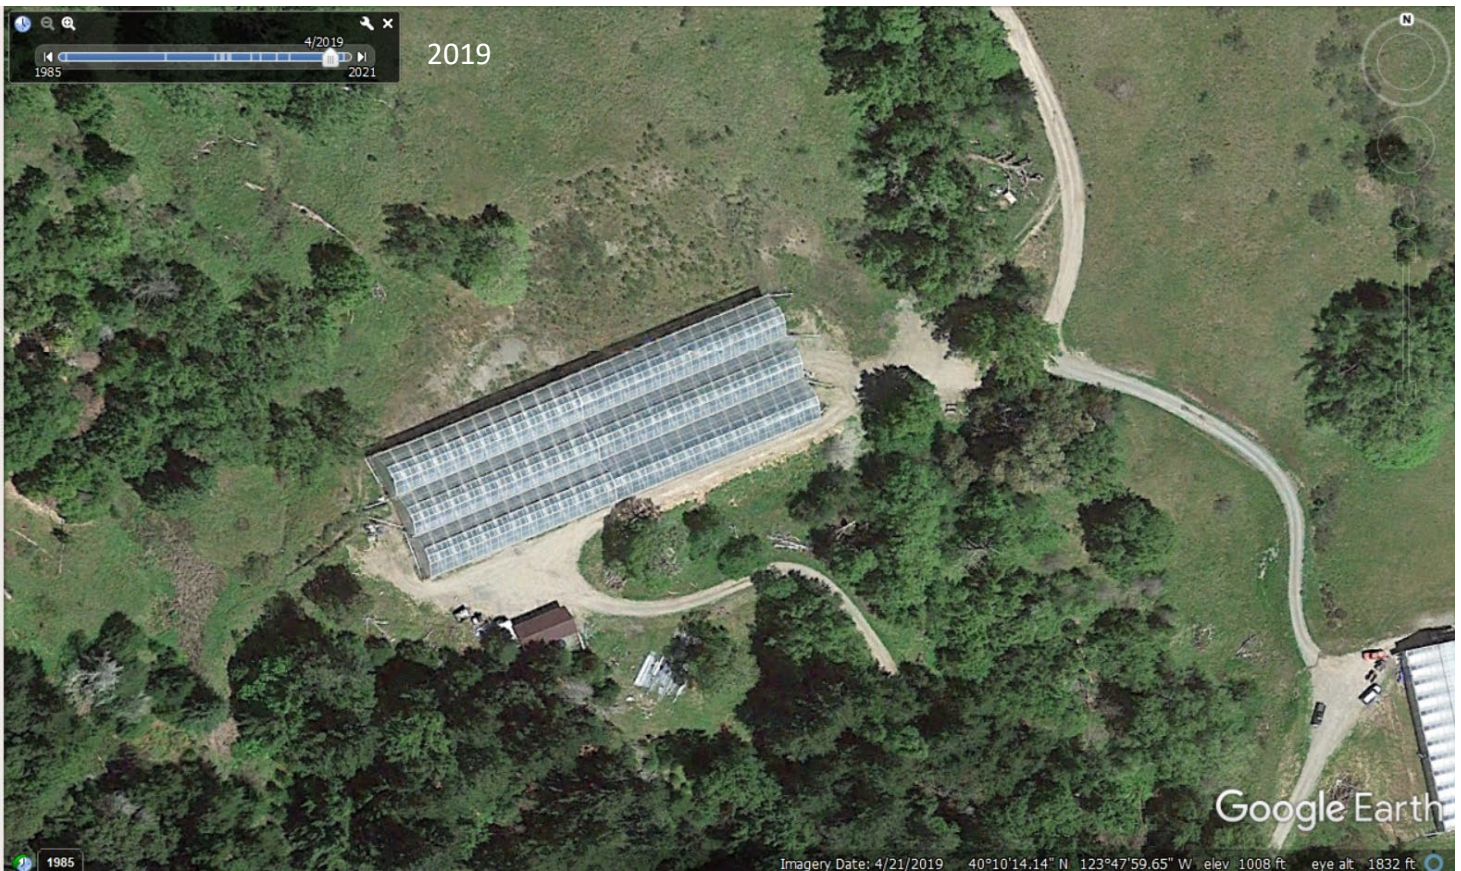
Site A Google Earth Images

brush, oaks, and other hardwoods indicative of upland conditions (Appendix B). There is no evidence of rushes typically visible in the images in other wetlands on the property. Similar color is also present elsewhere on the same images in areas on the property that are undisturbed that are upland.
