Environmental Justification for Onsite Relocation of Cannabis Cultivation

1250 WOOD RANCH ROAD, REDWAY, CA

APPS# 12312, APN 214-233-002

February 4, 2019

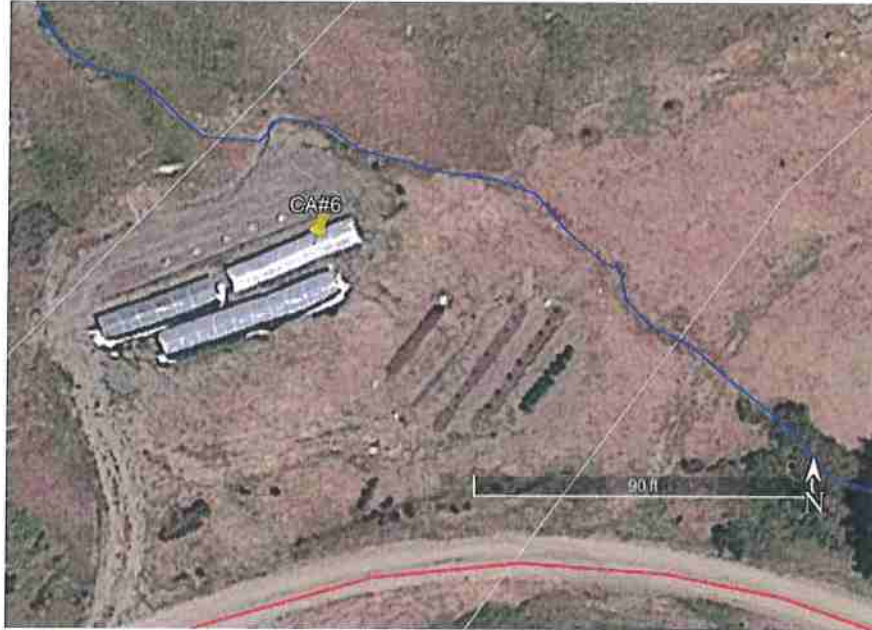
Figure 4: CA#6 in very close proximity to a stream which may have been partially diverted by grading activities. Image date 5/29/2014.

CA#6 was created by grading a small bench into the hillslope. The graded flat is approximately 39 feet wide by 83 feet long and appears to extend right into the bank of an existing class III

stream, approximately 150 feet from its origin. An SWRCB required 50-foot buffer to the top of bank of the stream would essentially cover the entirety of the cultivation area. In addition, it has impacted the natural flow of drainage and delivers concentrated flow into the inboard road ditch below the site. Due to the encroachment of the graded flat into the banks of the stream, OE believes a high priority should be placed in discontinuing cultivation at this site, and in fact the owner has voluntarily ceased cultivation on this site since 2016.

Per the county CAV document, this area was the site of 3,200 ft² of outdoor cultivation and 1,250 ft² of mixed light cultivation. OE recommends total relocation of all cultivation square footage from this location. A detailed discussion of the proposed relocation receiving area(s) can be found in Section 6.0 of this report.

OE recommends that the site be subject to remediation including removal of all cultivation related supplies and man-made materials. Since the site has revegetated well with native grasses matching the nearby vegetation, OE recommends against extensive regrading, but suggests that modest grading may be required as part of the Site Management Plan to ensure integrity of the class III stream banks, and to help aid in dispersal of drainage onto the hillslope below rather than concentrated and delivered onto the road below. OE also recommends that CDFW be contacted as part of the LSA Notification process to highlight the issues and weigh the options of leaving the existing drainage which is concentrating and channelizing (creating potential habitat) versus regrading for dispersal into the hillslope below.

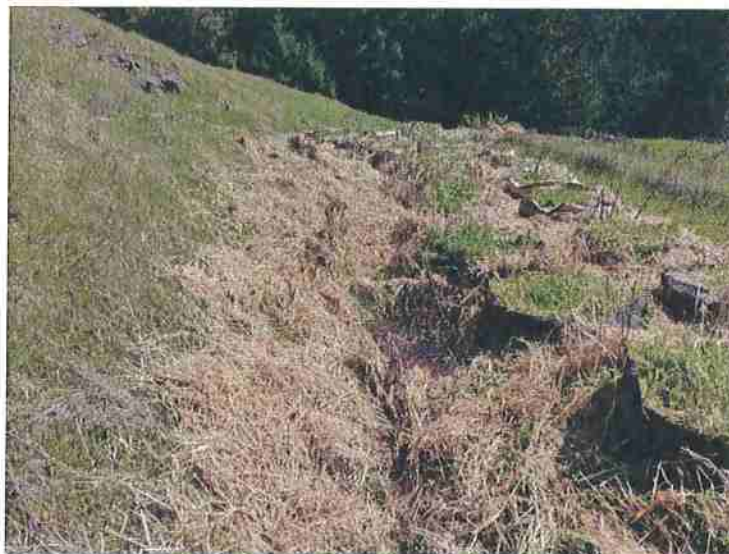
Figure 5: CA#6 view looking Northeast showing pots which require removal and revegetation of native grasses on the flat itself. Note potential drainage issues with water collecting alongside the uphill side of the graded flat.

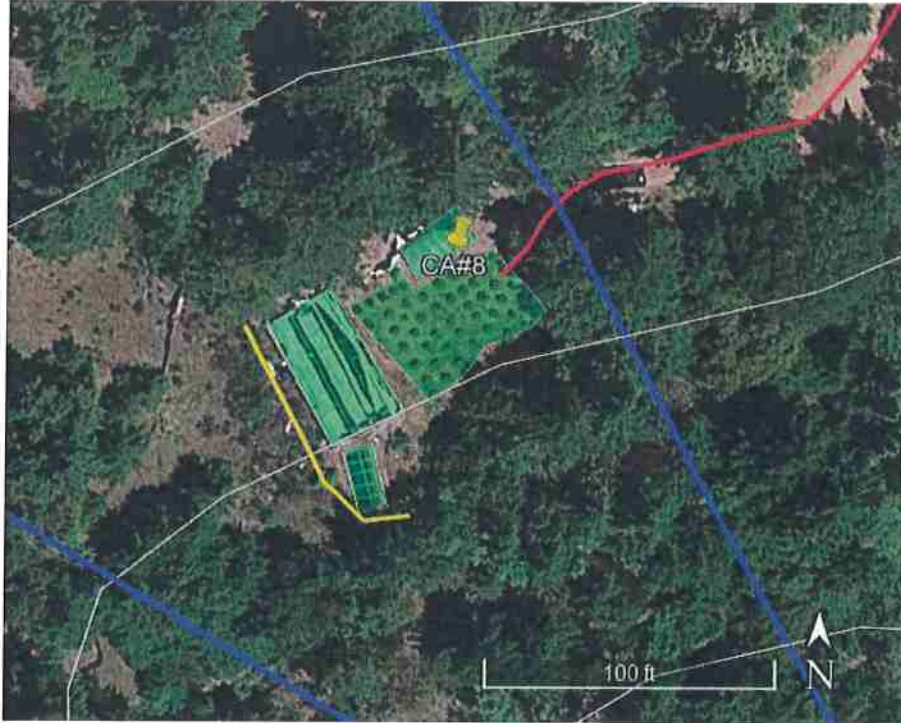
Figure 6: CA#8. Note the class II stream to the Southwest and unclassified stream to the Northeast. The approximate top of bank for the Southwest stream is shown in yellow. Note the close proximity to the two streams. Image date: 5/29/2014

CA#8 is located between two class II streams on what appears to be a natural bench with minimal grading. The entirety of this cultivation area falls within the SWRCB 100-foot riparian buffers of both streams.. In addition, the greenhouses and cultivation beds to the southwest are located immediately adjacent to the top of bank pictured in yellow in Figure 6 above with ground level view shown in Figure 7 below.

OE concludes that the extreme proximity to nearby watercourses eliminates the potential for ongoing cultivation at CA#8 from both a regulatory and environmental standpoint. OE does not see the potential for any form of mitigation of the potential hazards in this location therefore all cultivation on CA#8 should be subject to relocation. Per the county CAV document, this area was the site of 600 ft² of outdoor cultivation and 3,374 ft² of mixed light cultivation. A detailed discussion of the proposed relocation receiving area can be found in Section 6.0 of this report.

OE recommends that remediation of this site proceed according to documentation in the WRPP (See Water Resource Protection Plan (WRPP): “Legacy Cultivation Area #3” and the subject property LSA Notification Additional Pages: “Stream Crossing 9” for additional details). The stream crossing on the road leading to this flat has failed and the Lake and Streambed Alteration Notification calls for its removal. The WRPP calls for removal of all cultivation soil and supplies, and revegetation of any exposed earth near the site. In addition, the road leading out to the site should be blocked off and abandoned with no further remediation recommended due to a lack of erosive issues. OE does not believe the site would benefit from any regrading or changes to the existing site topography.

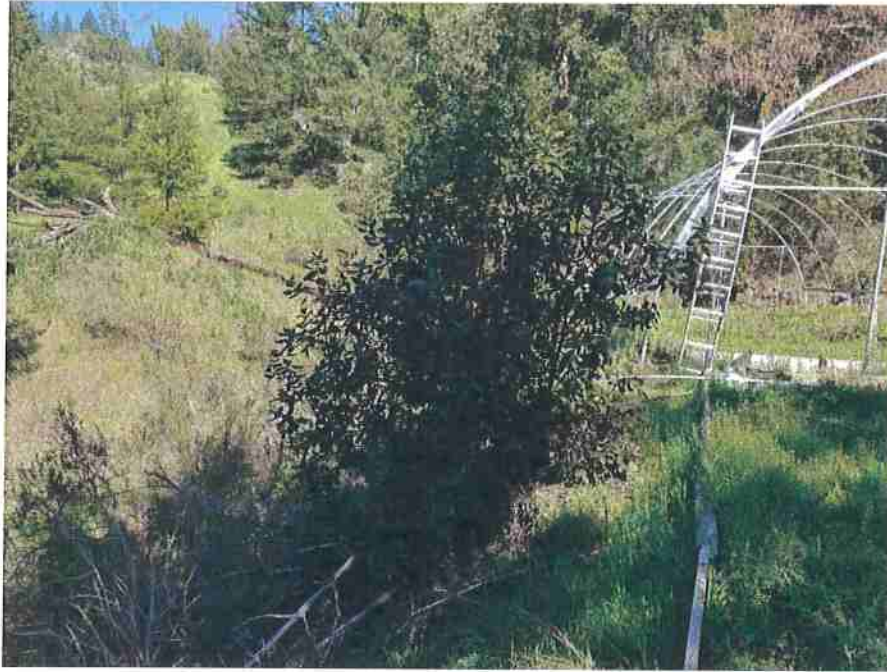
Figure 7: CA#8 View from SE corner looking westward. Note the legacy greenhouse immediately adjacent to top of bank of the Southern Class II watercourse.

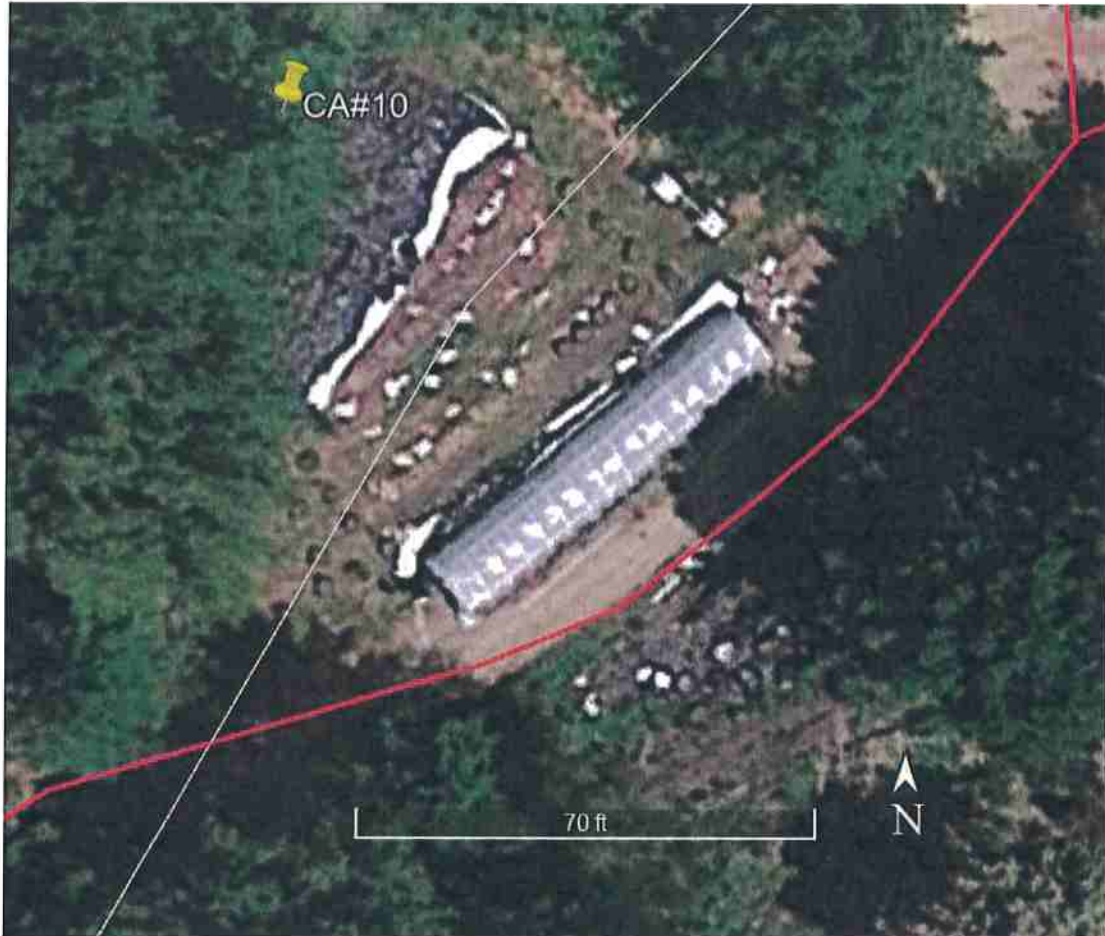
Figure 8: Cultivation area CA#10 aerial view. Image date: 5/29/2014

CA#10 is located in a relatively flat (5-10% slope) clearing and does not appear to have been the site of legacy grading. However, it appears to have standing water and several hydrophilic plant species growing in the vicinity and the owner states that it stays wet for much of the growing season. While a formal wetland delineation was not performed at this location, OE believes that most of the site would meet the criteria to qualify as a wetland. Figure 9, below shows the ground level view with some of the standing water and plant-life pictured.

Per OE's CAV Response memo, this cultivation area was home to approximately 896 ft² of full-sun and 3,980 ft² of greenhouse cultivation for a total cultivation footprint of 4,876 ft². OE recommends total relocation of all cultivation square footage from this location in the interest of protection of the sensitive wetland environment. A detailed discussion of the proposed relocation receiving area can be found in Section 6.0 of this report.

Little remediation is required at this site other than ceasing cultivation and removal of all cultivation materials and supplies. The owner has already voluntarily ceased cultivation at this site since 2016 and has begun the process of dismantling and removing the greenhouses that were present. There does not appear to be any remaining cultivation soil. Removal of the remaining construction materials should be sufficient to essentially restore the site to native conditions.

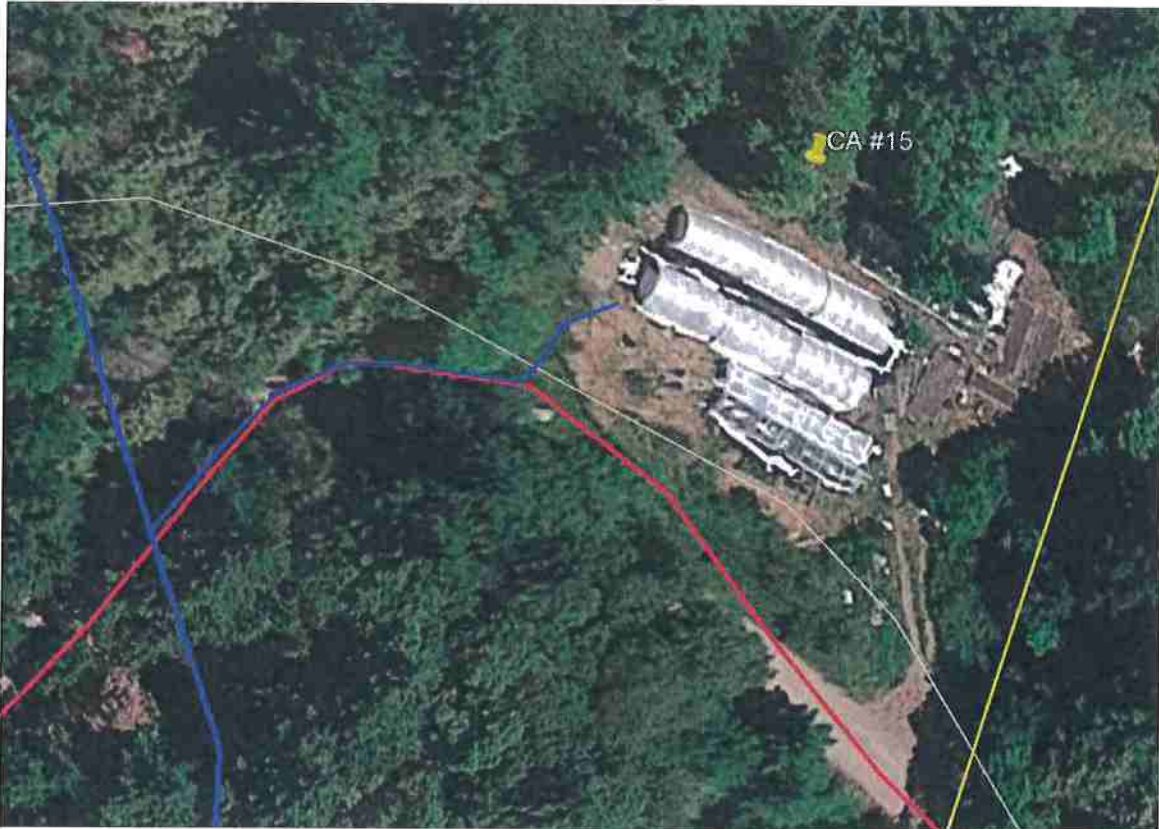
Figure 10: Aerial view of CA#15 as it appeared in 5/29/2014. Note class III stream origin toward the West of the clearing.

CA#15 consists of an approximately 115-ft by 65-ft clearing which was made on a natural flat. No grading appears to have occurred in the development of this site. The origin of a class III stream channel begins on the West side of the clearing. In addition, there are hydrophilic plants growing above the channel origin. While neither a wetland classification nor delineation were performed, OE concludes that the required 50' setback to the stream channel alone would eliminate approximately half of the cultivation area and drainage from the site may still run in the direction of the stream channel.

Per OE's CAV Response Memo, this area was the site of approximately 437 ft² of outdoor cultivation and 2,926 ft² of greenhouse cultivation for a total cultivation footprint of 3,363 ft². While a wetland delineation may confirm that a portion of the site could be used for cultivation, due to the proximity to the class III stream channel and possible wetland areas, OE concludes that there are more environmentally sound locations on the subject parcel. In the absence of such a delineation, OE recommends total relocation of all cultivation square footage from this location. A detailed discussion of the proposed relocation receiving area can be found in Section 6.0 of this report.

Little remediation is required at this site other than ceasing cultivation and removal of all supplies. The owner has already voluntarily ceased cultivation at this site since 2016 and begun the process of dismantling the greenhouses that were present. There does not appear to be any remaining cultivation soil. Removal of the remaining construction materials should be sufficient to essentially restore the site to native conditions.

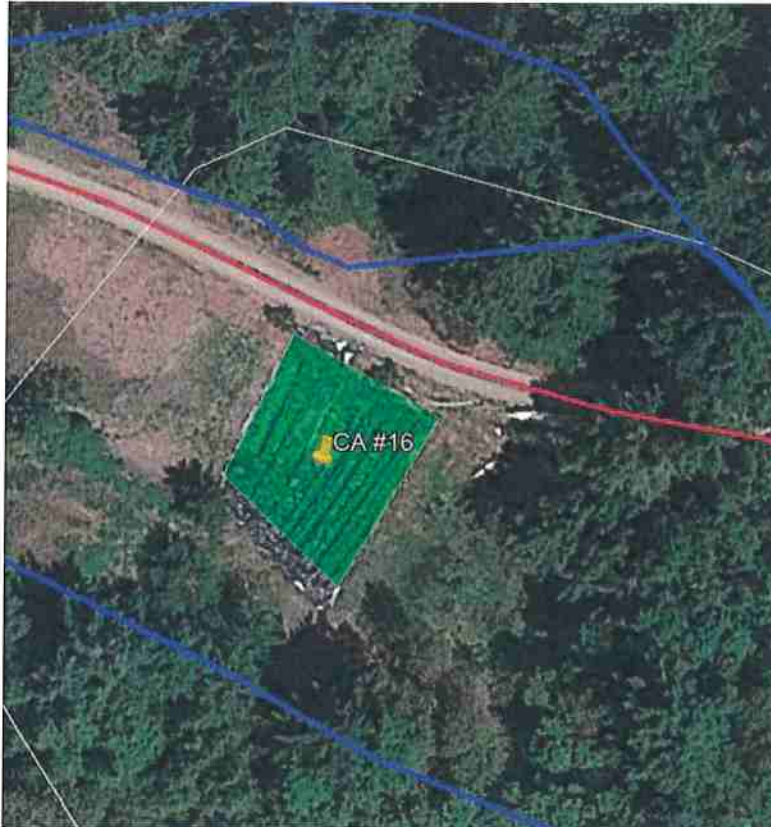
Figure 11: CA#16 shown in close proximity to several watercourses. Drainage from the site is directly toward the watercourse to the South.

CA#16 consists of cultivation beds measuring approximately 61 ft by 51ft which were set on native ground. This site is located approximately 30 feet from a nearby class III watercourse with drainage from the site traveling directly toward the stream. Maintaining the SWRCB required 50-foot buffer to the riparian areas to the North and South of the cultivation area is impossible at this location.

Per OE's CAV Response Memo, this area was the site of approximately 2,973 ft² of outdoor cultivation. Due to the proximity to the class III stream channels, OE recommends total relocation of all cultivation square footage from this location. A detailed discussion of the proposed relocation receiving area can be found in Section 6.0 of this report.

No remediation is required at this site other than ceasing cultivation. The owner has already voluntarily ceased cultivation at this site since 2016 and cleaned up all supplies that were present. There does not appear to be any remaining cultivation soil.

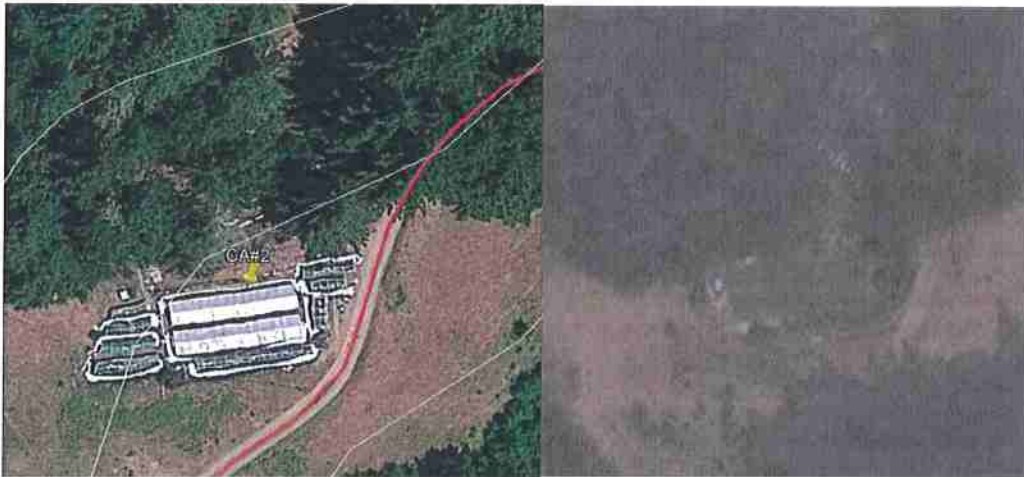
CA #2 is an “administrative” reduction (See methodology section above for details). OE staff determined proposed square footages based on in-field measurements. OE has concluded that any reduction is apparent in nature. Cultivation which appears under the tree canopy has been rearranged into greenhouses which appear in the revised county site plan as greenhouses #28 & 29. Pre-existing square footage under the canopy is hard to determine, but the final arrangement in CA #2 has less square footage than authorized in the County CAV for this subarea. No nearby watercourses or wet areas were identified by OE. Cultivation slopes are 0-10%. No remediation is proposed, although some measures were identified in the WRPP.

Figure 12: (Left) CA#2 as it appeared on 5/29/2014, and (right) as it appeared on 9/28/2018.

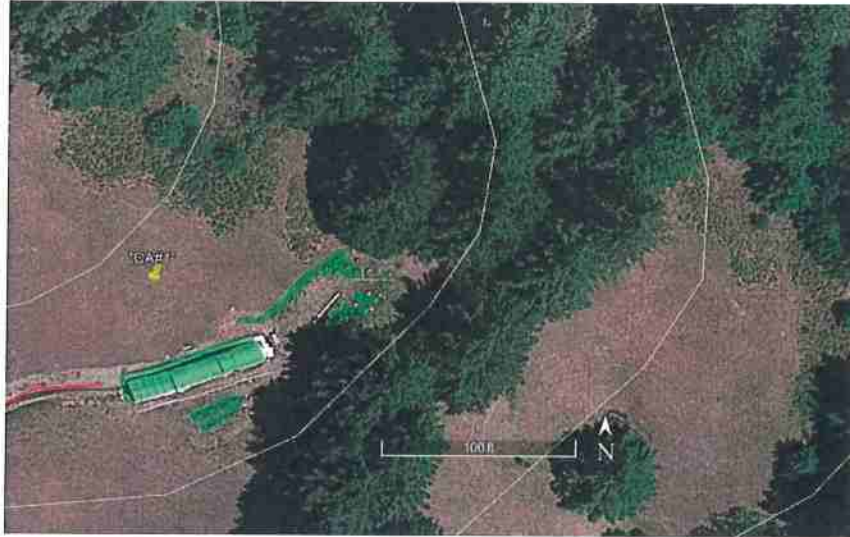
Figure 13: Cultivation area 1 as it appeared in May of 2014 Image source: Google Earth Pro

CA#1 is the main proposed relocation site and will receive approximately half the relocated square footage amounting to approximately 13,100 ft² of “new” cultivation. The “existing” site according to the County’s 2014 “basis year” appears in Figure 13 above with 2,500 ft² of authorized mixed light cultivation per the County CAV. However, in assessing the impacts of this “proposed” cultivation site, the area should be considered in the context of its 2015 configuration. Figure 14 shows the site as it existed on 6/09/2015 which clearly shows the pre-2016 development consisting of dense rows of cultivation amounting to approximately 9,000 – 10,000 ft² of outdoor cultivation which was not have been accounted for with a 2014 basis year.

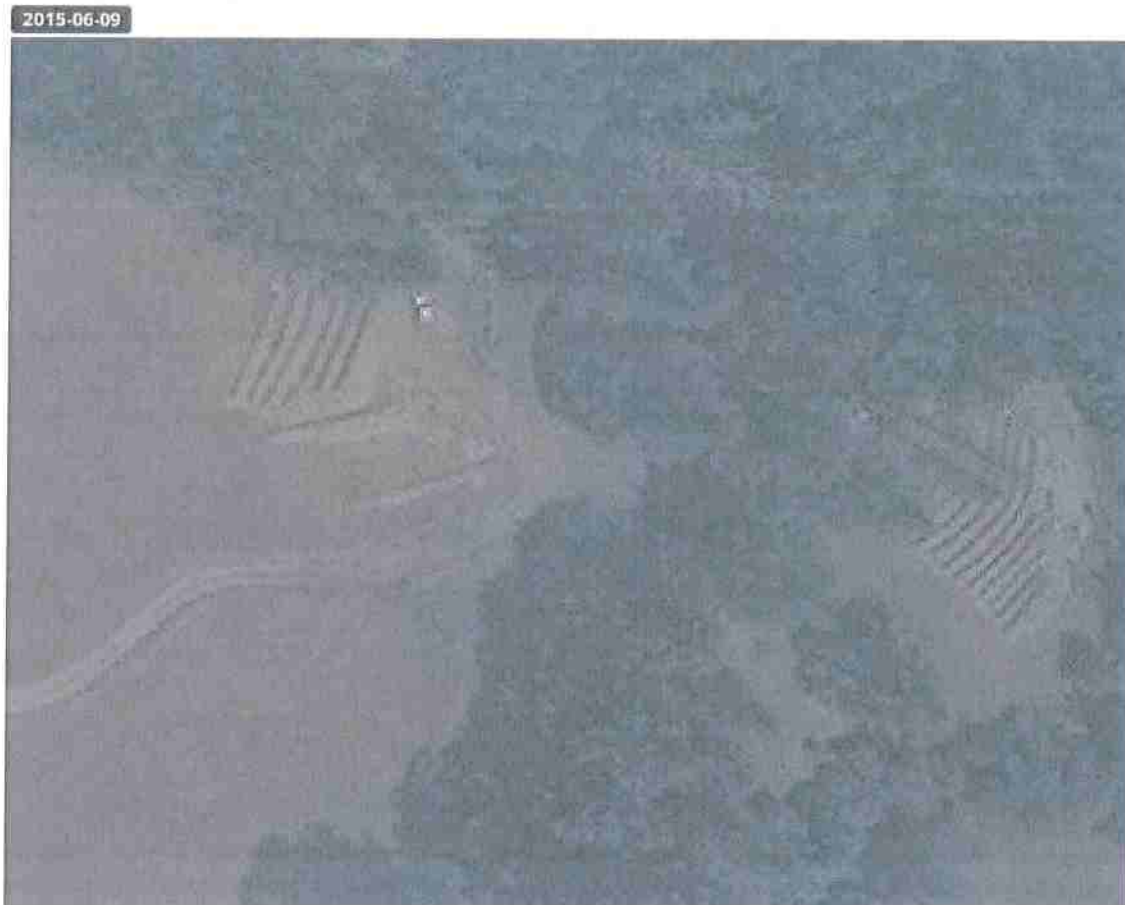
Figure 14: CA#1 as it appears on 6/09/2015. Image source: Terraserver

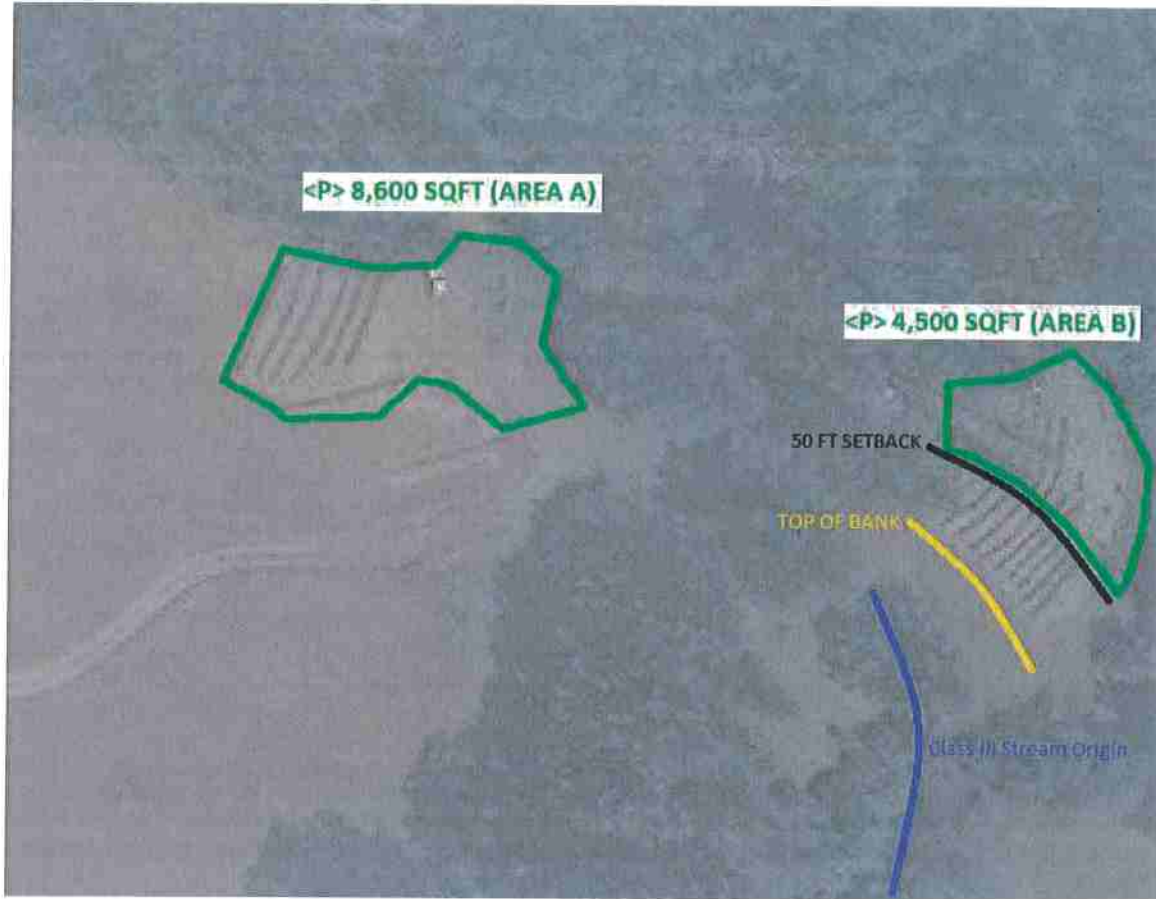
Figure 15, below, shows the location of the proposed 13,100 ft² cultivation areas. An additional 2,500 ft² of authorized mixed light cultivation will be present in the arrangement shown in Figure 13 above which is not shown on the figure below.

Figure 15: The proposed areas for cultivation relocation in CA#1. Note, existing authorized 2,500 SQFT not shown. See revised County Site Plan for additional details. North is oriented up.

In area B from the figure above, the cultivation area needs to be set back (compared to the 2015 arrangement pictured) from the top of bank where a class III stream originates. Drainage from the site is to the northeast where no nearby watercourse is present. Slopes on the proposed cultivation area are approximately 20%, and no grading is proposed as part of this relocation except that required by hand tools to stabilize outdoor cultivation pots. Access to the cultivation pots will occur via existing roads and footpaths.

Area A from the figure above involves an expansion of the existing footprint to the available area to the East up to the tree-line as pictured. When considered with the reduction in size from Area B, the total cultivation footprint is likely subject to only a modest increase. There are no nearby watercourses with long vegetated buffers for run-off control. The cultivation slope is similar to Area B, at approximately 20% across the proposed cultivation perimeter. No grading is proposed at this location except that required by hand-tools to stabilize outdoor cultivation pots. Access to the area will be performed via existing roads and footpaths.

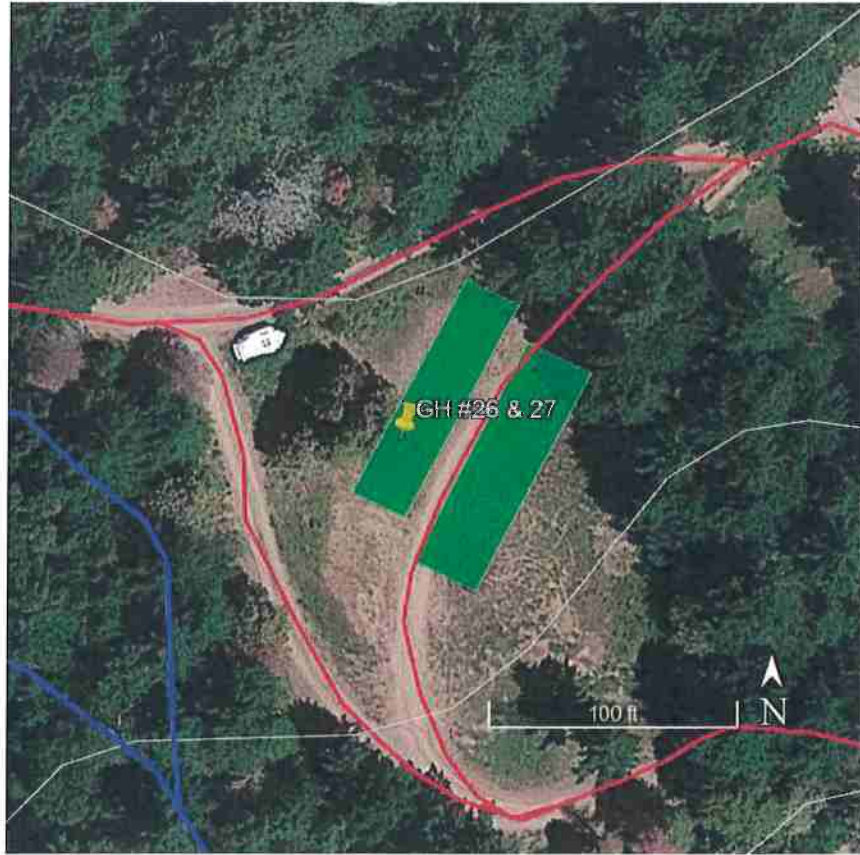
Figure 16: Greenhouses #26 & 27.

Greenhouses #26 & 27 (Left and right, respectively in the figure above) are located on what appears to be a natural bench with 0-5% slopes. The flat is located near a Class III watercourse to the South with the nearest greenhouse approximately 63 feet to top of bank. Drainage from the site is disconnected from any nearby watercourses and travels approximately East-Southeast. Greenhouse #26 is dimensioned 23.5-ft x 100-ft and greenhouse #27 is 30-ft x 100-ft.

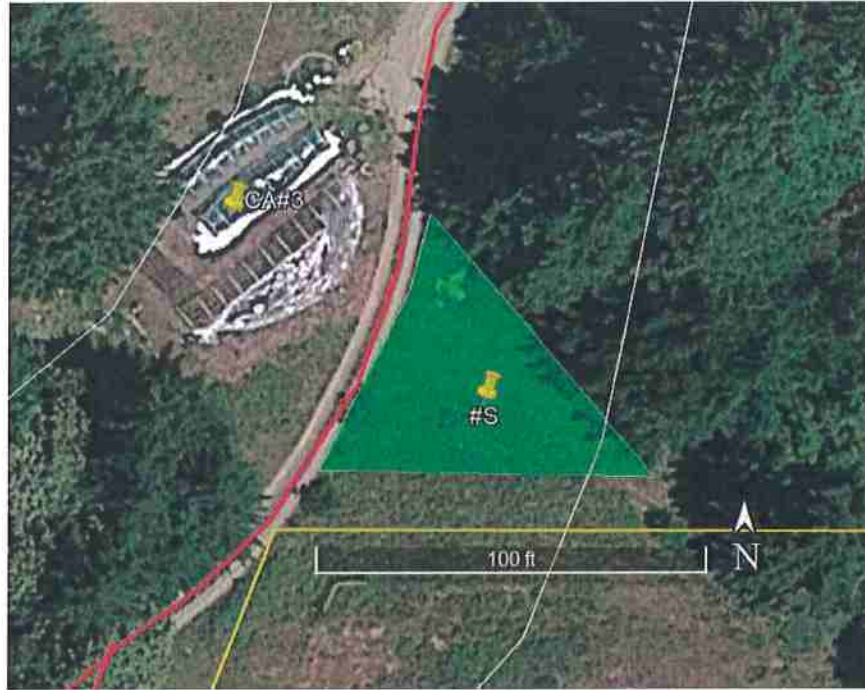
Figure 18: Proposed Area #S aerial view. Image date 5/29/2014 Yellow line shows approximate parcel boundary per Humboldt County GIS shapefile, but existing fence in image appears approximately 20-ft further in the Southeast direction.

Area #S has no current nor known historical cultivation activity. It is located across the road from cultivation area “CA#3”. It consists of a grassy clearing with approximate slopes of 5% shaped in an approximately 2,758-ft² triangle with approximate base 85-ft and height of 32-ft. There are no nearby watercourses. Development of this location for the purposes of cultivation would consist of laying cultivation pots and irrigation line for full-sun cultivation. No grading or significant hand-tool work is anticipated as part of the proposed relocation to this area.

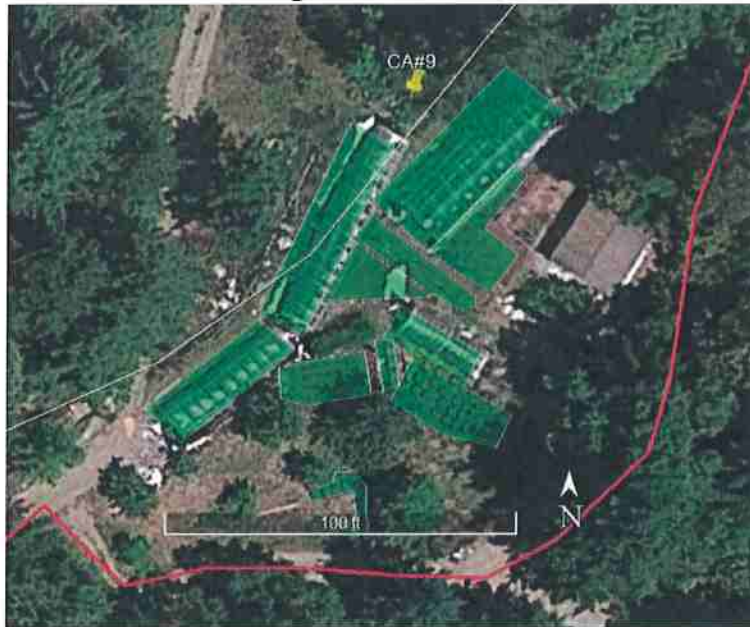
Figure 19: Cultivation area CA#9 as it appeared on 5/29/2014.

CA#9 consists of a historic cultivation area with a total estimated square footage of 4,692 ft² per OE's CAV Response Memo and consisted of a mix of greenhouses and full sun cultivation beds and pots. The owner has not cultivated in this area for the last 2 years, but it remains a viable cultivation area with historic precedent and is consistent with the proposed operation. The square footage was assessed by drawing relatively tight boundaries around pre-existing cultivation. OE believes that infill between these boundaries can easily account for an additional 2,300 ft² of cultivation in the form of cultivation pots placed on the ground. Some light clearing of existing fruit trees and small shrubbery may be required, but OE does not believe cultivation will need to extend beyond the existing developed perimeter. No grading is anticipated as a result of this expansion via infill. The nearest watercourse is approximately 180 feet to the Southwest, and the ground does not appear saturated nor was the presence of any hydrophilic plants noted.

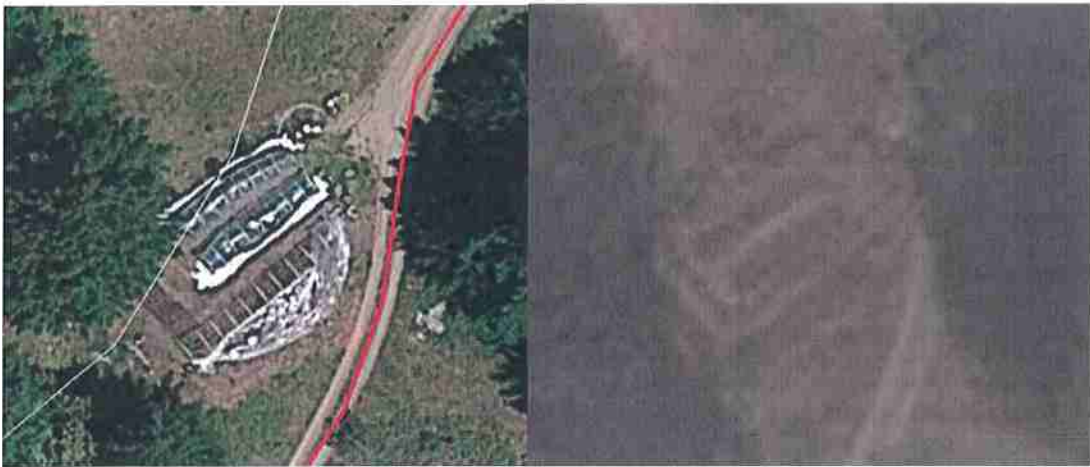
CA #3 is not a true relocation area. Since it was identified in the County CAV document, OE opted not to challenge the square footage authorization for the 2014 basis year. The “additional” 500 ft² at this site is proposed to count against the total square footage of the site, formally making it a “relocation area”, but it does not in fact represent any actual increase in cultivation square footage. The square footage estimate made by OE was derived from in-field measurements of actual existing cultivation and not subject to the types of errors inherent to orthographic projection of an oblique angled photograph of a curved surface. The following figure is a comparison of the 2014 aerial image and the 2018 aerial. While the image quality is poor, it is clear that the cultivation arrangement in both years is essentially identical.

Figure 20: Left image CA#3 on 5/29/2014, Right image same site on 9/28/2018
