# Site Management Plan

WDID - 1\_12CC418891

Humboldt County  
APN: 211-183-008-000, 211-184-006-000  
APPS 10820

9/8/2021

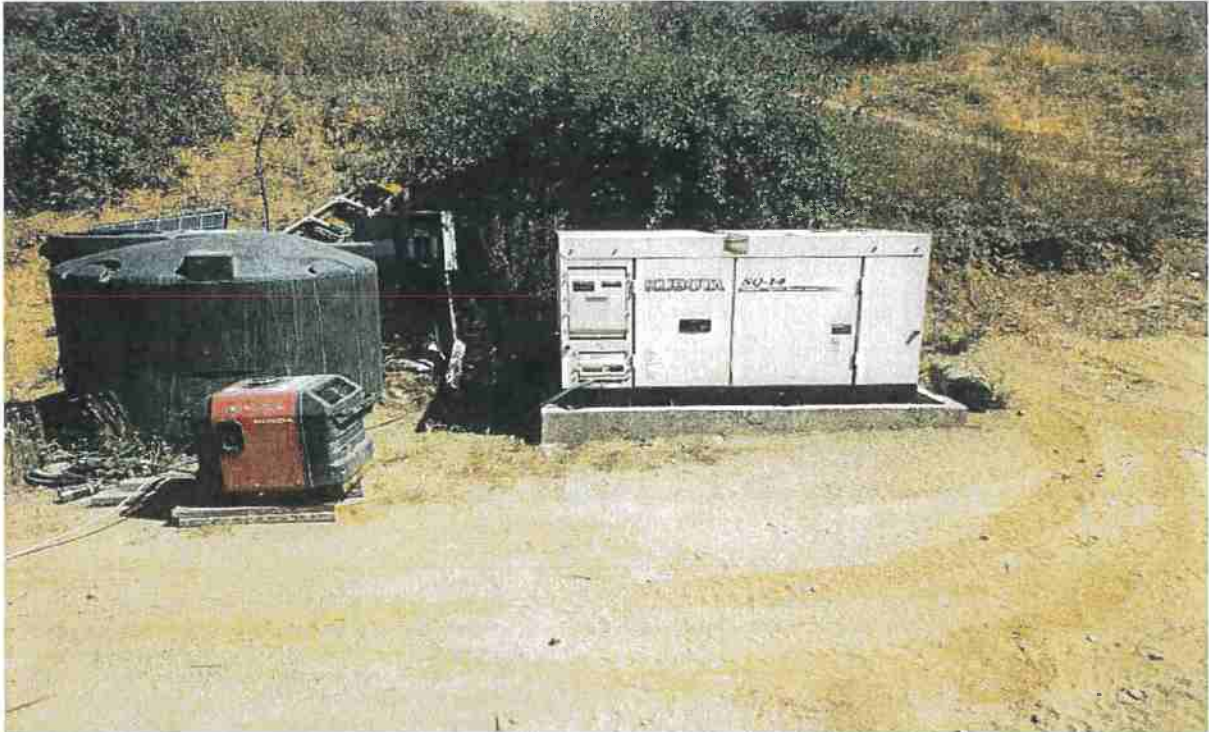
*Photo looking at gasoline and diesel generators without proper containment at Site 01.*

Unique Point	Lat-Long NAD 83	Road Type	Mitigation Planned	Monitor	1600	Treatment Priority	Date Completed
Site 01	-124.003436 40.254575	Permanent	X	-	-	Prior to 10/15/21	
Current Condition: A diesel and gasoline generator located next to Cultivation Area A does not have proper secondary cover.						Prescribed Action: Provide proper covering for generator and store away in the winter. See attached BMPs: Generator, Fuel, and Oil Management for further details. All petroleum products are required to be used and stored per Cannabis Cultivation Policy, Att. A, Sec. 2, - Term 103 - 110, and 116 - 118 attached.	
Unique Point	Lat-Long NAD 83	Road Type	Mitigation Planned	Monitor	1600	Treatment Priority	Date Completed
Site 02	-124.002989 40.254733	Permanent	X	-	-	Prior to 10/15/22	
Current Condition: Permanent road leading down to Cultivation Area A contains an erosional gully that extends up to the parking lot of the residence. The road is currently out-sloped with dirt surfaces.						Prescribed Action: Regrade the road with gentle out-sloping from Site 01 to Site 03 then install a waterbar per the specifications outlined in the attached BMPs: Waterbar Construction, General Operations BMPs, and General Erosion Control specifications. Maintain as needed per Cannabis Cultivation Policy, Att. A, Sec. 2, - Term 1 - 29.

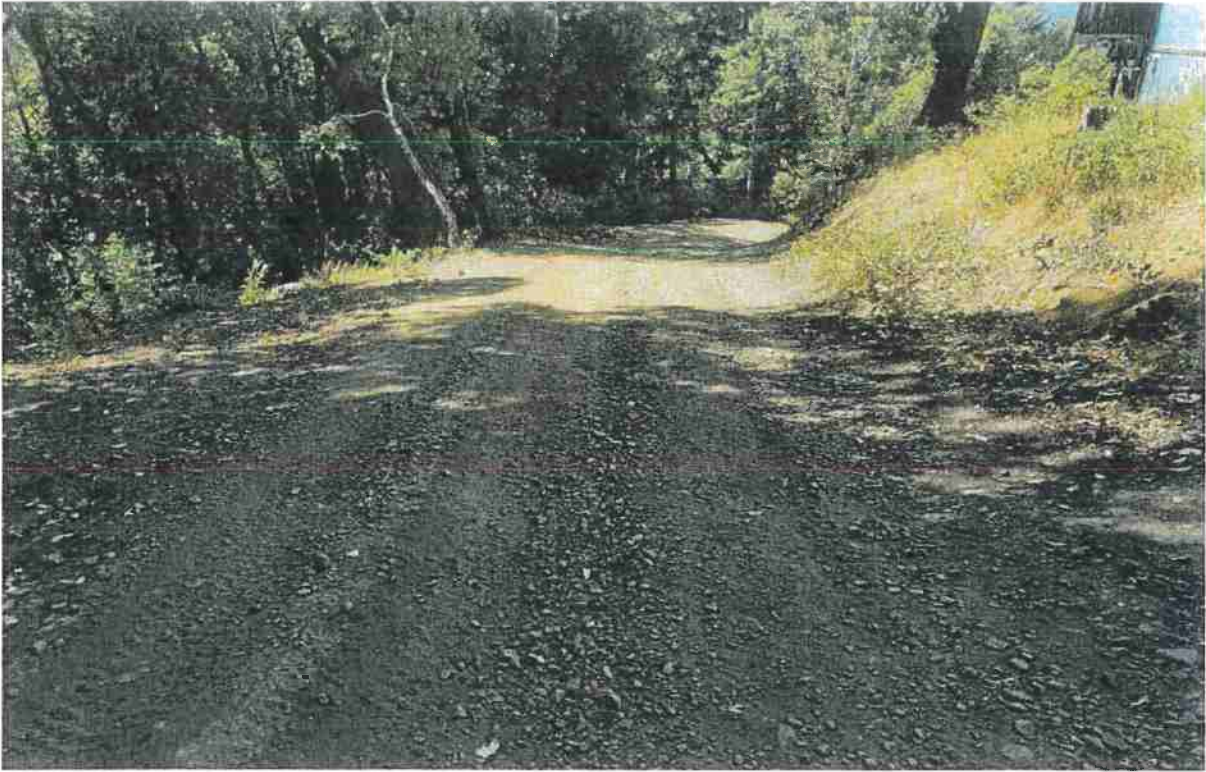
*Photo looking up grade at the erosional gully at Site 03.*

*Photo looking down grade at the erosional gully at Site 03.*

Unique Point	Lat-Long NAD 83	Road Type	Mitigation Planned	Monitor	1600	Treatment Priority	Date Completed
Site 03	-124.002912 40.254908	Permanent	X	-	-	Prior to 10/15/22	
Current Condition: Permanent road leading down to Cultivation Area A contains an erosional gully that extends up to the parking lot of the residence. The road is currently out-sloped with dirt surfaces.						Prescribed Action: Regrade the road with gentle out-sloping from Site 01 to Site 03 then install a waterbar per the specifications outlined in the attached BMPs: Waterbar Construction, General Operations BMPs, and General Erosion Control specifications. Maintain as needed per Cannabis Cultivation Policy, Att. A, Sec. 2, - Term 1 - 29.	
Unique Point	Lat-Long NAD 83	Road Type	Mitigation Planned	Monitor	1600	Treatment Priority	Date Completed
Site 04	-124.002689 40.255078	Permanent	X	-	X	Prior to 10/15/22 pending the approval of any required permits

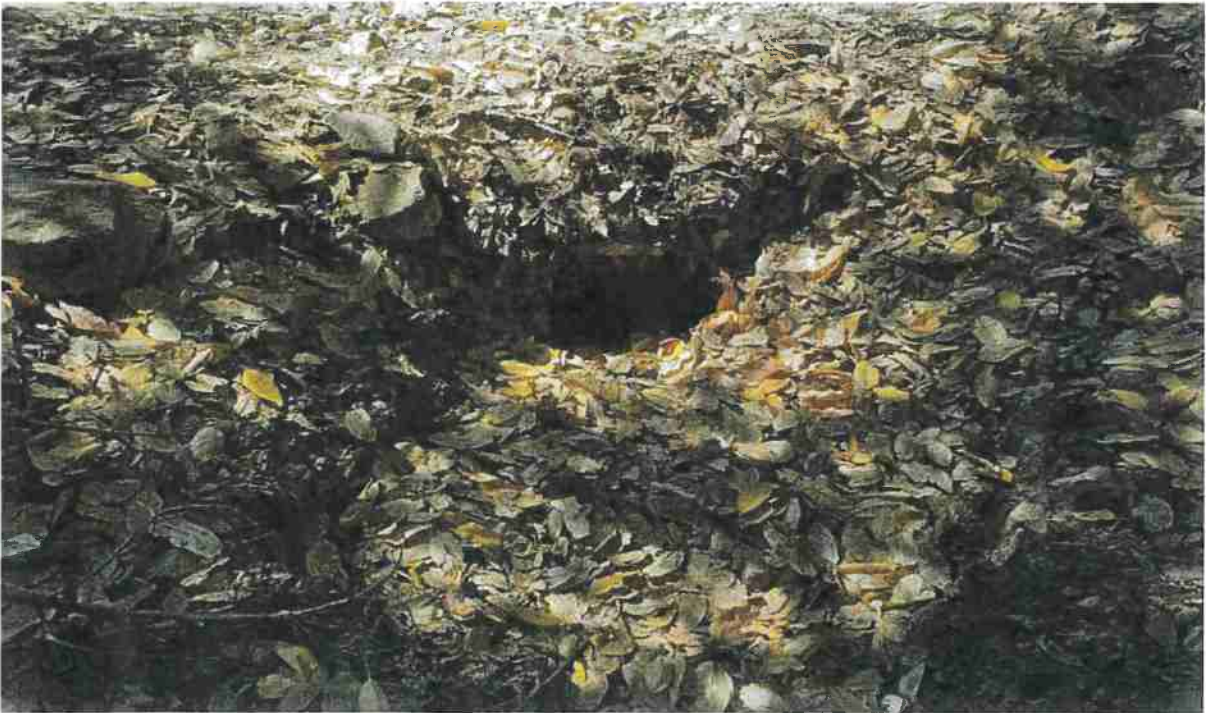
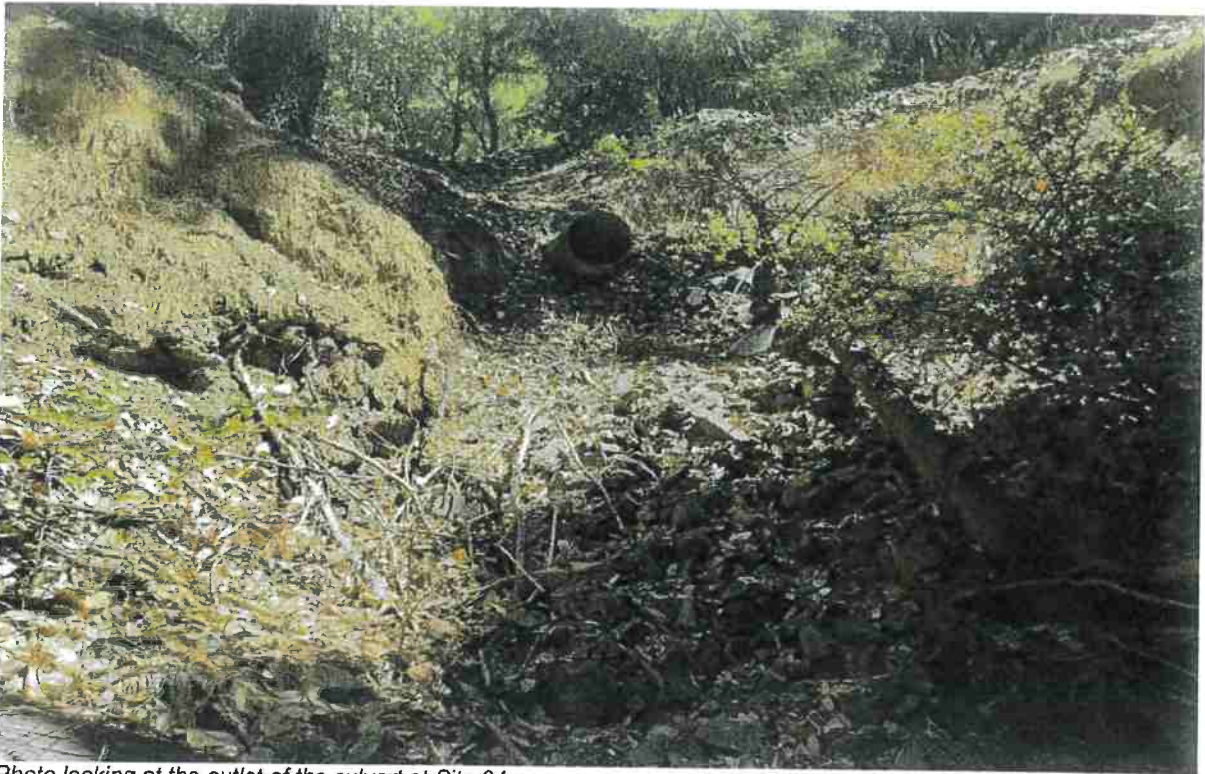
Current Condition: Existing 18-inch diameter corrugated metal culvert on a Class III watercourse. Culvert is undersized, shot-gunned, and partially plugged with forest litter at the inlet.						Prescribed Action: Clean-out inlet then upgrade culvert to minimum 36-inch diameter culvert that is installed to grade, aligned with the natural stream channel, and long enough that it extends lengthwise completely beyond the toe of fill. The crossing upgrade will require the excavation and temporary displacement of approximately 44 cubic yards of fill (30 feet long by 10 feet deep by 4 feet wide) and 120 ft <sup>2</sup> of overall disturbance (30 feet length and 4 feet width) per the LSAA #1600-2019-0447-R1.

*Photo looking at the inlet of the culvert at Site 04.*

*Photo looking at the outlet of the culvert at Site 04.*

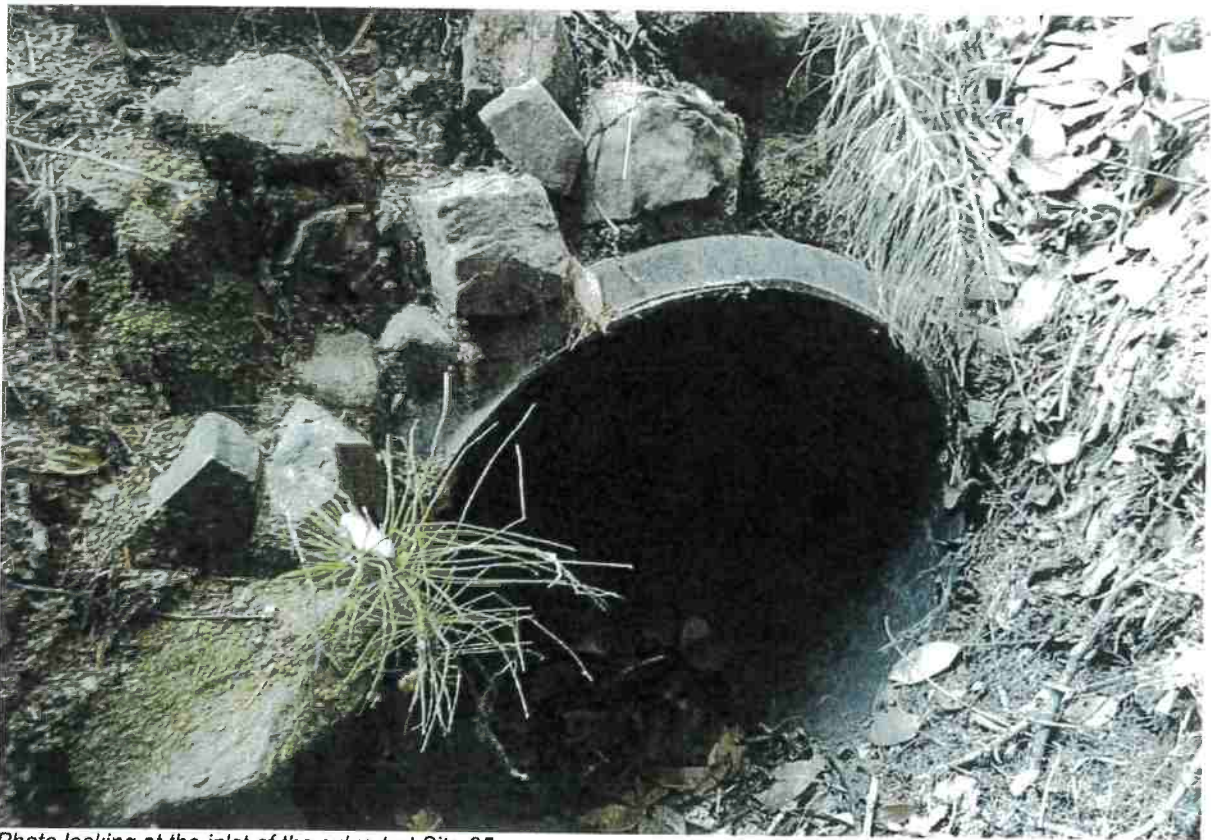
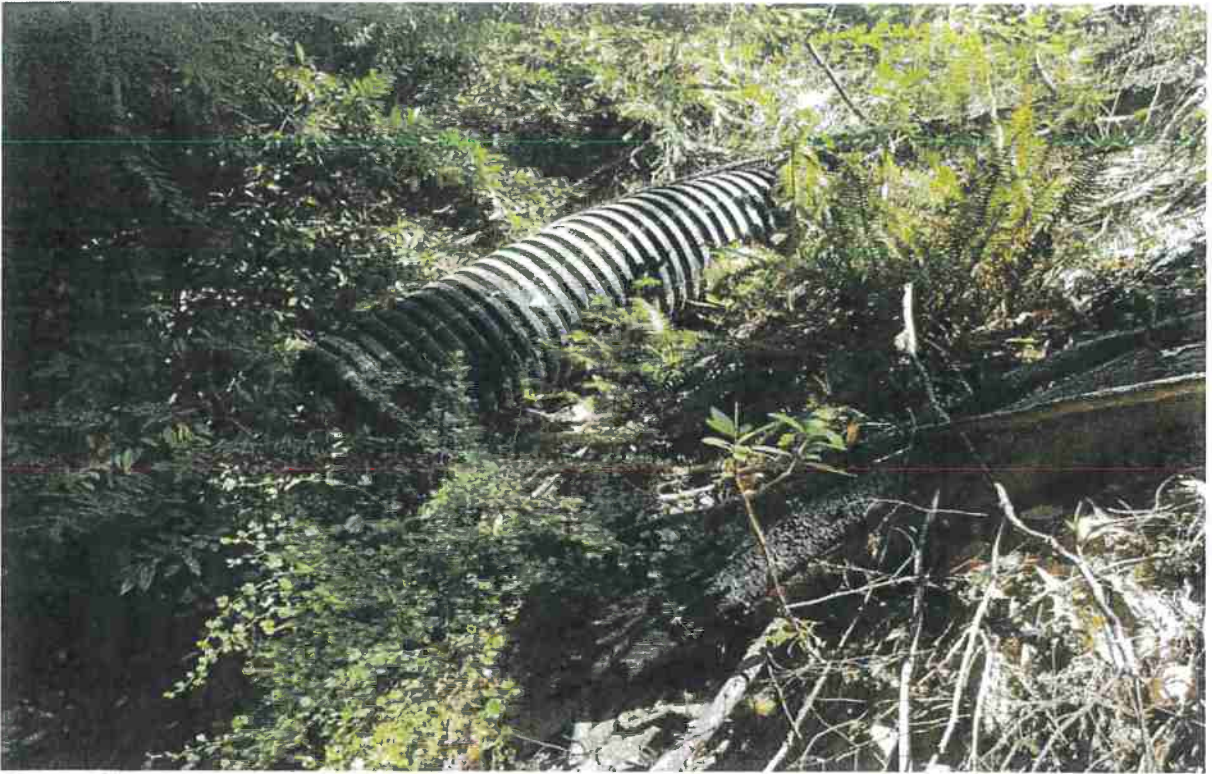
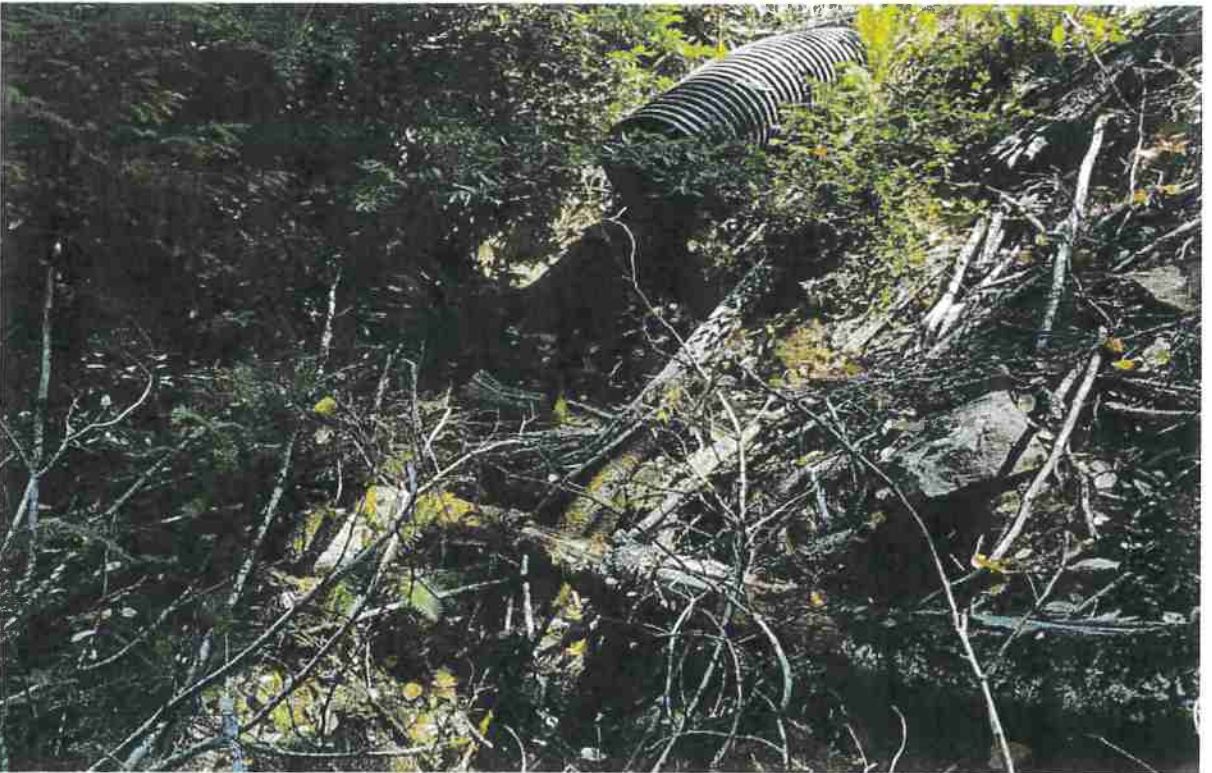
*Photo looking at the inlet of the culvert at Site 05.*

*Photo looking at the outlet of the culvert at Site 05.*

Unique Point	Lat-Long NAD 83	Road Type	Mitigation Planned	Monitor	1600	Treatment Priority	Date Completed
Site 05	-124.002172 40.25481	Permanent	X	-	X	Prior to 10/15/22 pending the approval of any required permits	
Current Condition: Existing 24-inch diameter corrugated plastic culvert on a Class III watercourse. The culvert is undersized, too short, and shot-gunned.						Prescribed Action: Upgraded to a 30-inch diameter culvert to grade, aligned with the natural stream channel, and long enough that it extends lengthwise completely beyond the toe of fill. The crossing upgrade will require the excavation and temporary displacement of approximately 41 cubic yards of fill (35 feet long by 8 feet deep by 4 feet wide) and 140 ft2 of overall disturbance (30 feet length and 4 feet wide) per the LSAA #1600-2019-0447-R1.	
Unique Point	Lat-Long NAD 83	Road Type	Mitigation Planned	Monitor	1600	Treatment Priority	Date Completed

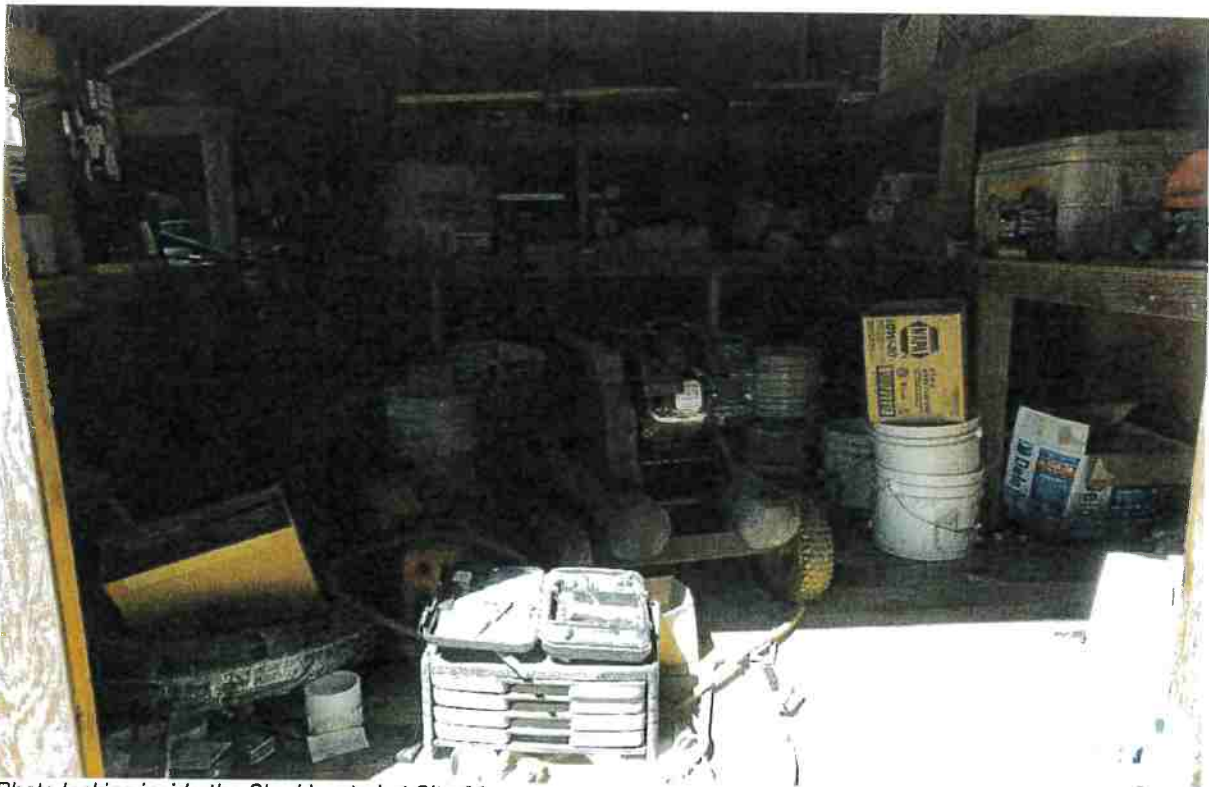
Photo looking at the outside of the Shed at Site 06.

Photo looking inside the Shed located at Site 06.

Site 06	-124.002108 40.254772	Permanent	X	-	-	Prior to 10/15/21	
Current Condition: Shed used for storage of petroleum products is located within the riparian setback of a Class III watercourse. The shed has wooden floors and adequate cover, but petroleum products are not in proper secondary containment.						Prescribed Action: Put all petroleum products in proper secondary containment. See attached BMPs: Generator, Fuel, and Oil Management for further details. All petroleum products are required to be used and stored per Cannabis Cultivation Policy, Att. A, Sec. 2, - Term 103 - 110, and 116 - 118 attached.	
Unique Point	Lat-Long NAD 83	Road Type	Mitigation Planned	Monitor	1600	Treatment Priority	Date Completed
Site 07	-124.001691 40.254495	Permanent	X	-	X	Prior to 10/15/22 pending the approval of any required permits	
Current Condition: Existing 24-inch diameter corrugated plastic culvert on a Class III watercourse. The culvert is adequately sized, slightly shot-gunned, and the inlet is partially buried.						Prescribed Action: Replace 24-inch diameter corrugated plastic culvert with 24-inch diameter corrugated metal culvert that is set to grade and aligned correctly. Rock armor the inlet and outlet with appropriately sized rock per the LSAA #1600-2019-0447-R1.

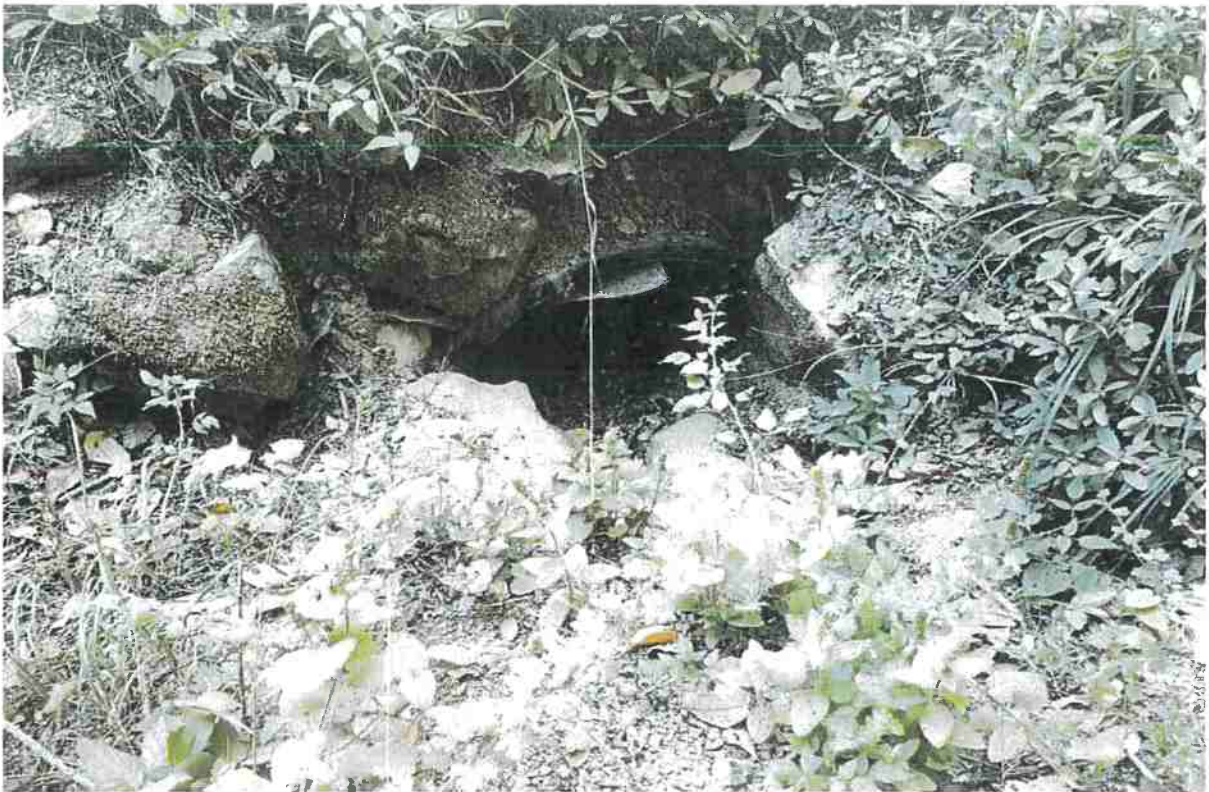
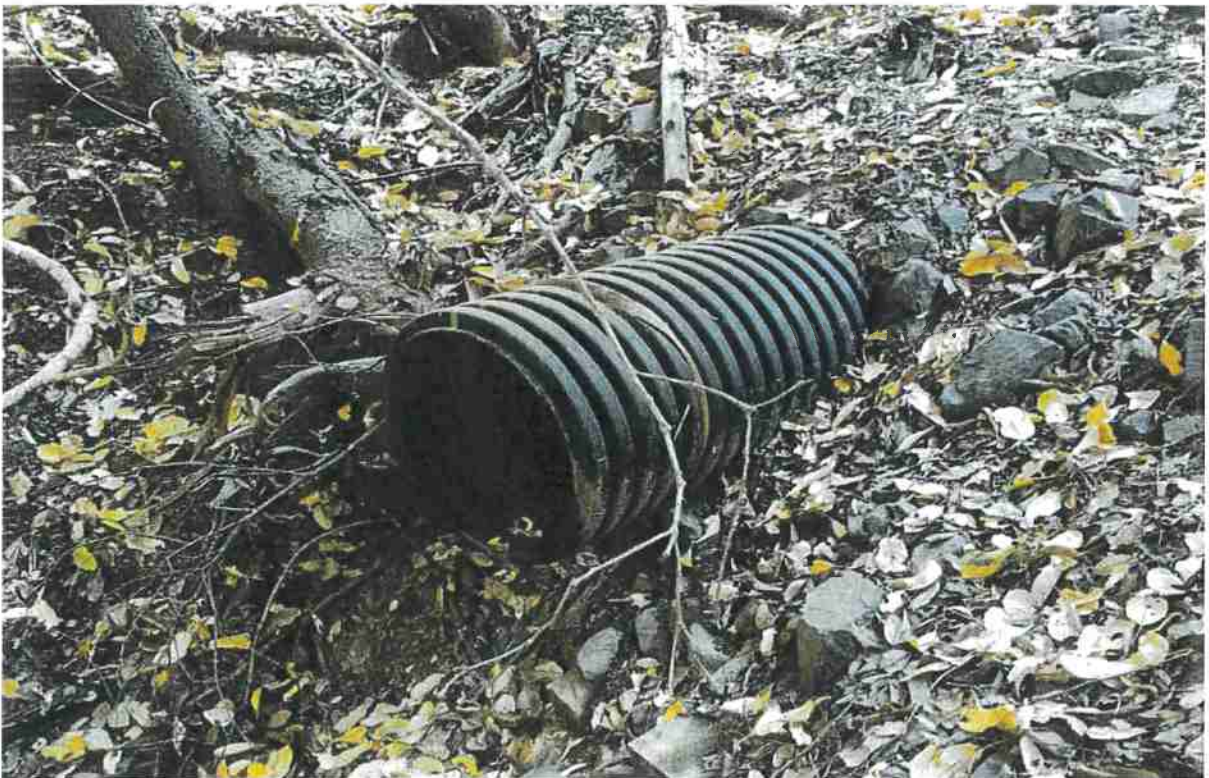
*Photo looking at the inlet of the culvert at Site 07.*

*Photo looking at the outlet of the culvert at Site 07.*

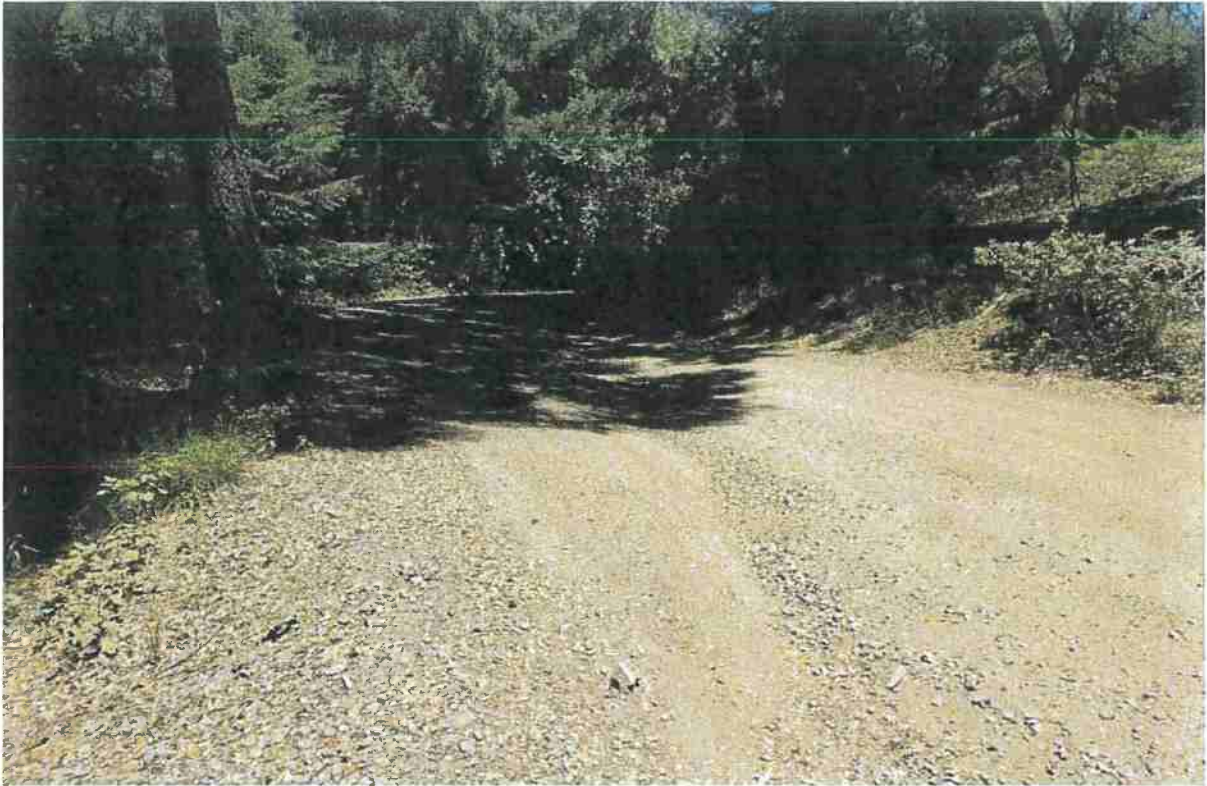
*Photo looking up grade at the erosion at Site 11.*

*Photo looking down grade at the erosion at Site 11.*

*Photo looking at where the proposed rock armored lead out will be at Site 11.*

Unique Point	Lat-Long NAD 83	Road Type	Mitigation Planned	Monitor	1600	Treatment Priority	Date Completed
Site 11	-124.001157 40.255205	Permanent	X	-	-	Prior to 10/15/22	
Current Condition: Erosional gully exists on a permanent road downhill of Cultivation Area B. The section of road with erosion occurring is located within riparian setbacks of two separate Class III watercourses and has the potential of becoming hydrologically connected to both watercourses.						Prescribed Action: Regrade the road from Site 11 to Site 13 with gentle out-sloping then install a rolling dip along with a 8' x 8' leadout that is rock armored with adequate sized rock. See "Rolling Dip Design and Placement" in the attached BMP's. See Cannabis Cultivation Policy, Att. A, Sec. 2, - Term 1 - 29 that is attached for specifications.	
Unique Point	Lat-Long NAD 83	Road Type	Mitigation Planned	Monitor	1600	Treatment Priority	Date Completed

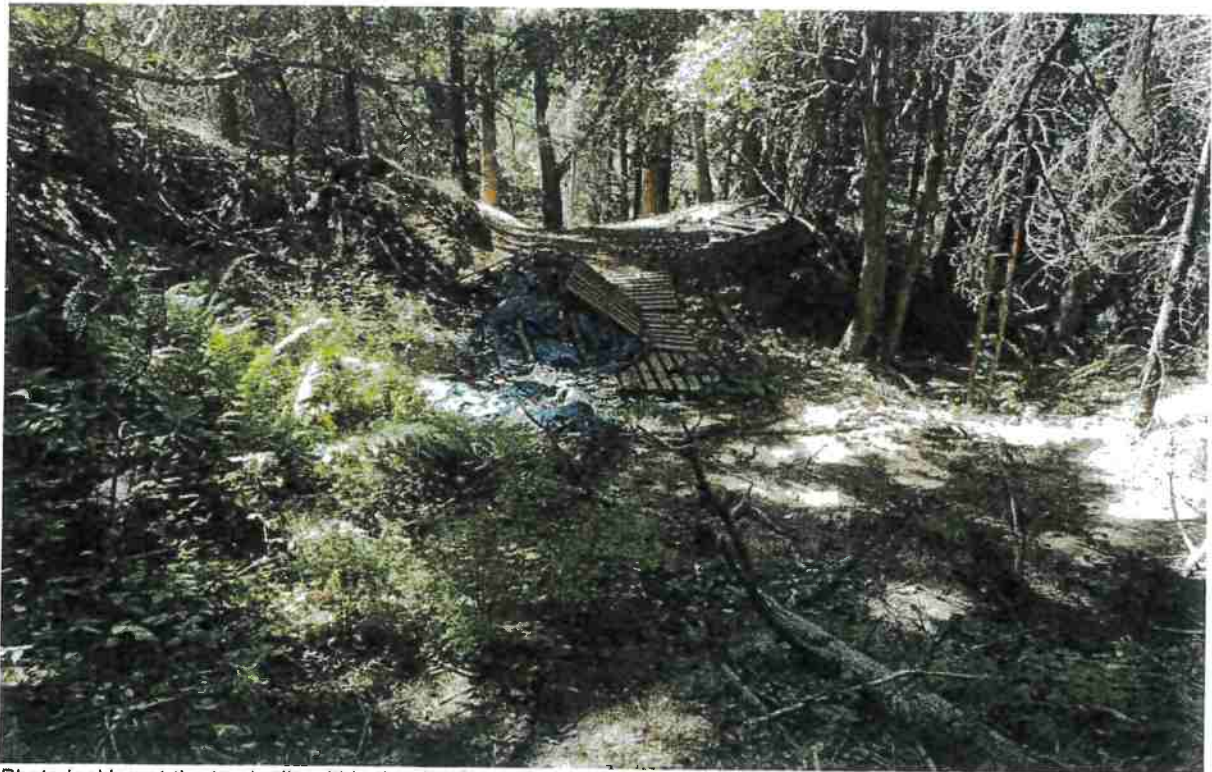
**Trash/refuse is stored in the structures labeled Storage and Barn, as well as around the Cultivation Areas. However, there are cultivation-related waste piles improperly stored at Sites 12, 17, and 18. The refuse pile at Site 12 is within the riparian zone and must be immediately removed to prevent the movement of cultivation related waste into a Class III watercourse. See attached Site Maps.**

*Photo looking at the trash pile within the riparian setback of a Class III watercourse at Site 12.*

Site 12	-124.00116 40.255235	Permanent	X	-	-	Immediately	
Current Condition: A pile of cultivation related debris is within the riparian setback of a Class III watercourse.						Prescribed Action: Cultivation-related wastes shall be removed and stored in a manner where they cannot be transferred into a watercourse. See Cannabis Cultivation Policy, Att. A, Sec. 2, - Term 119 - 125 that is attached for specifications.	
Unique Point	Lat-Long NAD 83	Road Type	Mitigation Planned	Monitor	1600	Treatment Priority	Date Completed
Site 13	-124.00106 40.255266	Permanent	X	X	-	Prior to 10/15/22	
Current Condition: Erosion at the outfall of a roadside ditch that is just outside the riparian setback of a Class III watercourse that extends up to Site 14.						Prescribed Action: Rock armor the entire roadside ditch with adequately sized rock as well as the outfall of the roadside ditch per the specifications outlined in the attached BMPs: General Operations BMPs and General Erosion Control specifications. See Cannabis Cultivation Policy, Att. A, Sec. 2, - Term 1 - 29 that is attached for specifications.

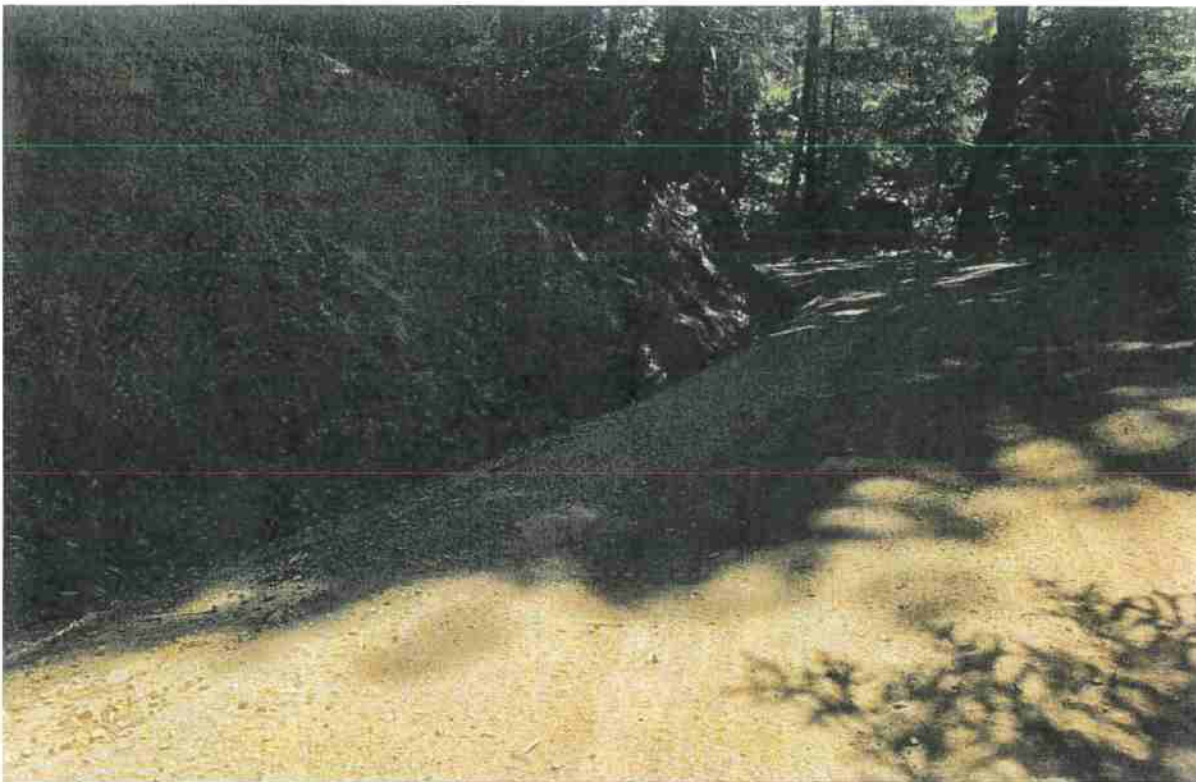
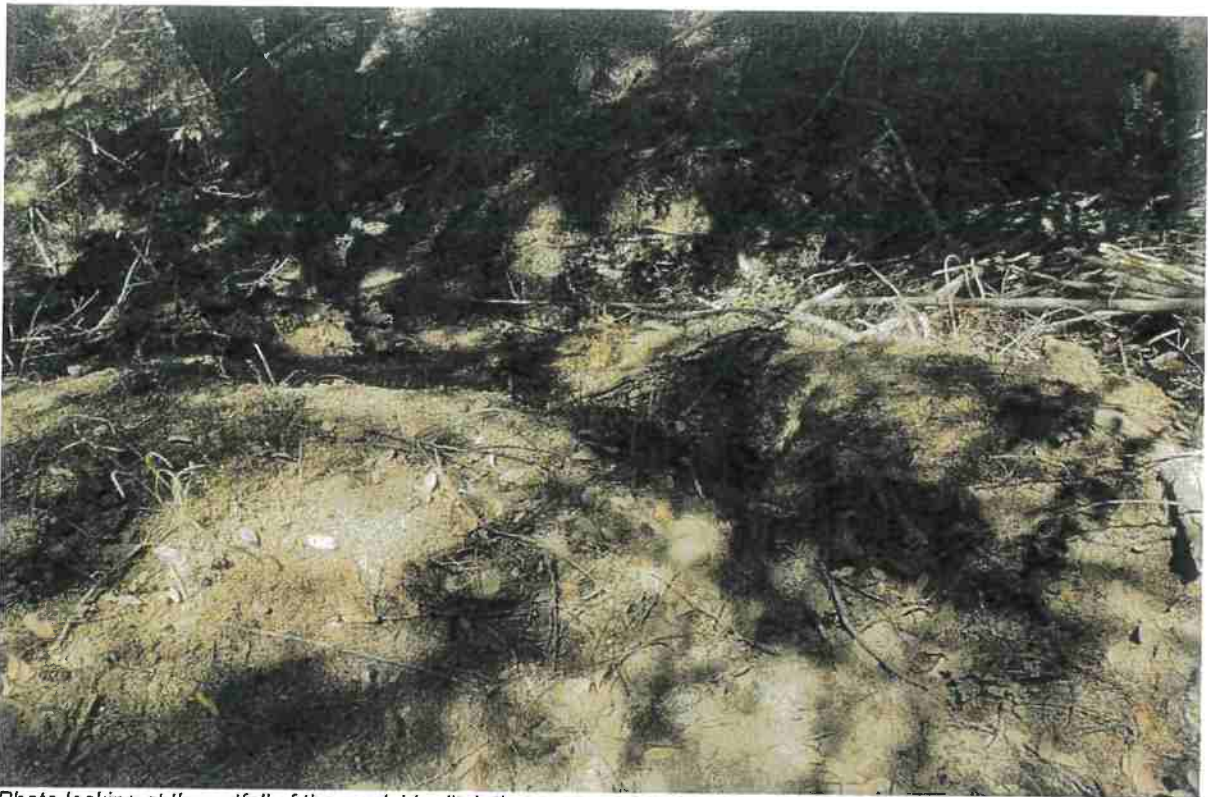
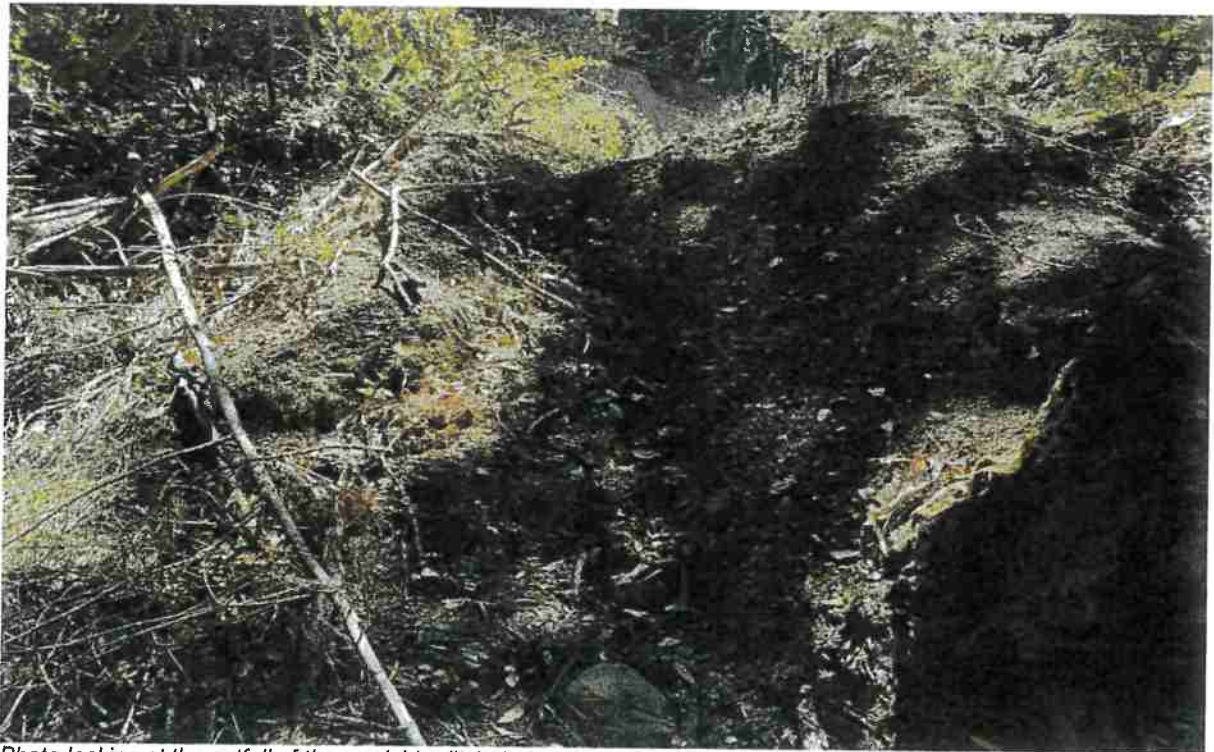
*Photo looking up grade at the inside ditch that starts at Site 14 and extends down to Site 13.*

*Photo looking down grade at the inside ditch that starts at Site 14 and extends to Site 13.*

*Photo looking at the outfall of the roadside ditch that starts at Site 14 and extends down to Site 13.*

Unique Point	Lat-Long NAD 83	Road Type	Mitigation Planned	Monitor	1600	Treatment Priority	Date Completed
Site 14	-124.000612 40.255264	Permanent	X	X	-	Prior to 10/15/22	
Current Condition: Start of a roadside ditch that leads down to Site 13 is hydrologically connected to a Class III watercourse.						Prescribed Action: See Site 13	
Unique Point	Lat-Long NAD 83	Road Type	Mitigation Planned	Monitor	1600	Treatment Priority	Date Completed
Site 15	-124.000378 40.255548	Permanent	-	X	-	Annually prior to 10/15	
Current Condition: French drain extending to Site 16 is installed correctly and functioning properly.						Prescribed Action: Monitor and maintain as needed.	
Unique Point	Lat-Long NAD 83	Road Type	Mitigation Planned	Monitor	1600	Treatment Priority	Date Completed
Site 16	-124.001033 40.255925	Permanent	-	X	-	Annually prior to 10/15	
Current Condition: See Site 15						Prescribed Action: See Site 15

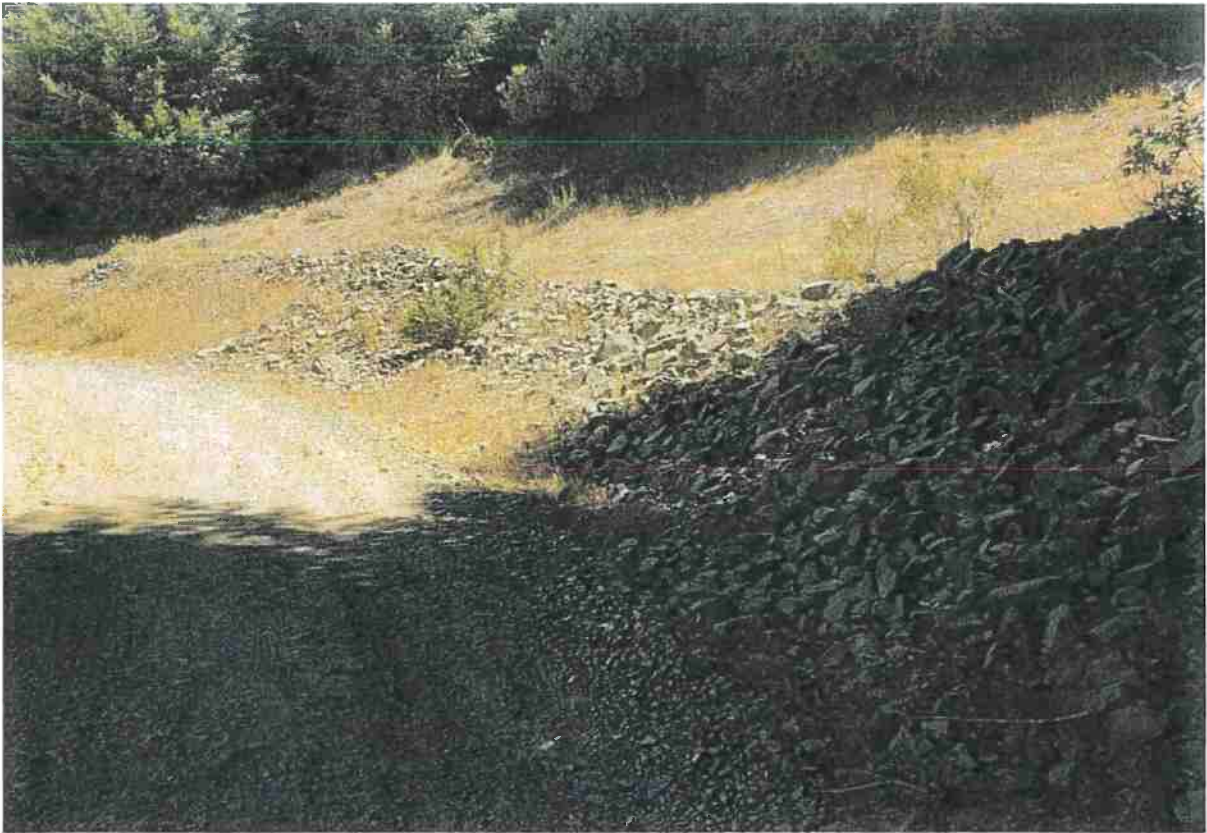
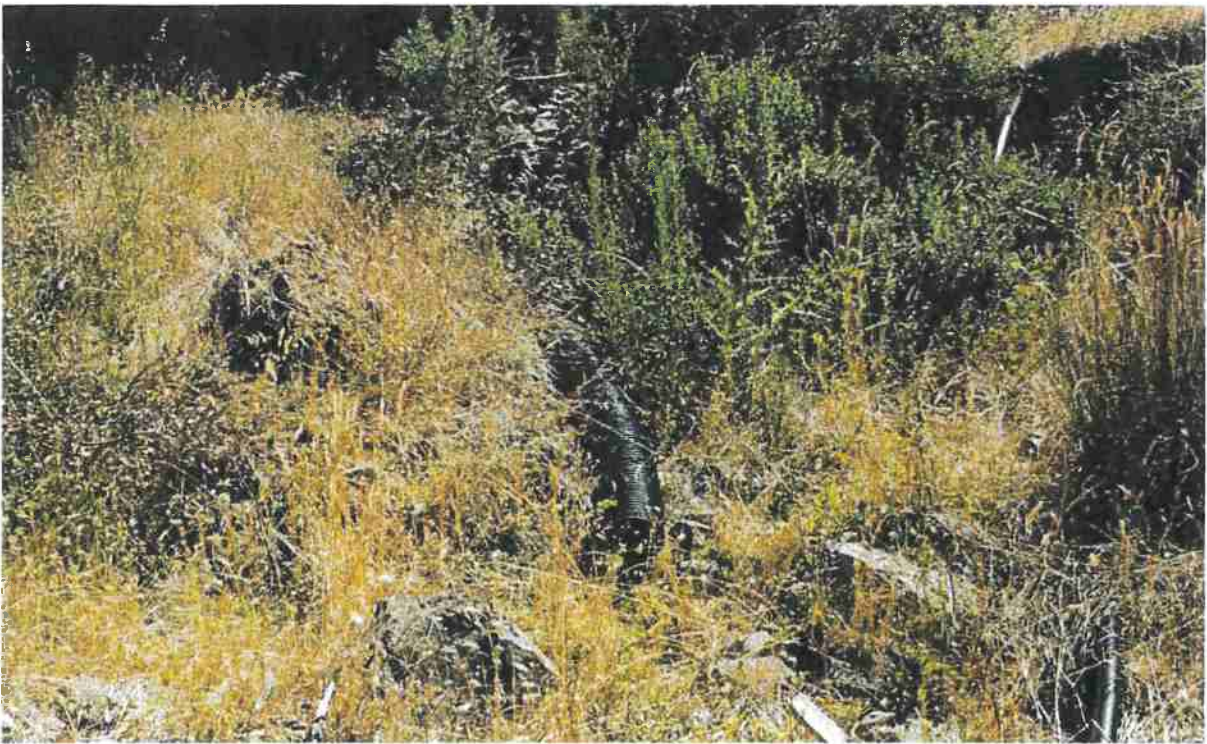
the property that are installed correctly and functioning properly, as well as a French drain extending from Site 15 to Site 16 that is also installed correctly and functioning properly. However, there is erosion occurring on the permanent road from Site 13 to 11 that is hydrologically connected to a Class III watercourse 30' downslope, south of Site 11.

*Photo looking at the French drain starting at Site 15 and extending to Site 16.*

*Photo looking at the outlet of the French drain at Site 16.*

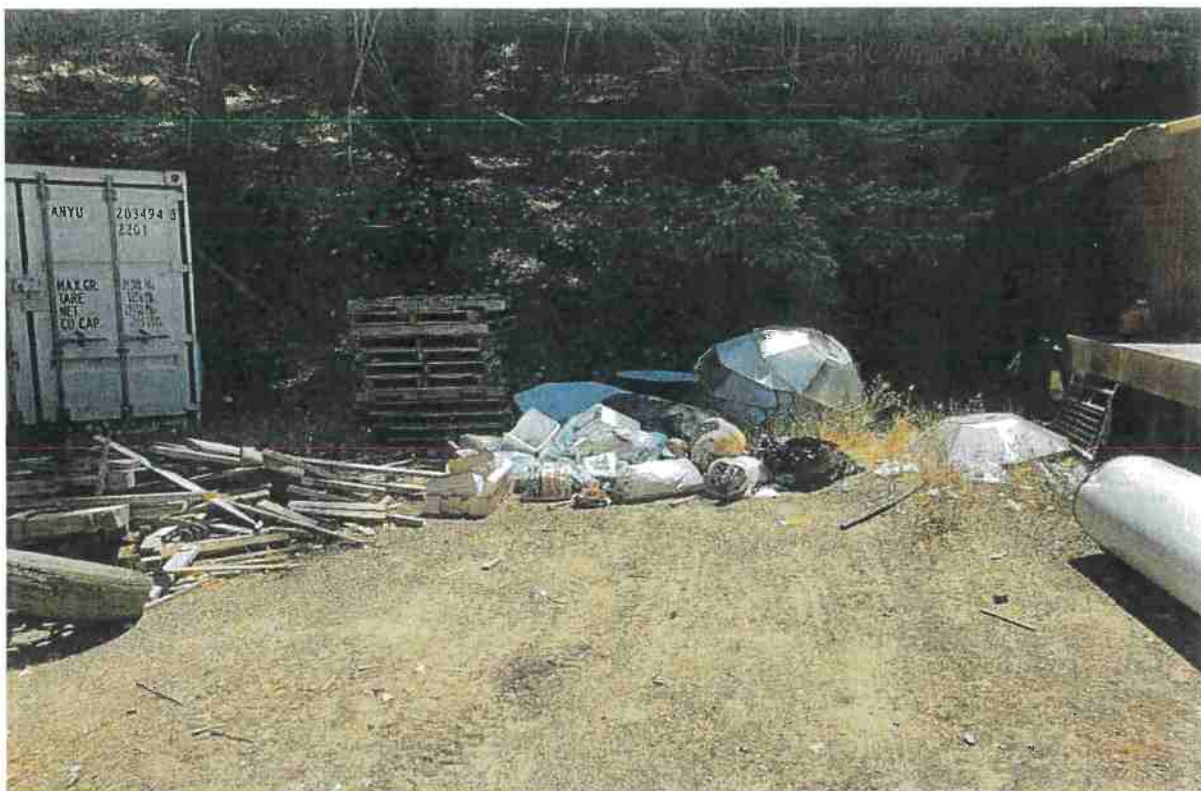
*Photo looking at the cultivation related waste at Site 18.*

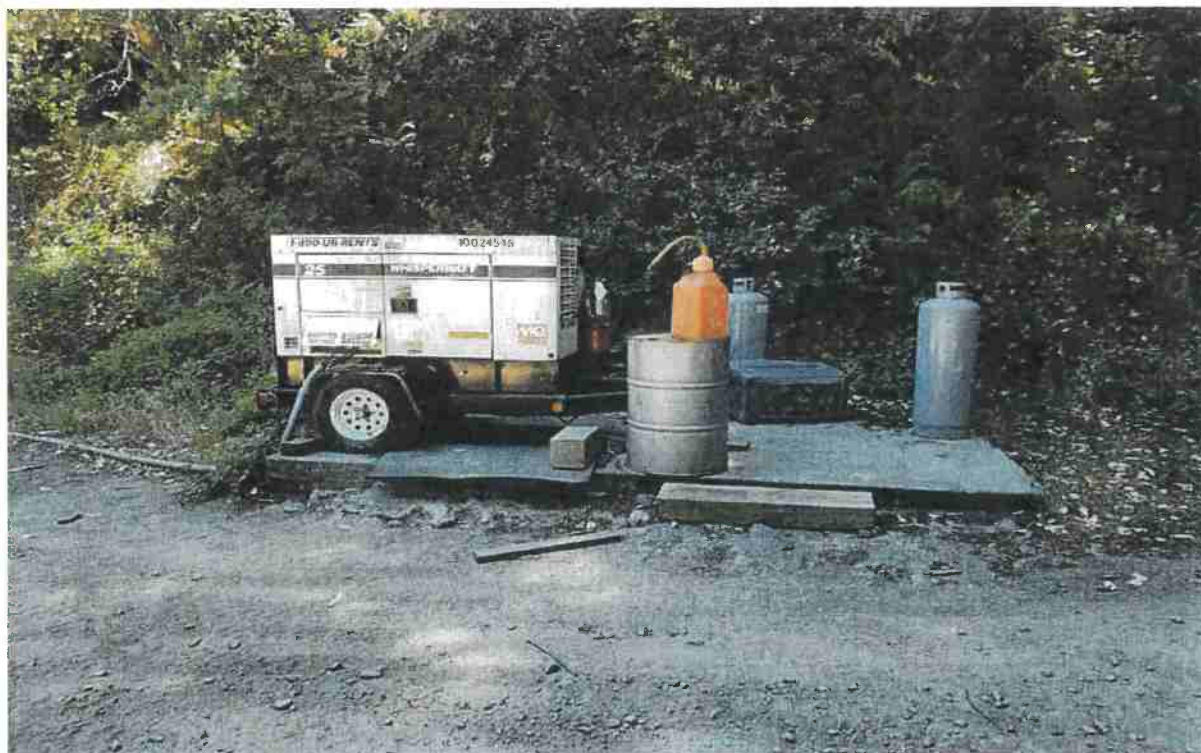
*Photo looking at the uncovered diesel generator at Site 20.*

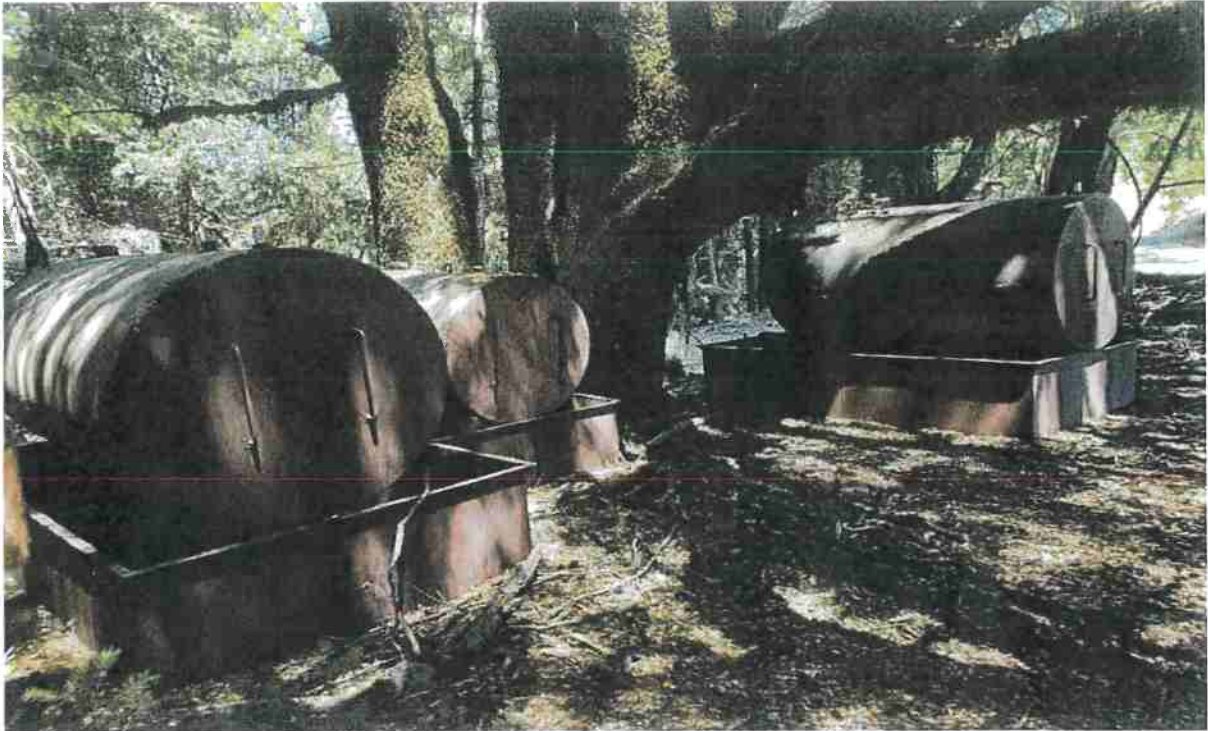
*Photos looking at the petroleum tanks that don't have proper cover at Site 21.*

Unique Point	Lat-Long NAD 83	Road Type	Mitigation Planned	Monitor	1600	Treatment Priority	Date Completed
Site 21	-124.000514 40.253043	Permanent	X	-	-	Prior to 10/15/21	
Current Condition: Two 500-gallon diesel tanks and one 500-gallon gasoline tank that have proper secondary containment but no secondary cover.						Prescribed Action: See attached BMPs: Generator, Fuel, and Oil Management for further details. All petroleum products are required to be used and stored per Cannabis Cultivation Policy, Att. A, Sec. 2, - Term 103 - 110, and 116 - 118 attached.	
Unique Point	Lat-Long NAD 83	Road Type	Mitigation Planned	Monitor	1600	Treatment Priority	Date Completed
Site 22	-123.999952 40.253427	Permanent	X	-	-	Prior to 10/15/21	
Current Condition: Existing soil pile is uncovered. The soil shows no signs of migration away from the pile is located outside of riparian areas.						Prescribed Action: The soil pile shall be properly cover prior to a rain event and throughout winter per Cannabis Cultivation Policy, Att. A, Sec. 2, - Term 57 - 62 attached.

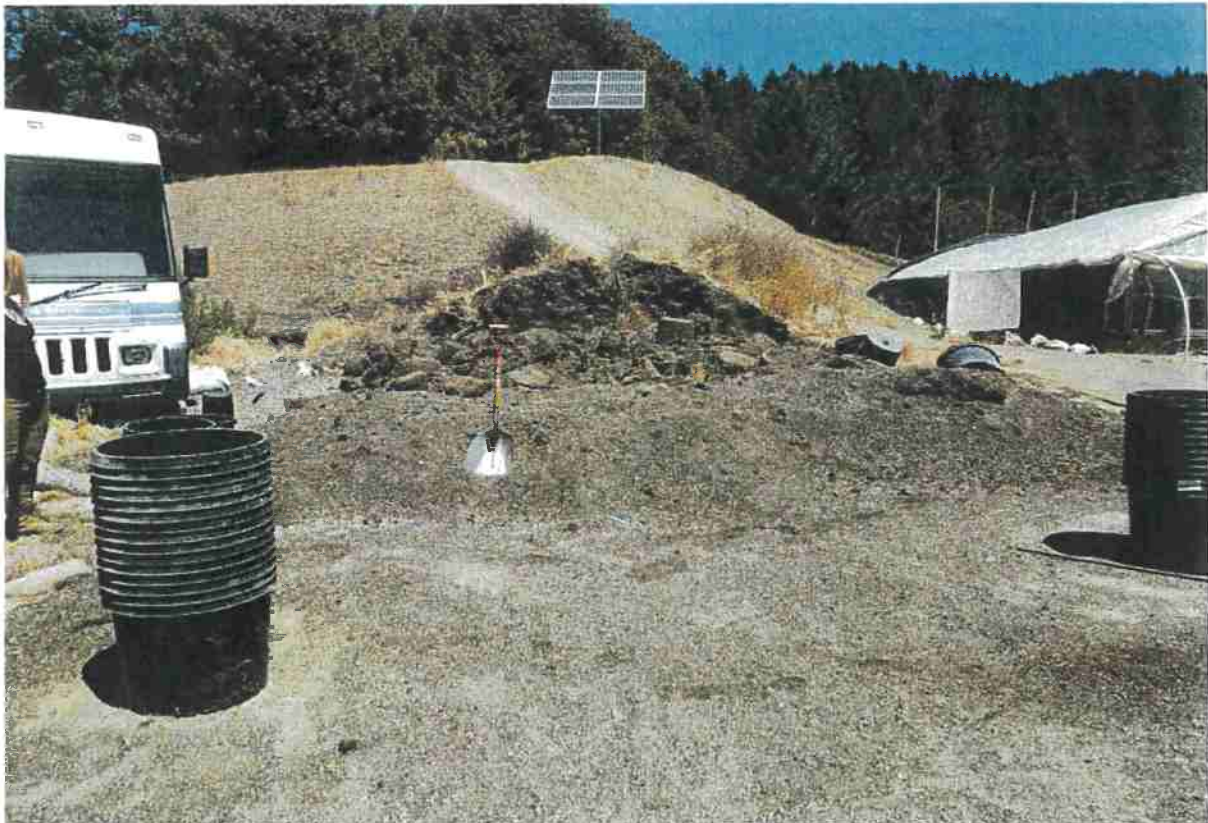
*Photo looking at the uncovered soil pile at Site 22.*
