# Site Management Plan

WDID - 1\_12CC418891

Humboldt County  
APN: 211-183-008-000, 211-184-006-000  
APPS 10820

9/8/2021

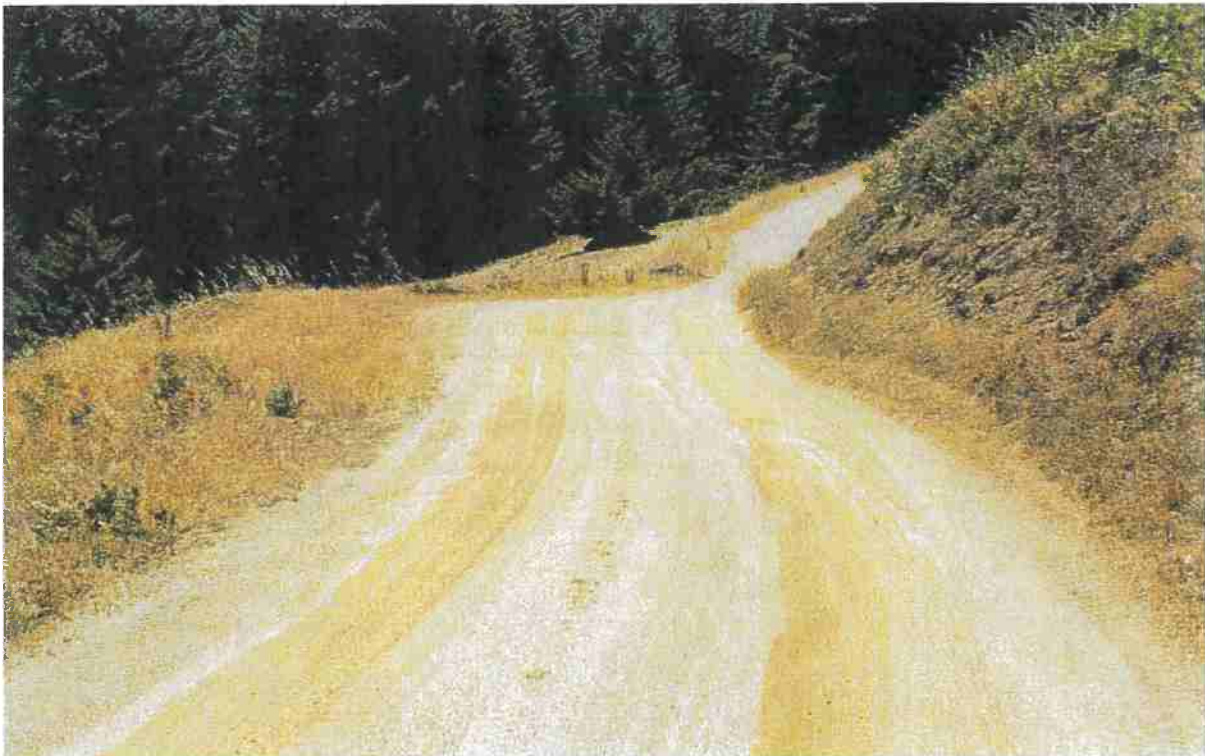
Photo looking at the head of the erosional gulley (indicated by the blue arrows) at Site 24.

*Photo looking up grade at the existing rolling dip at Site 24.*

*Photo looking down grade at the existing rolling dip at Site 24.*

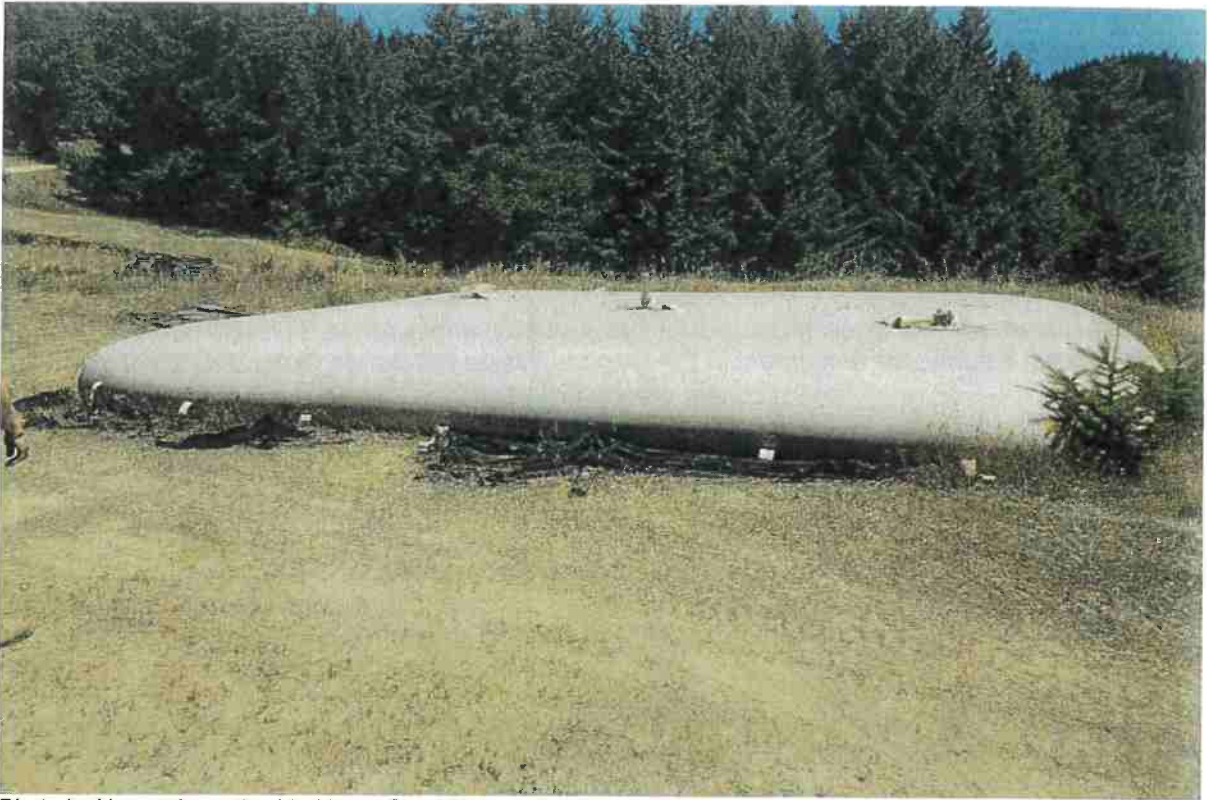
*Photo looking at the active bladder at Site 25.*

Unique Point	Lat-Long NAD 83	Road Type	Mitigation Planned	Monitor	1600	Treatment Priority	Date Completed
Site 25	-123.999656 40.254345	-	X	X	-	Prior to 10/15/22	
Current Condition: A large active bladder is not properly stored in secondary containment.						Prescribed Action: Provide proper secondary containment for the existing bladder per Cannabis Cultivation Policy: Attachment A, Section 2, No. 87 - 89 for cannabis cultivators.	
Unique Point	Lat-Long NAD 83	Road Type	Mitigation Planned	Monitor	1600	Treatment Priority	Date Completed
Site 26	-123.998768 40.255448	Permanent	-	X	-	Annually prior to 10/15	
Current Condition: Existing series of rolling dips are installed correctly and functioning adequately.						Prescribed Action: Monitor and maintain as needed. See "Rolling Dip Design and Placement" in the attached BMP's. See Cannabis Cultivation Policy, Att. A, Sec. 2, - Term 1 - 29 that is attached for specifications.
