New Earth Farms, LLC

Road System Assessment Report – Staton Drive

APN: 524-072-010

Humboldt county, CA

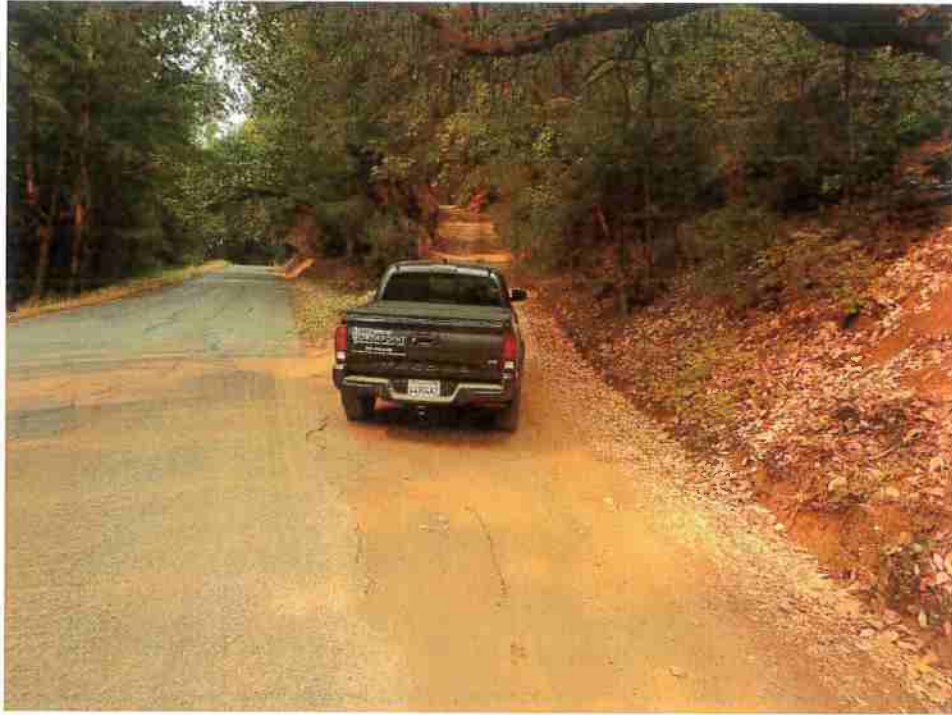
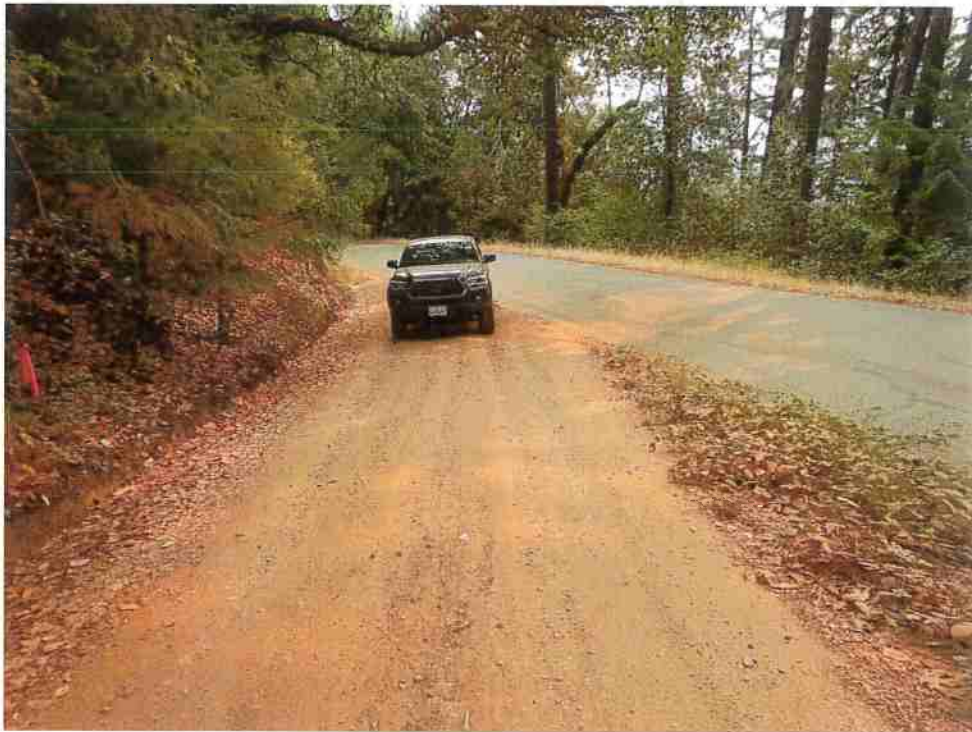
| RP # | Photo # in Appendix B | Measured Road Width (ft.) | Lat., Long. | Description | Turnout Provided? | Recommendations |
|---|---|---|---|--|---|--|
| 1 | 1-2 | 18 | 40.8834, -123.6304 | Intersection of Staton Drive and Friday Ridge Road (State Road No.: 8L100). No sight distance restrictions. | N/A | Maintain existing roadway width |

Photo 1: RP 1. Vehicle traveling west, photo taken facing west.

Photo 2: RP 1. Vehicle traveling west, photo taken facing east.

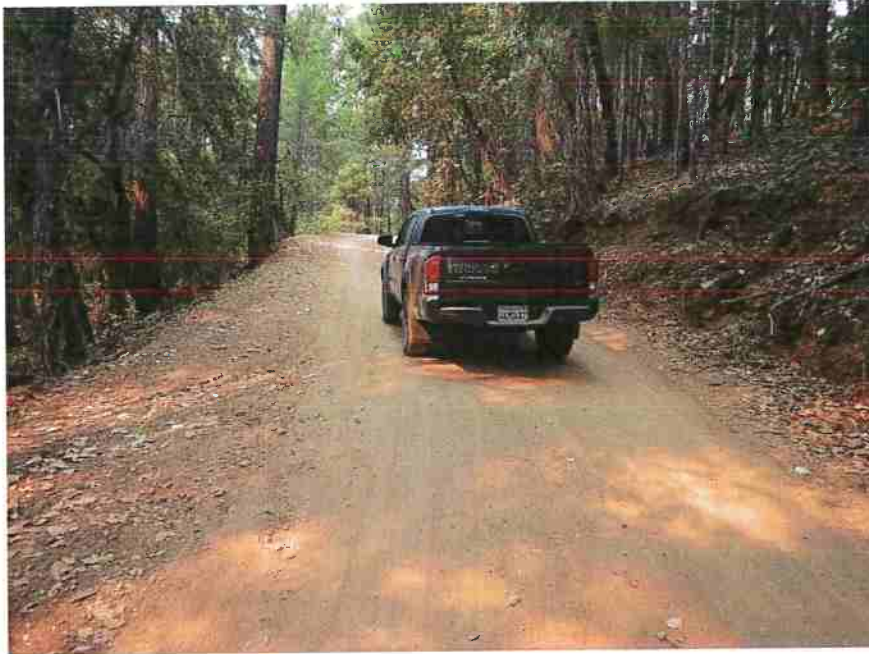
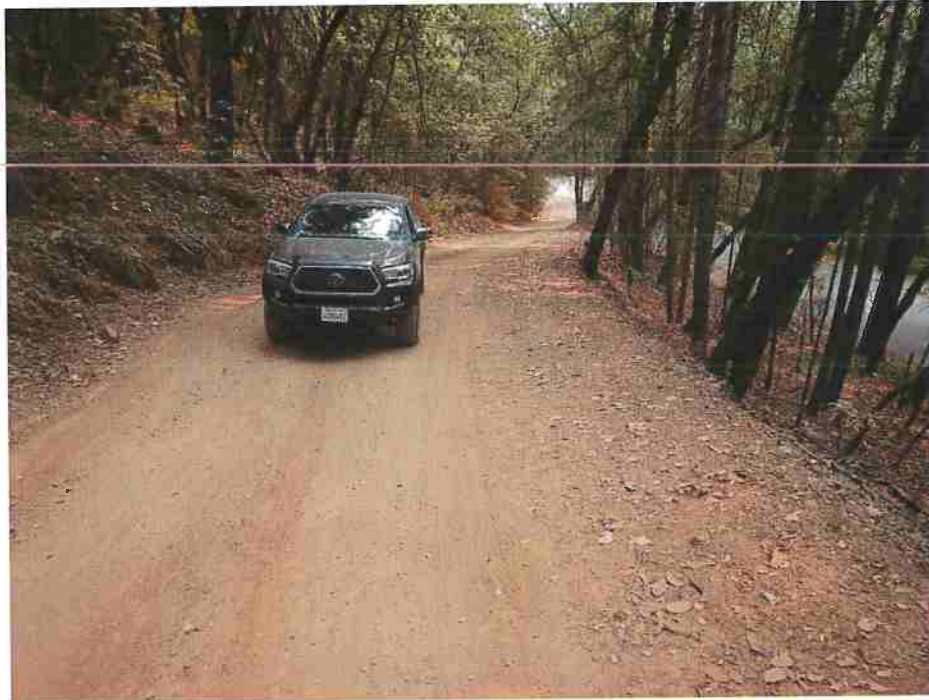
| RP # | Photo # in Appendix B | Measured Road Width (ft.) | Lat., Long. | Description | Turnout Provided? | Recommendations |
|---|---|---|---|--|---|--|
| 2 | 3-4 | 18 | 40.8832, -123.6310 | Typical section of roadway. Location of drainage feature - Water bar. | N/A | Maintain existing roadway width and drainage feature |

| RP # | Photo # in Appendix B | Lat., Long. | Description | Potential Threat to Water Quality / Biological Resources | Recommendations |
|---|---|---|--|--|--|
| 2 | 3-4 | 40.8832, -123.6310 | Typical section of roadway. Location of drainage feature - Water bar. | None | Maintain existing roadway width and drainage feature |

Photo 3: RP 2. Vehicle traveling west, photo taken facing west.

Photo 4: RP 2. Vehicle traveling west, photo taken facing east.

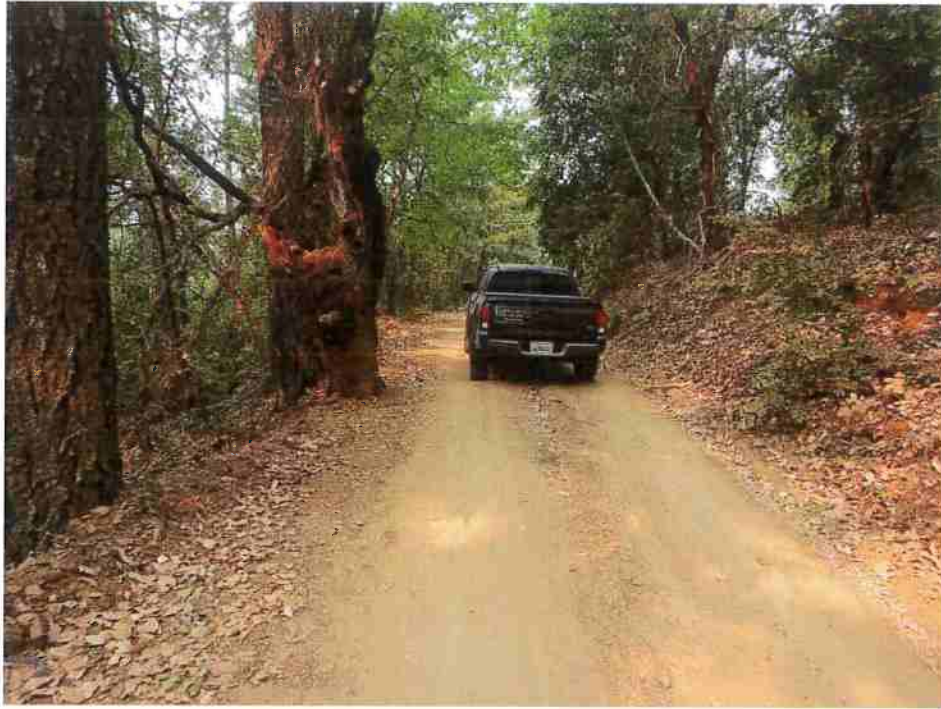
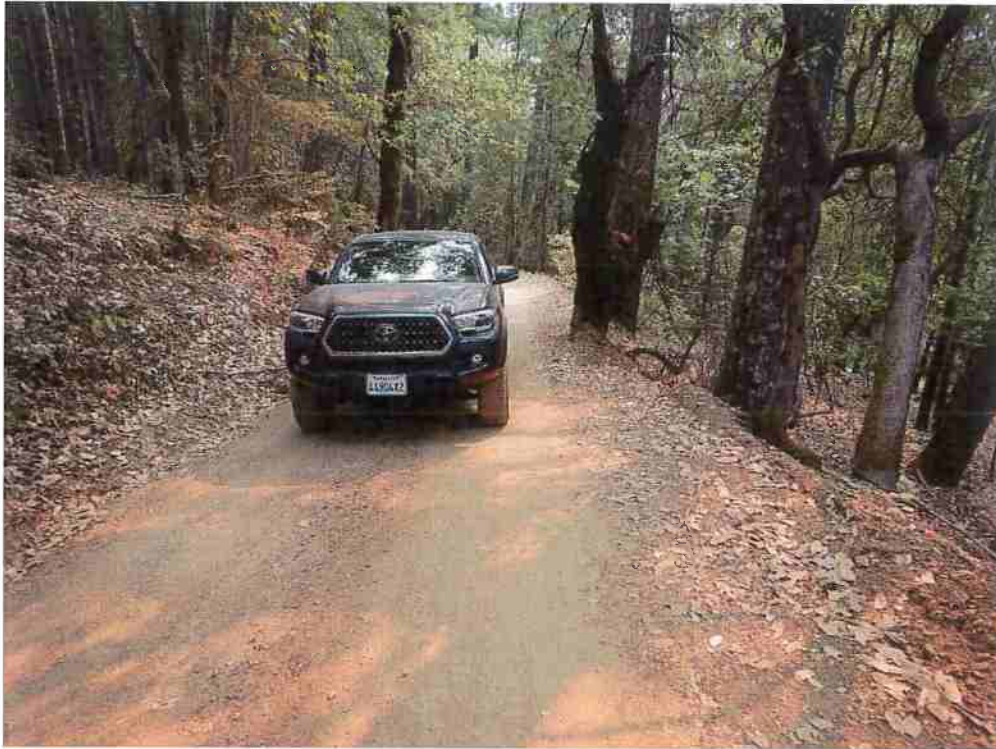
| RP # | Photo # in Appendix B | Measured Road Width (ft.) | Lat., Long. | Description | Turnout Provided? | Recommendations |
|---|---|---|---|--|---|--|
| 3 | 5-6 | 12 | 40.8832, -123.6318 | Pinch point. Large tree reduces roadway width. No visibility restrictions. Location of drainage feature - Water bar. | Yes | Maintain existing roadway width, drainage feature and turnout. |

| RP # | Photo # in Appendix B | Lat., Long. | Description | Potential Threat to Water Quality / Biological Resources | Recommendations |
|---|---|---|--|--|--|
| 3 | 5-6 | 40.8832, -123.6318 | Pinch point. Large tree reduces roadway width. No visibility restrictions. Location of drainage feature - Water bar. | None | Maintain existing roadway width, drainage feature and turnout. |

Photo 5: RP 3. Vehicle traveling west, photo taken facing west.

Photo 6: RP 3. Vehicle traveling west, photo taken facing east.

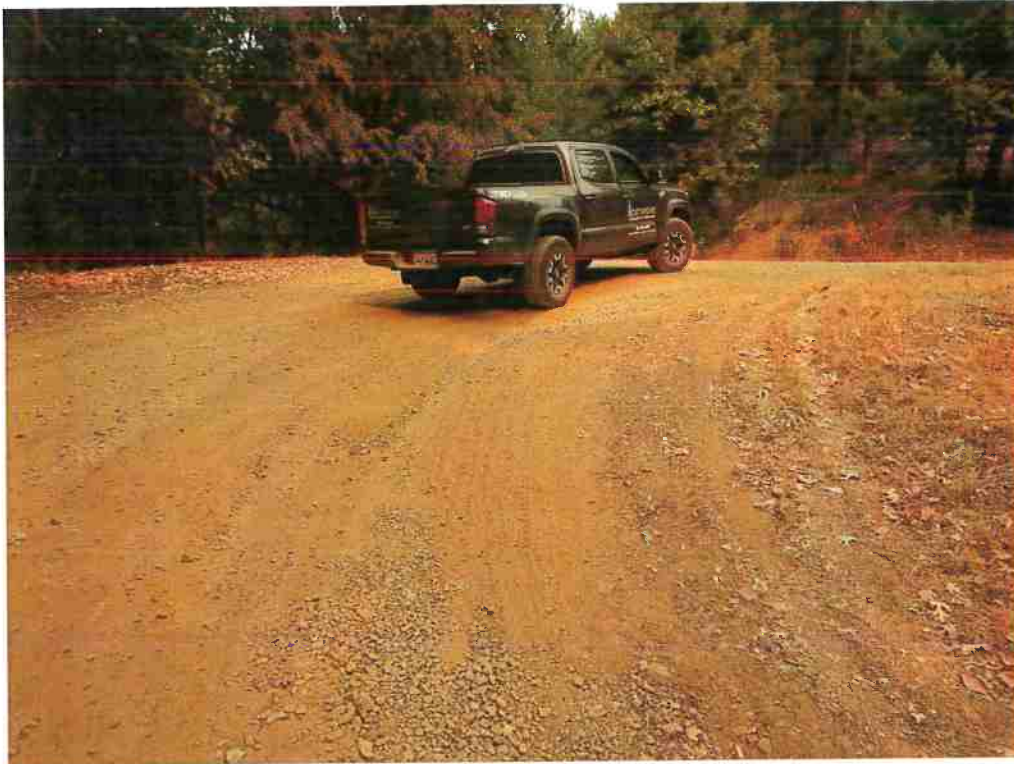
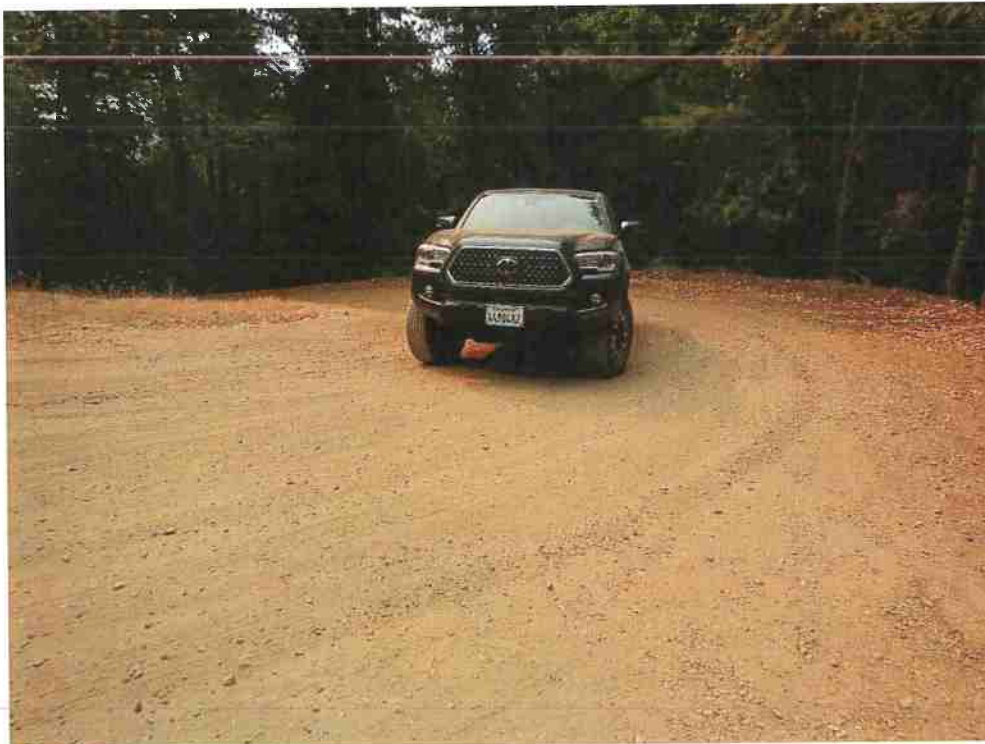
| RP # | Photo # in Appendix B | Measured Road Width (ft.) | Lat., Long. | Description | Turnout Provided? | Recommendations |
|---|---|---|---|--|---|--|
| 4 | 7-8 | 25+ | 40.8833, -123.6324 | Typical section of roadway. No visibility restrictions. | N/A | Maintain existing roadway width. |

Photo 7: RP 4. Vehicle traveling west, photo taken facing west.

Photo 8: RP 4. Vehicle traveling west, photo taken facing east.

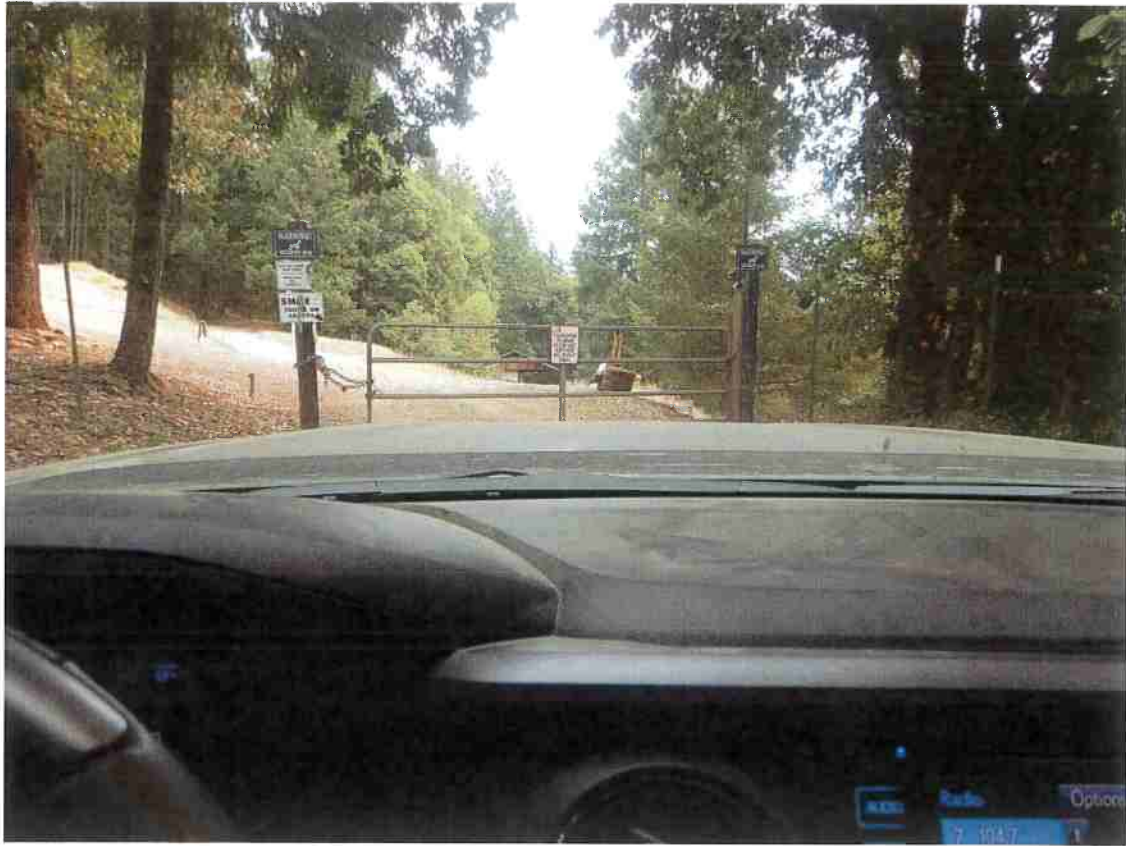
| RP # | Photo # in Appendix B | Measured Road Width (ft.) | Lat., Long. | Description | Turnout Provided? | Recommendations |
|---|---|---|---|--|---|--|
| 5 | 9 | 14 | 40.8834, -123.6323 | Neighborhood gate. Gate measures 14 feet in width. No visibility restrictions. | Yes | Maintain existing gate, roadway width and turnout. |

Photo 9: RP 5. Vehicle traveling north, photo taken facing north.

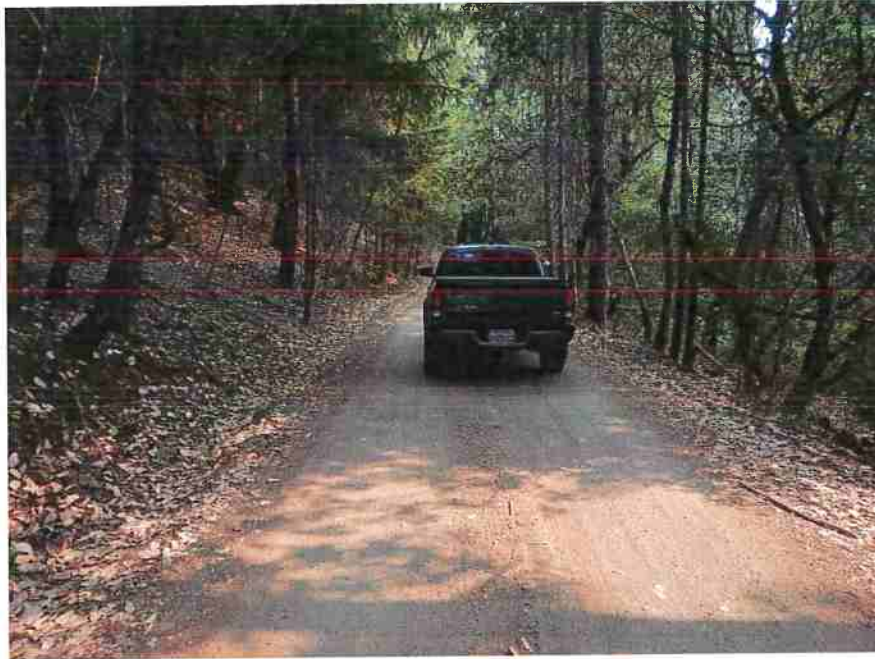
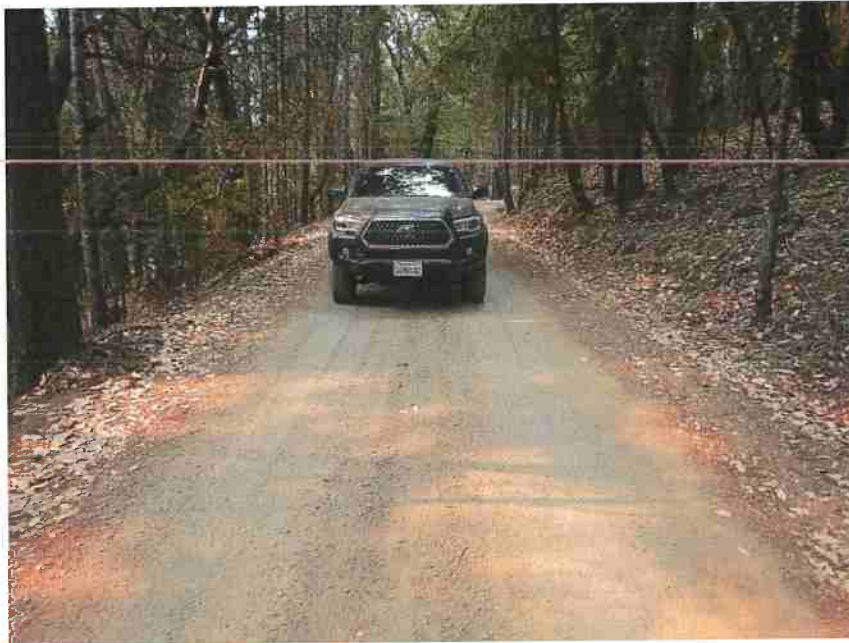
| RP # | Photo # in Appendix B | Measured Road Width (ft.) | Lat., Long. | Description | Turnout Provided? | Recommendations |
|---|---|---|---|--|---|--|
| 6 | 10-11 | 18 | 40.8844, -123.6312 | Typical section of roadway. Appropriate inboard ditch along roadway. No visibility restrictions. | N/A | Maintain existing roadway width. |

| RP # | Photo # in Appendix B | Lat., Long. | Description | Potential Threat to Water Quality / Biological Resources | Recommendations |
|---|---|---|--|--|--|
| 6 | 10-11 | 40.8844, -123.6312 | Typical section of roadway. Appropriate inboard ditch along roadway. No visibility restrictions. | None | Maintain existing roadway width. |

Photo 10: RP 6. Vehicle traveling north, photo taken facing north.

Photo 11: RP 6. Vehicle traveling north, photo taken facing south.

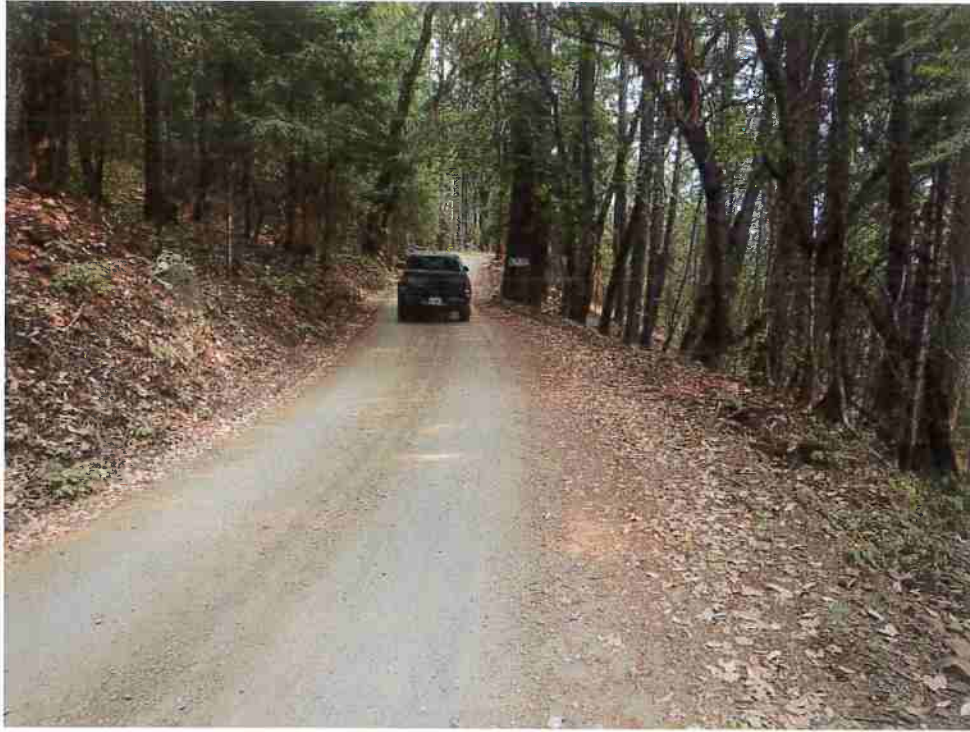
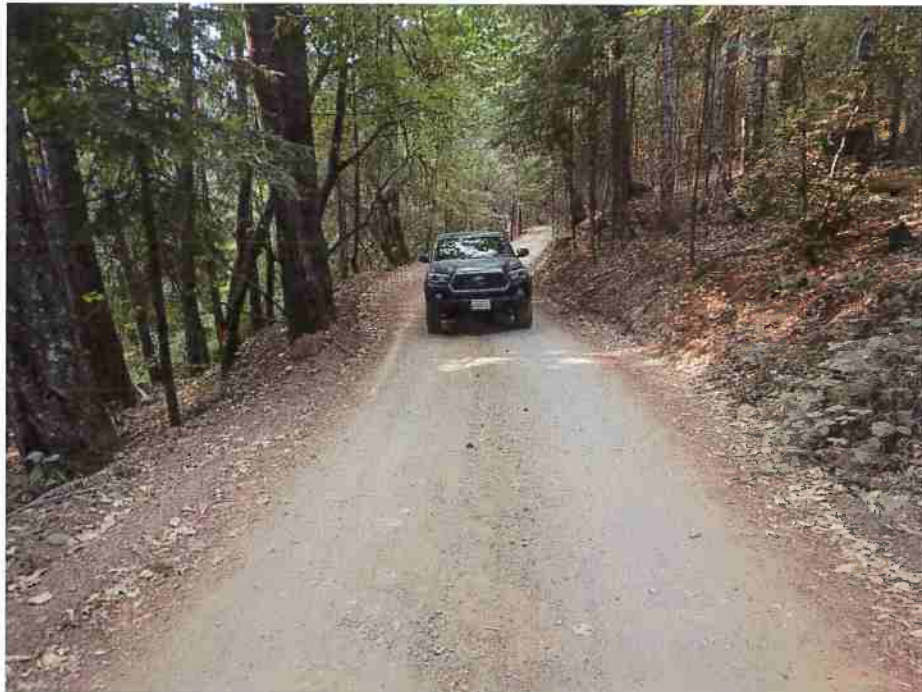
| RP # | Photo # in Appendix B | Measured Road Width (ft.) | Lat., Long. | Description | Turnout Provided? | Recommendations |
|---|---|---|---|--|---|--|
| 7 | 12-13 | 15 | 40.8848, -123.6309 | Pinch point. Large tree reduces roadway width. No visibility restrictions. | Yes | Maintain existing roadway width and turnout. |

Photo 12: RP 7. Vehicle traveling north, photo taken facing north.

Photo 13: RP 7. Vehicle traveling north, photo taken facing south.

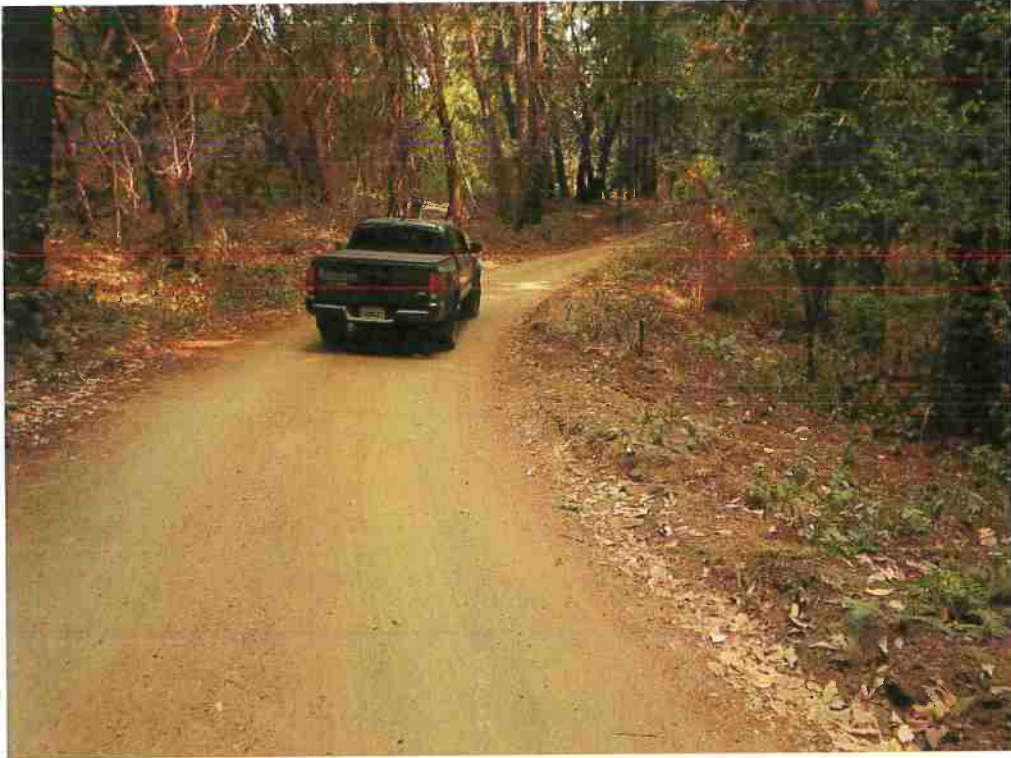
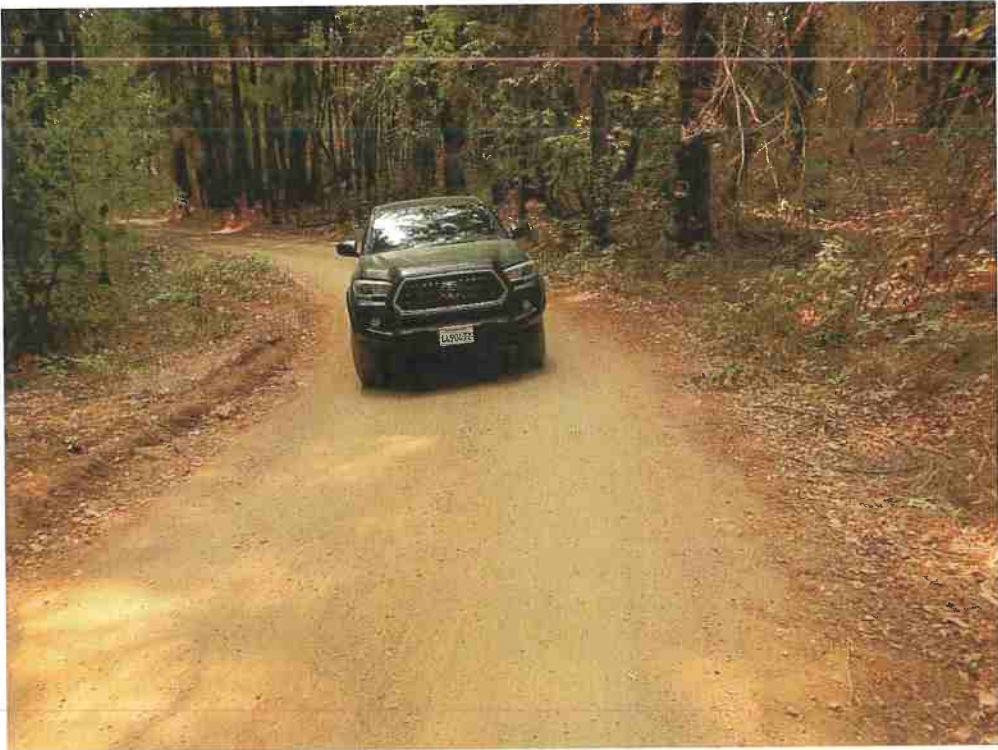
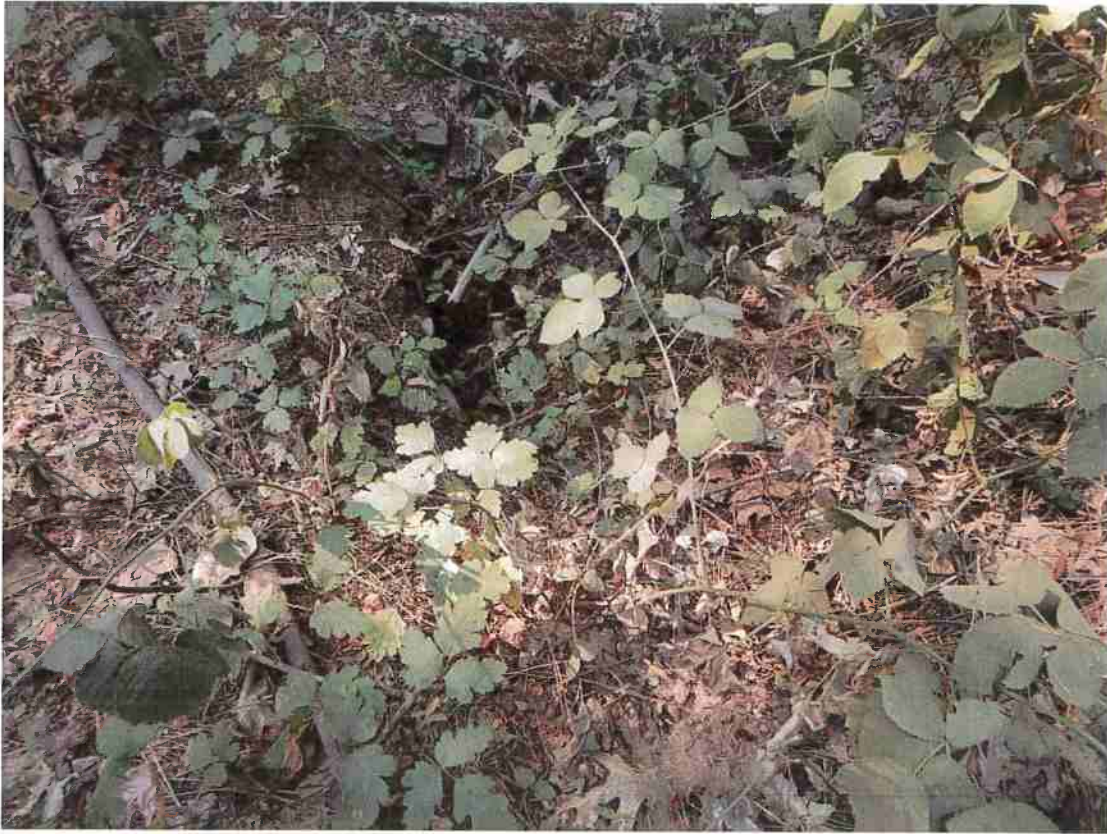
| RP # | Photo # in Appendix B | Measured Road Width (ft.) | Lat., Long. | Description | Turnout Provided? | Recommendations |
|---|---|---|---|--|---|--|
| 8 | 14-16 | 18 | 40.8856, -123.6307 | Location of drainage feature - drainage relief culvert. Only observed inlet due to vegetation. Appeared to be functioning correctly. | N/A | Maintain existing roadway width and drainage feature |

| RP # | Photo # in Appendix B | Lat., Long. | Description | Potential Threat to Water Quality / Biological Resources | Recommendations |
|---|---|---|--|--|--|
| 8 | 14-16 | 40.8856, -123.6307 | Location of drainage feature - drainage relief culvert. Only observed inlet due to vegetation. Appeared to be functioning correctly. | None | Maintain existing roadway width and drainage feature |

Photo 14: RP 8. Vehicle traveling north, photo taken facing north.

Photo 15: RP 8. Vehicle traveling north, photo taken facing south.

Photo 16: RP 8. Inlet to drainage relieve culvert.

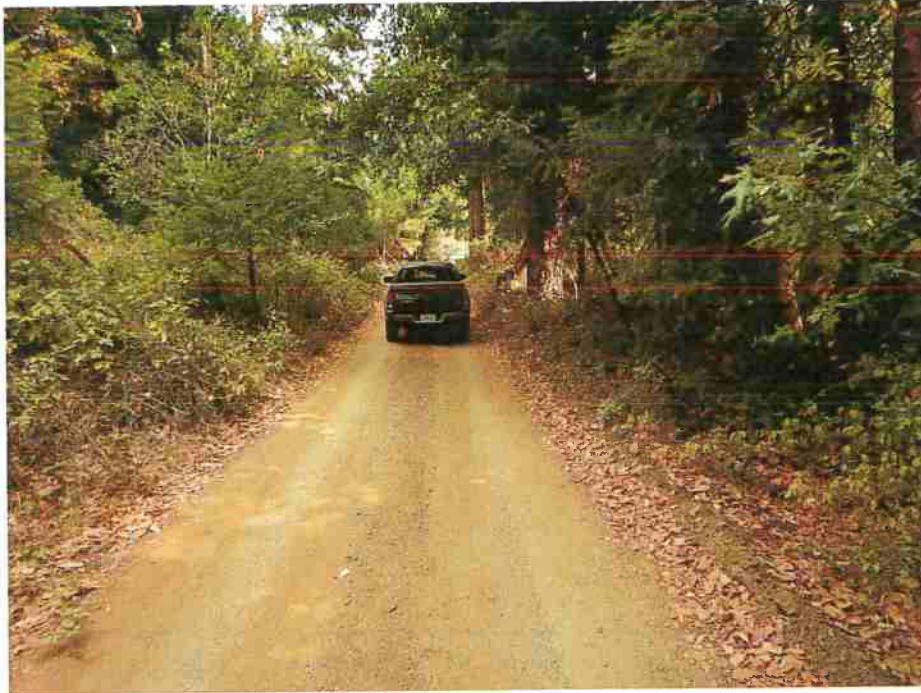
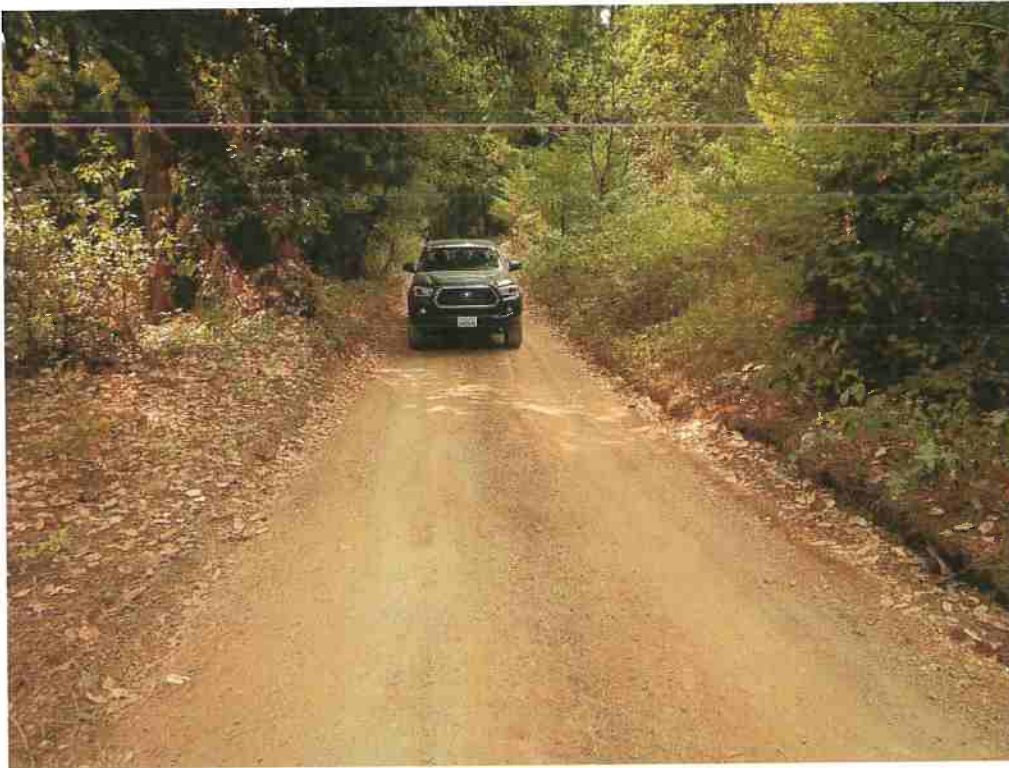
| RP # | Photo # in Appendix B | Measured Road Width (ft.) | Lat., Long. | Description | Turnout Provided? | Recommendations |
|---|---|---|---|--|---|--|
| 9 | 17-18 | 12 | 40.8861, -123.6306 | Pinch point. Reduced roadway width for ±200 feet in length. Vegetation growth reduces roadway width. No visibility restrictions. | No | Clear vegetation and widen roadway to extent possible. |

Photo 17: RP 9. Vehicle traveling north, photo taken facing north.

Photo 18: RP 9. Vehicle traveling north, photo taken facing south.

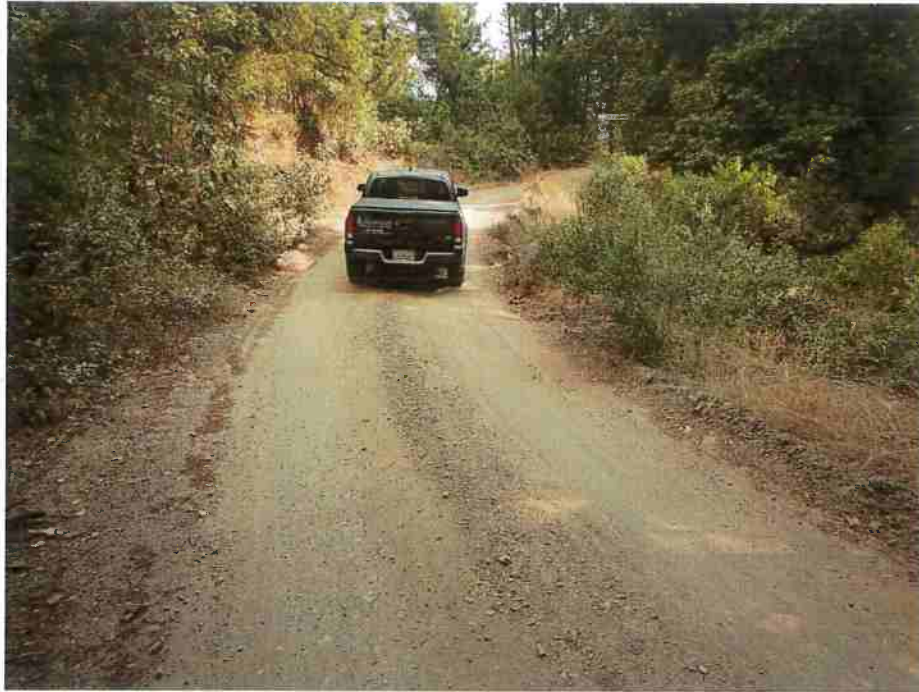
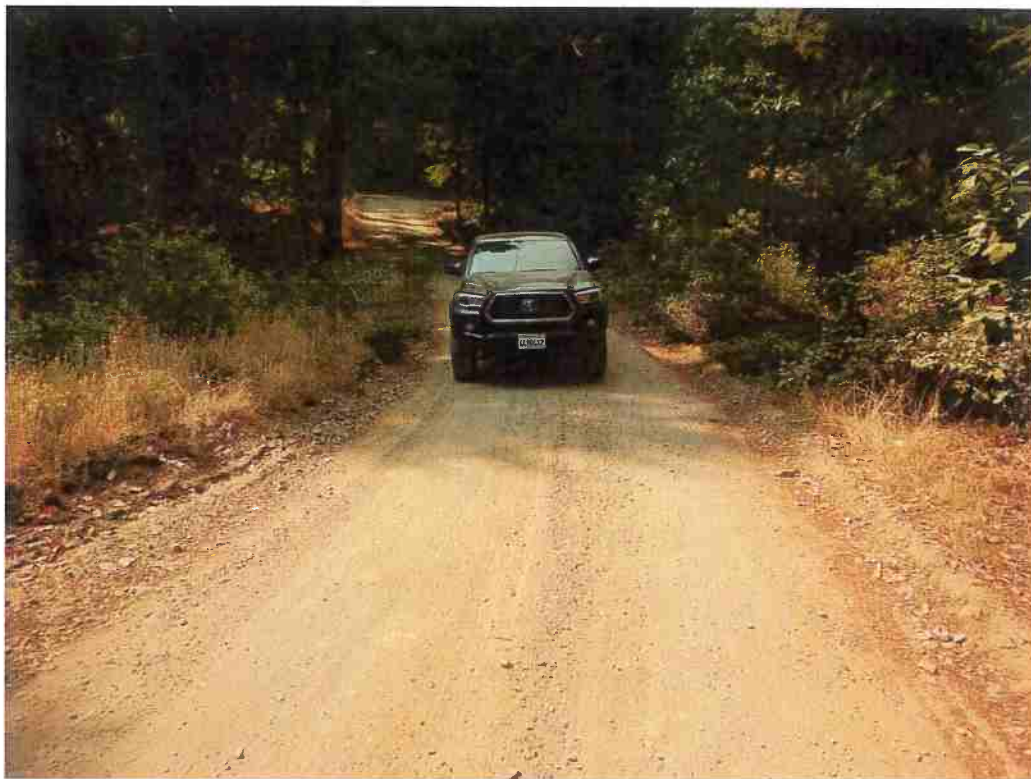
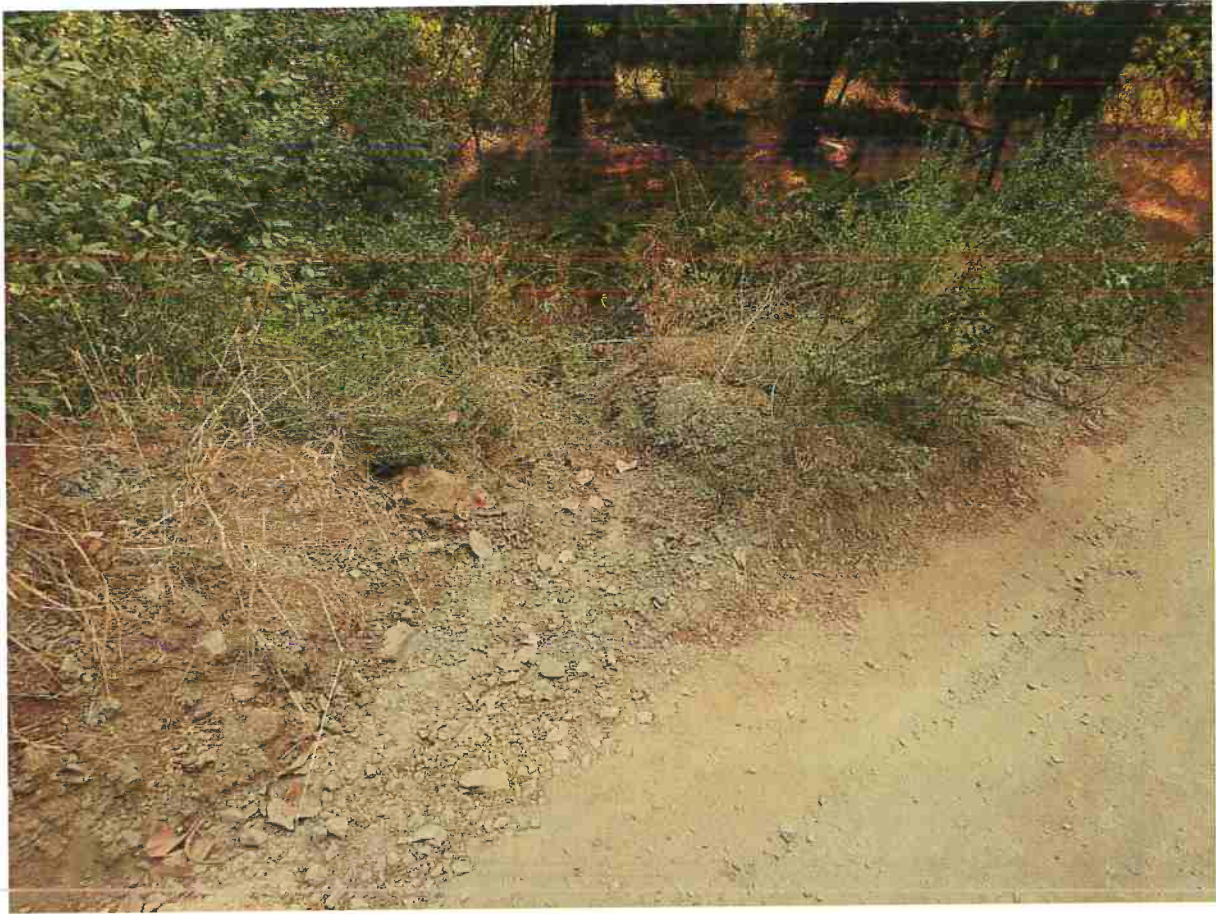
| RP # | Photo # in Appendix B | Measured Road Width (ft.) | Lat., Long. | Description | Turnout Provided? | Recommendations |
|---|---|---|---|--|---|--|
| 10 | 19-21 | 12 | 40.8869, -123.6307 | Pinch point. Reduced roadway for short distance. No visibility restrictions. Location of drainage feature - leadout ditch. | Yes | Maintain existing roadway width, turnout and drainage feature |

| RP # | Photo # in Appendix B | Lat., Long. | Description | Potential Threat to Water Quality / Biological Resources | Recommendations |
|---|---|---|--|--|--|
| 10 | 19-21 | 40.8869, -123.6307 | Pinch point. Reduced roadway for short distance. No visibility restrictions. Location of drainage feature - leadout ditch. | None | Maintain existing roadway width, turnout and drainage feature |

Photo 19: RP 10. Vehicle traveling north, photo taken facing north.

Photo 20: RP 10. Vehicle traveling north, photo taken facing north.

Photo 21: RP 10. Leadout ditch.

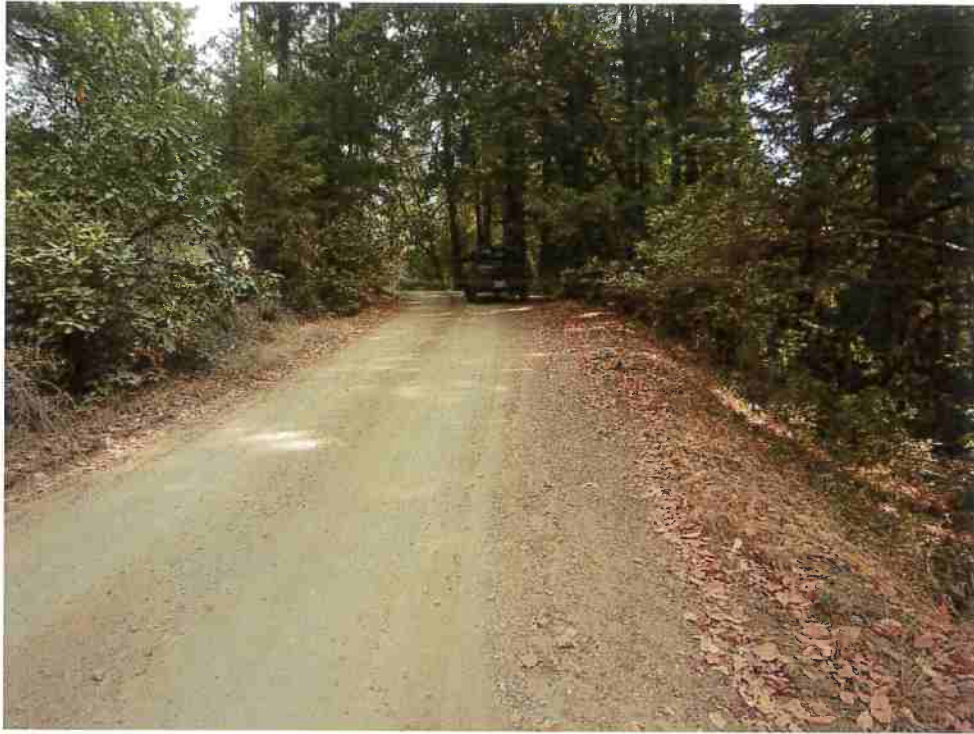
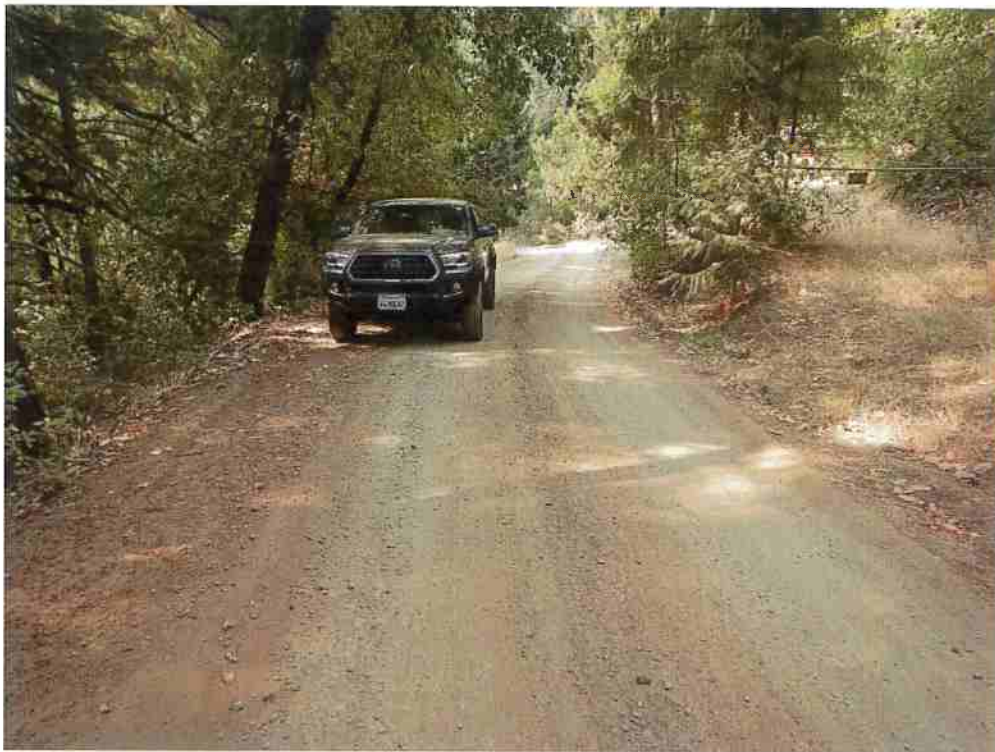
| RP # | Photo # in Appendix B | Measured Road Width (ft.) | Lat., Long. | Description | Turnout Provided? | Recommendations |
|---|---|---|---|--|---|--|
| 11 | 22-23 | 18 | 40.8872, -123.6307 | Typical section of roadway. No visibility restrictions. | N/A | Maintain existing roadway width. |

Photo 22: RP 11. Vehicle traveling north, photo taken facing north.

Photo 23: RP 11. Vehicle traveling north, photo taken facing south.

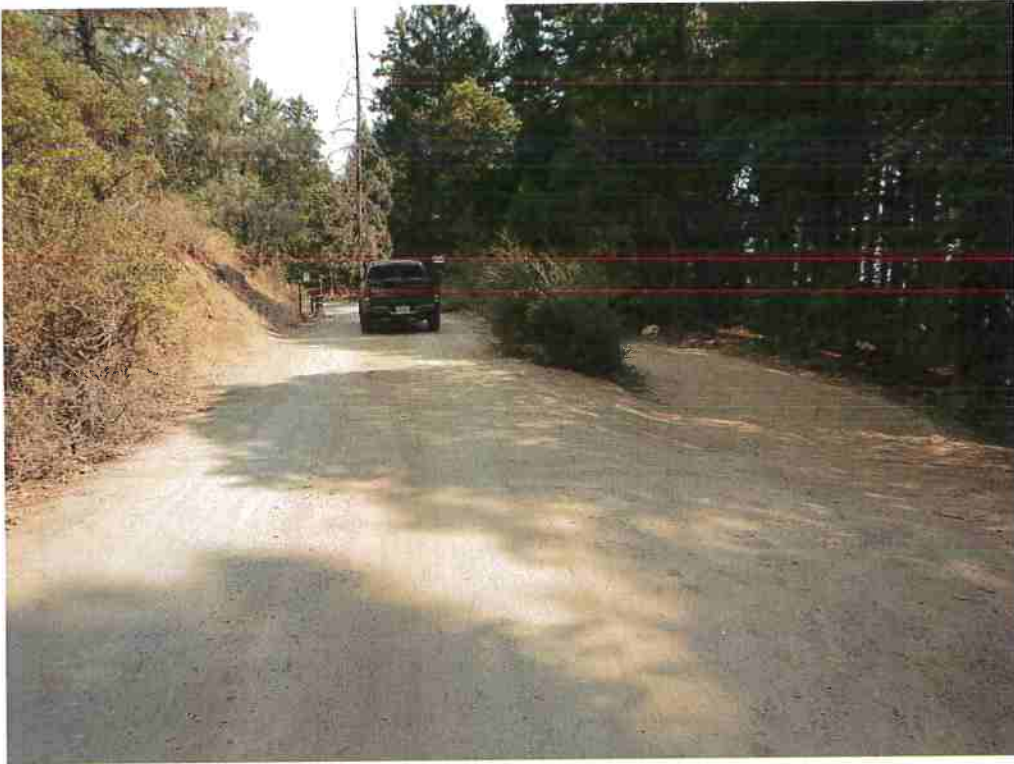
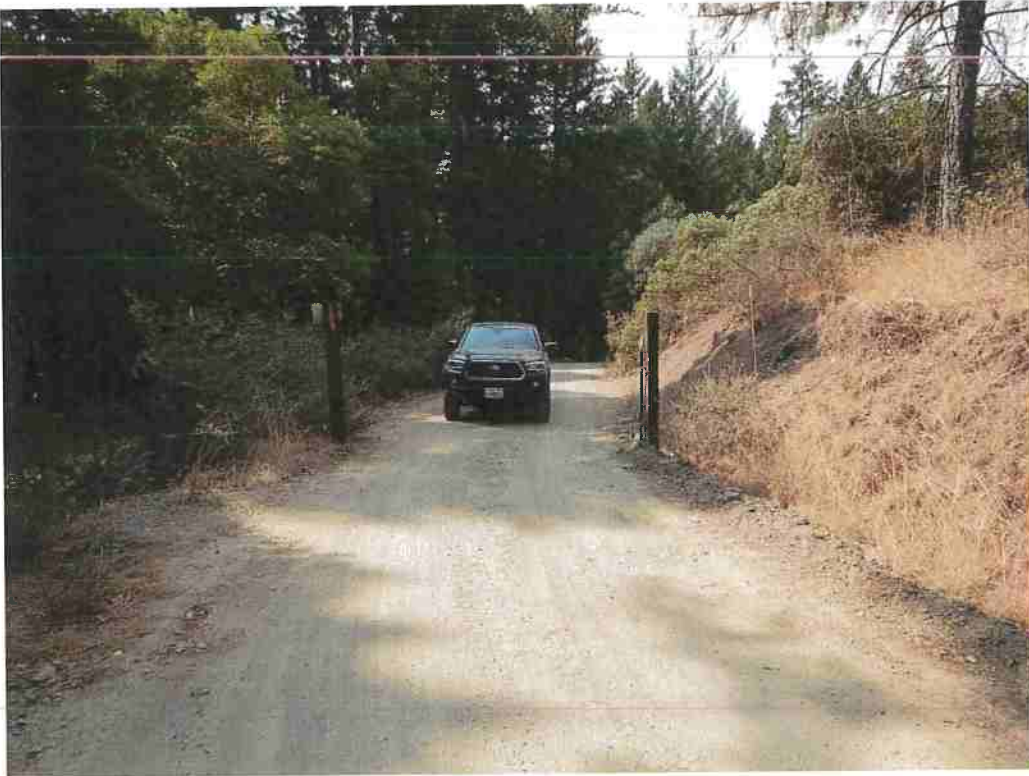
| RP # | Photo # in Appendix B | Measured Road Width (ft.) | Lat., Long. | Description | Turnout Provided? | Recommendations |
|---|---|---|---|--|---|--|
| 12 | 24-25 | 18 | 40.8880, -123.6299 | Gate. Gate measures 12.5 feet in width. Intersection of Staton Drive and USFS 6N13. No visibility restrictions. | Yes | Maintain existing roadway, gate width and turnout. |

Photo 24: RP 12. Vehicle traveling north, photo taken facing north.

Photo 25: RP 12. Vehicle traveling north, photo taken facing south.

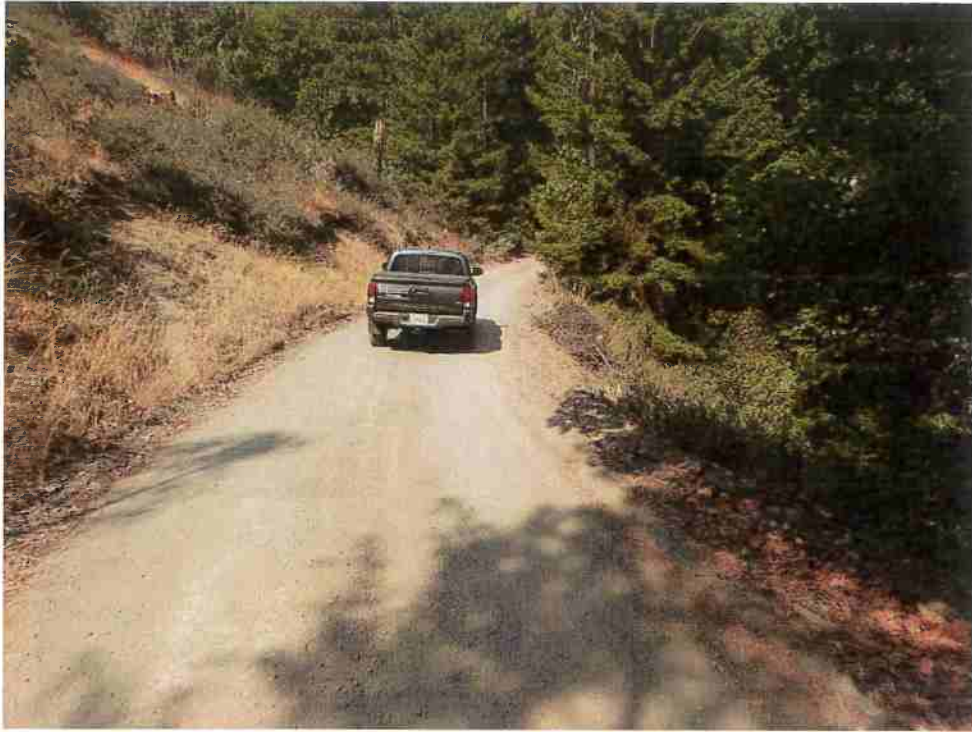
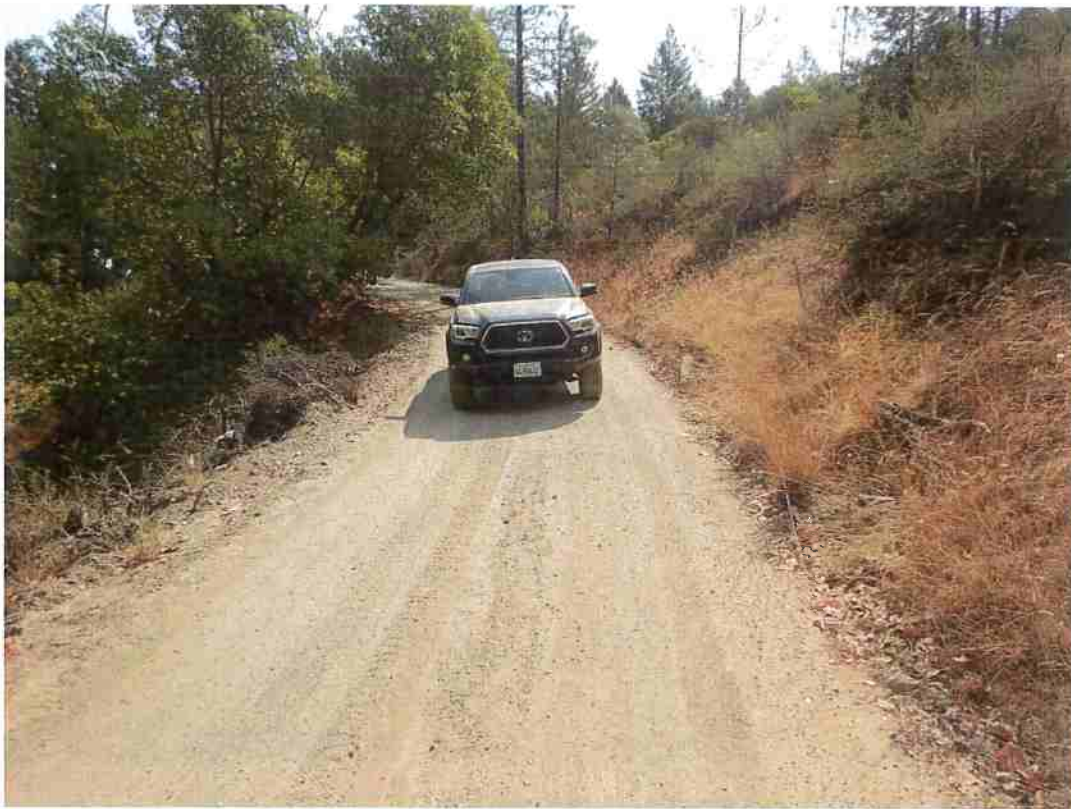
| RP # | Photo # in Appendix B | Measured Road Width (ft.) | Lat., Long. | Description | Turnout Provided? | Recommendations |
|---|---|---|---|--|---|--|
| 13 | 26-27 | 14 | 40.8884, -123.6306 | Pinch point. Bench cut roadway for ±200 feet in length. No visibility restrictions. | Yes | Maintain existing roadway width and turnouts. |

Photo 26: RP 13. Vehicle traveling north-west, photo taken facing north-west.

Photo 27: RP 13. Vehicle traveling north-west, photo taken facing south-east.
