New Earth Farms, LLC

Road System Assessment Report – Staton Drive

APN: 524-072-010

Humboldt county, CA

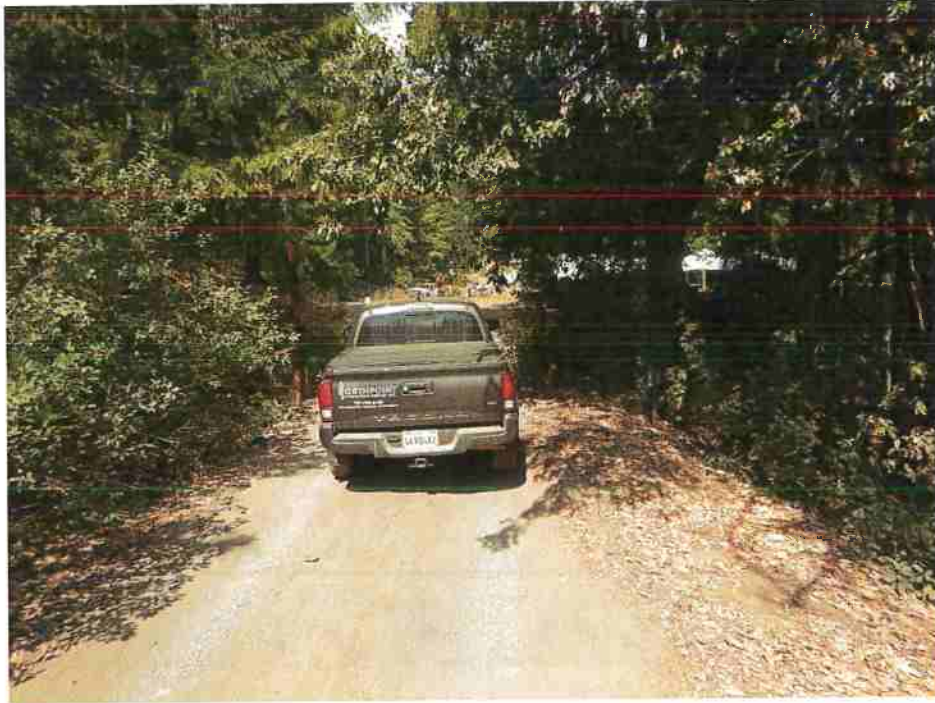
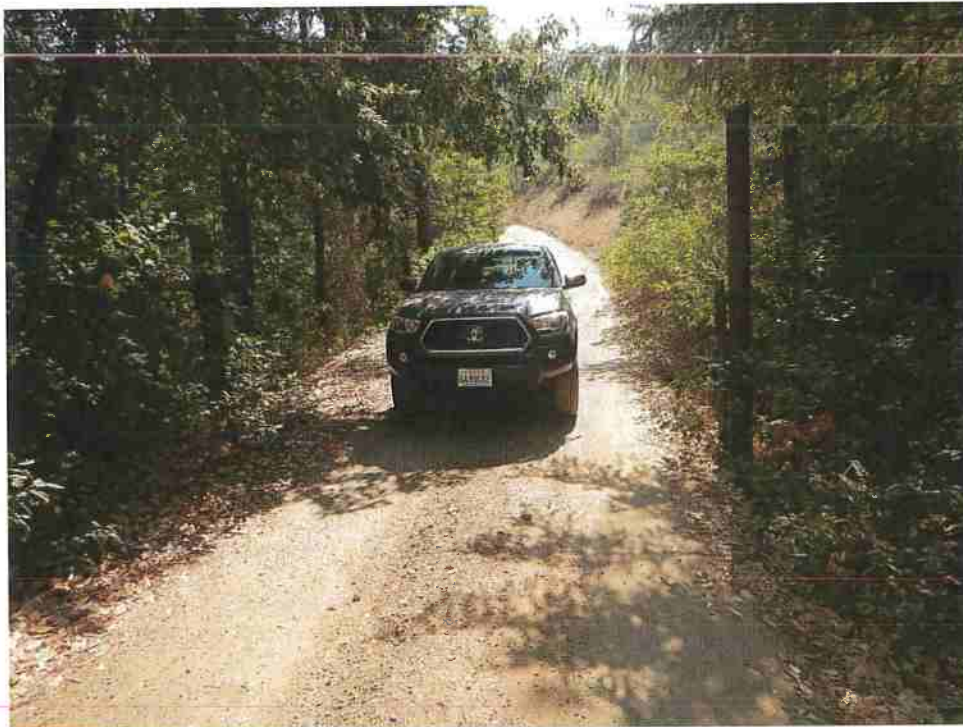
| RP # | Photo # in Appendix B | Measured Road Width (ft.) | Lat., Long. | Description | Turnout Provided? | Recommendations |
|---|---|---|---|--|---|--|
| 14 | 28-29 | 14 | 40.8886, -123.6309 | Entrance to subject parcel. Gate. Gate measures 13 feet in width. No visibility restrictions. | Yes | Maintain existing roadway, gate width and turnout. |

Photo 28: RP 14. Vehicle traveling north-west, photo taken facing north-west.

Photo 29: RP 14. Vehicle traveling north-west, photo taken facing south-east.
