NILSEN REAL ESTATE APPRAISALS

September 15, 2022

**Re: Courthouse Union Inc.
803 4th Street
Eureka, CA 95501**

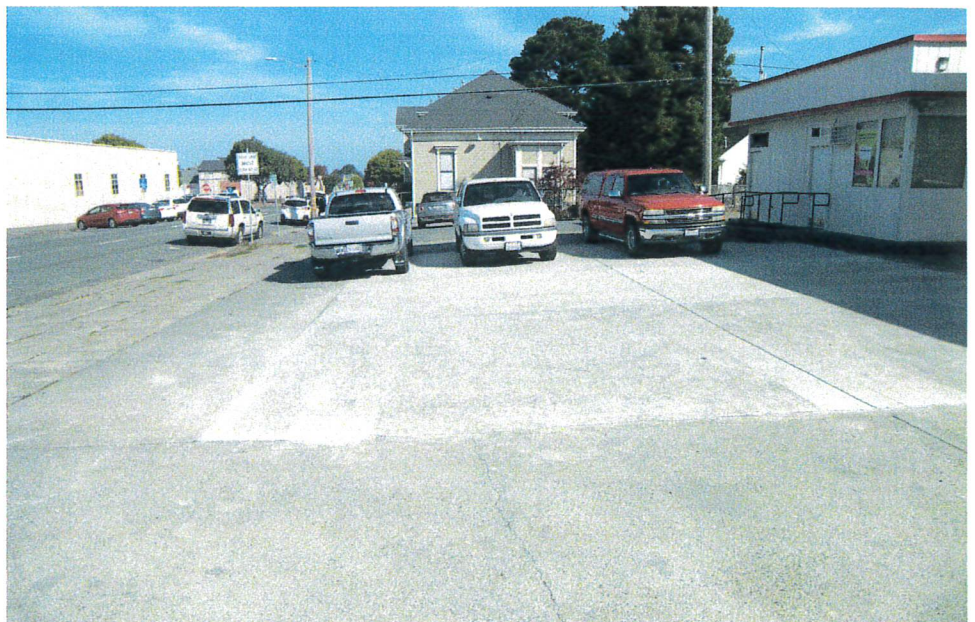
Looking northerly over former location of underground fuel storage tanks. There is a combination of regular size and handicap parking straight ahead.

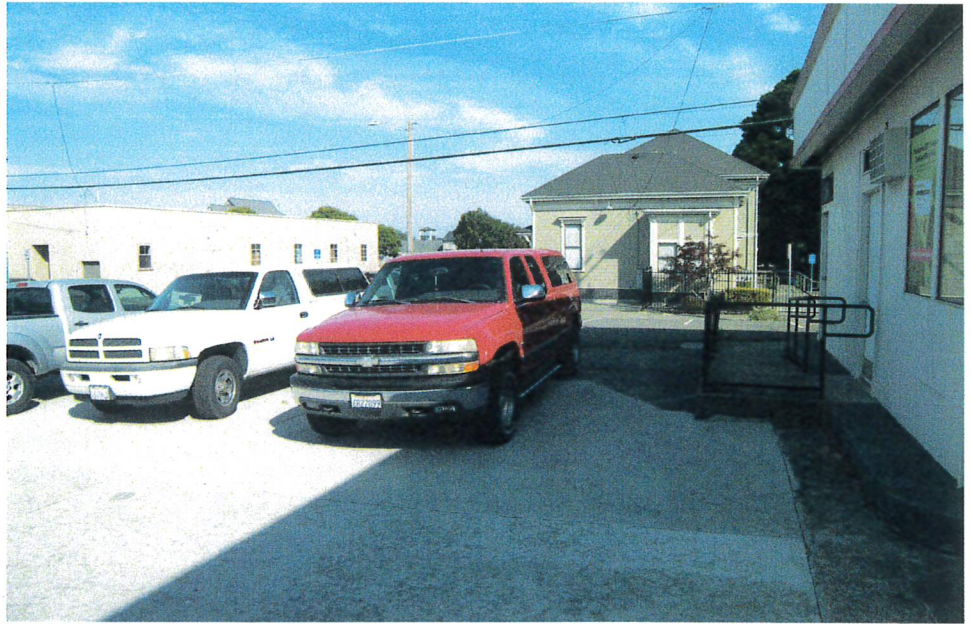
Looking north along west side of building. Angled concrete ramp accessing the restroom is straight ahead.

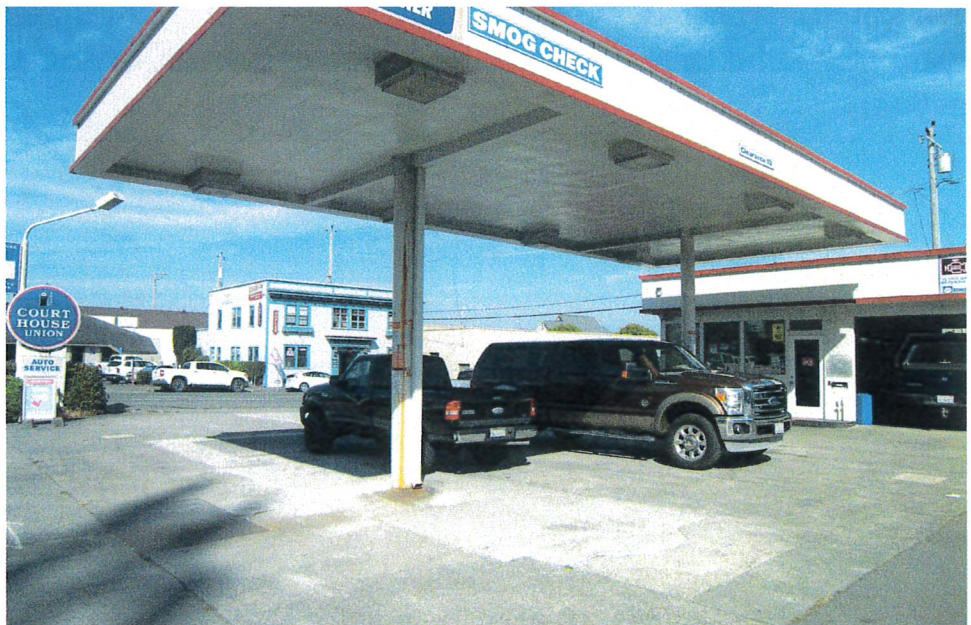
Looking northwest over steel frame canopy. This extends 45' south of the building.

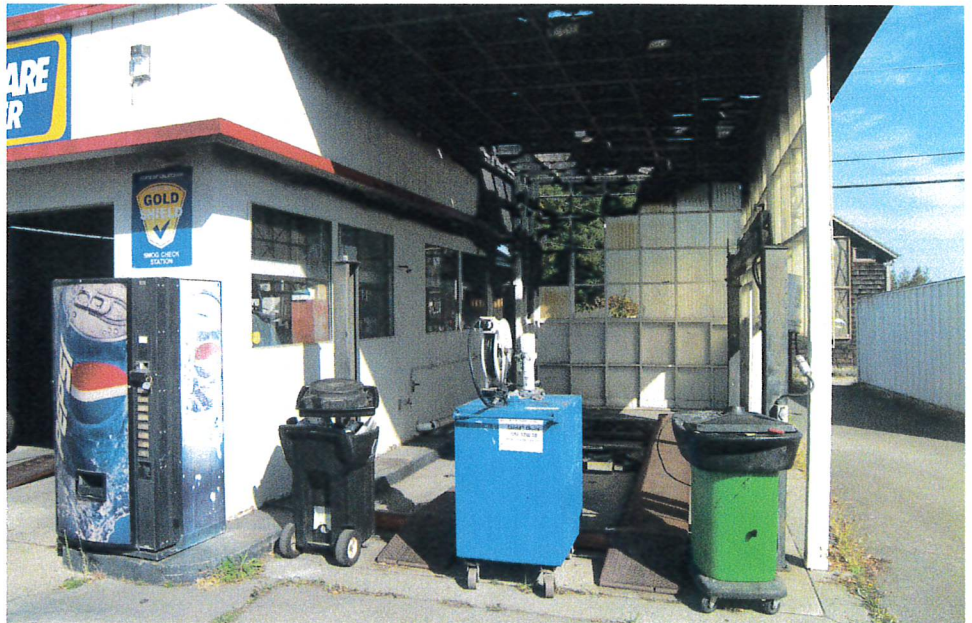
Looking northerly over attached shop building. The roof, siding and rear wall were extensively damaged by the fire.

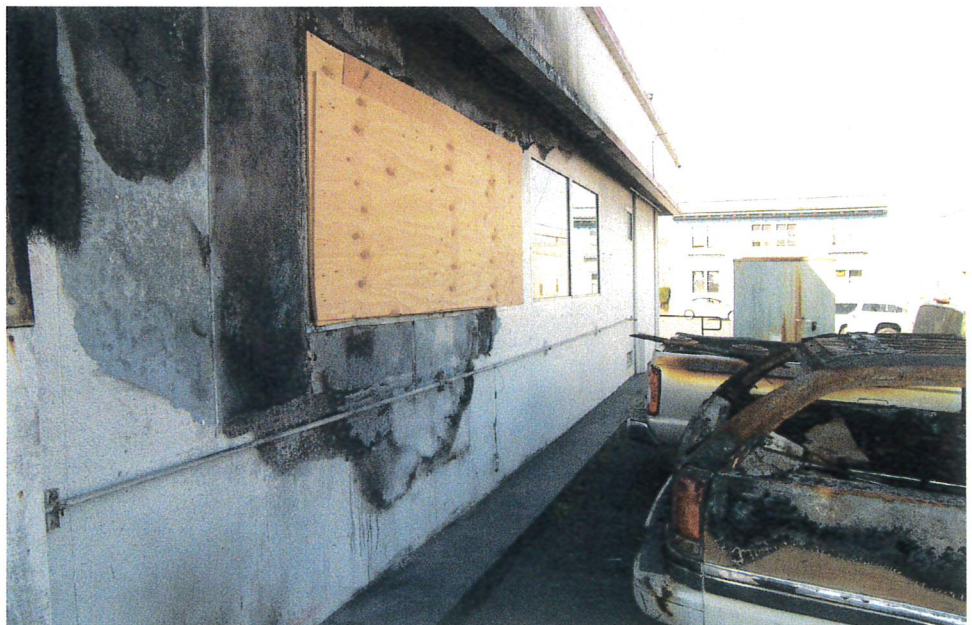
About 1.5± months ago, a fire partially burned the north side of the building, attached work area/cover, and nearby vehicle. Reportedly, there was a considerable amount of smoke and soot damage to the interior. Some cleanup has occurred, yet no corrective/repair work has begun as of the date of my inspection. The overall condition of the electrical, plumbing, foundation, HVAC system, roof, and other building components are unknown by this appraiser. The estimated value shown herein assumes the overall condition of the above mentioned items, and others not stated earlier, are in below average± condition. Client to be aware of the above information and satisfy themselves accordingly.

Looking westerly along north side of building. The fire supposedly began within vehicle to right which caused exterior damage to the improvement, including window and fascia straight ahead and to the left.

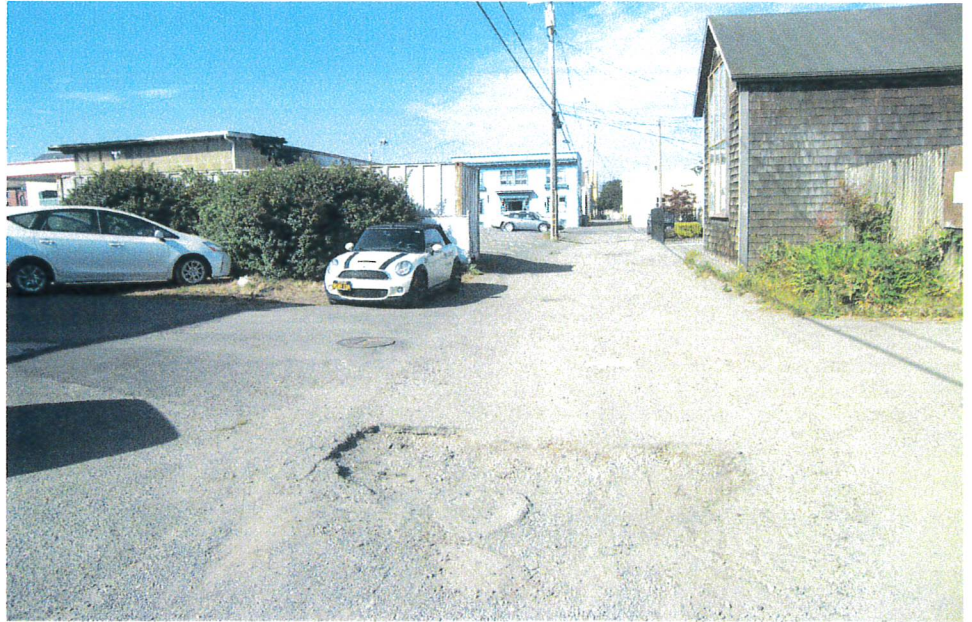
Looking westerly over 20' wide alley. Notice condition of this thoroughfare. The appraisal property is farther down and to the left.

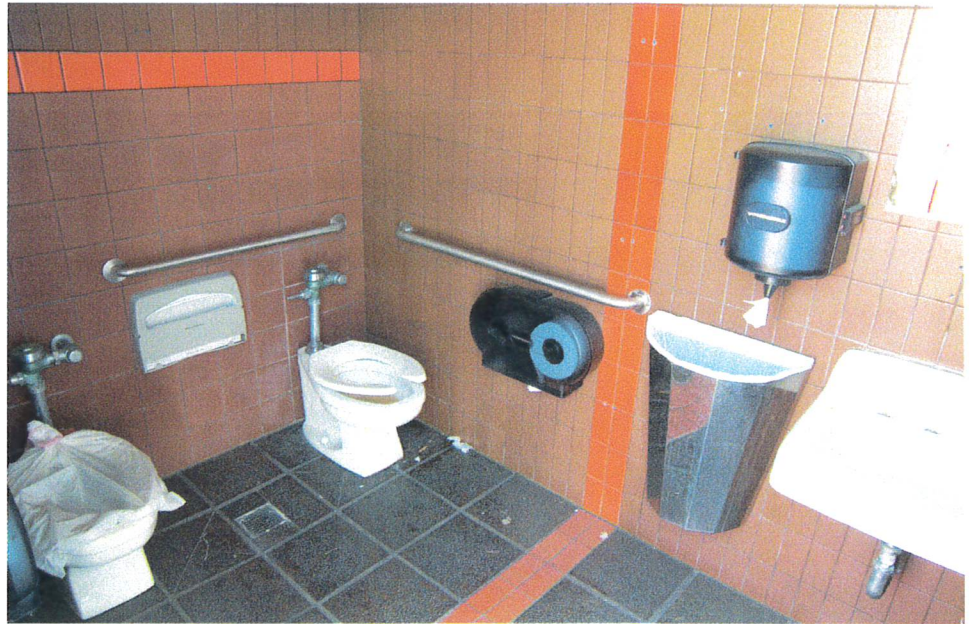
Southern restroom which has been enlarged and updated to partially comply with ADA.

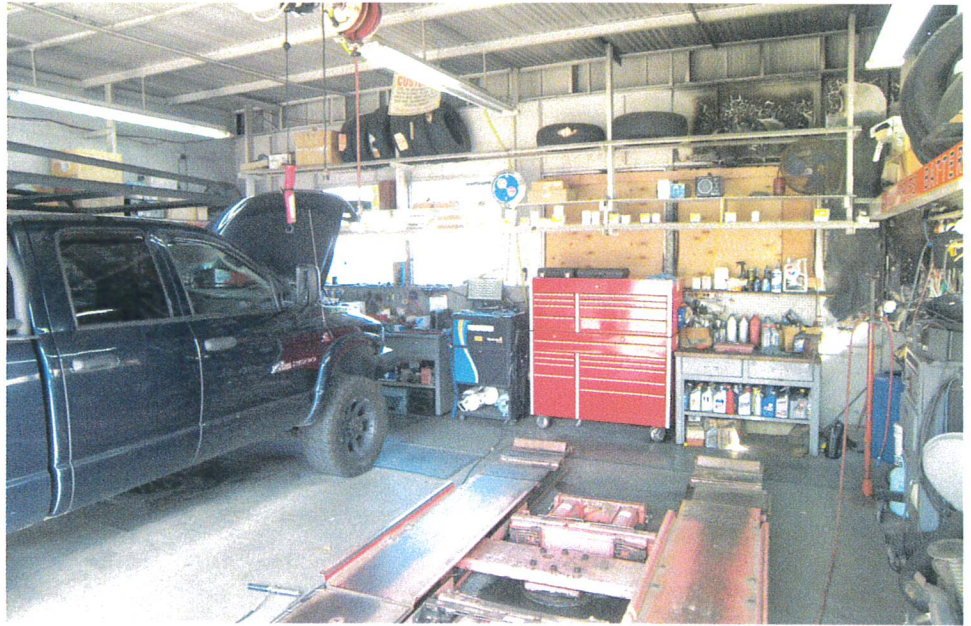
Looking northerly over two bay shop space. Soot and fire damaged ceiling and walls are straight ahead and to the right.

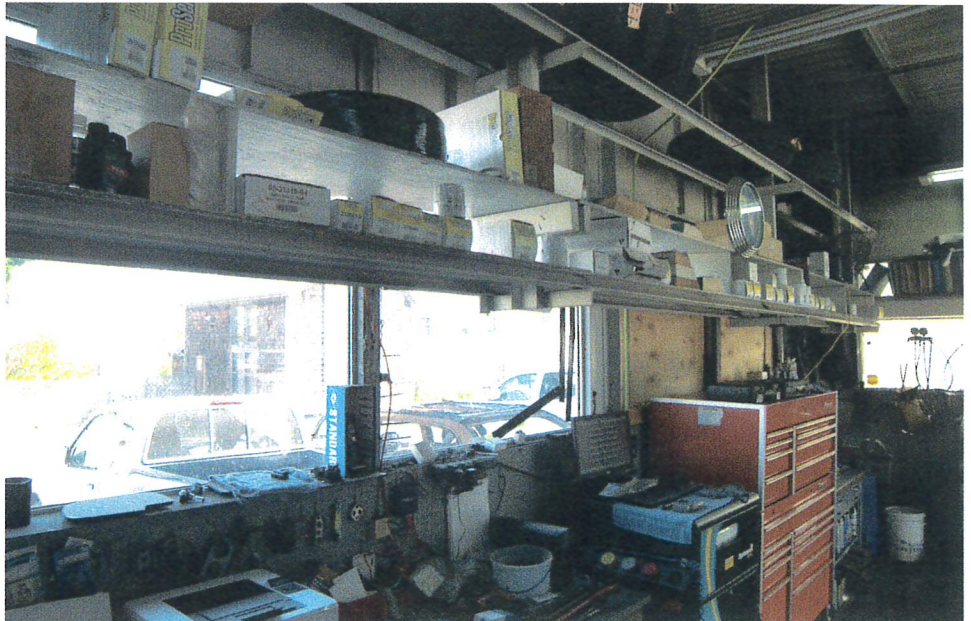
Looking easterly along northern portion of shop space. There is a considerable amount of soot along the ceiling and walls within this specific area.
