MEMORANDUM

RE: **Revised Notification for 1600-2019-0011 – Description of informational items**

Notification 1600-2019-0011 - Revision
Site 1 Remediation Area: 1,293 sq. ft.
Site 2 Remediation Area: 2,741 sq. ft.

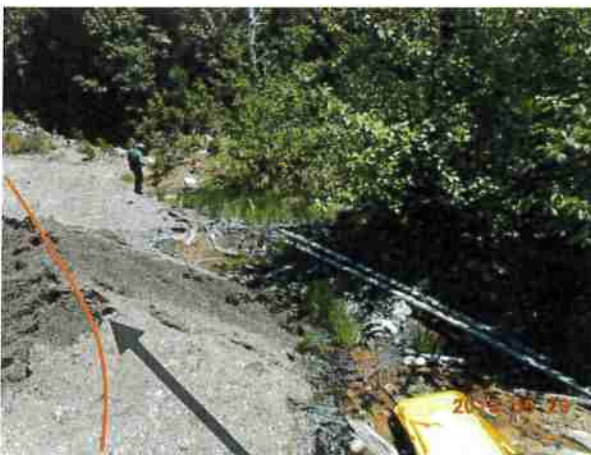
During the 2019 site visit, cultivation soils had been temporarily placed on the road next to the depression and some had entered the water due to lack of BMPs. The toe of the fillslope touches the west end of the depression as well.

Fig. 1. Soil on skid road next to wetted depression, looking east

1. All cultivation-related spoils will be removed from and adjacent to the depression
2. The fillslope will be pulled back and recontoured
3. Temporary and permanent BMPs will be established, which includes stabilizing the fillslope with fiber rolls, straw, and straw wattles, anchoring in a silt fence at the base of the fillslope, and staking in construction fencing between the skid road and depression as an avoidance measure.
4. Avoidance of riparian vegetation during and after construction

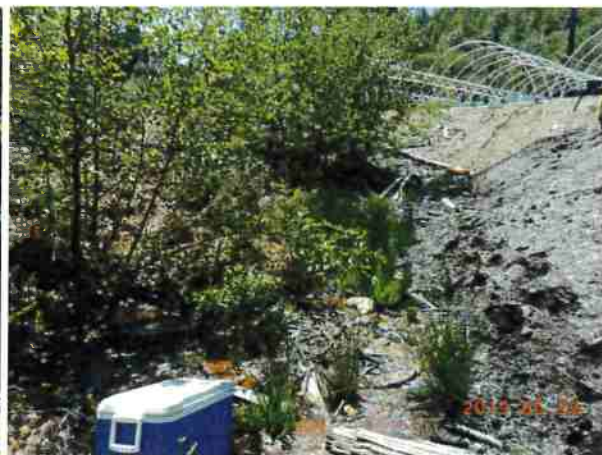
Fig. 2. Fillslope and soil encroaching on riparian vegetation

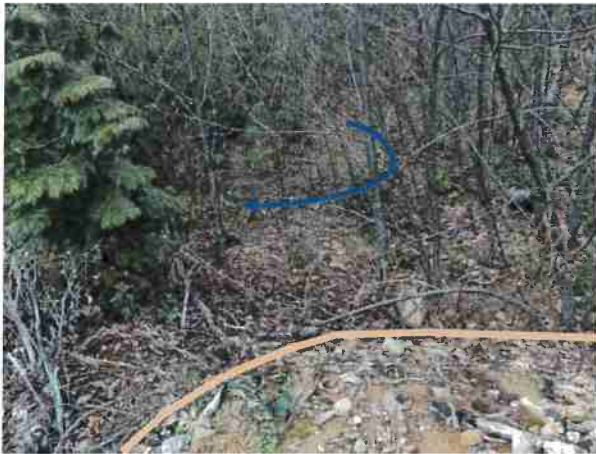
A class III ephemeral stream is near the southern edge of the cultivation flat. When this section of the original landing was expanded, it encroached upon the riparian habitat of the stream. The toe of the slope is just a few feet away from the top of bank and creek alders are growing along the fillslope (Figure 3). Erosion is not apparent on this southern fillslope, but it has not been stabilized with appropriate erosion and sediment control measures.

Fig. 3. Class III stream and toe of the fillslope

1. Pull the fillslope back 50 ft from the top of bank and recontour to a 2:1 slope
2. Install erosion and sediment control BMPs before and after construction, similar to Site 1
3. Avoid riparian vegetation to the extent feasible

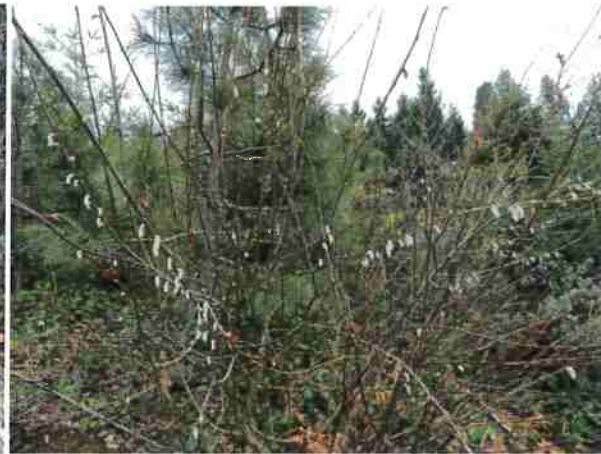
Approximately 6-10, 4-6" trees growing out of the fillslope will likely need to be cut down as part of the landing retreat. This includes Jeffrey pine, willow, and creek alder (Figure 4).

Fig. 4. Vegetation on top of the southern edge of the cultivation flat fillslope

Once the fillslope is pulled back and stabilized, the thicket-forming alders are expected to regrow within the first year, widening and enhancing the riparian habitat.
