ATTACHMENT 5

SLOPES, STABILITY, SEISMIC SAFETY, AND HOUSING INVENTORY FIGURES

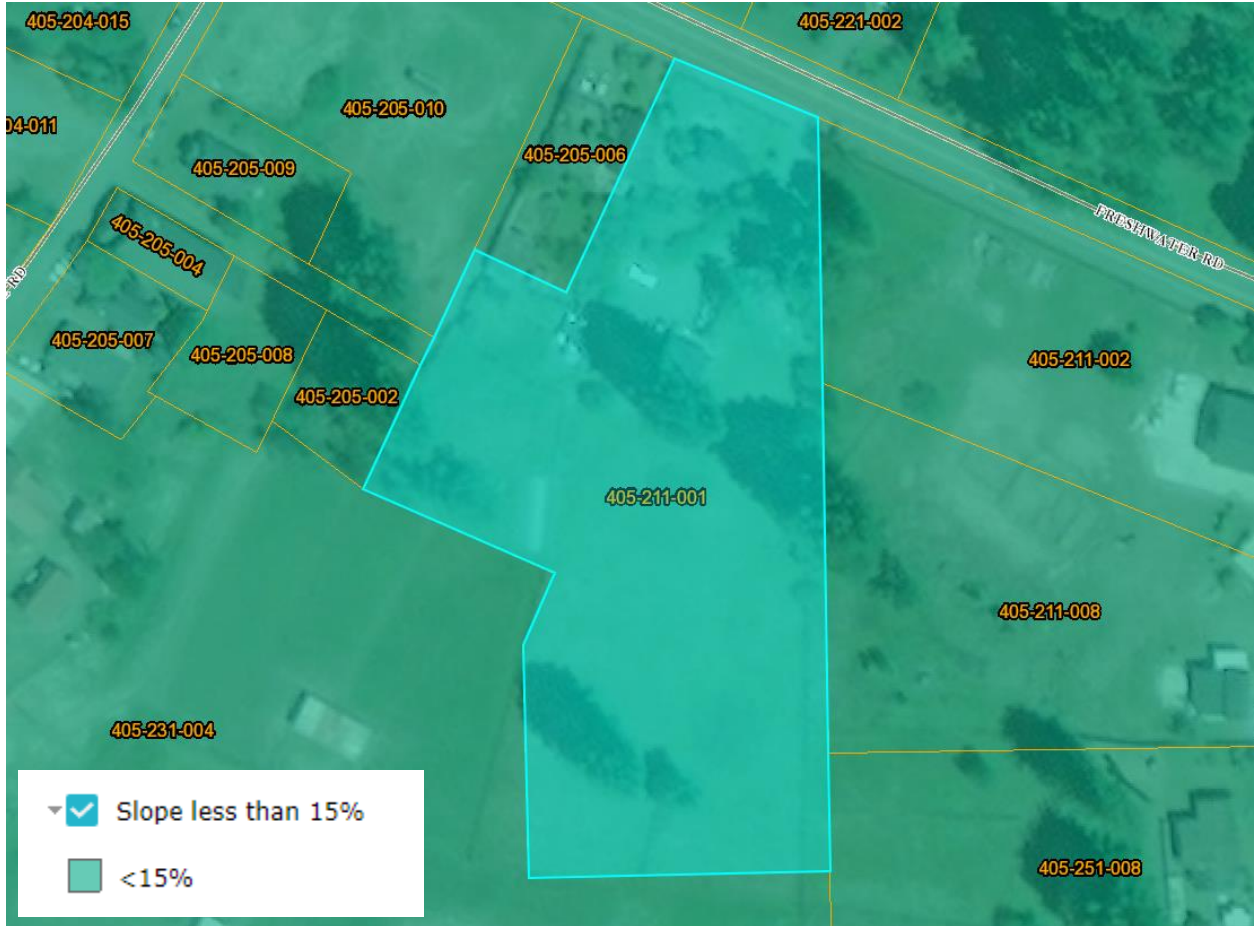
FIGURE 1 -SLOPE MAP

Note: The entire 2.30 acres of the Project Area contain slopes under 15%
