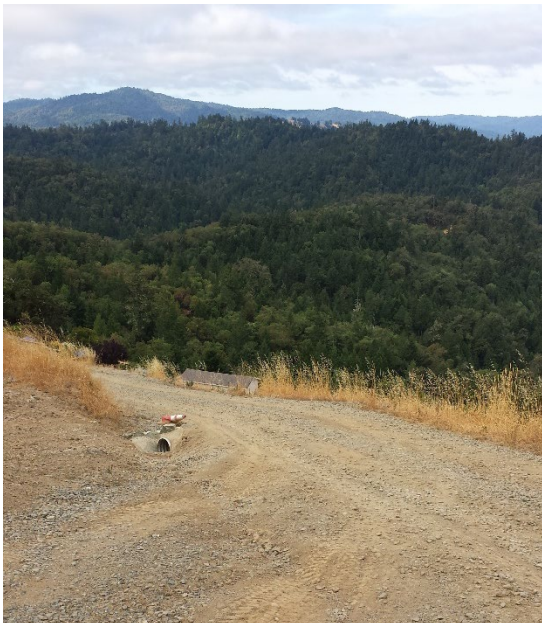
In 2015, prior to Mr. Carmichael adding the second dwelling to his property under County application 13979 SP18-002, the culvert that brought the water across the private road looked like this:

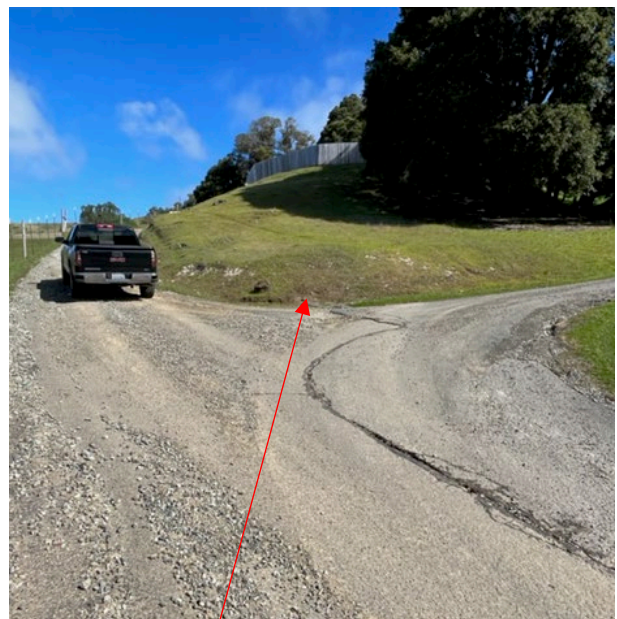
Approximate location of culvert inlet

The existing culvert across Mr. Carmichael's driveway from the private road is well beyond the footprint of the project and the District does not intend on making any changes to that culvert.

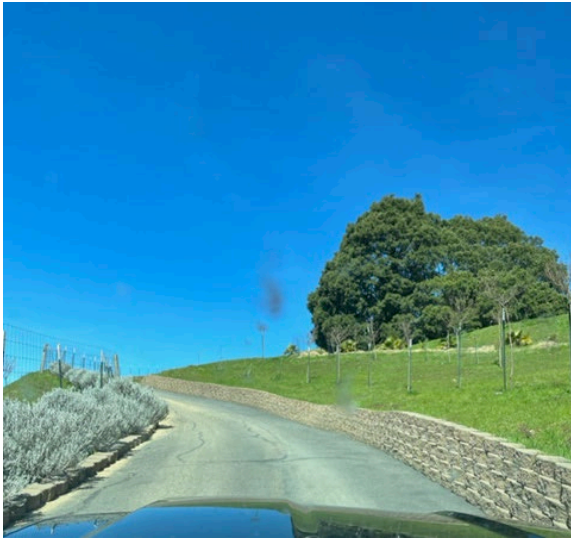
As can be seen in the photo below, the overall drainage problems on the bottom section of this driveway are due to Mr. Carmichael filling in the ditch and installing a retaining wall.

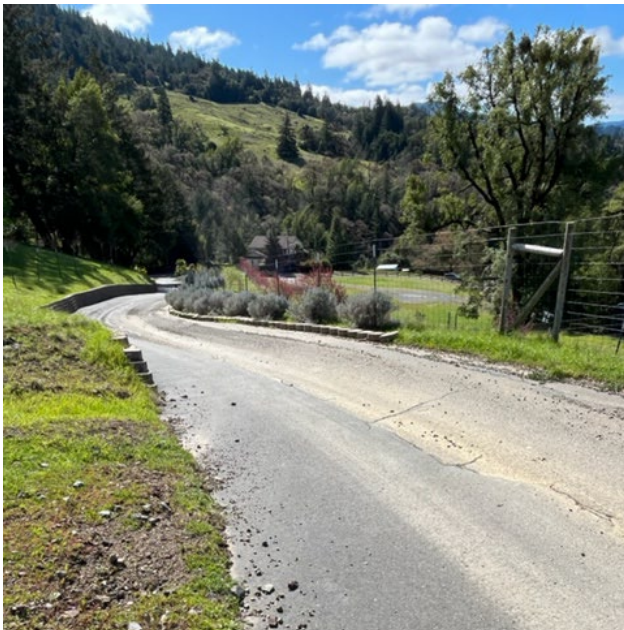
The water used to be able to run off the side of the road into the pasture, but the installation of blocks along both sides of the road has created a funnel for the water to run down the roadway on the paved section. These blocks were installed by Mr. Carmichael.

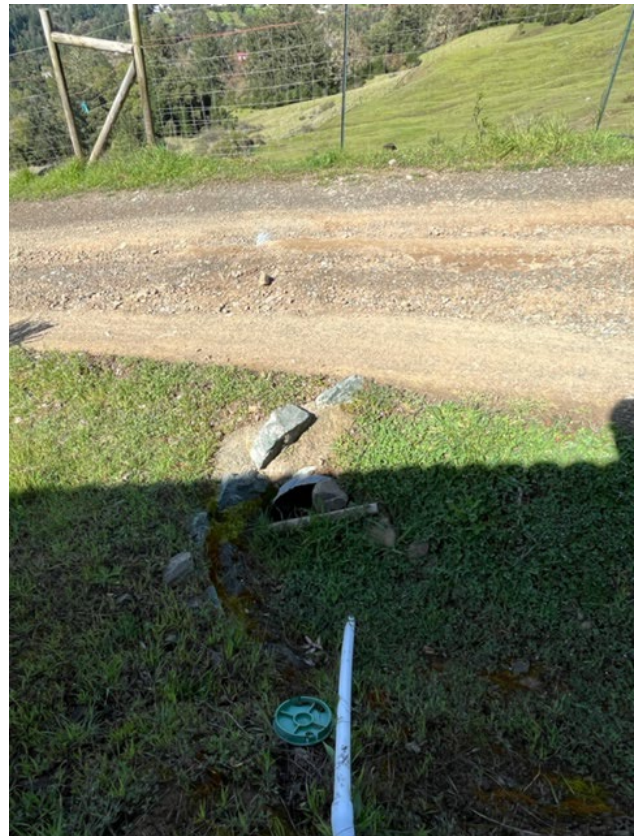
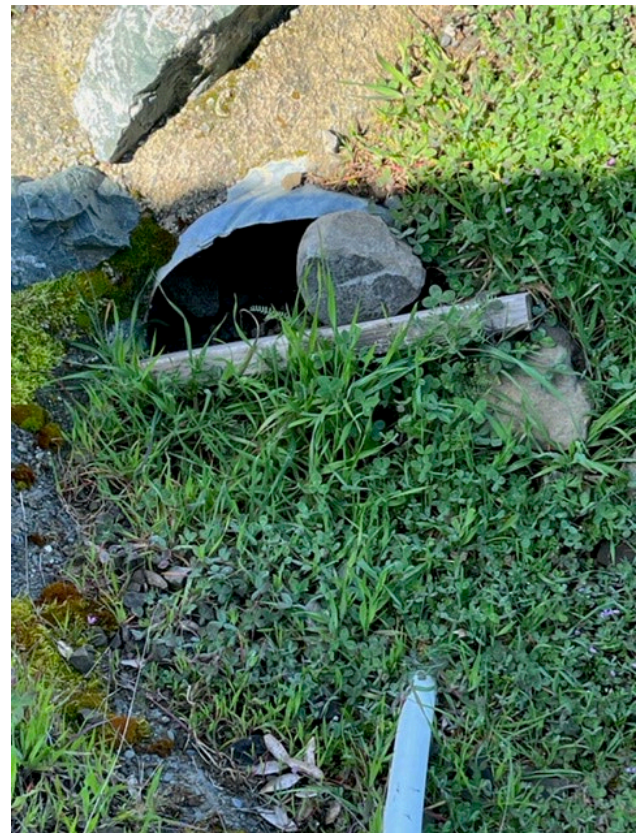
In addition, he has placed a personal waterline to water his stock in the culvert that brings water across the roadway and placed pieces of wood and rock to block the culvert in an effort to redirect the runoff away from his property and onto an adjacent neighbor's property.
