Subject: Notice of Violation, Transmittal of Inspection Report for September 7, 2023, Inspection of Humboldt County Assessor's Parcel Number 107-054-036-000, and Requirement to Respond within 30 days

North Coast Regional Water Quality Control Board
Cannabis Water Quality Inspection Report
 APN(s): 107-054-036-000

Inspection Date and Time			
Inspection Date		September 7, 2023	
Inspection Start Time:	07:30	Inspection End Time:	10:30
Site Location			
Address/Location		47730 Mattole Road, Honeydew, CA 95545	
County		Humboldt	
Assessor's Parcel Number(s) (APN(s))		107-054-036-000	
Watershed		Upper North Fork Mattole River	
Property Owner Contact Information			
Property Owner		Evan Kouchalakos	
Mailing Address		74 Amherst Road, Merrimack, NH 03054	
Warrant Information			
Agency Responsible for Warrant		CDFW	
Person Responsible for Warrant		Josh Zulliger	
Warrant Date		September 7, 2023	
Lead Inspector, Team Members, Other Agencies and Personnel Onsite			
Lead Inspector Name		Katherine Hawken	
Lead Inspector's Credentials		Water Resource Control Engineer	
Office/Regional Board		North Coast Regional Water Quality Control Board	
Author of Report		Katherine Hawken	
Database Identifier			
C

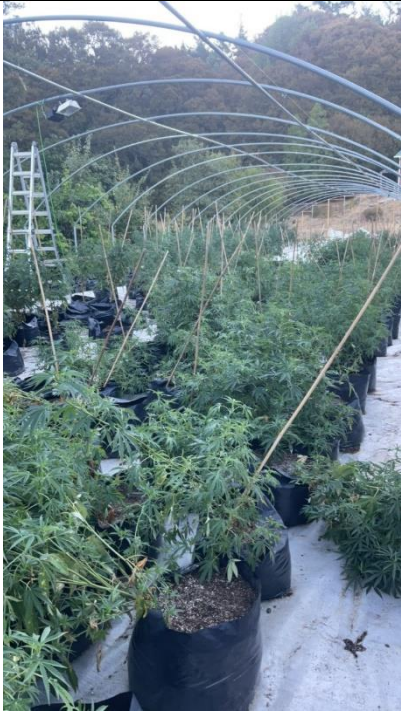
Photo Number: 2
	Photo Description: Inside view of second hoop house.
	Facing Northeast

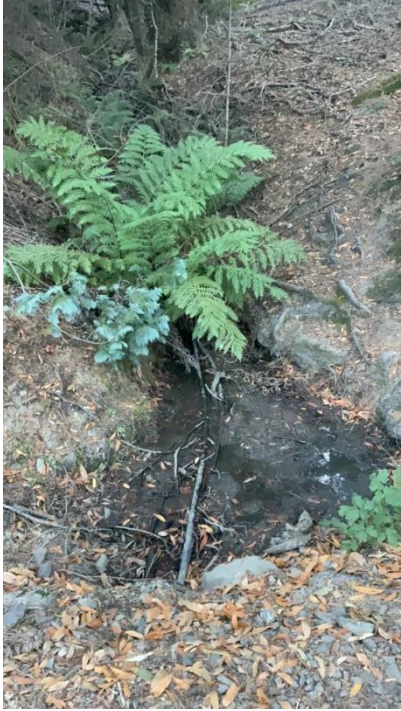
Photo Number: 2
	Photo Description: Ponding at undersized culvert inlet.
	Facing East

4. Retain a qualified professional to assess the culvert stream crossings for capacity to convey a 100-year flow event and associated debris, disconnect road ditches from watercourses, and recontour roads to prevent discharge to receiving waters.
5. Apply for a 401 water quality certification prior to work instream to replace culverts.
6. Work with the State Water Board Division of Water Rights and the California Department of Fish and Wildlife to obtain necessary permits to divert and store water.
7. Do not use water storage bladders unless the bladder is safely contained within a secondary containment system with sufficient capacity to capture 110 percent of a bladder's maximum possible contents in the event of bladder failure.

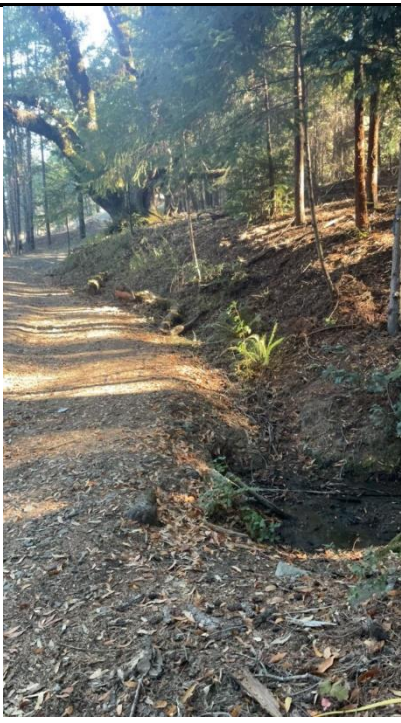
<p>Photo Number: 4</p> <p>Photo Description: Road ditch discharging into inlet of culvert.</p> <p>Facing North</p>

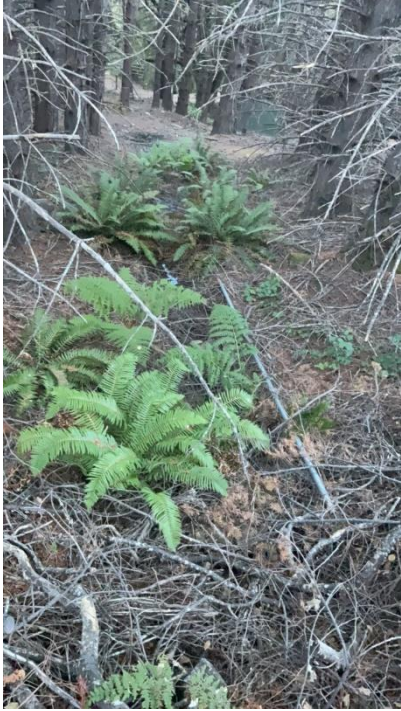
P4: I observed a spring with an approximately 50-foot wet area below it. I observed electrical conduit in the spring channel.

Photo Number: 2
	Photo Description: Electrical conduit in spring channel.
	Facing West

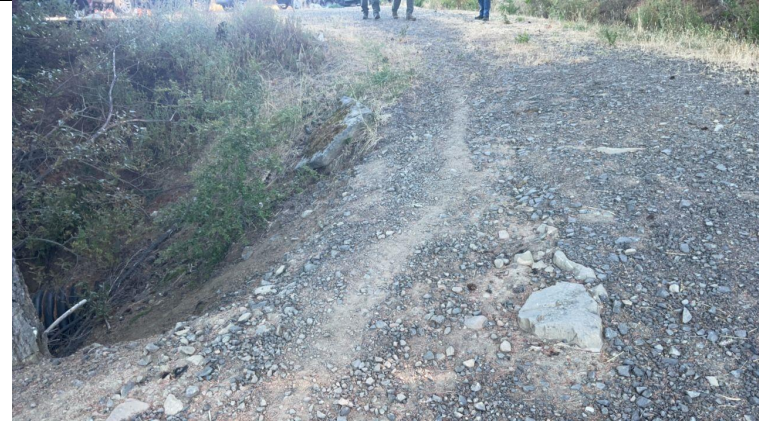
Photo Number: 4
Photo Description: Eroding dirt road prism.
Facing West

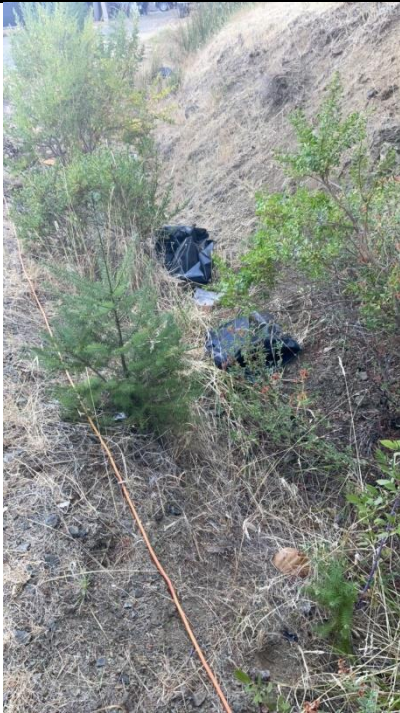
Photo Number: 5
Photo Description: Road ditch with trash
leading to culvert inlet.
Facing North

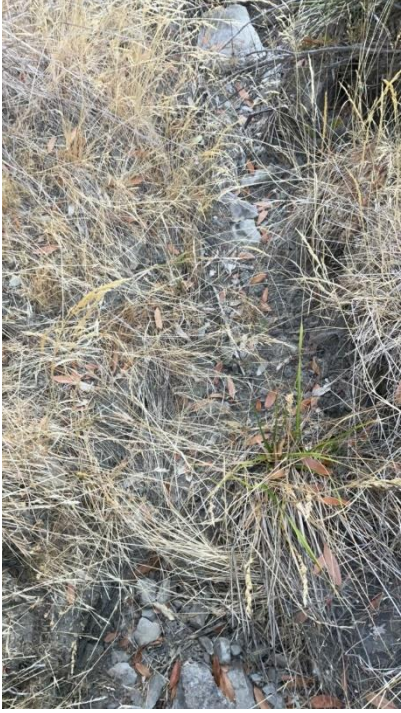
Photo Number: 7
	Photo Description: Watercourse channel approximately 20 feet from cultivation area.
	Facing East
