Integrated Horticulture Systems LLC Less Than Three Acre Conversion Mitigation Plan

This document has been prepared pursuant to Section 55.4.10(j) of the Humboldt County Commercial Medical Marijuana Land Use Ordinance, applications for Commercial Cannabis Activity occupying sites created through prior unauthorized conversion of timberland. The document evaluates site conditions and conversion history for the parcel and contains a Registered Professional Foresters (RPF's) recommendation as to remedial actions necessary to bring the conversion area into compliance with provisions of the Forest Practice Act.

a. Site Address: 8200 Salmon Creek Road Miranda, CA

c. Assessor's Parcel No(s): 221-011-021

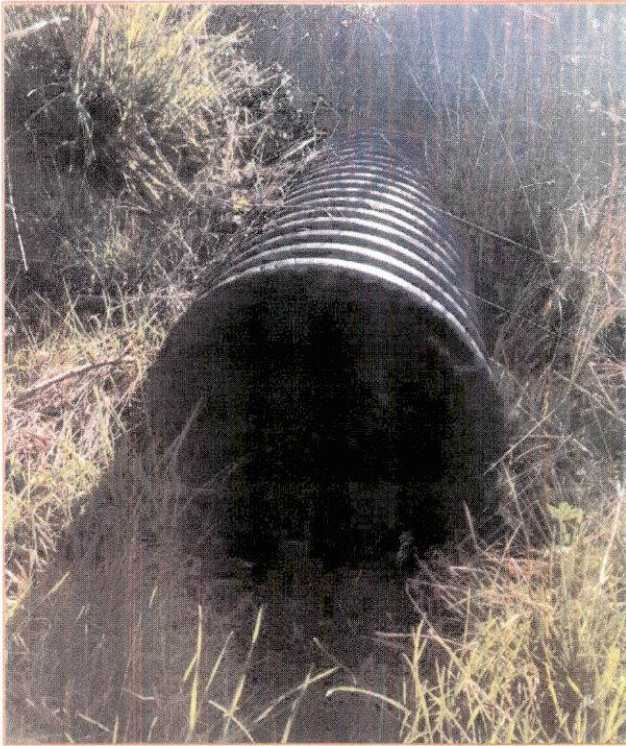
RP6) View of outlet, existing and functional DRC.

RP6 Existing and functional 18" diameter ditch relief culvert (DRC). Clean and maintain the inlet and outlet. If DRC fails, install oversized 24" diameter DRC.

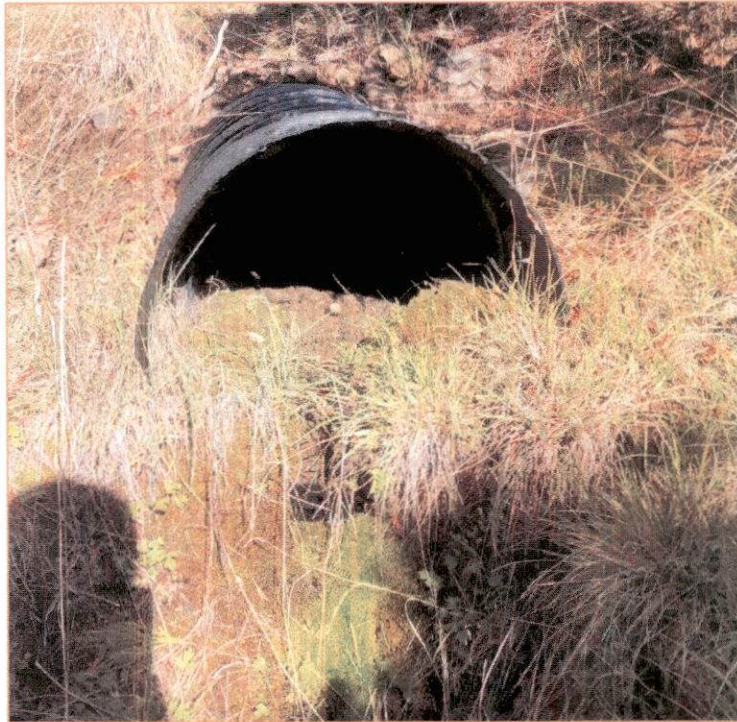
RP9) Clean and maintain DRC inlet.

RP9) Clean and maintain DRC outlet.

RP9 Existing and functional 18" diameter DRC. Clean and maintain the inlet and outlet.

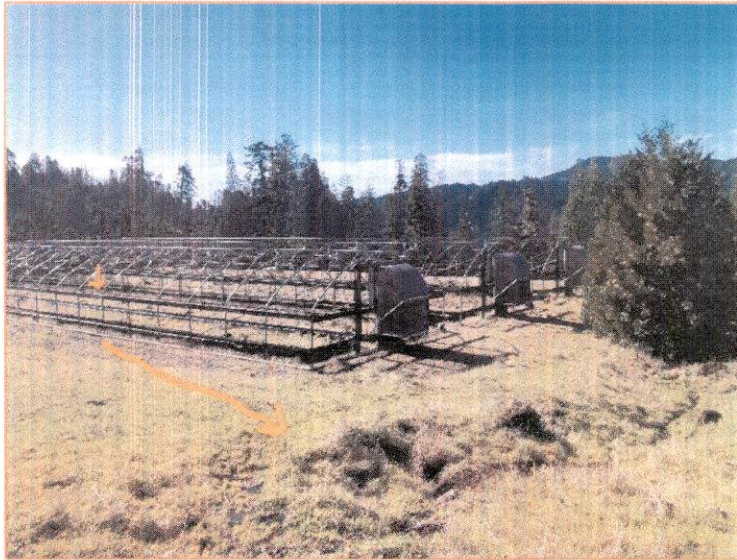
RP12) Remove greenhouse infrastructure within a class III stream buffer.

RP12) View of greenhouses from class III stream, note arrows display 50' riparian buffer setback.

RP12 Three greenhouses present at Site 2 within 35' of a Class III watercourse. Pull back the cultivation infrastructure outside of the 50' ELZ riparian buffer, including all grow soil. Seed and mulch all exposed native soil within the buffer once removal of cultivation infrastructure and grow soil is complete.
