DIRECTOR OF DEVELOPMENT SERVICES
 STAFF REPORT
 November 13, 2023

Title:	Carrington Company Lot Line Adjustment Coastal Development Permit
Project:	Coastal Development Permit CDP-23-0003
Location:	4775 Broadway (aka 4635 Broadway)
APN:	302-171-035
Applicant:	The Carrington Company
Property Owner:	Francis and Carole Carrington, Trustee of the Carrington Family 2000 Trust
Purpose/Use:	Lot line adjustment between three parcels resulting in three parcels
Application Date:	May 8, 2023
General Plan:	Coastal Agriculture (A), and Inland Agriculture (A) and Residential Estates (RE)
Zoning:	Coastal Agriculture (AC), and Inland Agriculture (A) and Residential Estates (RE)
CEQA:	Exempt under §15305, Class 5 Minor Alterations in Land Use Limitation
Staff Contact:	Caitlin Castellano, Senior Planner
Recommendation:	Hold a public hearing; and Adopt a resolution finding the project exempt from CEQA, and approving with conditions
Action:	<i>"I hereby adopt a resolution finding the project exempt from CEQA, and approving with conditions a coastal development permit for a lot line adjustment at 4775 Broadway (APN 302-171-035)."</i>

Wetland Delineation
Carrington Company Subdivision
4775 Broadway, Eu

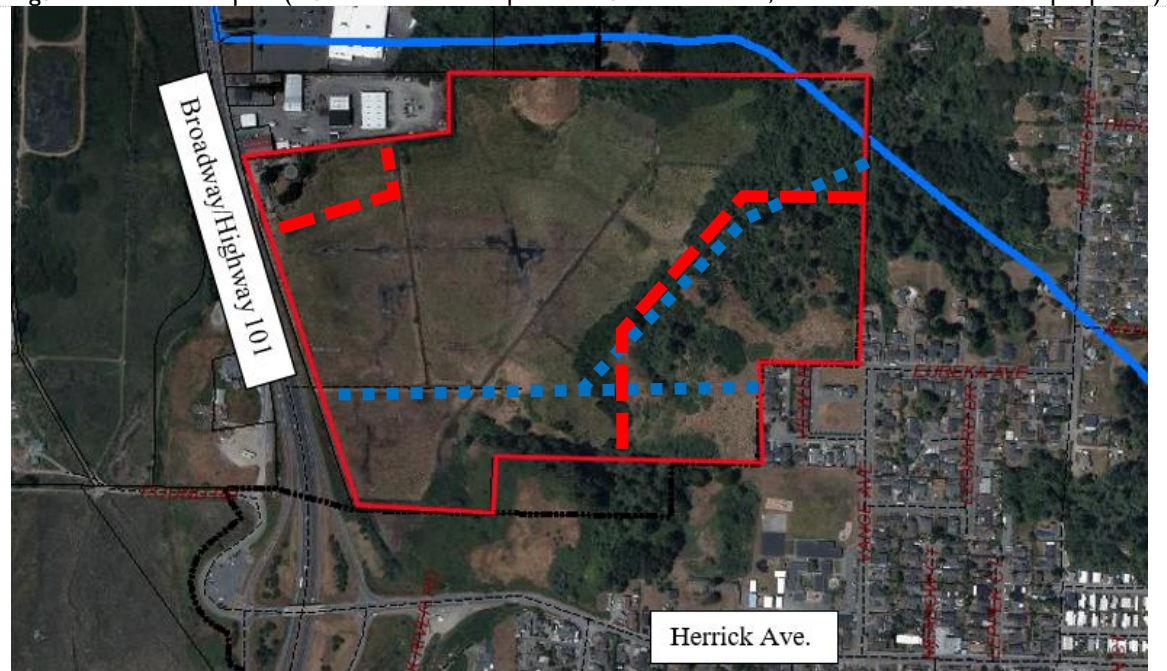
Figure 3: Aerial site plan (blue broken lines represent current lot lines, and red broken lines are proposed)

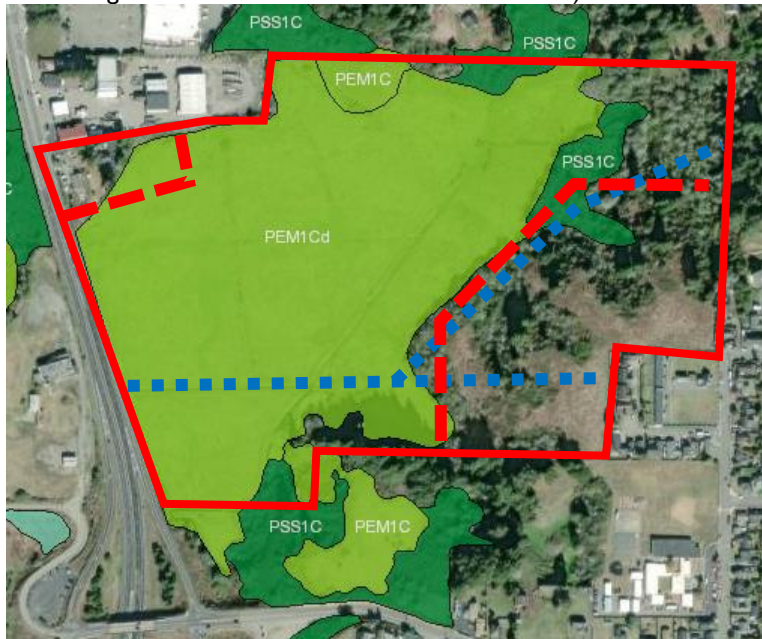
Figure 5: U.S. Fish and Wildlife Service's National Wetlands Inventory (light green is freshwater emergent wetland, and dark green is freshwater forested/shrub wetland)

In total, ~54 acres of the property are lowland (mapped as wetland in the U.S. Fish and Wildlife Service's National Wetlands Inventory [Figure 5]) and ~31 acres are upland (~1.4 acres located in the northwestern portion of the property are associated with the existing development, and ~29.5 acres are located on the eastern portion of the property). Resultant Parcel A would contain all existing development and contain upland and lowland, resultant Parcel B would contain mostly lowland and continue to be used as grazed wetland, and resultant Parcel C would be mostly upland. In 2012, a wetland delineation (Attachment 3) was completed for the eastern upland-portion of the property (proposed resultant Parcel C) when the property owner previously contemplated development there, and it showed that the upland terrace could be accessed and developed without filling wetlands. However, no wetland delineation has been submitted as part of this application, and given the National Wetlands Inventory mapping shows most of resultant Parcel B is wetland, it can't be assumed that resultant Parcel B would have an upland footprint that could be accessed and developed without filling wetlands.

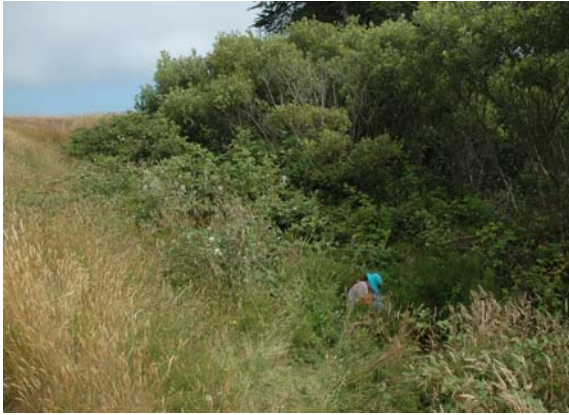
Photo 1. Ravine top showing geomorphic position, hydrophytic vegetation and wildlife habitat.

The dominant geomorphic characteristic of this site is the gullying that dissects the terrace slope faces. These gullies are filled with riparian plant species providing excellent habitat for a wide variety of bird species (Photo 1, Attachment 4). As rainwater infiltrates the terrace, it hits the lower, compacted layers where it flows laterally to the west. The subterranean water reaches the gullies where it comes close to, or even emerges from, the soil surface and flows downhill (Photo 2, Attachment 4). This water creates riparian/wetland habitat along the gullies (Photo 3, Attachment 4). In some areas of the site, the water table remains too deep to be classified as a Corps wetland, but deep-rooted riparian plants such as willow and ferns are able to grow on the site (Pits 9&10 and associated gully).

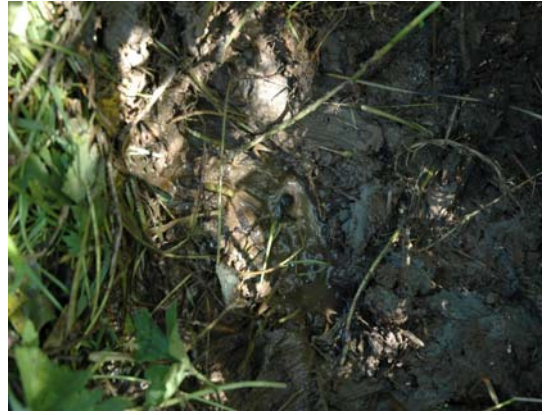
Photo 2. Obvious wetland hydrology at Pit #3.

Four jurisdictional wetlands were found in the study area (Table 1 and Attachment 2). The four wetland areas are visually revealed by either surface water or saturation, along with hydrophytic vegetation and geomorphic position (photos 2 & 3). A total of six wetland pits were dug, with wetland Pits 6, 11 and 12 in the same wetland. Pit #s 3, 4, 6, 11, 12 and 15 fell into this category. Generally the presence of hydric soil indicators corresponded well with surface hydrology, hydrophytic vegetation and geomorphic position, all of which were found at the wetland pits (Photos 11-14, respectively).

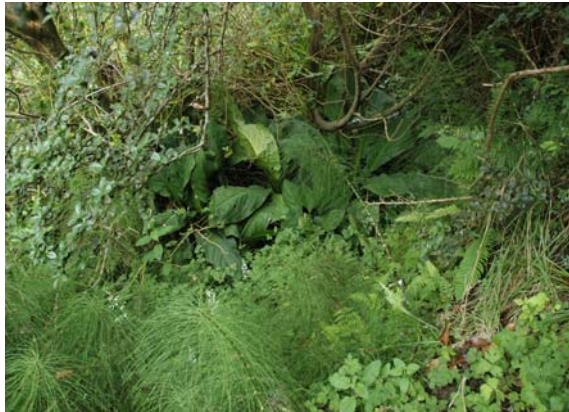
Photo 3. Hydrophytic vegetation at Pit #11.

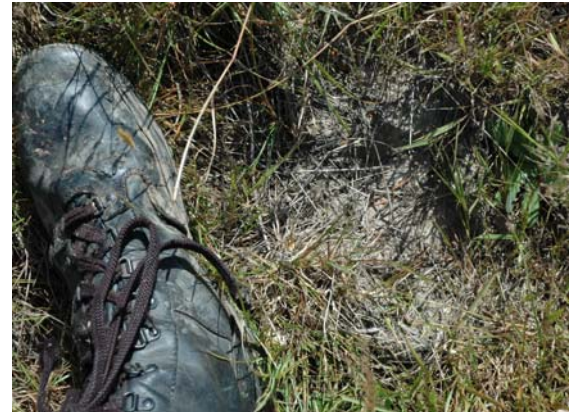
Photo 4. Cowpaction preventing plant growth.

This site has historically been used for cattle grazing, extending into the wet season when hoof traffic had its maximum negative impact via erosion and soil compaction throughout the site, particularly in the streams (Photo 4, Attachment 4). Soil compaction leads to increased runoff volume and velocity, which degrades adjacent waterways. Furthermore, unrestricted access to the streams would allow animal feces and urine to enter streams directly. Bacterial, protozoan and viral pathogens can comprise biological pollution in these settings (Atwill et al. 2011). Additionally, concentrated animal traffic has led to areas favoring invasive species such as *Anthemis cotula* (Photo 5, Attachment 4).

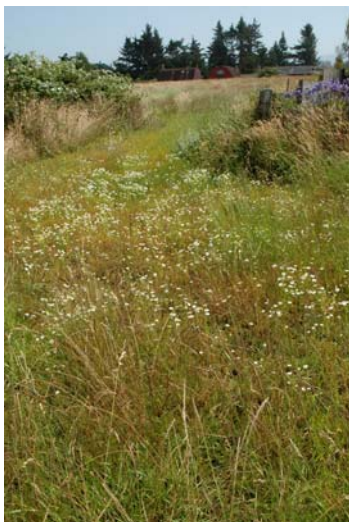
Photo 5. Invasive *Anthemis cotula* revealing livestock-induced compaction.

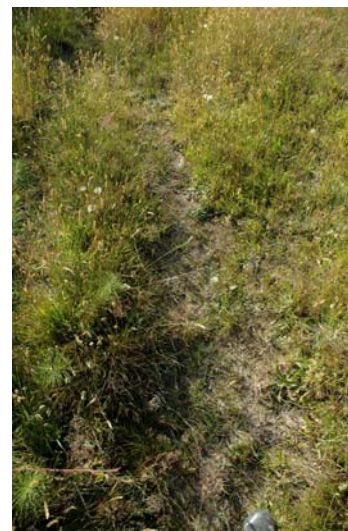
Photo 6. Compacted cow trail where grass barely grows during height of growing season.

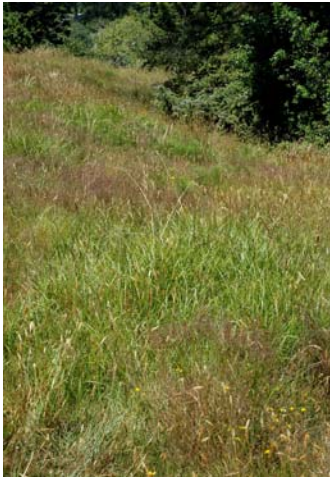
Photo 7. Sedge growing on upland below slope break.

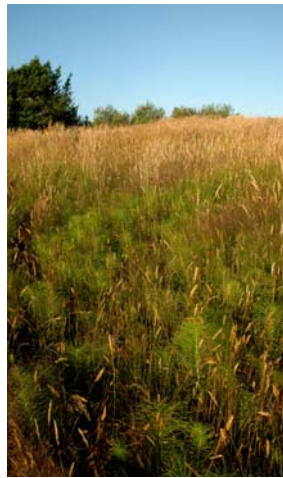
Photo 8. Equisetum growing below slope break.

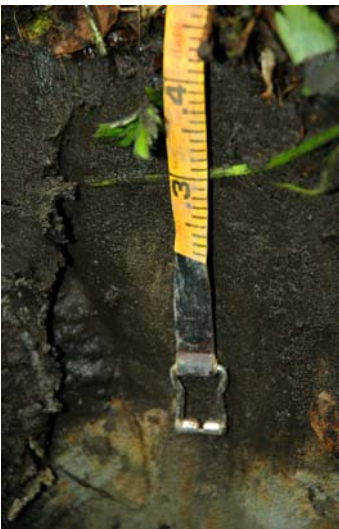
Photo 9. Loamy Mucky Mineral revealing wetland.

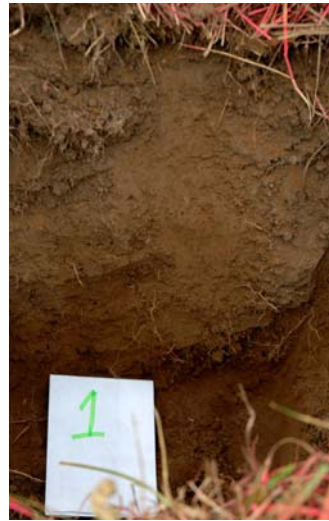
Photo 10. Dark red upland soil with no indicators.

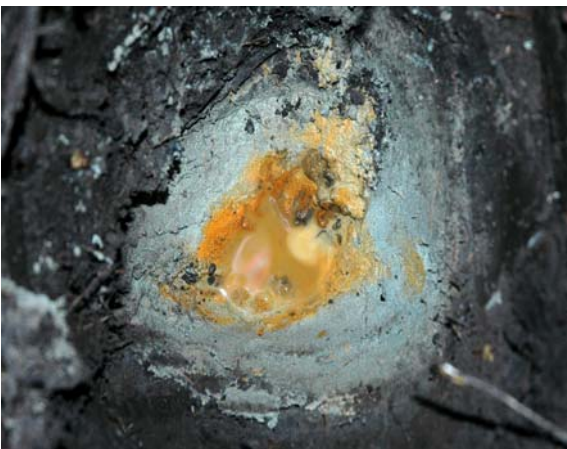
Photo 11. Loamy Mucky Mineral with gleyed subsoil indicating hydric soil.

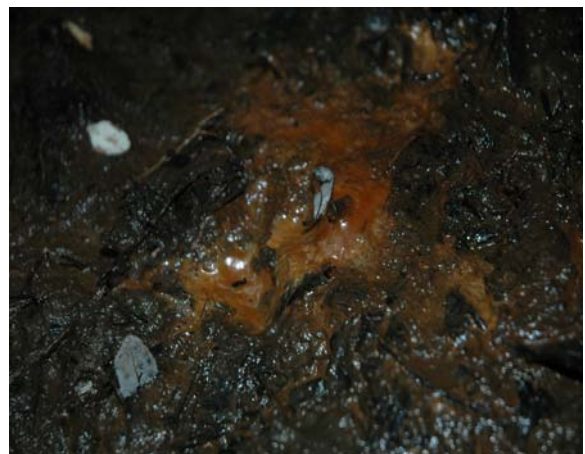
Photo 12. Surface water and iron deposit wetland hydrology indicators.

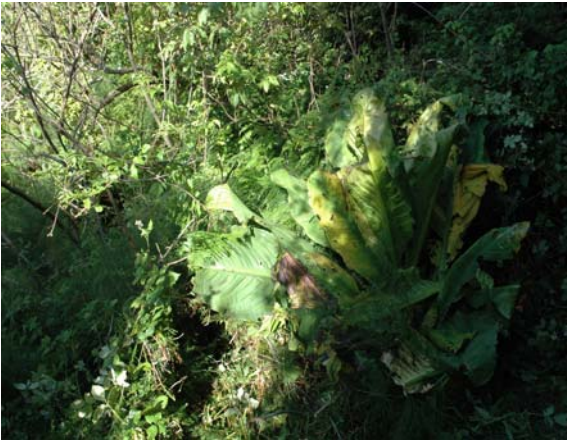
Photo 13. Hydrophytic vegetation including skunk cabbage.

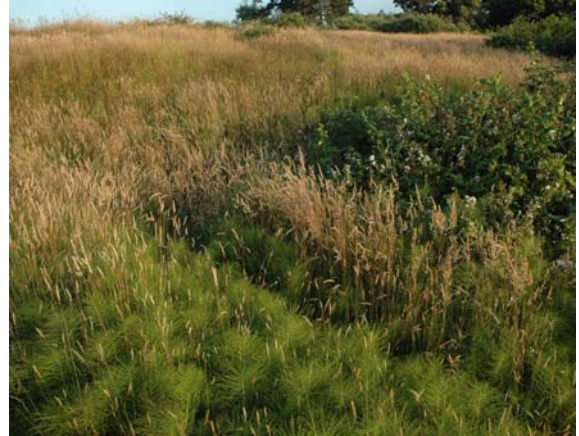
Photo 14. Geomorphic position at head of ravine (ESHA #4).

The only exception to this correspondence between wetland parameters was the presence of hydrophytic vegetation at Pit #s 2, 8, 10, 13 and 14, where wetland hydrology and hydric soils were lacking (Photo #s 14 & 15). These pits represented areas that appeared to be potential wetlands when looking at the vegetation, but lacked the obvious hydrology. These areas included slumps and the areas below the terrace slope breaks where large patches of sedge or *Equisetum* were found. Examination of soil pits at these sites revealed a lack of wetland hydrology or hydric soils.

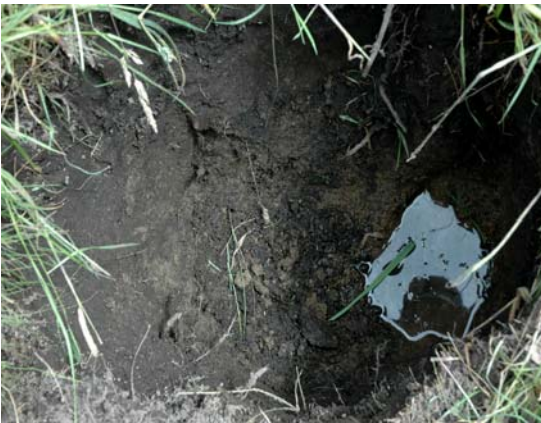
Photo 15. Groundwater too deep to form hydric soil or meet wetland hydrology indicator status.

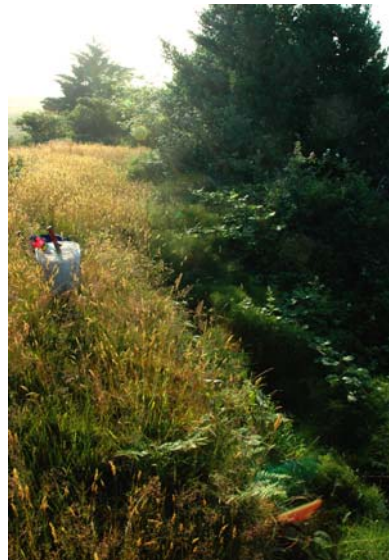
Photo 16. Slope break dropping into ravine above Pit #s 11-14 showing beginning of riparian habitat.
