**Riparian and Stream Assessment**  
**For**  
Showers Creek  
Kneeland, CA

April 26th, 2017

*Prepared for:*  
**Timberland Resource Consultants**  
Fortuna, CA

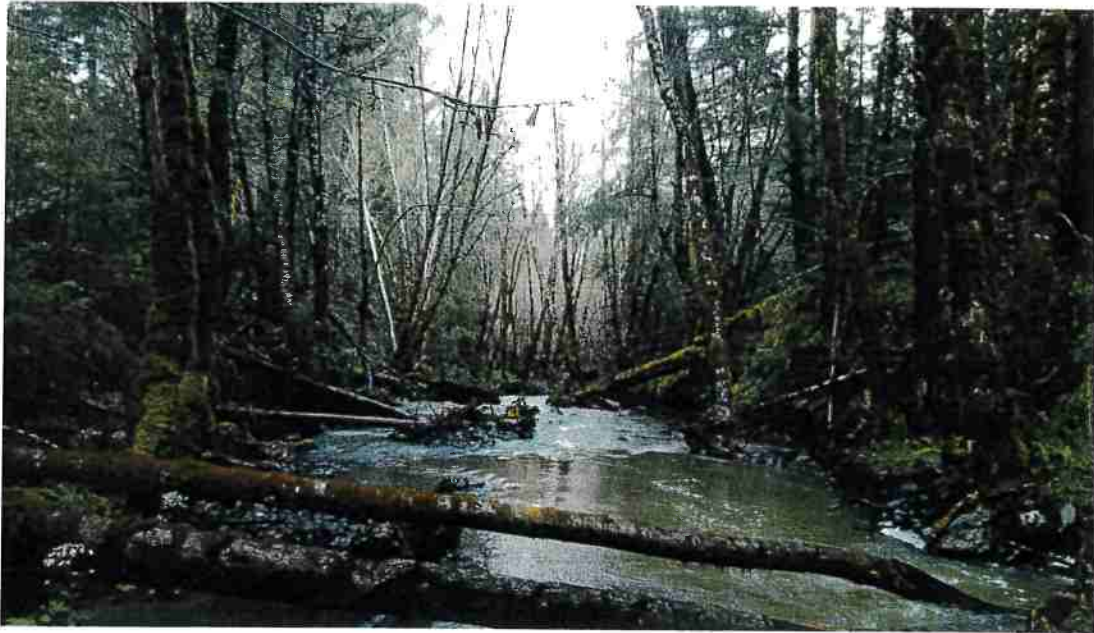
**Picture 1:** This is a photograph facing downstream towards the proposed bridge location. Photo date: 04/07/2017

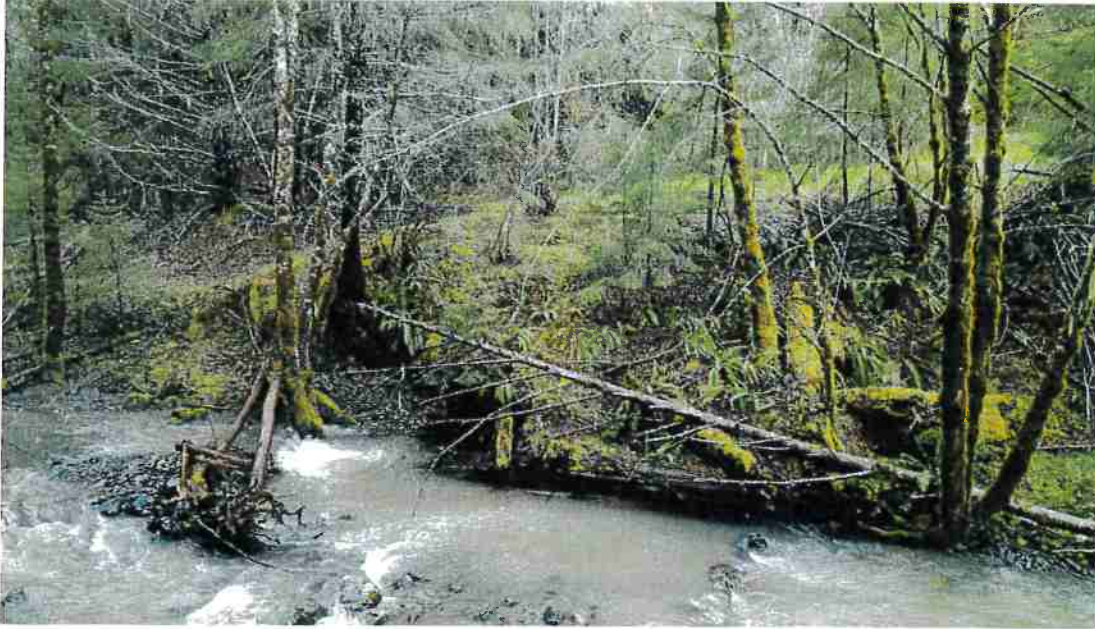
**Picture 2:** This is a photograph of the western stream bank. Note the log which marks the legacy bridge abutment at the bottom of the bank. Photo date: 04/07/2017

Both approaches will require earth work to remediate their current condition. The western approach will be reconstructed by removing all perched fill from the failed abutment. Old logs remnant from the previous stringer bridge shall be removed. Sound logs may be re-used; otherwise they will be disposed of at the designated spoils site. The eastern approach will have approximately 3' of fill removed from the top. Both stream banks will be contoured to a minimum 1.5:1 slope and rock armored with at least ¼ ton riprap. Riprap shall be built up to a minimum 4' above the stream bed. All materials placed below the high water mark shall not constrict the width of the channel. Abutments shall be constructed of rock, log, or prefabricated materials that will withstand erosion within the watercourse. No native soils will be excavated as a part of this project.

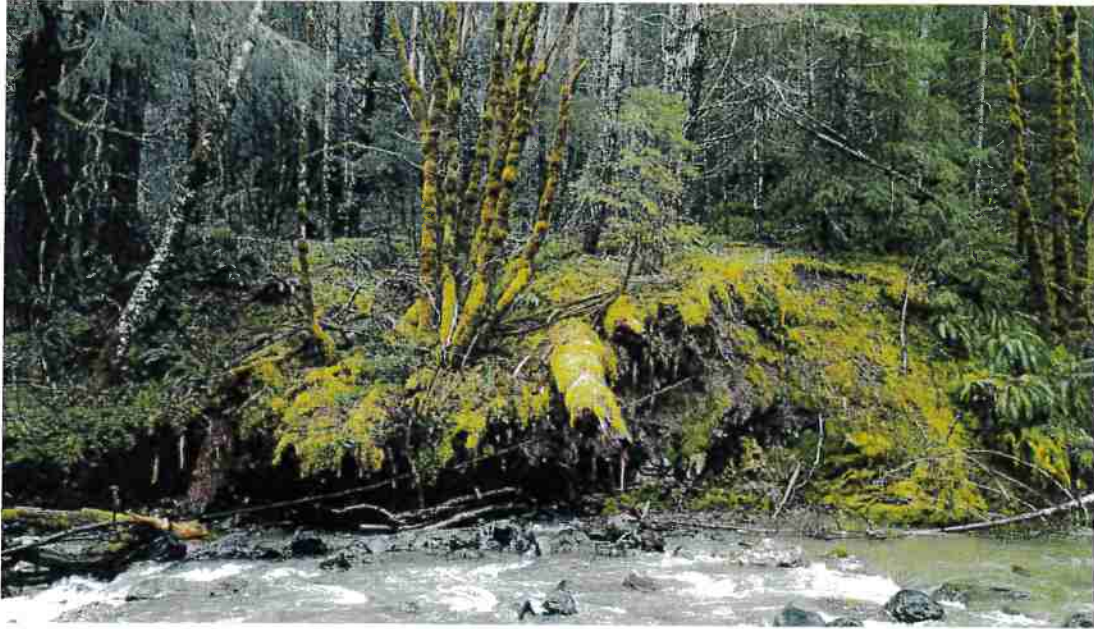
**Picture 3:** This is a photograph of the eastern stream bank. Photo date: 04/07/2017

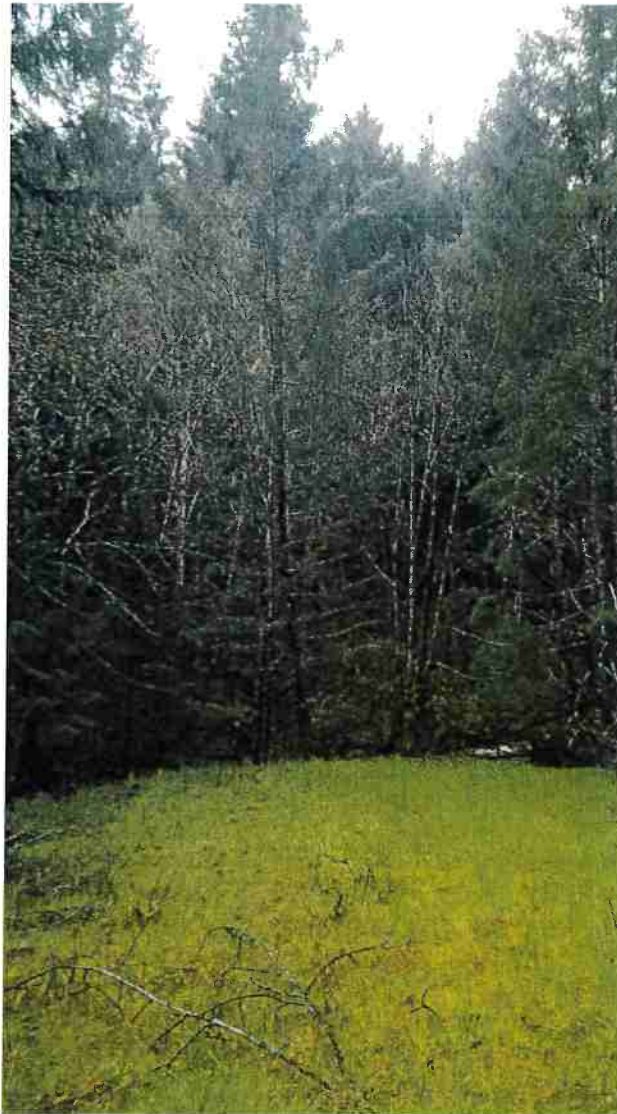
**Picture 4:** This is a photograph of the western approach looking towards Showers Creek. A road surface will be graded through this small meadow. Vegetation seen in the center of this photograph will be removed as a part of the project. Photo date: 04/07/2017

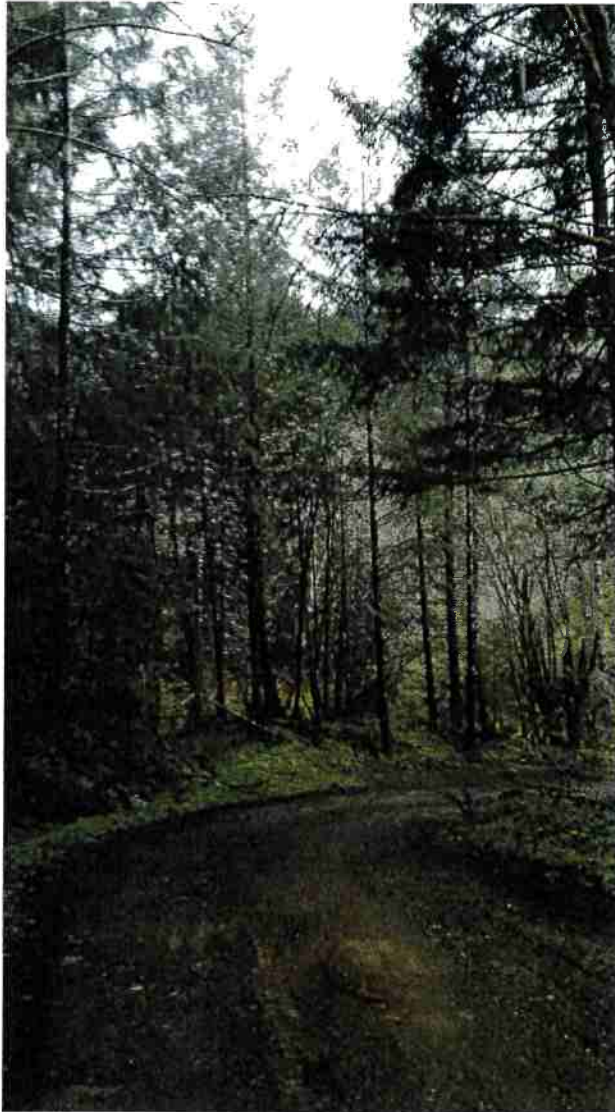
**Picture 5:** This is a photograph of eastern approach looking towards Showers Creek. This road will continue through the Douglas-fir trees straight to the proposed bridge installation. Photo date: 04/07/2017

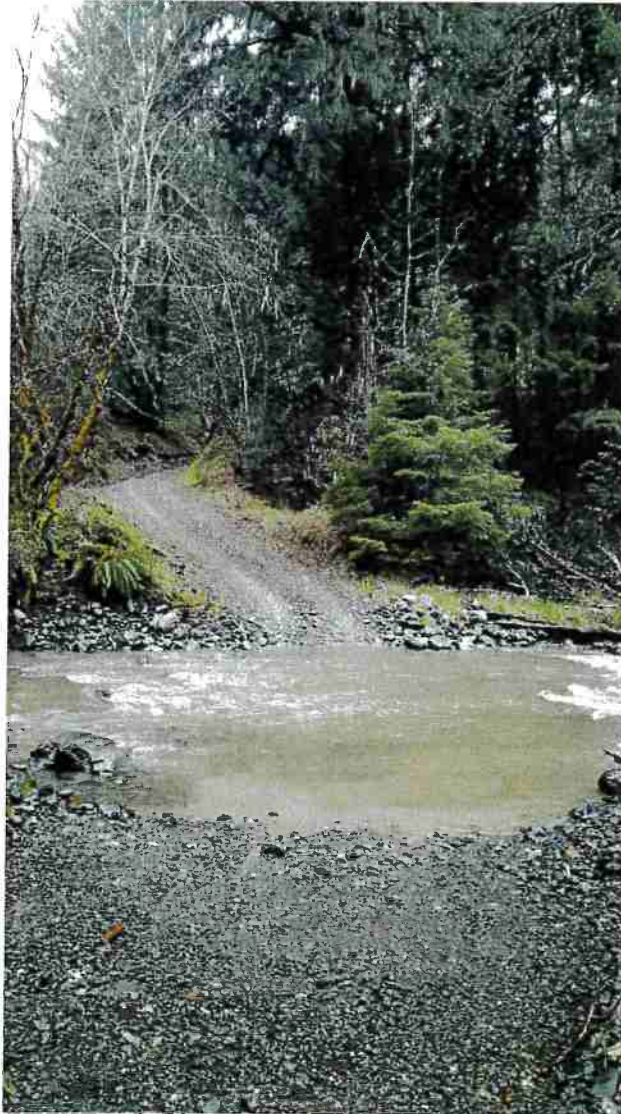
The existing rock ford crossing is used by 15-20 landowners to access a subdivision on the opposing side of Showers Creek. Although the stream bed substrate consists of gravel, cobbles and even some large boulders sediment discharge and an increase in

turbidity was observed with every crossing of a vehicle. The installation of this bridge will mitigate all impacts associated with the use of this ford crossing.

**Picture 6:** This is a photograph of the existing rock ford crossing downstream of the project area. Turbidity can be seen in the photo from recent vehicle traffic. The completion of the bridge installation will negate the use of this crossing. Photo date: 04/07/2017
