# Timberland Resource Consultants

165 South Fortuna Boulevard, Fortuna, CA 95540

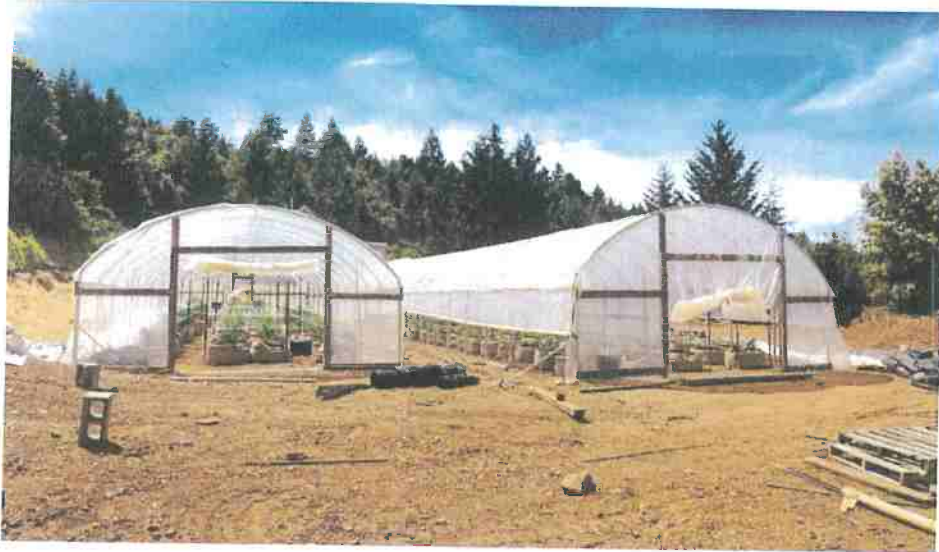
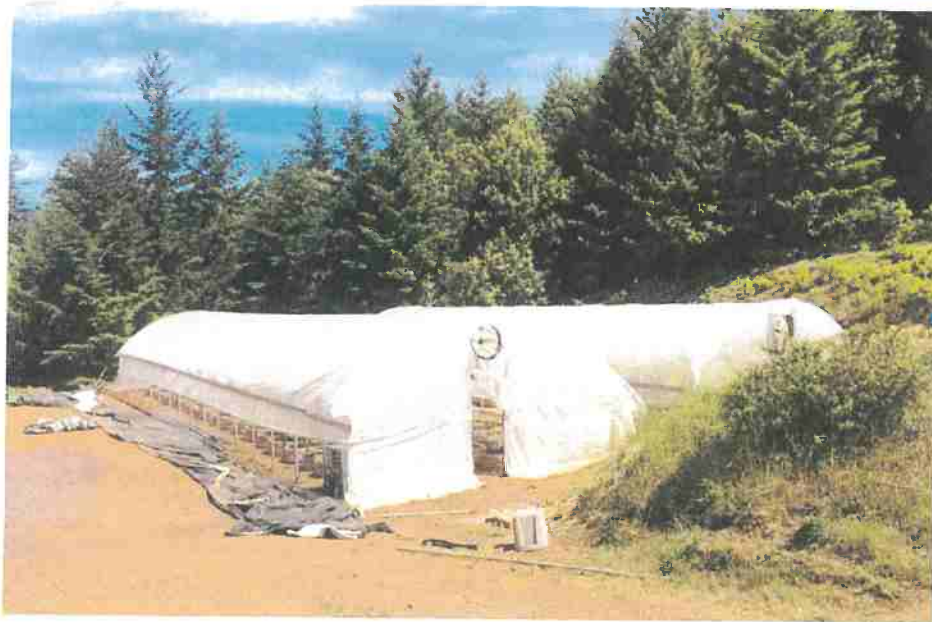
**Photos 1, 2, and 3:** Views of Cultivation Site 1 facing east (top, Photos 1 and 2) and west (bottom, Photo 3). The timber stand in the background is representative of the stand throughout the property, dominated by Douglas-fir with a minor component of hardwoods.
