RE: Revocation of Kern Construction Conditional Use Permit – Public Hearing, December 3, 2024

**California Regional Water Quality Control Board
North Coast Region**

Subject: Notice of Violation of Water Code Section 13267 Investigative Order R1-2022-0025 (13267 Order or Order) and Industrial General Permit Order No. 2014-0057-DWQ (IGP) for Kernen Construction and **Directive to Apply for Water Quality Certification/Waste Discharge Requirements** for Activities in Waters of the State pursuant to Water Code section 13260.

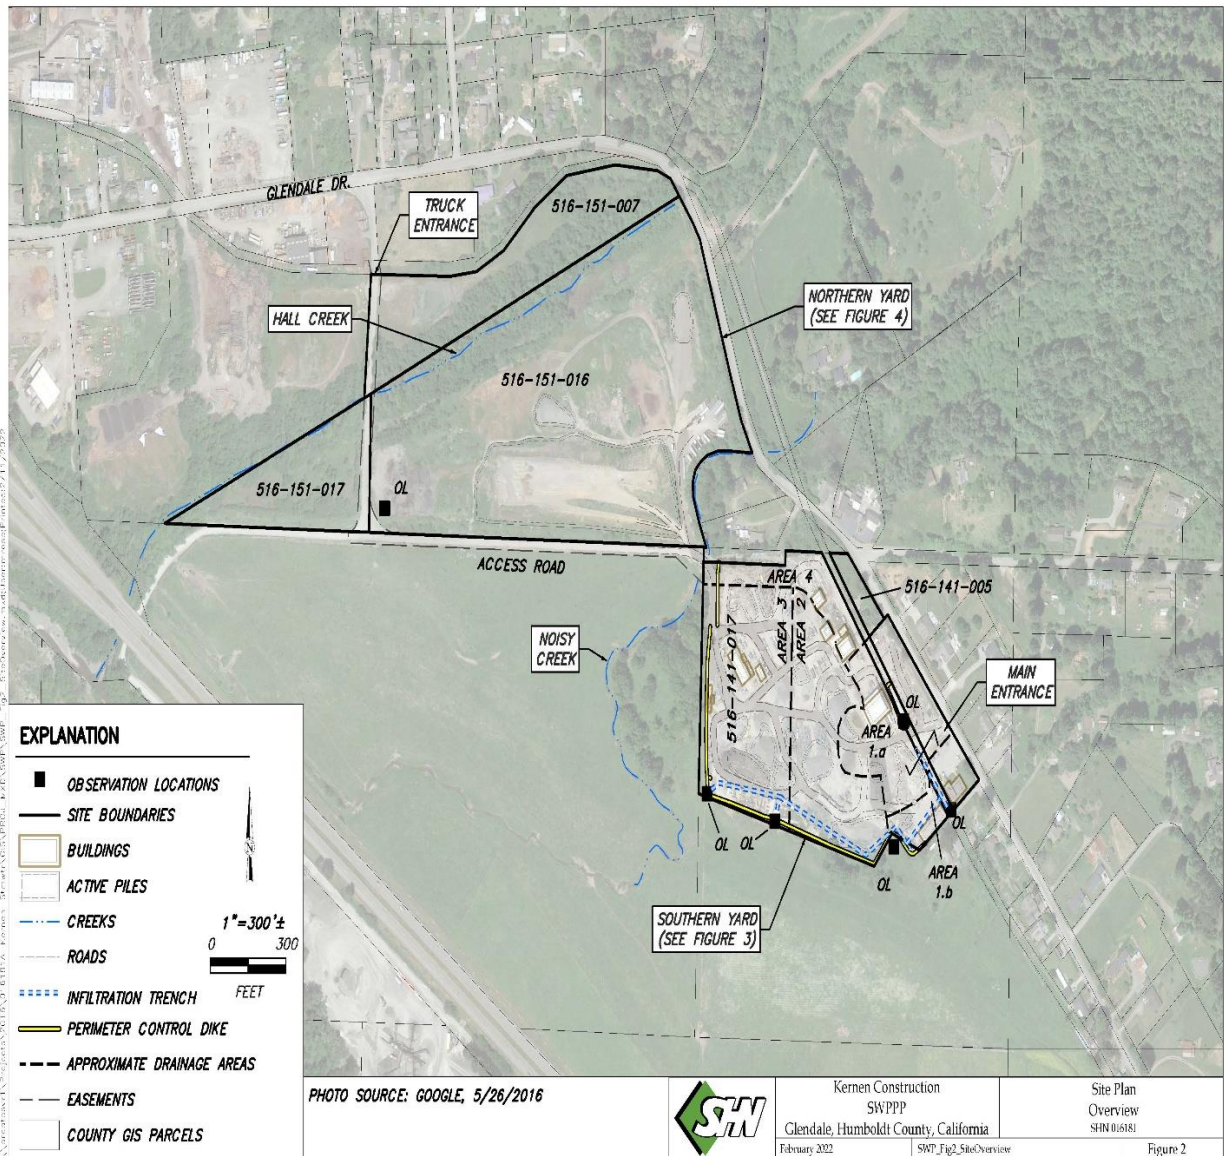
Site map 1. Uploaded site map in SMARTS prepared by the Kernen Construction consultant that indicates drainage areas within the upper yard and the receiving water locations that receive runoff from both yards. Note that the parcel labeled 516-151-007, is incorrectly labeled and is actually APN 516-151-008 per County Assessor records available through LandVision.

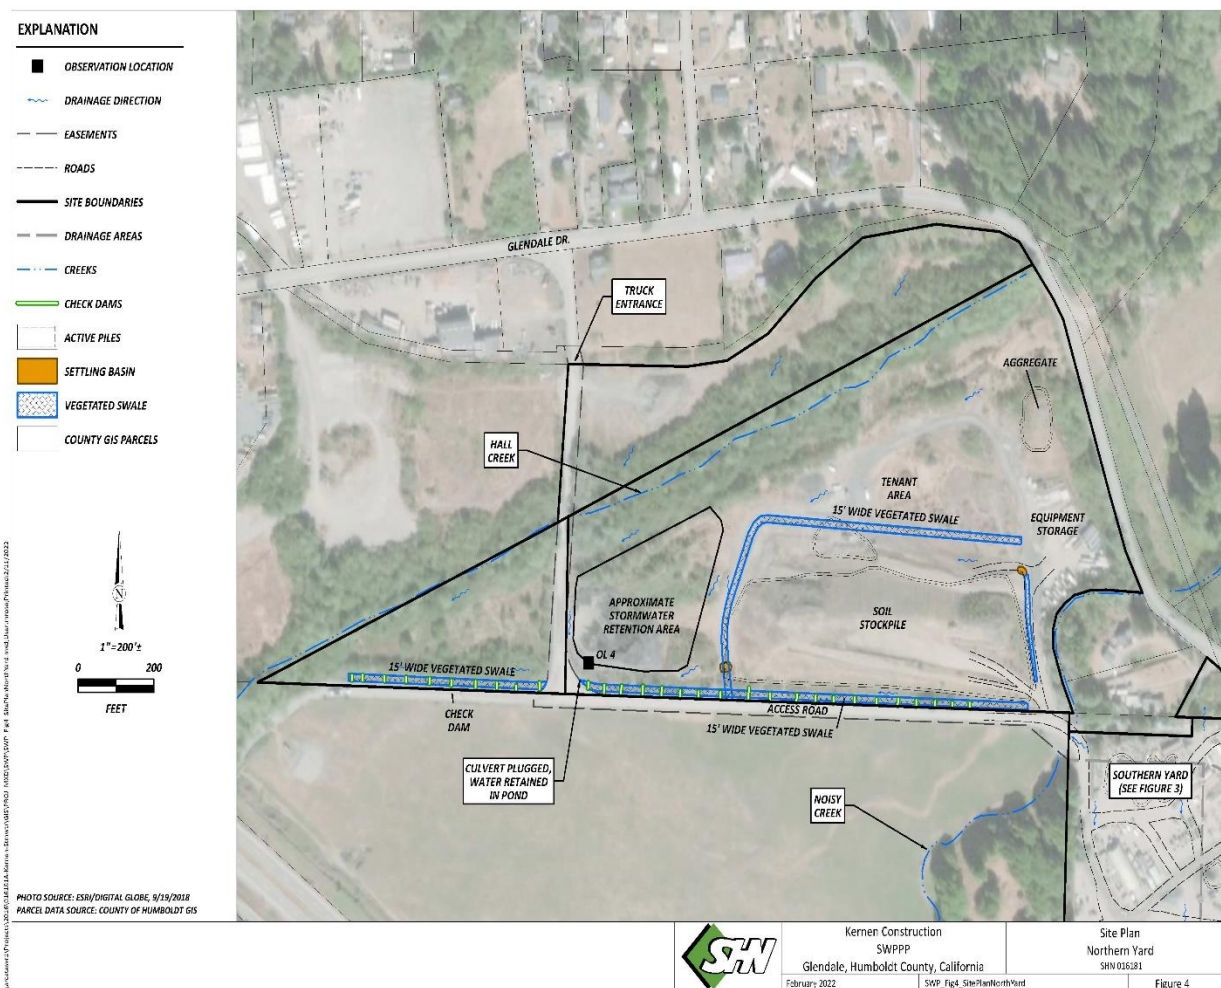
Site map 2. Uploaded site map in SMARTS prepared by the Kernen Construction consultant that indicates the sediment traps and infiltration trench locations within the upper yard.

Site map 3. Uploaded site map in SMARTS prepared by the Kernen Construction consultant that indicates the existing Swale along the south side of the lower yard and the new stormwater retention area within the lower yard.

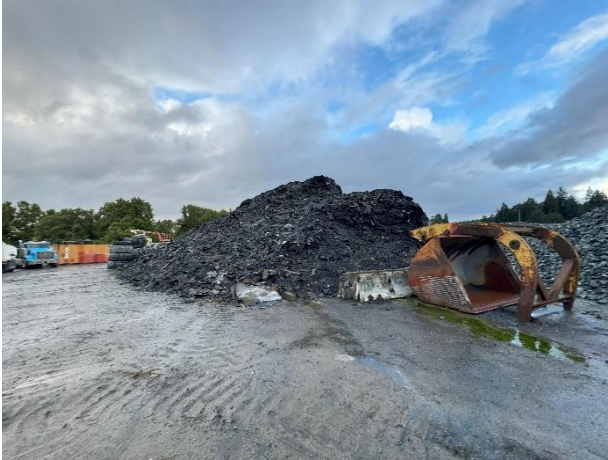
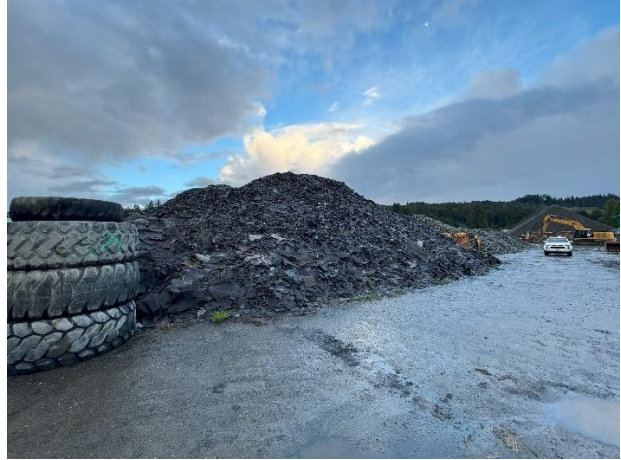
Pictures 1a, 1b – View of uncovered asphaltic roofing waste materials that were exposed to rain located in the Upper Yard. No BMPs are installed to avoid releasing pollutants from the piles or to minimize the exposure to rain. Picture taken by Walt Dragaloski.

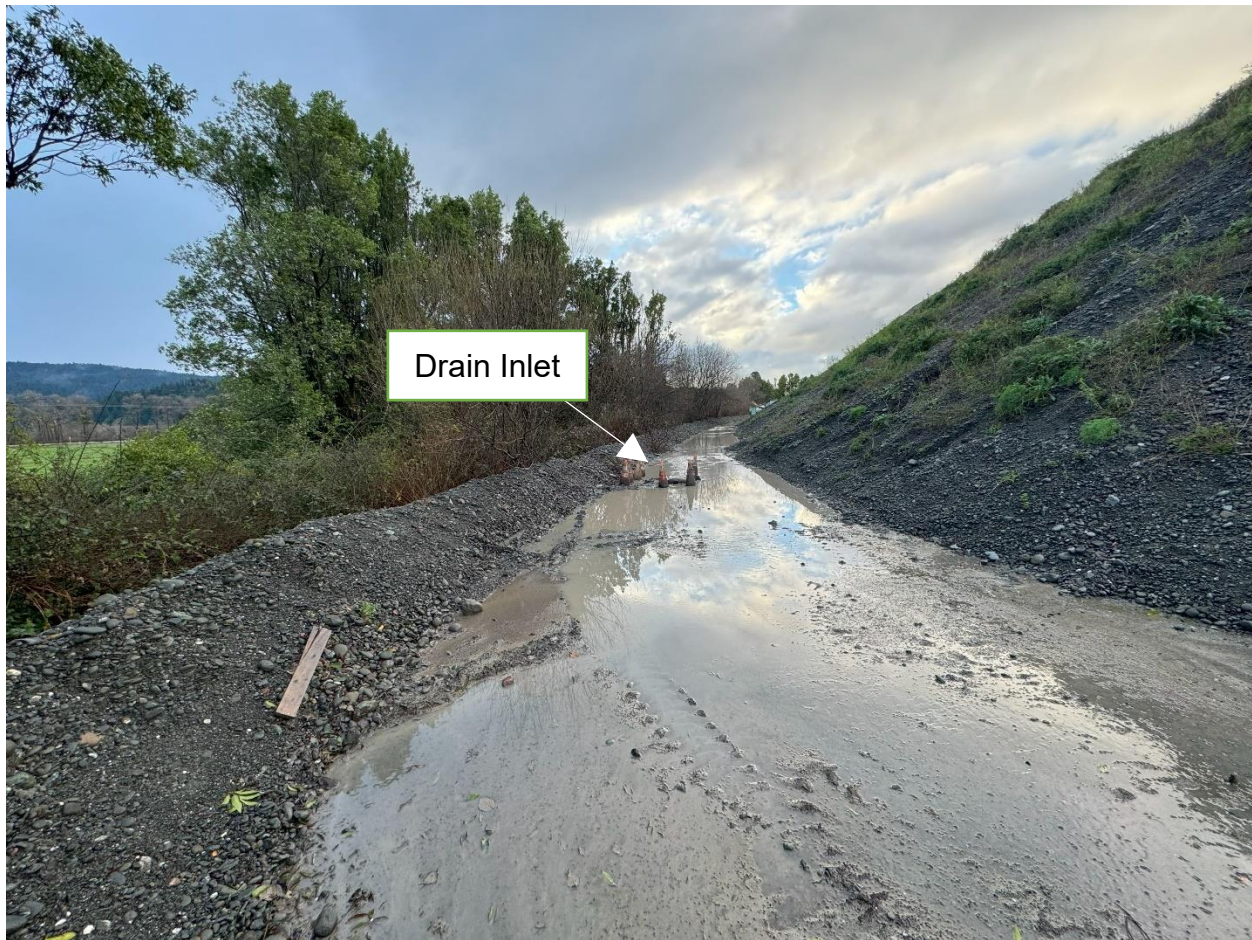
Picture 2- View of a large and uncovered aggregate stockpile located in the Upper Yard. Accumulated turbid runoff was observed around the stockpile within this muddy area. The runoff from this area drains to the infiltration trench via an infiltration trench inlet. Picture taken by Walt Dragaloski.

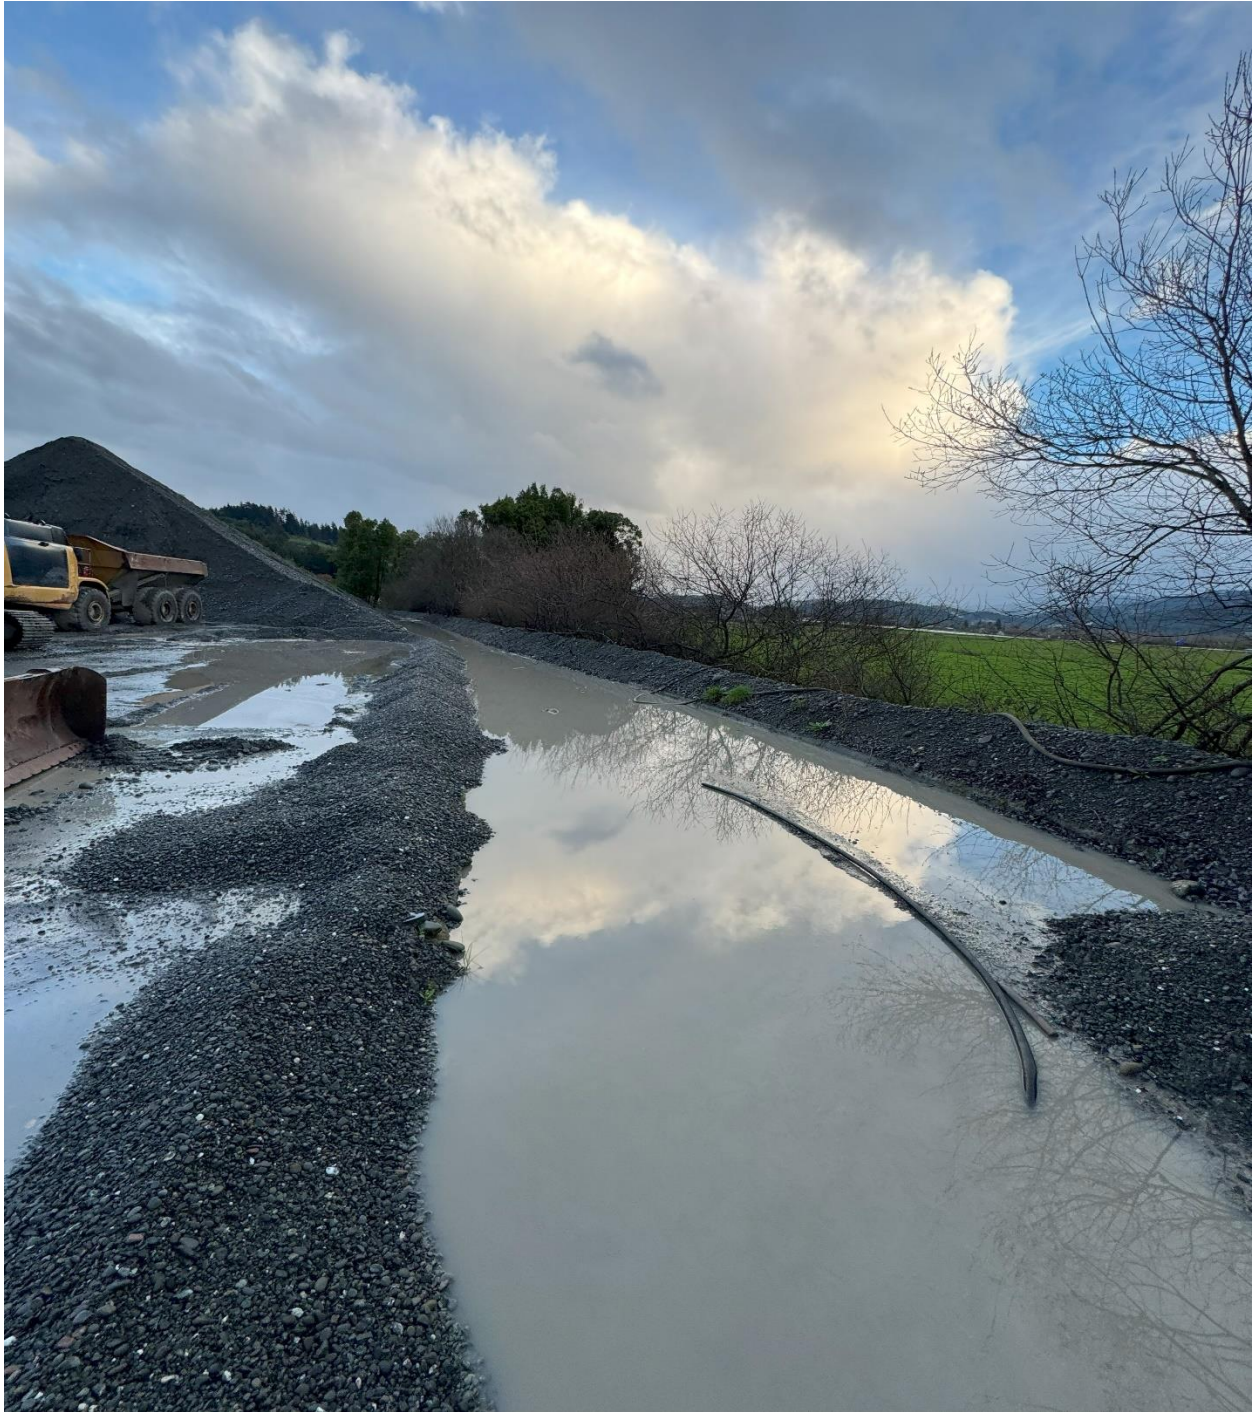
Picture 3 – Looking east at accumulated turbid stormwater along southern portion of the upper yard flowing to infiltration trench inlet. Picture taken by Walt Dragaloski.

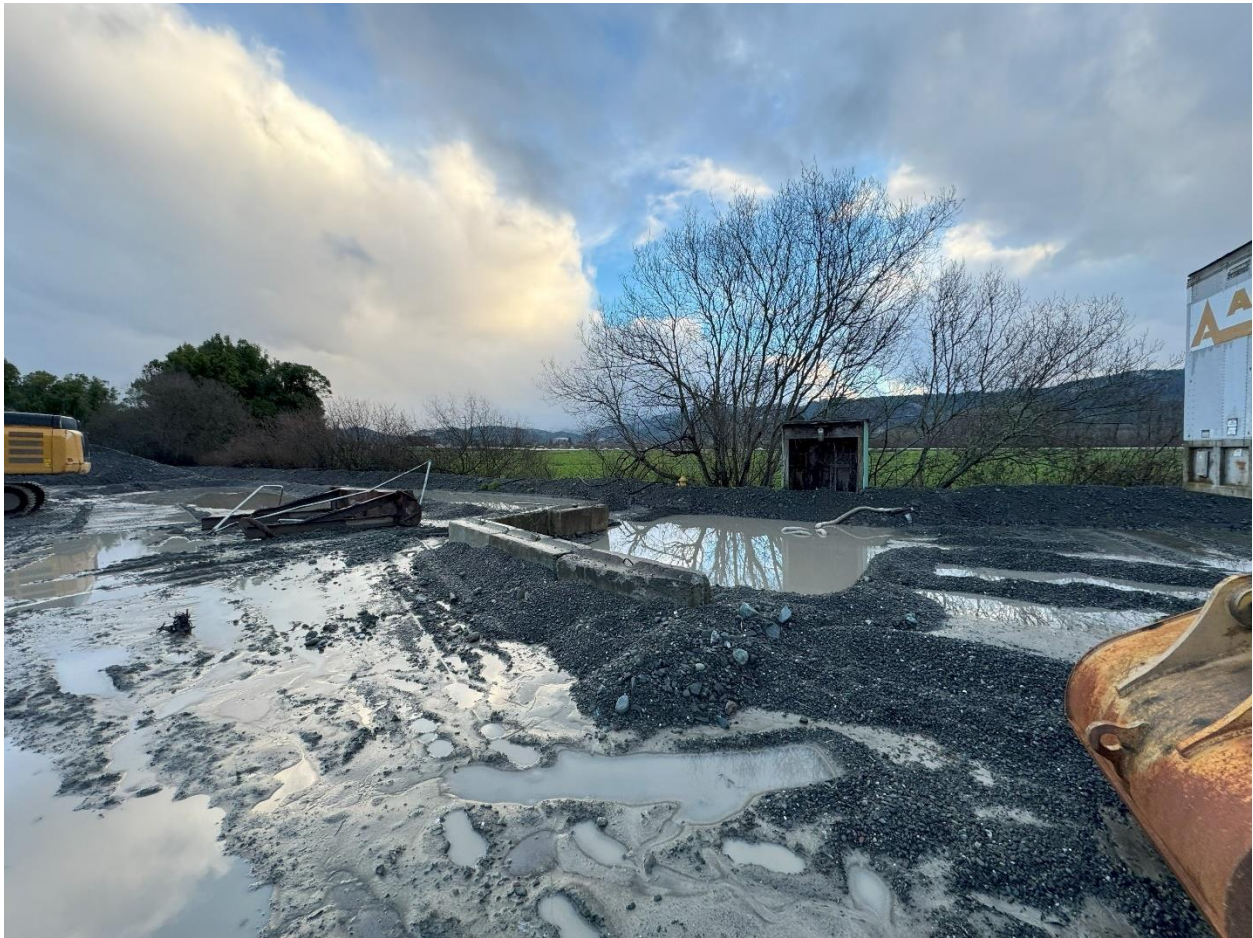
Picture 4 - View of sediment trap at the southern portion of the upper yard. The adjacent upper yard area flows through this sediment trap to the infiltration trench inlet. A thick layer of sediment was observed on the ground within the sediment trap. Additionally, a sheen was observed on the water surface and a black residue stain was visible in this area. This sediment trap drains the turbid water into the infiltration trench. Minimum BMPs were not observed within this area. Picture taken by Walt Dragaloski.

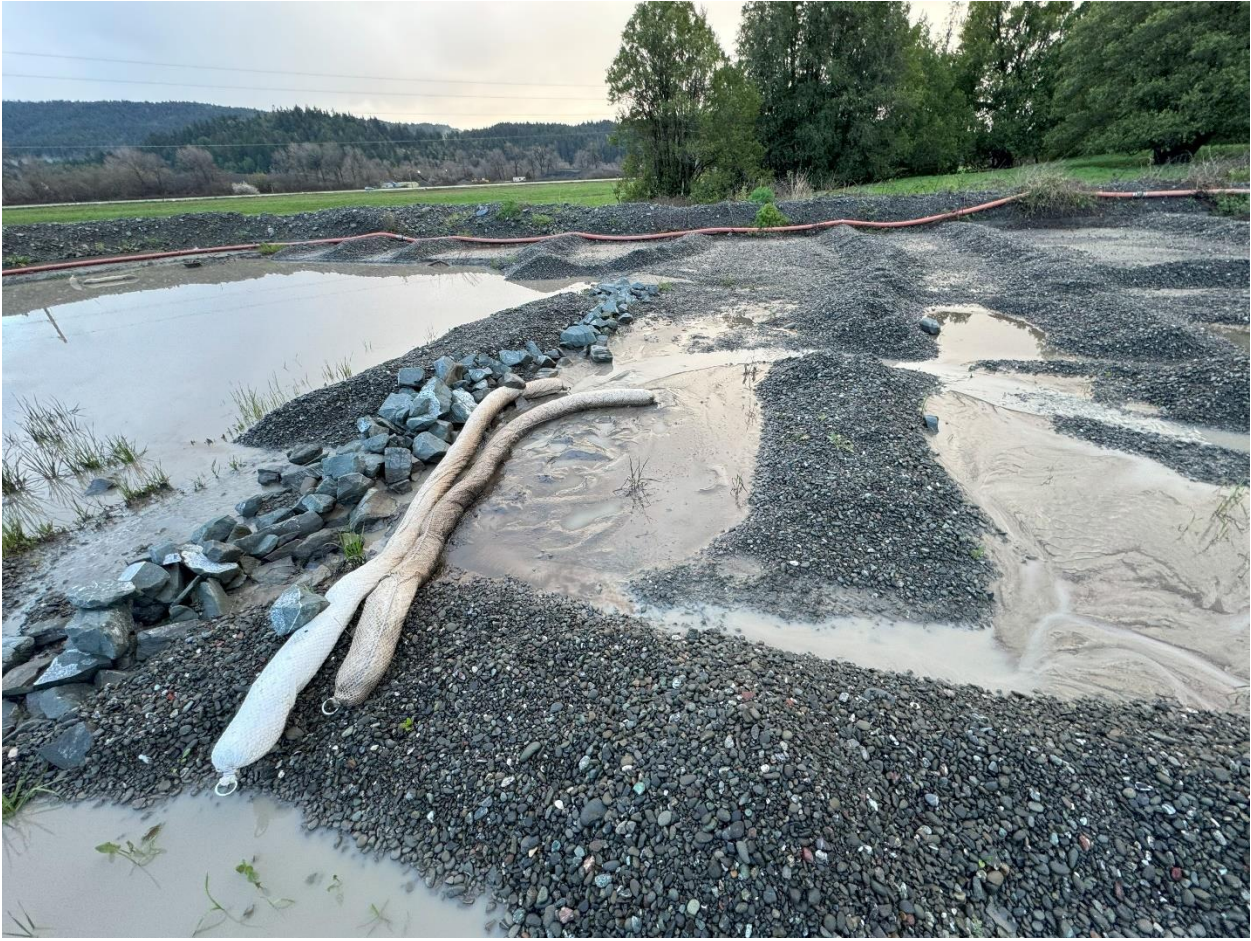
Picture 5 – Looking west at the sediment trap located on the southwest corner of the upper yard. A significant amount of sediment is captured with this non-standard sediment and erosion control BMP. Picture taken by Walt Dragaloski.

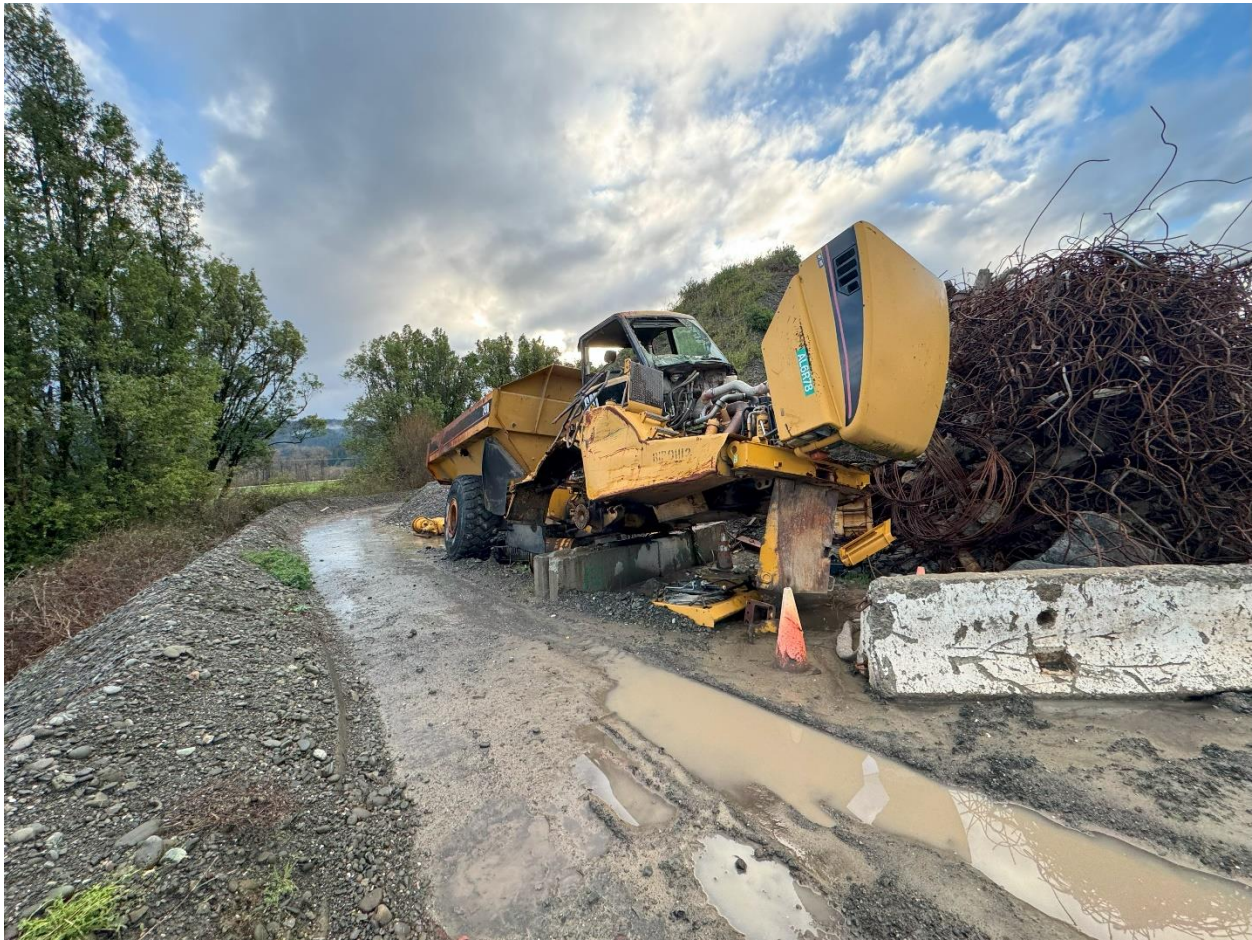
Picture 6 – View of construction waste material and salvaged hauling vehicle. No BMPs are implemented to minimize the exposure of industrial/construction wastes and equipment to rain. Picture taken by Walt Dragaloski.

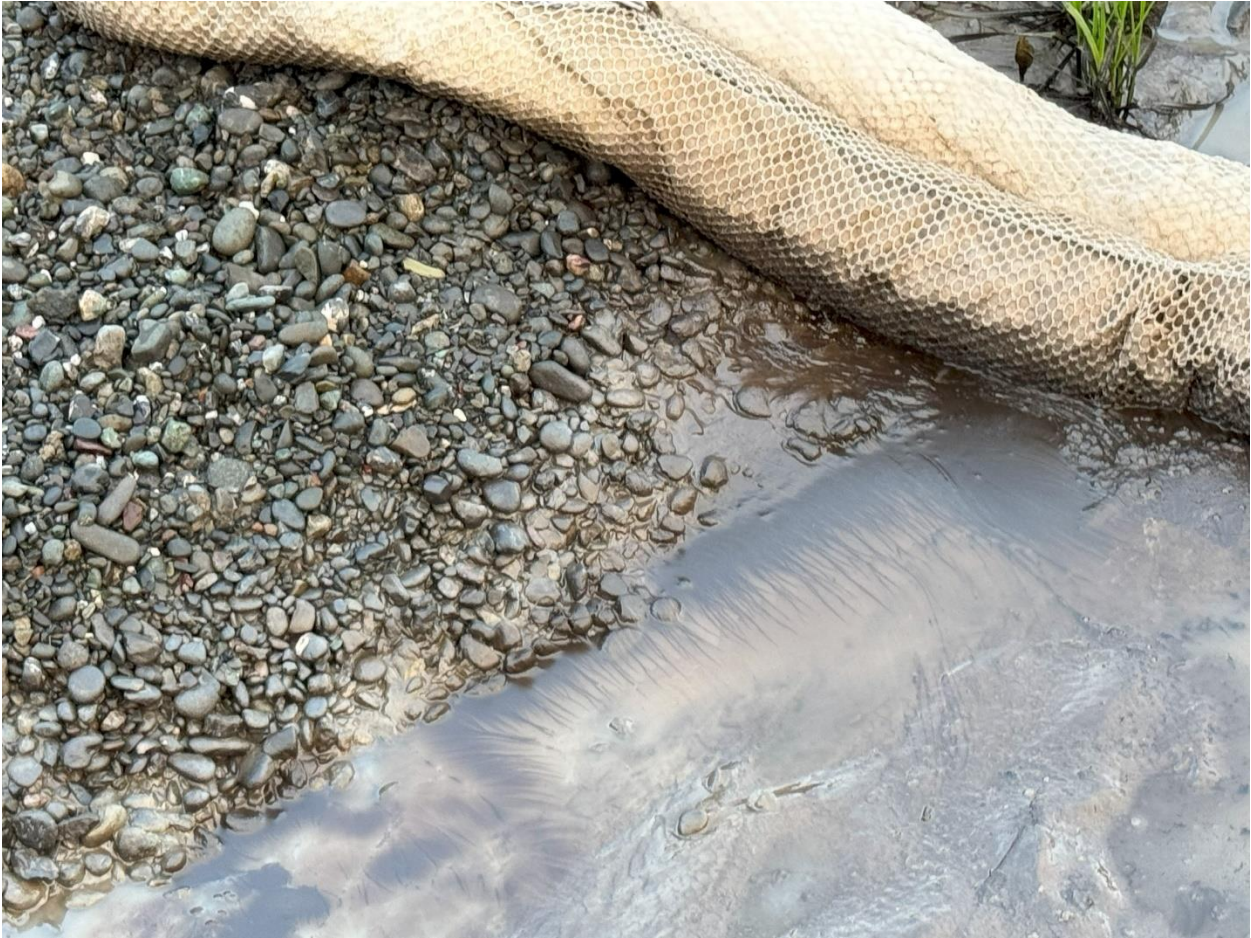
A sheen was observed on the water surface and a black oily residue was observed on the gravel and the absorbent sock within the sediment trap within the upper yard (See picture 7). The IGP requires the Discharger to evaluate the Facility for areas where spills and leaks can likely occur and control these sources of pollutants. The preventative maintenance and spill prevention and response sections of the IGP must be implemented.

Picture 7 - View of an absorbent sock in the sediment trap. A sheen was observed on the water surface and a black oily residue was observed on the gravel and the absorbent sock within the sediment trap. Picture taken by Walt Dragaloski.

Staff Evaluation of Compliance: A sheen was observed on the water surface and a black oily residue was observed on the gravel within the sediment trap in the upper yard with no spill response, cleanup, or containment BMPs deployed. (See Inspection Memo, Attachment A)

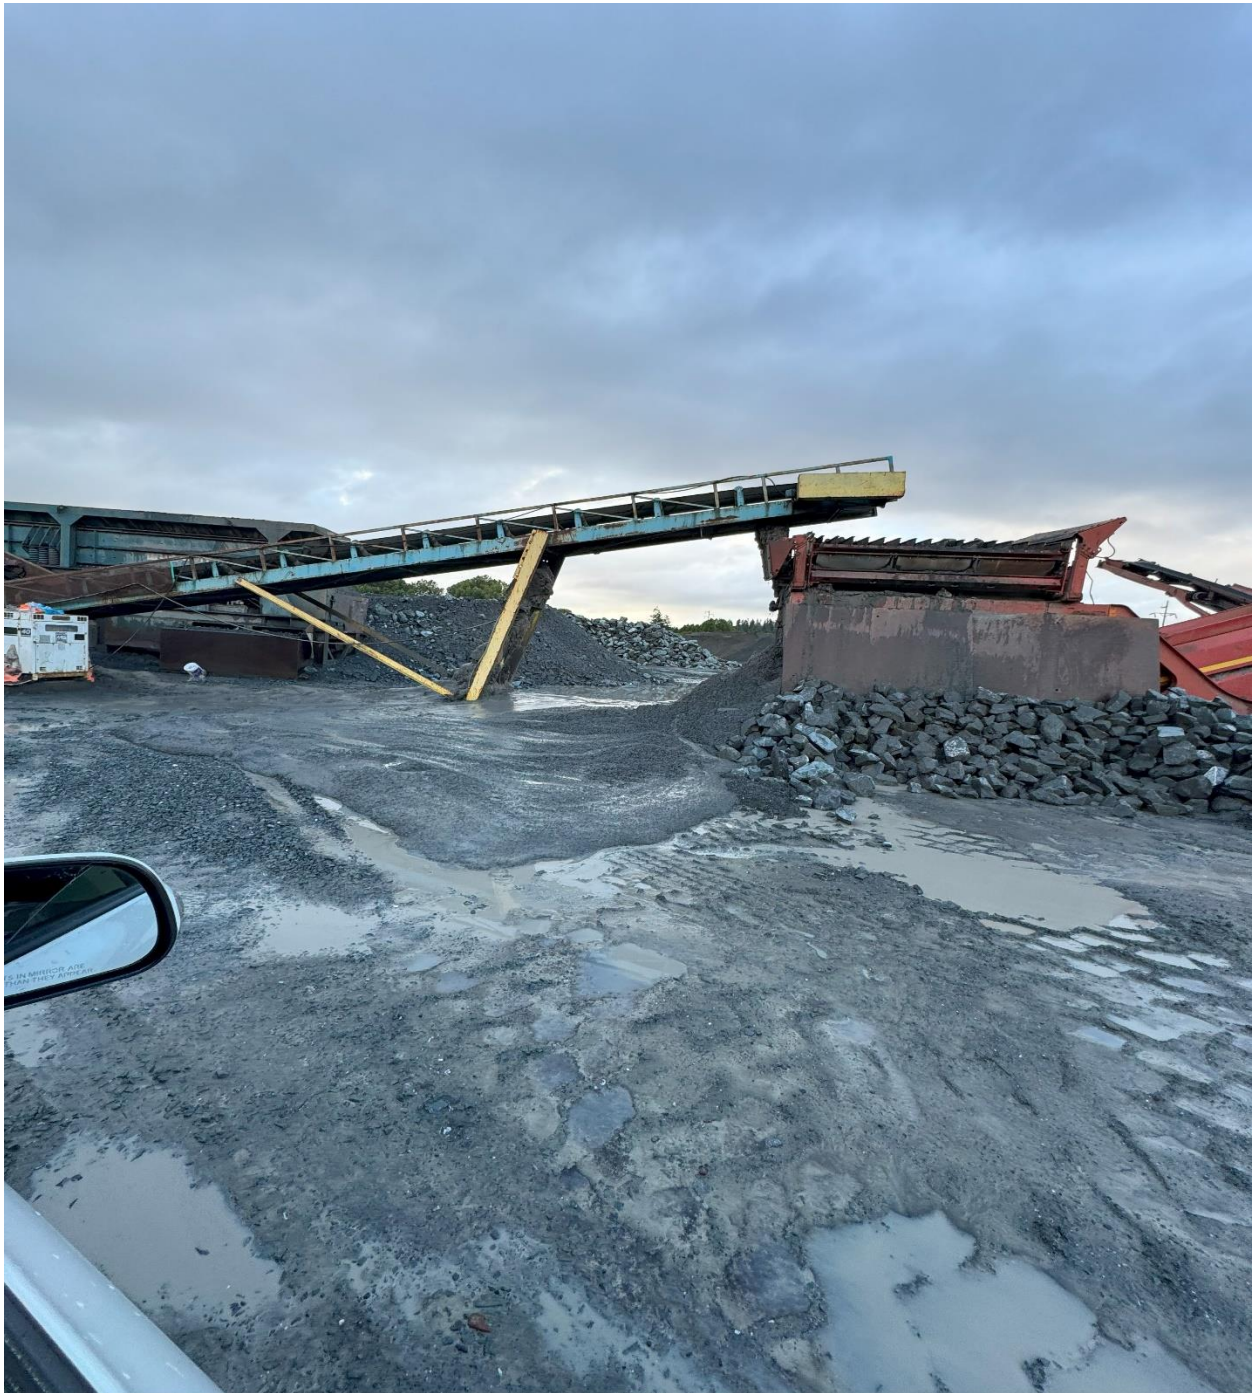
Process wastewater slurry was observed on the ground underneath the screen deck within the upper yard (See picture 8). There is no designated pond to capture the wastewater and slurry adjacent to this operation. No BMPs were observed within this area. The material handling and waste management requirements of the IGP are not implemented.

Picture 8 - View of the processing area in upper yard. Wastewater slurry was observed on the ground. Picture taken by Walt Dragaloski.

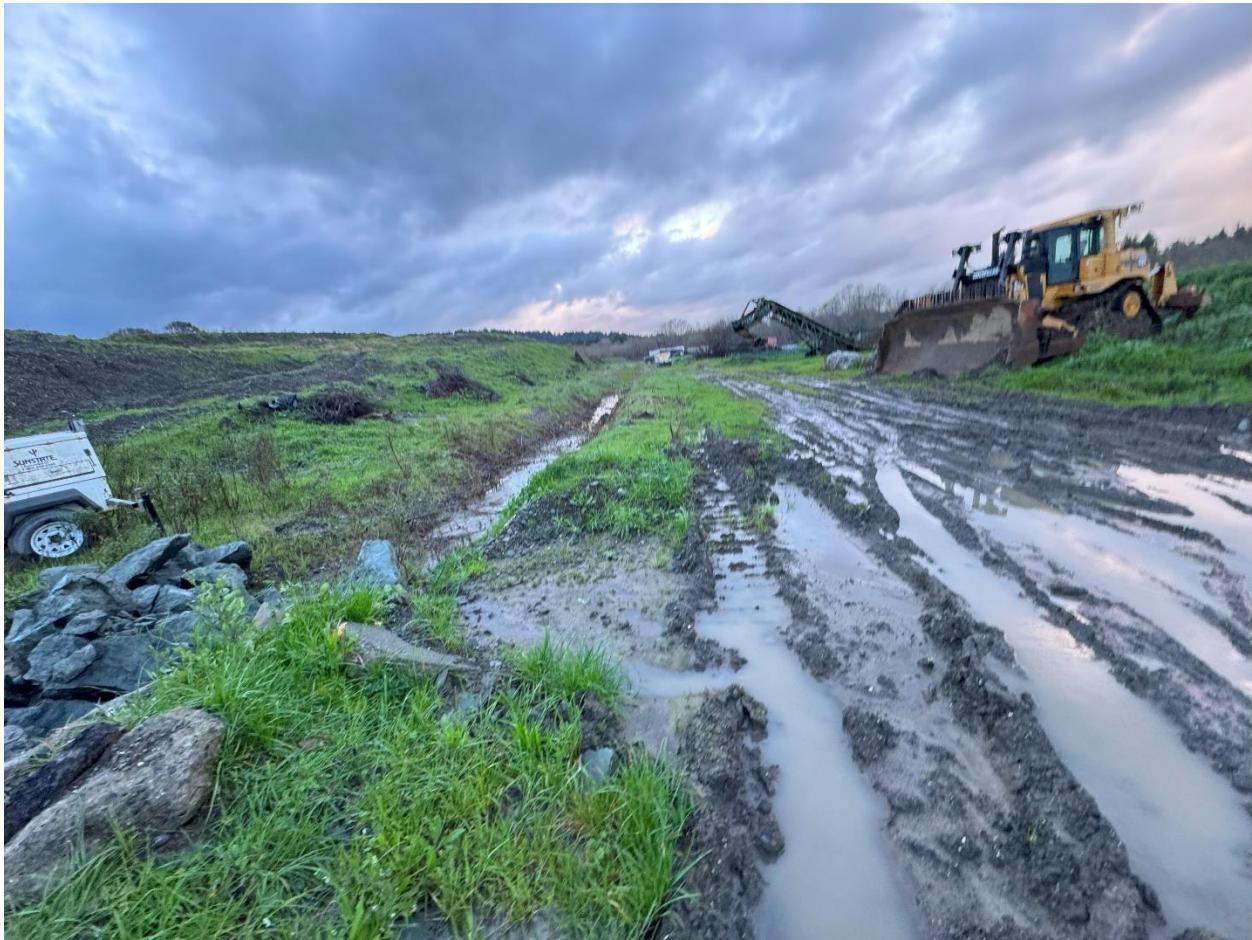
Picture 9 - View of unpaved access road adjacent to an on-site drainage ditch in the lower yard. No sediment and/or erosion control BMPs were observed. Overflow from this ditch discharges into Waters of the State into Noisy Creek or into Waters of the State at an unnamed tributary to Hall Creek. Picture taken by Walt Dragaloski.

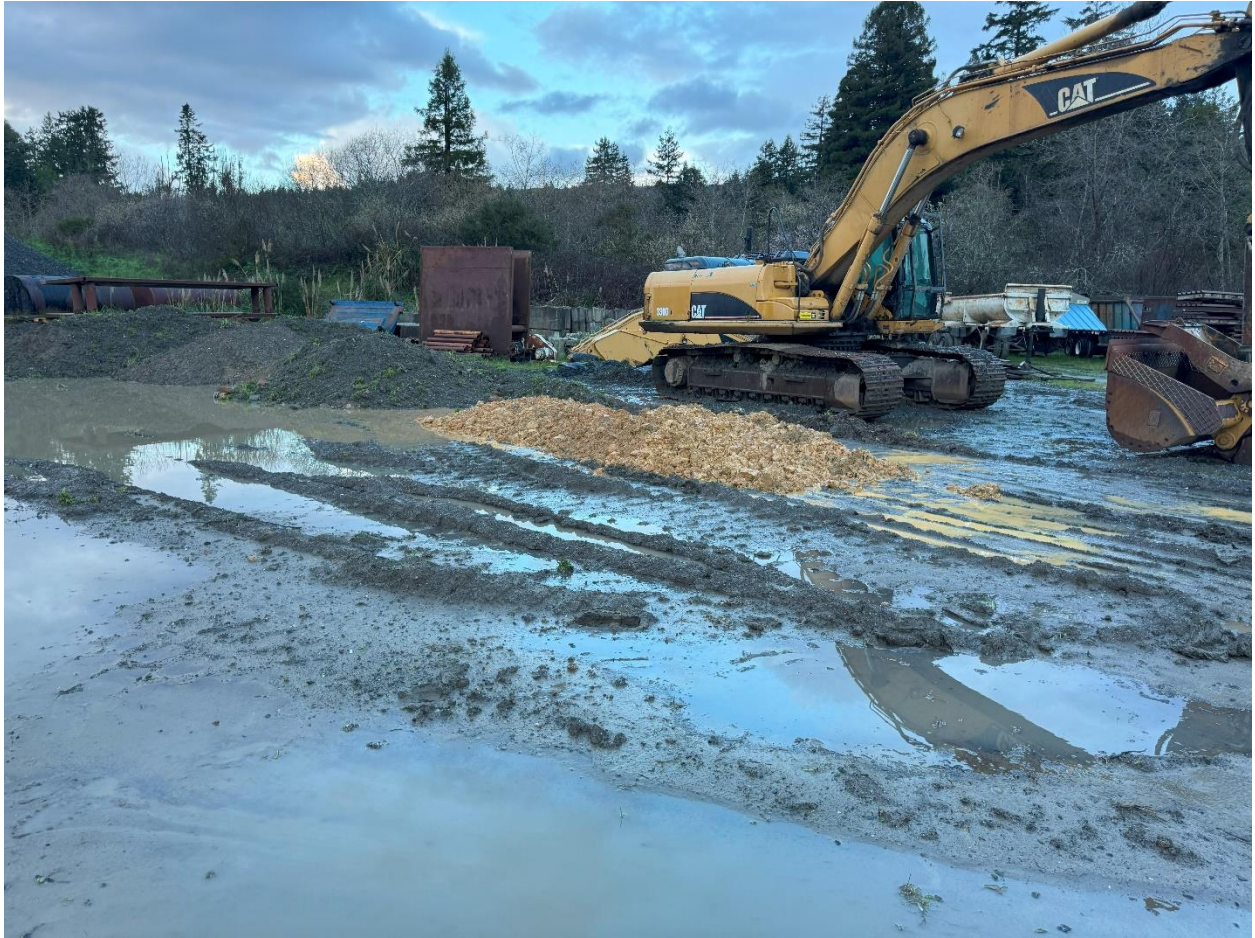
Picture 10 – View of fine clay sediment material (light colored material in picture) that was stockpiled on the ground in the lower yard. This entire area was exposed to rain and no sediment and/or erosion control BMPs were observed. Picture taken by Walt Dragaloski.

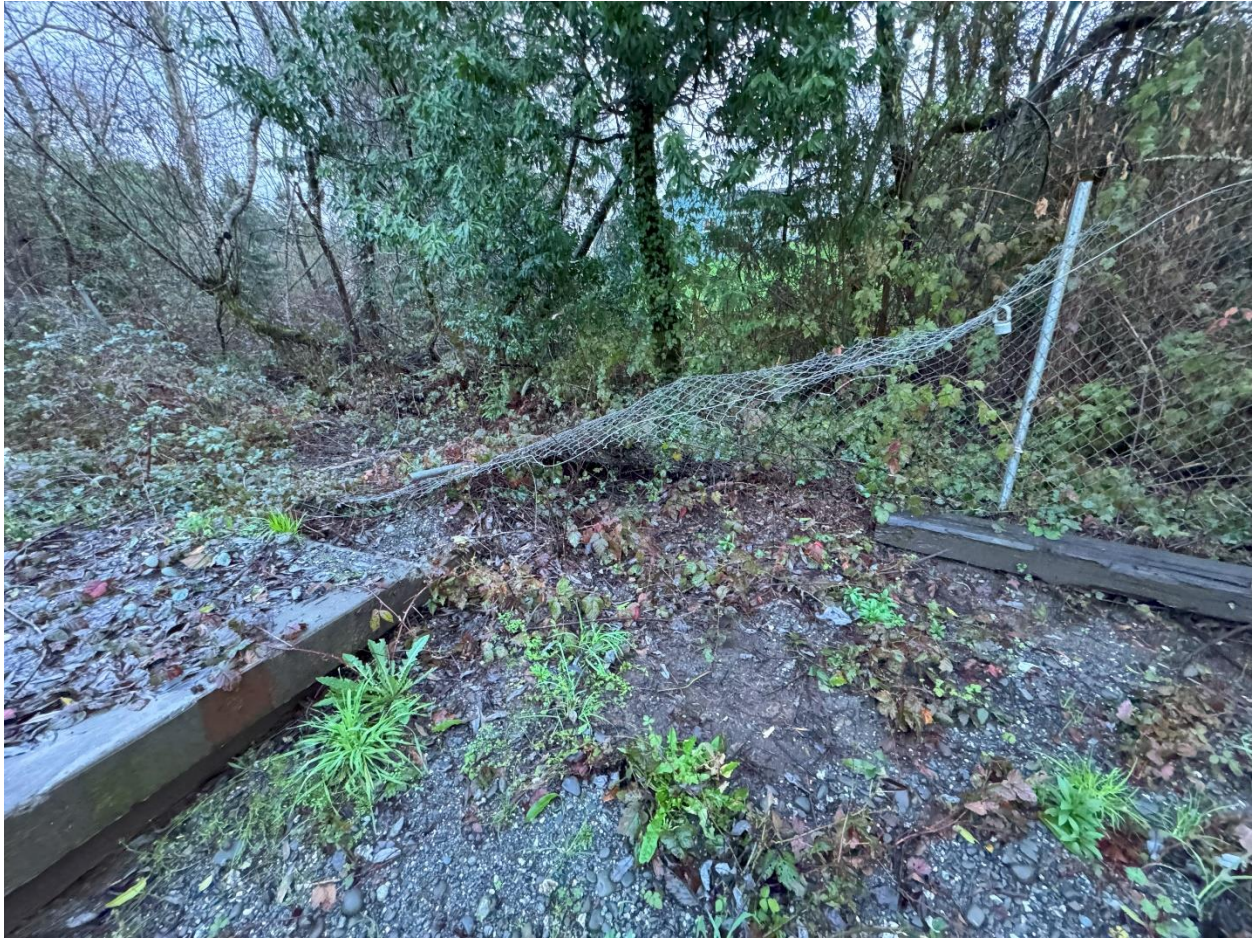
Evidence of erosion due to concentrated flow from the Facility toward and into Noisy Creek was observed near the fence line within the lower yard, corroborating observation of stormwater discharge by the adjacent homeowner on the east side of the lower yard (See picture 11 and attached site map for the location). No BMPs such as perimeter control and/or sediment and erosion control BMPs were installed within this area to control the discharge of sediment from the Facility. Per the SWPPP, this location has not been identified as a potential discharge/sampling point and no samples were collected which is a violation of the IGP requirement.

Picture 11 - View of damaged fences adjacent to Noisy Creek along the eastern boundary of the Facility in the lower yard. Evidence of erosion due to concentrated flow towards Noisy Creek was observed near the fence line, corroborating observation of stormwater discharge from the Facility to Waters of the State by the adjacent homeowner. Picture taken by Walt Dragaloski.

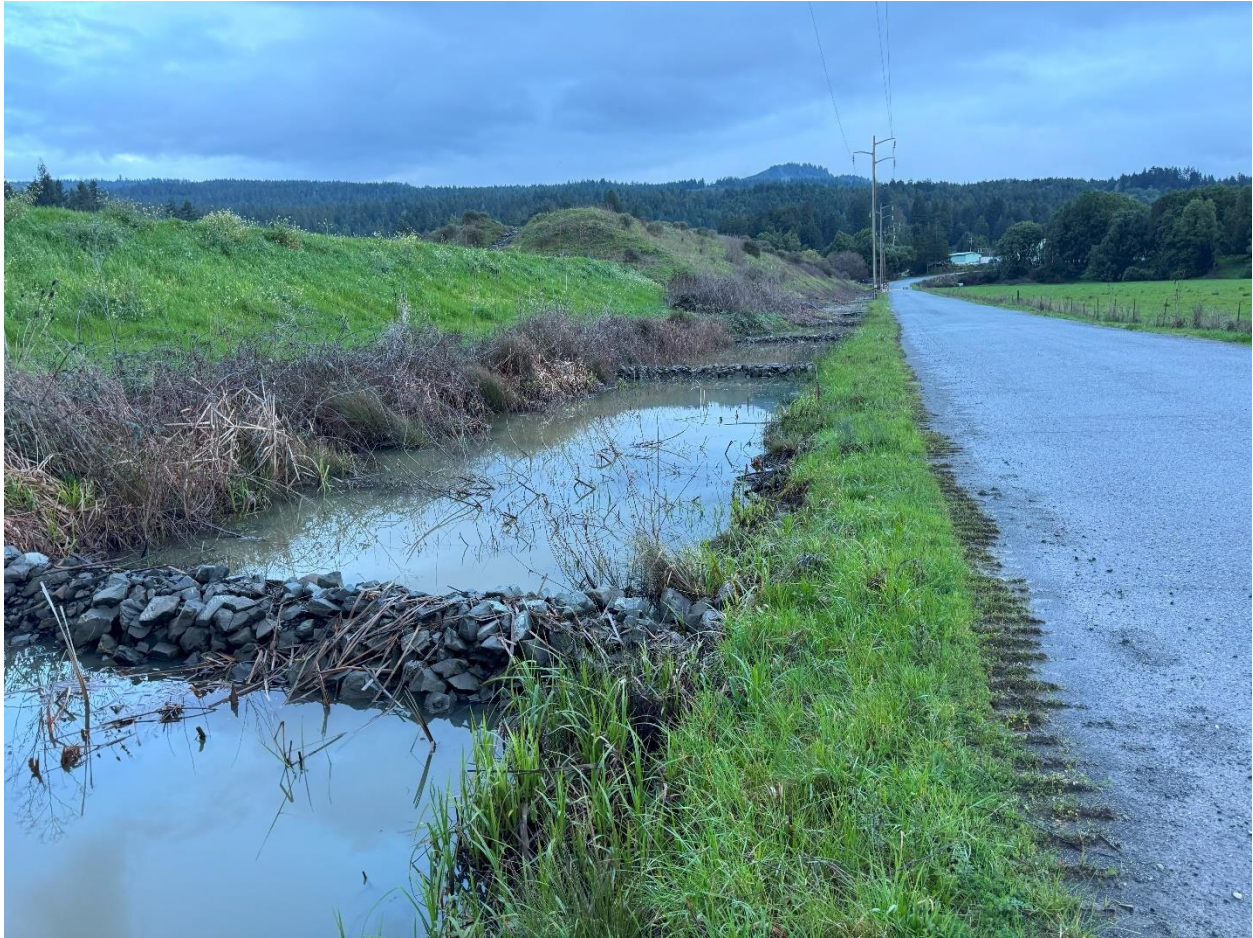
The Discharger disturbed the roadside Swale, a Waters of the State, on the south portion of the lower yard by installing rock check dams within the Swale, the runoff from the Swale is pumped into the newly constructed retention pond and again pumped from the pond to the infiltration trenches in the upper yard using three diesel pumps (See the site map for the location). Furthermore, the Discharger has recently plugged the culvert within the roadside swale immediately downstream of the pumping location preventing discharge into Hall Creek. These diesel pumps are placed directly on the ground without required secondary containments to contain any potential leaks (See pictures 12, 13, 14a and 14b). This work within Waters of the State has been done without obtaining the appropriate permits.

Picture 12 – Looking east at the roadside swale adjacent to the lower yard. These Waters of the State receive runoff from the adjacent stockpile and from the haul roads in the lower yard area. The non-standard rock check dams were installed by the Discharger without obtaining an appropriate permit from the Regional Water Board. Picture taken by Walt Dragaloski.

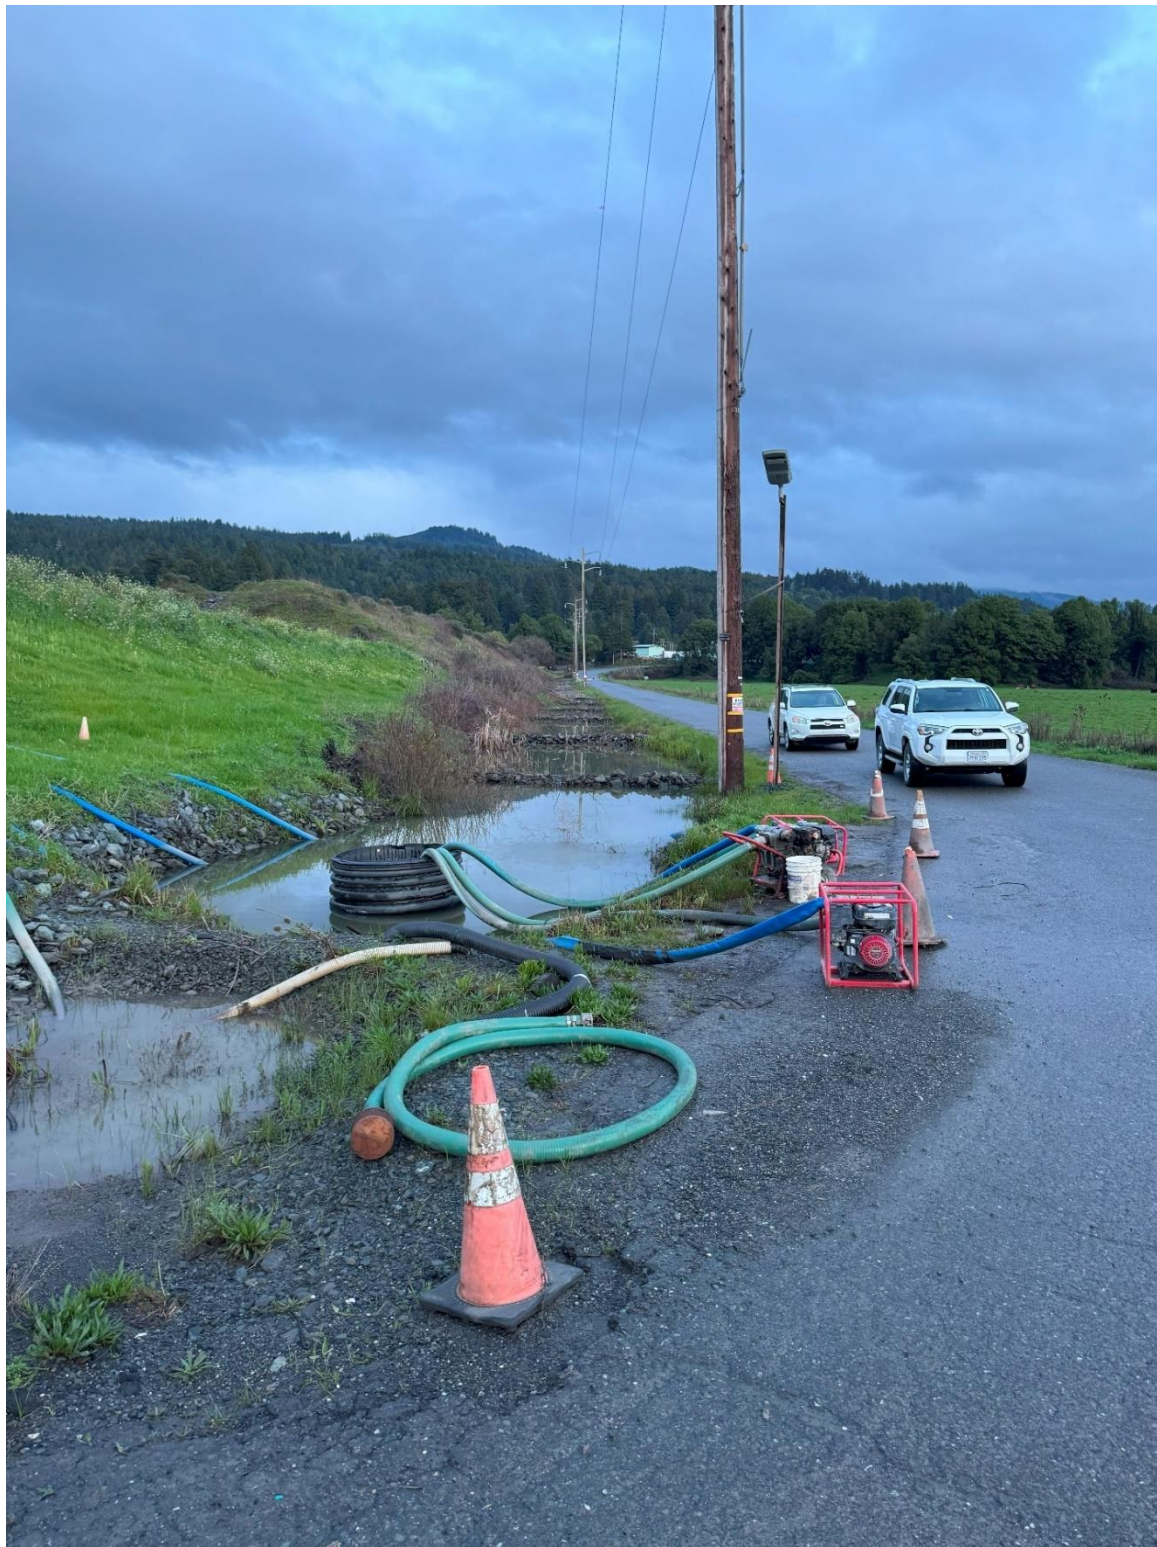
Picture 13 – View of three diesel generators and their pumps observed without required secondary containments. Stormwater is pumped from the swale via the black riser pipe into the newly constructed retention pond. Picture taken by Walt Dragaloski.

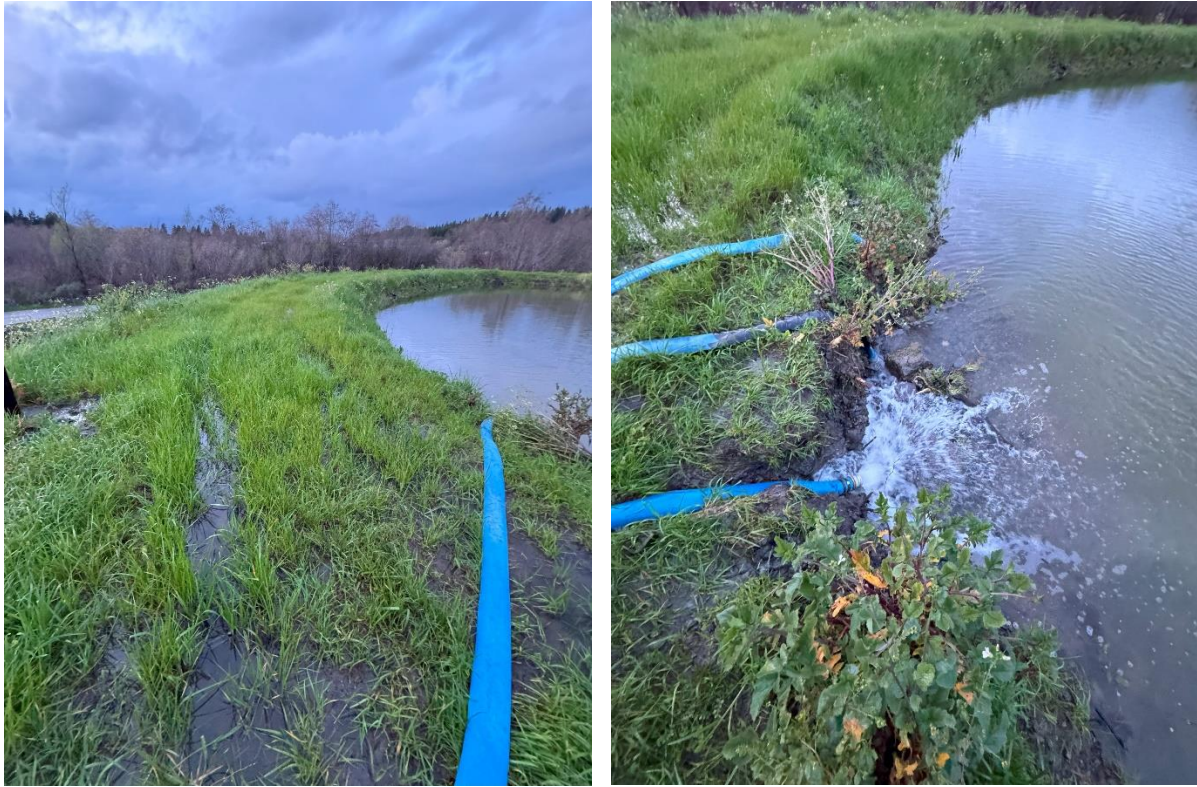
6. The culvert at the end of the Swale, a Waters of the State, has been plugged and the Discharger deployed three pumps to pump the runoff from the Swale, and from the Swale to infiltration trenches in the upper yard. The SWPPP has not been updated since 2022. Since the roadside Swale is considered as a Waters of the State, any discharge to this swale must be sampled. As a result, the SWPPP and site map must be revised to include any potential discharge point(s) to this receiving water (Swale).

Picture 14a and 14b – The left picture shows the hose used to pump the stormwater from this retention pond in the lower yard to the infiltration trenches in the upper yard. The right picture shows the three hoses used to pump stormwater from the swale shown in the previous picture into the retention pond. Picture taken by Walt Dragaloski.
