RE: Revocation of Kern Construction Conditional Use Permit – Public Hearing, December 3, 2024

**California Regional Water Quality Control Board
North Coast Region**

Subject: Notice of Violation of Water Code Section 13267 Investigative Order R1-2022-0025 (13267 Order or Order) and Industrial General Permit Order No. 2014-0057-DWQ (IGP) for Kernen Construction and **Directive to Apply for Water Quality Certification/Waste Discharge Requirements** for Activities in Waters of the State pursuant to Water Code section 13260.

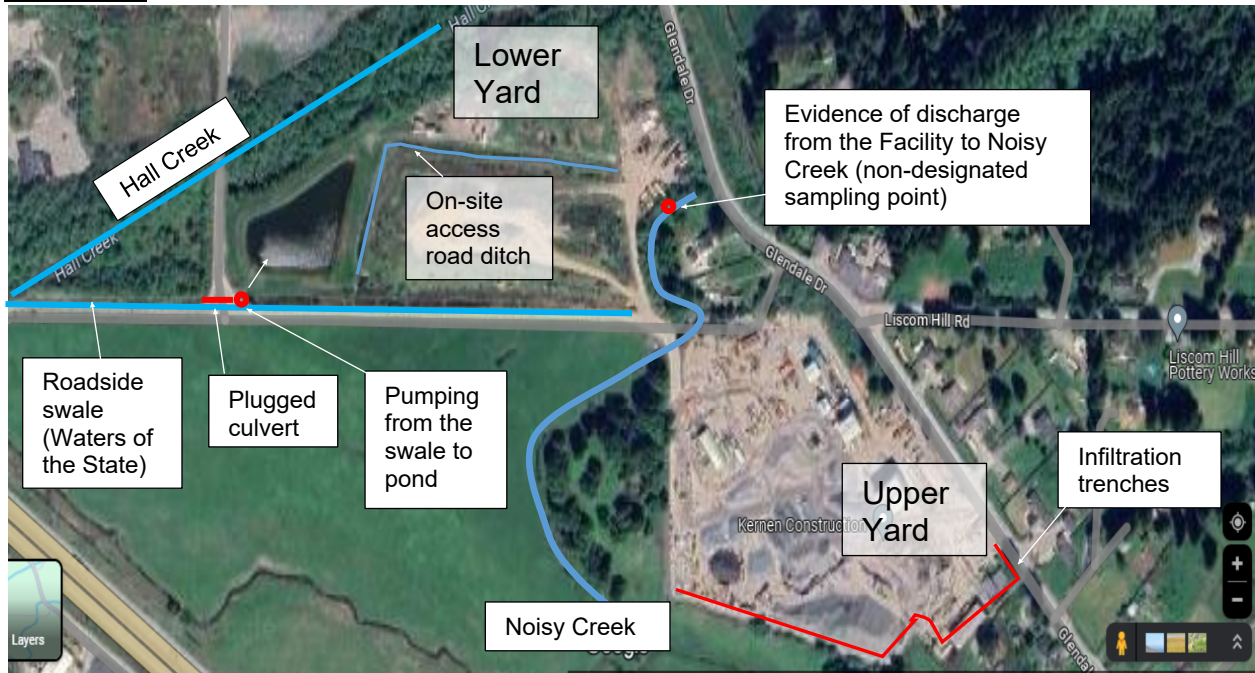
Picture 15 – Site map prepared by Regional Water Board staff indicating the lower and upper yards, Noisy and Hall Creeks, roadside swale and plugged culvert.
