**LINDBERG GEOLOGIC CONSULTING**

February 9, 2017

Subject: Preliminary Engineering-Geologic (R-2) Soils Exploration Report  
APN: 210-074-008, Hidden Valley Road, Butte Creek, Larabee Valley Area

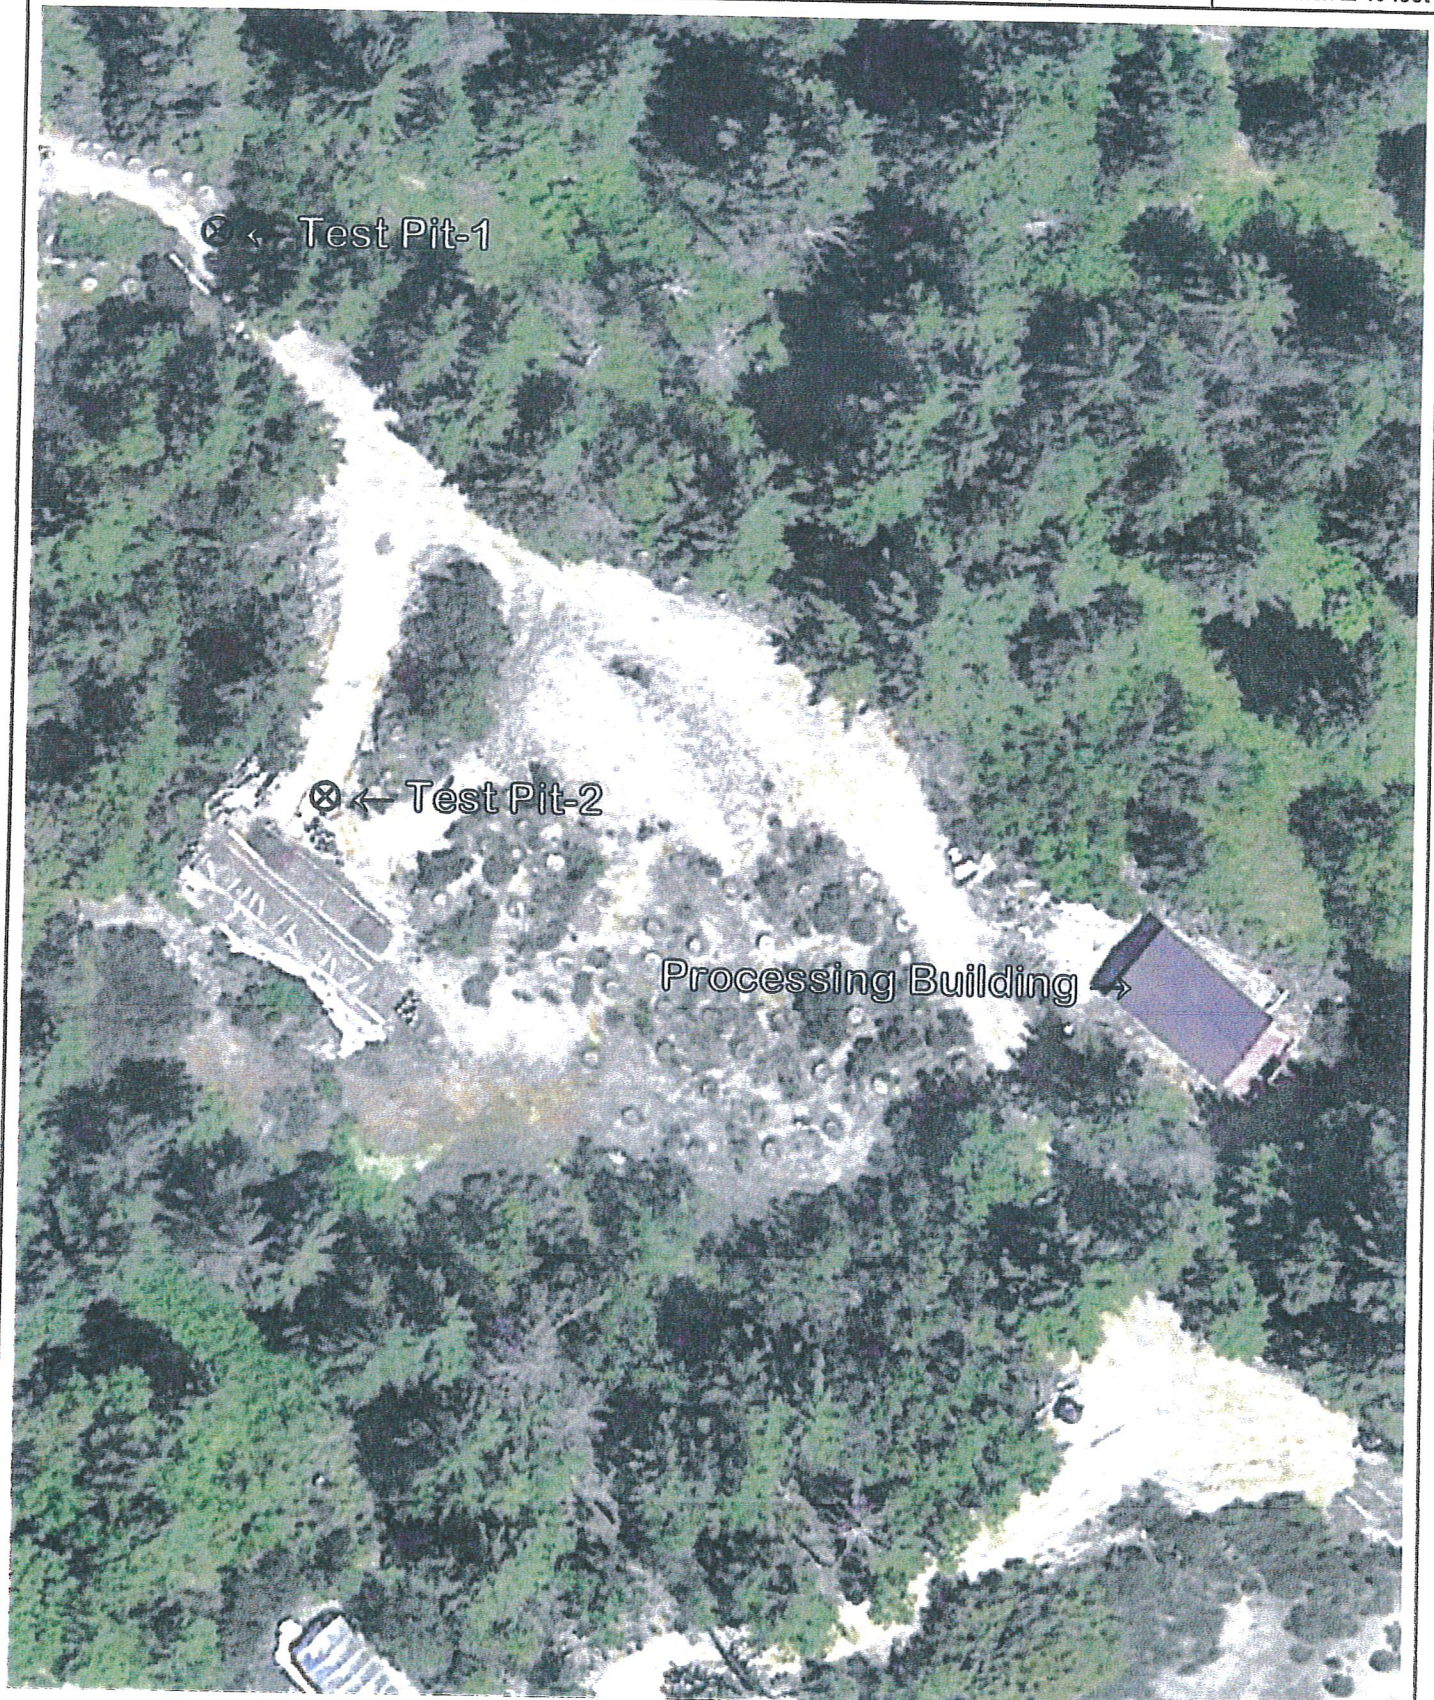
| Lindberg Geologic Consulting | Preliminary Engineering Geologic Soils Exploration Report | Figure 4 |

Site geology, as mapped by McLaughlin and others (2000), consists of mélange rocks of the Central Belt of the Franciscan Complex (Figures 4, 4a). McLaughlin describes the (cm1) mélange unit underlying this parcel as consisting of “predominantly penetratively sheared, locally tuffaceous, scaly meta-argillite, and less abundant blocks of metasandstone. Exhibits rounded, poorly incised, lumpy and irregular topography.” The subgrade soils, beginning approximately one foot below the existing native ground surface are expected to be suitable bearing material for the structural loads anticipated to be imposed by the processing building or storage shed. Structures founded on firm undisturbed materials below this depth should not be expected to be subject to detrimental differential settlement. Foundations should be engineered and designed of reinforced concrete to resist settlement.

proposed residence. Published geologic mapping in the vicinity (Figure 4) does not show any active or dormant landslides in the immediate vicinity of the subject property. Small landslides and unstable ground are common in the region. Based on our field observations and research, the potential for slope stability hazards in the form of differential settlement of foundations placed on improperly constructed fill to adversely affect the existing storage shed during its economic life appears to be significant.

| (707) 442-6000 | Geologic Map of Project Vicinity | Not to Scale |
