**4 Wheel Properties LLC**

**Invasive Plant Management, Restoration  
and Monitoring Plan**

APNs #210-071-001, #210-054-008, and #210-062-007

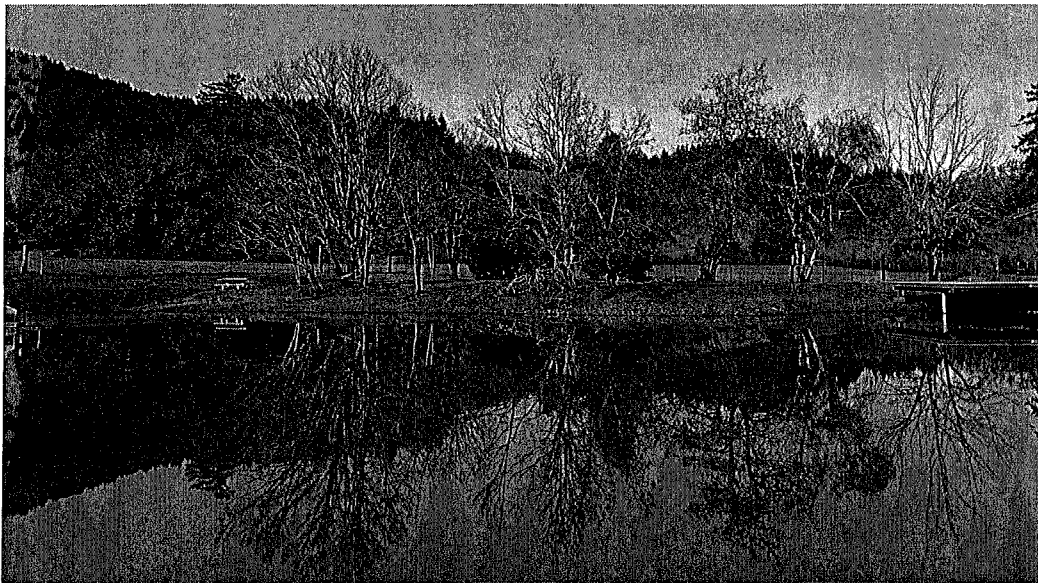
The on-stream pond near the residence is located in open grassland on an altered stream course. Cultivated Port Orford cedar and invasive black locust trees are planted around the pond. Some native willows are naturally recruiting to the edge of the pond, which was mostly bare, with patches of pasture grasses and pennyroyal. The culverts at the inlet and outlets on a class II watercourse are failing and must be replaced (Road Points 5 and 6). The culverts should be replaced according to specifications in the LSAA. The inlet and outlet should be rocked with 12" – 18" diameter rock. The pond shall not be stocked with fish. The pond was evaluated on 1/30/2020. The water clarity was low, but high numbers of invertebrates that indicate high water quality (caddisflies, water boatmen) were present along the edge of the pond. The pond is likely high quality habitat and potential breeding habitat for the western pond turtle and northern red legged frogs. The foothill yellow legged frog also has the potential to use this site. When surveyed under winter conditions, the pond maintained relatively low temperatures. At 11am on 1/30/20, the stream running into the pond was 49 degrees F, the pond was 50 degrees F, and the shallow water coming out of the pond outlet was elevated to 51 degrees F. With low vegetation cover, the pond has the potential to increase water temperatures substantially during the summer, which may negatively impact habitat quality for native amphibians and sensitive aquatic invertebrates found in the area.

Photo 3. The pond at Site K is on-stream, and native habitat enhancement is recommended.

At least 20 native riparian shade trees such as white alder, California buckeye, big leaf maple, Oregon ash, or black cottonwood should be planted around the pond edge where they may provide shaded native habitat. Invasive black locust trees on the northern pond edge are in poor health. Black locust trees have the potential to spread to the natural environment and alter native vegetation communities. The nine black locust trees should be removed and replaced with native trees such as the riparian trees listed above or Oregon white oak or Douglas fir in upland areas. Native willows (such as arroyo willow, Sitka willow, or shining Pacific willow) should also be planted in saturated soil approximately every ~6-10 feet around the edge of the pond. Some willows appeared to be naturally recruiting to the pond edge, and these should be supplemented by planting where bare areas remain. Willow cuttings may be sourced onsite or from a local nursery. Areas for recreational access to the pond may be left clear of vegetation. Willows are expected to improve water quality and habitat quality for native amphibians, western pond turtles, songbirds, and waterfowl. Willows should also be planted between the outlet culvert and road along channel leading the away from the pond to improve the quality of water flowing back into the stream channel (Photo 7). Herbaceous native wetland plants such as small-fruited bulrush or spreading rush may also be planted as desired in lieu of willows. The area should be surveyed for invasive American bullfrogs annually according to CDFW guidelines. Amphibian surveys targeting the CESA Candidate foothill yellow-legged frog and other sensitive species are recommended prior to work on the inlet and outlet.

- a) Cut down invasive black locust trees on the northern edge of the pond and replace them with at least 9 native trees (potential species listed in Table 1).
- b) Complete all recommended culvert replacements, earthwork, etc.
- c) Plant native willows along the saturated edge of the pond every ~6-10 feet.

- d) Plant 20 native riparian trees approximately 5-20 feet back from the saturated edge of the pond.

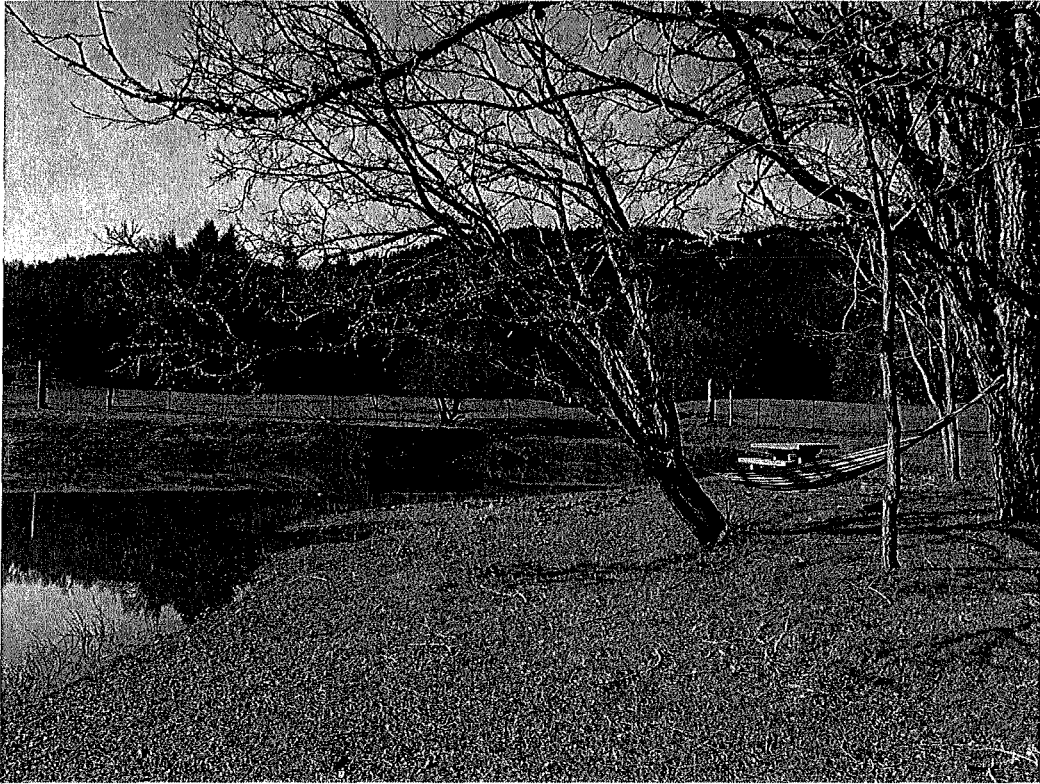
Photo 4. Invasive black locust trees (seen here in winter) to be removed from the pond area may be identified by their cascade of white pea-like flowers and seed pods.

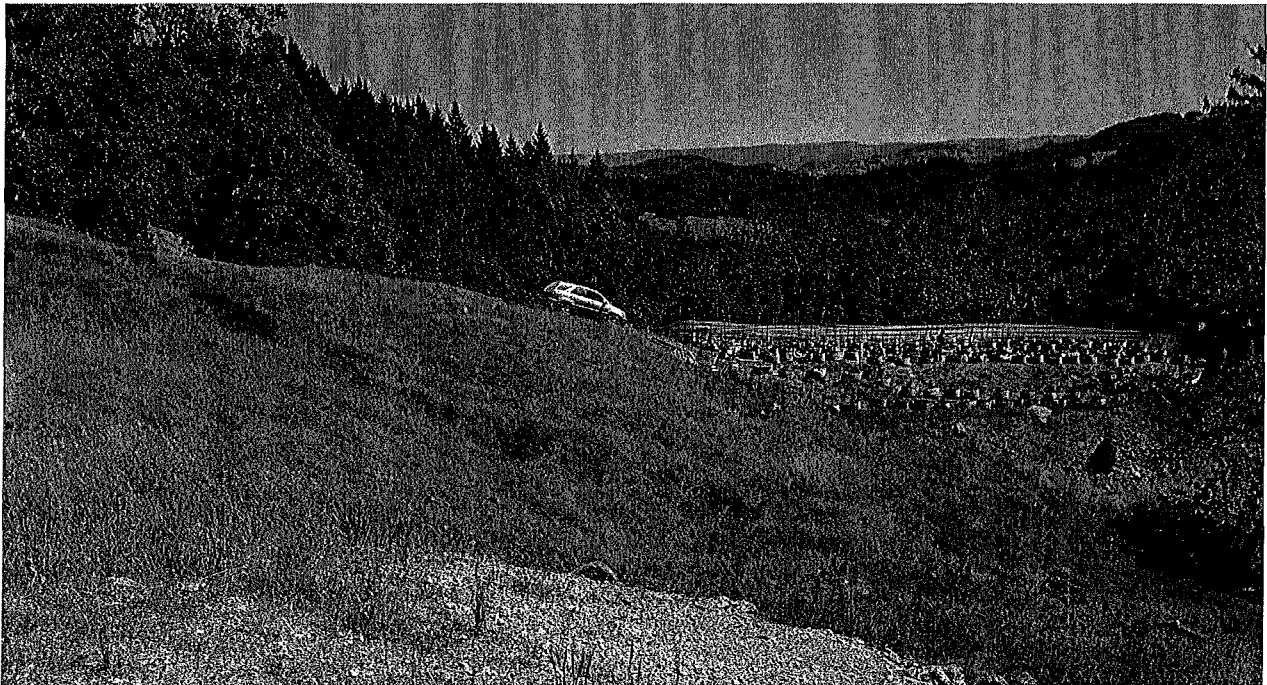
The mid-slope site is located on >15% slope with poor access trails. This 86' x 100' site was first converted for cannabis cultivation around 2012 when aerial imagery shows that an outdoor garden was planted. It is recommended that this site be relocated out of the TPZ to the AG field proposed. Several greenhouses have occupied the site over the years, but currently no greenhouse is present. The site is located on the edge of oak woodland and a grassy meadow with some serpentine soils. Serpentine soils should be left undisturbed in the remediation process. Surrounding vegetation includes Douglas- fir, and mixed oak woodlands. It is estimated that ~3-6 oaks and other hardwoods were removed from the area between 2010 and 2012. The road system is primarily a skid trail and can only be used seasonally. It is recommended that the site be removed and the planted with oak, and/or other native upland trees listed in Table 1. The road should be decommissioned and all cultivation materials should be removed from the slope.

Photo 7. Site M cultivation site should be remediated and restored by planting native trees and grass. The nearby serpentine area is characterized by a blue-green tinge, and this area should be avoided.

- a) Remove green houses and all cultivation related materials from the site.
- b) Maintain all existing vegetation. No grading required. Maintain outsloped flat.
- c) Straw mulch all disturbed bare soil within 100 feet and seed with a native grass seed mix such as Pacific Coast Seed Native Erosion Control Mix.

- d) At least 10 native tree species shall be planted the first winter following completion of the earth work.

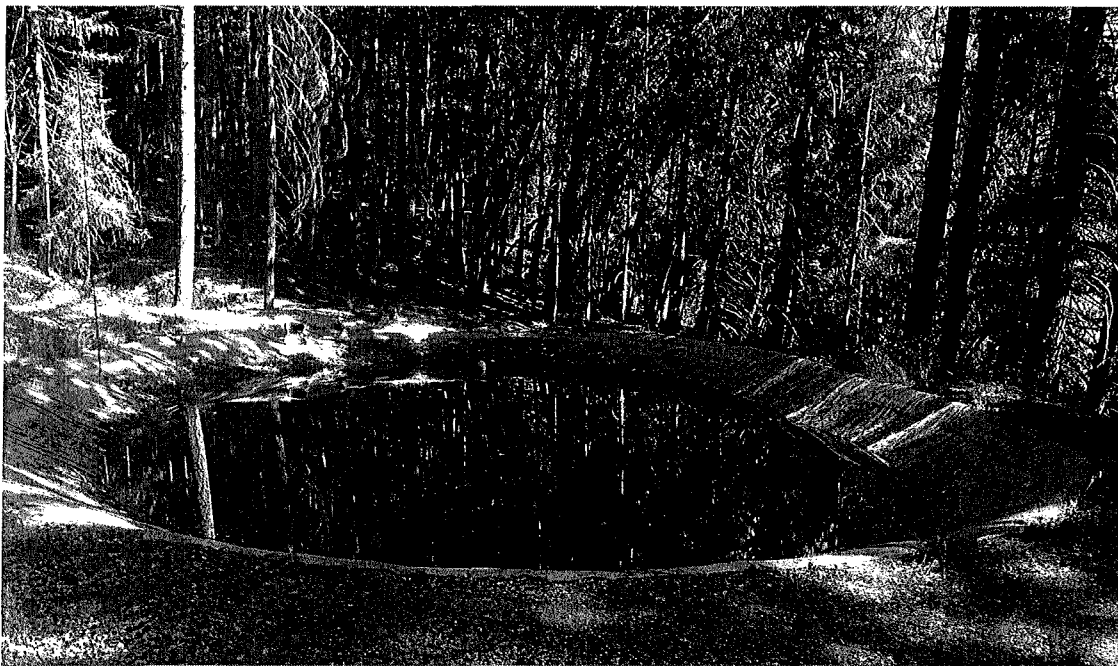
Conversion Site B2 is an on-stream pond within the forested slope. The site was first converted for a recreational pond (90' by 62') between 2014 and 2016. Surrounding vegetation includes Douglas-fir and black oak, with a minor amount of other hardwoods. The pond and fill material to create the earthen dam expands the site to 95' x 116'. The pond is failing with the flex pipe eroding the earthen fill. The pond has been recommended to be removed, contoured and planted with trees. Work should take place during dry conditions in the summer to early fall.

Photo 8. The onstream pond in the forested area.

- a) Remove existing pond outlet, the earthen dam and relief culvert structures.
- b) Excavate and align the 90' channel to grade. Spoils from excavation shall be placed within the southern section of the pond and feathered into to the slope.
- c) Slope the watercourse banks back to a 1: 1.5 ratio and compact.
- d) Straw mulch all bare soil within 100 feet of the watercourse.
- e) Slash piles from past logging may be lopped and scattered across the site to reduce rill erosion.
- f) Restoration work shall occur on dry rainless periods between June 1st and October 15<sup>th</sup>

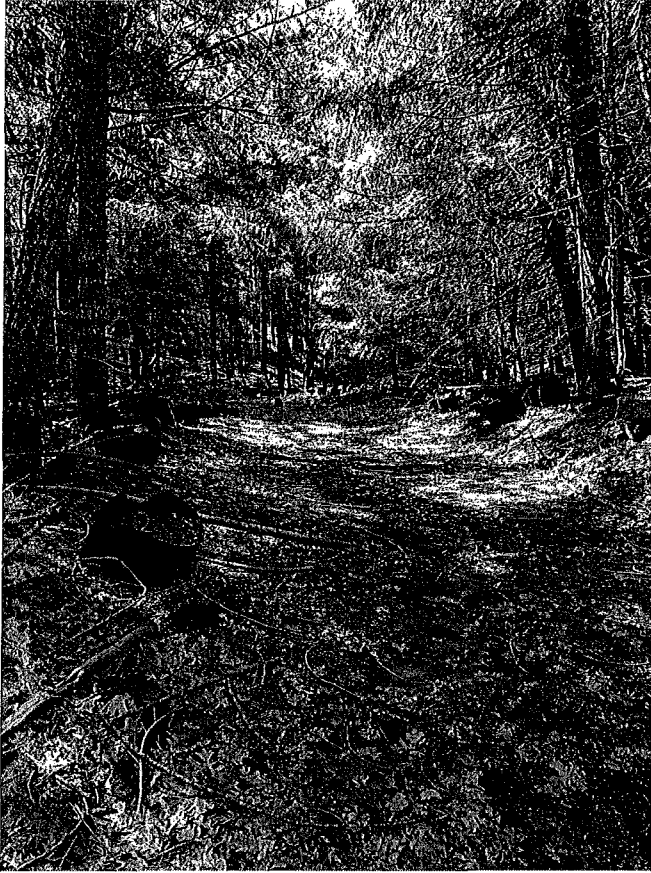
Former cultivation materials scattered along the mid-slope road should be removed. All pots, potting soil, and other cultivation materials and debris must be removed from the road and properly stored or taken to the dump. Potting soil and other materials should not be left in areas not designated for cultivation.

Photo 11. Cultivation materials need to be removed from the spur road. Potting soil should be composted in a designated covered compost pile, and other materials should be stored in sheds or taken to the dump.
