# Jurisdictional Wetland Delineation Report

## Foster Clean Power A & B Project

November 2022

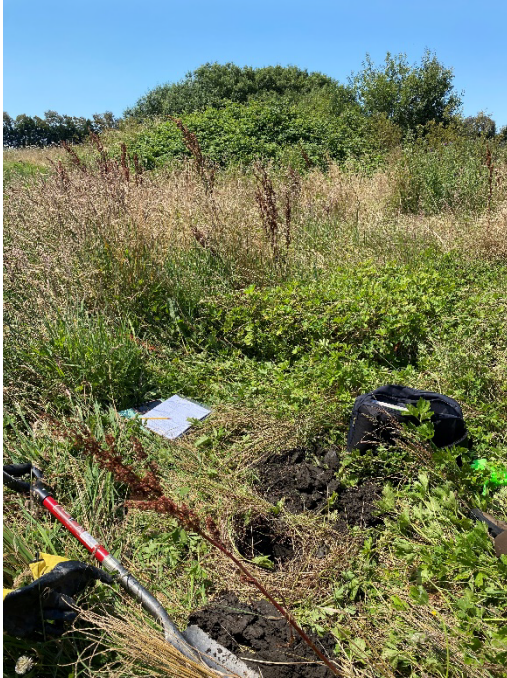
Photo 1. TP1

Depth (inches)	Matrix		Redox Features			Type <sup>1</sup>	Loc <sup>2</sup>	Texture	Remarks
	Color (moist)	%	Color (moist)	%					
0-15"	10YR 2/1	98	7.5YR 3/4	2	C	M		silty clay loam

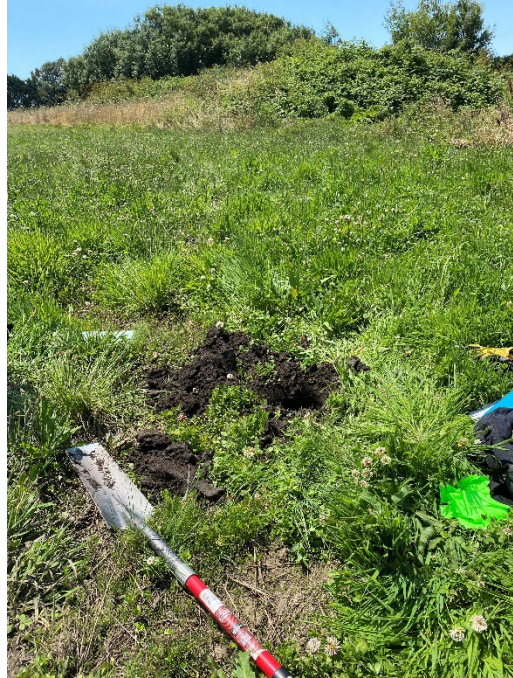
Photo 2. TP2

Depth (inches)	Matrix		Redox Features				Texture	Remarks
	Color (moist)	%	Color (moist)	%	Type <sup>1</sup>	Loc <sup>2</sup>		
0-15	7.5YR 3/2	100					silty clay

Remarks:  
*less moisture; no red ox; more brown (not black)  
tilled*

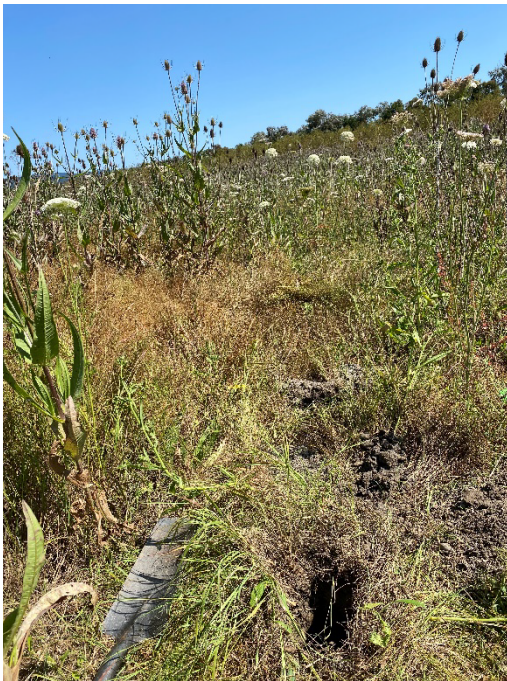
Photo 3. TP3

Depth (inches)	Matrix		Redox Features				Texture	Remarks
	Color (moist)	%	Color (moist)	%	Type <sup>1</sup>	Loc <sup>2</sup>		
<u>0-14"</u>	<u>10R4/2</u>	<u>88</u>	<u>10YR4/6</u>	<u>12</u>	<u>C</u>	<u>M</u>	<u>silty clay</u>

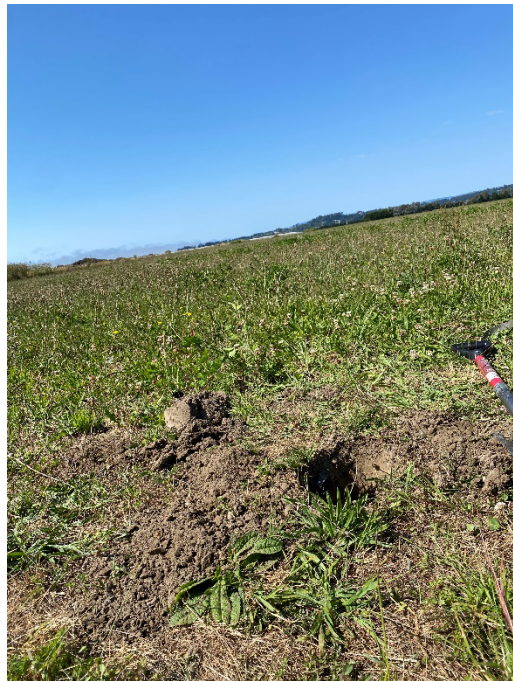
Photo 4. TP4

Depth (inches)	Matrix		Redox Features				Texture	Remarks
	Color (moist)	%	Color (moist)	%	Type <sup>1</sup>	Loc <sup>2</sup>		
0-14	10YR 3/2	100					Silt loam

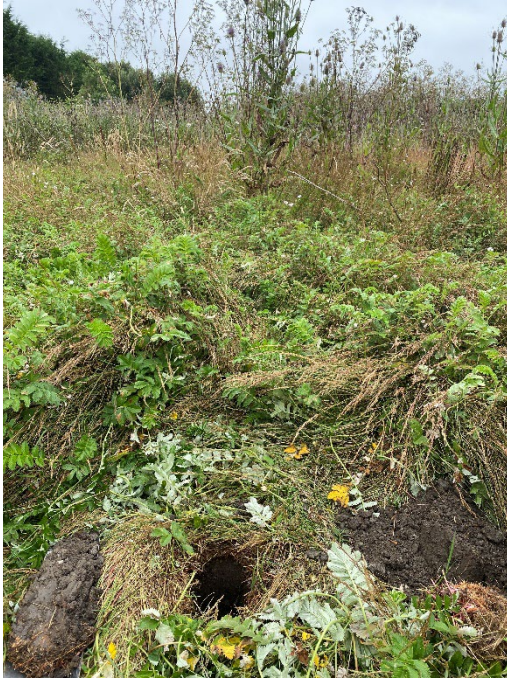
Photo 5. TP5

Depth (inches)	Matrix		Redox Features				Texture	Remarks
	Color (moist)	%	Color (moist)	%	Type <sup>1</sup>	Loc <sup>2</sup>		
0-5"	10YR3/2	100					silty clay loam	
5-14"	10YR3/2	93	7.5YR4/6	17	C	M	silty clay loam

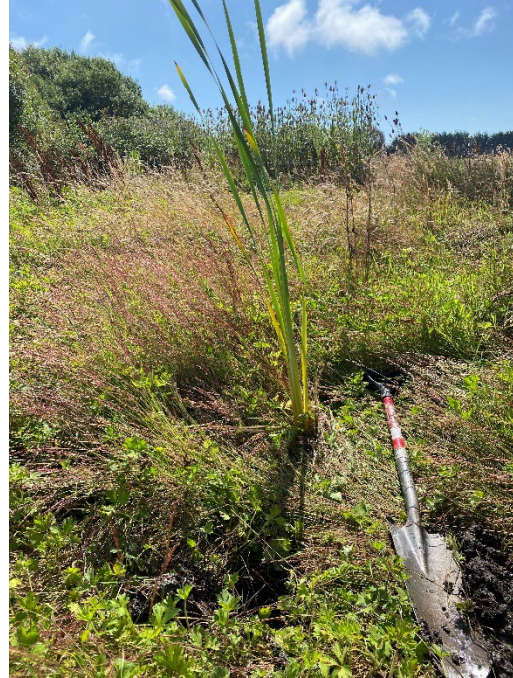
Photo 6. TP6

Depth (inches)	Matrix		Redox Features				Texture	Remarks
	Color (moist)	%	Color (moist)	%	Type <sup>1</sup>	Loc <sup>2</sup>		
0-12	10YR2/1	100					silty clay loam

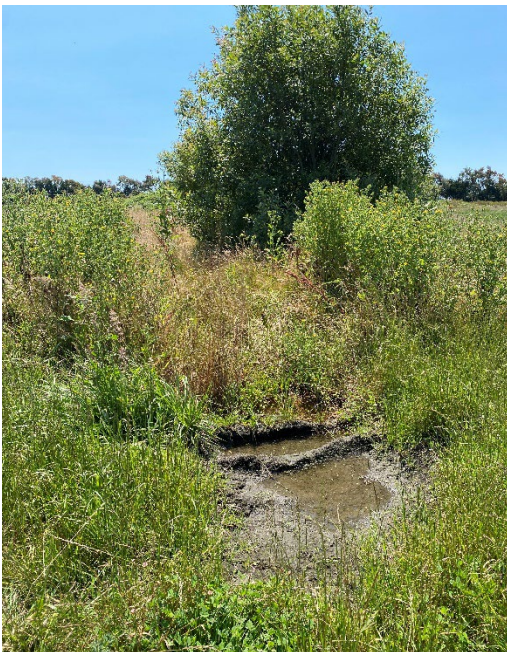
Photo 7. View of wetland from Northeast edge

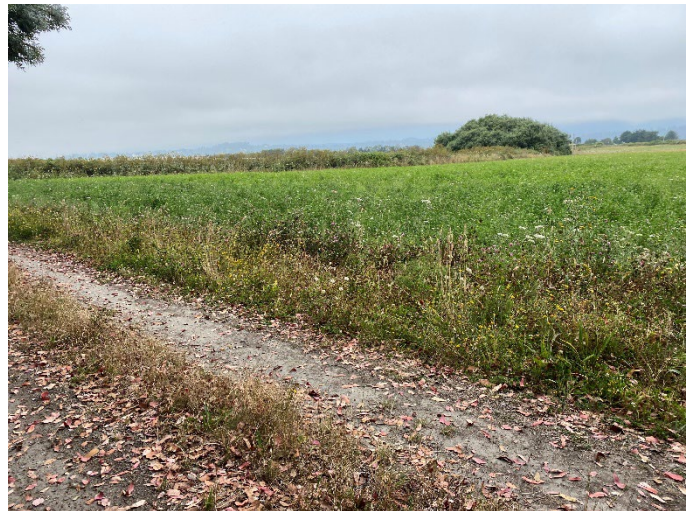
Photo 8. View of wetland from the south
