# We Are Up Project

# **Initial Study & Proposed Mitigated Negative Declaration**

County of Humboldt PLN-2022-18047 CUP/SP APN 509-181-057

# Aquatic Resources Delineation and Sensitive Habitat Report\_Rev2 We Are Up Housing Project

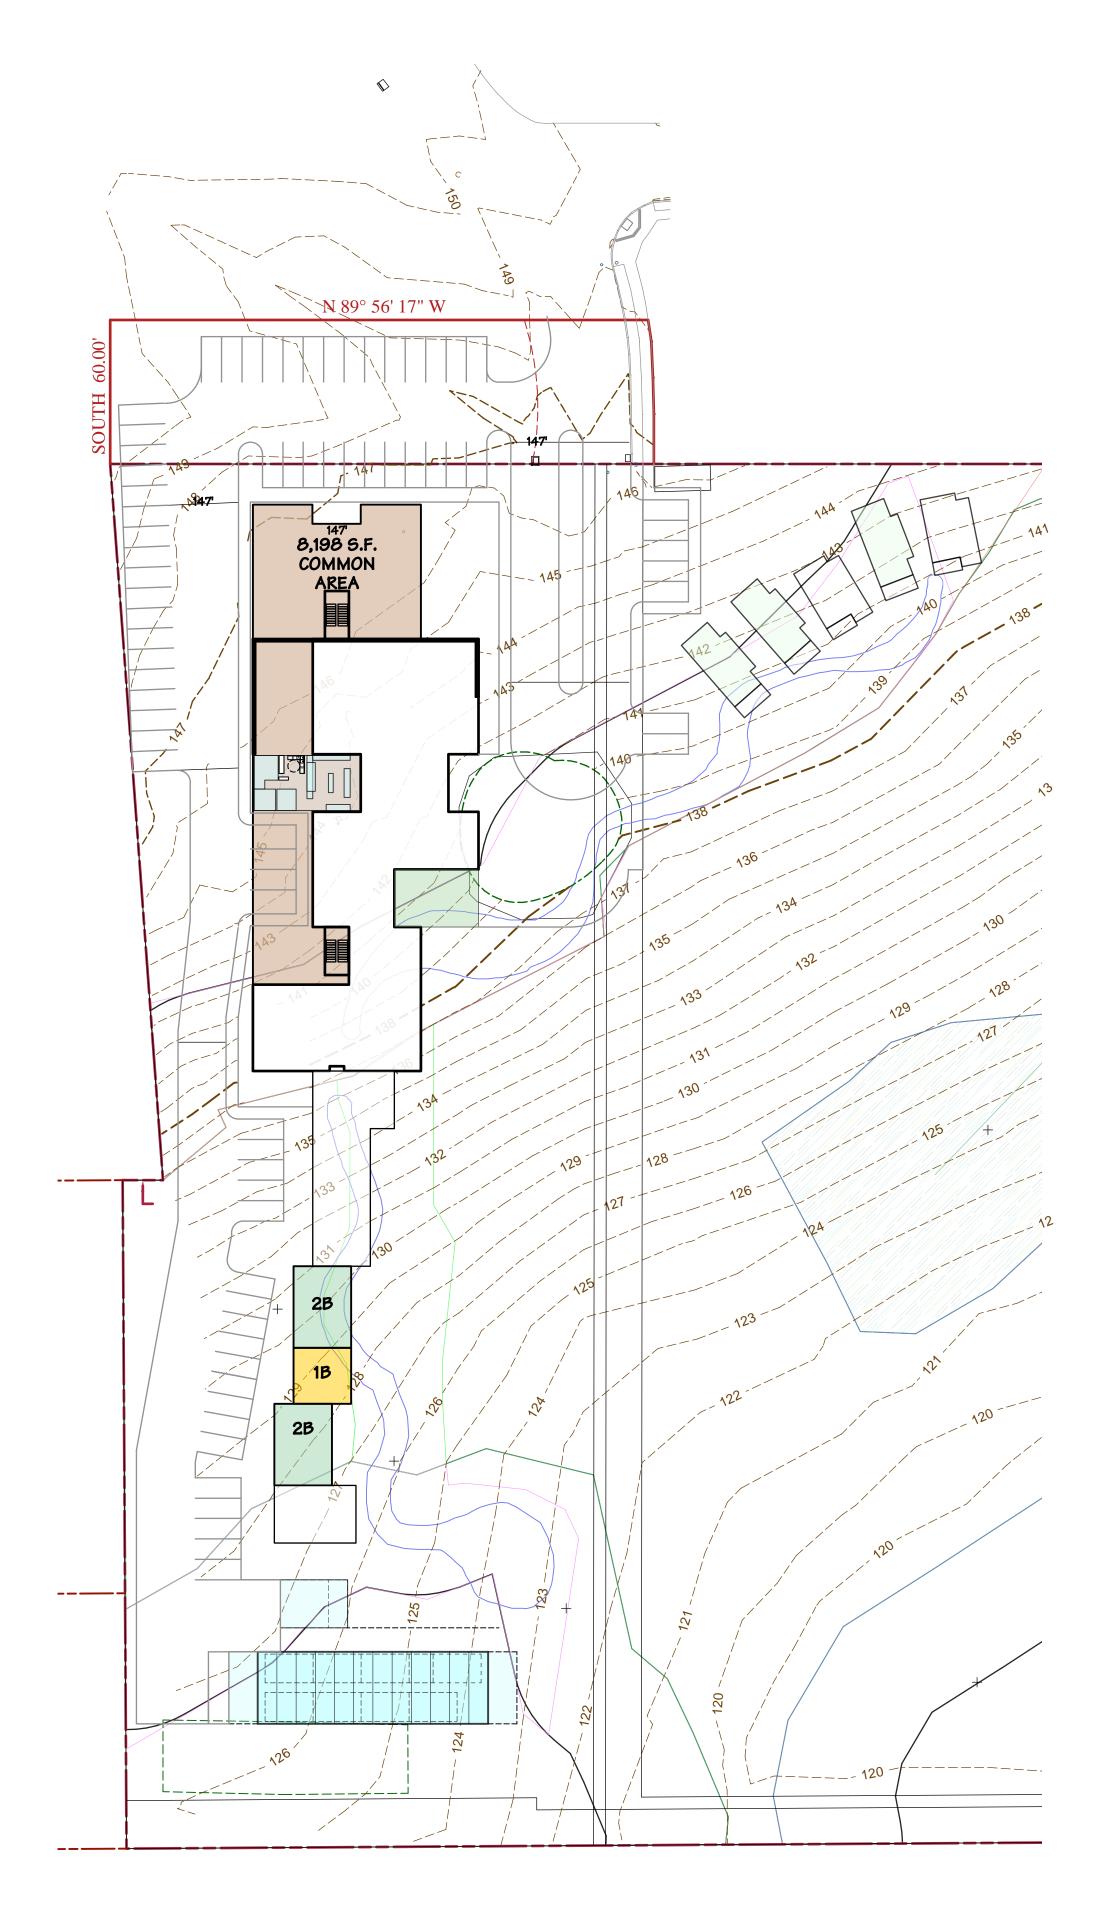
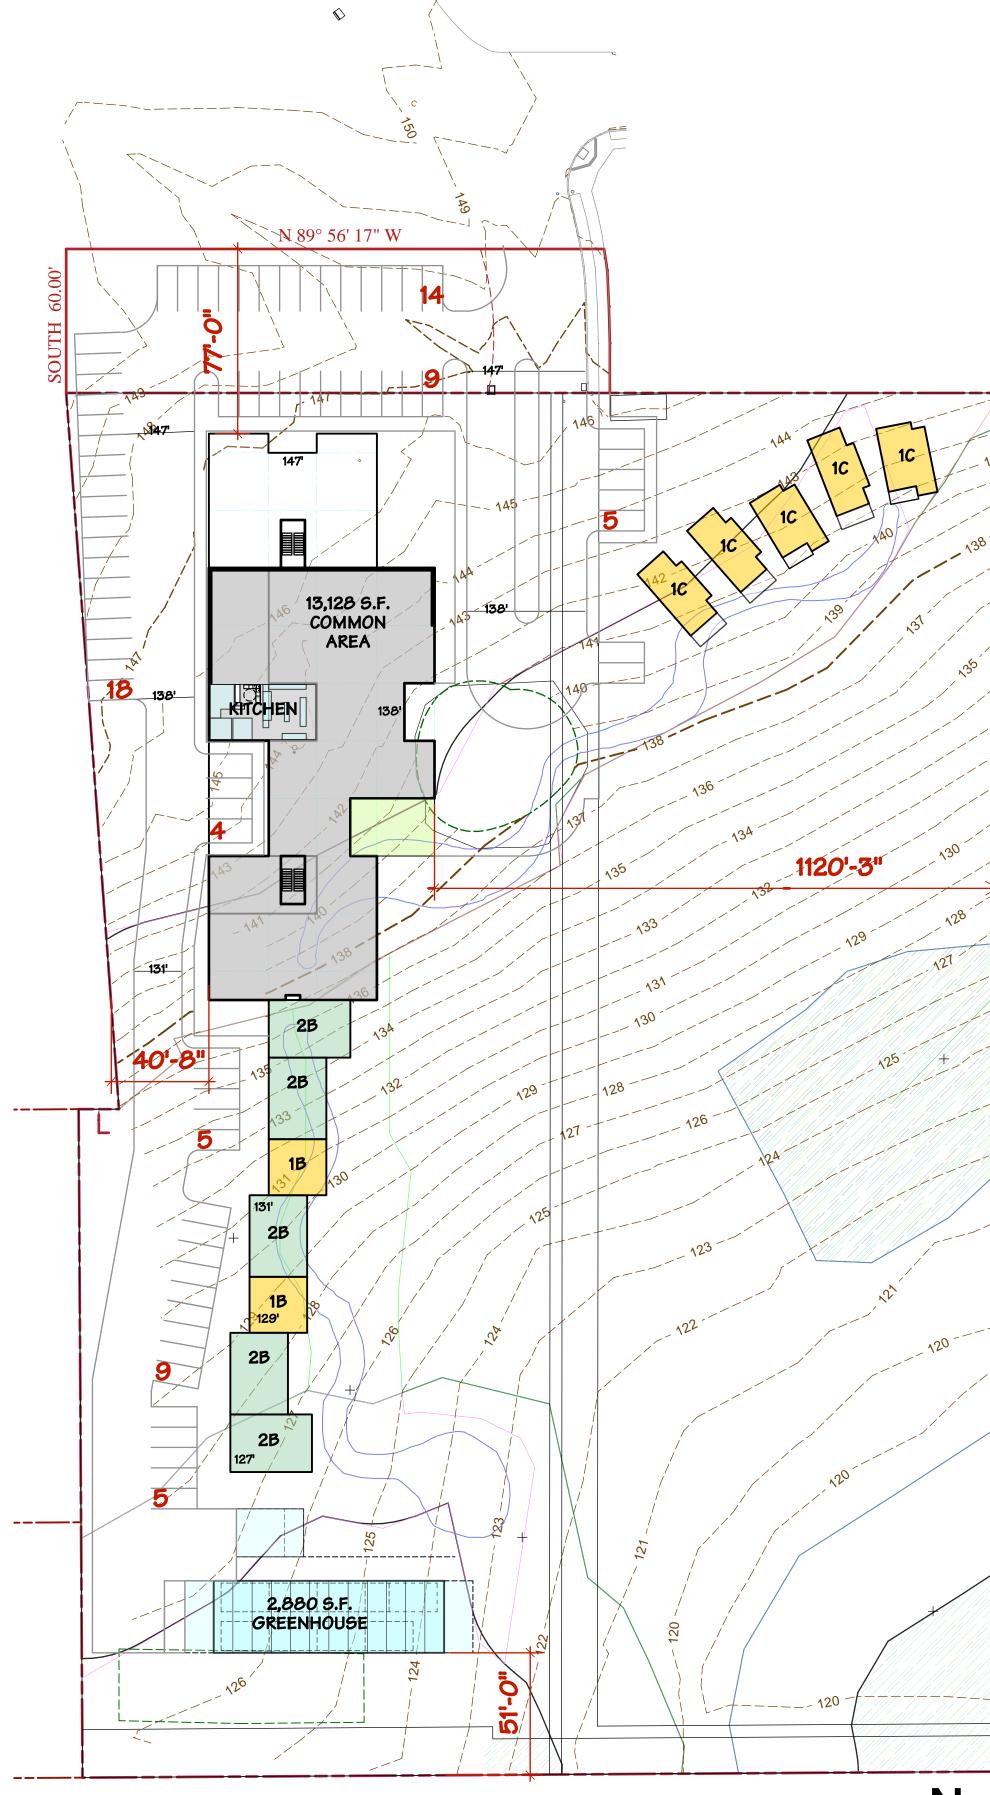
Main and Mezzanine Layout

MEZZANINE LEVEL

MAIN LEVEL

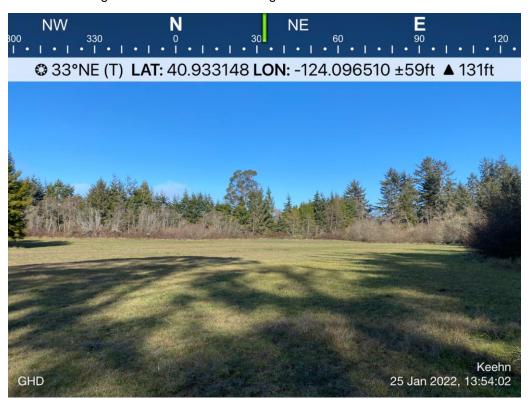
Photo 2. The northeastern edge of the PSB, showing the Coastal Willow Alliance backed by the Sitka Spruce Alliance behind it.

The Coastal Willow Alliance corresponds to the Rapid Assessment datasheet WEIR002 in **Appendix D**. The Coastal Willow Alliance was observed in the north, northwest, and southwest edges of the PSB and covers 0.85 acres of the PSB. This SNC contained a tree canopy cover of 2% red alder (*Alnus rubra*), a shrub layer of 85% coastal willow (*Salix hookeriana*), and 20% California blackberry. The Coastal Willow Alliance has a State ranking of S3, therefore qualifying it as an SNC.

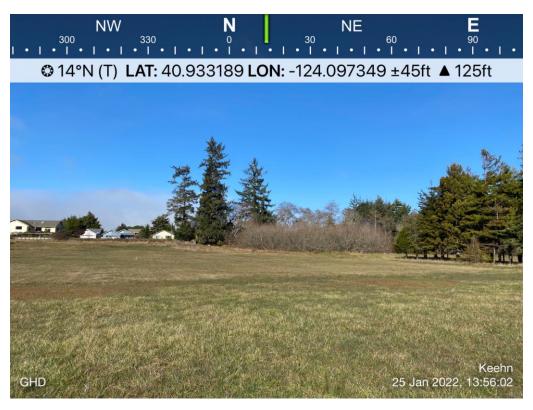
Photo 5. Viewing a swale in the center of the PSB facing North.

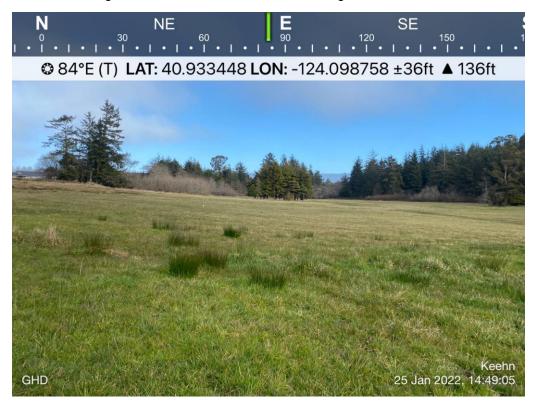
Photo 6. Viewing more hydrophytic vegetation within Wetland 1, present on the upper slope.

Wetland 1 was open and mostly free of rooted woody vegetation and is classified according to the Cowardin system as a Palustrine Emergent wetland (PEM) (FGDC 2013). The vegetation was primarily characterized by redtop (*Agrostis stolonifera*, FAC), reed fescue (*Festuca arundinacea*, FAC), common velvetgrass (*Holcus lanatus*, FAC), Italian rye grass (*Festuca perennis*, FAC), slough sedge (*Carex obnupta*, OBL), and mountain bod sedge (*Scirpus microcarpus*, OBL). Wetland 1 mostly passed the dominance test for hydrophytic vegetation (wetlands plots).

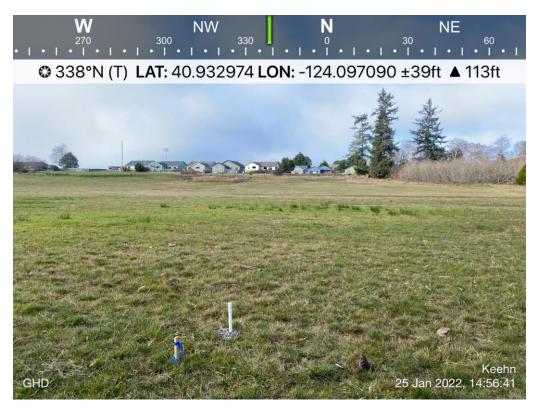
Photo 7. Viewing a swale at the base of the slope within Wetland 1.

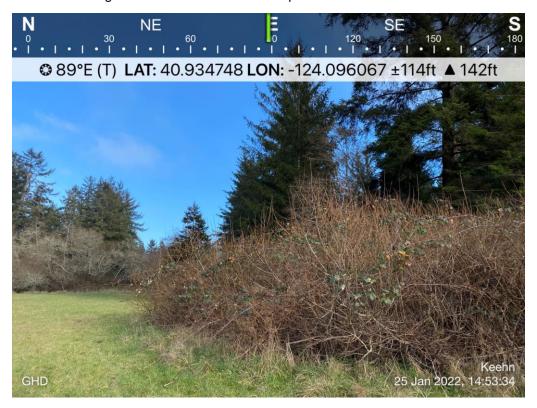
Photo 8. Dormant Coastal Willow Alliance SNC within the riparian corridor of Mill Creek.

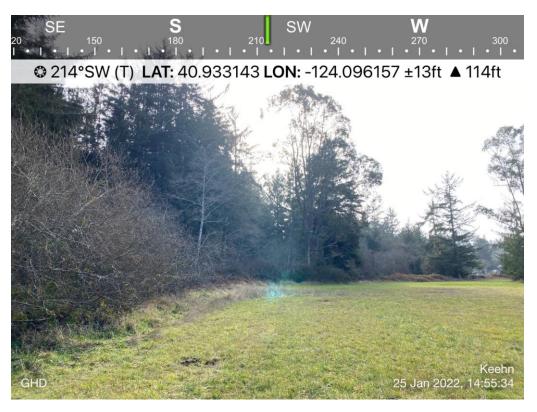
Photo 9. SNCs Coastal Willow Alliance backed by Sitka Spruce Alliance within the riparian corridor of Mill Creek.

The Riparian Corridor of Mill Creek was mapped to the drip line, and no wetlands were assessed underneath the canopy. The Riparian Dripline can be found in **Appendix A, Figure 3**. Much of the two SNCs are present within the Mill Creek Riparian corridor.

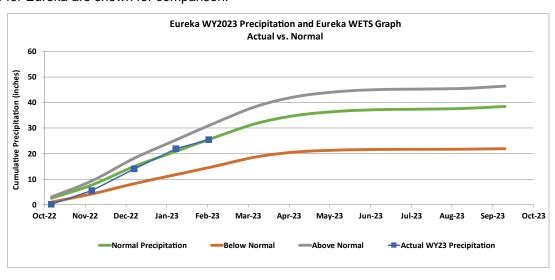
Figure 1 Eureka, California WY 2023 Precipitation and WETS graph

Rainfall data (as of February 24, 2023) for Eureka for the 2023 water year (October 1, 2022, to September 30, 2023) is shown in **Figure 1**. Below normal, normal, and above normal rainfall data from the WETS Table for Eureka are shown for comparison.

Precipitation	on (inches)	
Month	Below Normal	Normal	Above Normal
January	3.59	5.98	7.25
February	3.21	5.35	6.49
March	3.74	5.53	6.61
April	1.94	3.2	3.88
May	0.73	1.57	1.91
June	0.25	0.66	0.79
July	0.05	0.17	0.18
August	0.06	0.28	0.27
September	0.19	0.8	0.88
October	0.96	2.45	2.96
November	3.25	5.26	6.36
December	4.02	7.22	8.8
