Wetland and Other Waters Delineation Report

Assessor's Parcel Number
512-072-002
5364 Fieldbrook Road
Fieldbrook, California

February 2023

022203

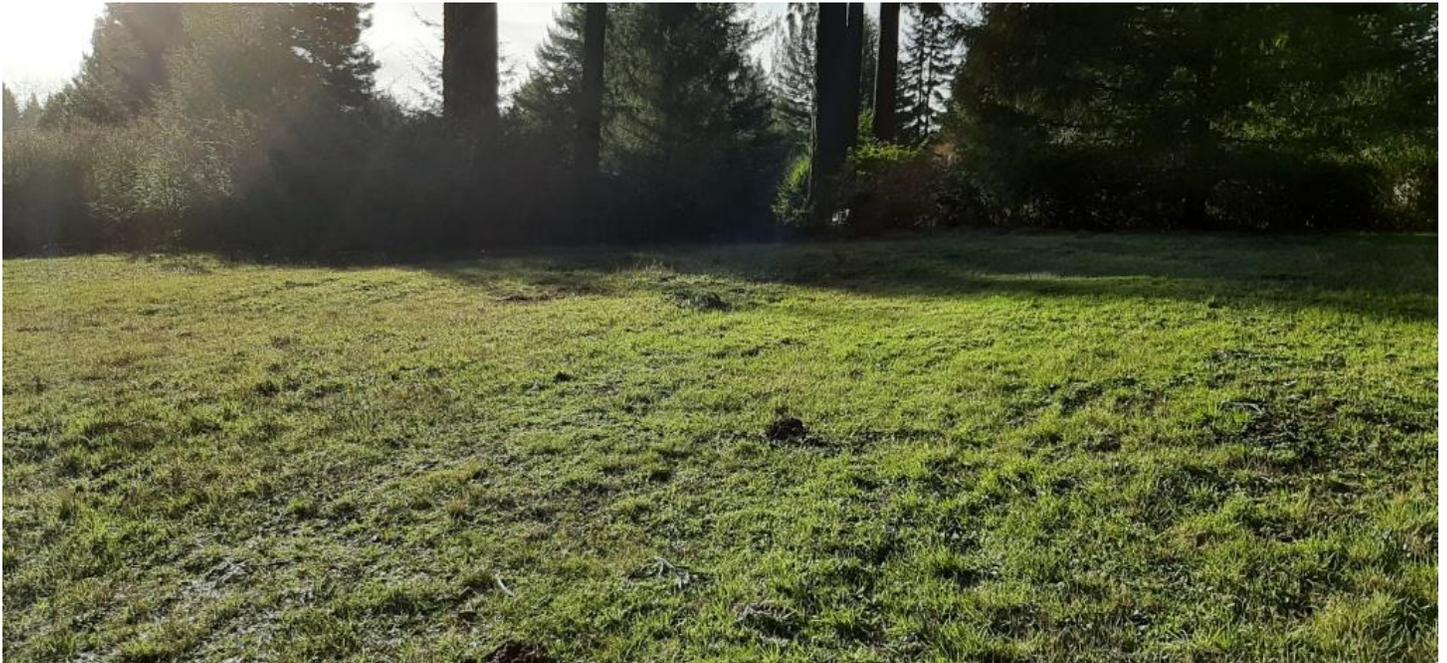
Photo 1: North view of project site. Photo taken January 19, 2023.

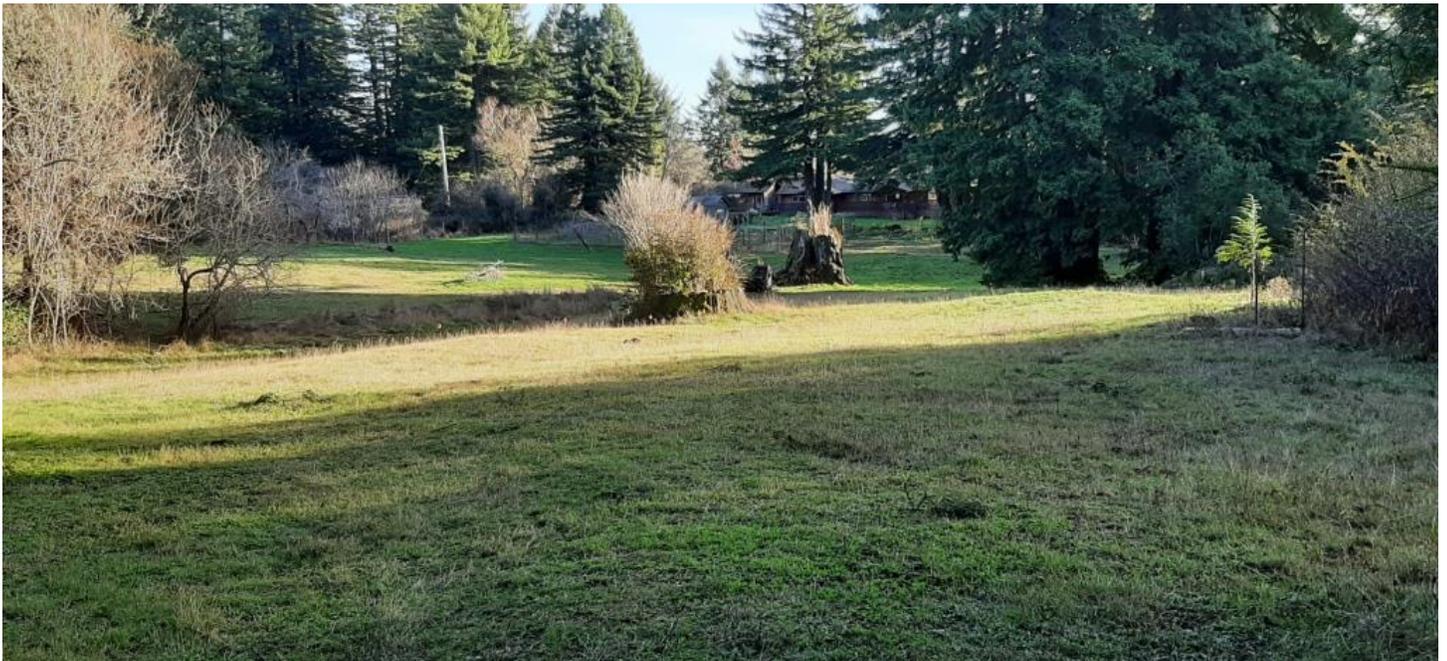
Photo 2: South view looking towards existing residential home with wetland and stream in swale. Photo taken January 19, 2023.

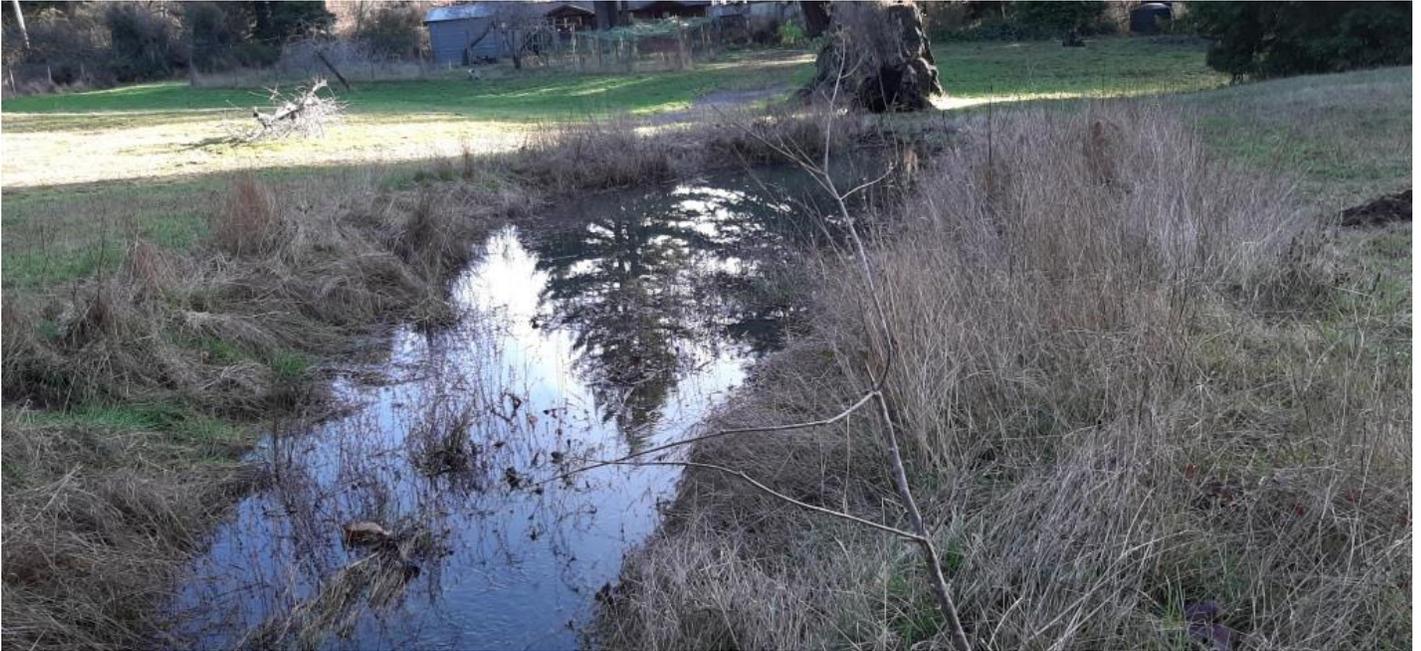
TP1 was excavated within the wetland that is in the study area (Figure 2; Appendix 1, Photos 3 and 4). The wetland was created by adding a dam in an intermittent stream that drains the forested hillslope north of the parcel. The owner indicated this occurred several years ago; therefore, normal circumstances were assumed. The test site was chosen to determine if the pond has enough hydrology during the year to support wetland conditions. All three parameters were present (hydrophytic vegetation, hydrology, and hydric soils); therefore, it is considered a USACE wetland.

Photo 3: Looking south, towards the existing residence. The constructed wetland is in the foreground in the stream that flows southwest. Photo taken January 19, 2023.

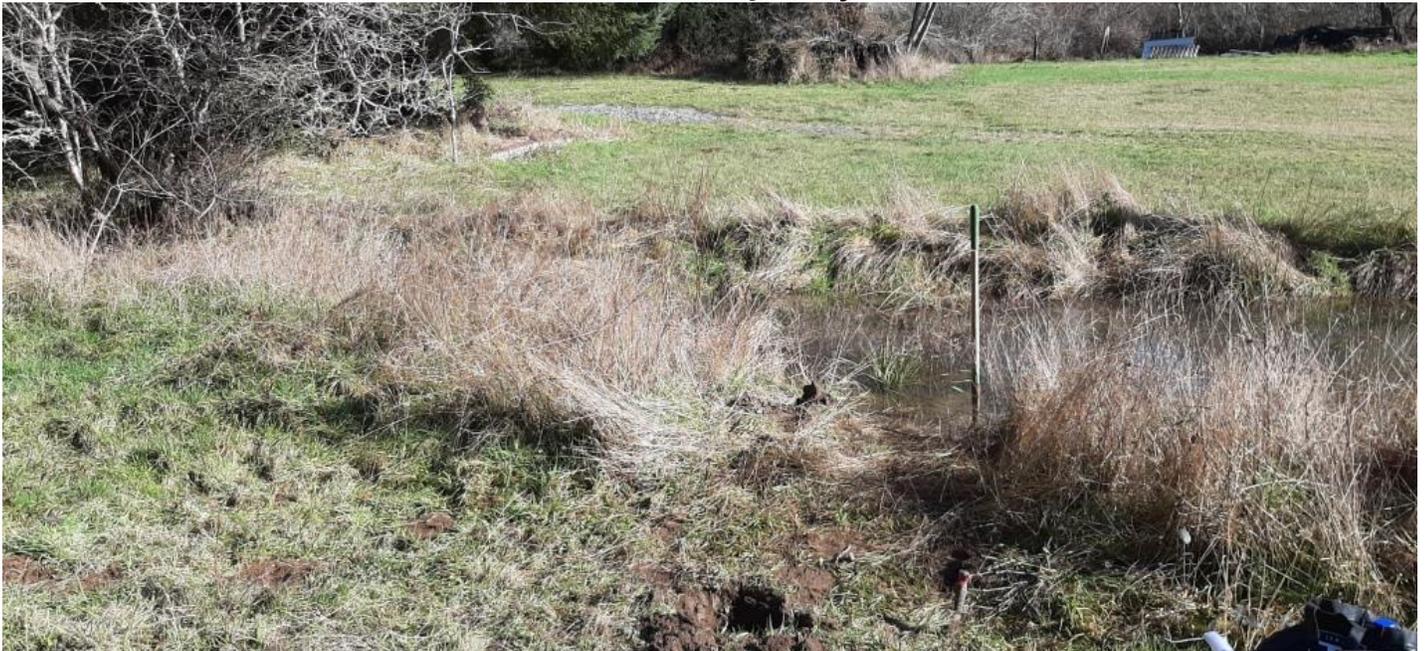
TP1 vegetation contained the Sapling/Shrub and Herb stratum. The dominant shrub species was the Himalayan blackberry (*Rubus armeniacus* [FAC]) with only 4-percent cover and is therefore not part of the dominance test (under 5-percent cover). The dominant herb vegetation were Colonial bentgrass (*Agrostis capillaris* [FAC]) with 20-percent cover, and penny royal (*Mentha pulegium* [OBL]) with 17-percent cover. The vegetation dominance meets the hydrophytic vegetation parameter.

The hydrology parameter was met with the primary indicators of Surface Water (A1), High Water Table (A2), Saturation (A3), Drift Deposits (B3), Inundation Visible on Aerial Imagery (B7), Aquatic Invertebrates (B13), and the secondary indicators of Water-Stained Leaves (B9), Drainage Patterns (B10), Geomorphic Position (D2), and the FAC-Neutral Test (D5).

The hydric soil Depleted Matrix (F3) indicator was observed, in addition to the reaction of manganese oxide to hydrogen peroxide (H₂O₂), and a slight reaction to the alpha, alpha dipyridyl reagent. Therefore, the hydric soil parameter was met.

TP2 was excavated 10 feet above TP1 in the mowed field above the wetland and is the paired plot to TP1. It is at the base of a well-drained 20-percent sloped hillslope. None of the three parameters were observed; and therefore, is not considered a USACE wetland (Figure 2; Appendix 1, Photo 4).

A primary indicator of Saturation (A3) was observed at 11 inches. Saturation must be above the 12-inch level to qualify. Because of the very heavy rains from the day before and the strong indication of upland vegetation with no redox observed in the soils, professional judgment was used to determine that the hydrology would not ordinarily qualify for this parameter.

Photo 4: Looking east at TP1 (located at shovel). TP2 is in foreground at excavated pit in the upland mowed field. Photo taken January 19, 2023.

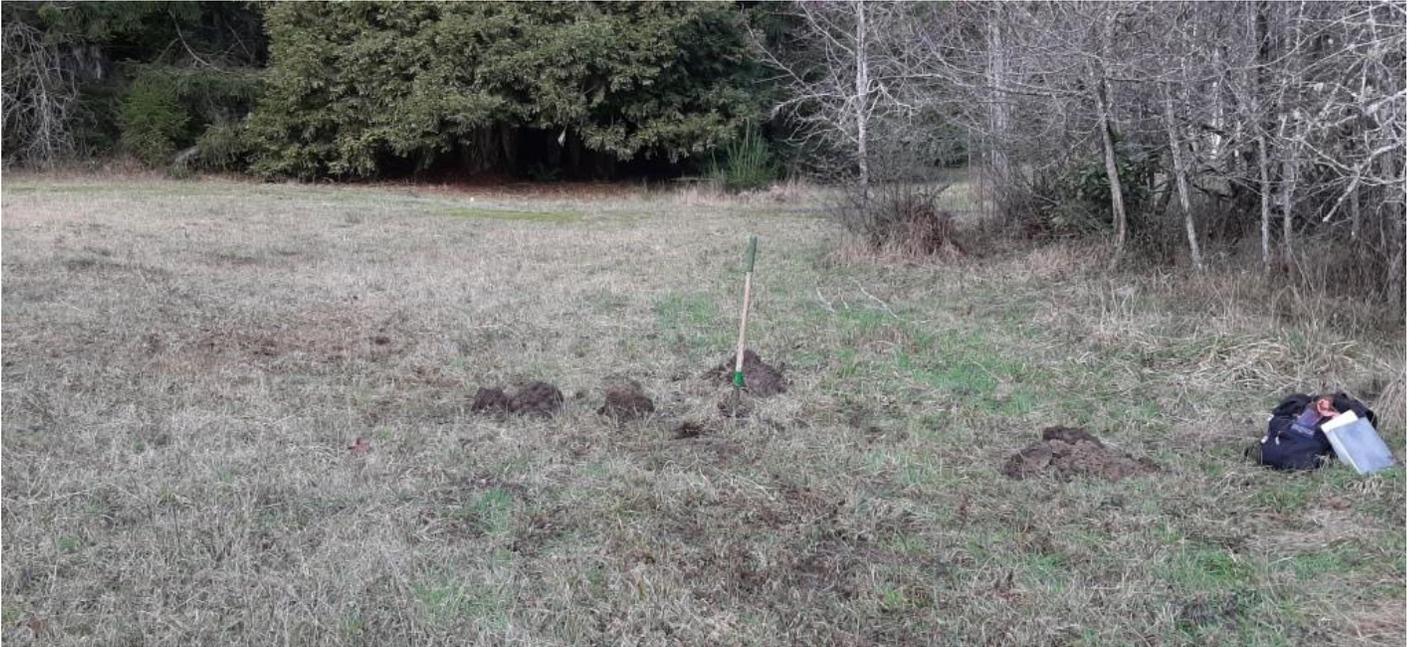
There were no hydric soil indicators observed; therefore, not qualifying for this parameter.

The hydrology primary indicators observed were High Water Table (A2) and the Saturation (A3), with the secondary indicator Geomorphic Position (D2). This qualifies for the hydrology parameter.

Photo 5: Looking north at TP3 with surrounding exploratory pits. TP3 is 17 feet from the stream on the right. Photo taken January 19, 2023.

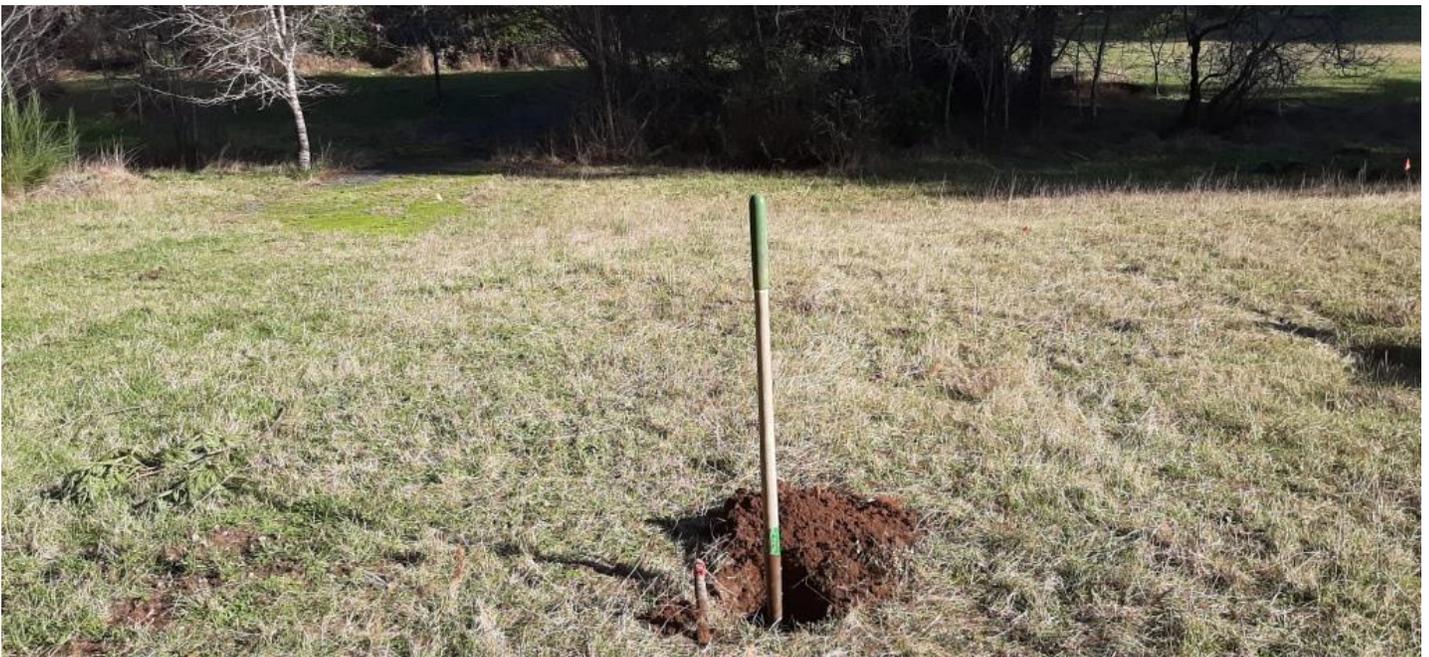
TP4 was excavated at the top of the hillslope where the ADU is anticipated to be constructed. This site is on well-drained soils with a high percentage of upland vegetation. None of the wetland parameters were observed and it is not considered to be a USACE wetland (Figure 2; Appendix 1, Photo 6).

Photo 6: Taken at TP4, looking east towards the stream. Photo taken January 19, 2023.

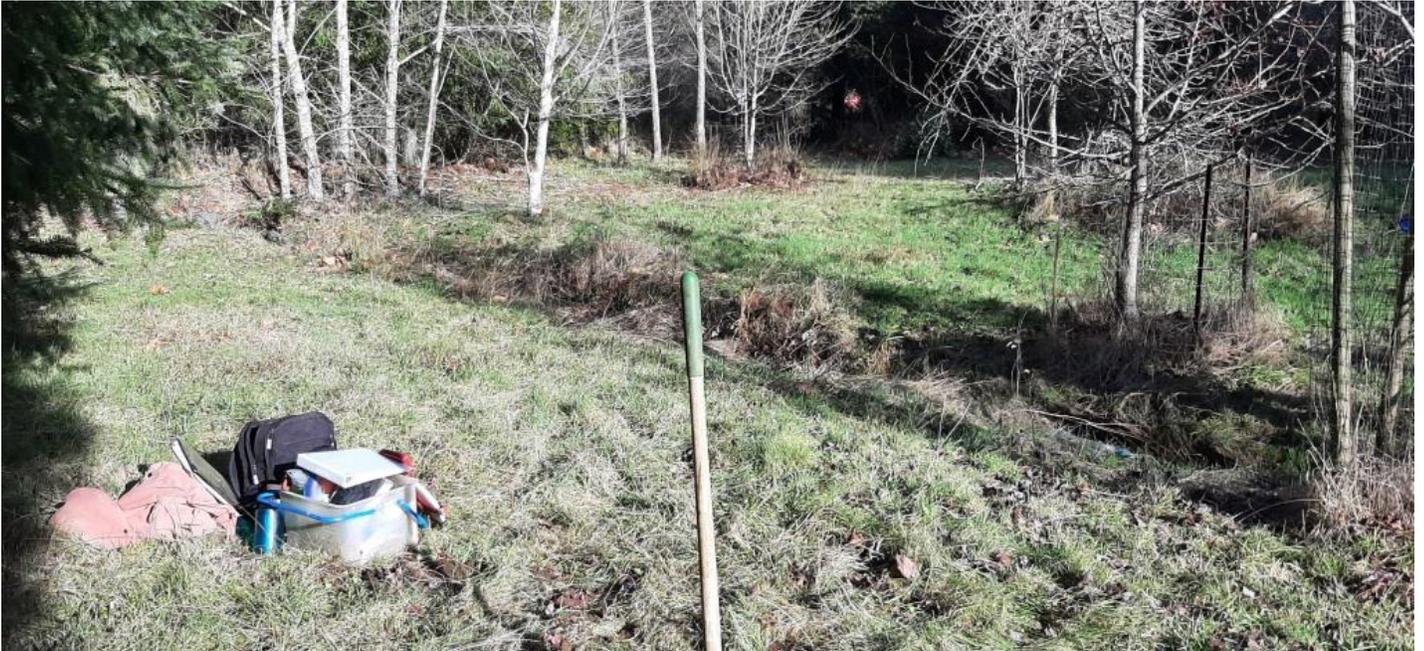
No hydric soil indicators were observed; therefore, it does not qualify for the hydric soil parameter.

Saturation (A3) was observed in TP5 at 12 inches, which would ordinarily qualify for a primary hydrology indicator. Because of the heavy rains during early January and on January 18, the day before the investigation, that the 12-inch depth is at the borderline for this indicator, and that neither vegetation nor soils suggested wetland properties, professional judgement discounted this as an indicator. Therefore, TP5 does not meet the hydrology parameter.

Photo 7: TP5 (at base of shovel) is in a low-sloped section near the stream. Photo is looking northeast, towards Fieldbrook Road. Photo taken January 19, 2023.

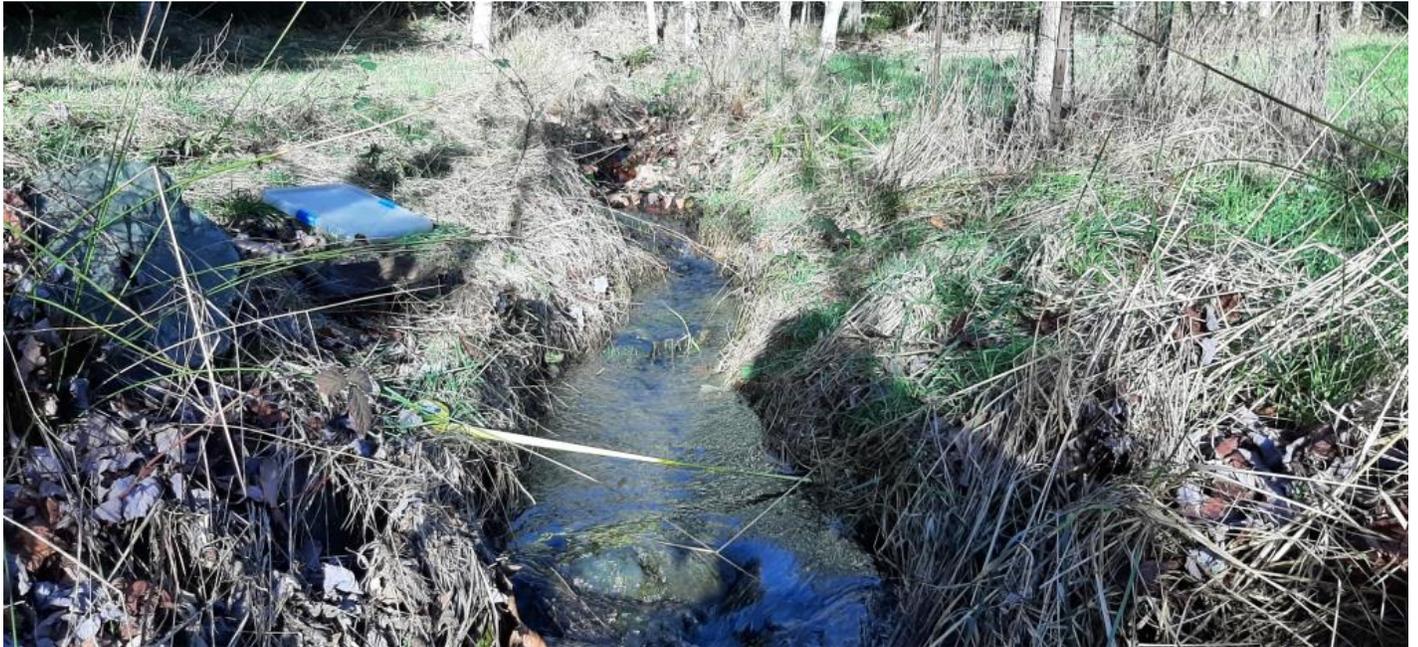
Ordinary high water mark indicators were observed within the intermittent stream that runs through the eastern side of the study area (Figure 2; Appendix 1, Photo 8). This stream drains the northern forested area north of the study area. An OHWM point was delineated near TP5, above the human-constructed wetland at the southern edge of the study area. The datasheet for this point (OHWM1) is in Appendix 3.

Photo 8: OWHM1 (tape shows approximate location) is in an intermittent stream that drains the forested area north of the study site. TP5 is approximately 14 feet to left of the stream. Photo looking north. Photo taken January 19, 2023.

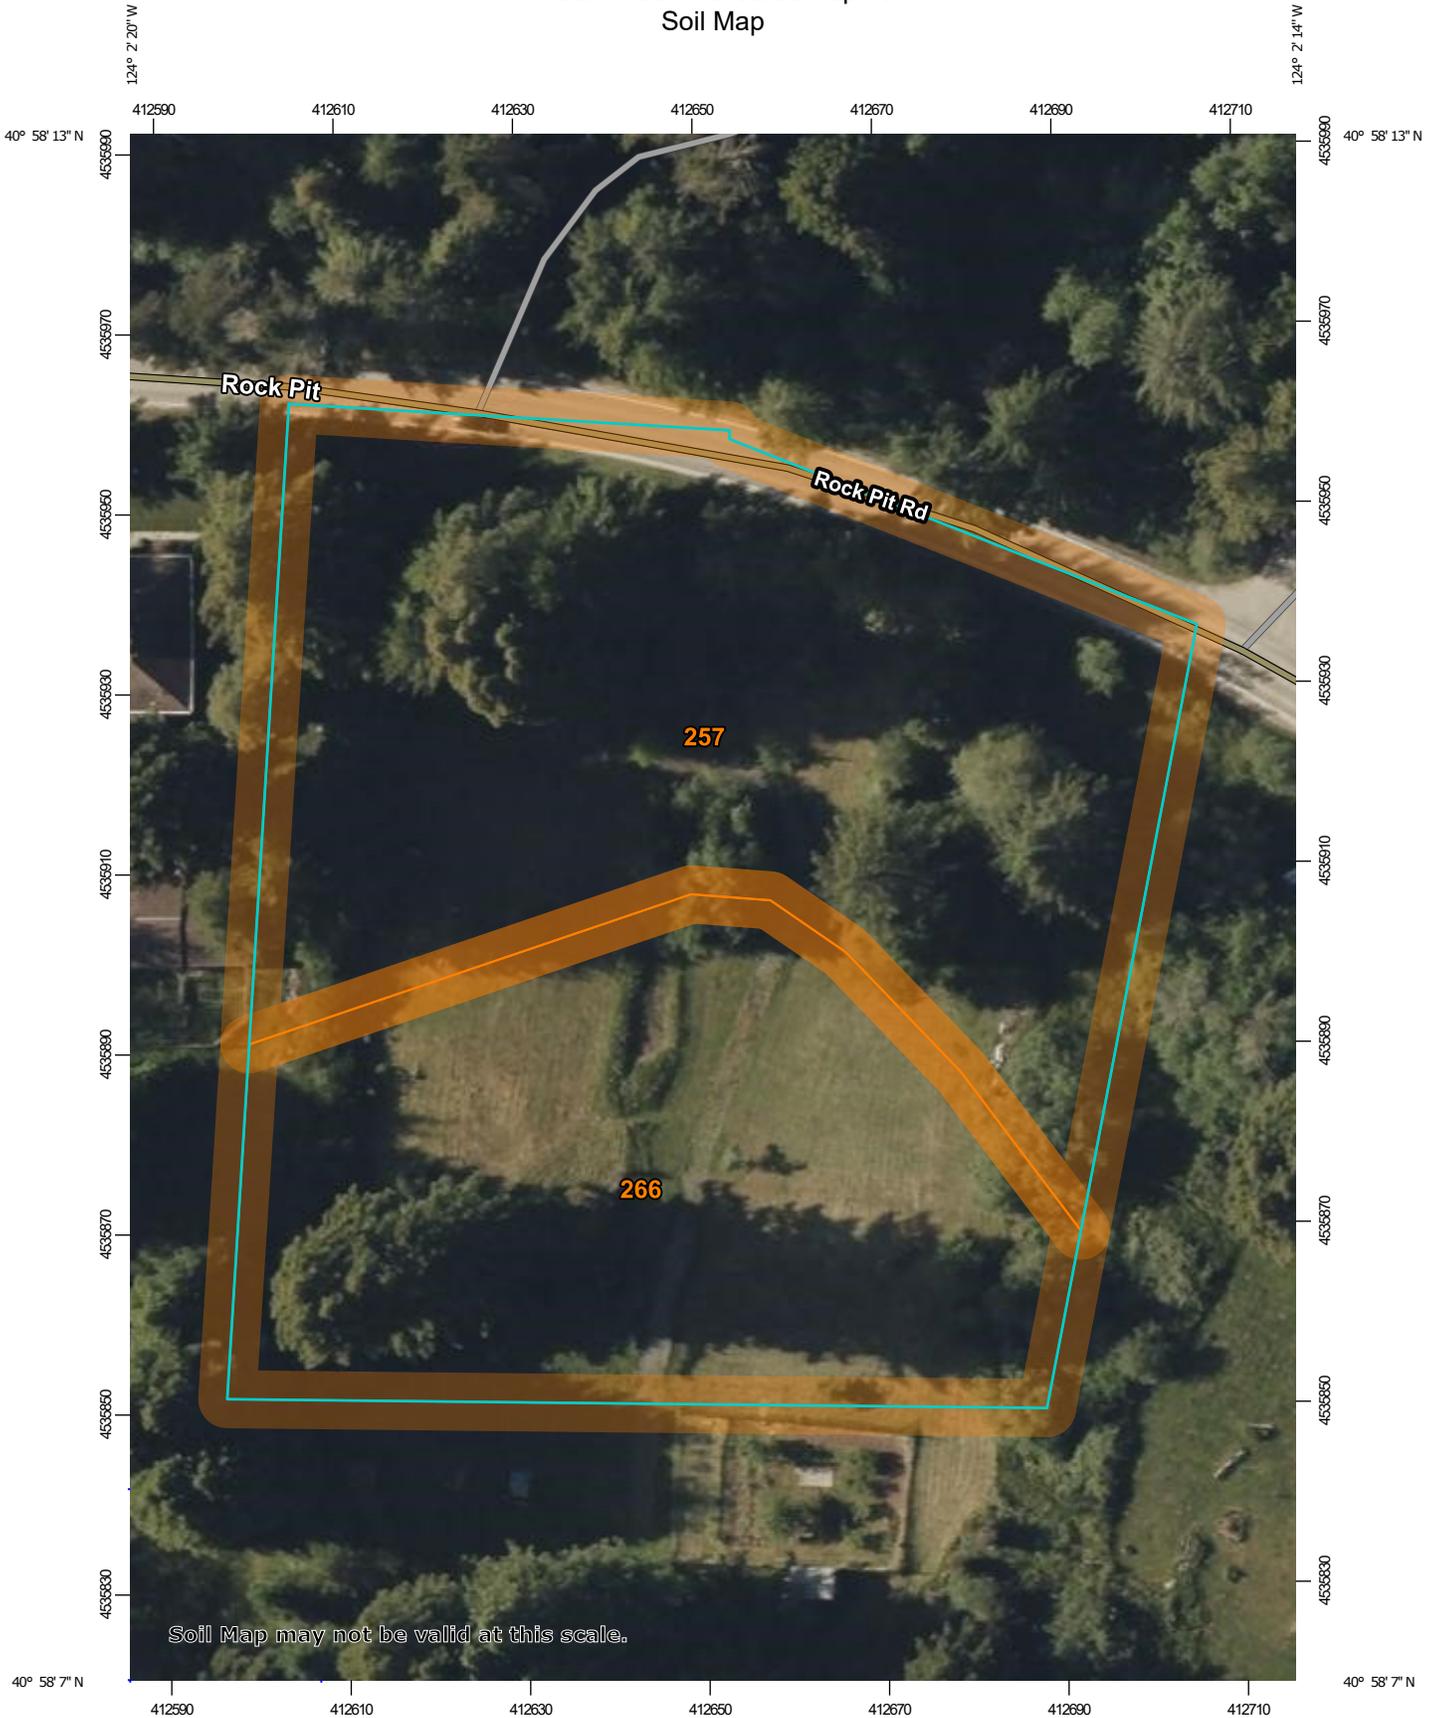
Custom Soil Resource Report Soil Map

The underlying soils in the study area have the USDA-NRCS soil map unit designation 257- Leopold Candy Mountain complex, 2-15 percent slopes and 266- Hookton-Urban Land complex, 0-2 percent slopes, as described below (full report in Appendix 2). Soils were characterized by loams to clay loams. The site-specific soil description at each exploratory soil TP is included in the wetland determination data forms found in Appendix 3, with photos in Appendix 1.
