# Wetland and Other Waters Delineation Report

Assessor's Parcel Number  
512-072-002  
5364 Fieldbrook Road  
Fieldbrook, California

**022203**

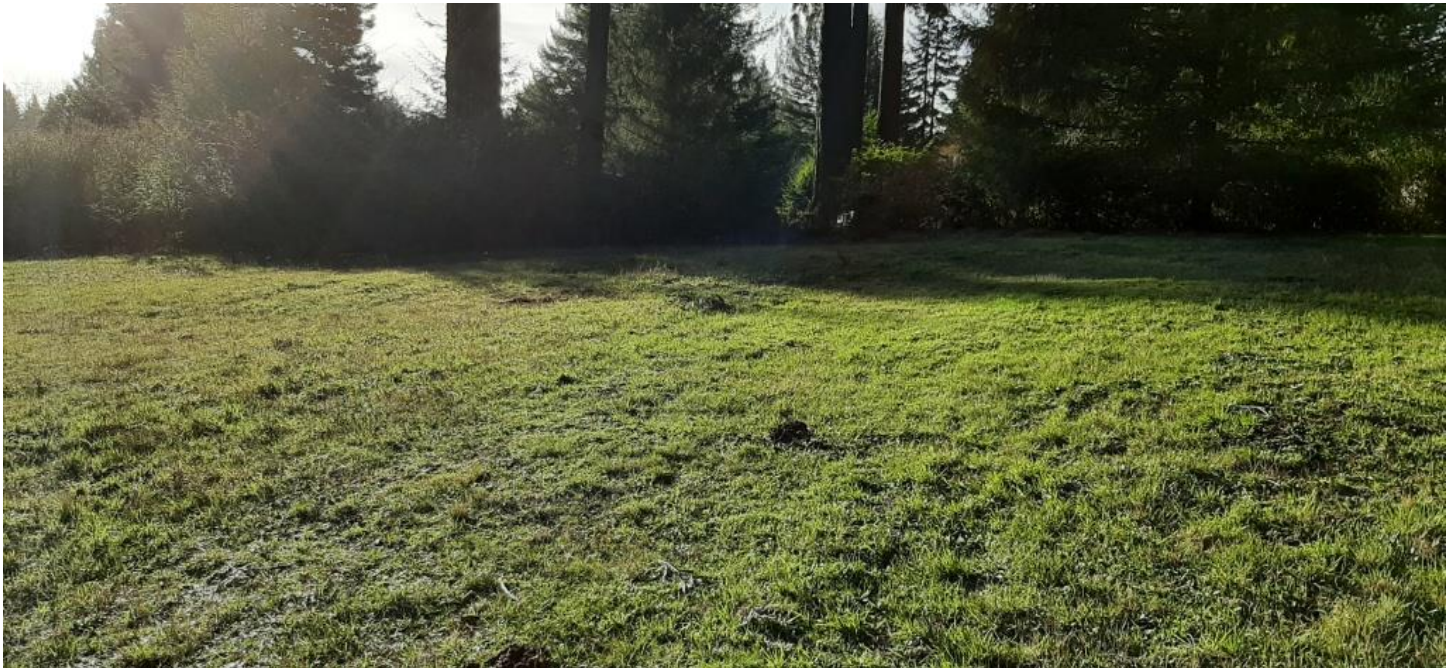
**1**

**Photo 1: North view of project site. Photo taken January 19, 2023.**

The study area is partially within a 2.9-acre parcel (Assessor's Parcel Number [APN] 512-072-002) and an unnamed easement on the western border. It is approximately 1.2 acres in the northwest corner of the parcel (Figure 2; Appendix 1, Photos 1 and 2). The parcel has an existing residential home in the southern portion of the lot. The undeveloped northern portion of the parcel is dissected by an intermittent stream that has been partially dammed, creating a small wetland pond.

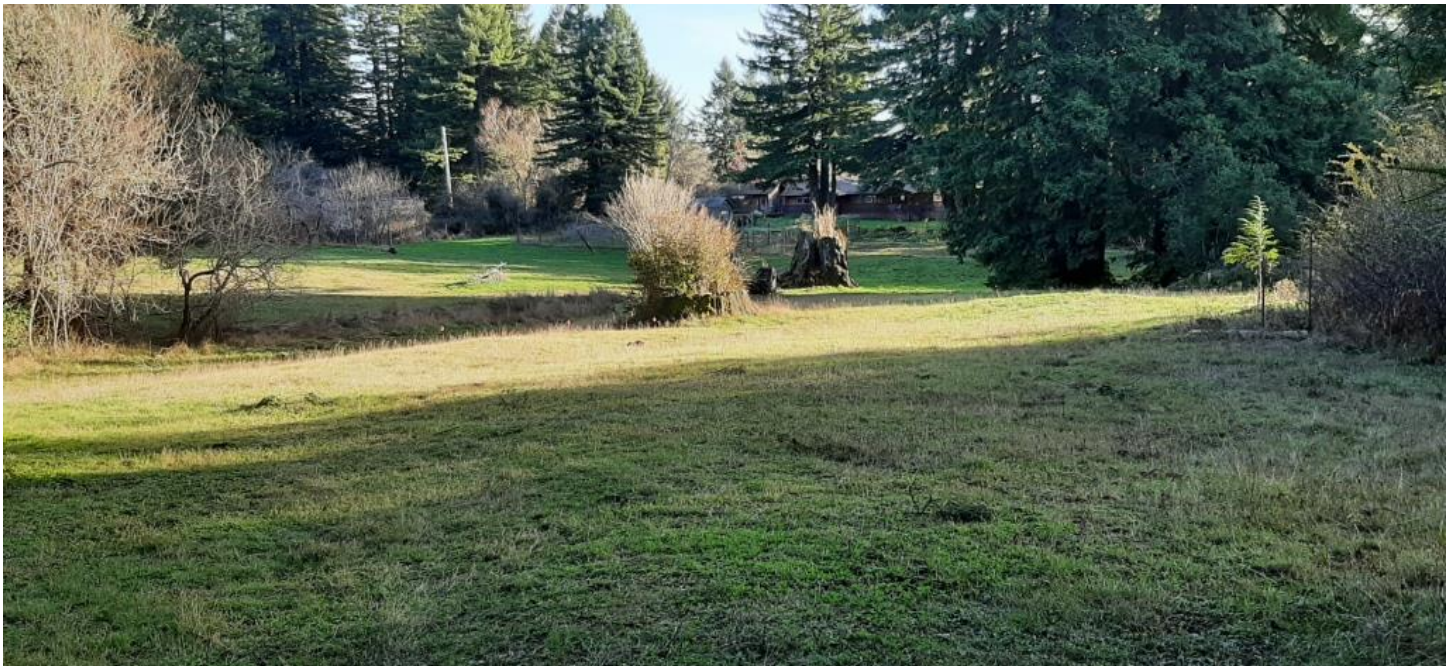
**Photo 2: South view looking towards existing residential home with wetland and stream in swale. Photo taken January 19, 2023.**

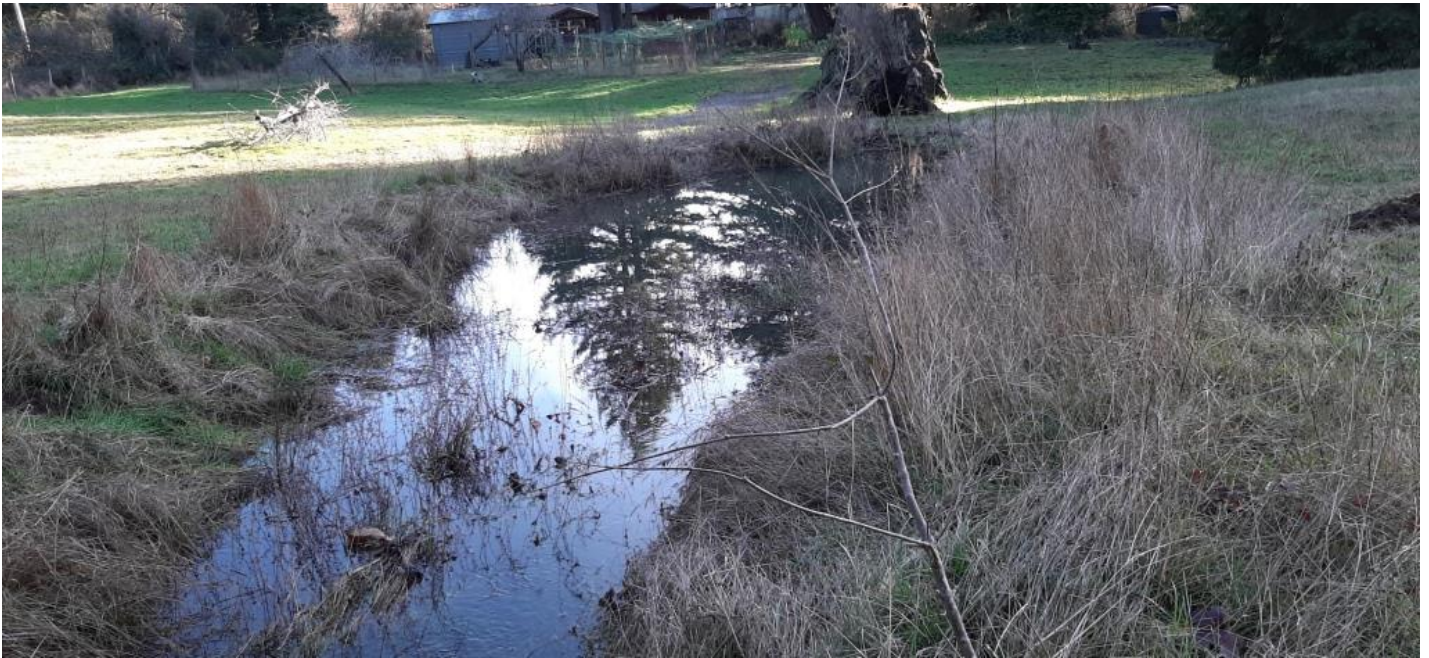
**Photo 3: Looking south, towards the existing residence. The constructed wetland is in the foreground in the stream that flows southwest. Photo taken January 19, 2023.**

TP1 was excavated within the wetland that is in the study area (Figure 2; Appendix 1, Photos 3 and 4). The wetland was created by adding a dam in an intermittent stream that drains the forested hillslope north of the parcel. The owner indicated this occurred several years ago; therefore, normal circumstances were assumed. The test site was chosen to determine if the pond has enough hydrology during the year to support wetland conditions. All three parameters were present (hydrophytic vegetation, hydrology, and hydric soils); therefore, it is considered a USACE wetland.

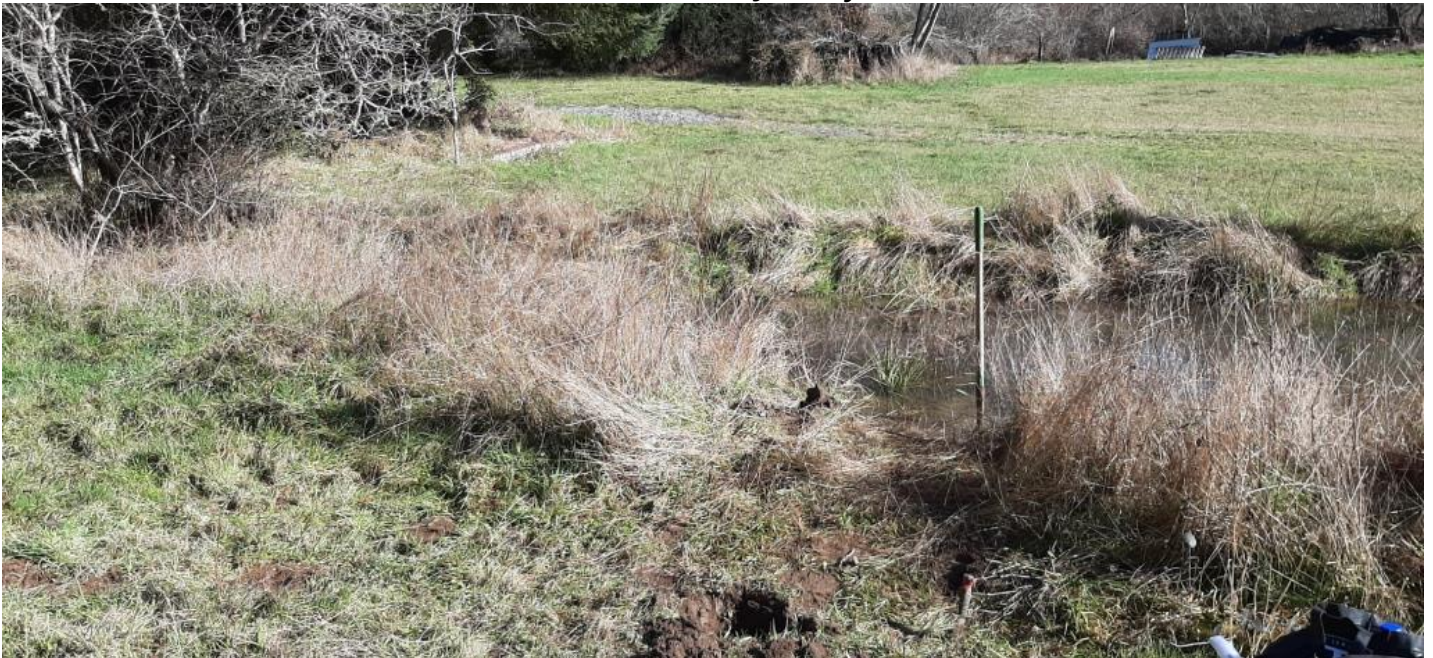
**Photo 4: Looking east at TP1 (located at shovel). TP2 is in foreground at excavated pit in the upland mowed field. Photo taken January 19, 2023.**

TP1 vegetation contained the Sapling/Shrub and Herb strata. The dominant shrub species was the Himalayan blackberry (*Rubus armeniacus* [FAC]) with only 4-percent cover and is therefore not part of the dominance test (under 5-percent cover). The dominant herb vegetation were Colonial bentgrass (*Agrostis capillaris* [FAC]) with 20-percent cover, and penny royal (*Mentha pulegium* [OBL]) with 17-percent cover. The vegetation dominance meets the hydrophytic vegetation parameter.

The hydrology parameter was met with the primary indicators of Surface Water (A1), High Water Table (A2), Saturation (A3), Drift Deposits (B3), Inundation Visible on Aerial Imagery (B7), Aquatic Invertebrates (B13), and the secondary indicators of Water-Stained Leaves (B9), Drainage Patterns (B10), Geomorphic Position (D2), and the FAC-Neutral Test (D5).

The hydric soil Depleted Matrix (F3) indicator was observed, in addition to the reaction of manganese oxide to hydrogen peroxide (H<sub>2</sub>O<sub>2</sub>), and a slight reaction to the alpha, alpha dipyrindyl reagent. Therefore, the hydric soil parameter was met.

TP2 was excavated 10 feet above TP1 in the mowed field above the wetland and is the paired plot to TP1. It is at the base of a well-drained 20-percent sloped hillslope. None of the three parameters were observed; and therefore, is not considered a USACE wetland (Figure 2; Appendix 1, Photo 4).

A primary indicator of Saturation (A3) was observed at 11 inches. Saturation must be above the 12-inch level to qualify. Because of the very heavy rains from the day before and the strong indication of upland vegetation with no redox observed in the soils, professional judgment was used to determine that the hydrology would not ordinarily qualify for this parameter.

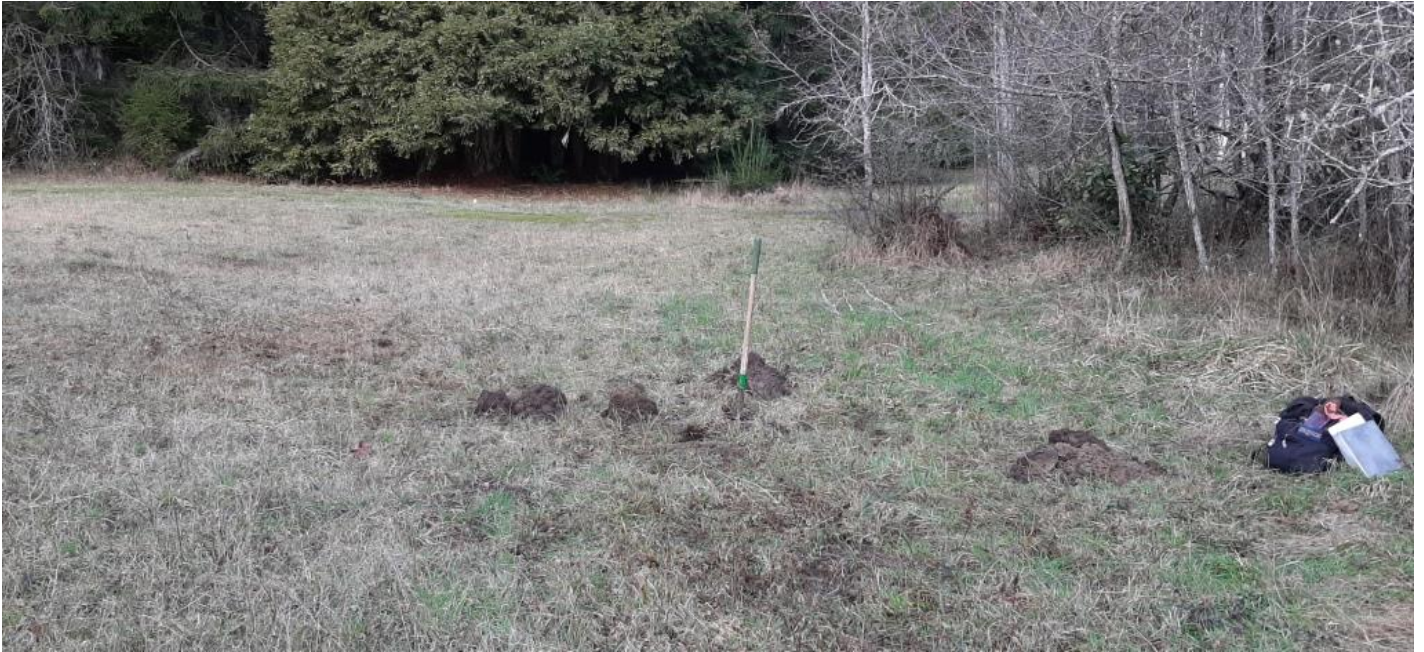
**Photo 5: Looking north at TP3 with surrounding exploratory pits. TP3 is 17 feet from the stream on the right. Photo taken January 19, 2023.**

There were no hydric soil indicators observed; therefore, not qualifying for this parameter.

The hydrology primary indicators observed were High Water Table (A2) and the Saturation (A3), with the secondary indicator Geomorphic Position (D2). This qualifies for the hydrology parameter.

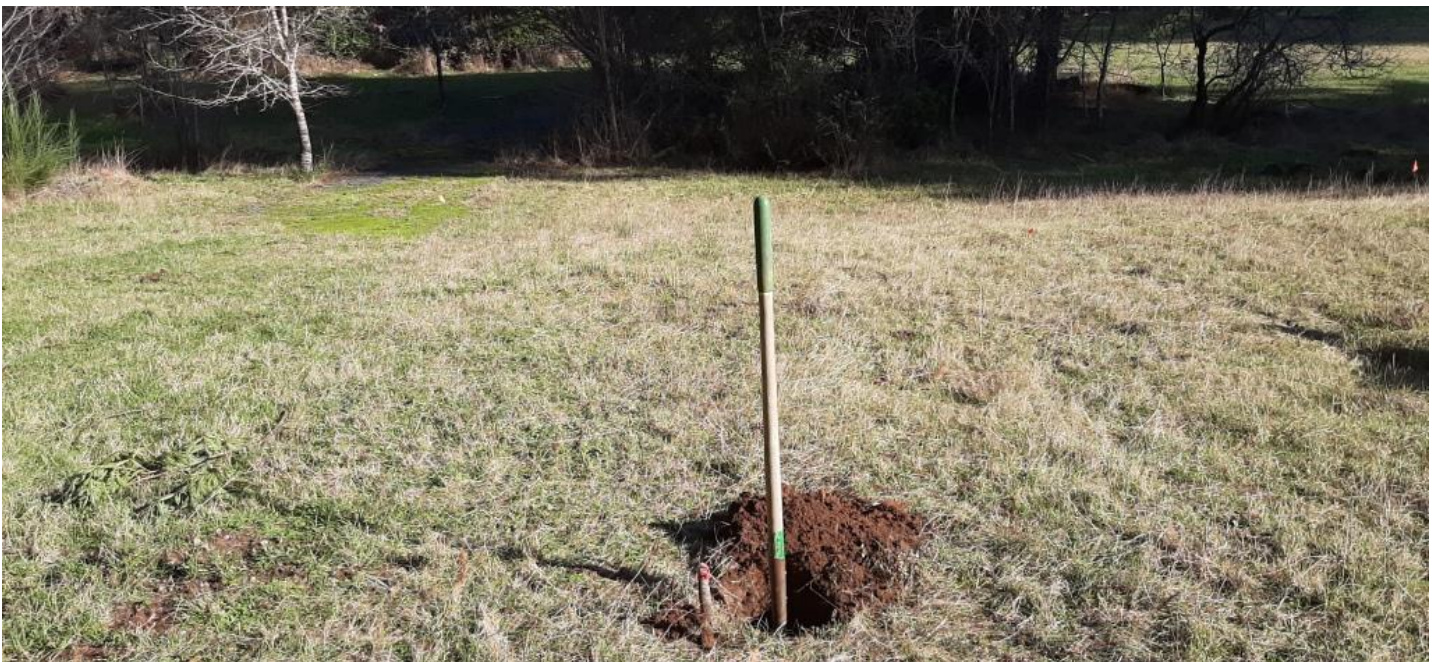
**Photo 6: Taken at TP4, looking east towards the stream. Photo taken January 19, 2023.**

TP4 was excavated at the top of the hillslope where the ADU is anticipated to be constructed. This site is on well-drained soils with a high percentage of upland vegetation. None of the wetland parameters were observed and it is not considered to be a USACE wetland (Figure 2; Appendix 1, Photo 6).

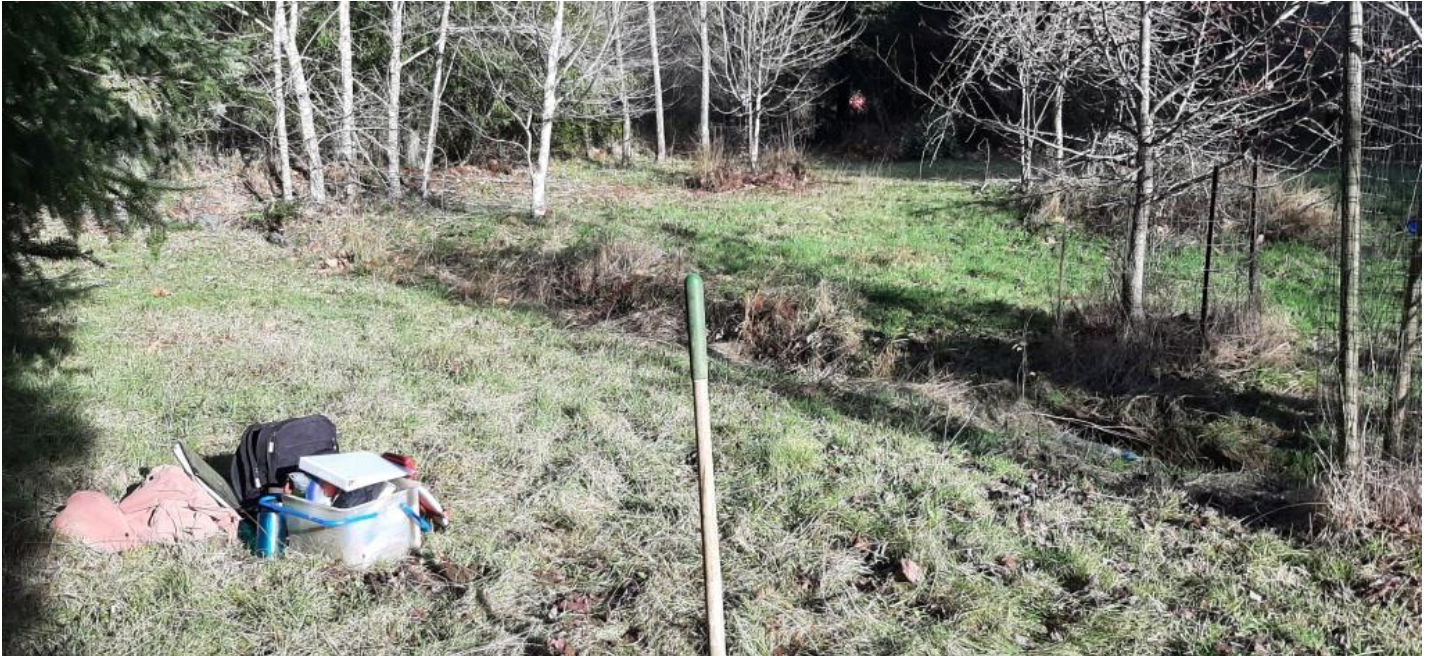
**Photo 7: TP5 (at base of shovel) is in a low-sloped section near the stream. Photo is looking northeast, towards Fieldbrook Road. Photo taken January 19, 2023.**

No hydric soil indicators were observed; therefore, it does not qualify for the hydric soil parameter.

Saturation (A3) was observed in TP5 at 12 inches, which would ordinarily qualify for a primary hydrology indicator. Because of the heavy rains during early January and on January 18, the day before the investigation, that the 12-inch depth is at the borderline for this indicator, and that neither vegetation nor soils suggested wetland properties, professional judgement discounted this as an indicator. Therefore, TP5 does not meet the hydrology parameter.

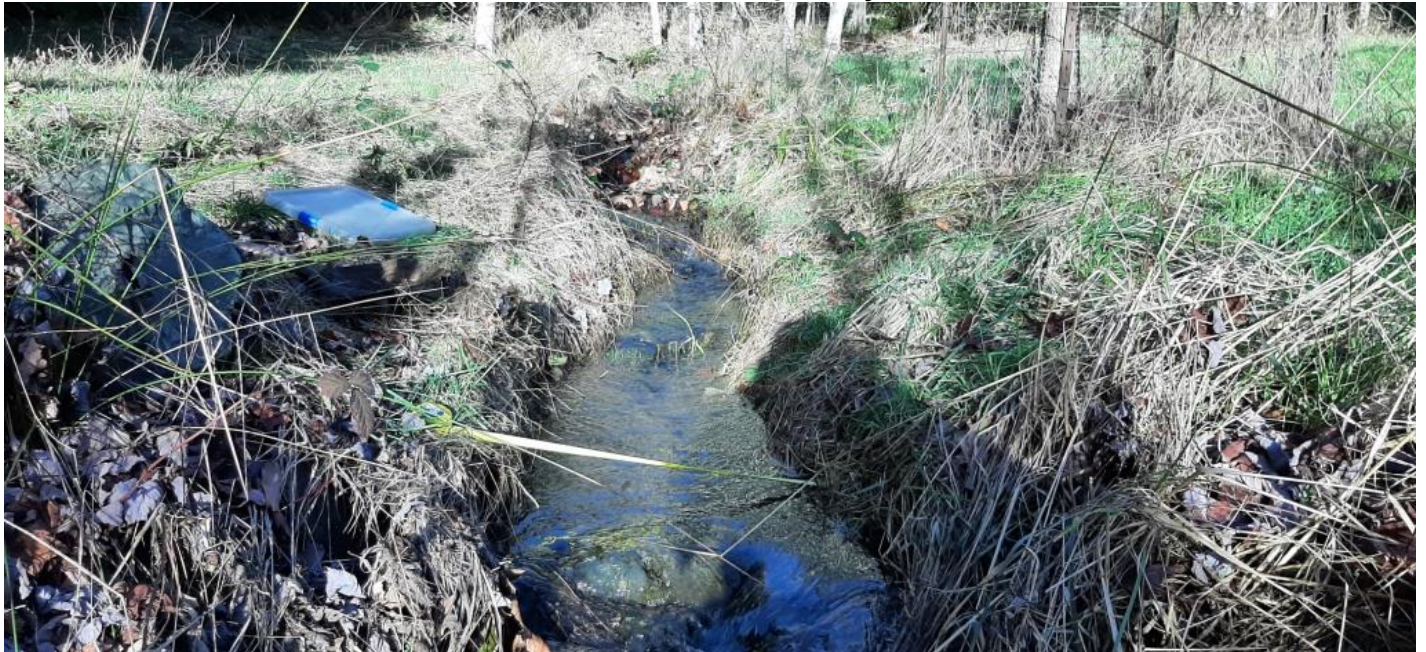
**Photo 8: OWHM1 (tape shows approximate location) is in an intermittent stream that drains the forested area north of the study site. TP5 is approximately 14 feet to left of the stream. Photo looking north. Photo taken January 19, 2023.**

Ordinary high water mark indicators were observed within the intermittent stream that runs through the eastern side of the study area (Figure 2; Appendix 1, Photo 8). This stream drains the northern forested area north of the study area. An OHWM point was delineated near TP5, above the human-constructed wetland at the southern edge of the study area. The datasheet for this point (OHWM1) is in Appendix 3.

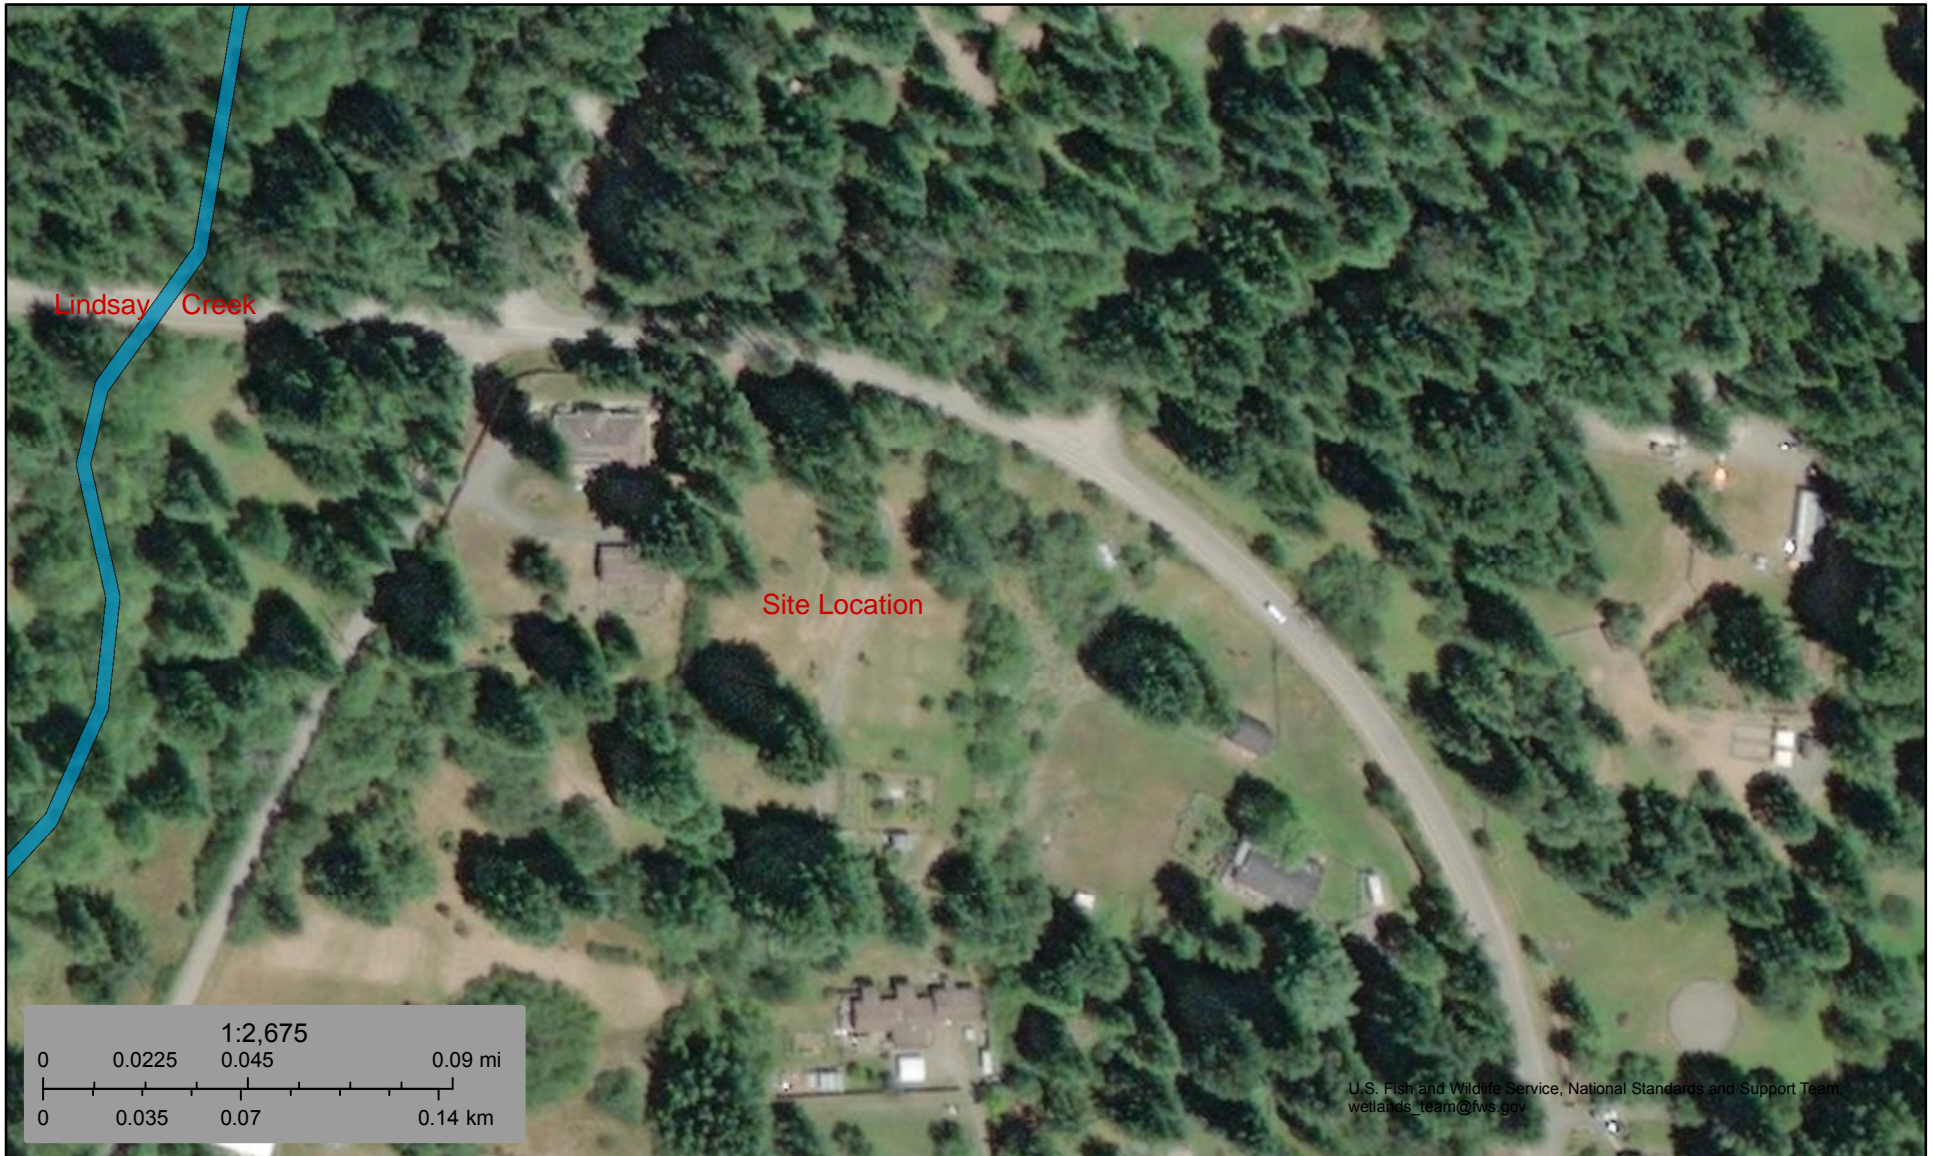
**2**

**Wetlands**

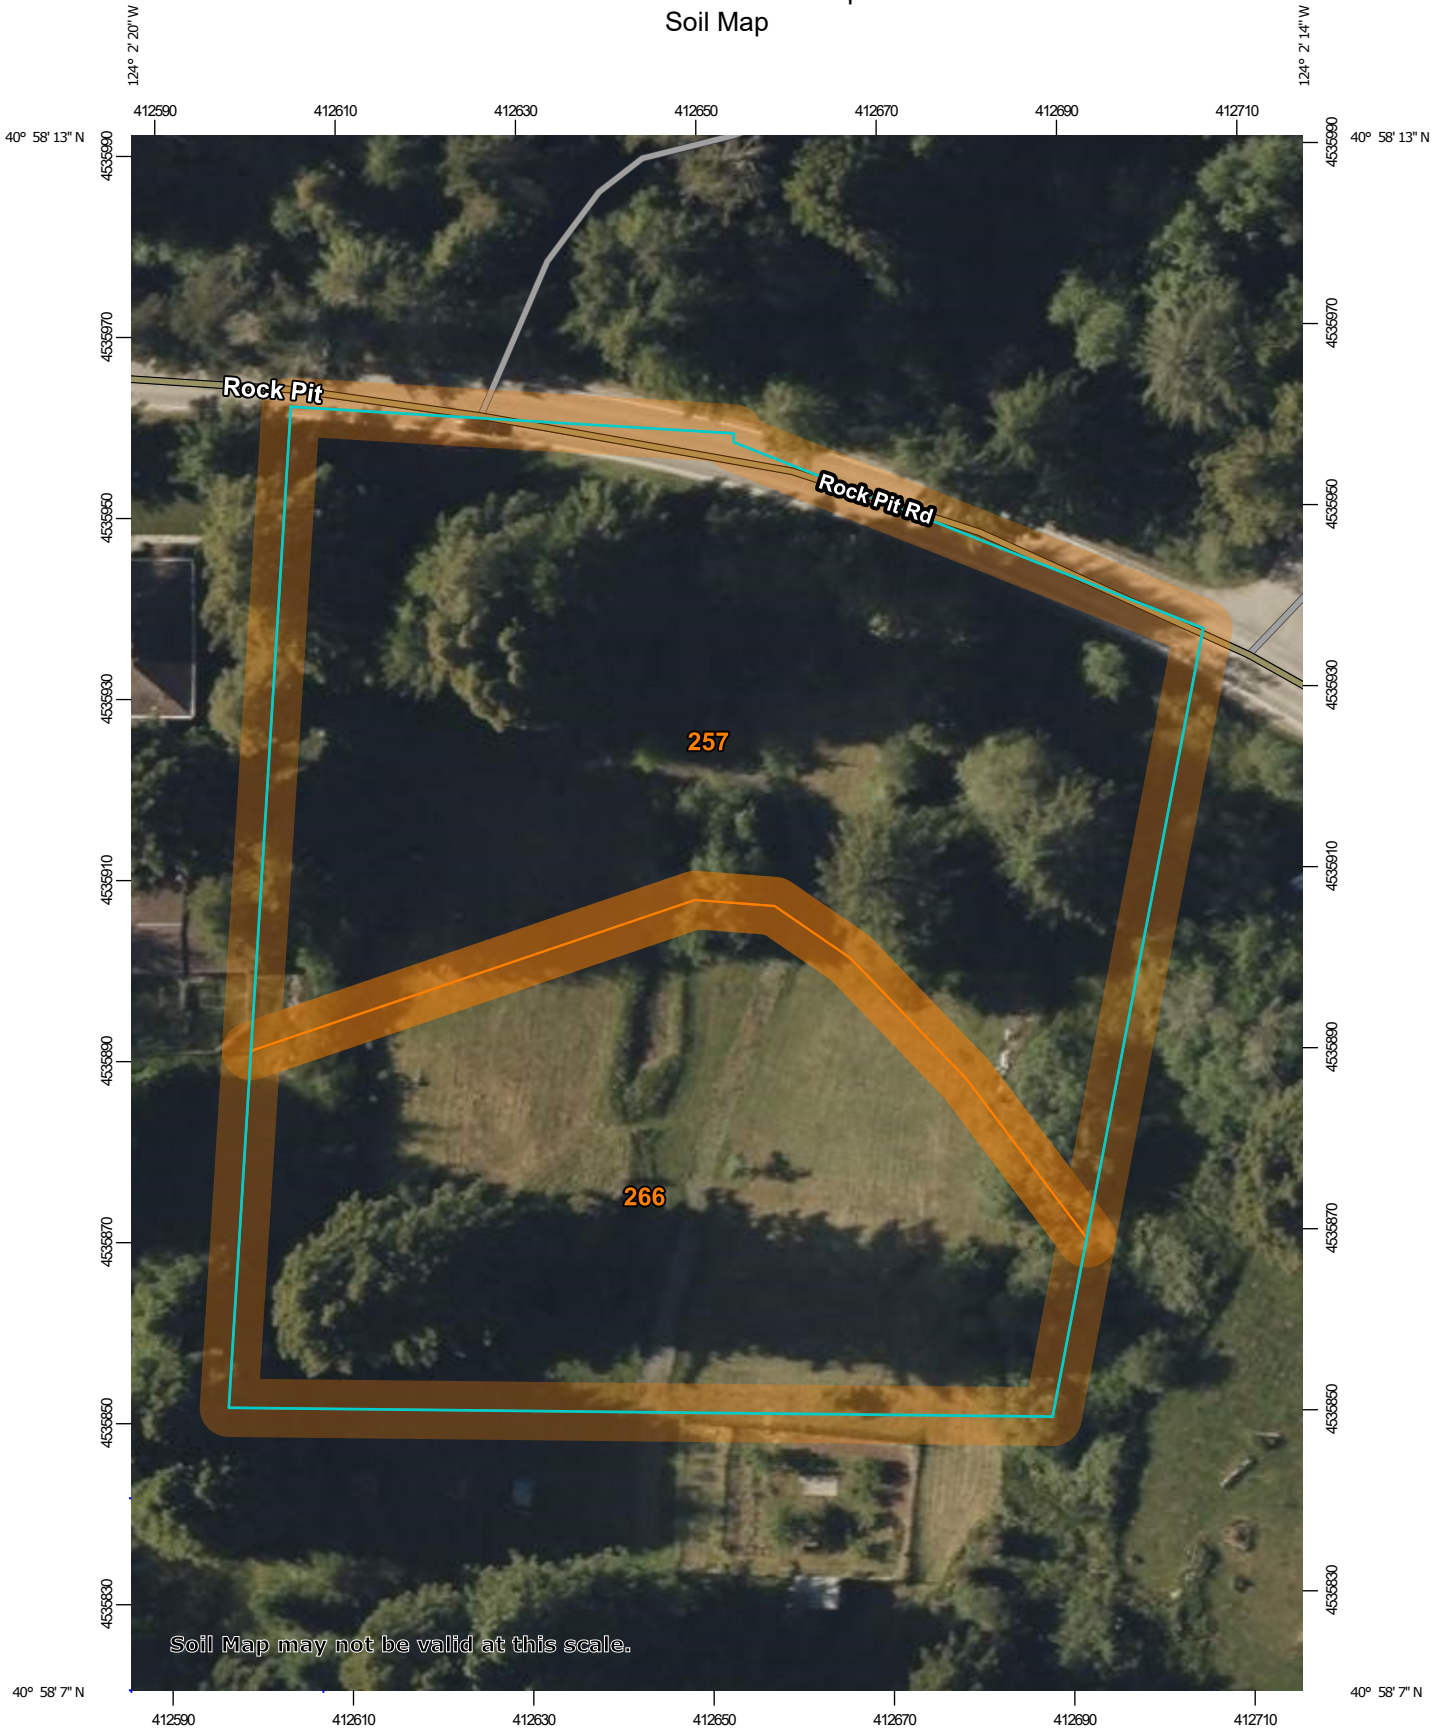
The underlying soils in the study area have the USDA-NRCS soil map unit designation 257- Leopold Candy Mountain complex, 2-15 percent slopes and 266- Hookton-Urban Land complex, 0-2 percent slopes, as described below (full report in Appendix 2). Soils were characterized by loams to clay loams. The site-specific soil description at each exploratory soil TP is included in the wetland determination data forms found in Appendix 3, with photos in Appendix 1.
