LINDBERG GEOLOGIC CONSULTING
David N. Lindberg, CEG
Post Office Box 306
Cutten California 95534
(707) 442-6000

May 15, 2023

Project No: 0500.00

Subject: Assessment of Hydrologic Isolation of Well from Surface Waters
Well WCR2018-010668, 1520 Wood Ranch Road, Redway, APN: 214-233-002

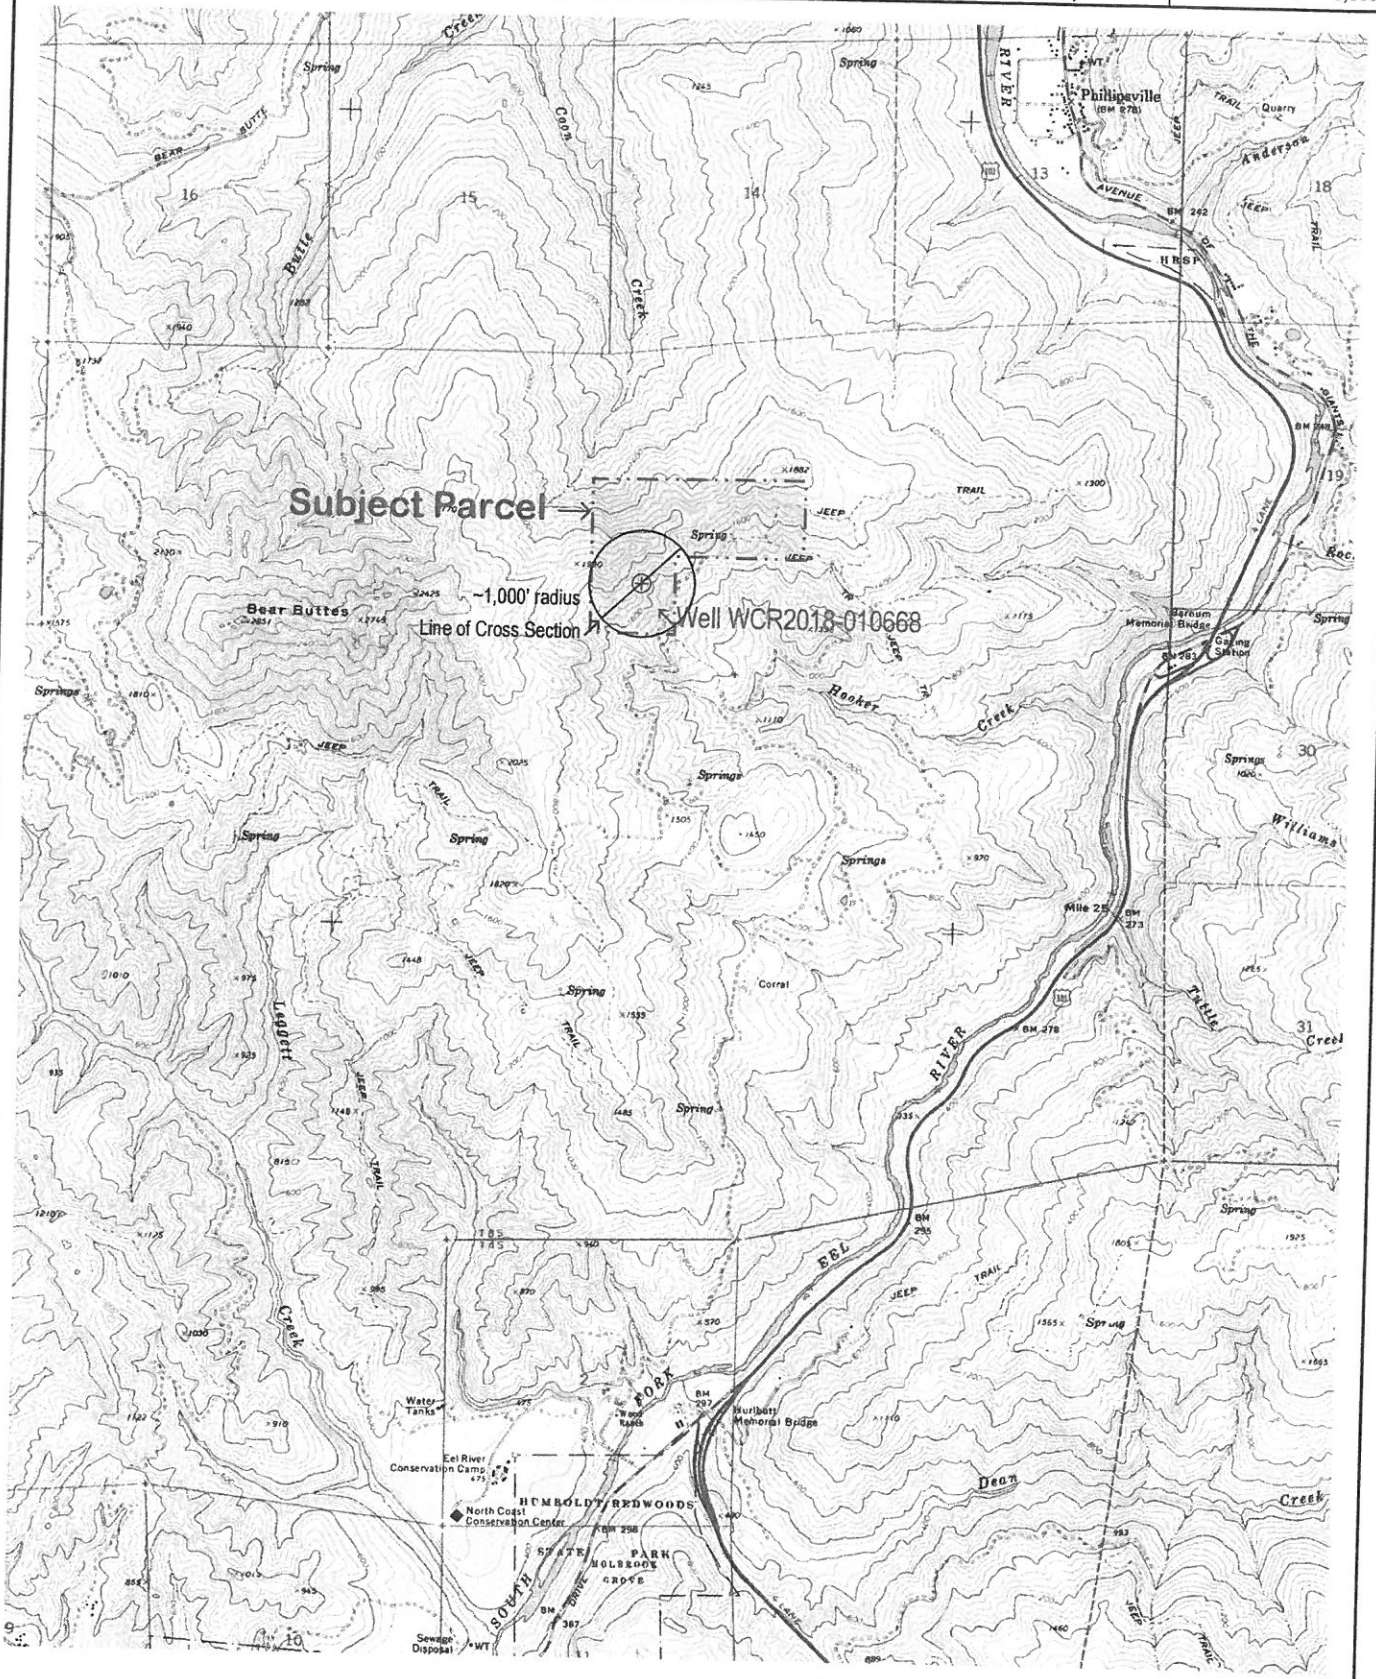
There are five springs mapped within one mile of the subject well on the 1970, Miranda, California, USGS topographic map (Figure 1). The nearest spring is on the subject parcel, more than 2,600 feet east-northeast of the subject well, at an estimated elevation of 1,560 feet. The next closest spring is more than 2,600 feet southeast of the subject well at an estimated elevation of 1,120 feet. More than 3,700 feet south of the subject well, there are two springs within 300 feet of each other at an approximate elevation of 1,360 feet. Another spring is mapped over 4,250 feet east of the subject well at an approximate elevation of 1,450 feet.

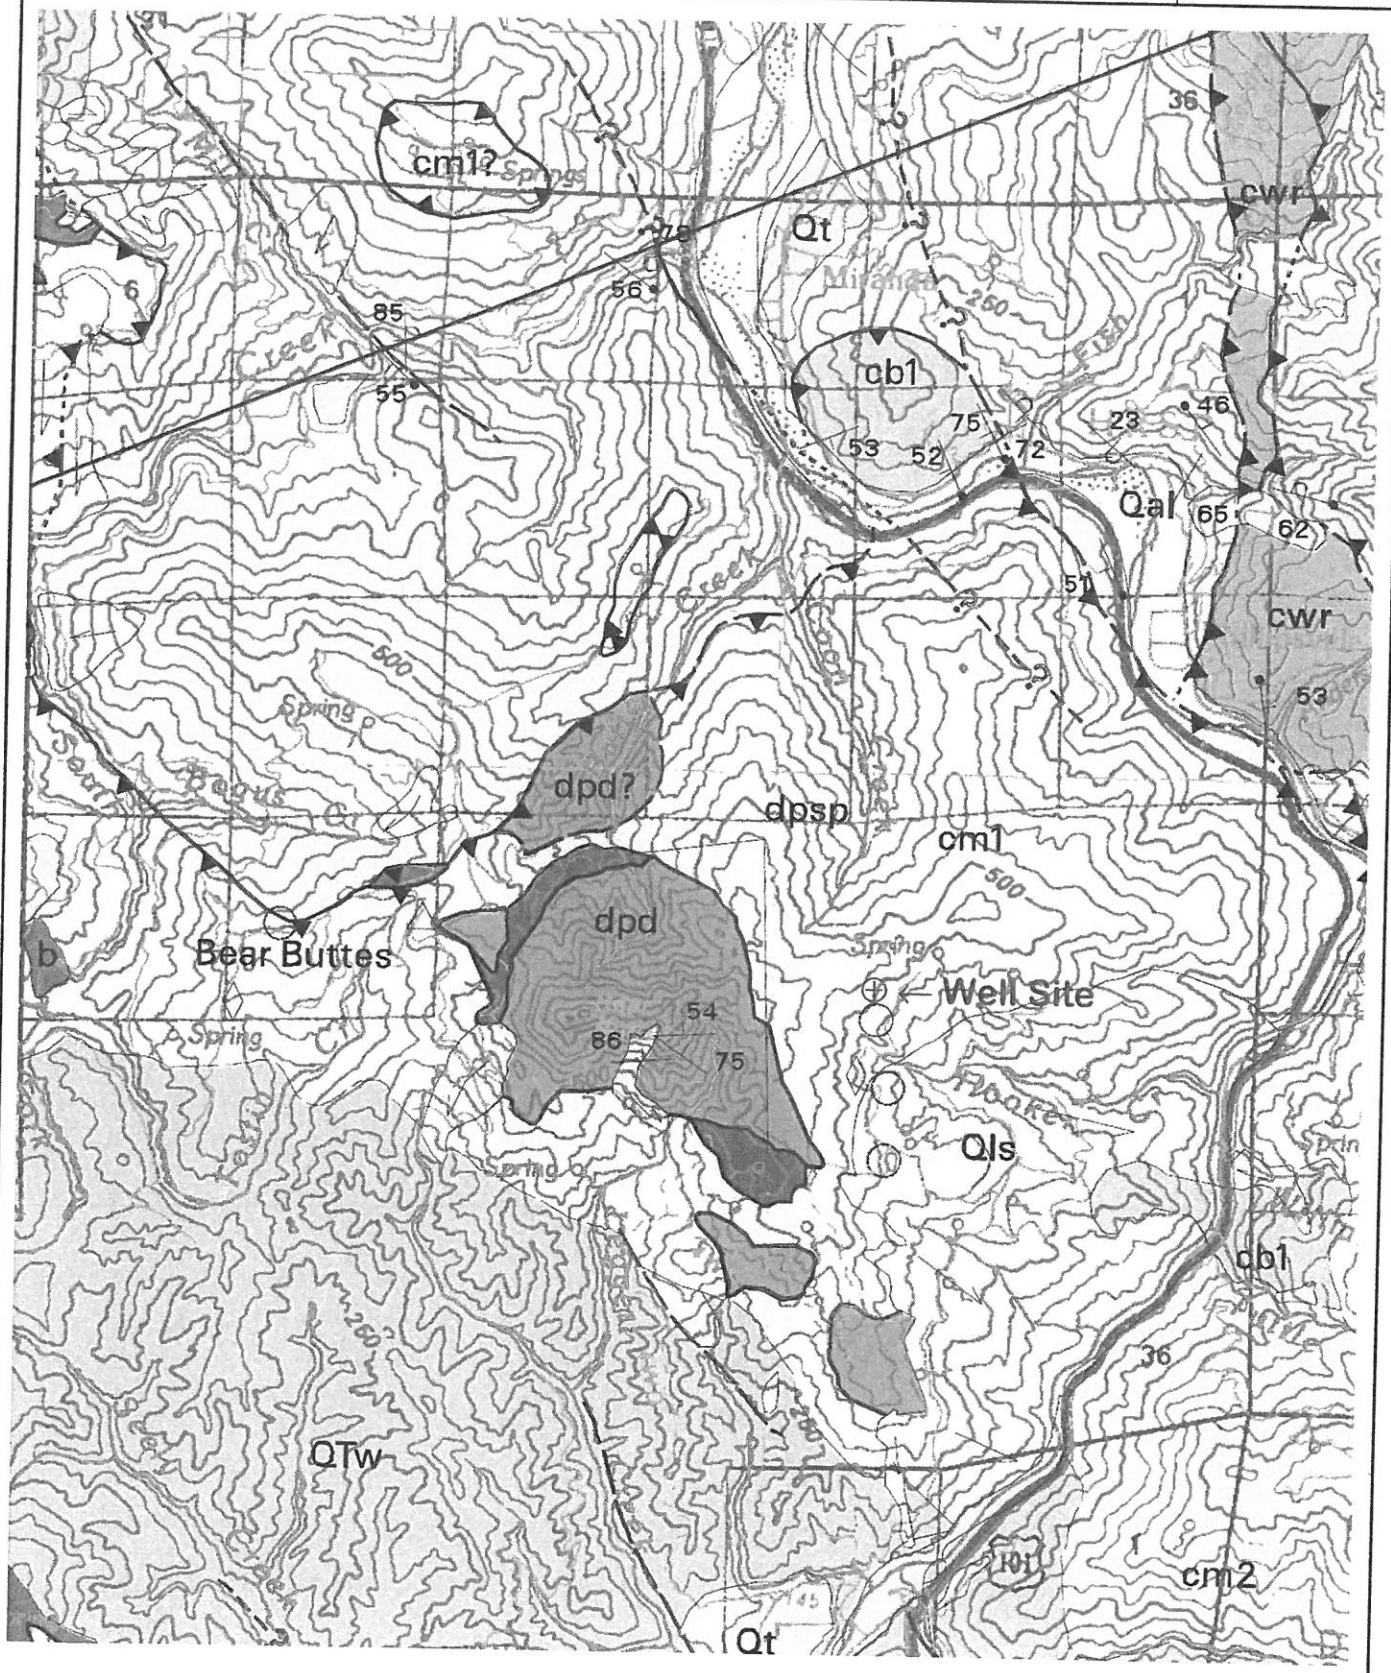
This parcel is within California's Coast Range Geomorphic Province, in the Central Belt of the Franciscan Complex (McLaughlin et at., 2000), a seismically active region in which large earthquakes are expected to occur during the economic life span (70 years) of any developments on the subject property. Geologic mapping by McLaughlin shows that the site is underlain by mélange (cm1) of the Central Belt of the Franciscan Complex, as shown in Figure 4.

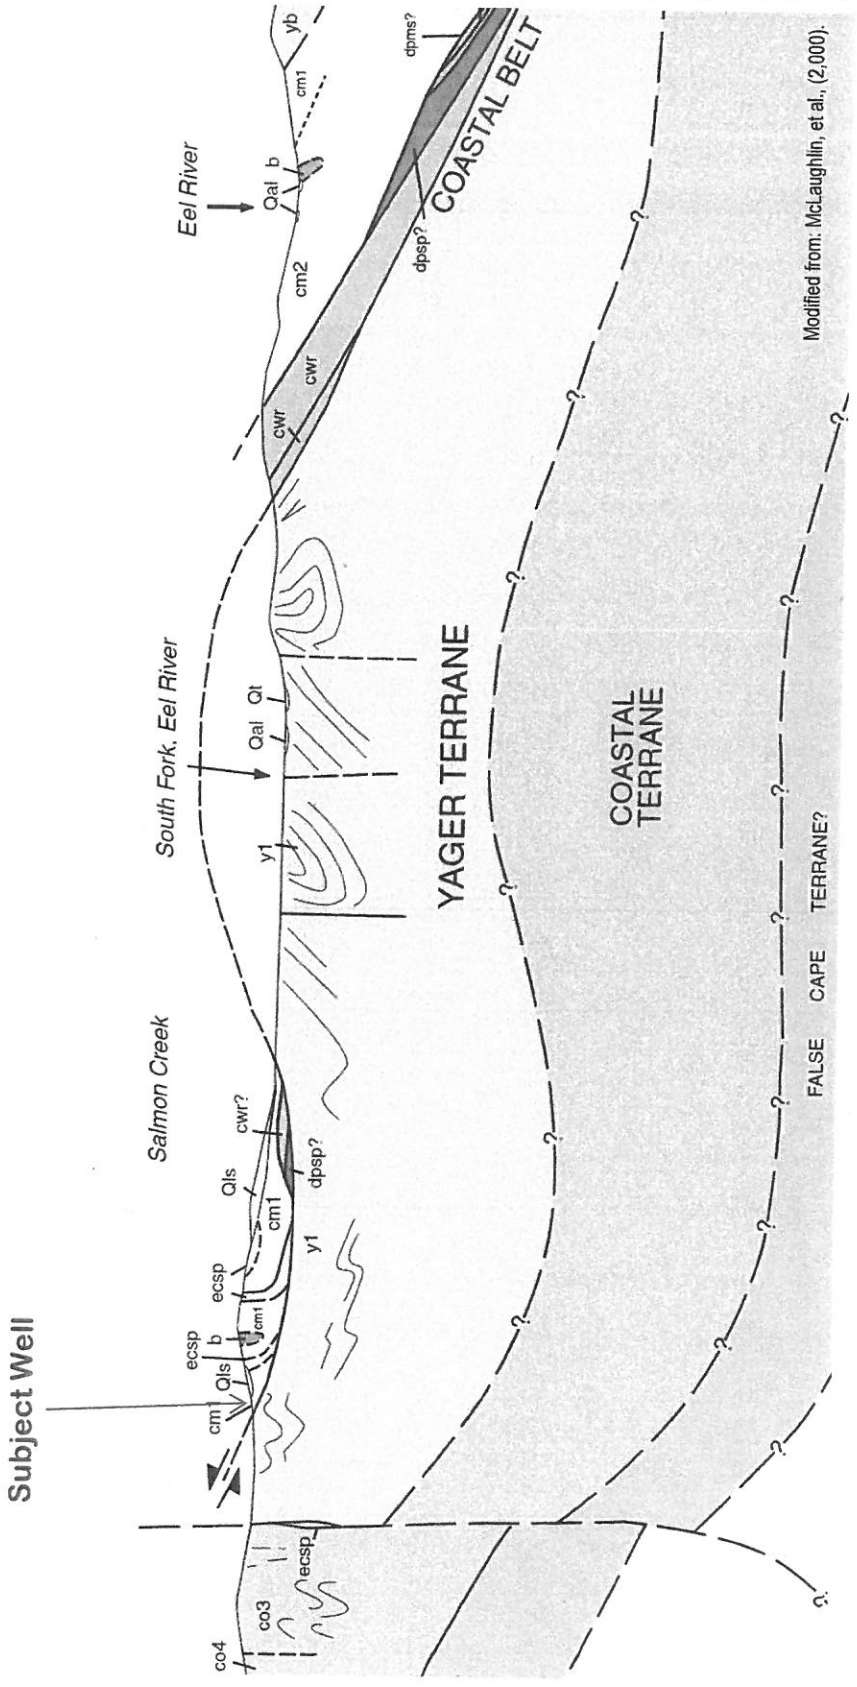
A geologic cross section of the area after McLaughlin et al., (2000) shows the structural and stratigraphic relationships between the regional geologic units (Figure 5). The central belt mélange is shown dipping east and bounded by thrust fault plane contacts. On-site, no dip of the rock units could be observed because they are mantled with soil and colluvium and obscured by vegetation. We interpret the faults in the subsurface to be hydrologic boundaries of reduced permeability (due to grinding and shearing along the fault planes), effectively separating units of the Franciscan from each other hydrologically, and limiting groundwater flow between the fault-bound units.

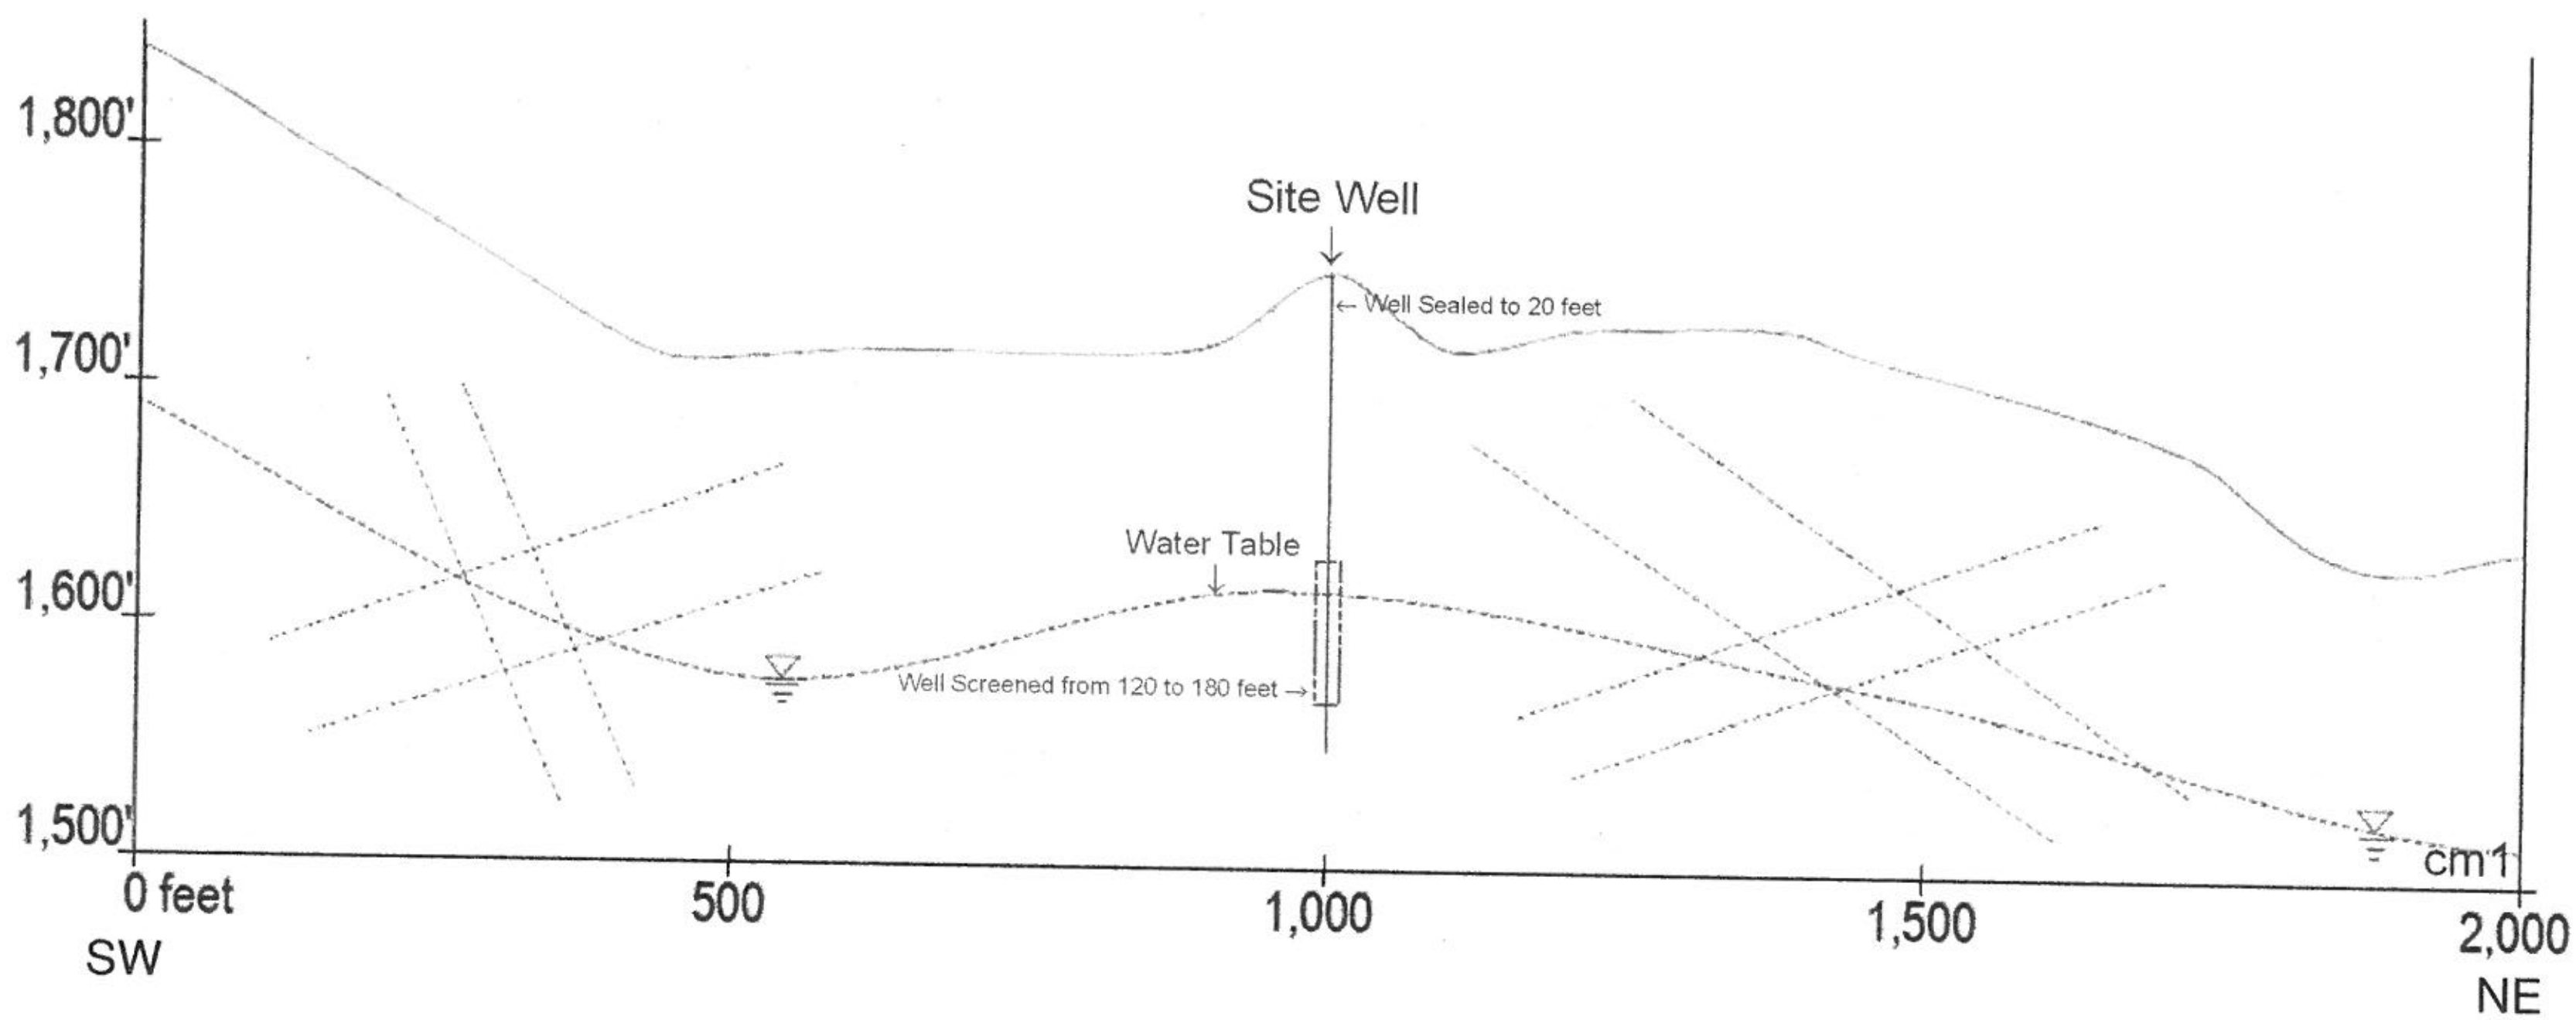
In this vertically exaggerated (~2x) cross section, the view is looking to the northwest toward Bear Buttes. Groundwater flow in this cross section is east-southeast, or toward the viewer, and out of the page. Groundwater is presumed to flow from recharge areas in the higher ground to the northwest. This well is sited high above the South Fork Eel River valley. Subgrade is composed of mélange, scaly argillite, and blocks of meta sandstone, of the Central Belt of the Franciscan Complex. Groundwater is envisioned to flow through bedrock fractures. Fractures are interpreted to be the primary permeability, providing preferential flow paths for the local groundwater. The driller noted that first water encountered 135 feet below the ground surface. Static water level was reported to be 128 feet below the surface. A bentonite seal was installed from the surface to the 22-foot depth. This well is cased to 200 feet below the ground surface and screened from 120 feet to 180 feet. This well thus draws groundwater from a 60-foot section of the profile from 120 feet to 180 feet below the surface. Bedrock mapping (Figure 4) is from McLaughlin et al., (2000).
