ATTACHMENT 1b  
Sprowl Creek Full Resubmittal

# ETA Humboldt, LLC

25 July 2023

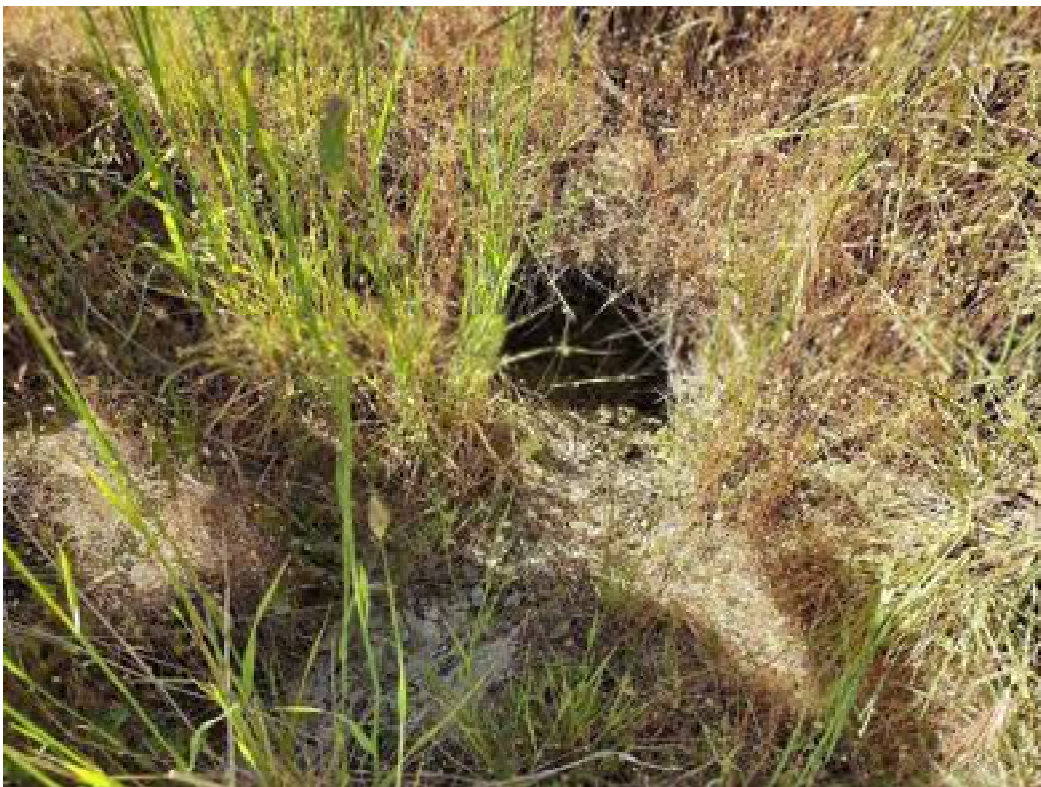
*Site 04. Looking at the inlet of the channel.*

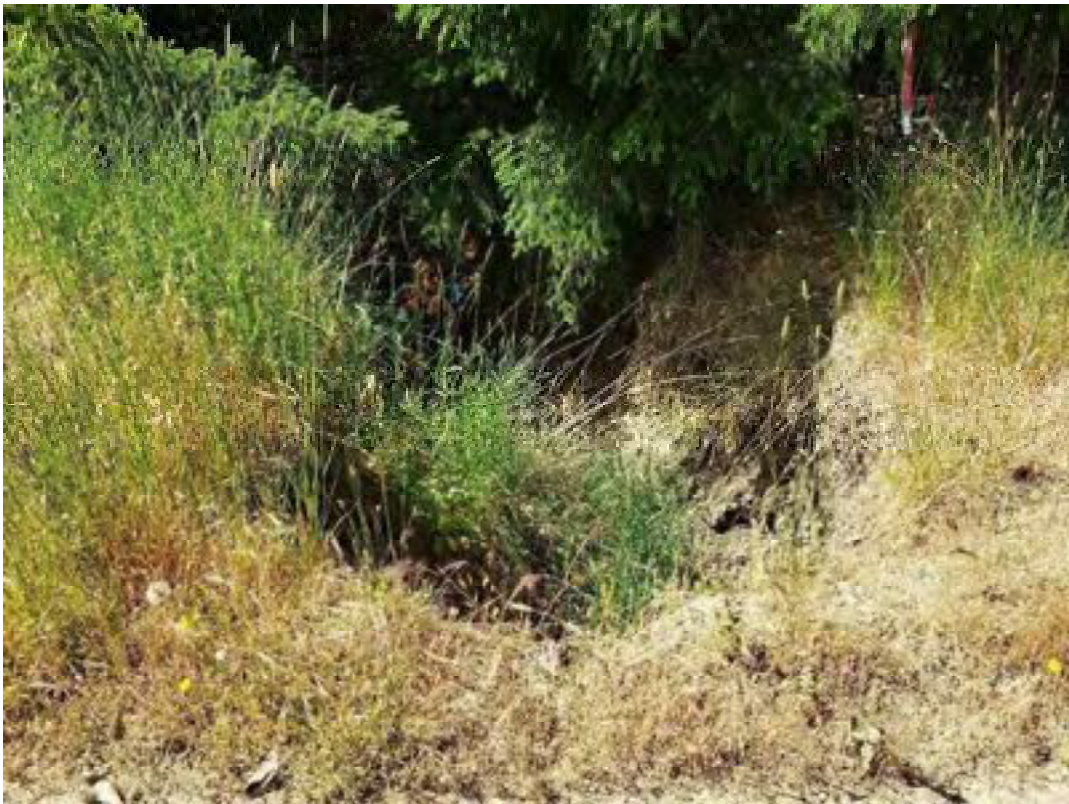
Site 04. Looking down channel from the outlet. The upgraded culvert will extend to where the man is hanging the blue flagging.

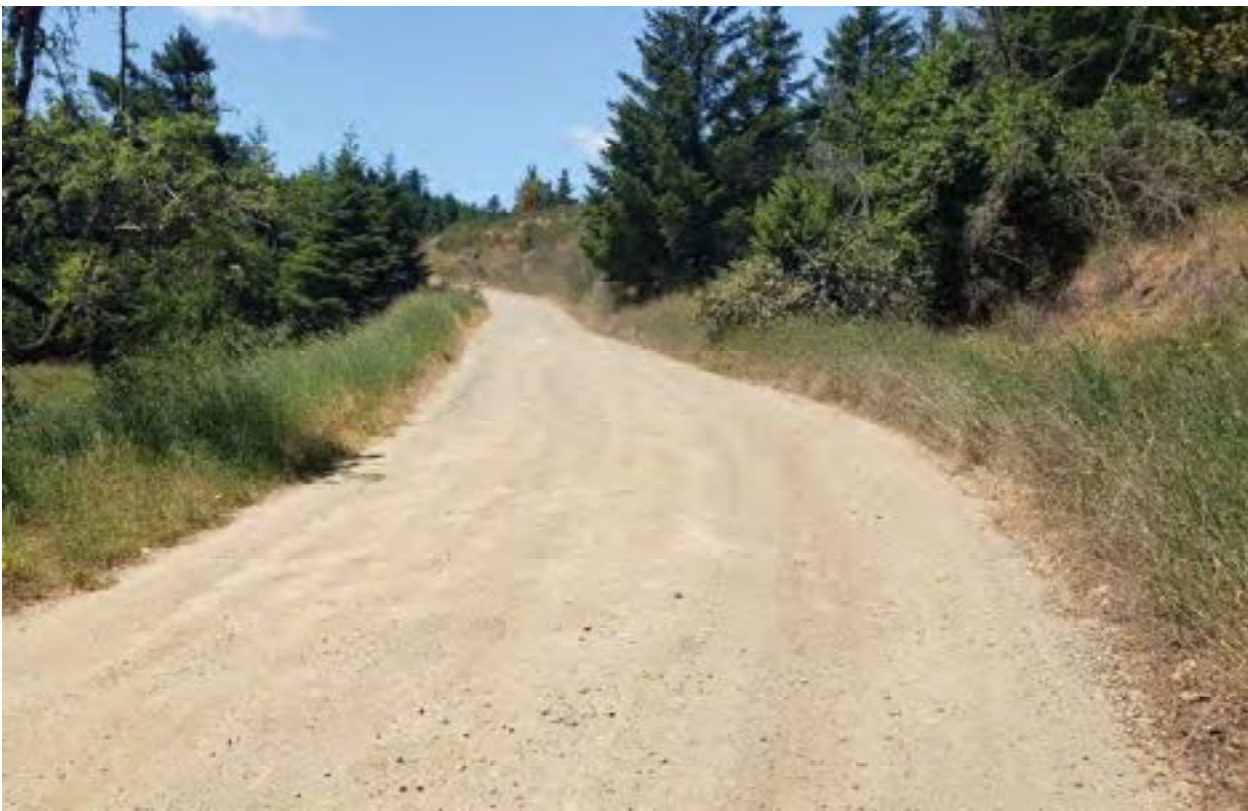
*Site 12. Hydrologic disconnect for Sites 13, 14, and 23.*

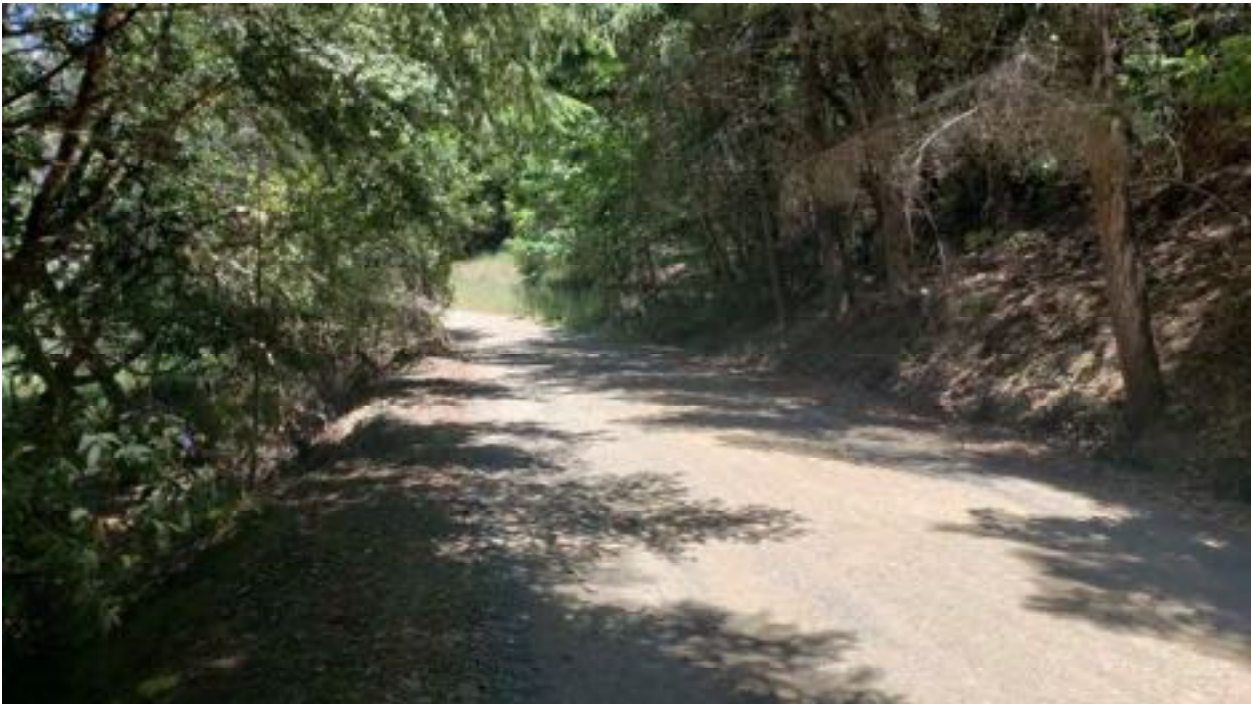
Site 14. Looking at the outlet of the ditch relief culvert.

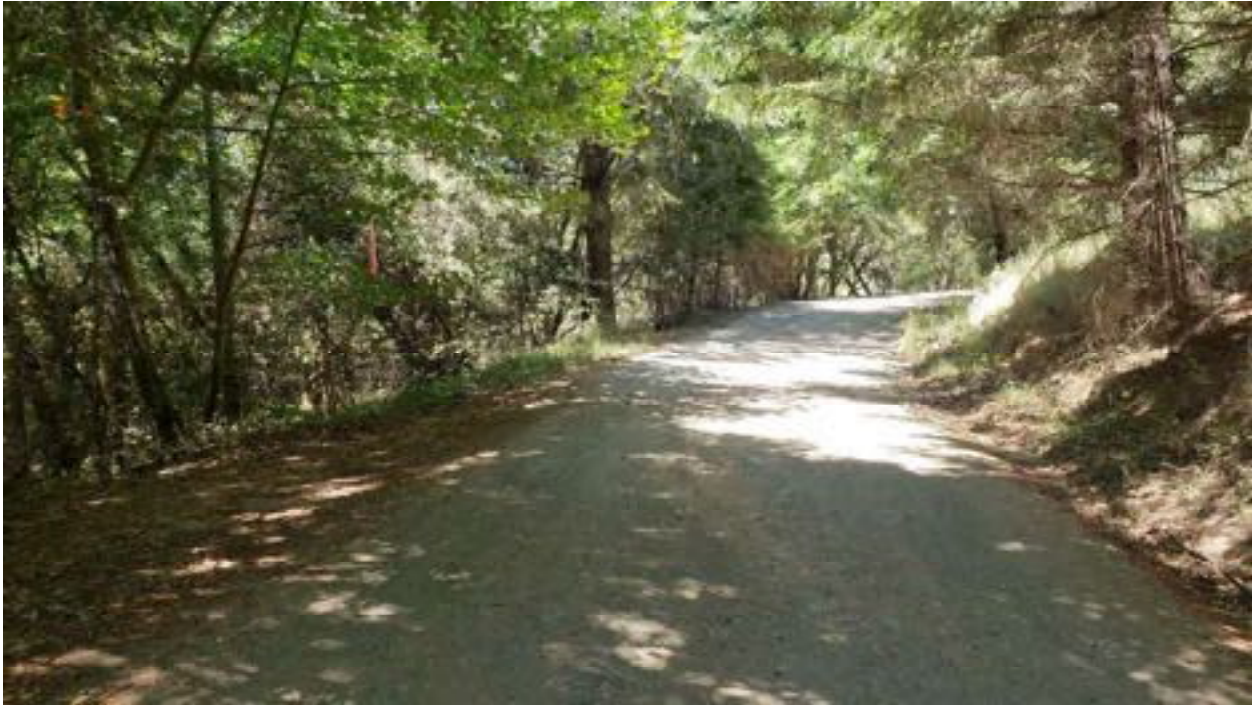
Site 14. Looking up grade towards Site 13.

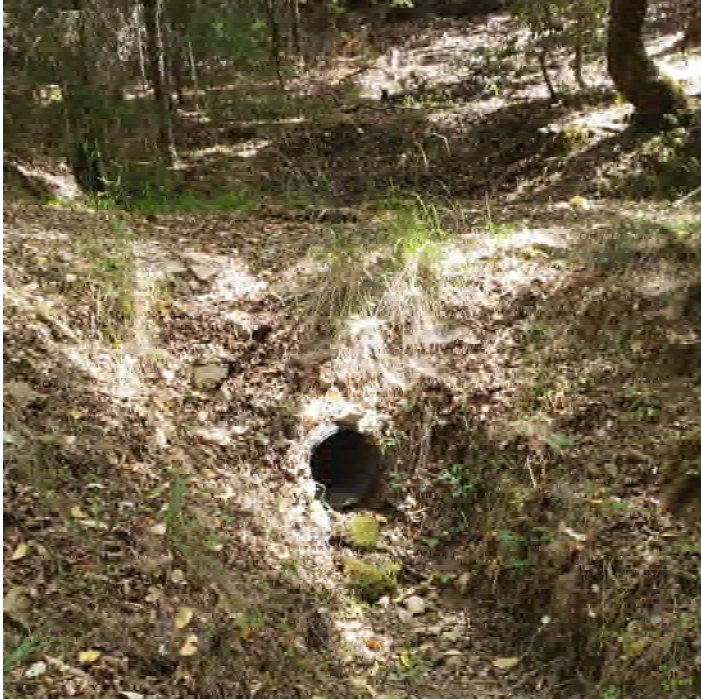
Inlet of the watercourse crossing at Site 17.

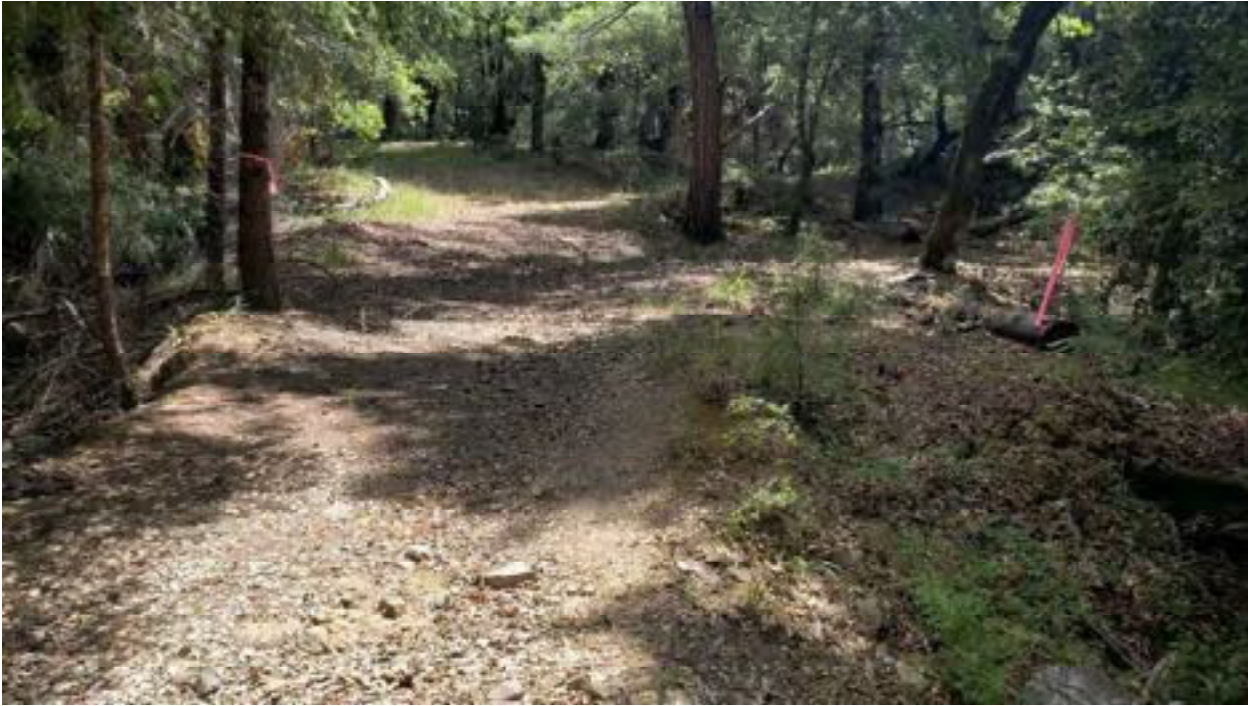
*Site 19. The watercourse crossing here will be decommissioned and will be re-aligned to its natural channel up grade approxiametly to where this photo was taken.*

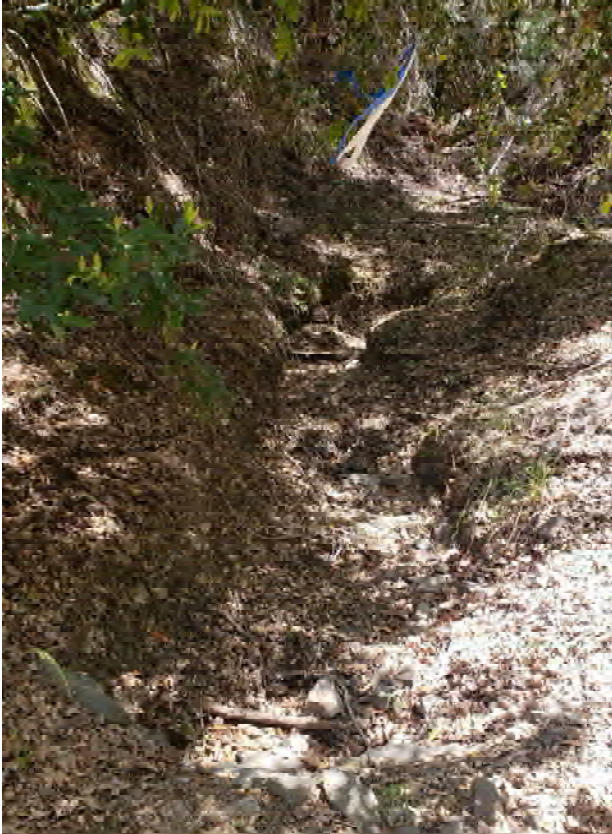
Inlet of Site 19

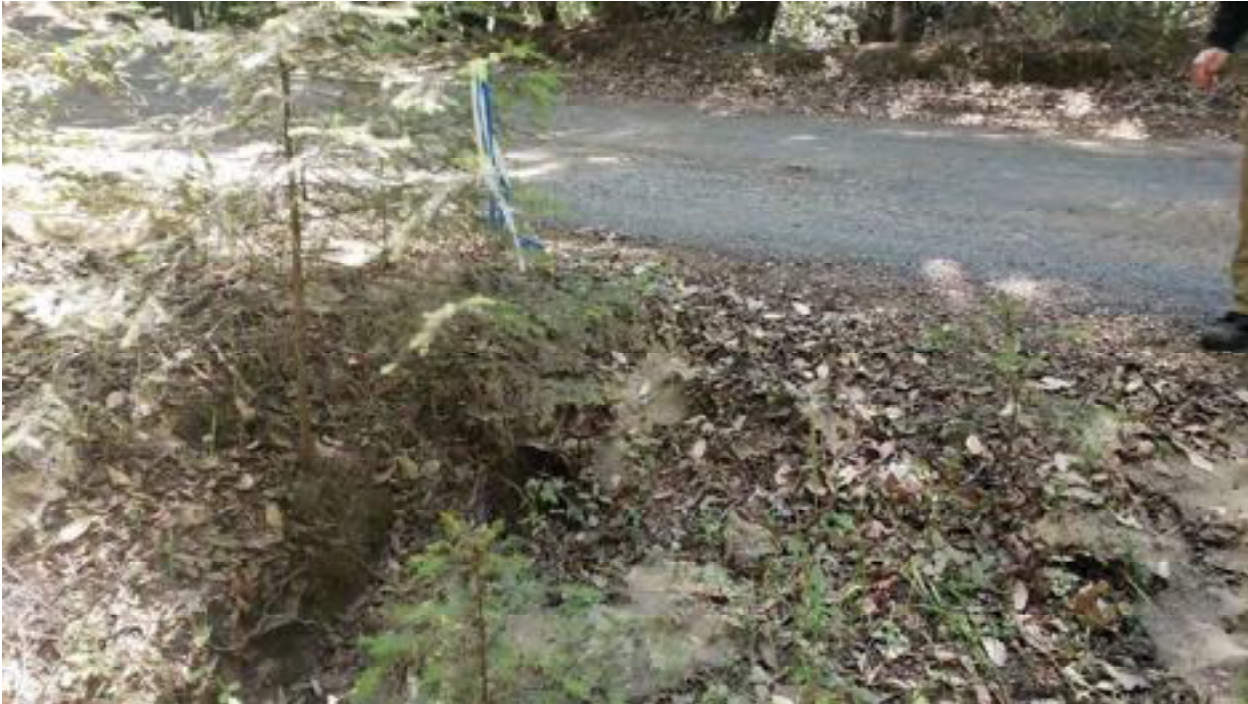
*Site 24. Looking down grade.*

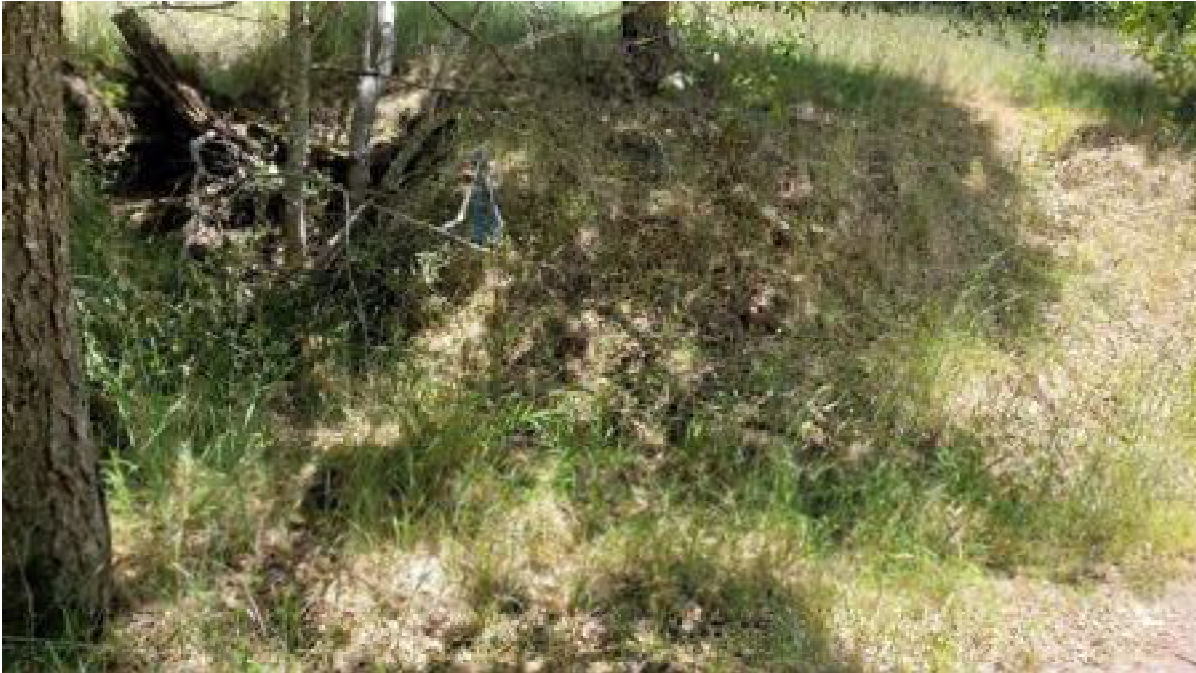
Site 35. Looking at the inlet to the lower center right and the incoming stream channel to the center left where the rotten stump is located.

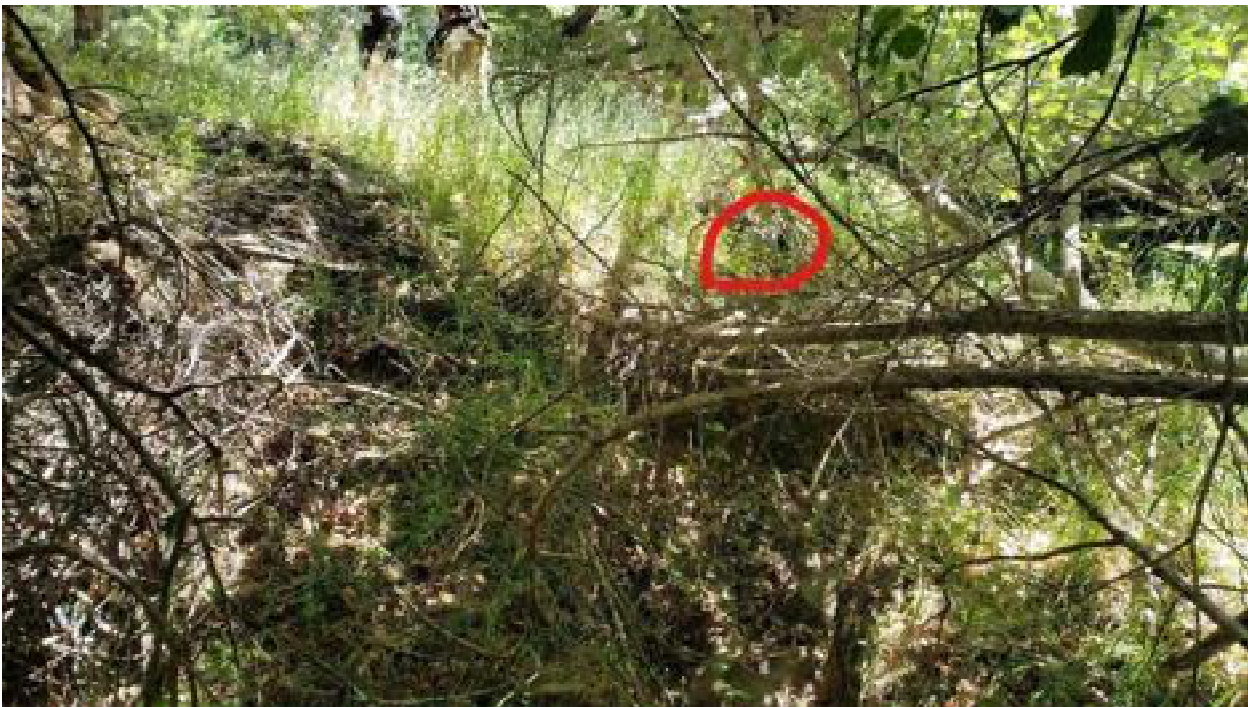
Site 35. Looking at the outlet(circled). The culvert upgrade will re-align the watercourse to its original channel, which will require the outlet to be placed in the lower left of the photo.

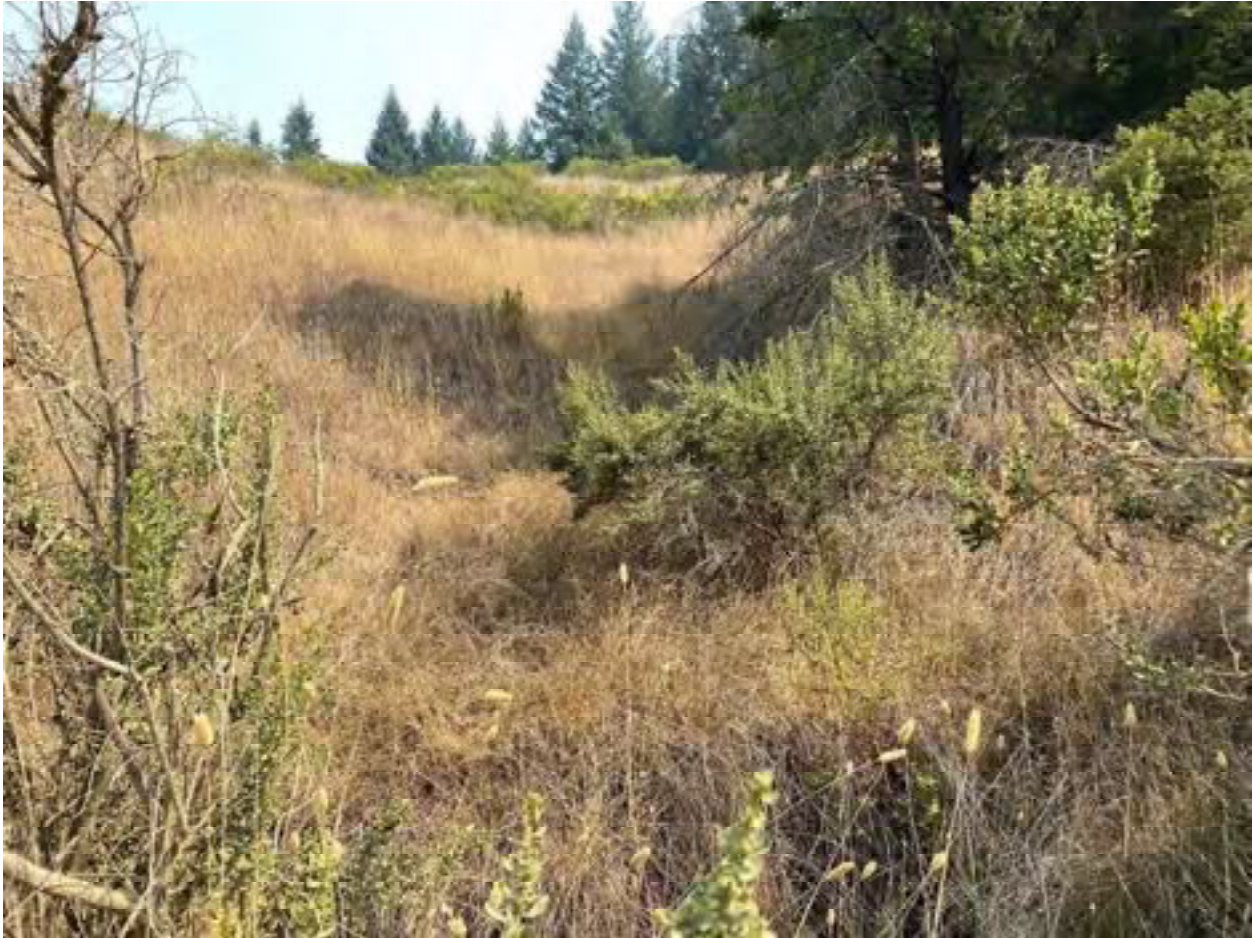
**Photo 36:** Stream Crossing 11. Looking upstream from the inlet of the 24-inch diameter culvert at stream crossing 11. Photo date 9-1-2021.

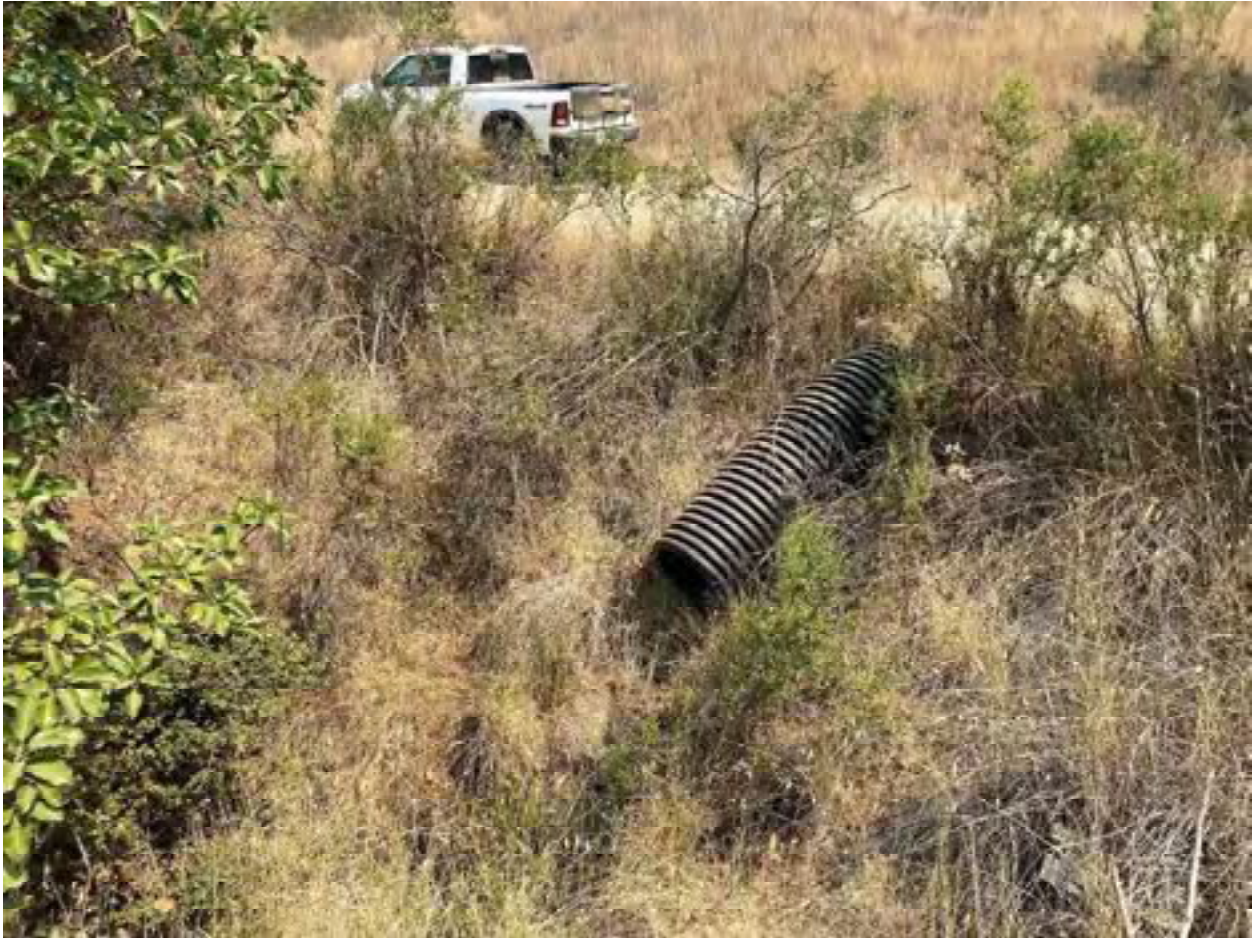
**Photo 38:** Stream Crossing 11. Looking towards the outlet of the 24-inch diameter culvert at stream crossing 11. Photo date 9-1-2021.

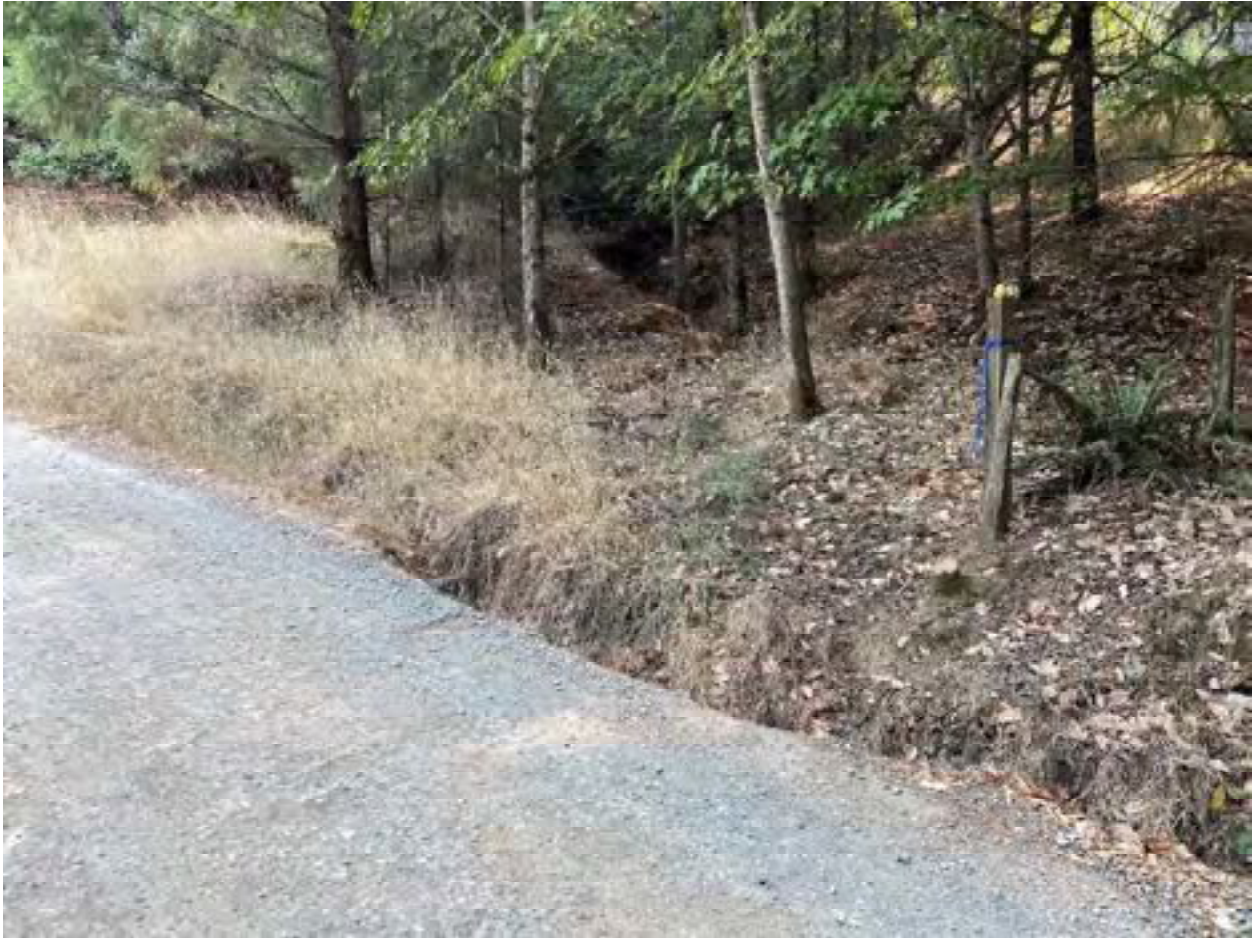
**Photo 40:** Stream Crossing 13. Looking upstream from the road where inlet of stream crossing 13 is proposed. Photo date 9-1-2021.

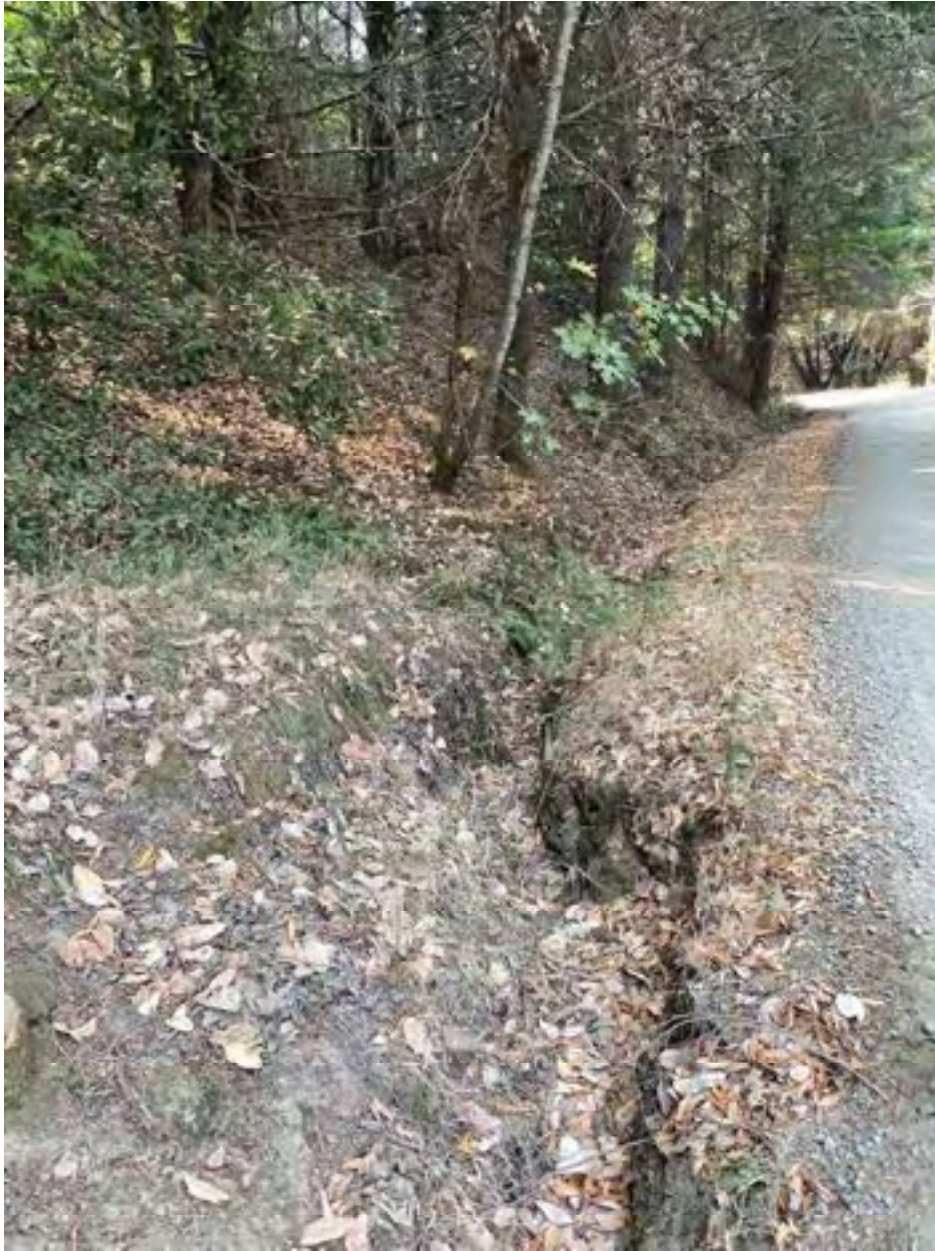
**Photo 43:** Stream Crossing 13. Looking downslope along the inside ditch that is currently diverting the flow away from the native stream channel at stream crossing 13. Photo date 9-1-2021.

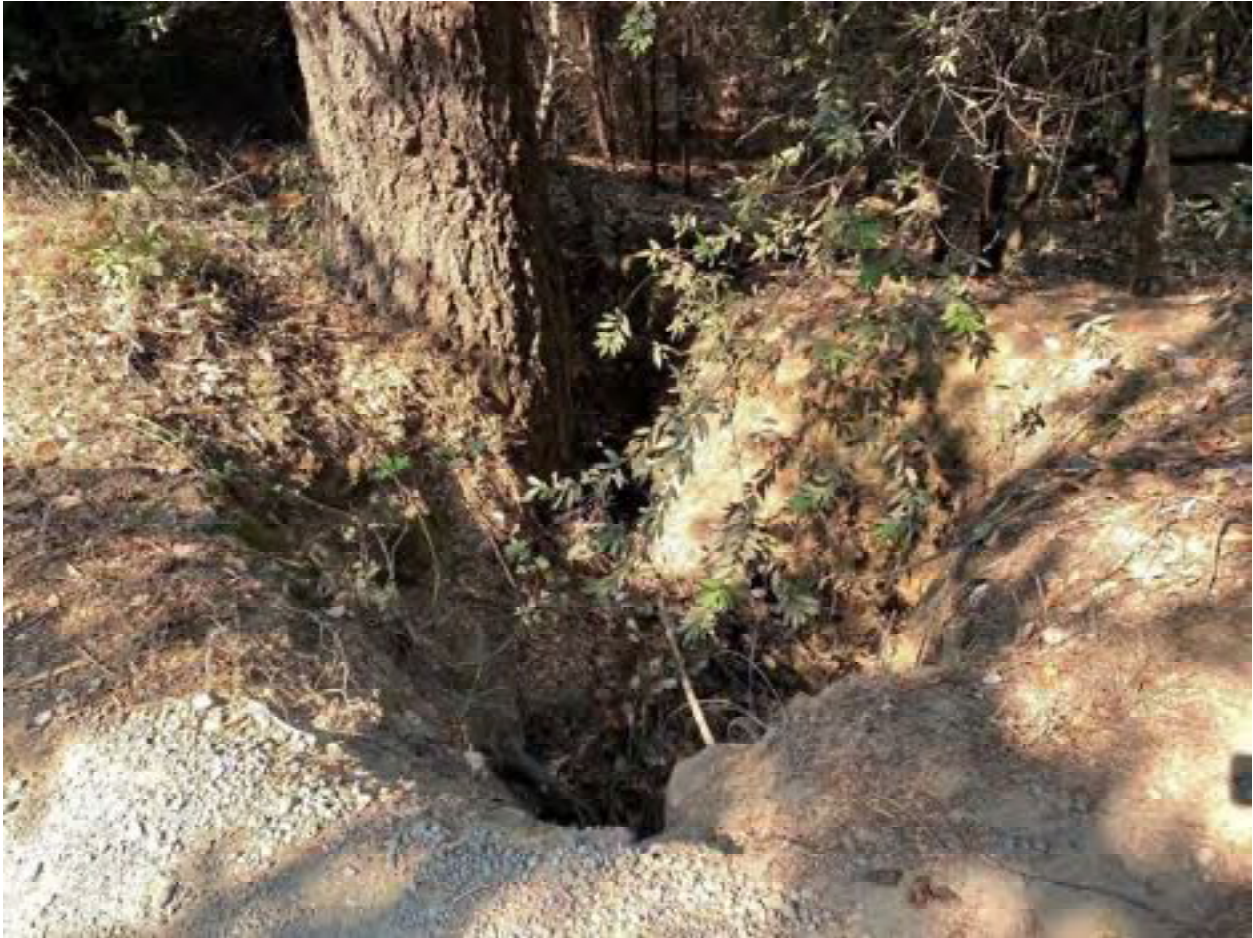
**Photo 46:** Stream Crossing 13. Looking downstream stream from the outlet of the 12-inch diameter DRC that is the current outlet of the water from stream crossing 13. Photo date 9-1-2021.

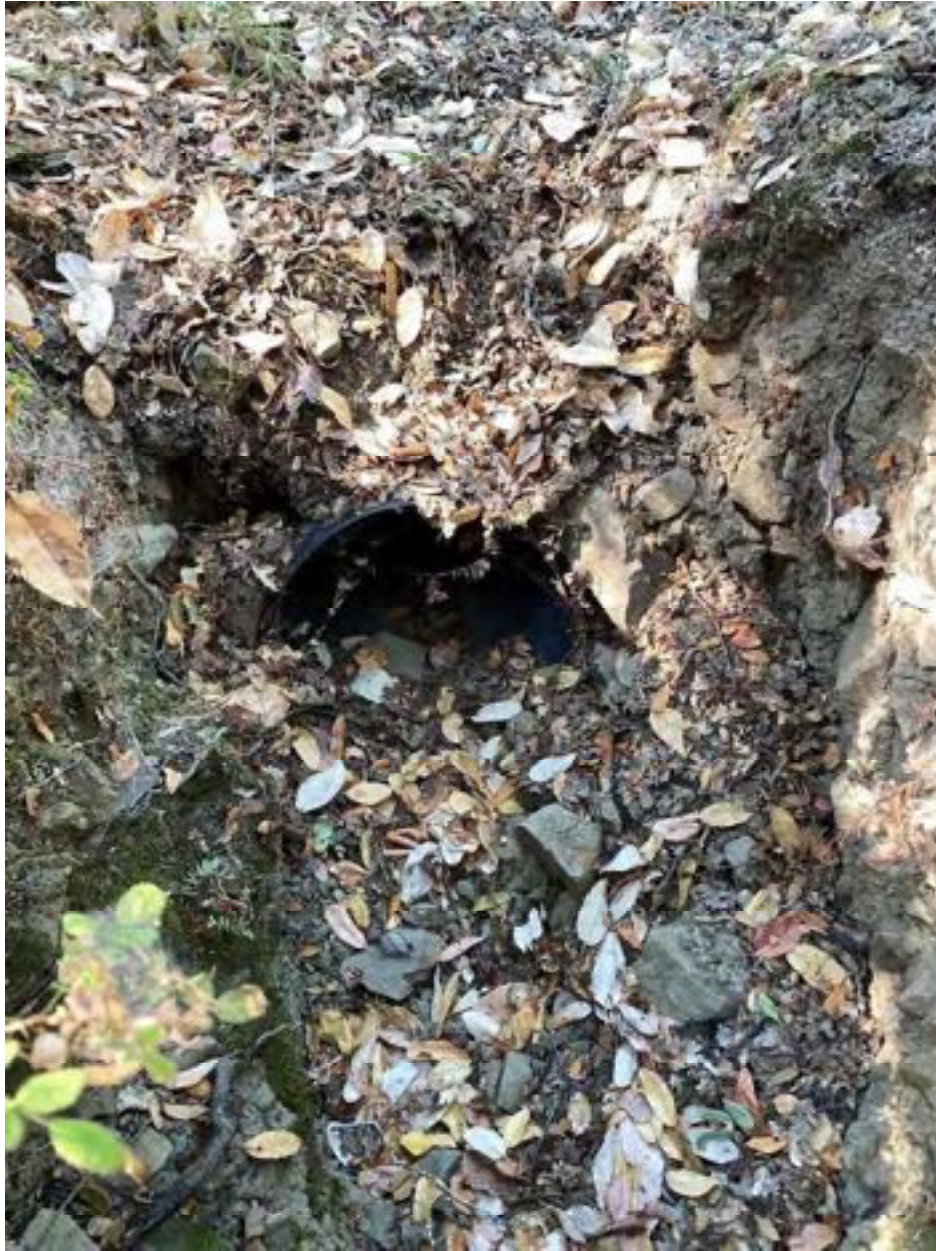
**Photo 47:** Stream Crossing 17. Looking downstream towards the inlet of the 18-inch diameter culvert at stream crossing 17 that is proposed for removal. Photo date 9-1-2021.

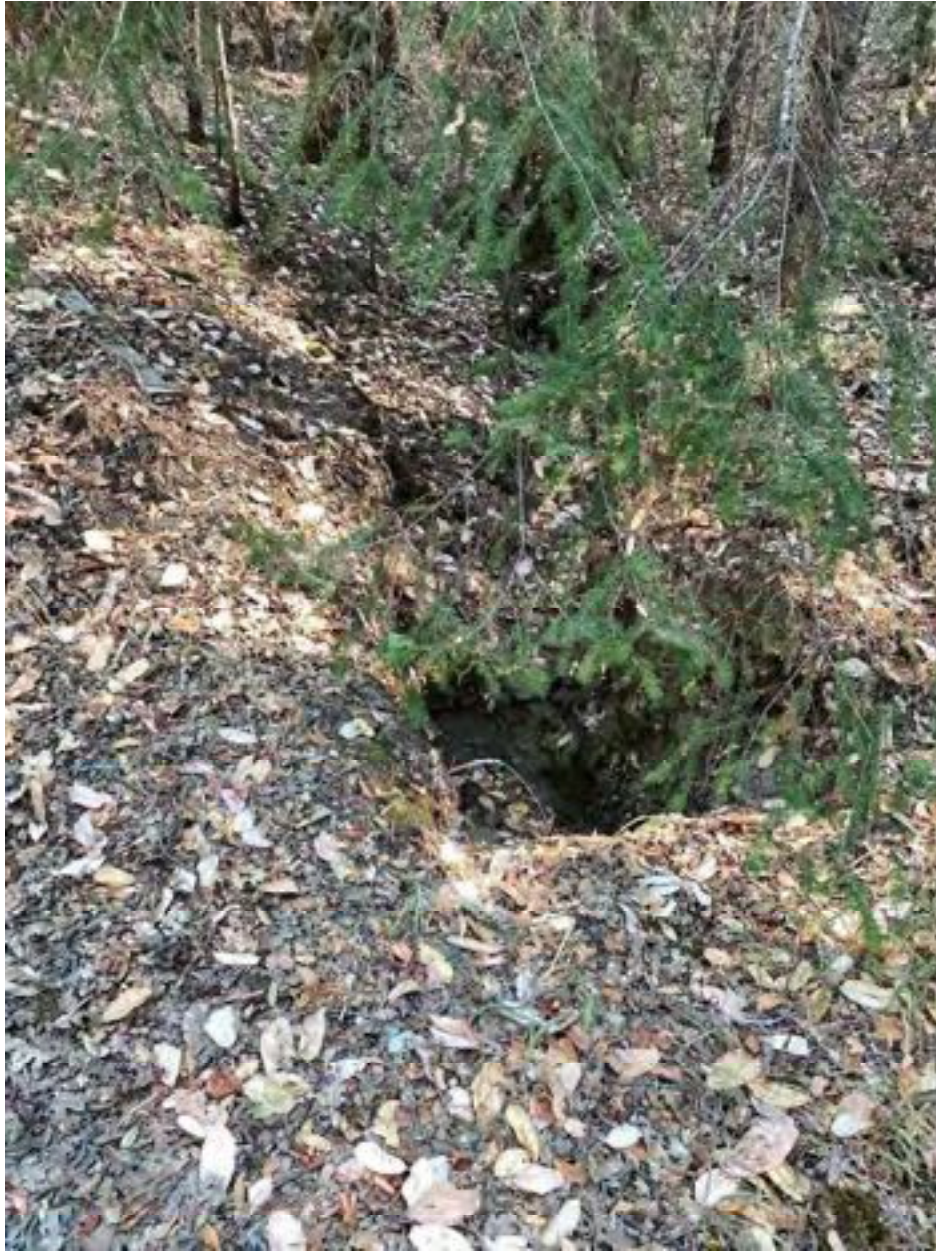
**Photo 51:** Stream Crossing 17. Looking downstream from the outlet of the 18-inch diameter culvert at stream crossing 17 that is proposed for removal. Photo date 9-1-2021.

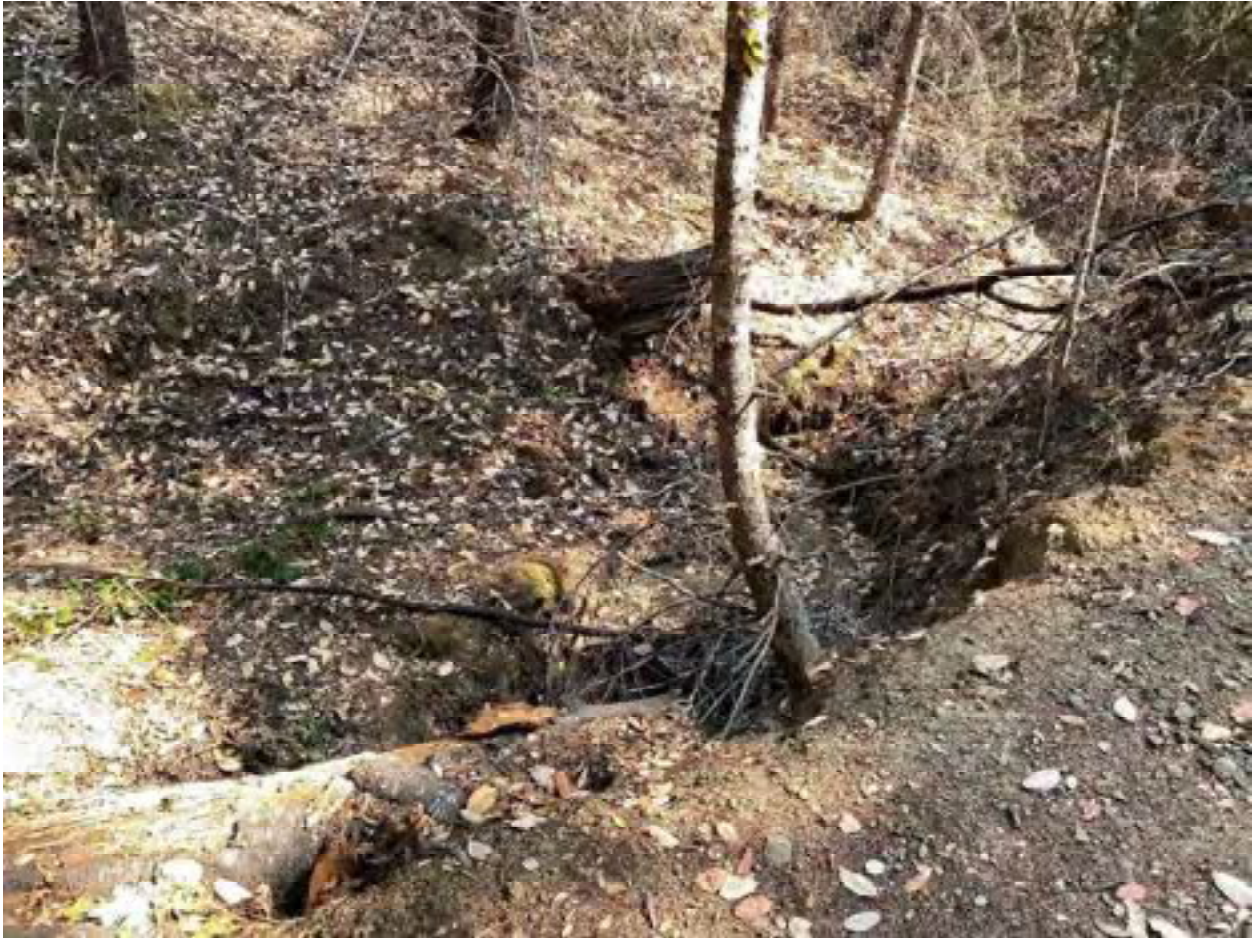
**Photo 53:** Stream Crossing 19. Looking upstream from the road along the native stream channel that is to be realigned at stream crossing 19. Photo date 9-1-2021.

Project Site Identification	Estimated Completion Date
SC-19	An existing, misaligned, and failing 18-inch culvert on an abandoned road shall be removed and the road decommissioned. The crossing shall be realigned to match with the native channel. This is a site of remediation. The proposed work shall be completed by no later than October 31, 2023.
SC-23	Replace an existing double barrel 18-inch diameter culvert(s) shall be removed and upgraded to a minimum 30-inch diameter culvert. The proposed work shall be completed by no later than October 31, 2024.
SC-24	Replace an existing 18-inch diameter culvert with a minimum 36-inch diameter culvert set to grade. Rock armor the inlet and outlet as necessary to minimize potential erosion. The proposed work shall be completed by no later than October 31, 2024.
SC-26	Replace an existing 18-inch diameter with a minimum 30-inch diameter culvert set to grade. Rock armor the inlet and outlet as necessary to minimize potential erosion. The proposed work shall be completed by no later than October 31, 2025.

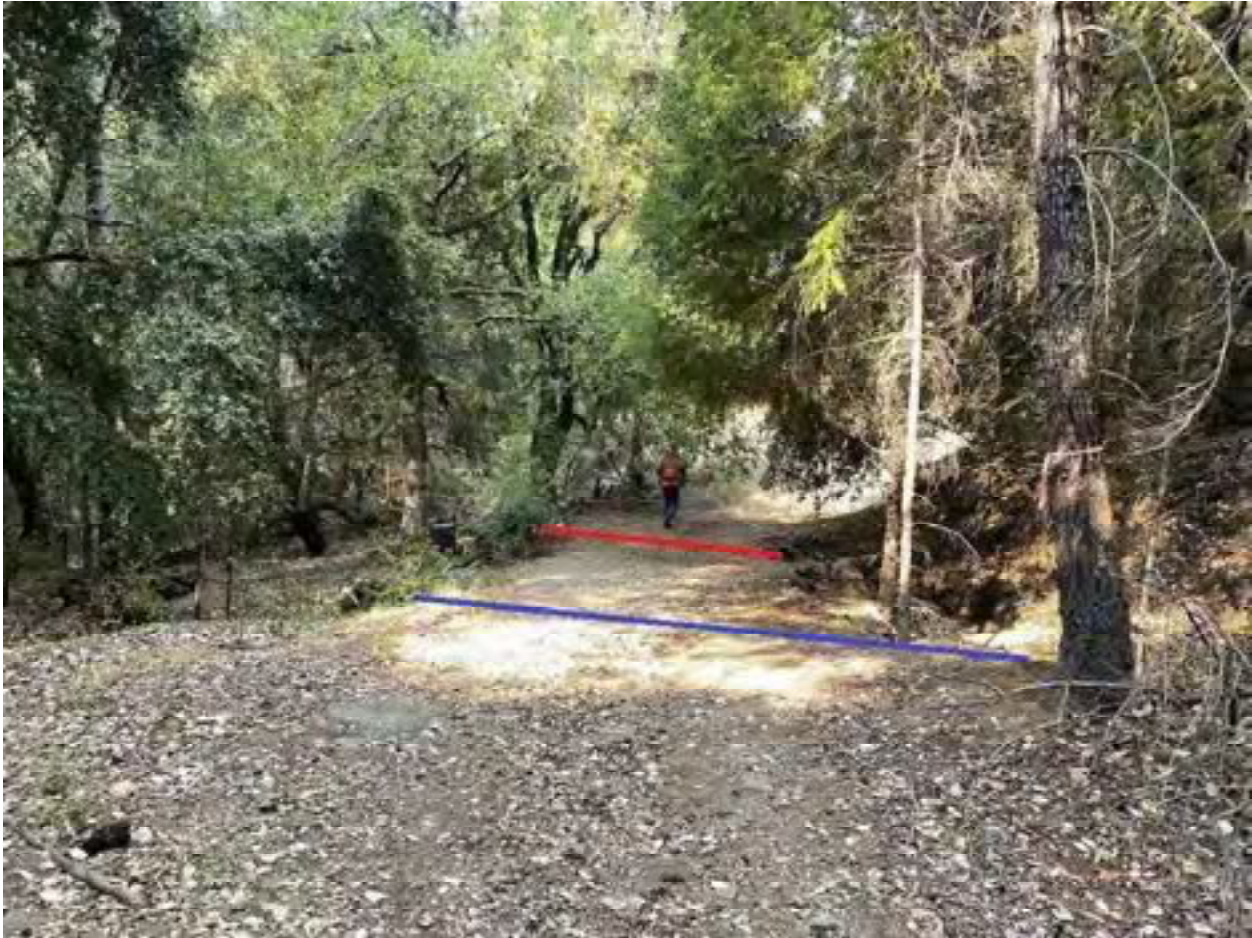
**Photo 54:** Stream Crossing 19. The roadside approach to stream crossing 19 facing West. The red line depicts where the current misaligned 18-inch culvert is located. The blue line depicts where the native channel used to flow and also where the channel will be realigned to after the stream crossing is decommissioned. Photo date 9-1-2021.

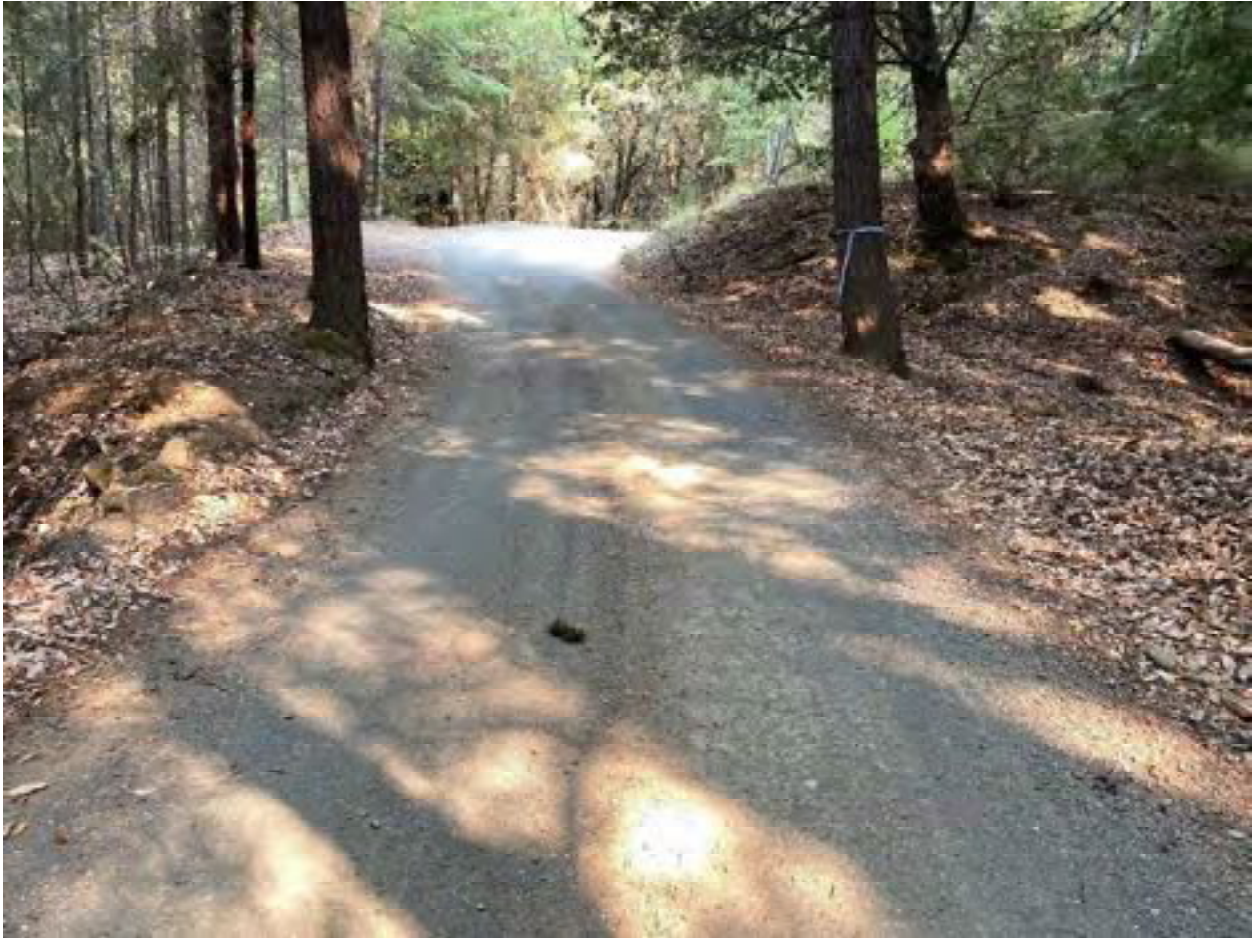
**Photo 60:** Stream Crossing 23. The roadside approach to stream crossing 23 facing North. Photo date 9-1-2021.

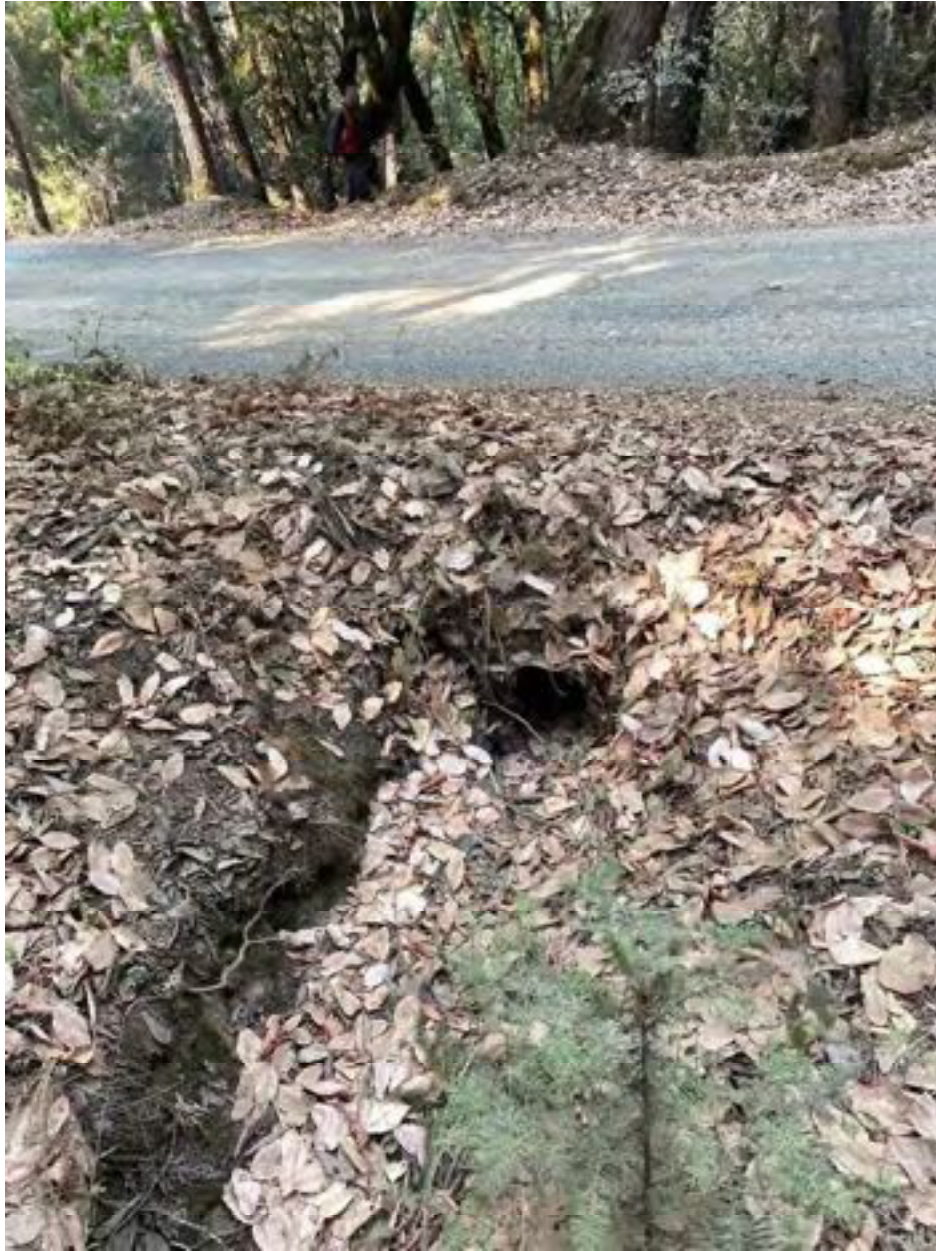
**Photo 63:** Stream Crossing 24. Looking downstream towards the inlet of the 18-inch diameter culvert at stream crossing 24. Photo date 9-1-2021.
