ATTACHMENT 1b  
Sprowl Creek Full Resubmittal

# ETA Humboldt, LLC

25 July 2023

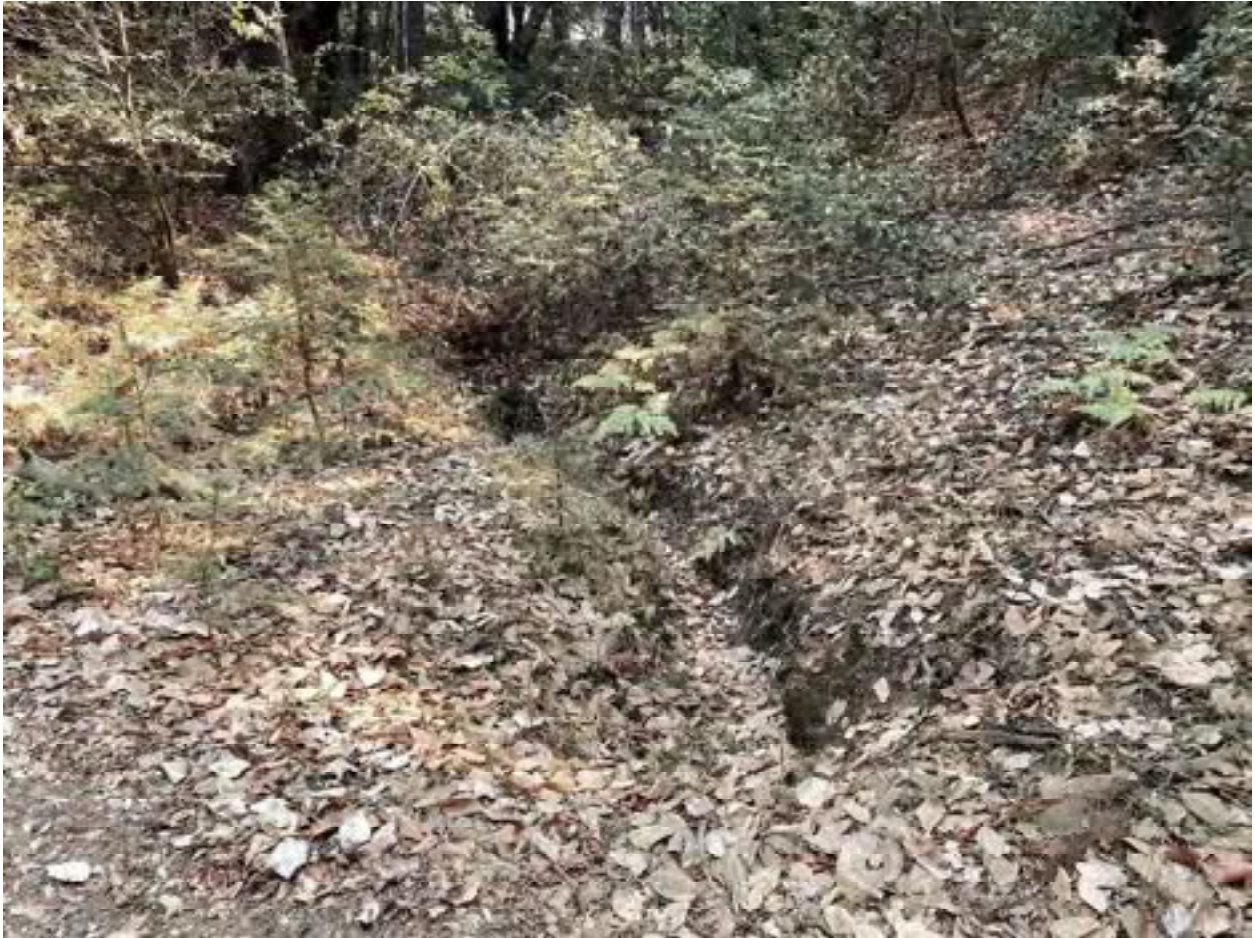
**Photo 64:** Stream Crossing 24. Looking upstream from the inlet of the 18-inch diameter culvert at stream crossing 24. Photo date 9-1-2021.

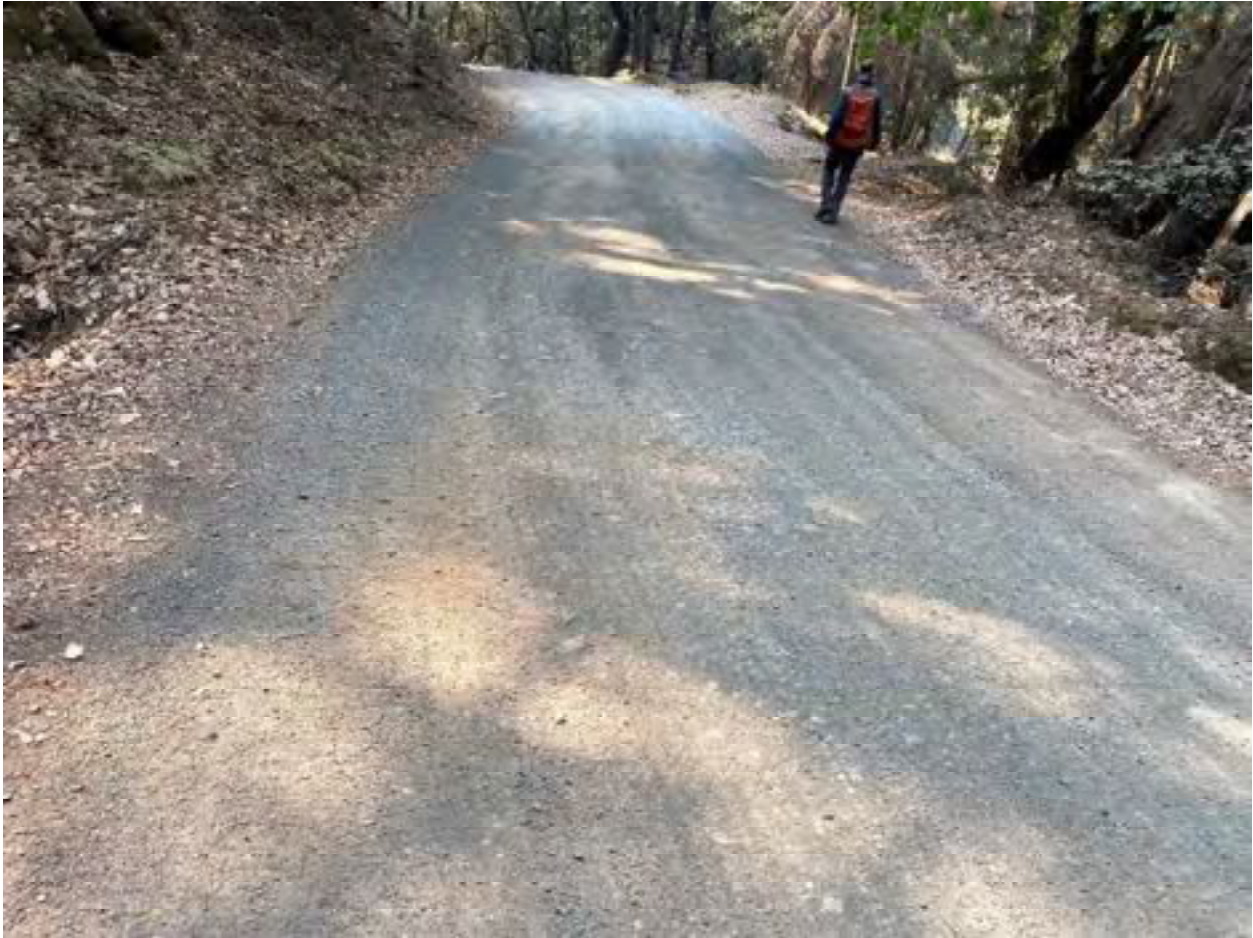
**Photo 65:** Stream Crossing 24. The roadside approach to stream crossing 24 facing South. Photo date 9-1-2021.

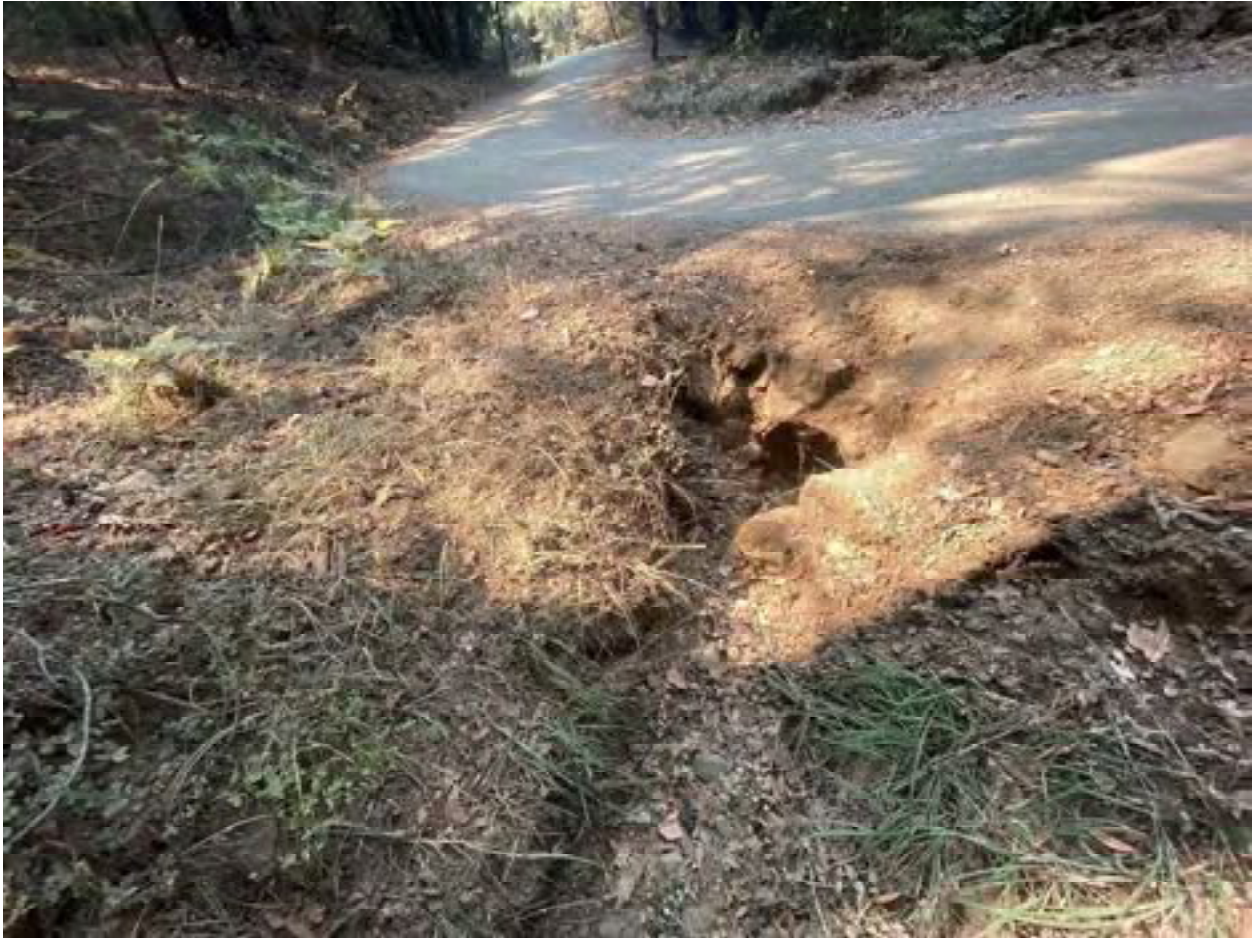
**Photo 68:** Stream Crossing 26. Looking downstream towards the inlet of the 18-inch diameter culvert at stream crossing 26. Photo date 9-1-2021.

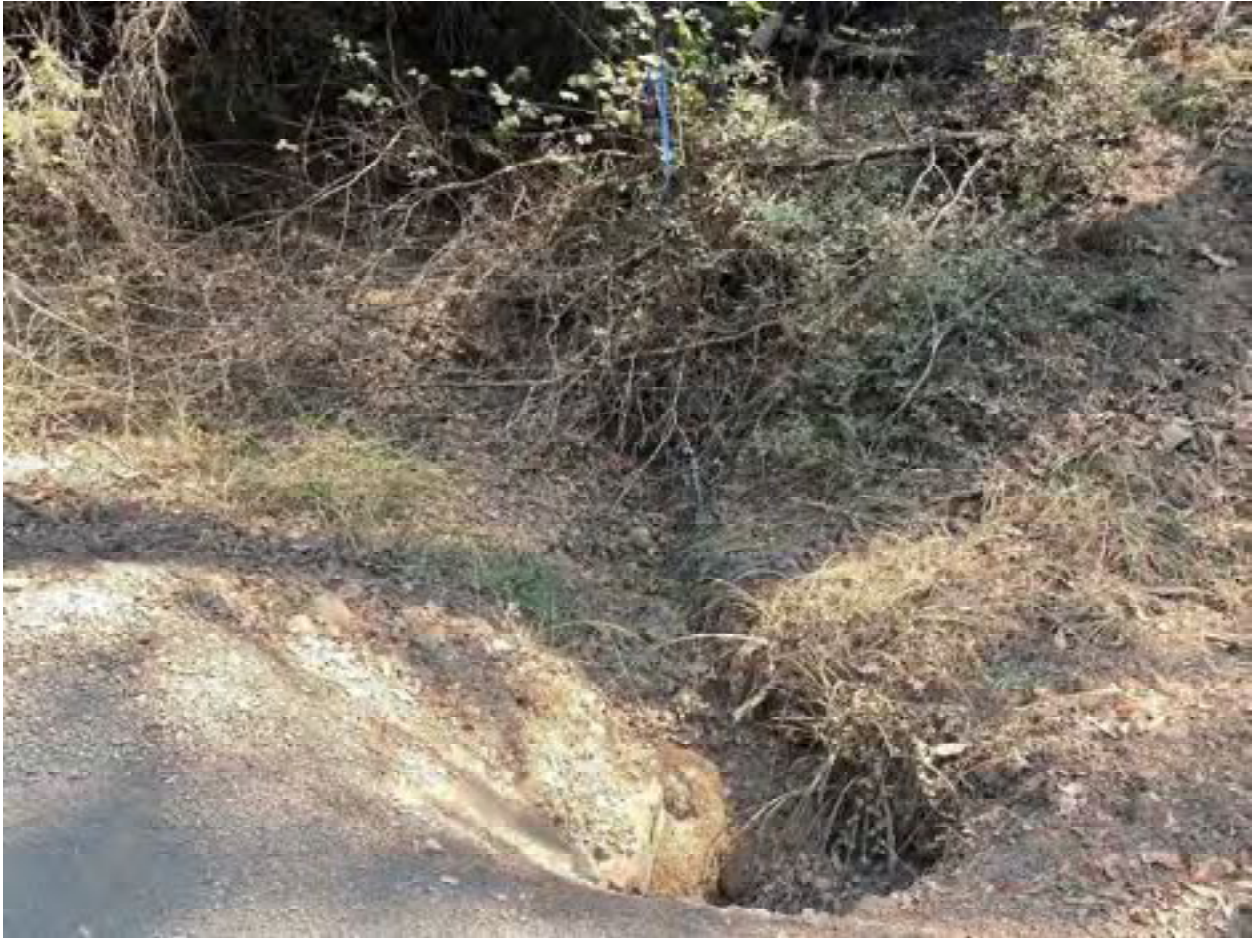
**Photo 69:** Stream Crossing 26. Looking upstream from the inlet of the 18-inch diameter culvert at stream crossing 26. Photo date 9-1-2021.

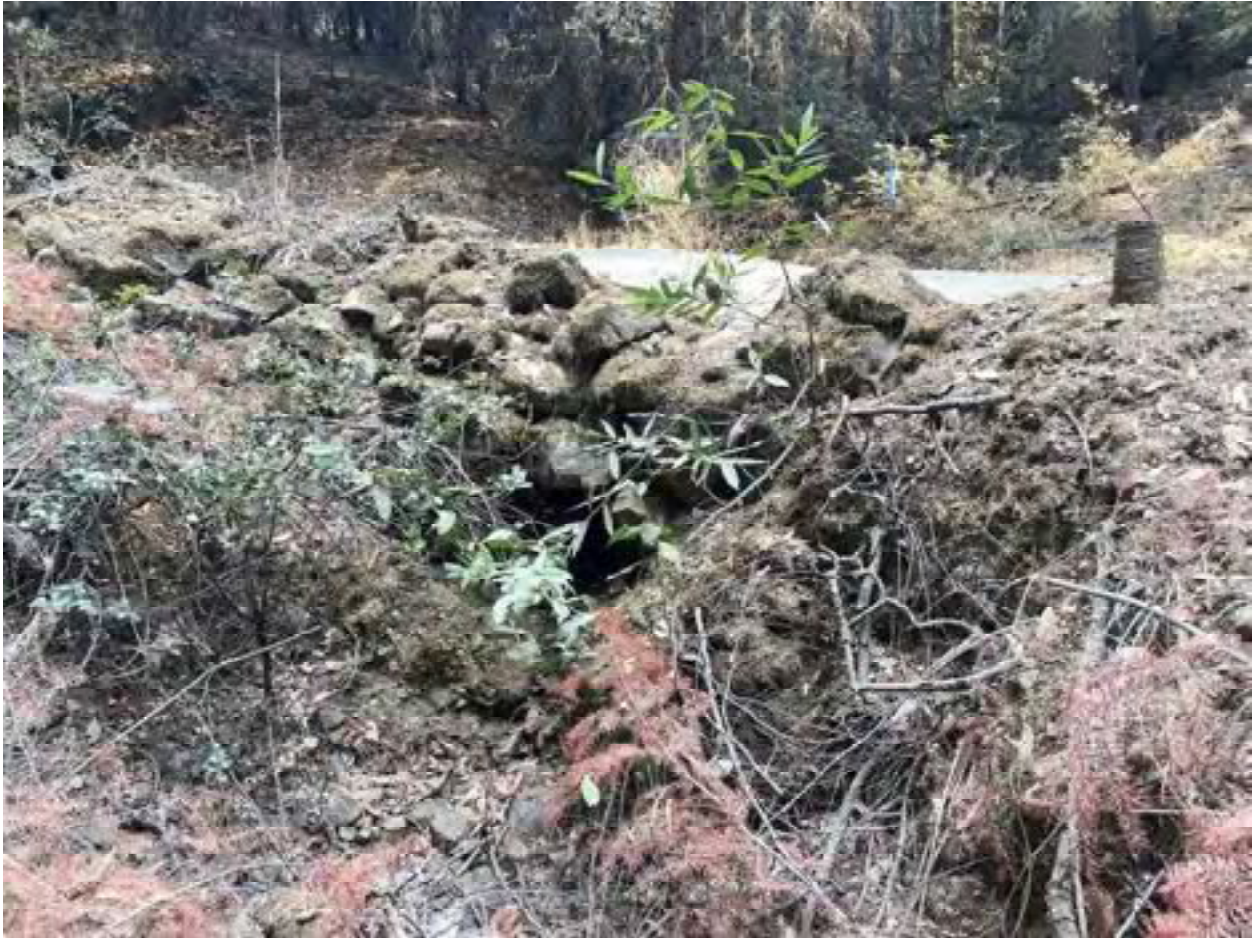
**Photo 71:** Stream Crossing 26. Looking upstream towards the outlet of the 18-inch diameter culvert at stream crossing 26. Photo date 9-1-2021.

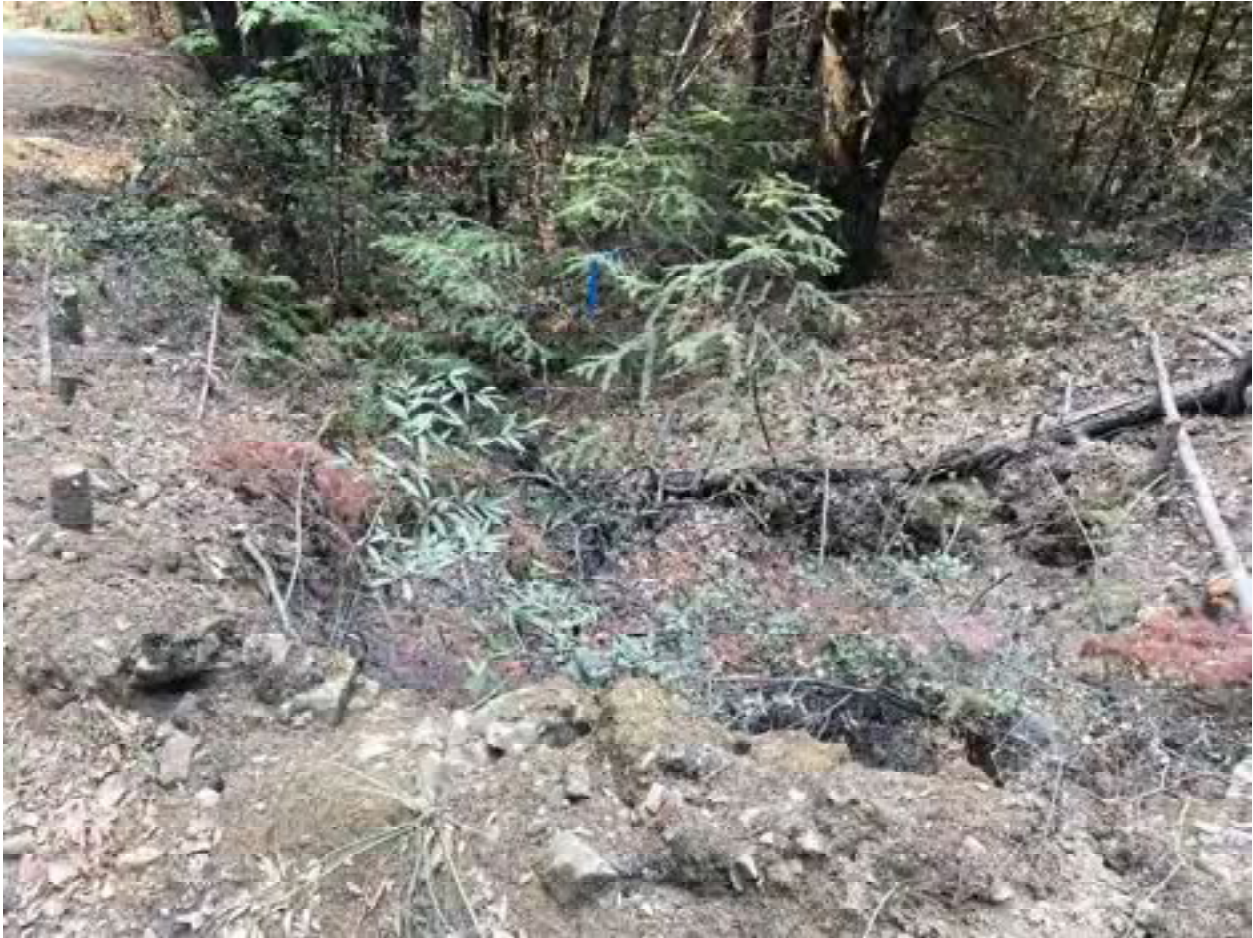
**Photo 72:** Stream Crossing 26. Looking downstream from the outlet of the 18-inch diameter culvert at stream crossing 26. Photo date 9-1-2021.

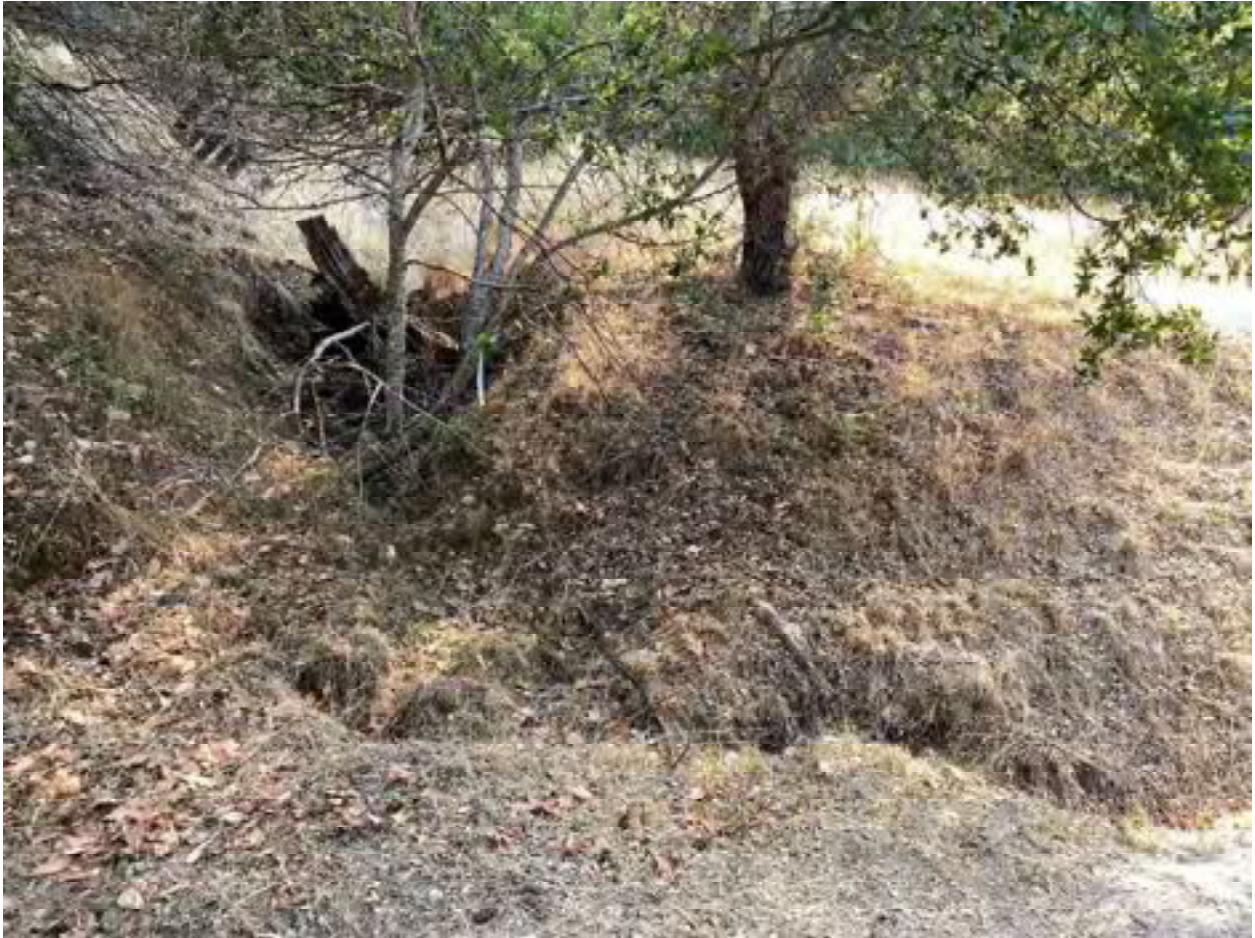
**Photo 74:** Stream Crossing 35. Looking upstream from the inlet of the 8-inch diameter culvert at stream crossing 35. Photo date 9-1-2021.

SC-35	Replace an existing undersized 8-inch diameter culvert with a minimum 18-inch diameter culvert set to grade. Rock armor as necessary to minimize potential erosion. The proposed work shall be completed by no later than October 31, 2024.
DRC-38	Legacy metal debris and refuse shall be removed from the watercourse channel below. The proposed work shall be completed by no later than October 31, 2025.
Off-stream Pond-1	An off-stream pond shall have the overflow spillway adequately rock armored extending past the toe of the embankment and into the stream channel below. The proposed work shall be completed by no later than October 31, 2024.

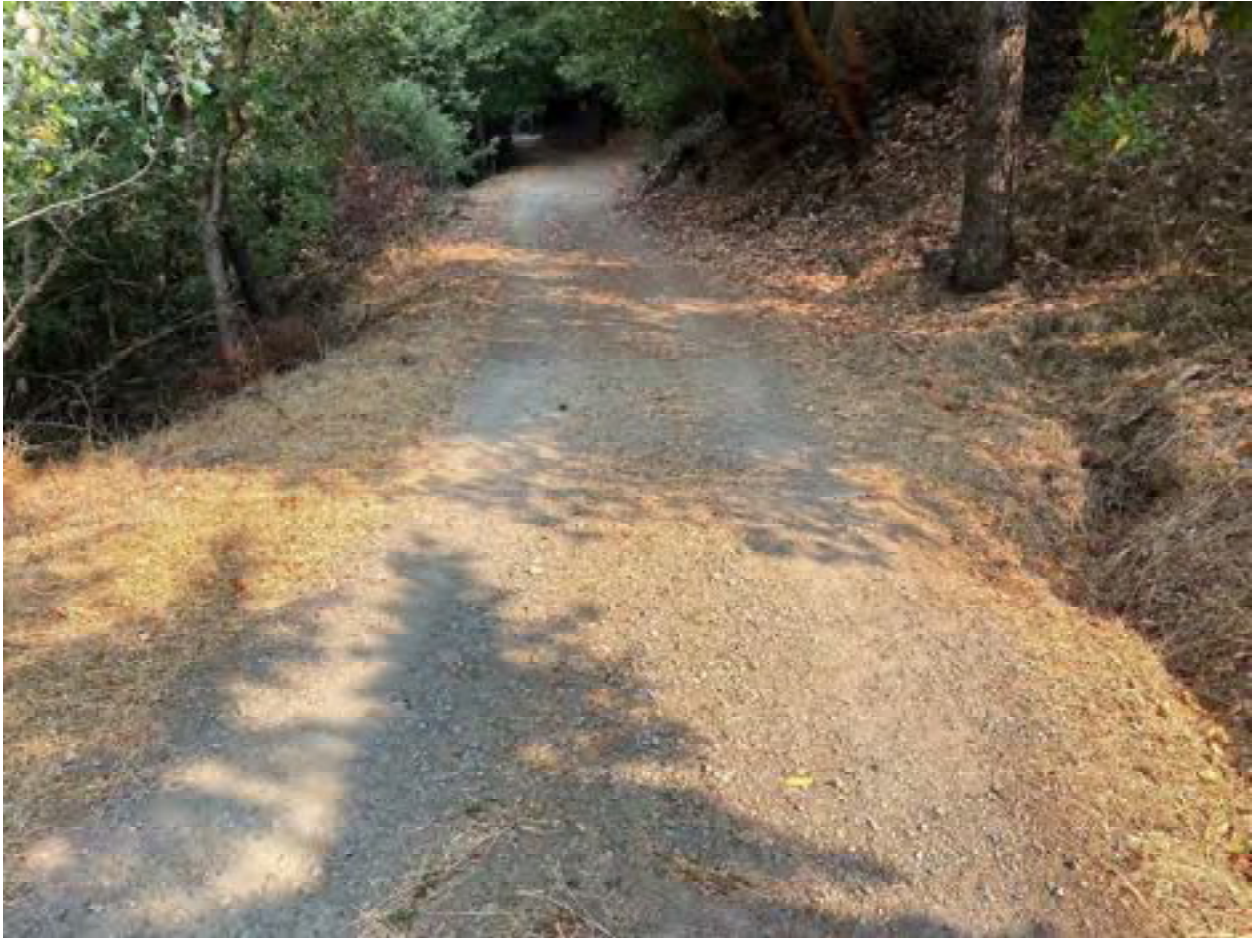
**Photo 75:** Stream Crossing 35. The roadside approach to stream crossing 35 facing North. Photo date 9-1-2021.

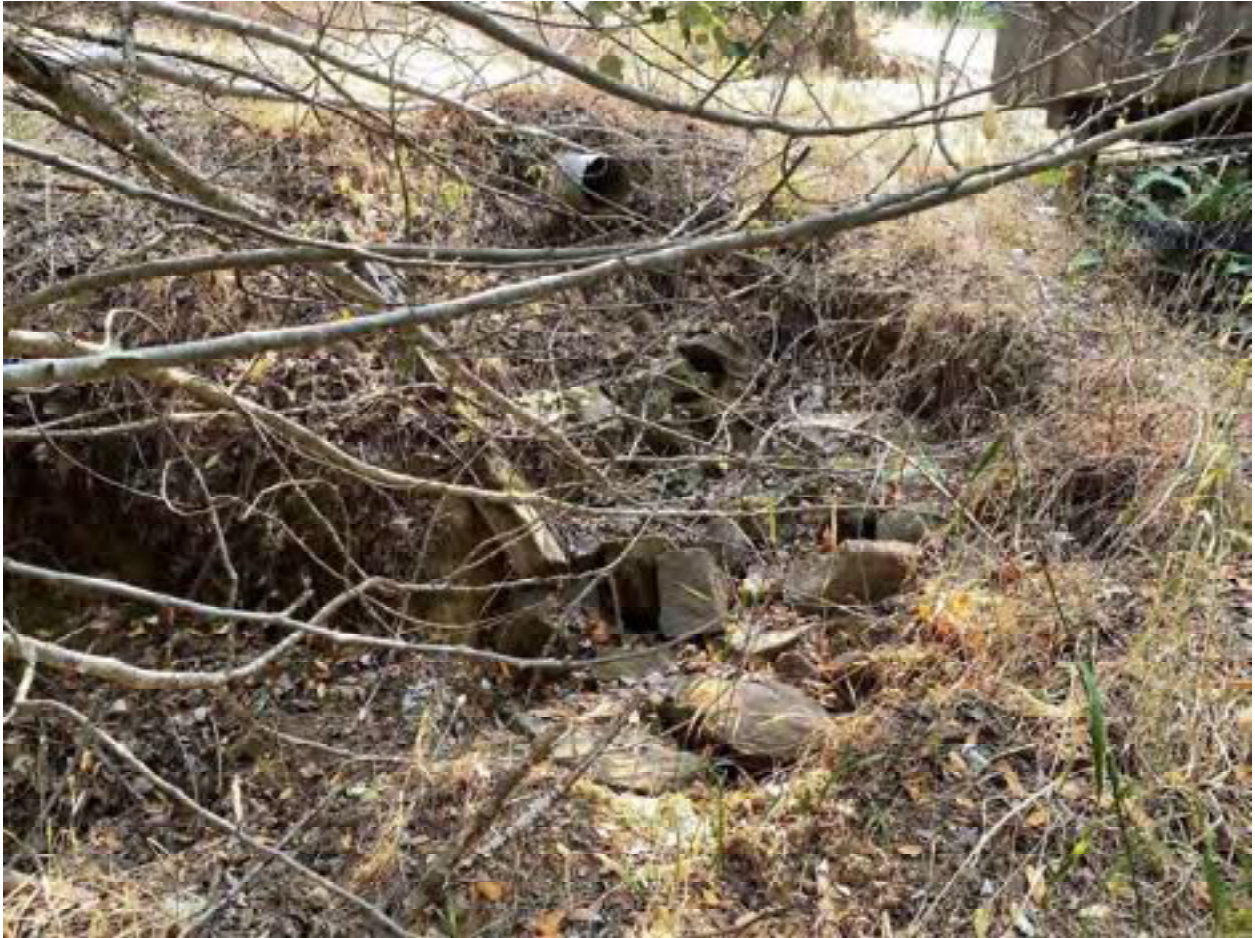
**Photo 76:** Stream Crossing 35. Looking upstream towards the outlet of the 8-inch diameter culvert at stream crossing 35. Photo date 9-1-2021.

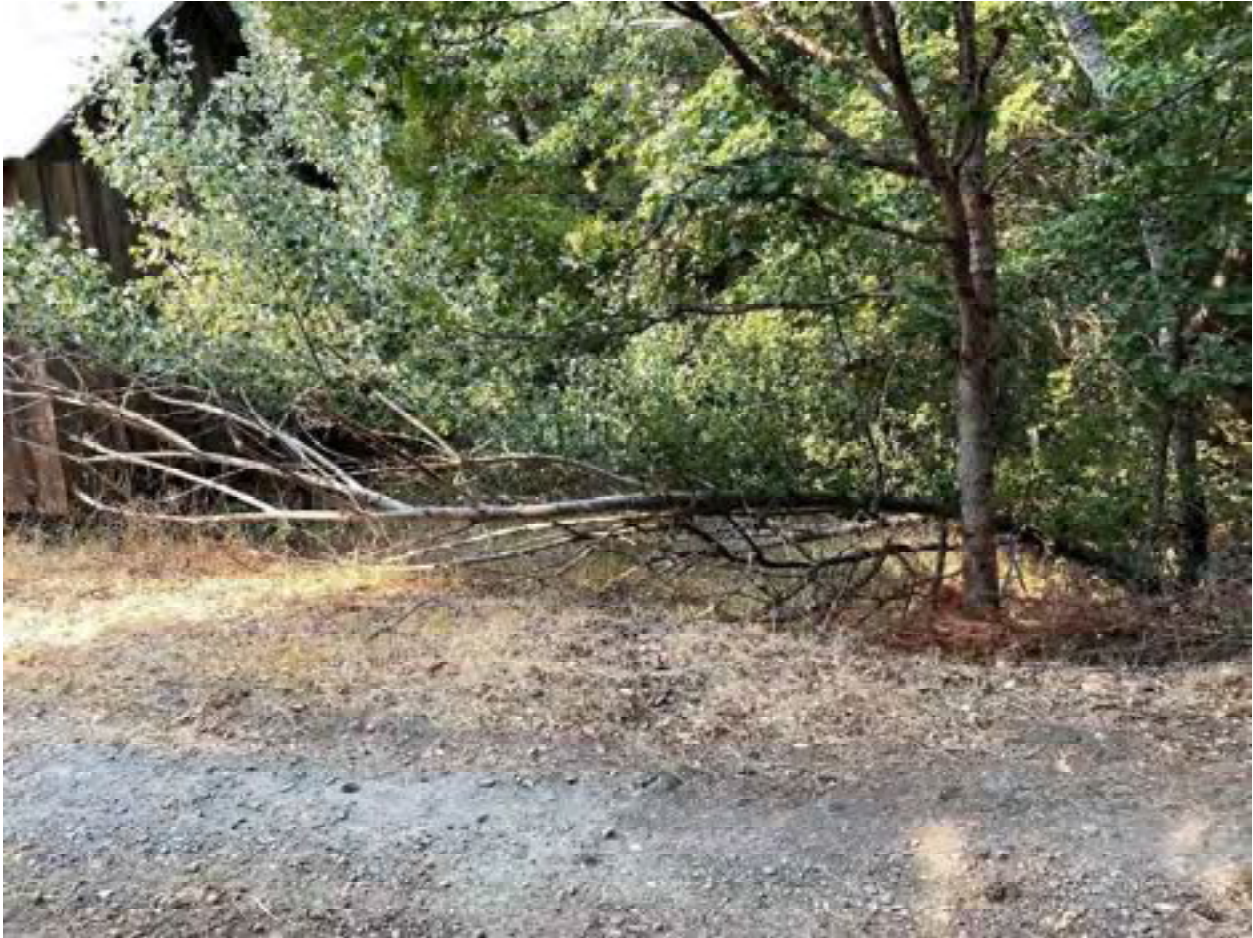
**Photo 77:** Stream Crossing 35. Looking downstream from the outlet of the 8-inch diameter culvert at stream crossing 35. Photo date 9-1-2021.

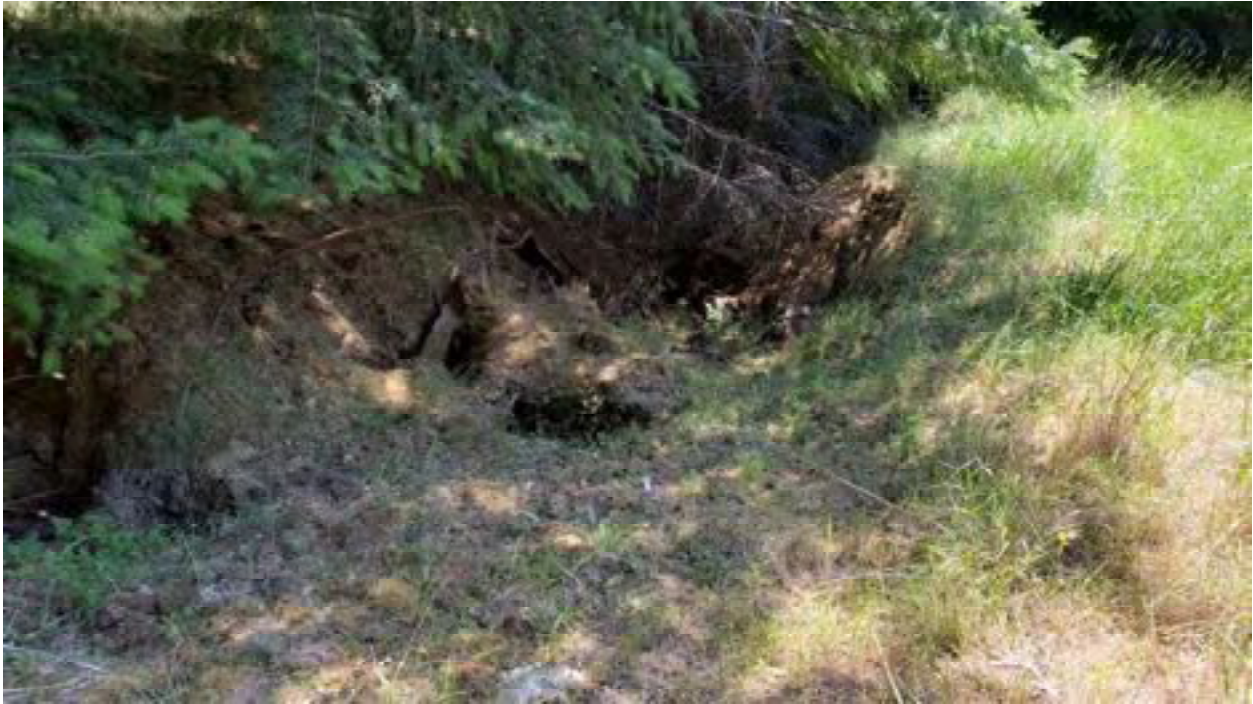
**Photo 78: DRC 38:** Looking at legacy Refuse downstream from the DRC. Photo date 6-10-2021

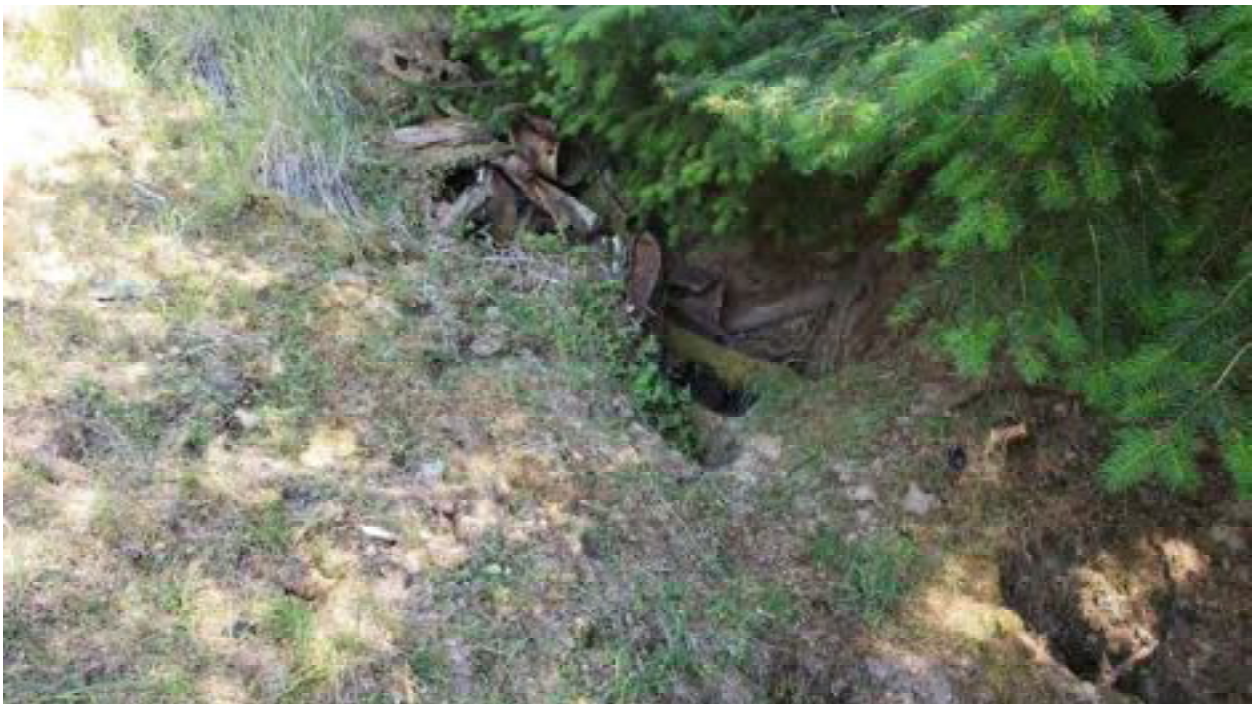
**Photo 79: DRC 38:** Looking at legacy Refuse downstream from the DRC. Photo date 6-10-2021

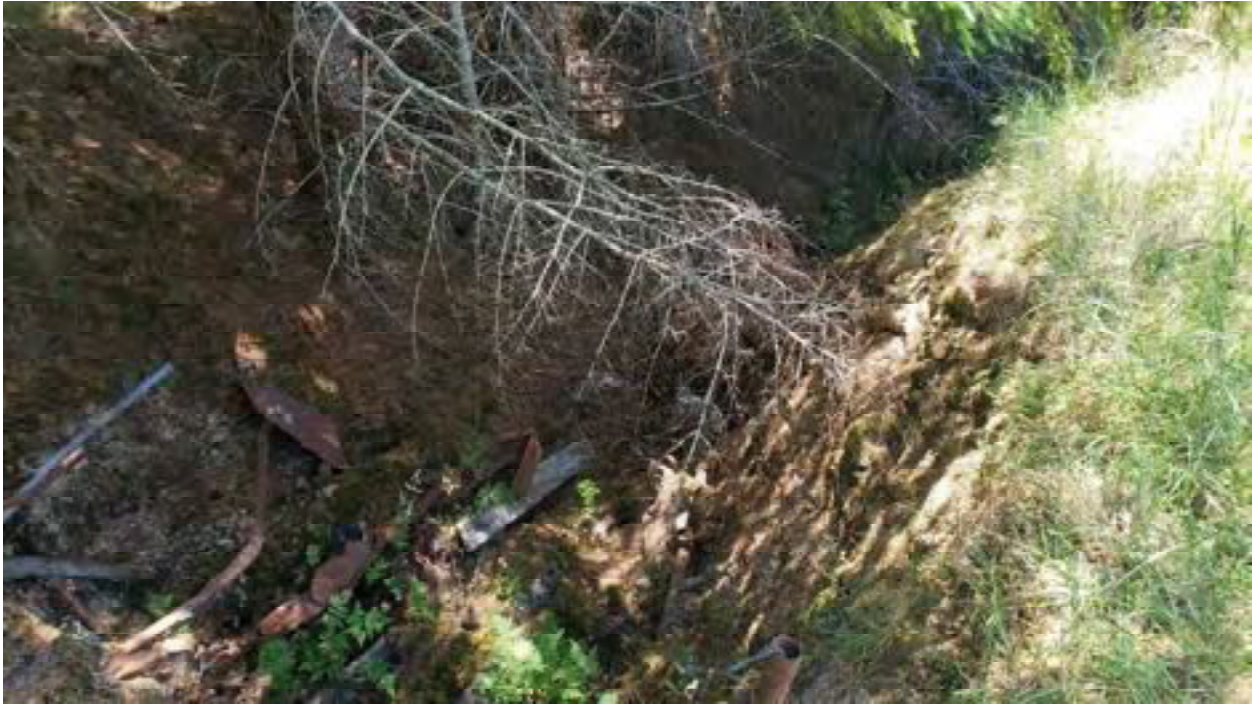
**Photo 80: DRC 38:** Looking at legacy Refuse downstream from the DRC. Photo date 6-10-2021

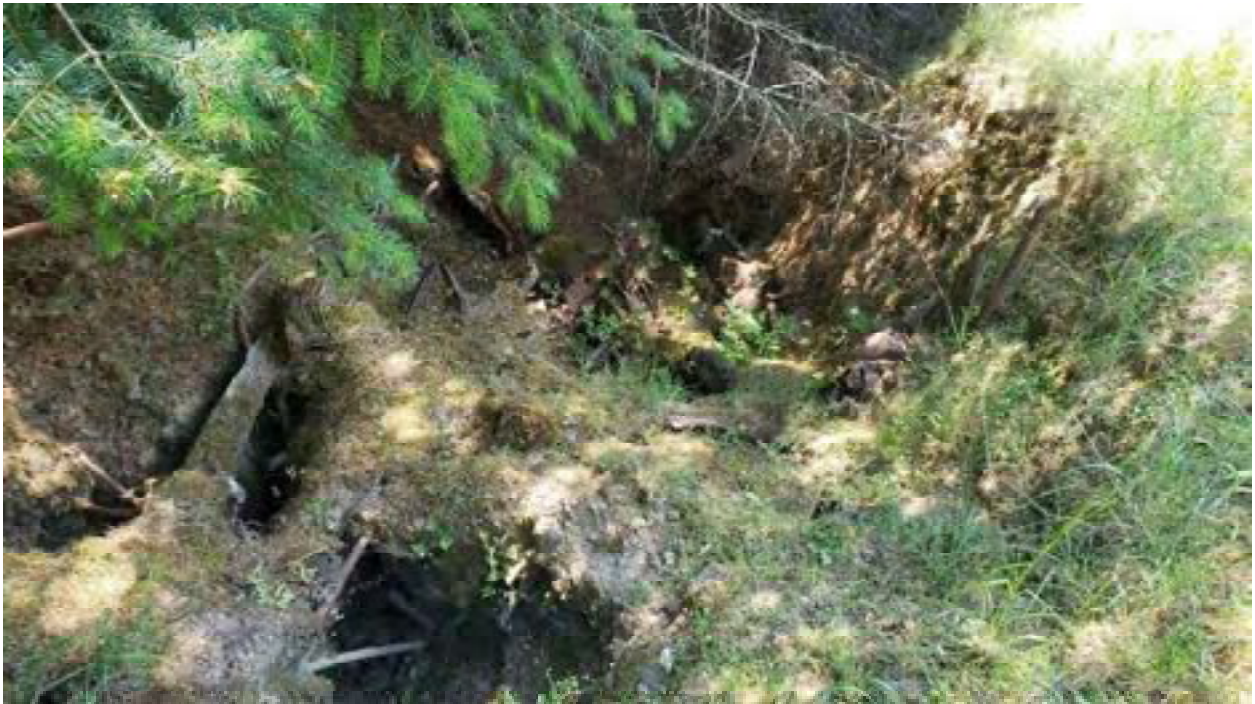
**Photo 81: DRC 38:** Looking at legacy Refuse downstream from the DRC. Photo date 6-10-2021
