DEPARTMENT OF FISH AND WILDLIFE
Northern Region, Eureka Field Office
619 2nd Street
Eureka, CA 95501

Field Note: Stream Setback Measurements and Coho Salmon Detections in Noisy Creek, Tributary to the Mad River, Humboldt County, California.

Survey Date: January 30, 2025

Survey Location: Kernen Construction (2350 Glendale Dr, McKinleyville, CA 95519) northern operations yard (APN 516-151-016). Lat/Long: 40.898260, -124.009751.

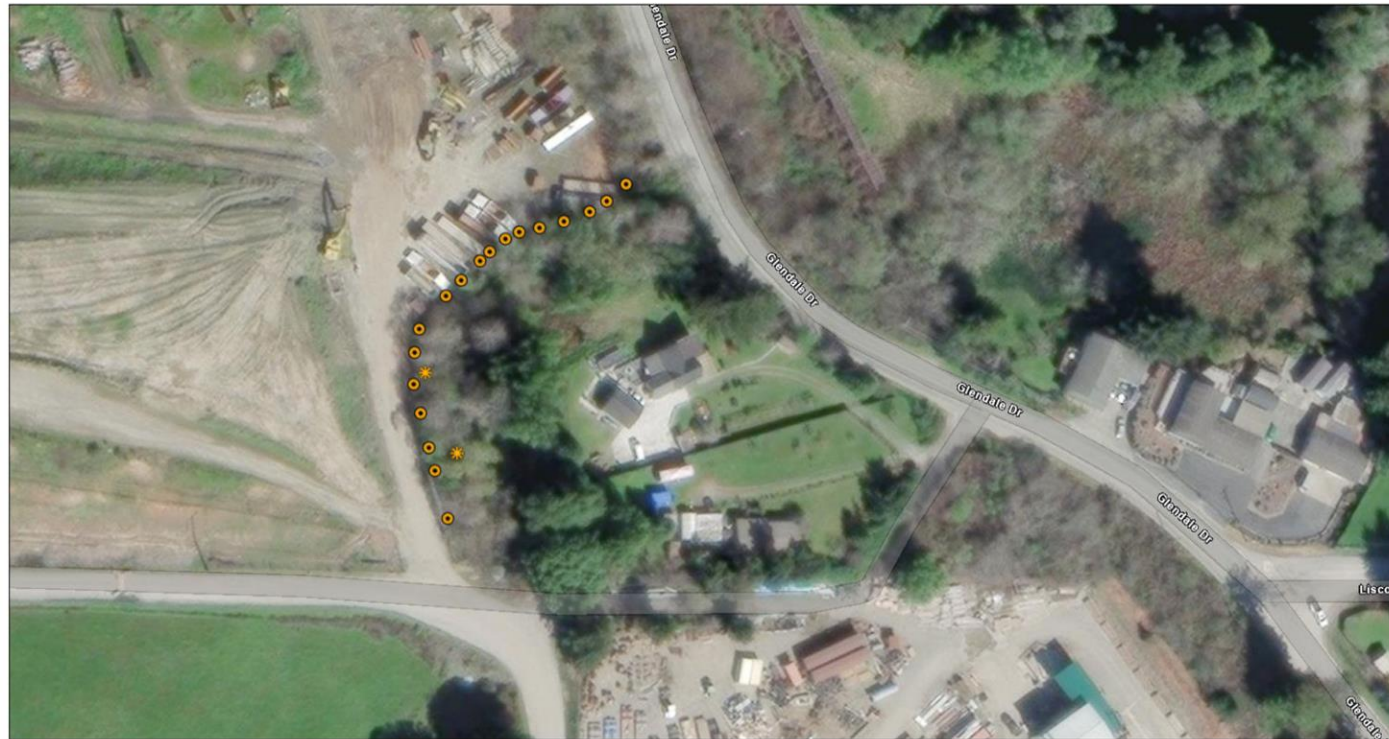
Figure 1. Map depicting the location of the California Department of Fish & Wildlife site visit conducted on January 30, 2025. Yellow dots denote survey points collected along the streamside edge of the recently constructed berm with an EOS Arrow 100® Submeter GNSS Receiver; distance measurement of the riparian buffer were made at each of these locations (Table 1). Yellow asterisks represent the approximate locations where coho salmon carcasses were observed by CDFW Scientists.
