Attachments (exhibits) to Letter/report 18024-40022, 10/08/2018

PROJECT NAME: Humboldt Bay Trail South - Limited Visual Tree Risk Assessment

PROJECT NUMBER: 715036

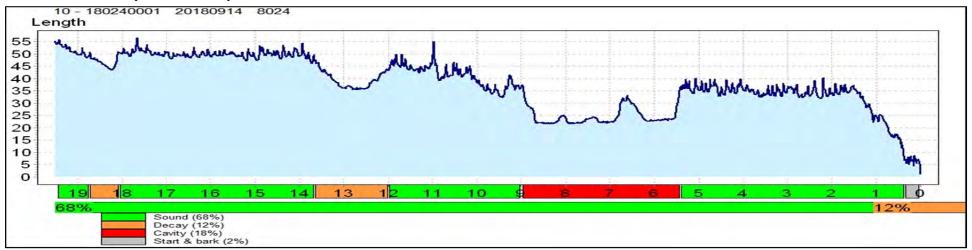
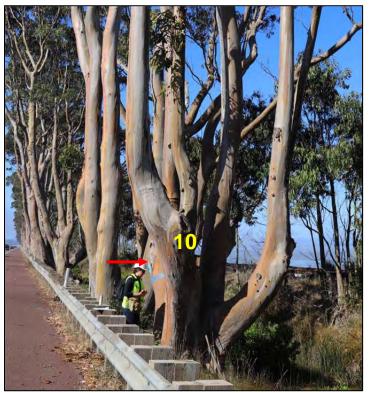
+ Tree no. 10 (continued):

10	Bluegum	Eucalyptus globulus	27	24	20	20	11	Moderate	High	5 codominant stems w/weak attachments Large dead branches to west Excess soil over root flare Large wounds from stem removals to east Decaying stub on trunk to east <5% canopy	1	E-W (60" hgt.) decay @ 5.5"-9.5"; 11"-14"; 17.5"=19"
